Is a thunderbolt about to finish the funicular pantomime?

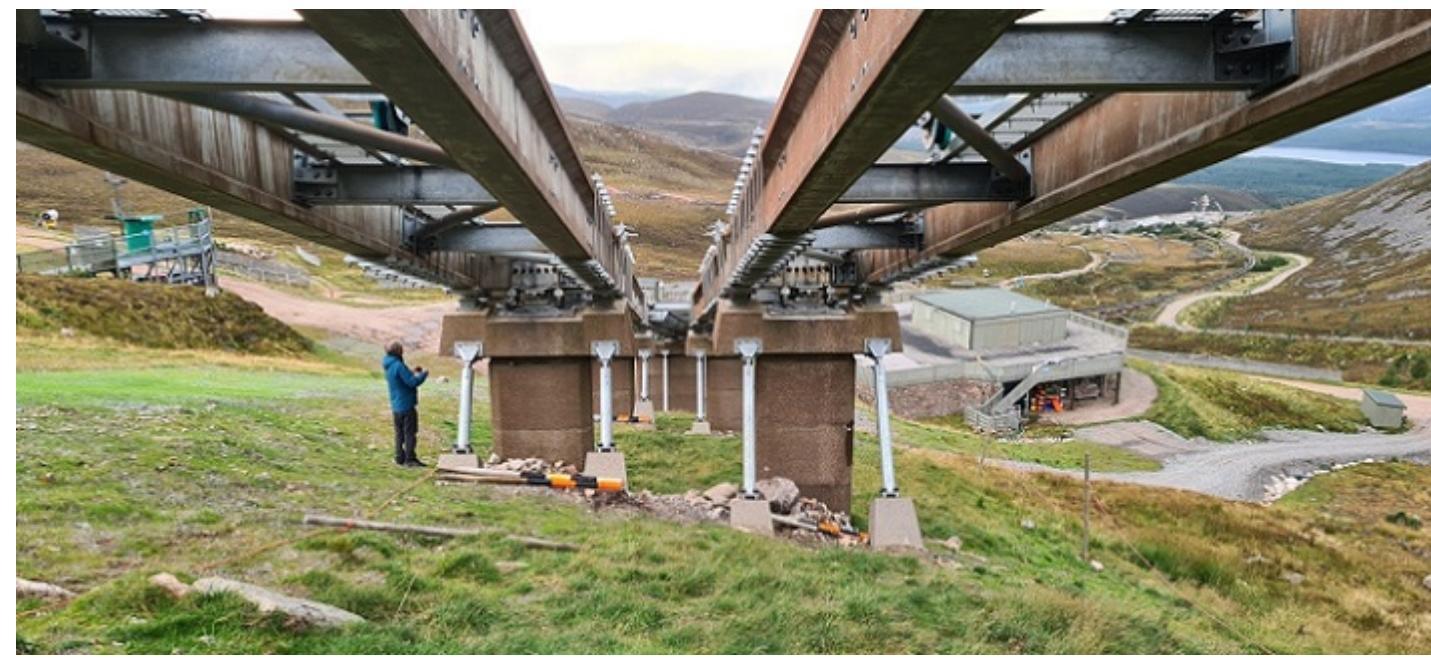
The repairs have involved the additions of multiple separate steel supports and brackets to the

existing steel cross members between the concrete beams. Photo credit Gordon Bulloch.

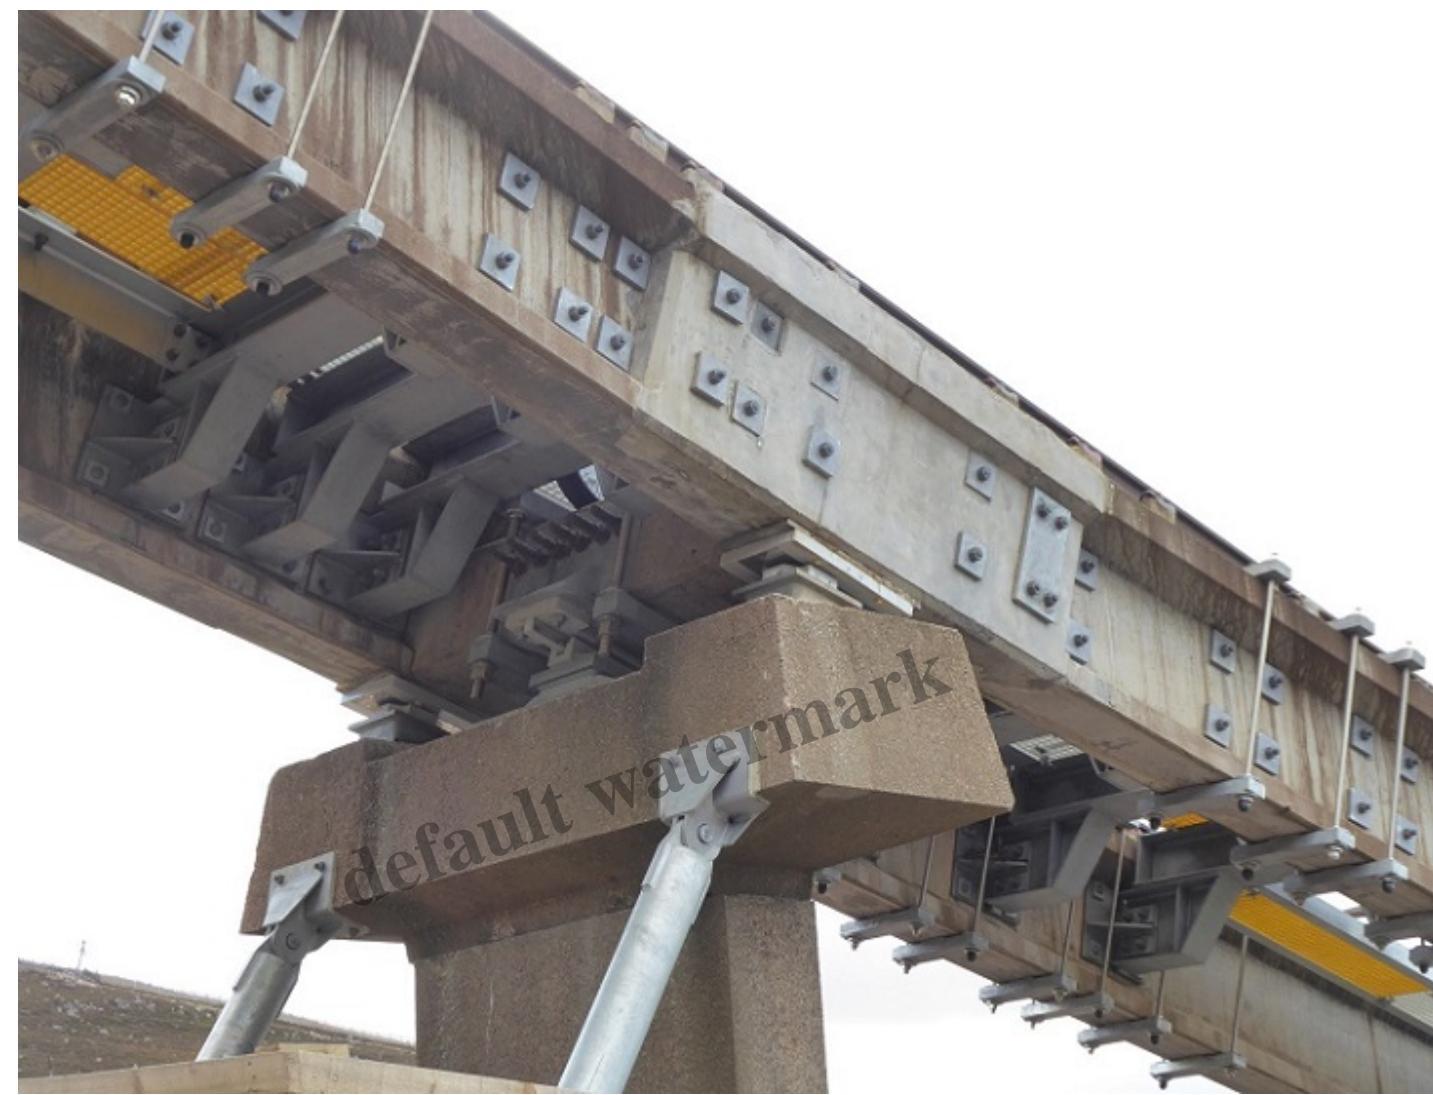
Multiple unearthed steel components. Photo credit Gordon Bulloch.

To determine how much earth bonding is required to make the structure lightning proof, a qualified electrical technician will first have to check for electrical resistance between <u>every</u> support bearing, bolt, cross member, plate, strengthening bracket, length of studding, steel prop etc. The plus side is that if the props were used as part of the lightning conductor arrangement, it may be that only the top and bottom of one prop would need to be connected to all the other bits of steel near it with a lightning rod at the bottom.

<u>Option 1:</u> link up and then earth all the various bits of steel being used to prop up the structure which is likely to be time-consuming and expensive, or
