## Safety and the closure of the funicular at Cairn Gorm in August 2023 (2)

This post comments further on the heavily redacted replies to Mr Gordon Bulloch's FOI request of 05/12/2024 about the 2023 closure of the funicular. **Email 1**, sent on 23<sup>rd</sup> August at 23.17, was considered in the first post in this series.

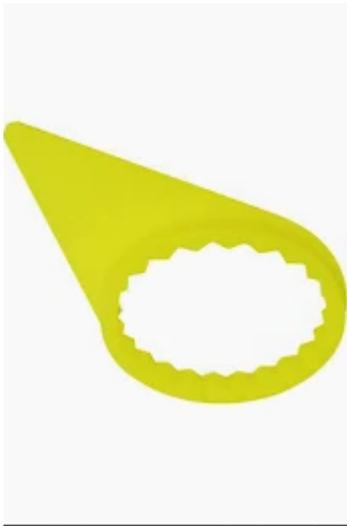
While *consider use of a paint marking system or something similar*•

might appear mickey mouse when you can buy nut position indicators (left) the key point is a system should have been in place for identifying whether nuts were at the right tension before the funicular was re-opened in January 2023.
