Safety and the closure of the funicular at Cairn Gorm in August 2023 (2)

Description

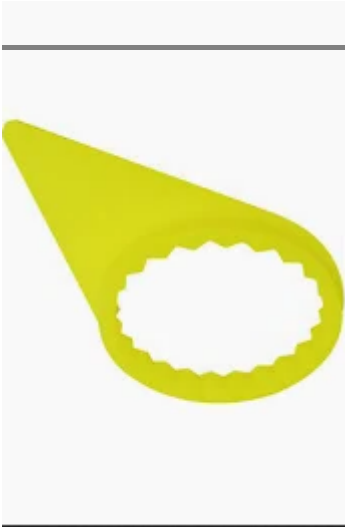
While “consider use of a paint marking system or something similar” might

appear mickey mouse when you can buy nut position indicators (left) the key point is a system should have been in place for identifying whether nuts were at the right tension before the funicular was re-opened in January 2023.

1. Consider use of a paint marking system or similar for the bar ends/nuts to indicate the final position of the nut relative to the bar on completion of all stressing operations. The aim being that a simple visual inspection would identify if significant loss of tension has occurred as this would be visible by change in relative paint marks.
