[REDACTED]
Subject: 2022/0157/PPP Flood Risk Assessment

2022/0157/PPP RESPONSE TO FLOOD RISK ASSESSMENT

Woodbank House/Old Luss Road Area

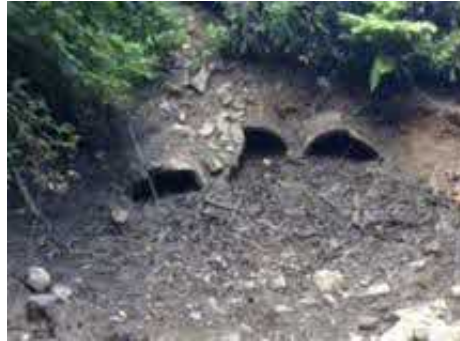
As can be seen from the above the silt/rocks/debris being washed down the watercourse have nowhere to go and the culvert slowly becomes blocked as is shown in the following photograph.

This photograph and a flood risk assessment has been discussed in Riverside West: Flood Risk Clarifications – Briefing Note 2, contained in Part 2 of 3 of Ref. A

2. It is also apparent that the flooding risk to the surrounding properties depends largely on a maintenance regime to keep the culverts clear. A satisfactory maintenance regime is not in place even though several mitigations have been identified to West Dunbartonshire Council, SEPA and LomondBanks as required. These are :-

- Excavate the bed of Unnamed Watercourse 2 to the level of the bottom of the burn
 - Keep the culverts clear
 - Repair the trash grill upstream of the Lower Stoneymollen Road culverts

- Excavate and keep clear the sediment tanks upstream of the above trash grill
 - Keep the drainage ditch down Lower Stoneymollen Road clear
3. Old Luss Road is also subject to flooding due to a defective gully drain system which has been apparent for at least the last 40 years but has not been addressed or rectified.

1.6 We do however recognise that based on the photographic information you have provided significant culvert blockage is prevalent at the site and to address this issue we would be in agreement **that culvert clearance should be undertaken along with regular inspection and maintenance.** We will also be requesting confirmation on who will be responsible for the ongoing inspection and maintenance of culverts and watercourses. It is our assumption that at this time West Dunbartonshire Council Roads Dept (WDC) will be the statutory body responsible for these works.

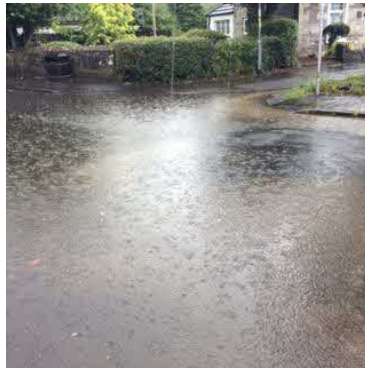
Fig1 shows a popping sewer lid which was a contributory reason for the flooding of Old Luss Road shown in Figure 2

Note: Once again this highlights that Lomondbanks only consideration is to protect their site to the detriment of the local area. Flood water will flow down Old Luss Road and exacerbate the flooding of Old Luss Road as shown in Fig2 above.

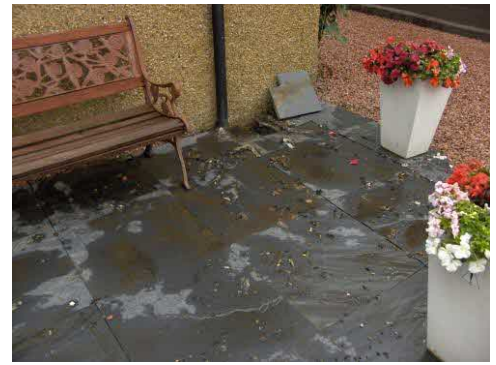
Figure 3 shows the aftermath of a sewage discharge into the gardens of properties in Old Luss Road. A subsequent investigation by Scottish Water found the local sewage system in a state of partial disrepair with ingress of tree roots into clay pipes causing blockage.

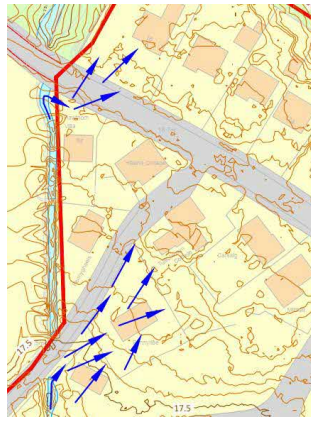
Figure 5

Flood Risk Assessment at Site E Woodbank Site from the Unnamed Watercourse 2 (UW2) dated 10 Dec 2018 (Fig5 below) shows overtopping of Unnamed Watercourse 2 flowing into residential properties.

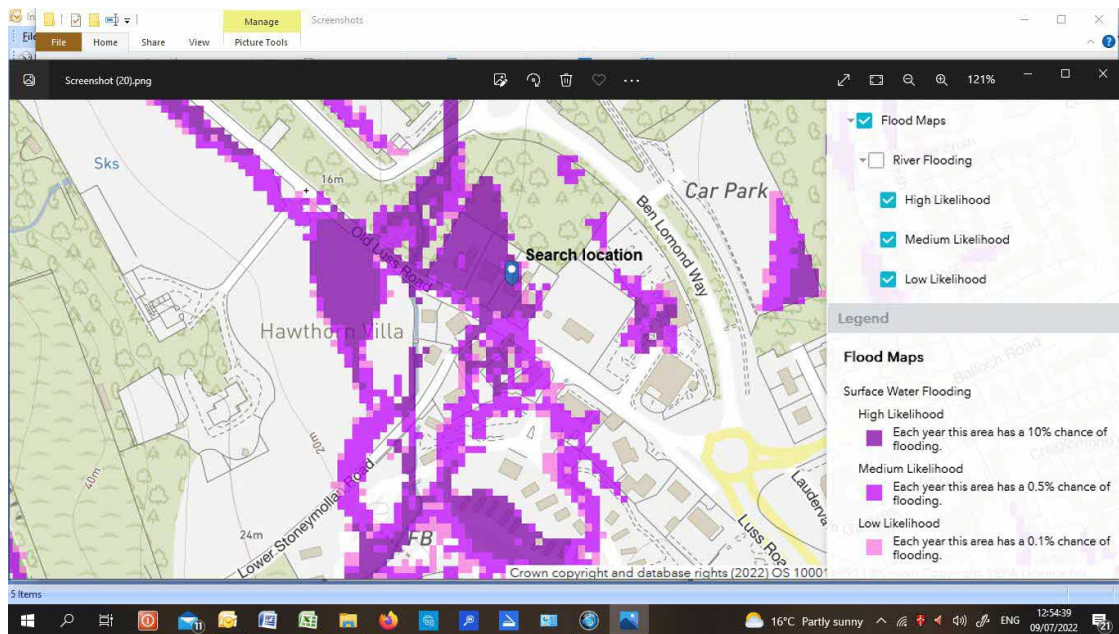
Figure 6 SEPA Flood Map

Note: This is consistent with the SEPA flood map in Fig6 below which highlights a 10% risk of flooding for properties in Old Luss Road and Lower Stoneymollen Road.
