## Bruar Hydro Scheme – Note to CNPA September 2016

Gilkes Energy Limited (GEL) and the Cairngorm National Park Authority (CNPA) visited the Bruar Hydro Scheme on Monday 26<sup>th</sup> September 2016.

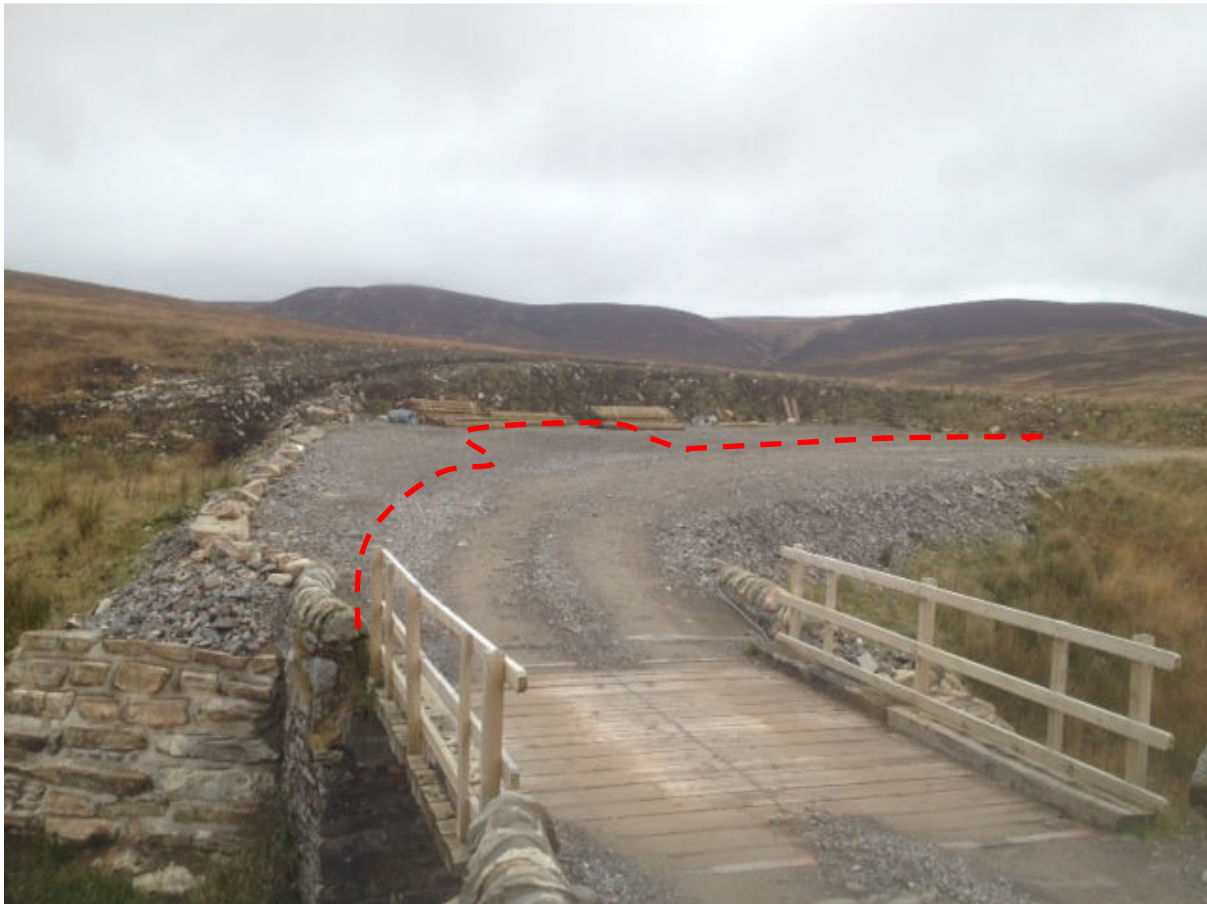
The corner after the existing bridge will be narrowed and reduced, taken back to existing profiles with a small passing place retained - as the existing track had prior to construction.

The stones and as much of the type 1 road layer as possible will be removed. The mound at the rear of the widening (see picture above) will then be used to cover over the track. There is evidence of regrowth in this mound and this will be carefully reutilised to assist in regenerating the area. Small areas of turfs will also be 'robed locally' and distributed across the area should the cover of vegetation be minimal. Removal of material in the bank will present the opportunity to smooth the banks and lessen the sharpness. The dashed line above in red shows the proposed profile.

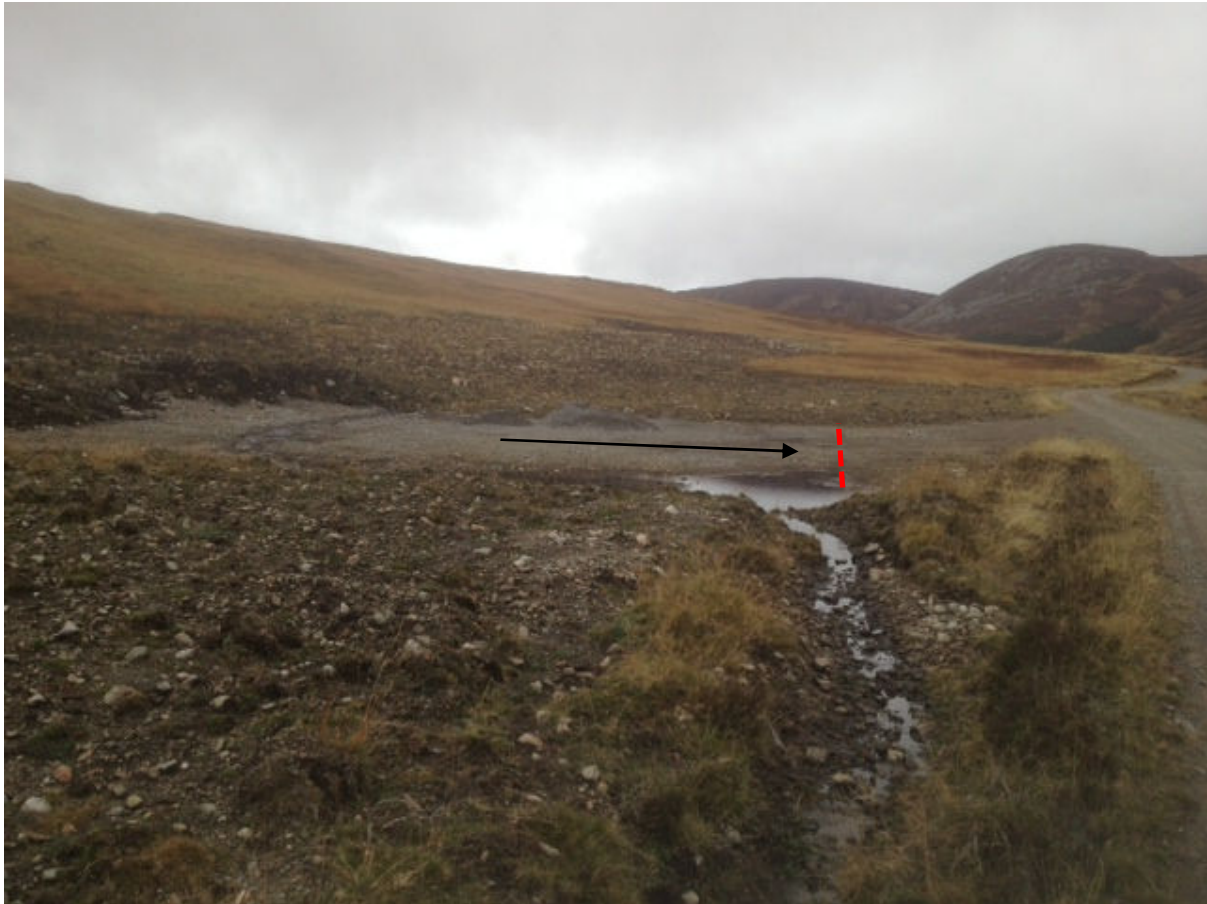
There is a large laydown area on the midpoint of the pipeline route. Prior to construction this was originally a storage area for stone to repair the road – allowing a local stock pile to aid repair of pot holes. This is why it was proposed to retain this but following dialogue with CNPA we consider it would be better to reduce it significantly to a similar scale to the existing lay down prior to construction commencing. See picture below with arrow showing reduction in size.

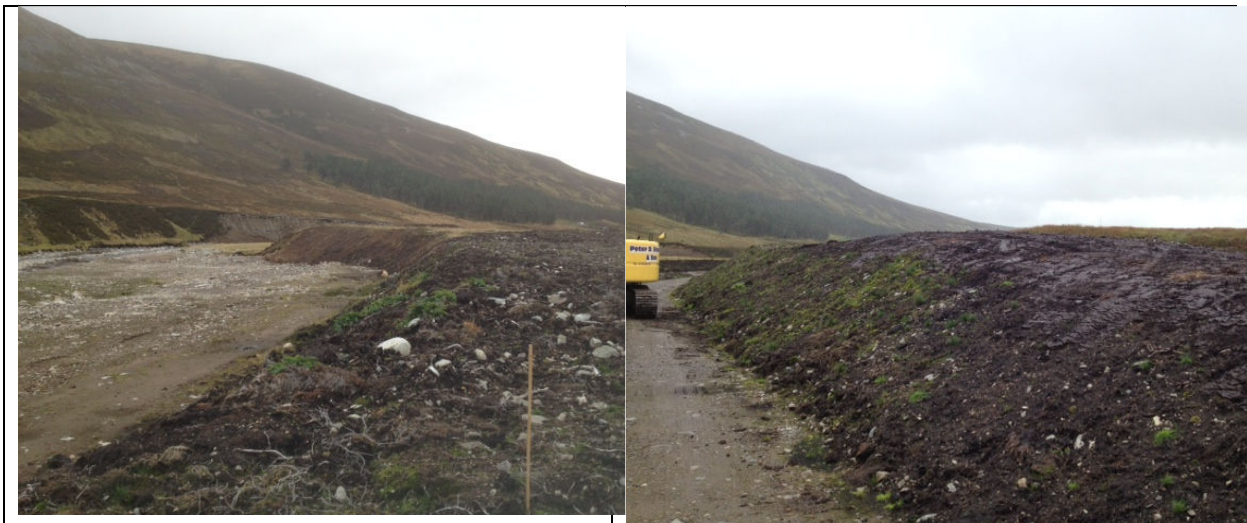
We have rounded the tops of slopes as previously reported. The fencing for the main planting area is installed; planting will be complete by the end of the month. We have carried out the removal of eyebrows.

Picture 1 eyebrows removed from terrace to the south west of intake. The lower area in the picture will undergo secondary planting.

Picture 2 – example of improvement to terraces with sharp feature at change in topography replaced with rounded edge.

This lower section, shown on the left in picture 1 below is part of the planting plan, refer to approved planting plan (Drawing No. L01.Revision I Mitigation Planting ).On the plans it was indicated that we may undertake this as a second stage and this will indeed be the case. So following the assessment of the rock armour (and completion of any remedial works) we will commence fencing this area and then proceed with planting in the Nov 17 season.

This lower section will have a higher percentage of willow; the approved main planting area at the intake has Grey Willow and Eared willow at 20% (each) we would propose to raise this to solely willow on the lower section with a 50/50 split on the species. We consider that willow would be best suited to this type of material.

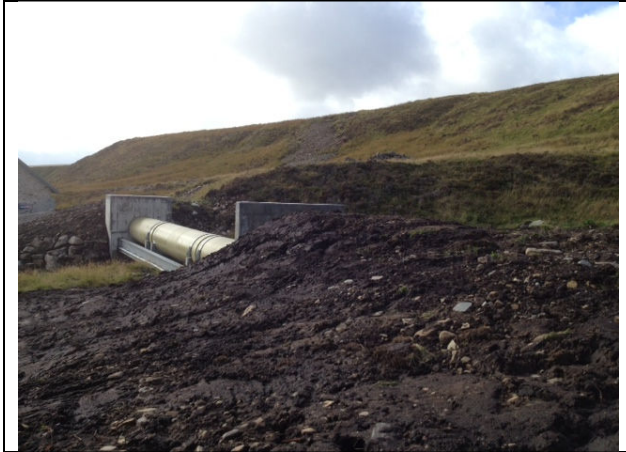
- 1) Pipe bridge peat was brought in round the northern face to cover the concrete abutment greatly reducing the area of visible concrete. This was carried out on Wednesday 28<sup>th</sup> October.

Profile over pipe modified to reduce exposed concrete
