Why has the destruction at Cairngorm happened?

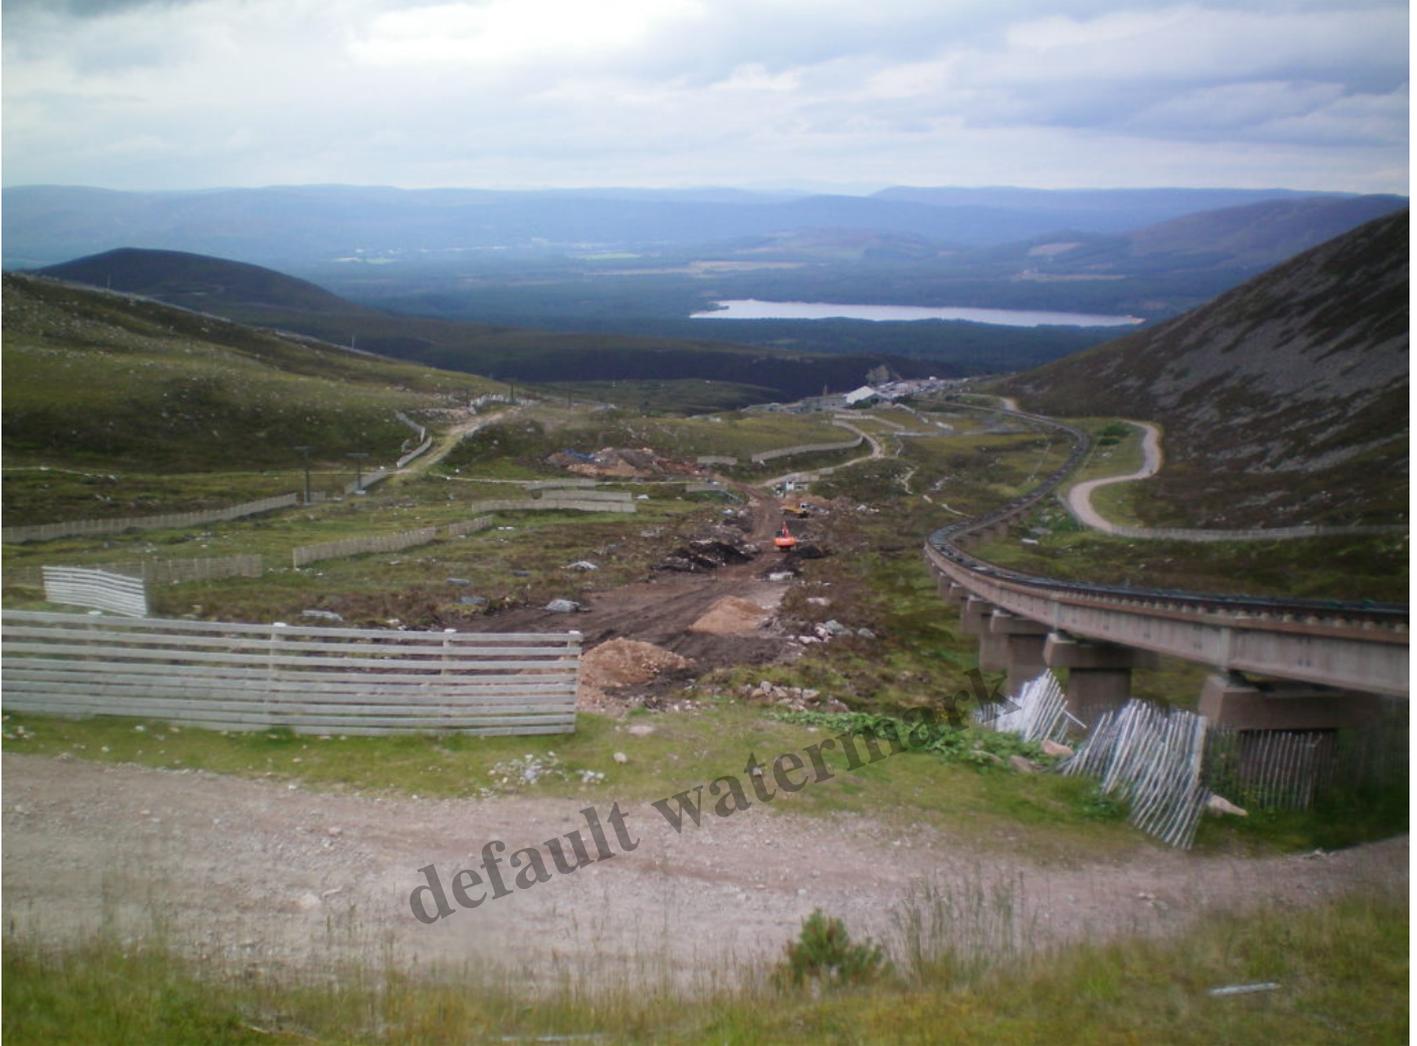
I am not sure the planner appreciated just how much soil and boulders would be shifted

Shifting and storage of soil and boulders was not mentioned in the Method Statement – a huge pile can be seen centre background outwith the area granted planning permission

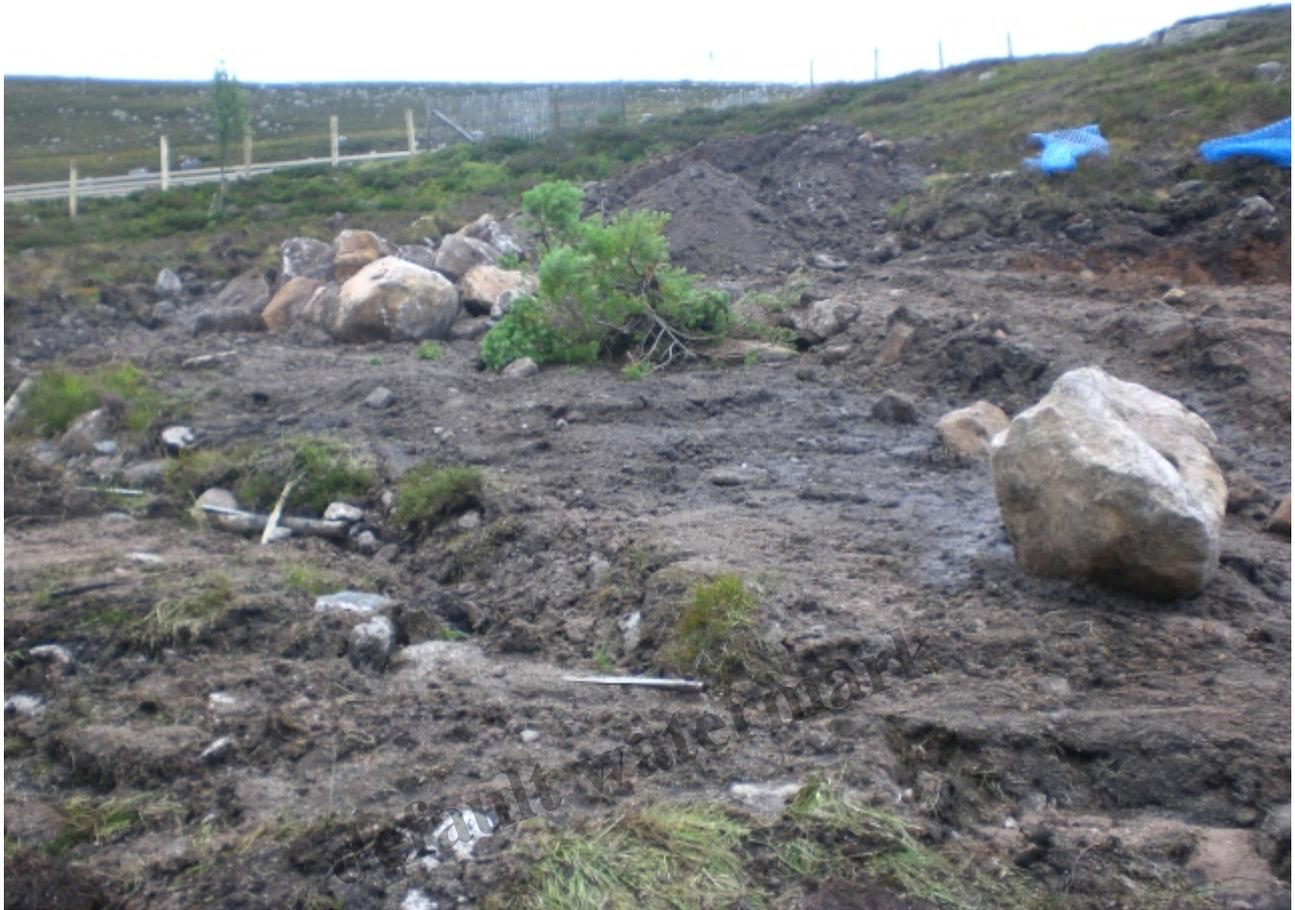
The Method Statement did not say what would happen to boulders that impacted on the “reprofiling” of the slope Photo credit Alan Bratney

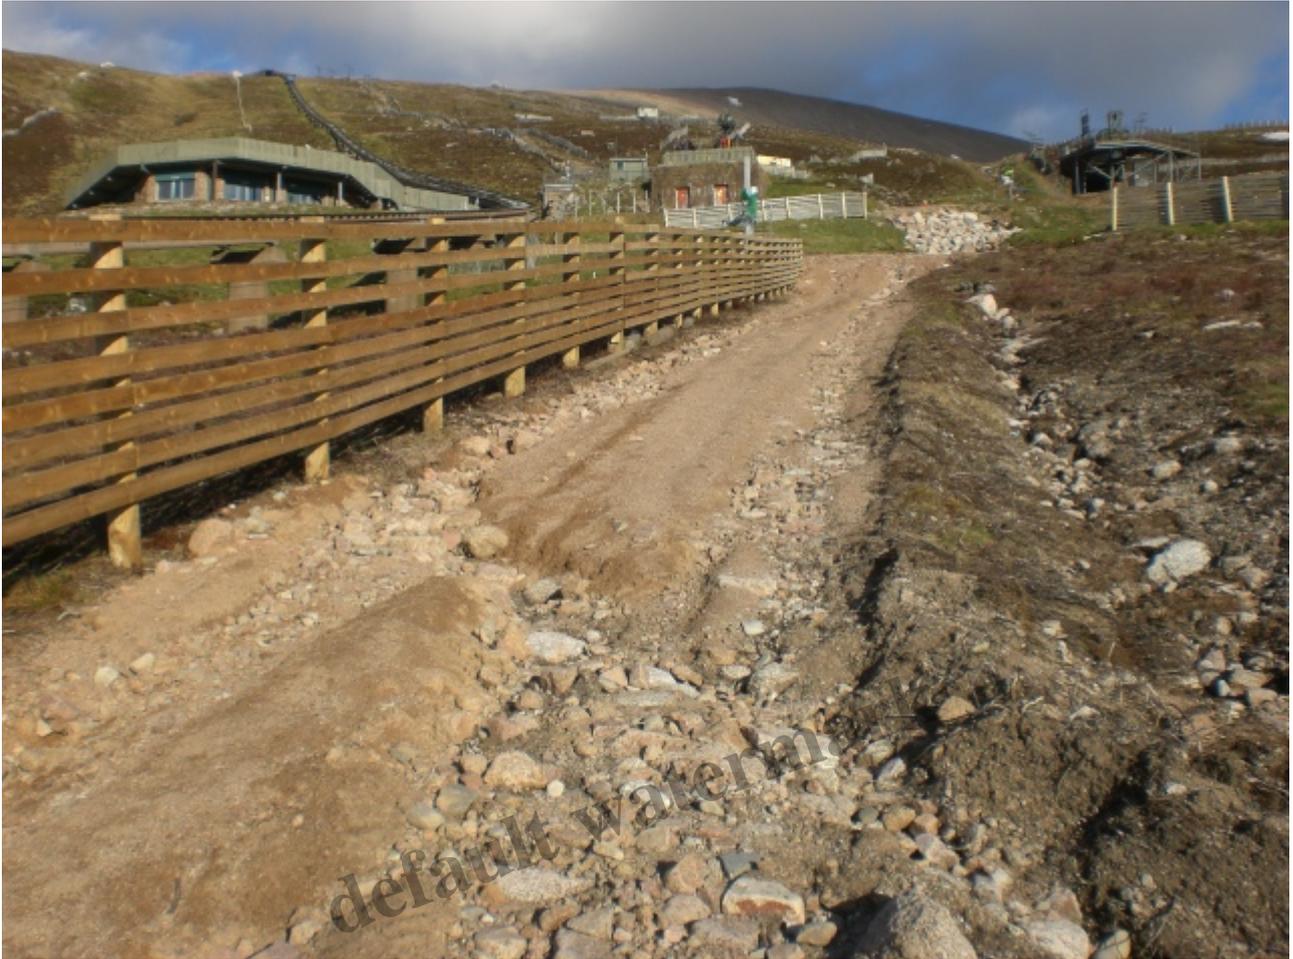
The new bulldozed track

There was no reference to a new bulldozed track in the planning application – a clear breach of planning requirements
George Paton

a full and public apology for what has happened and take a lead in re-instating the bulldozed track and repairing the other damage, I believe they are no longer fit to own the ski area.

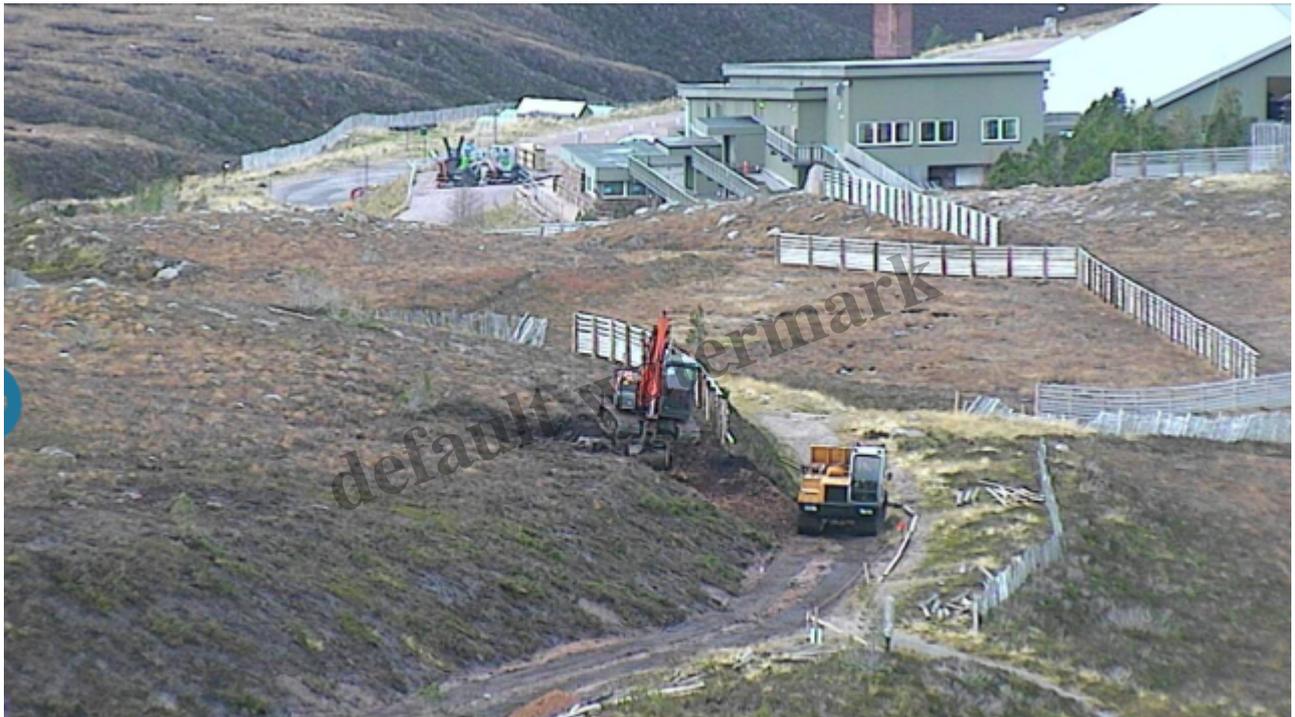
Work undertaken outwith the area granted planned permission

Working taking place on the bank below the shieling ski tow – the planning permission did not cover this area
credit George Paton

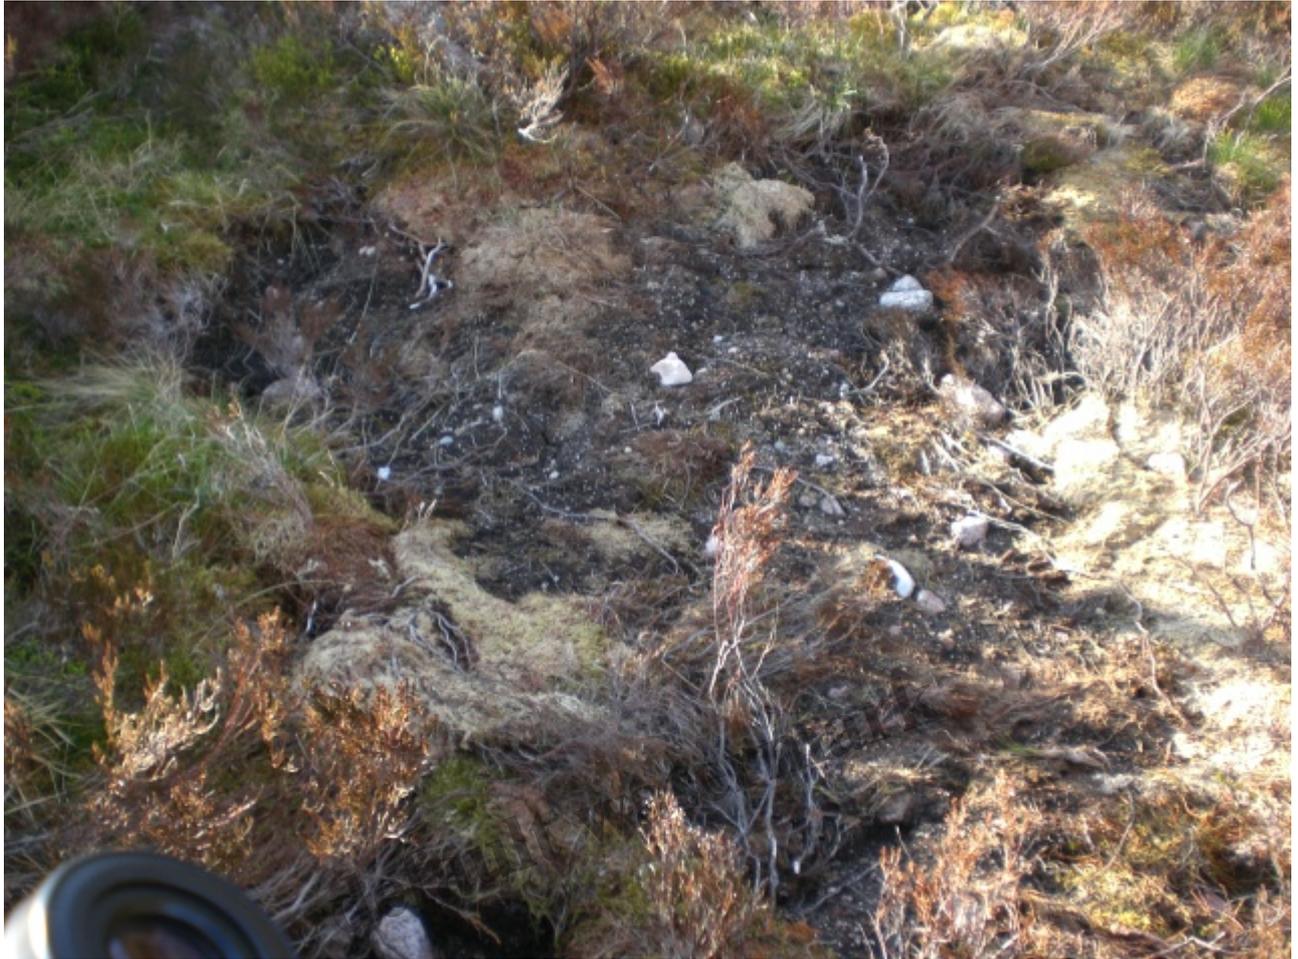
A hole excavated by a digger outwith the area granted planning permission – it appears the contractors were short of vegetation (implying they had not stored turf in the manner specified) and tried to address this failure by taking vegetation from elsewhere. There is no mention of this in the Method Statement and it is also clearly outwith the planning permission granted

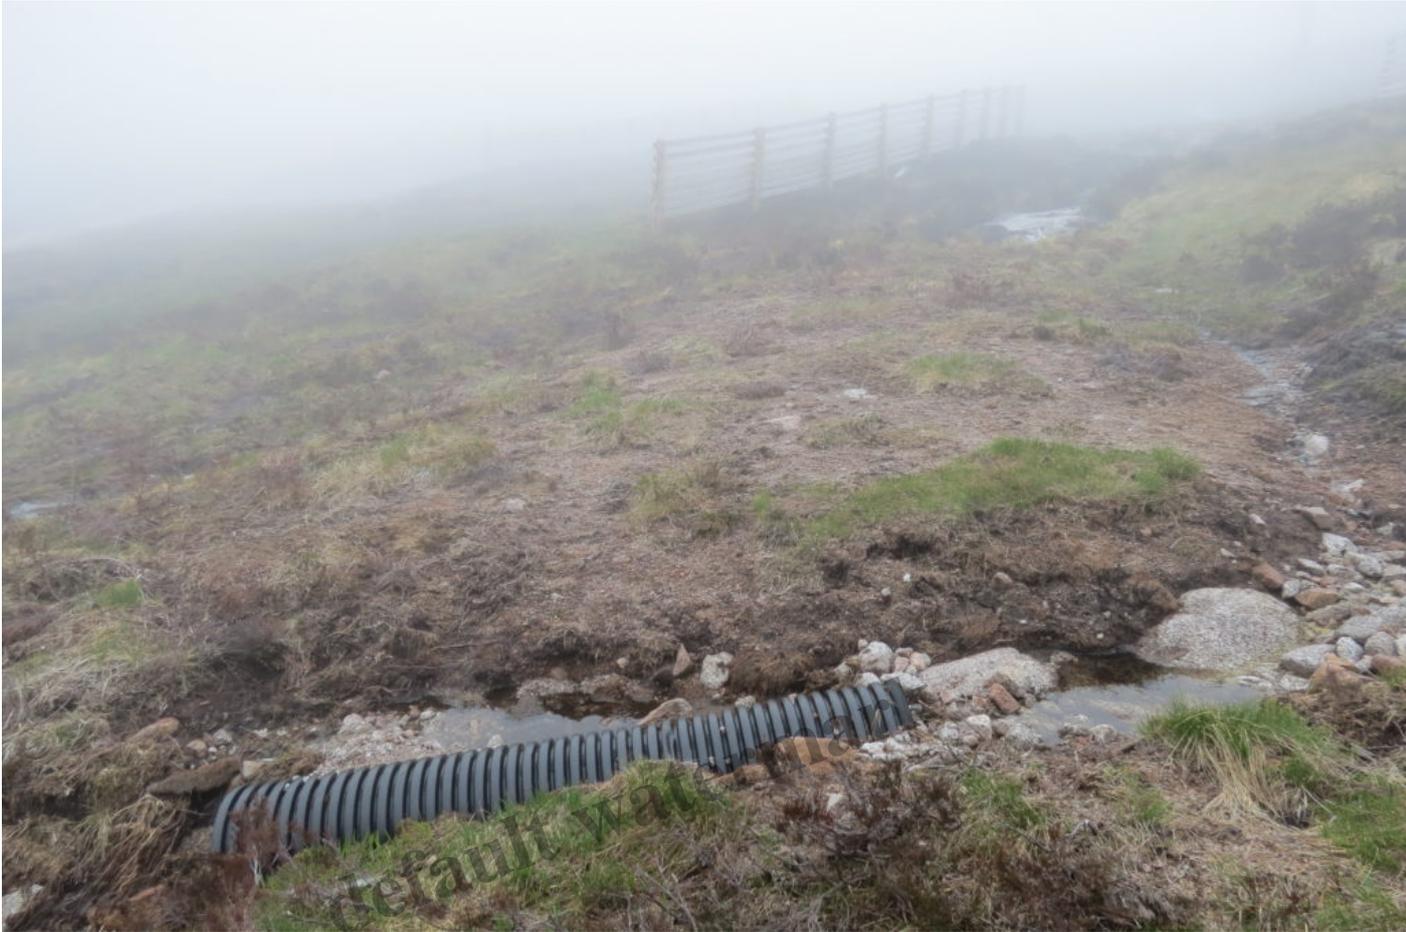
The contractor has failed to finish off the new culvert let alone in the manner specified

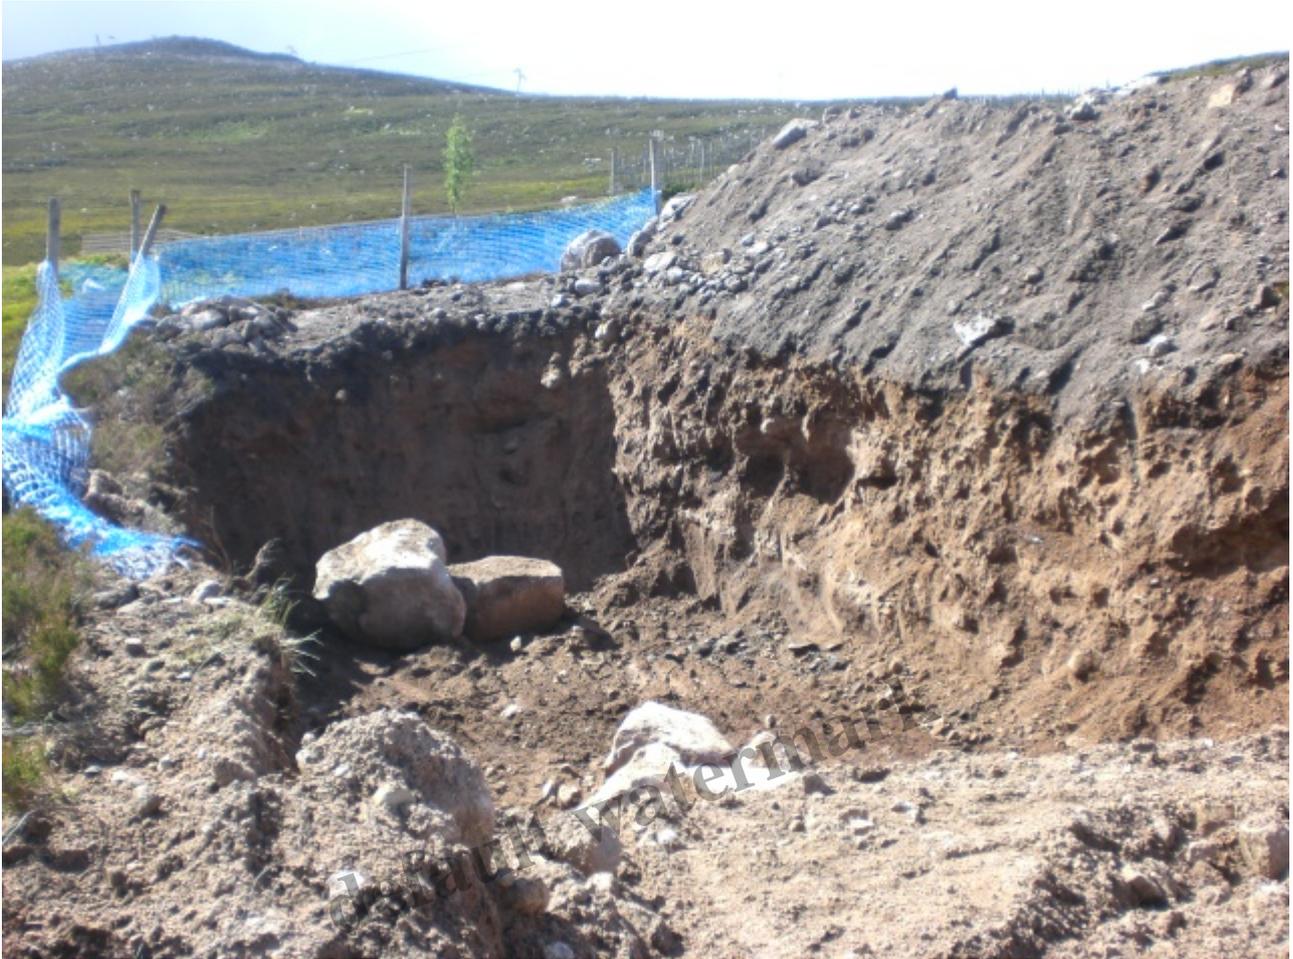
And there is the question of whether this pit was covered by the planning permission?

Pit into which soil, peat and boulders was later dumped Photo Credit Alan Bratney
