Why has the destruction at Cairngorm happened?

The creation of the new rope tow in Coire Cas, which created so much destruction at Cairngorm, required planning permission [Removal of Shieling Ski-Tow & replace with a modern rope-tow of similar length and profile](#). The Shieling tow replacement supporting images [document](#) is worth looking at as it gives a very clear picture of how this slope appeared before the works and what was planned: removal of the existing tow, smoothing out the existing bulldozed tow line and replacing the bridges over the Allt a Choire Chais with culverts. I don't think any of this was objectionable in principle and it had the potential both to improve the skiing and the appearance of this part of Coire Cas.

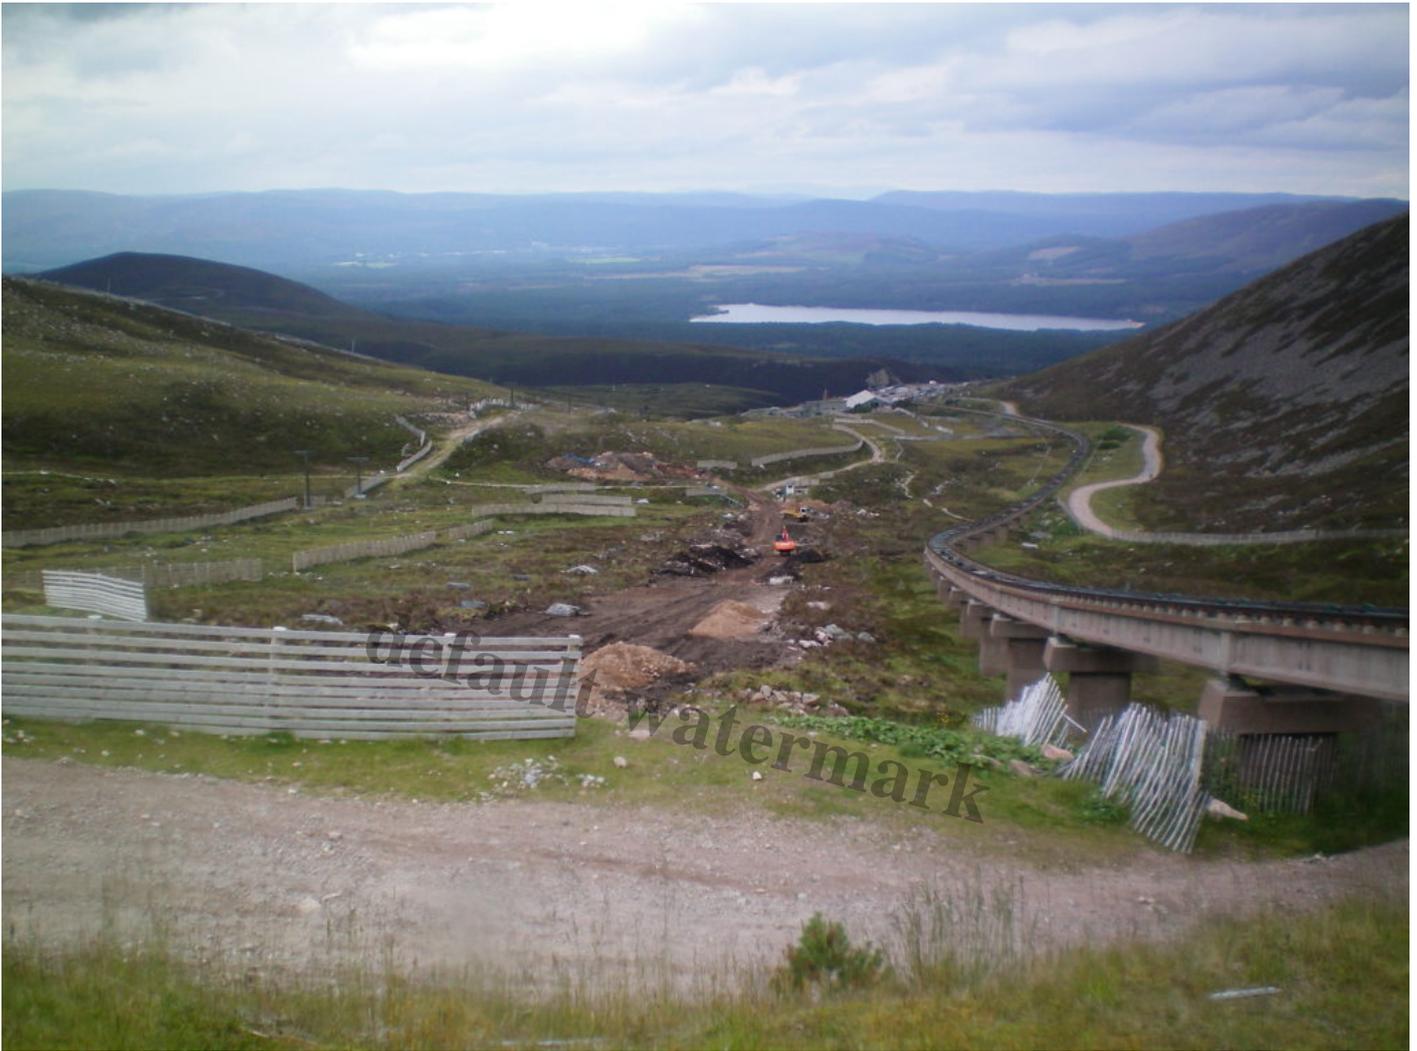
I am not sure the planner appreciated just how much soil and boulders would be shifted

Shifting and storage of soil and boulders was not mentioned in the Method Statement – a huge pile can be seen centre background outwith the area granted planning permission
Photo Credit Ron Greer

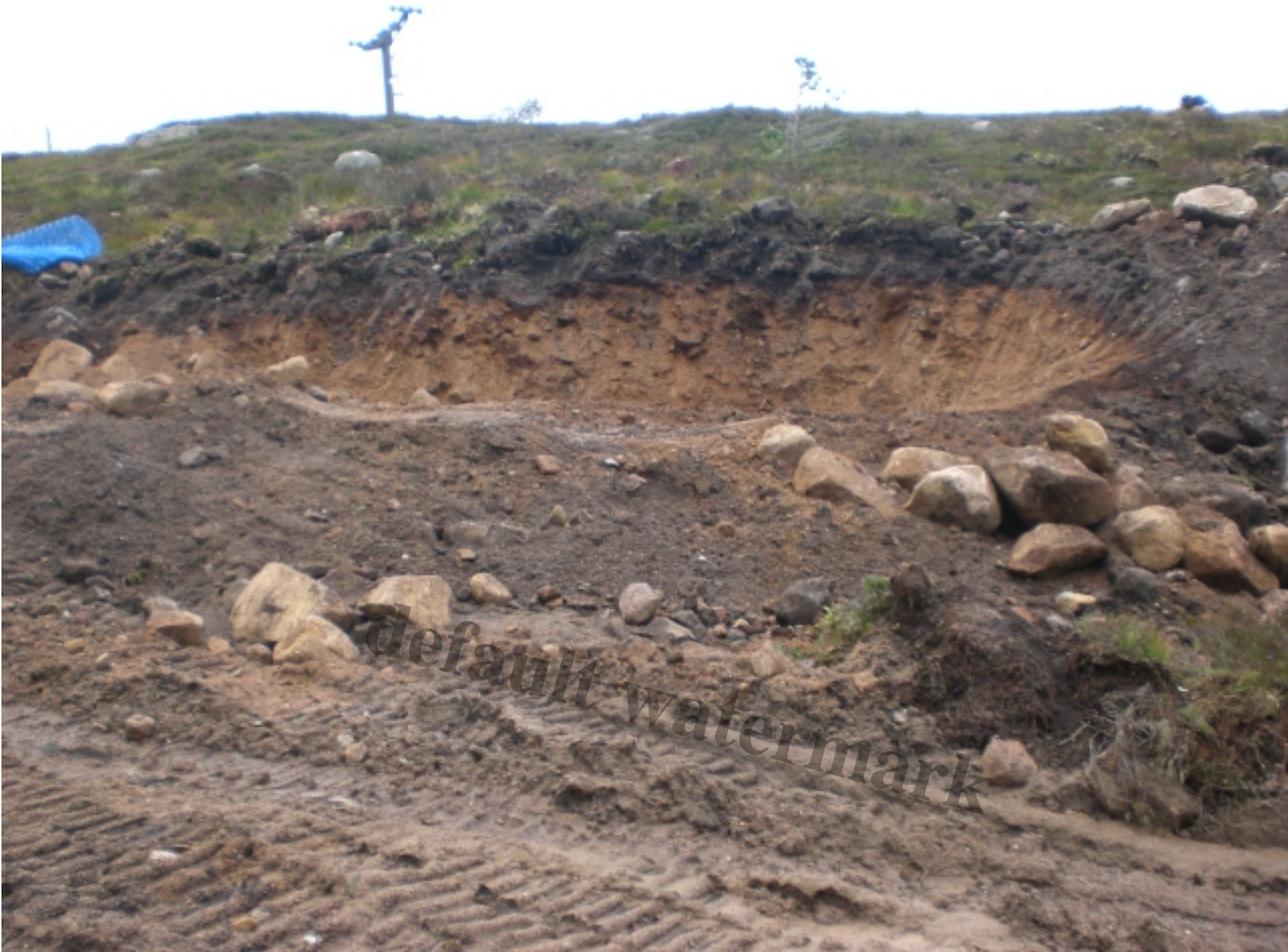
Photo credit Alan Bratney

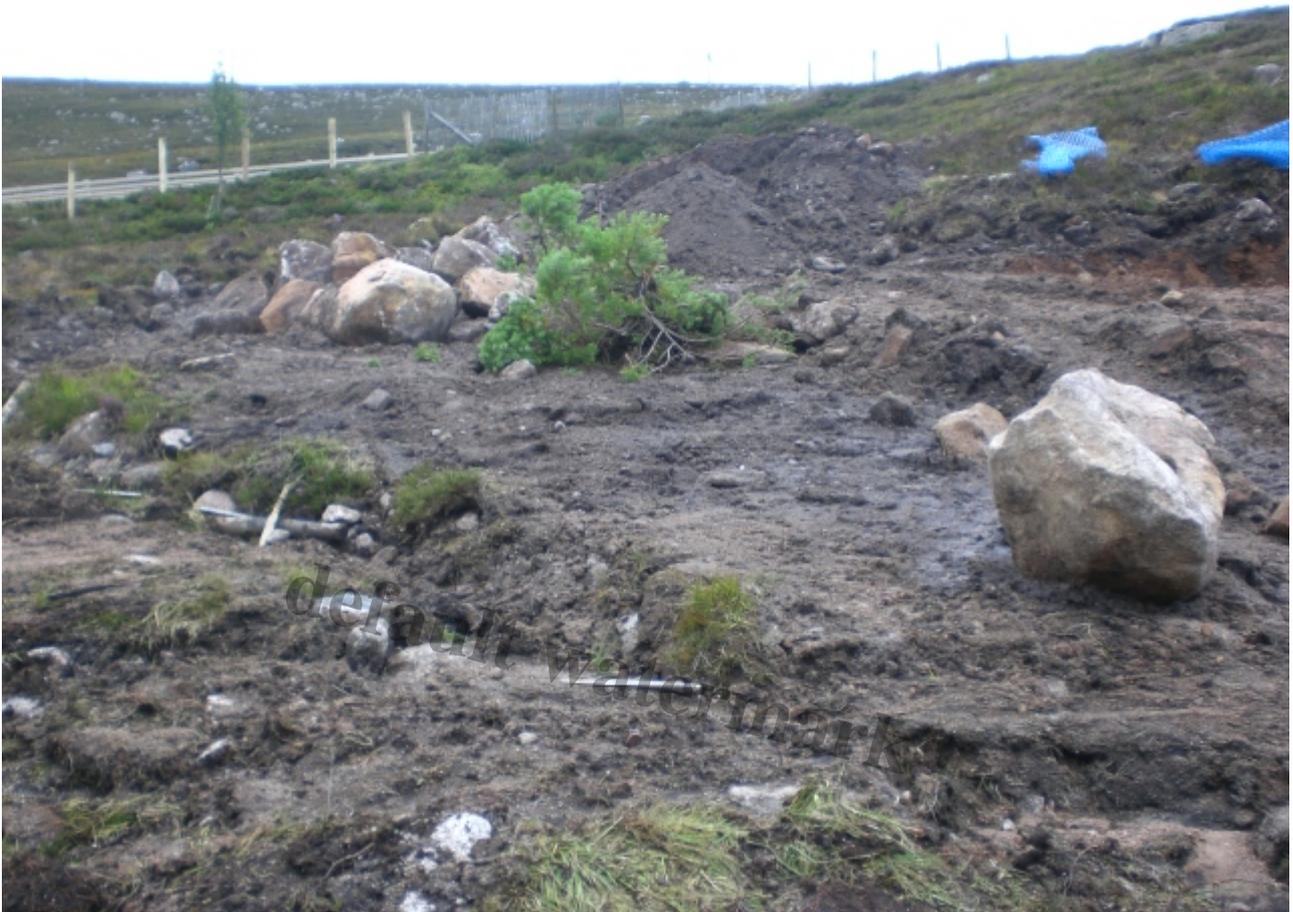
The Method Statement did not say what would happen to boulders that impacted on the reprofiling of the slope Photo credit Alan Bratney

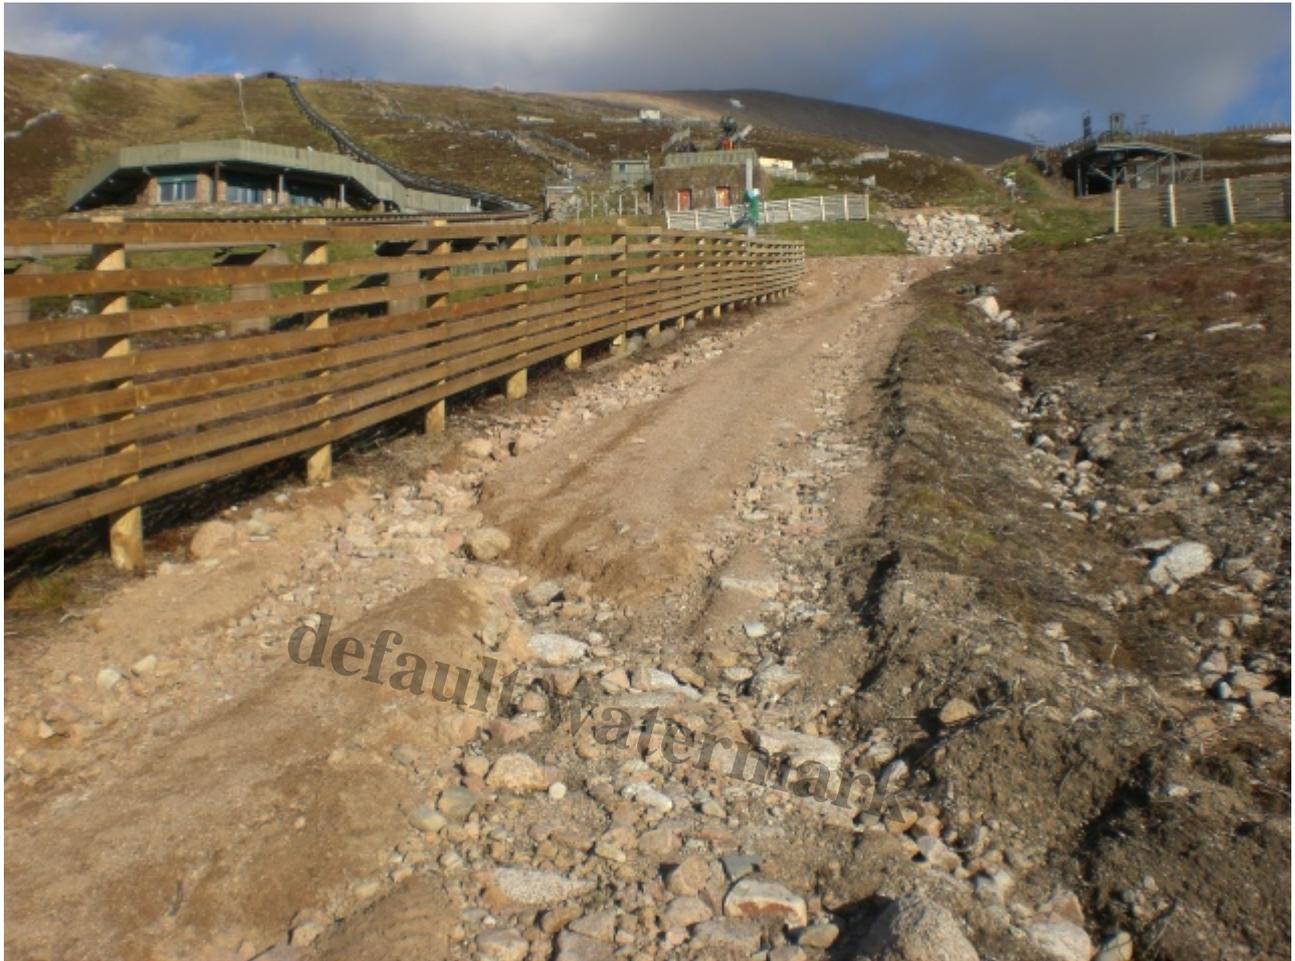
The new bulldozed track

There was no reference to a new bulldozed track in the planning application – a clear breach of planning requirements
George Paton

The CNPA now need to take firm action to enforce the requirements of the planning permission it granted otherwise its going to lose all credibility. I suspect that HIE will resist this and unless they offer a full and public apology for what has happened and take a lead in re-instating the bulldozed track and

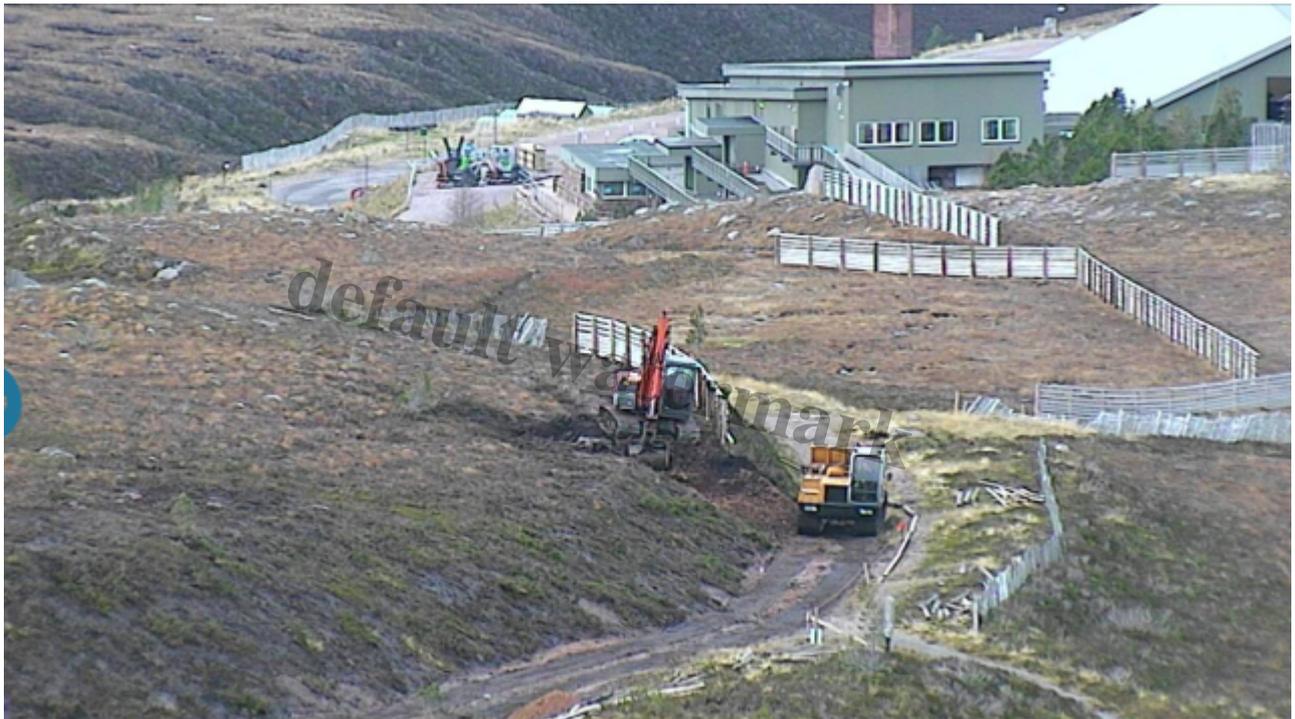
Work undertaken outwith the area granted planned permission

Working taking place on the bank below the shieling ski tow - the planning permission did not cover this area
credit George Paton

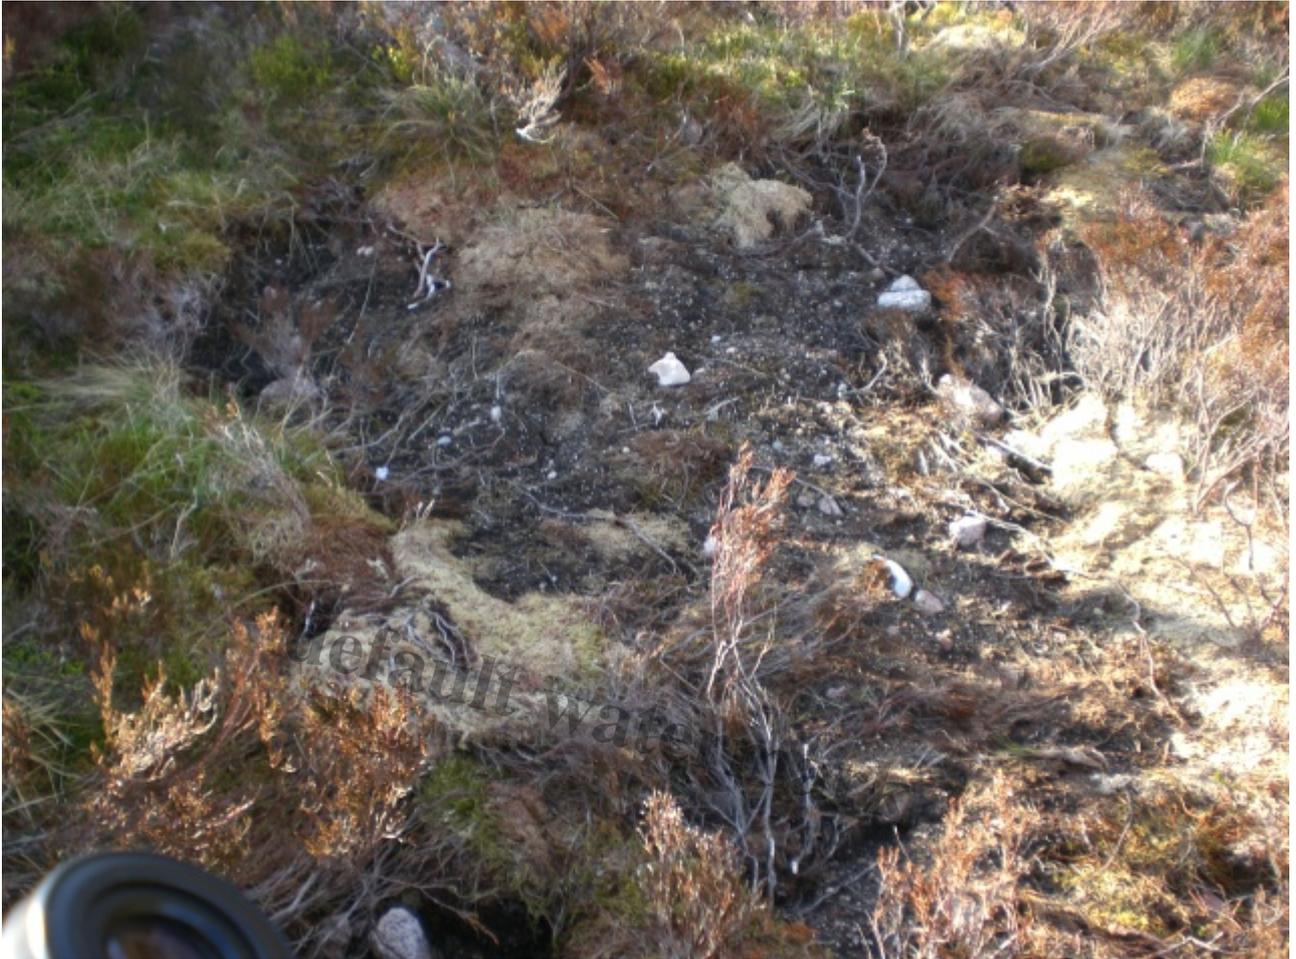
A hole excavated by a digger outwith the area granted planning permission â?? it appears the contractors were short of vegetation (implying they had not stored turf in the manner specified) and tried to address this failure by taking vegetation from elsewhere. There is no mention of this in the Method Statement and it is also clearly outwith the planning permission granted

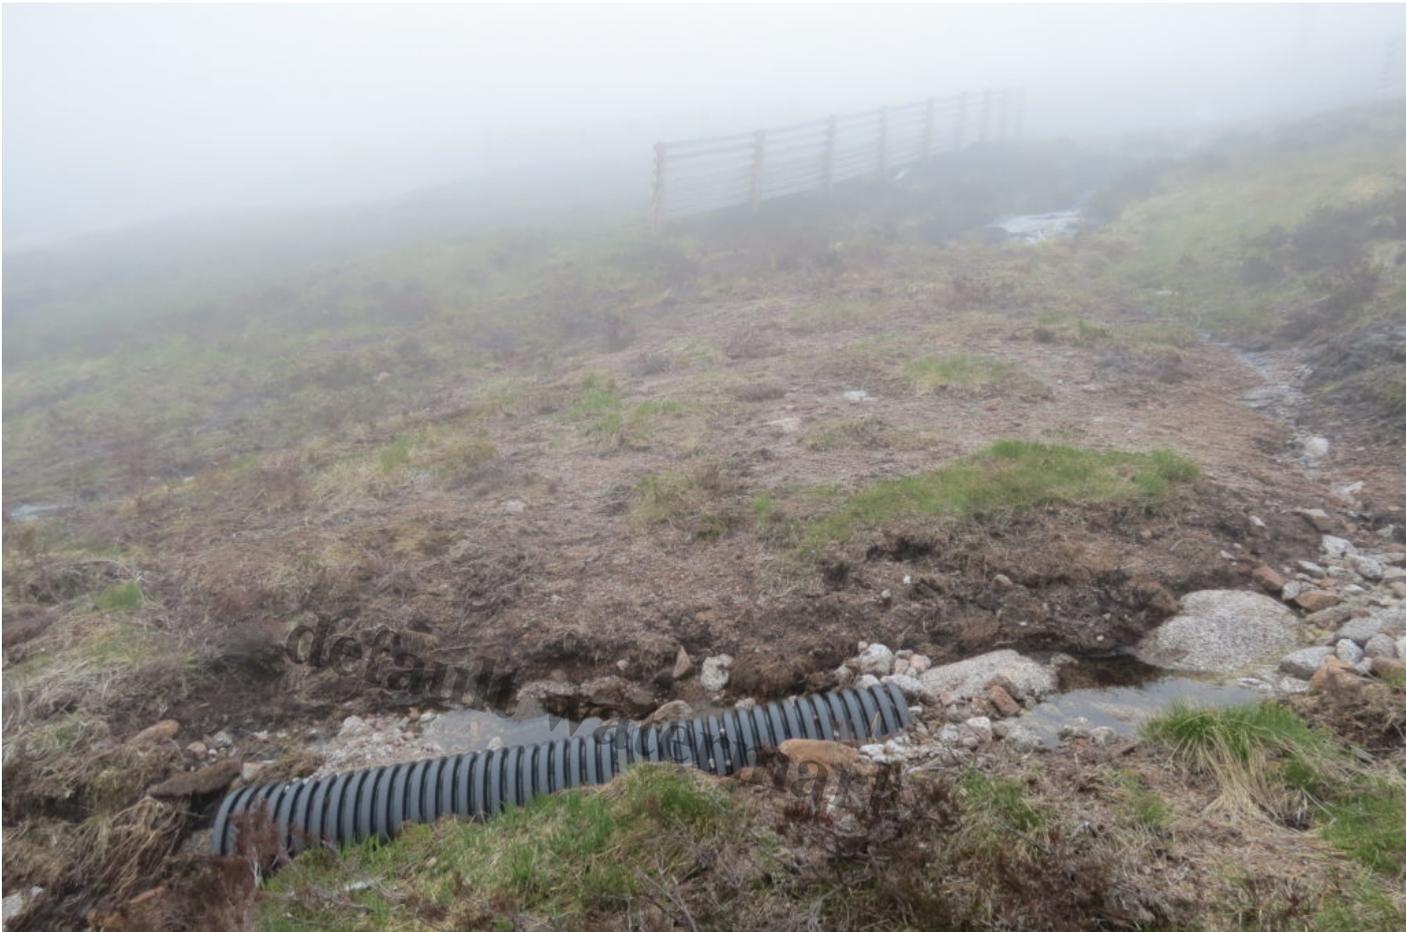
The contractor has failed to finish off the new culvert let alone in the manner specified

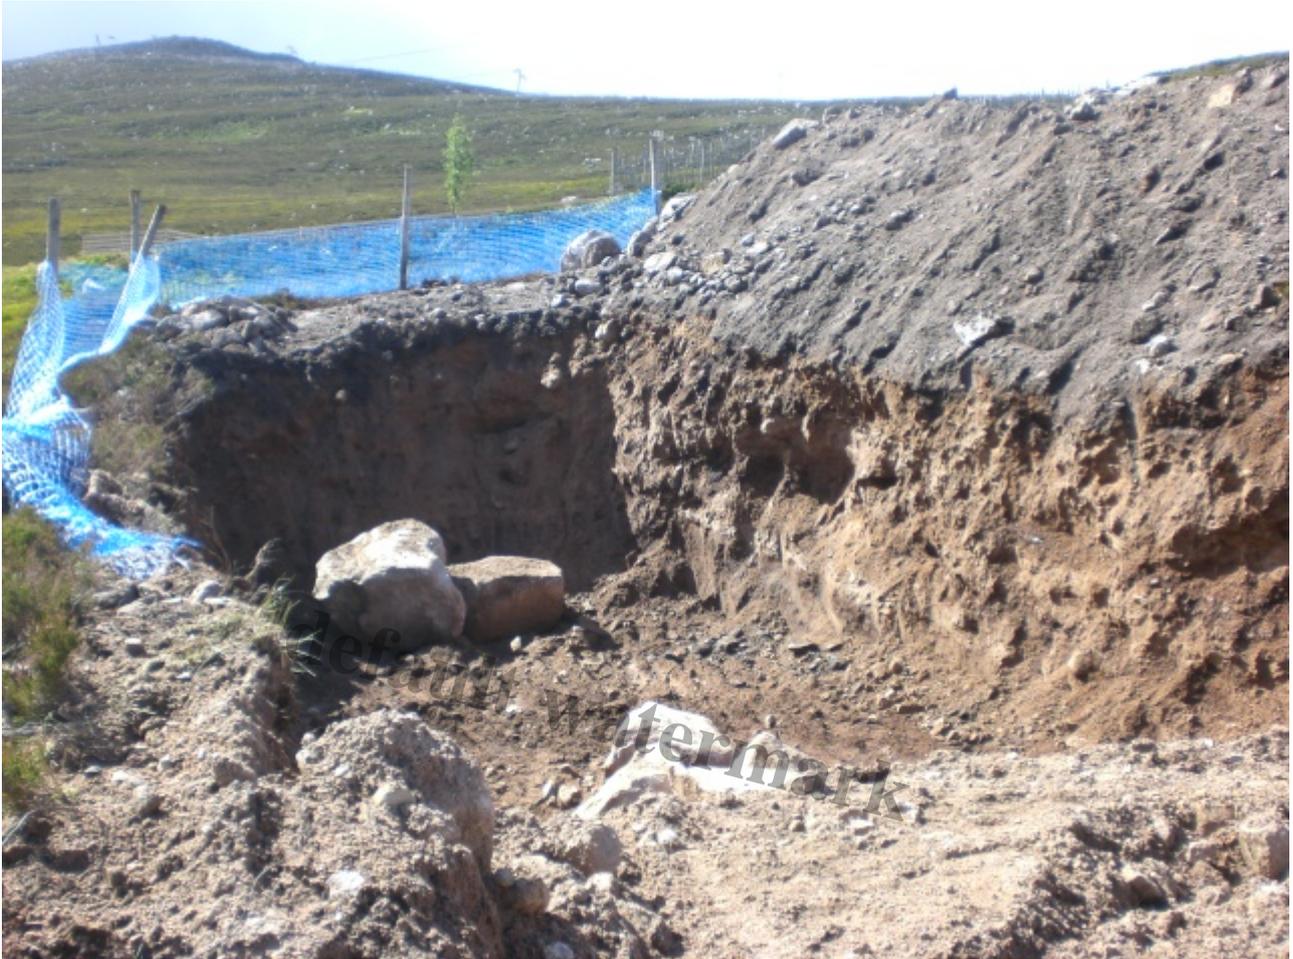
And there is the question of whether this pit was covered by the planning permission?

Pit into which soil, peat and boulders was later dumped Photo Credit Alan Bratney
