The sorry story of the destruction caused by the construction of the sheiling rope tow

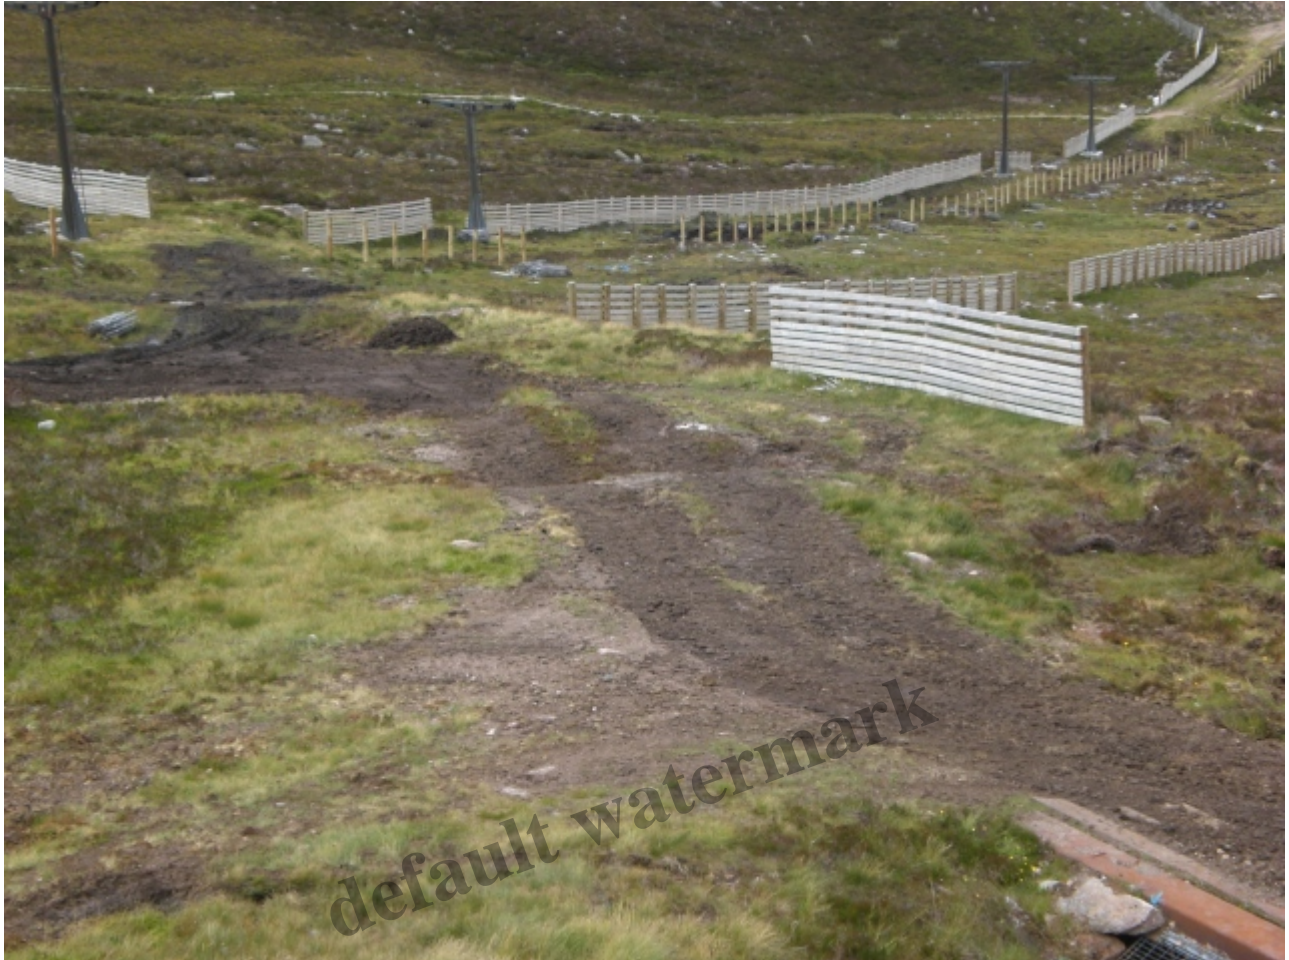
There was, however, still insufficient vegetation to cover the slopes and the constant and unnecessary movement of large vehicles had in any case eroded a trackline so what better solution to turn this into a new track and again hope no-one would notice?

The top part of the new track created by the constant passage of vehicles – photo credit Alan Bratney
