The sorry story of the destruction caused by the construction of the sheiling rope tow

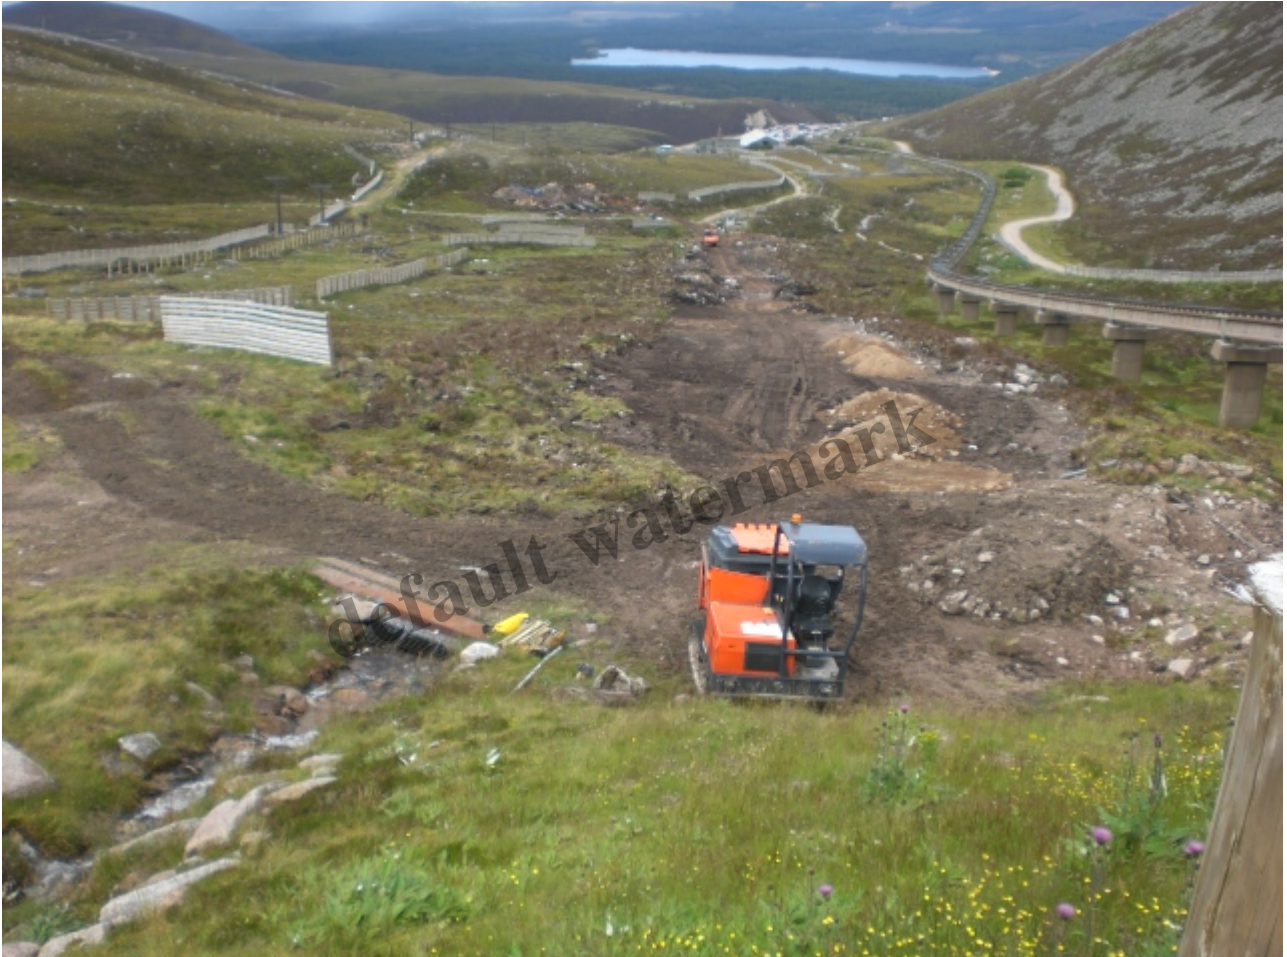
Work in progress on the Sheiling Poma 29th August 2015. Photo credit Alan Bratney

The planning permission that was granted to replace the shieling t-bar with a new lift, the sheiling rope tow, and to reprofile the slope was conditional on Natural Retreats keeping to the plans it had submitted, most of which were contained in the [Method Statement](#). The photo above provides proof that this was simply ignored: permission should have been clearly demarcated – it wasn't

- the works were supposed to be restricted to the area in the site plans (30m wide) – there is clear evidence of vehicles being driven over other vegetation which was supposed to be protected
- there is no sign of the terram mats on which the soil and aggregates were to be stored
- there is no sign of the turf having been removed and stored for re-use

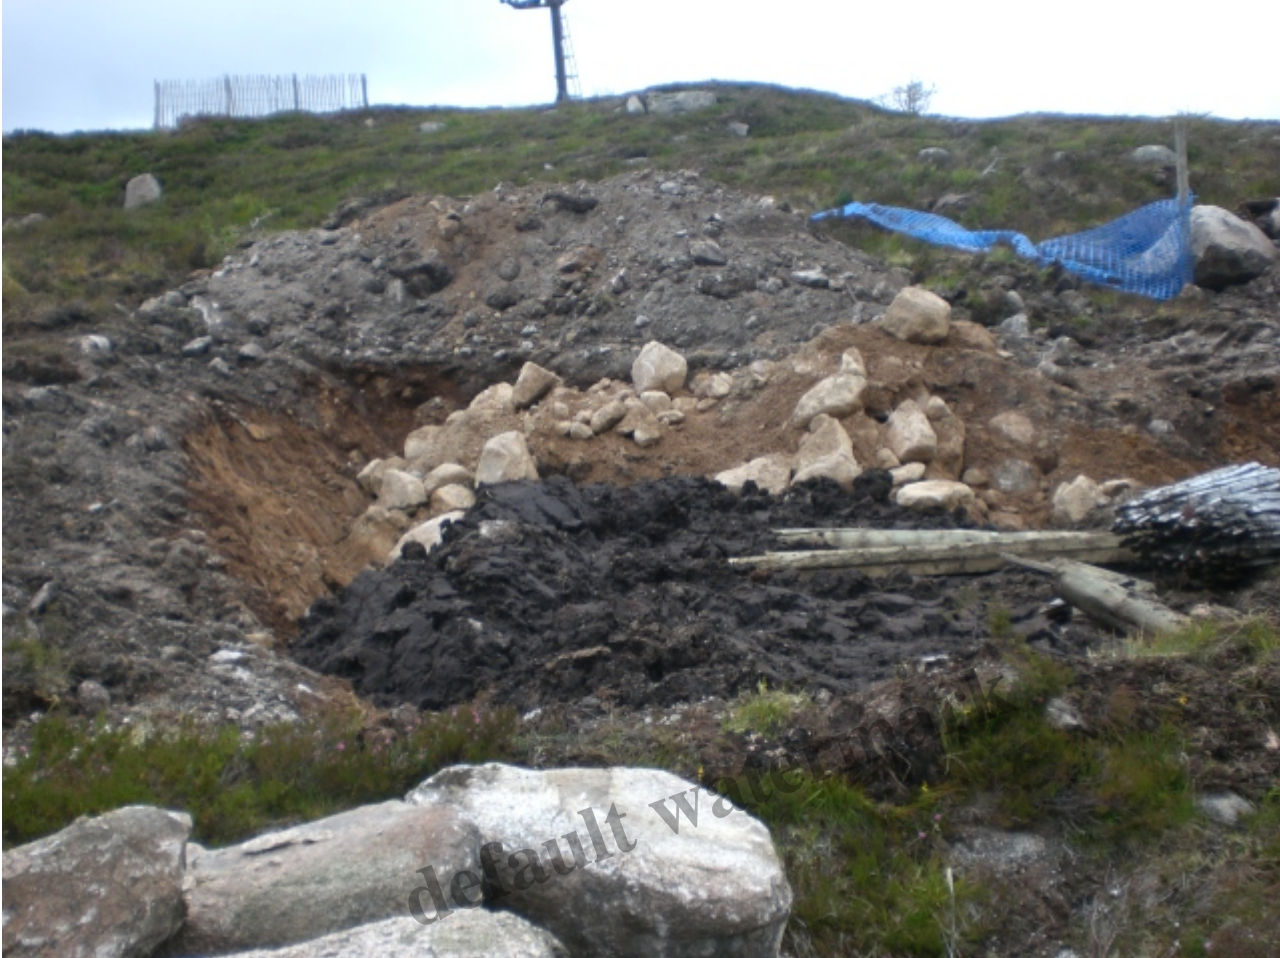
To make matters worse, the contractors removed the boulders from the ski slope – there is no mention of what should happen to them in the Method Statement – and buried them in a big hole that they dug

outside the area granted planning permission.

The backfilled hole – Car Park t-bar in background Photo Credit Alan Bratney

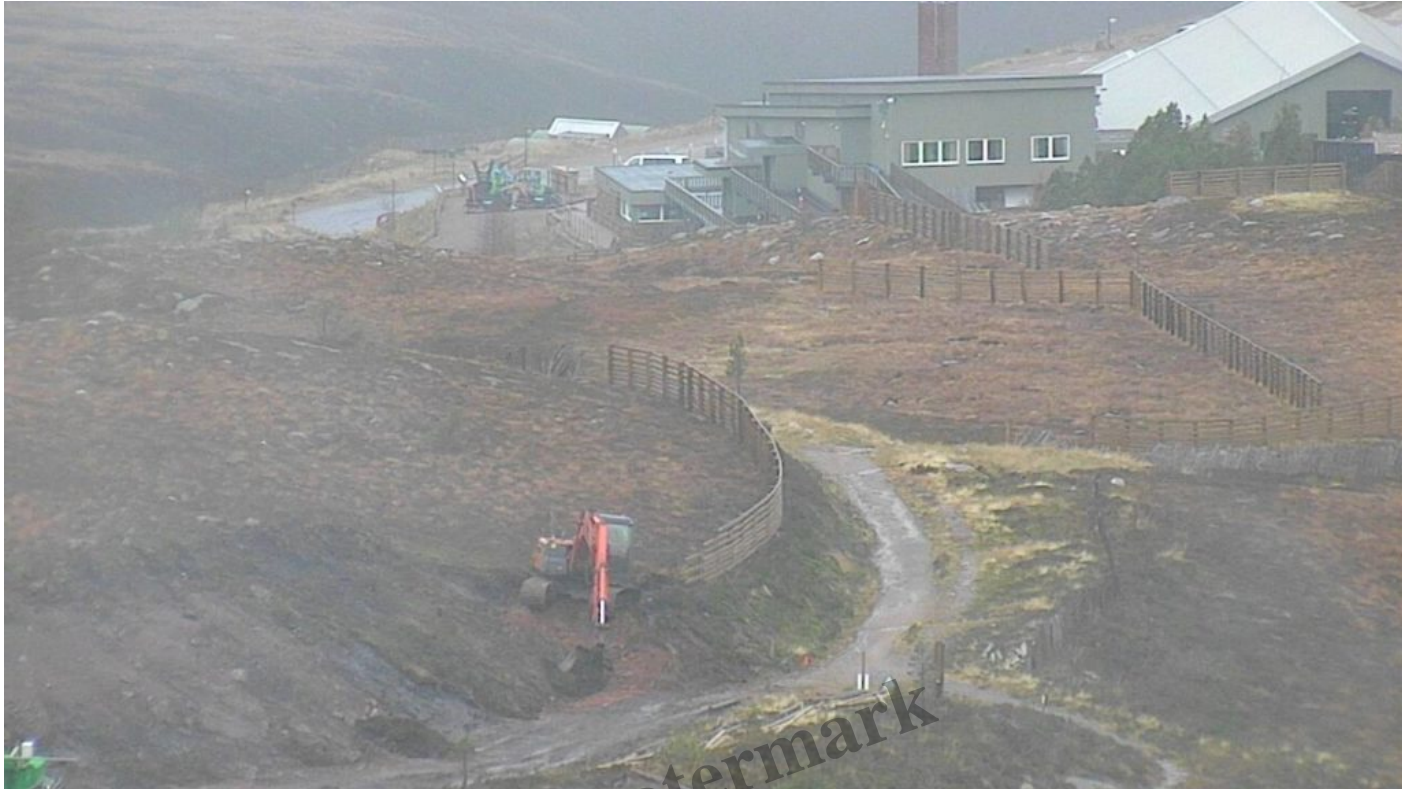
They then discovered they had not read the [instructions](#) properly and that the Sun Kid rope tow they were installing required a slope of consistent gradient. Having removed boulders and soil which could have been used to re-profile the slope further, it was easier simply to take soil from somewhere nearer at hand. The result was the destruction of the bank below the bottom of the poma, which again was clearly outwith the area granted planning permission.

Destruction of the bank – photo credit Cairngorm Mountain webcam

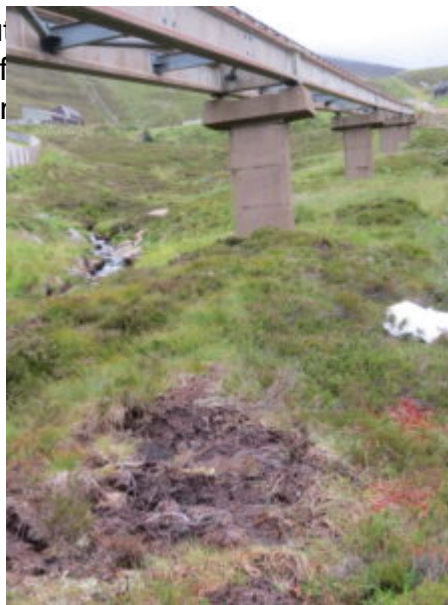
Having failed to retain all the turf as set out in the original design, the contractors were faced with the problem of what to do with the material they didn't have enough. So what happened next?

Local Residents and their representatives were consulted about the proposed slopes. They simply couldn't see how it was going to work out, was they?

They decided to help themselves to some more material from the area.

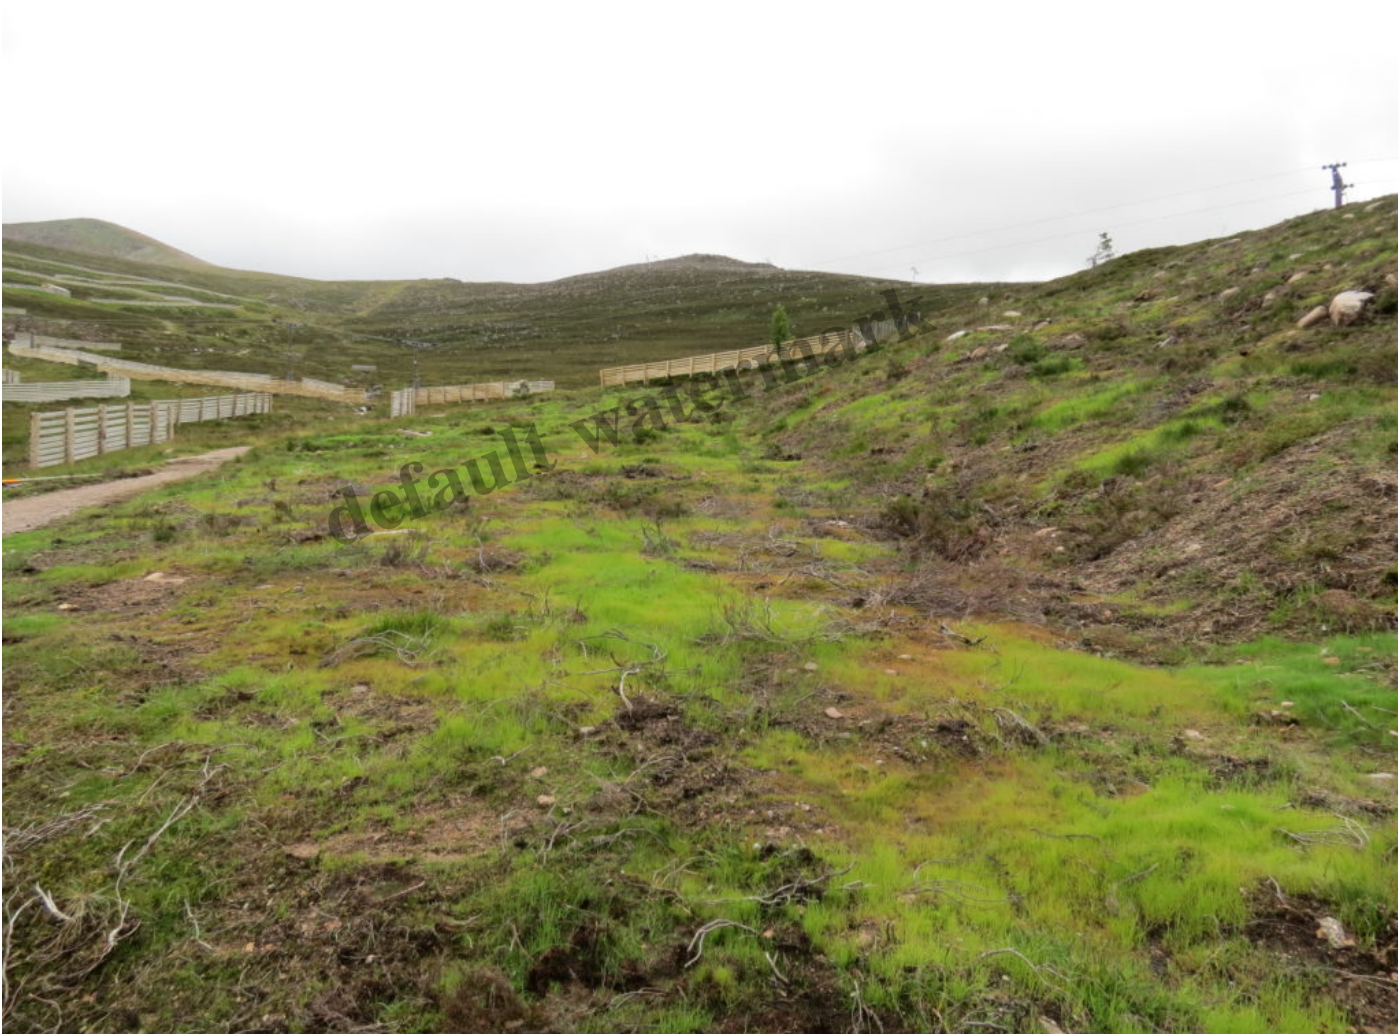
There is clear evidence of vegetation and peat being scooped out of the ground by the diggers, including areas which had been protected from machinery during the construction of the funicular. What was worthy of protection 1999-2001 is now apparently held to be of no account. There is also extensive evidence of slopes outwith the area granted planning permission being re-seeded. This would never have been required if turf and vegetation had not been removed outwith the planning permission that was granted.

Evidence of extensive re-seeding of areas outwith that granted planning permission

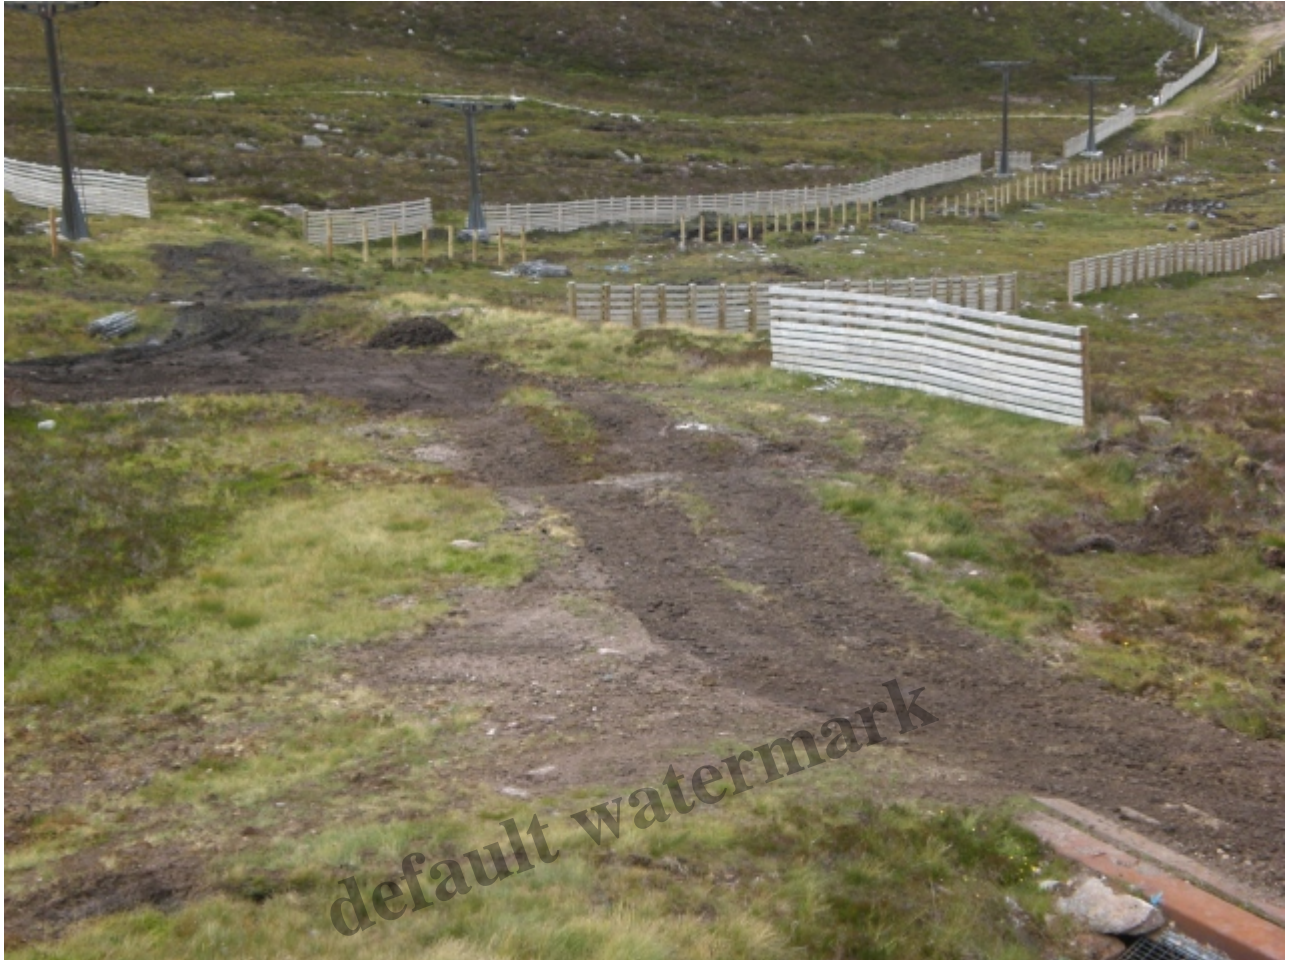
There was, however, still insufficient vegetation to cover the slopes and the constant and unnecessary movement of large vehicles had in any case eroded a trackline so what better solution to turn this into a new track and again hope no-one would notice?

The top part of the new track created by the constant passage of vehicles – photo credit Alan Bratney

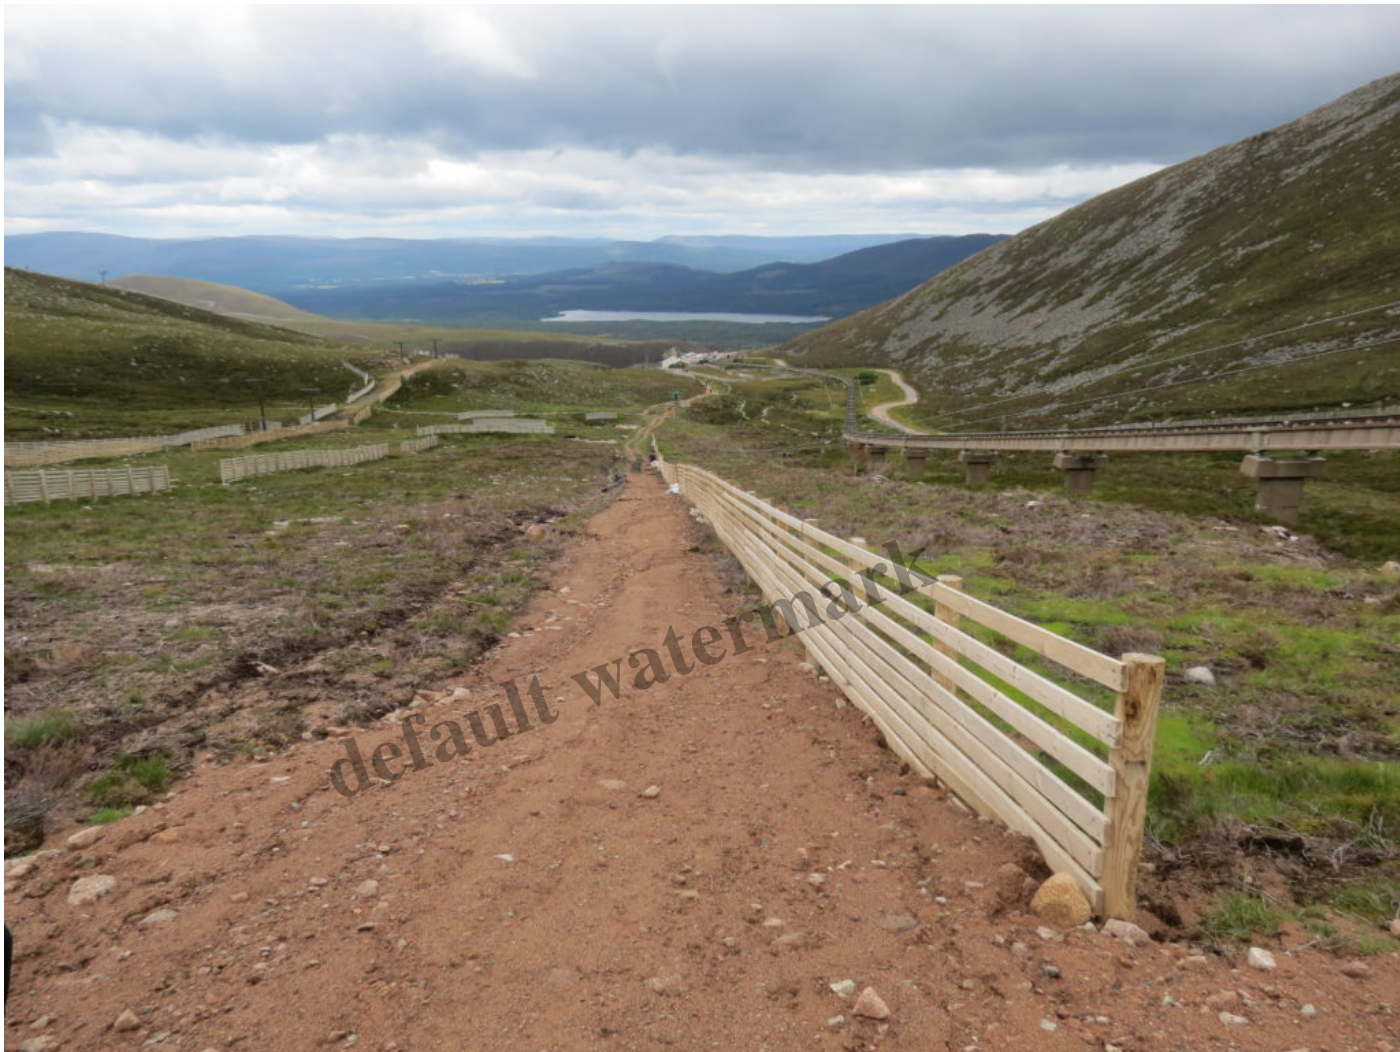
The straight lower section of the new track – in the far distance you can see where the middle of the track has been lined with a thin layer of soil and reseeded

After the media coverage of this track eroding away – water simply washes down it – Natural Retreats smoothed it out again and possibly added more material. It was already eroding again when I visited a week ago and the heavy rain since will have caused further damage.
