The sorry story of the destruction caused by the construction of the sheiling rope tow

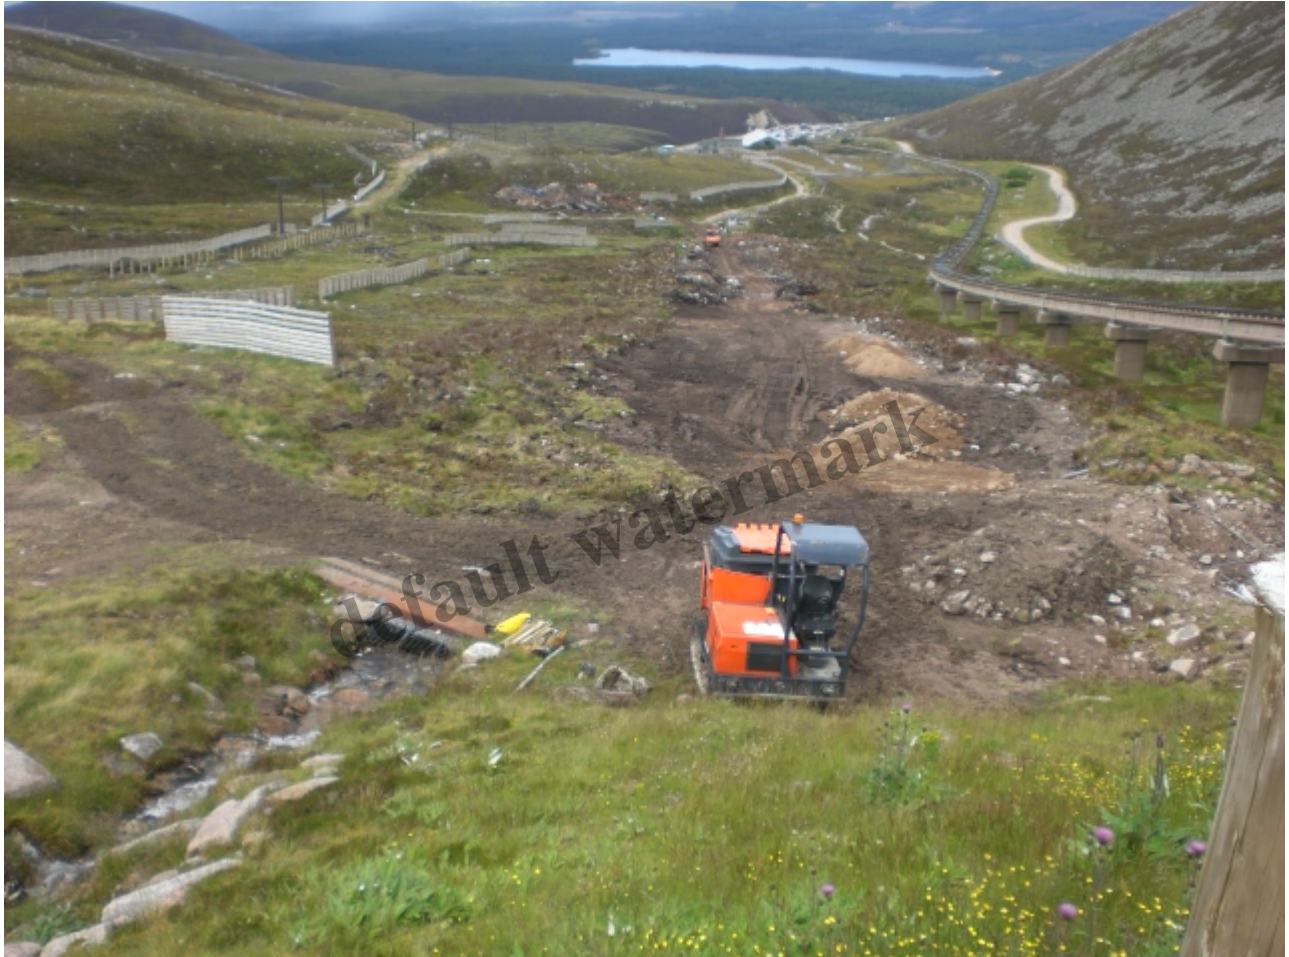
Work in progress on the Sheiling Poma 29th August 2015. Photo credit Alan Bratney

The planning permission that was granted to replace the shieling t-bar with a new lift, the sheiling rope tow, and to reprofile the slope was conditional on Natural Retreats keeping to the plans it had submitted, most of which were contained in the [Method Statement](#). The photo above provides proof that this was simply ignored: permission should have been clearly demarcated – it wasn't

- the works were supposed to be restricted to the area in the site plans (30m wide) – there is clear evidence of vehicles being driven over other vegetation which was supposed to be protected
- there is no sign of the terram mats on which the soil and aggregates were to be stored
- there is no sign of the turf having been removed and stored for re-use

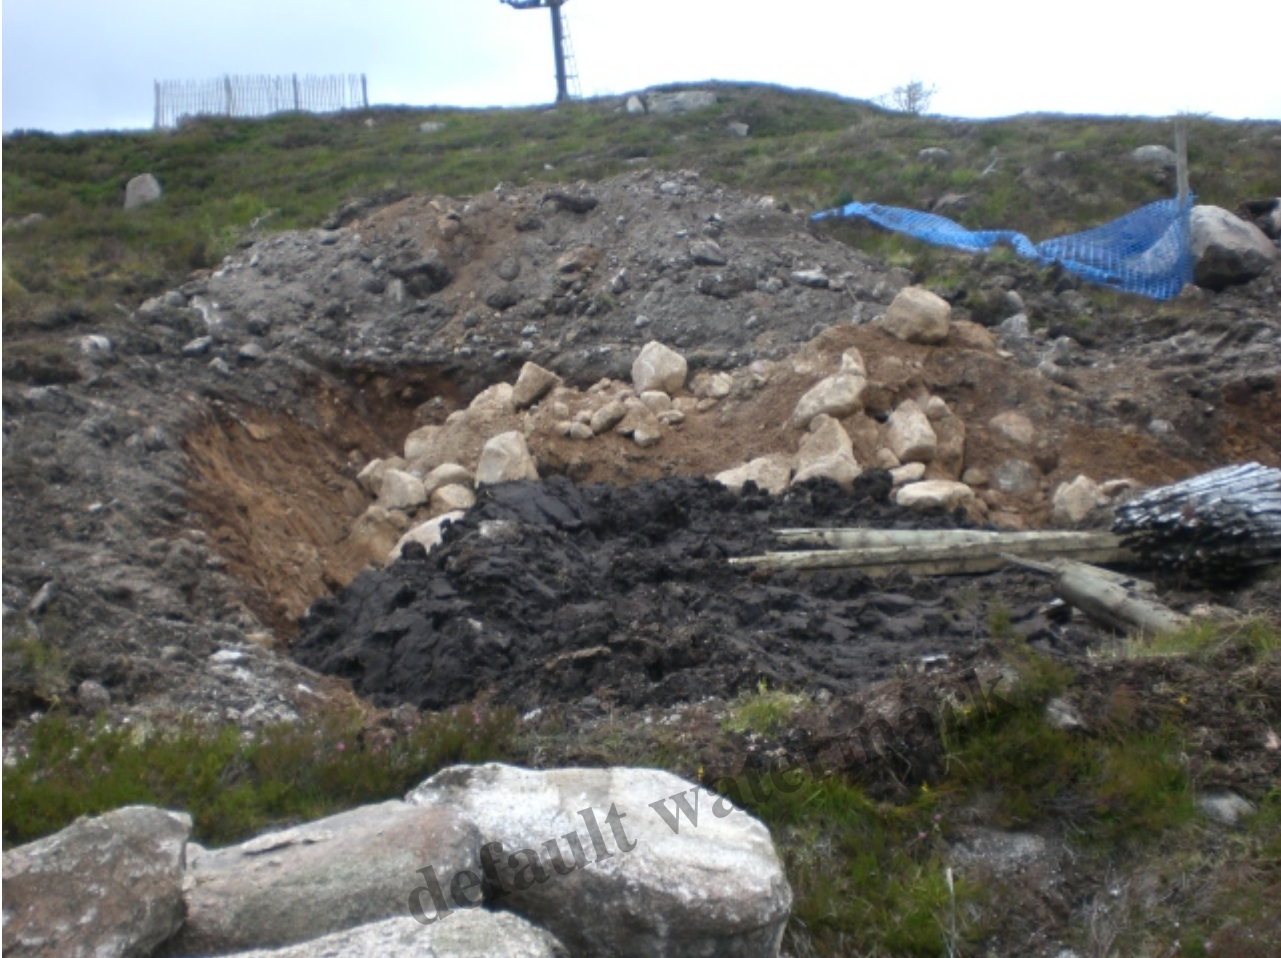
To make matters worse, the contractors removed the boulders from the ski slope – there is no mention of what should happen to them in the Method Statement – and buried them in a big hole that they dug

outside the area granted planning permission.

The backfilled hole – Car Park t-bar in background

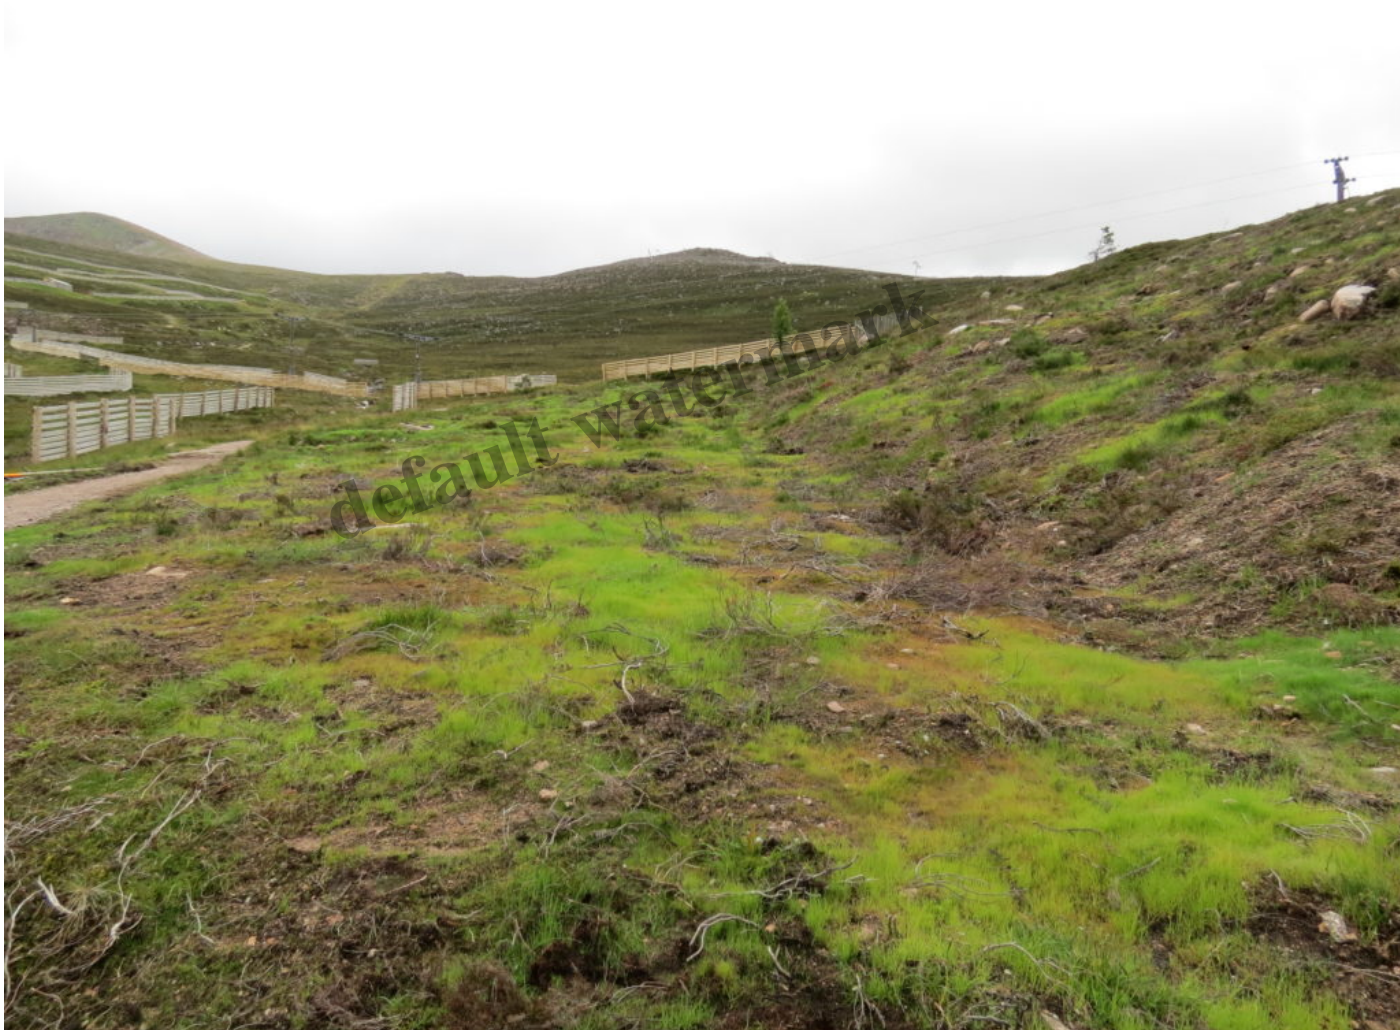
There is clear evidence of vegetation and peat being scooped out of the ground by the diggers, including areas which had been protected from machinery during the construction of the funicular. What was worthy of protection 1999-2001 is now apparently held to be of no account. There is also extensive evidence of slopes outwith the area granted planning permission being re-seeded. This would never have been required if turf and vegetation had not been removed outwith the planning permission that was granted.

Evidence of extensive re-seeding of areas outwith that granted planning permission

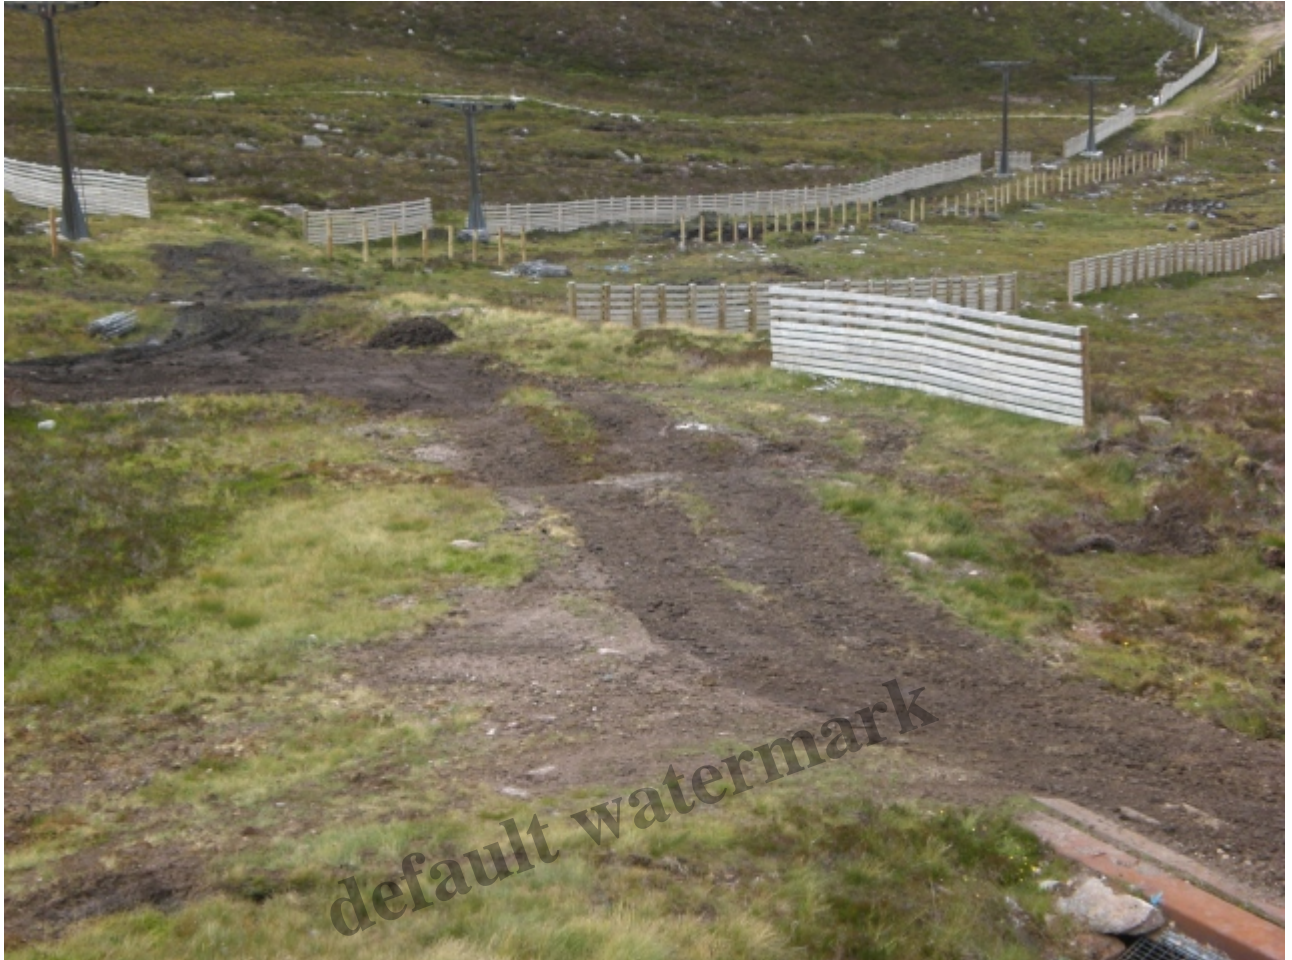
There was, however, still insufficient vegetation to cover the slopes and the constant and unnecessary movement of large vehicles had in any case eroded a trackline so what better solution to turn this into a new track and again hope no-one would notice?

The top part of the new track created by the constant passage of vehicles – photo credit Alan Bratney

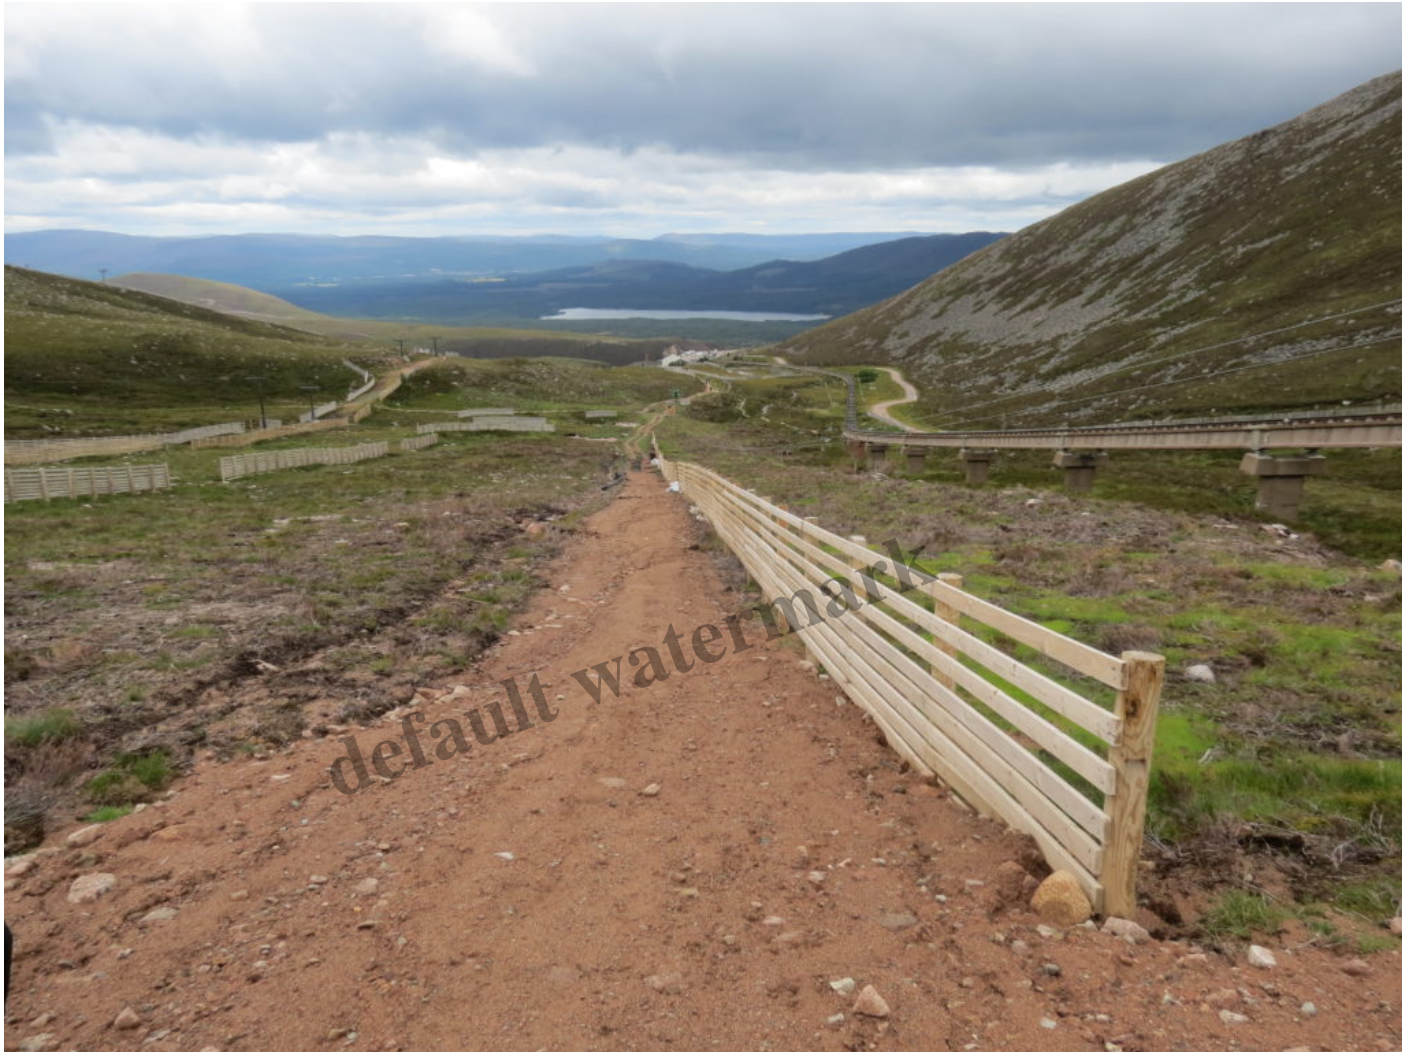
The straight lower section of the new track – in the far distance you can see where the middle of the track has been lined with a thin layer of soil and reseeded

After the media coverage of this track eroding away – water simply washes down it – Natural Retreats smoothed it out again and possibly added more material. It was already eroding again when I visited a week ago and the heavy rain since will have caused further damage.
