Compare and contrast Natural Retreats claims with the evidence

The claims

The evidence from yesterday

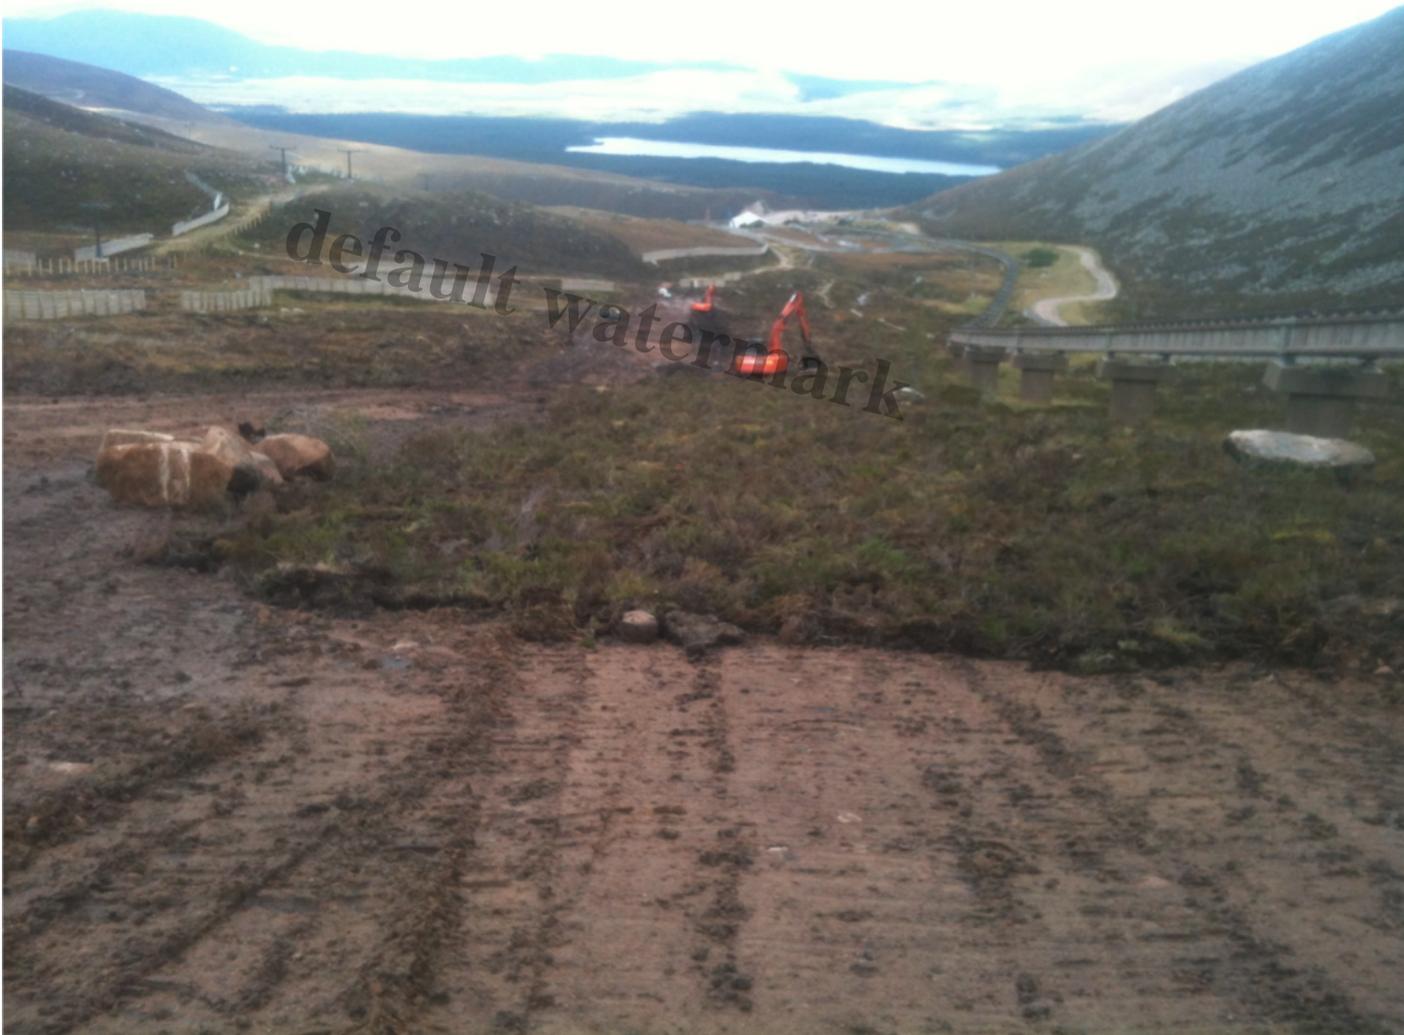
Image showing reinstatement of turf on new ground contours prior to lift installation Oct 2015. Track on left of work site retained to move materials and ski lift components avoiding tracking on reinstated vegetation.

Natural Retreats provided this photo in their [supporting statement](#) to the Cairngorms National Park Authority for retrospective planning application for the new track they created at Cairngorm. If the ground had been restored as well as this photo suggests, the heather would now be in bloom the reality is rather different.

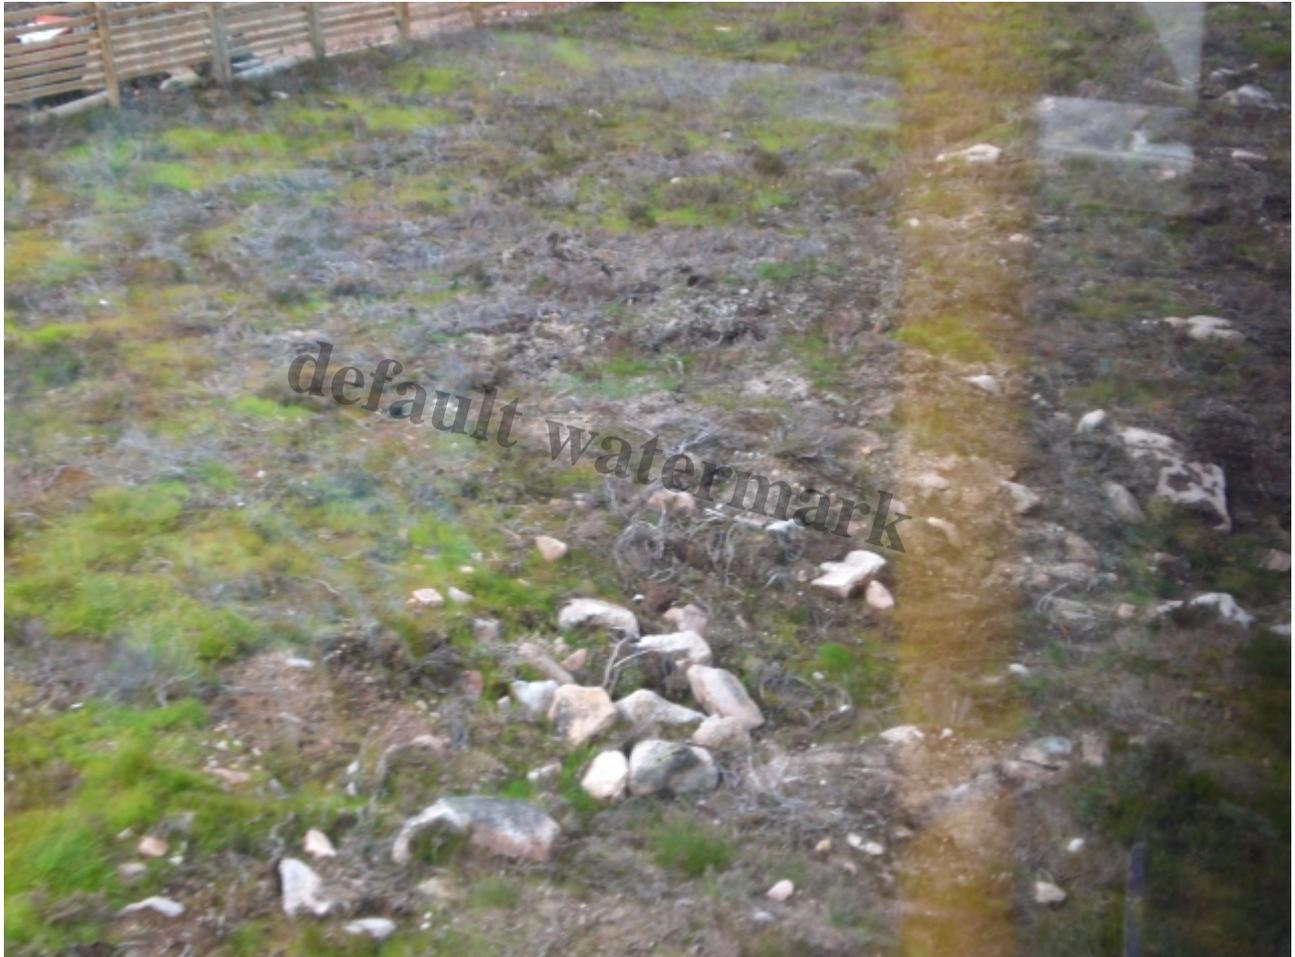
Photo credit Alan

No sign of blooming heather, in fact most of it is dead.
Bratney

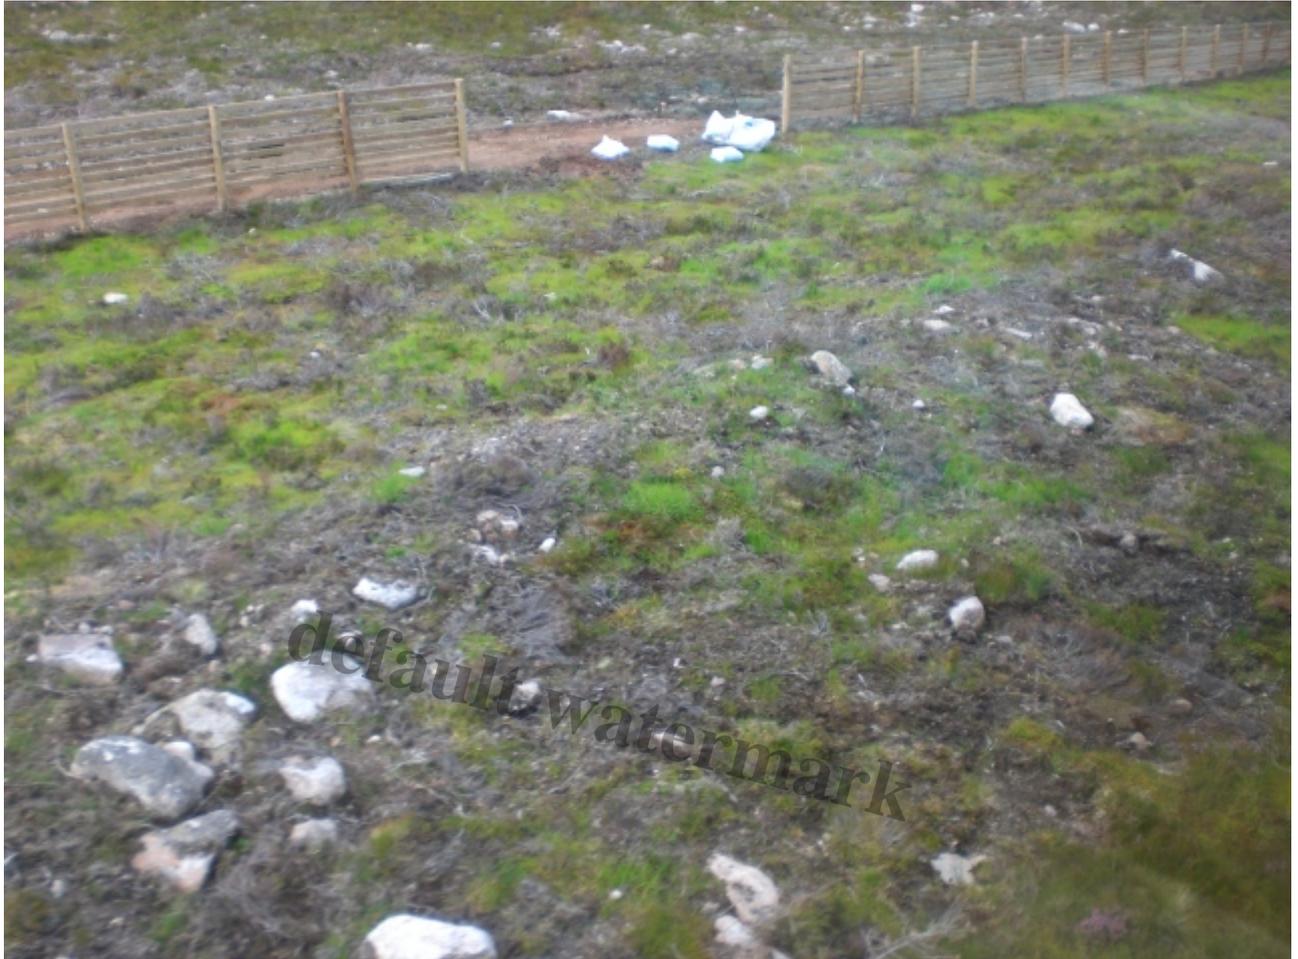
Why, if the restoration was as effective as appears to be shown in the Natural Retreats photo, has such extensive re-seeding (the bright green is the newly sown grass) been required? Photo credit Alan Bratney.

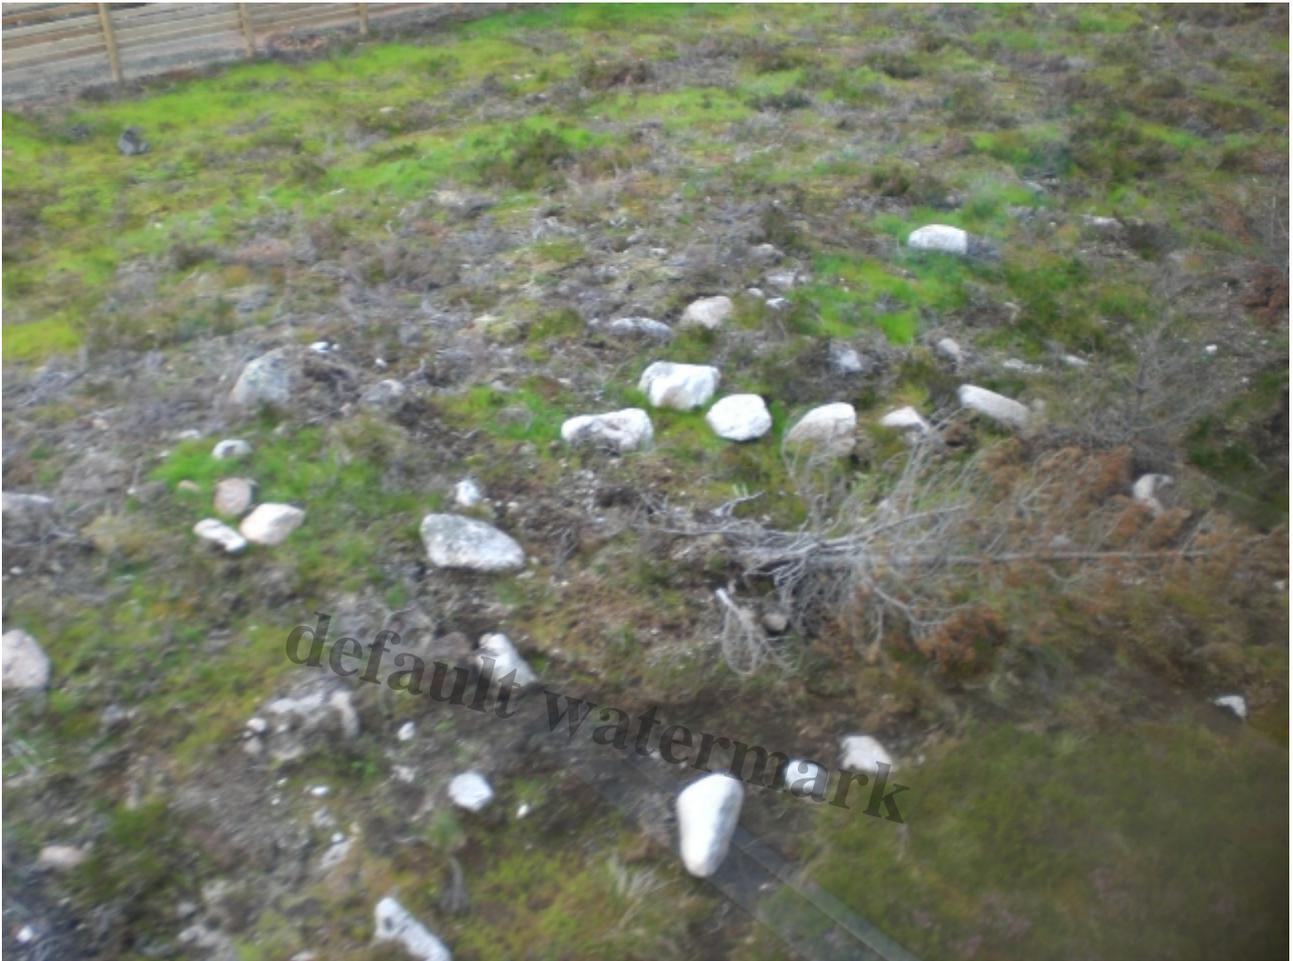
And how did this tree end up on its side and dying? You can see evidence on the ground that suggests it was knocked over by an earth moving machine â?? perhaps someone got a bit careless when scattering these boulders? Photo Credit Alan Bratney

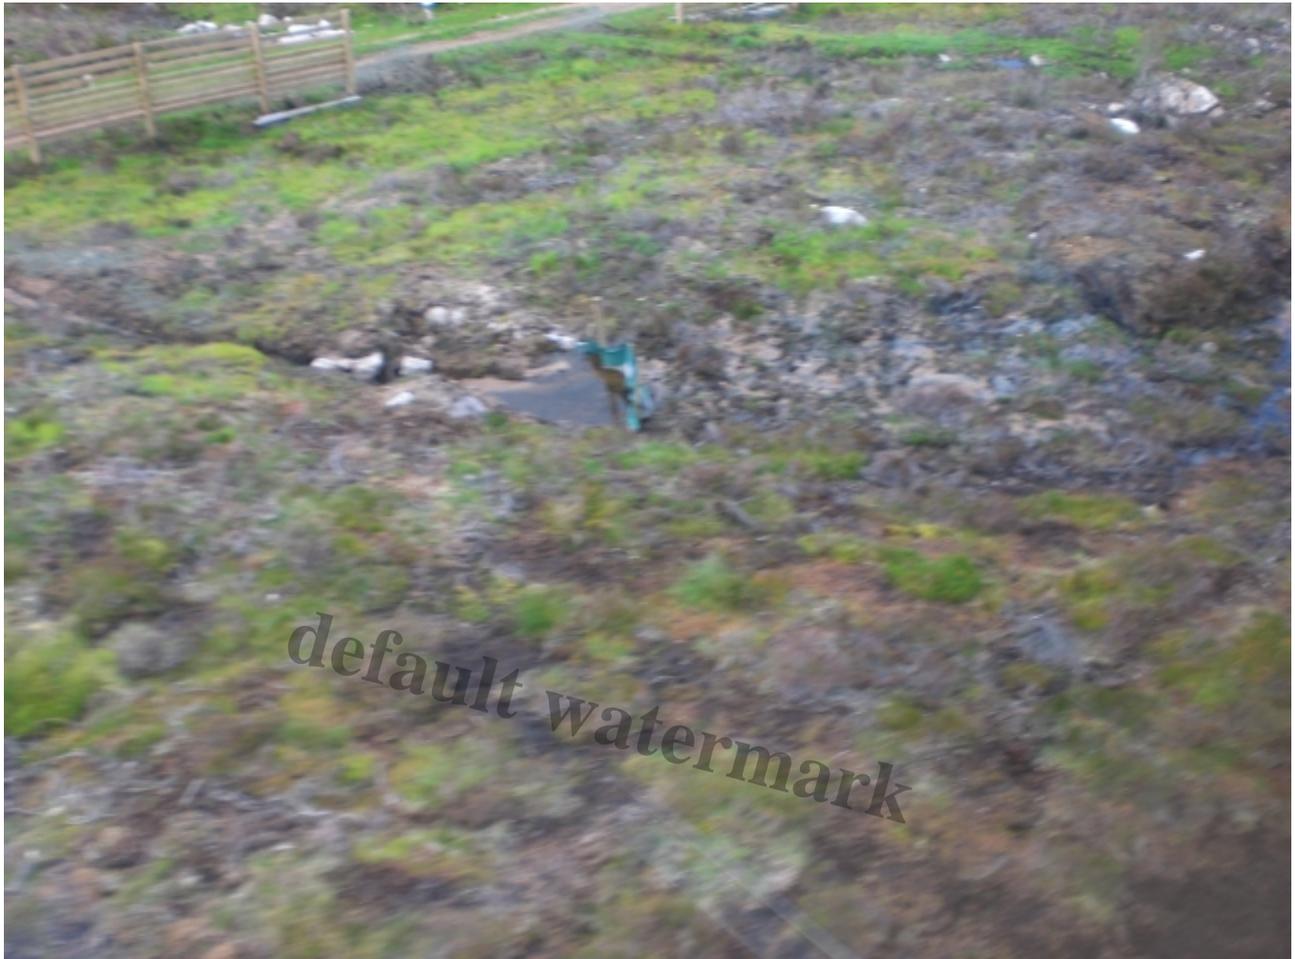
The machinery has turned the bottom of the rope slope into a quagmire. It might now turn into a bog but the whole reason for the CNPA granting planning permission to reprofile was to make it better for skiing and remove the old bulldozed tow line. Photo Credit Alan Bratney

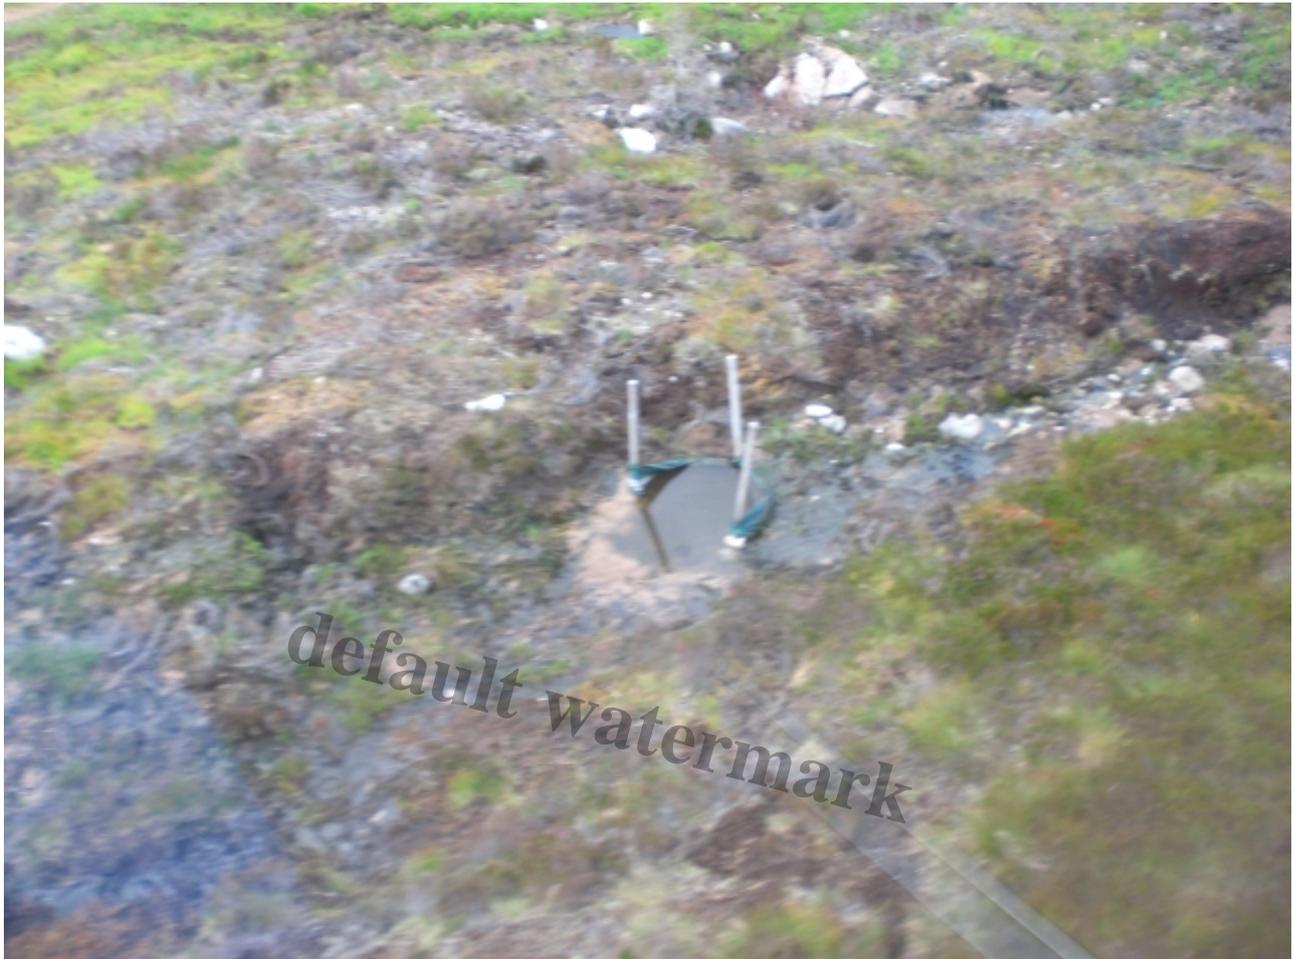
Part of the problem is Natural Retreats has simply failed to empty the silt traps required by the Scottish Environment Protection Agency. Unfortunately SEPA appears to believe Natural Retreats's claims that these are emptied on a daily basis. Photo Credit Alan Bratney.

- stop all off-road use of vehicles in the ski area without consent
- stop all further earth works at Cairngorms, whether requiring planning permission or not, until a proper plan is produced for the area. Any future works should be subject to outside and independent scrutiny/supervision
- CNPA should require Natural Retreats and HIE to pay for a fully independent ecological survey on the extent of the damage and options for restoration and meantime reject the current planning application for a track.

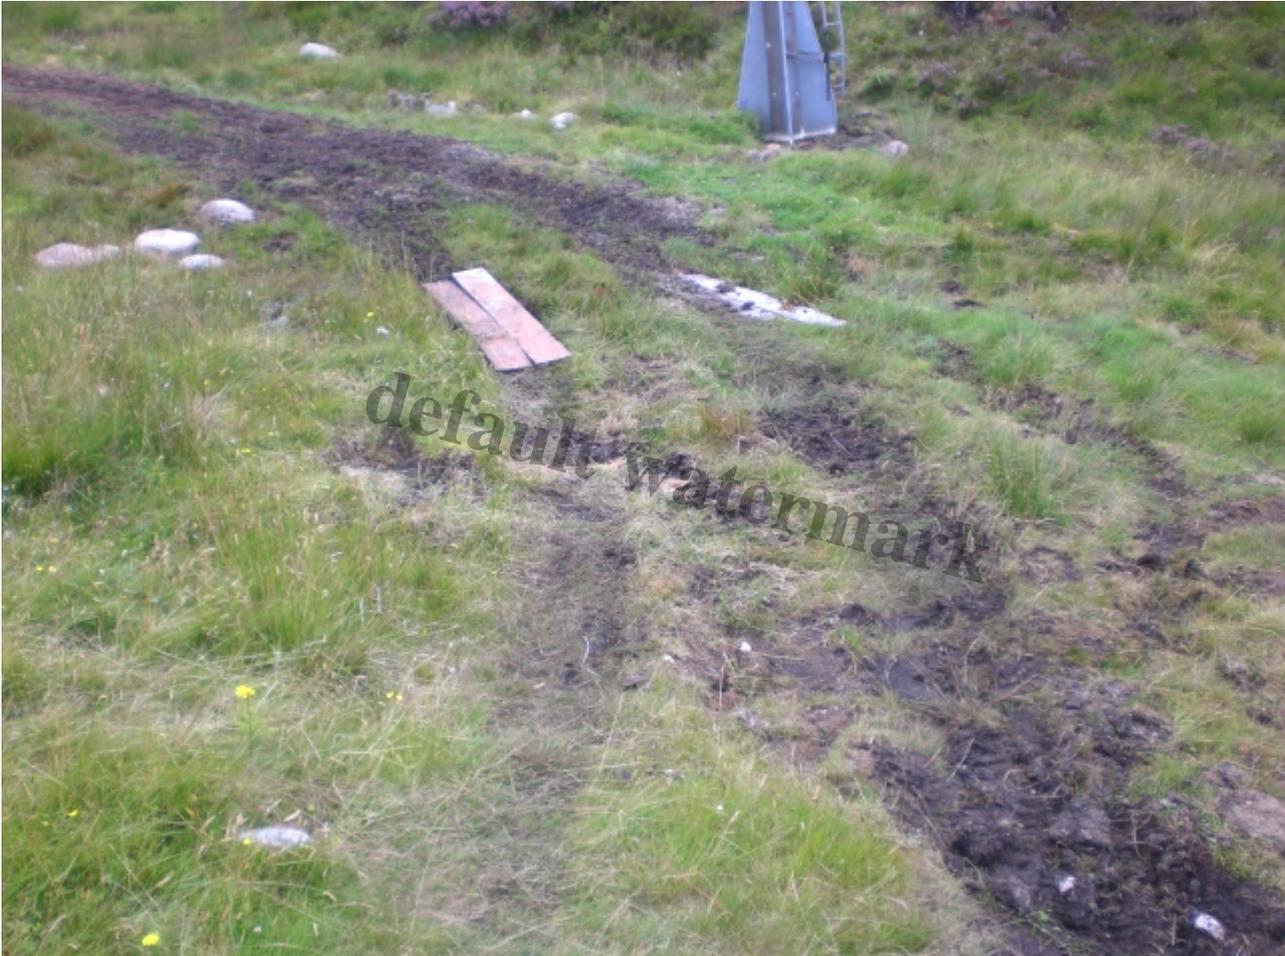
It was easier for Natural Retreats to dump a couple of planks to help their vehicles get across boggy ground rather than use the new track which they claim was needed to prevent this happening! Photo Credit Alan Bratley

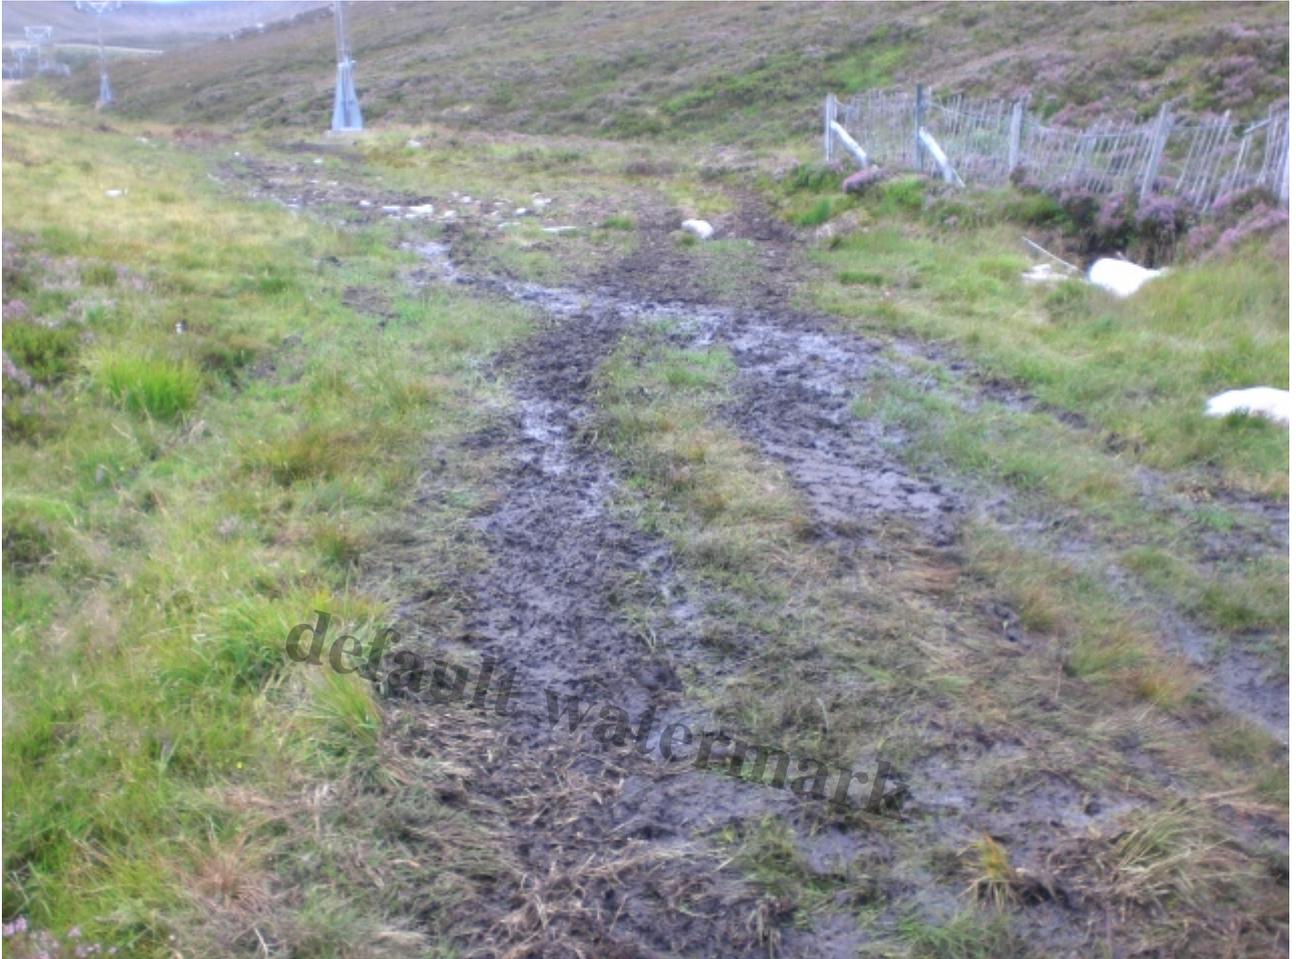
Photo credit Alan Bratney

Parkswatch has [already](#) published photographic evidence of vehicles driving down the line of the carpark tow damaging the ground which Natural Retreats claim has been "restored". These were taken at a distance so here are some from closer up which show what has happened.
