Compare and contrast Natural Retreats claims with the evidence

Natural Retreats further claims about car park ski tow

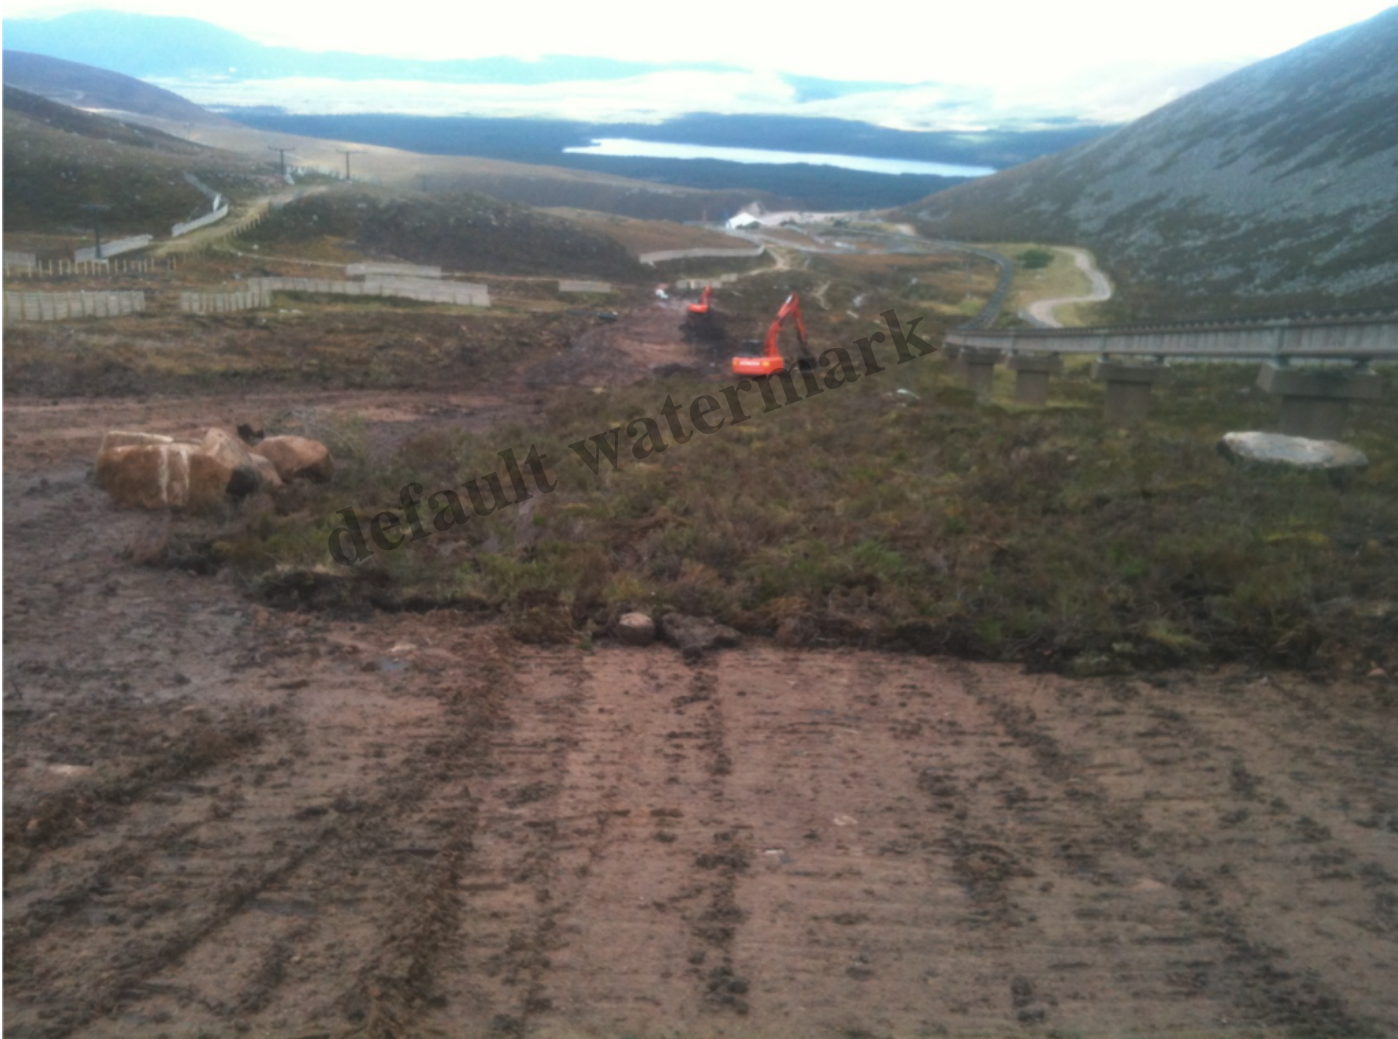
“Image showing reinstatement of turf on new ground contours prior to lift installation Oct 2015. Track on left of work site retained to move materials and ski lift components avoiding tracking on reinstated vegetation”.

Natural Retreats provided this photo in their [supporting statement](#) to the Cairngorms National Park Authority for retrospective planning application for the new track they created at Cairngorm. If the ground had been restored as well as this photo suggests, the heather would now be in bloom – the reality is rather different.

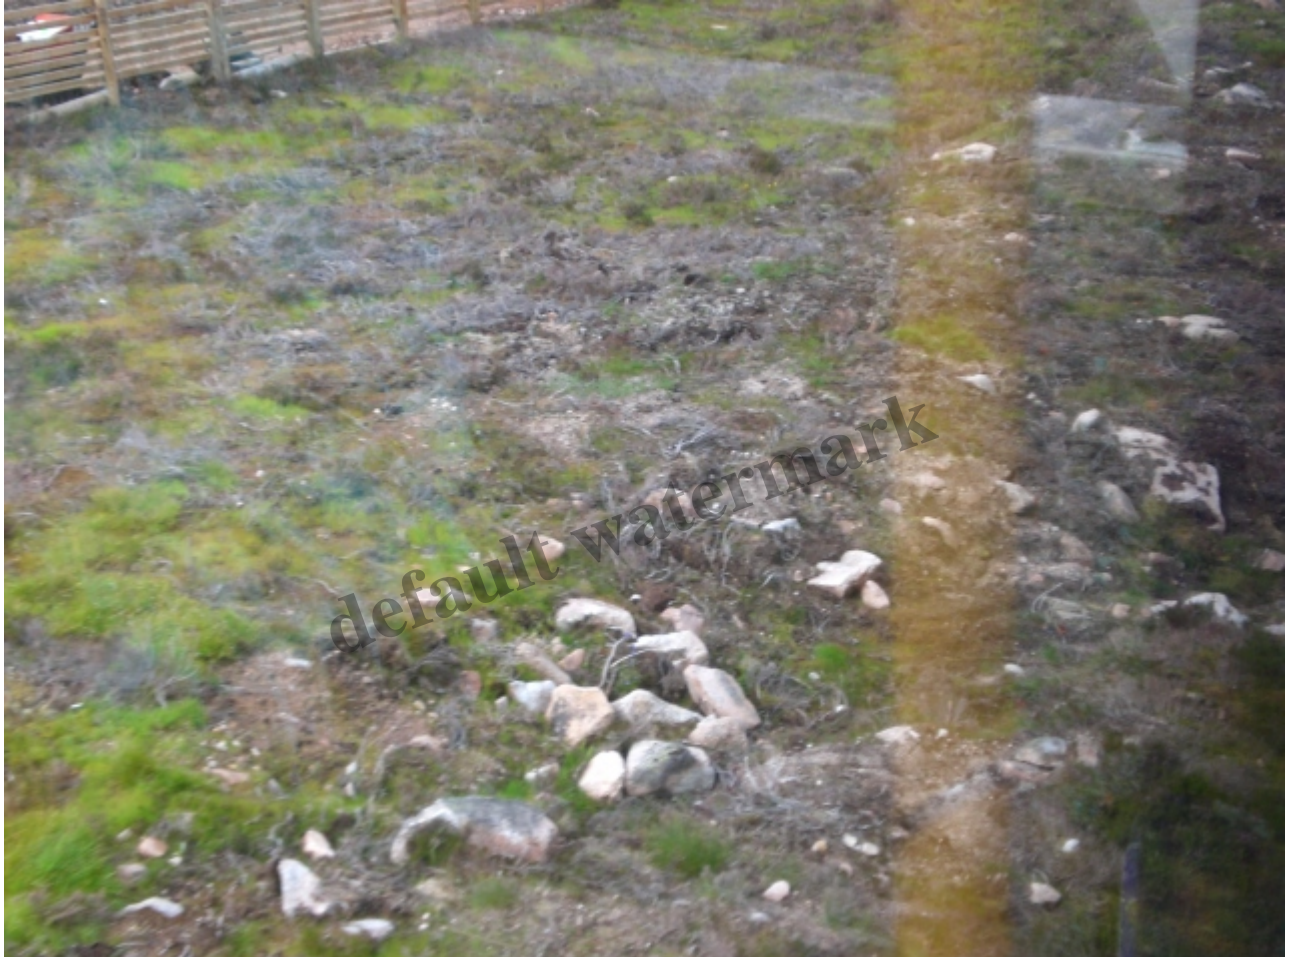
No sign of blooming heather, in fact most of it is dead.
Bratney

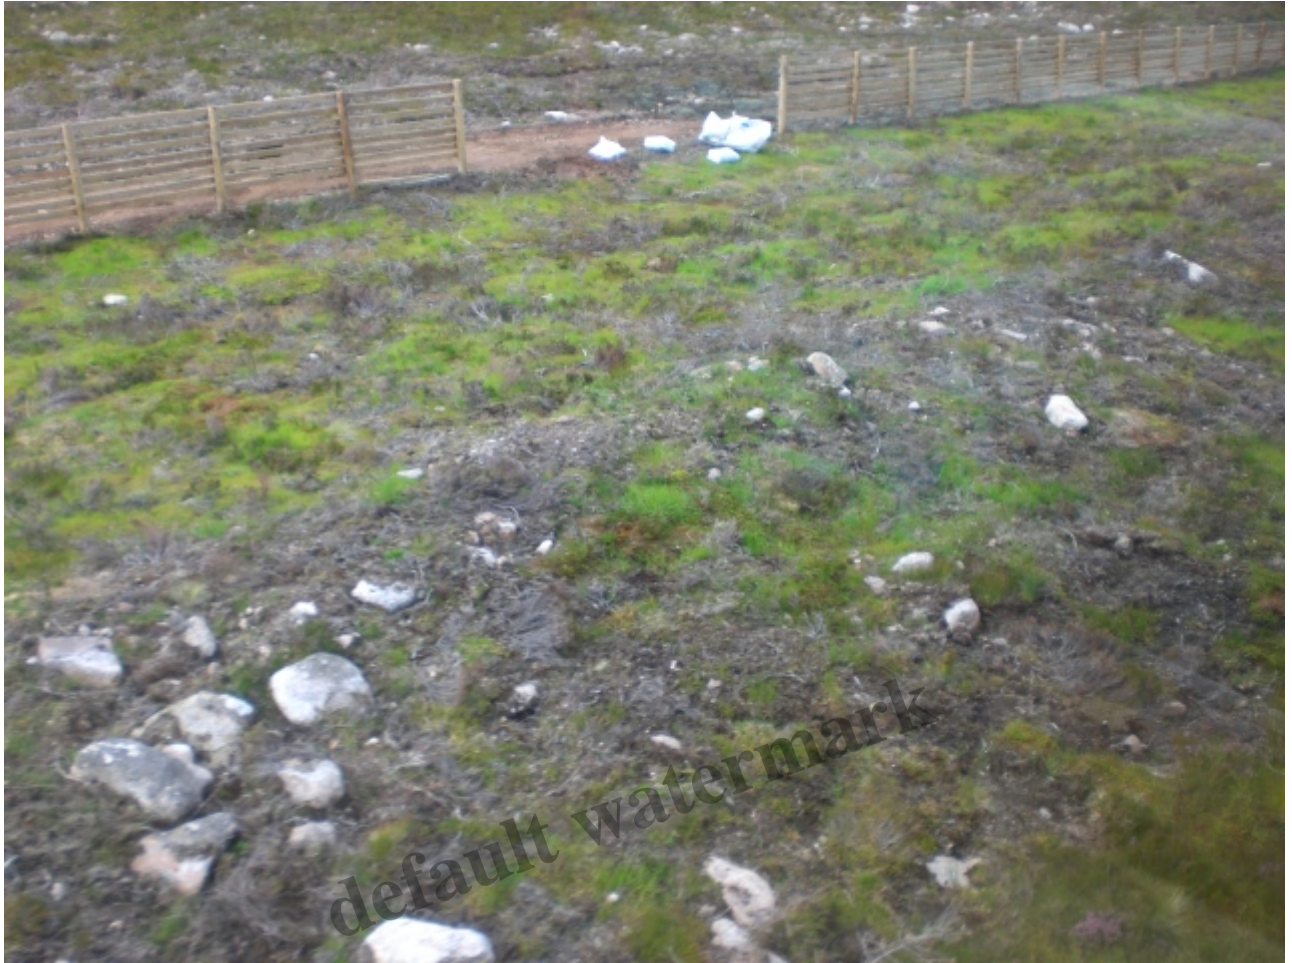
Why, if the restoration was as effective as appears to be shown in the Natural Retreats photo, has such extensive re-seeding (the bright green is the newly sown grass) been required? Photo credit Alan Bratney.

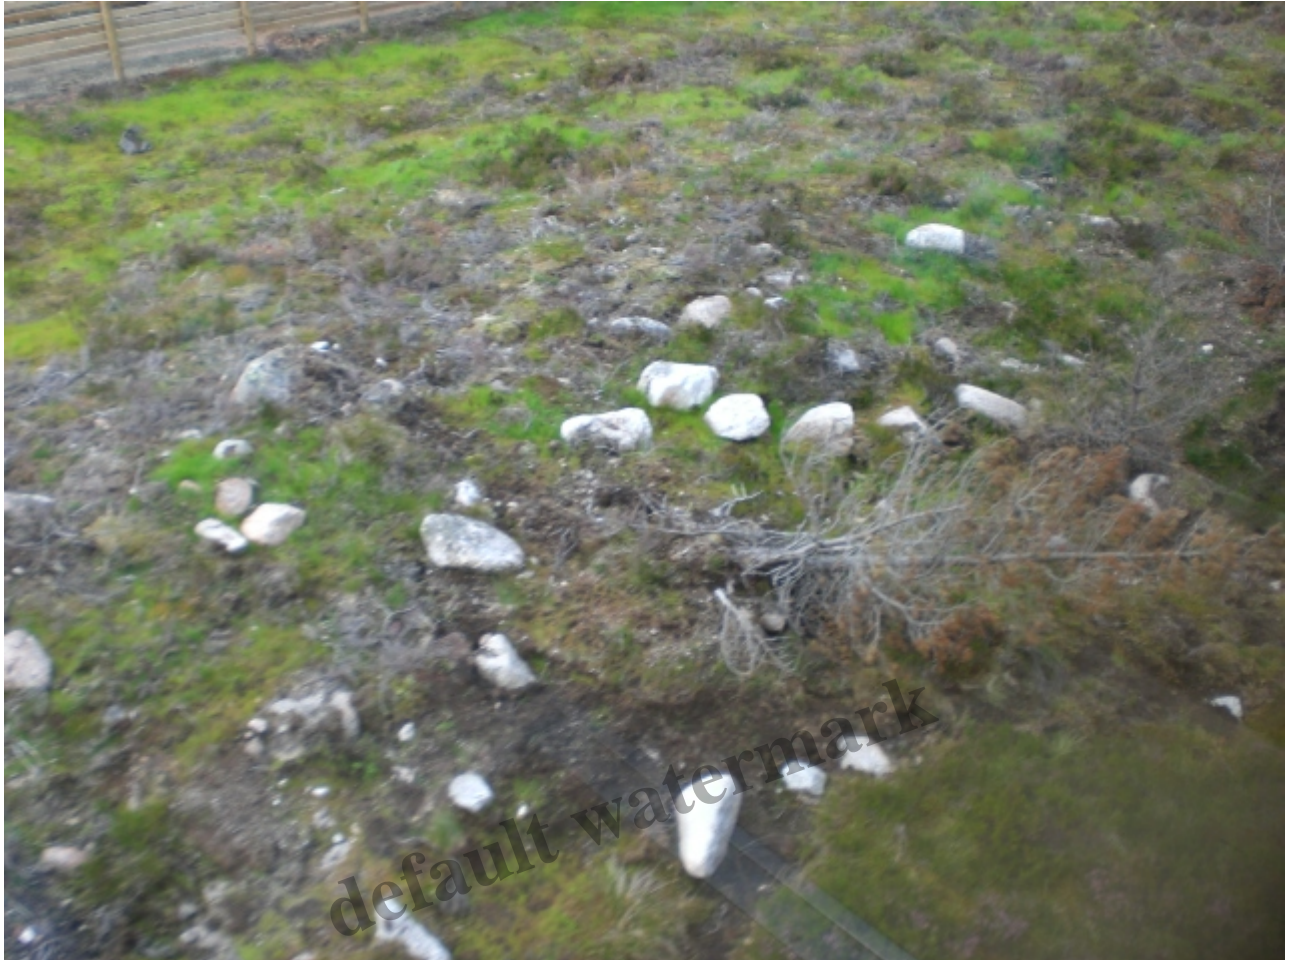
And how did this tree end up on its side and dying? You can see evidence on the ground that suggests it was knocked over by an earth moving machine – perhaps someone got a bit careless when scattering these boulders? Photo Credit Alan Bratney

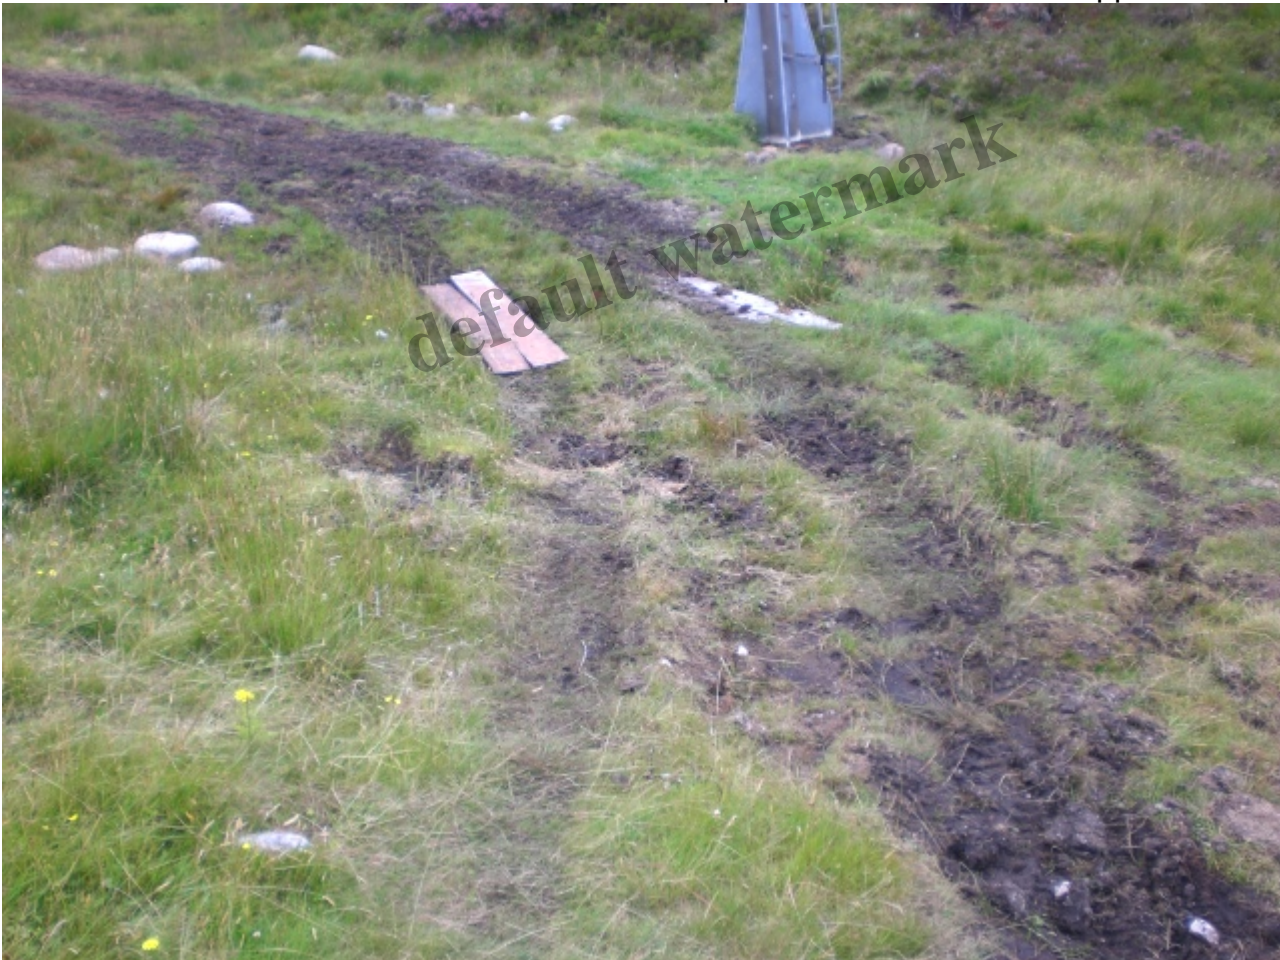
It was easier for Natural Retreats to dump a couple of planks to help their vehicles get across boggy ground rather than use the new track which they claim was needed to prevent this happening! Photo Credit Alan Bratney

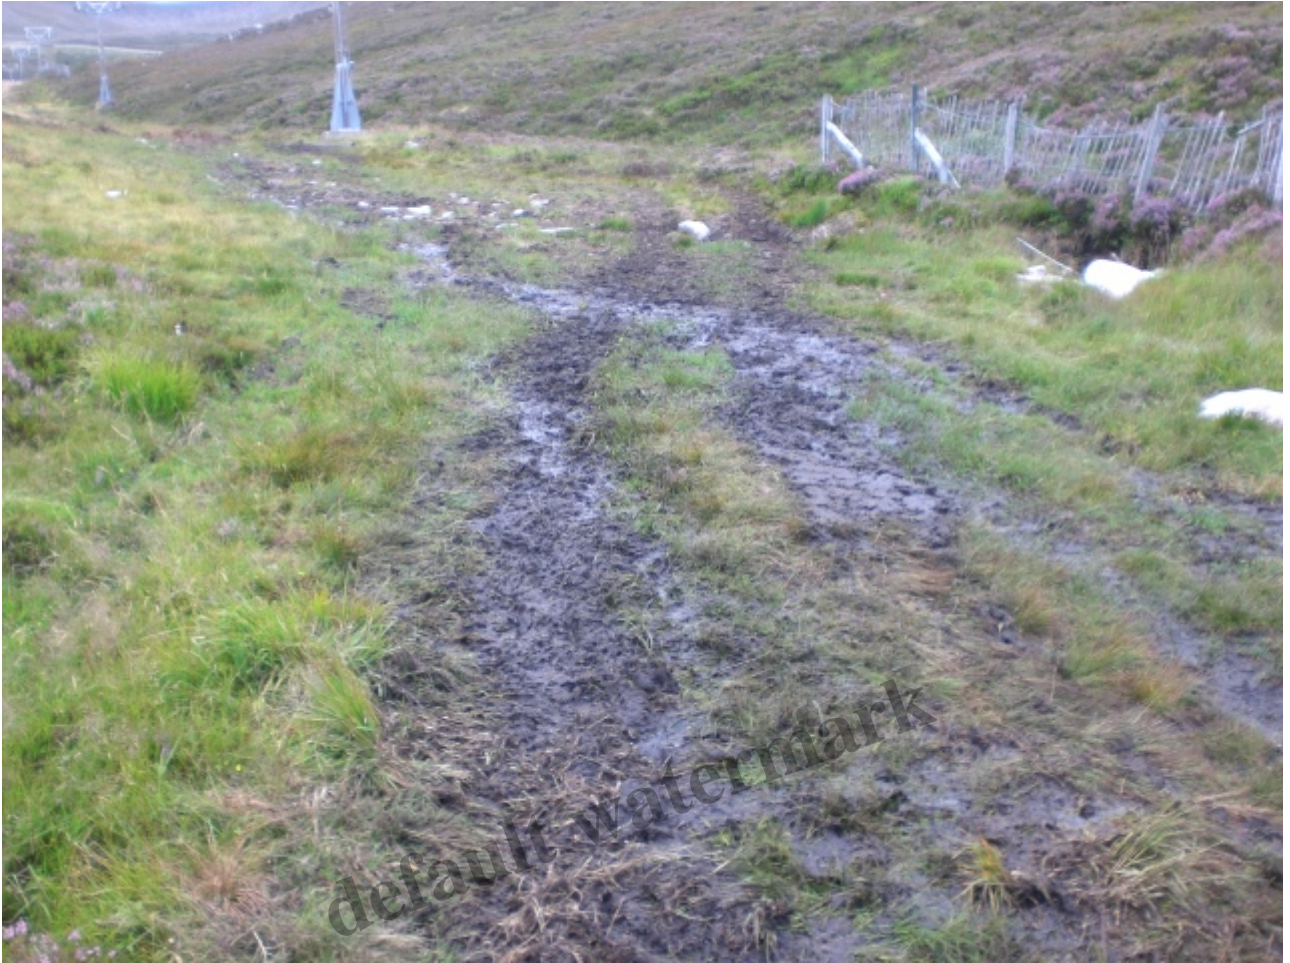
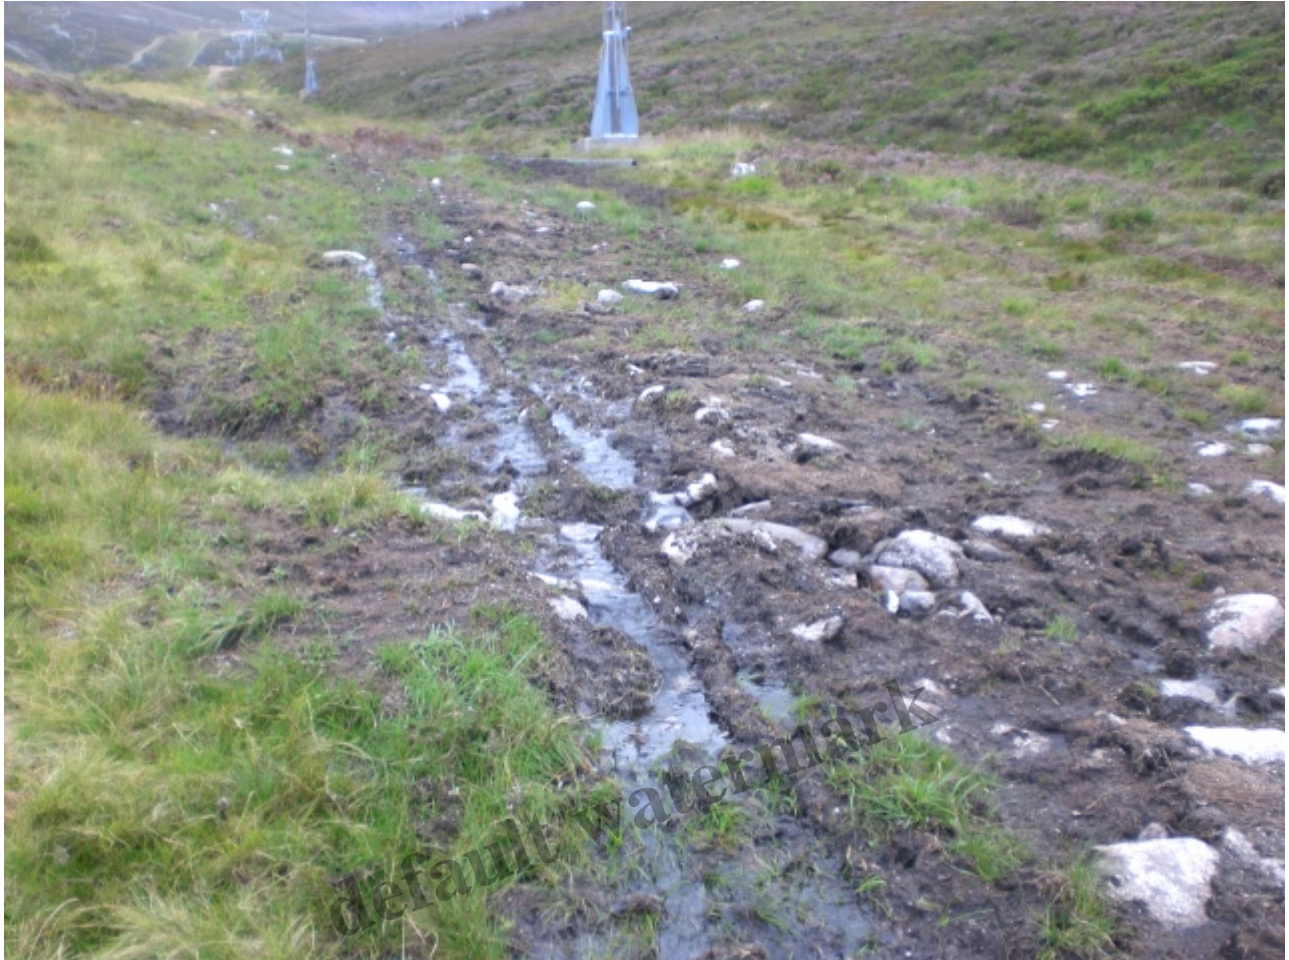
Parkswatch has [already](#) published photographic evidence of vehicles driving down the line of the carpark tow damaging the ground which Natural Retreats claim has been “restored”. These were taken at a distance so here are some from closer up which show what has happened.

- stop all off-road use of vehicles in the ski area without consent
- stop all further earth works at Cairngorms, whether requiring planning permission or not, until a proper plan is produced for the area. Any future works should be subject to outside and independent scrutiny/supervision
- CNPA should require Natural Retreats and HIE to pay for a fully independent ecological survey on the extent of the damage and options for restoration and meantime reject the current planning application for a track.
