Compare and contrast Natural Retreats claims with the evidence

# The claims

## The evidence from yesterday

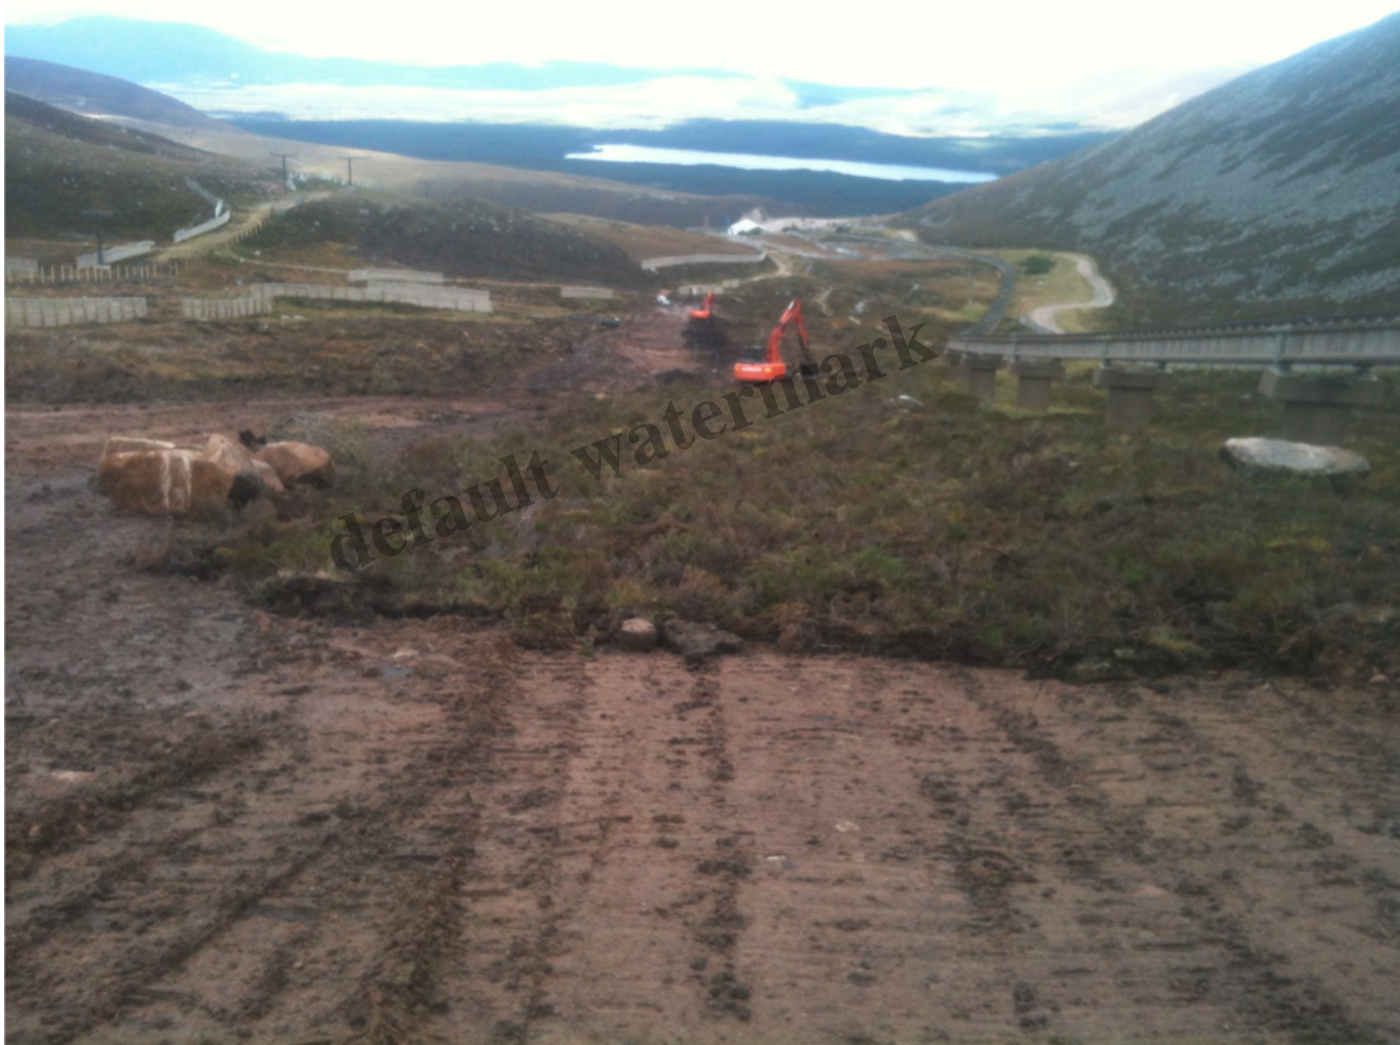
“Image showing reinstatement of turf on new ground contours prior to lift installation Oct 2015. Track on left of work site retained to move materials and ski lift components avoiding tracking on reinstated vegetation”.

Natural Retreats provided this photo in their [supporting statement](#) to the Cairngorms National Park Authority for retrospective planning application for the new track they created at Cairngorm. If the ground had been restored as well as this photo suggests, the heather would now be in bloom – the reality is rather different.

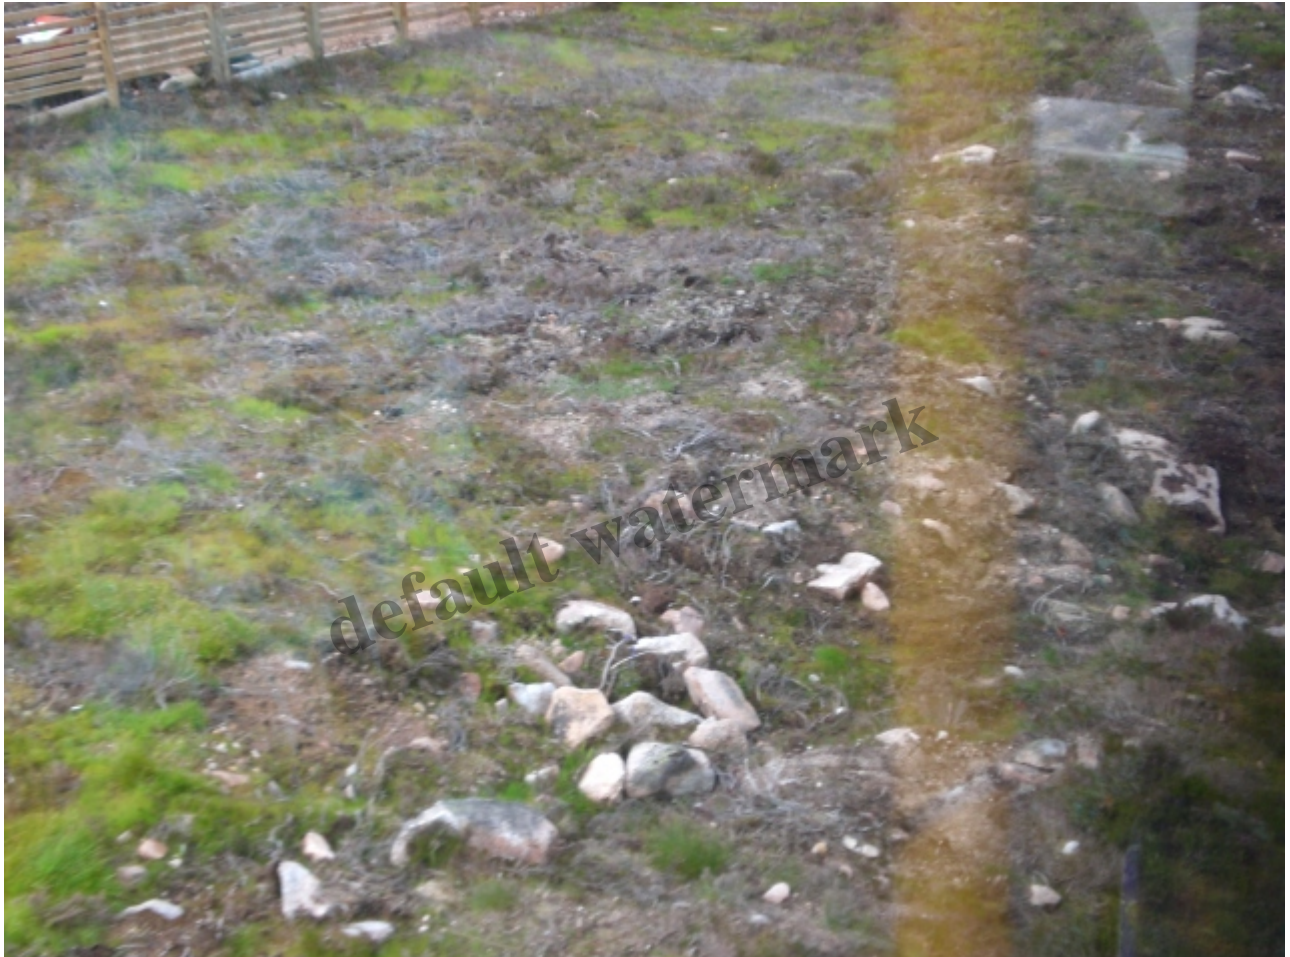
No sign of blooming heather, in fact most of it is dead.  
Bratney

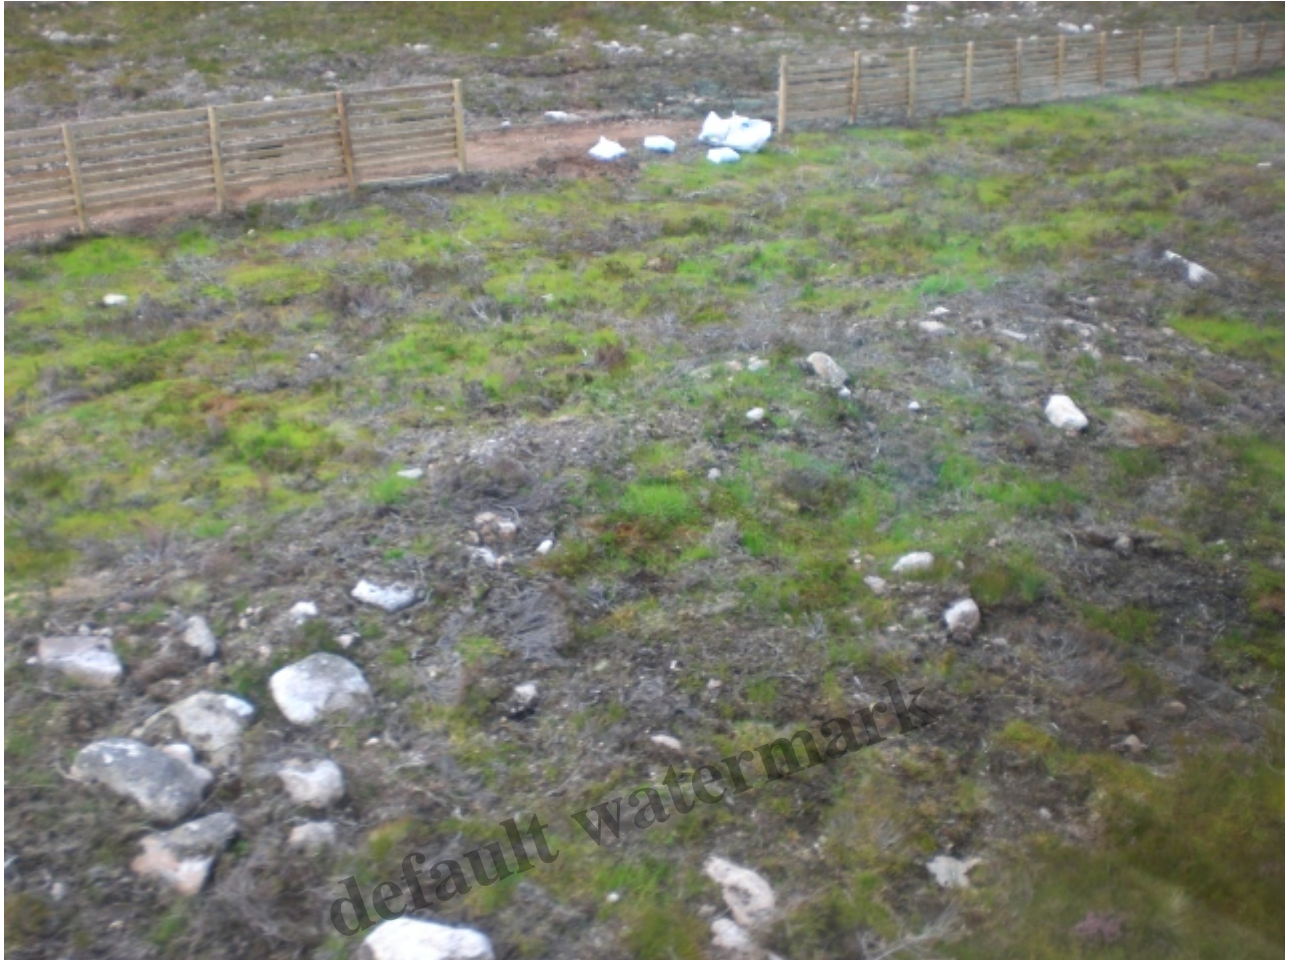
Why, if the restoration was as effective as appears to be shown in the Natural Retreats photo, has such extensive re-seeding (the bright green is the newly sown grass) been required? Photo credit Alan Bratney.

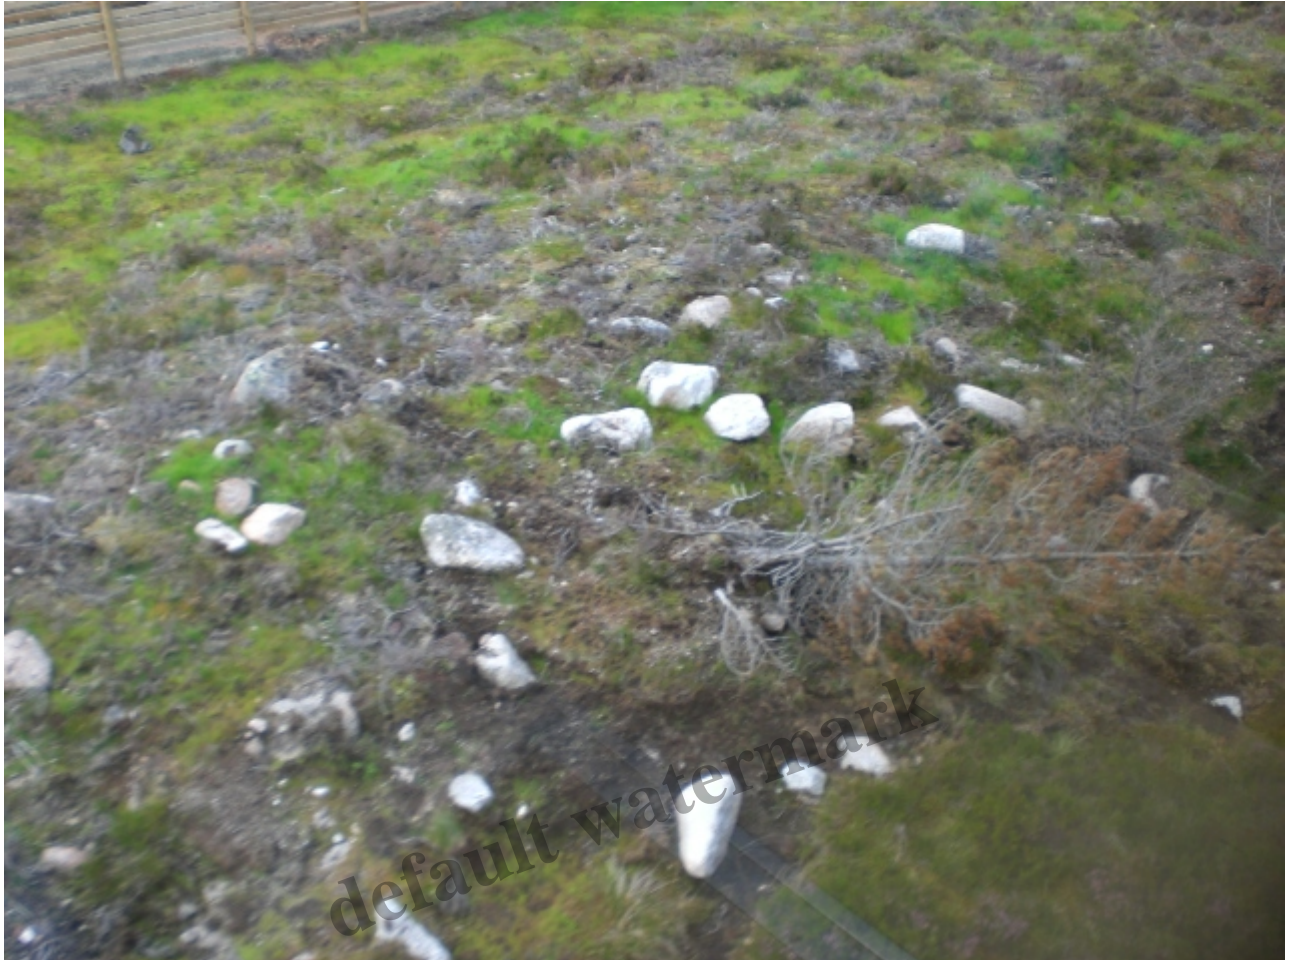
And how did this tree end up on its side and dying? You can see evidence on the ground that suggests it was knocked over by an earth moving machine – perhaps someone got a bit careless when scattering these boulders? Photo Credit Alan Bratney

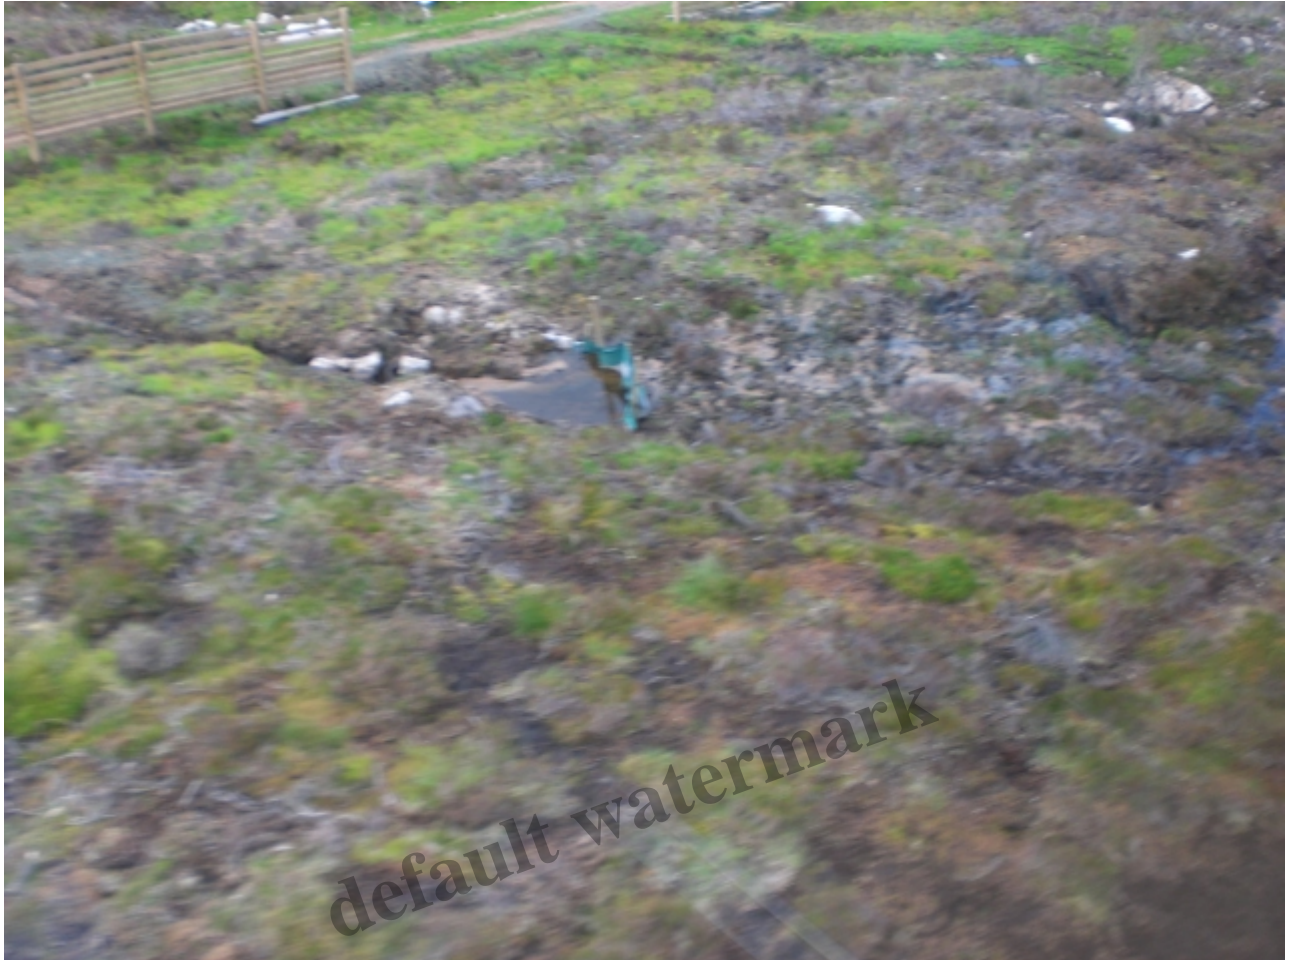
The machinery has turned the bottom of the rope slope into a quagmire. It might now turn into a bog but the whole reason for the CNPA granting planning permission to reprofile was to make it better for skiing and remove the old bulldozed tow line. Photo Credit Alan Bratney

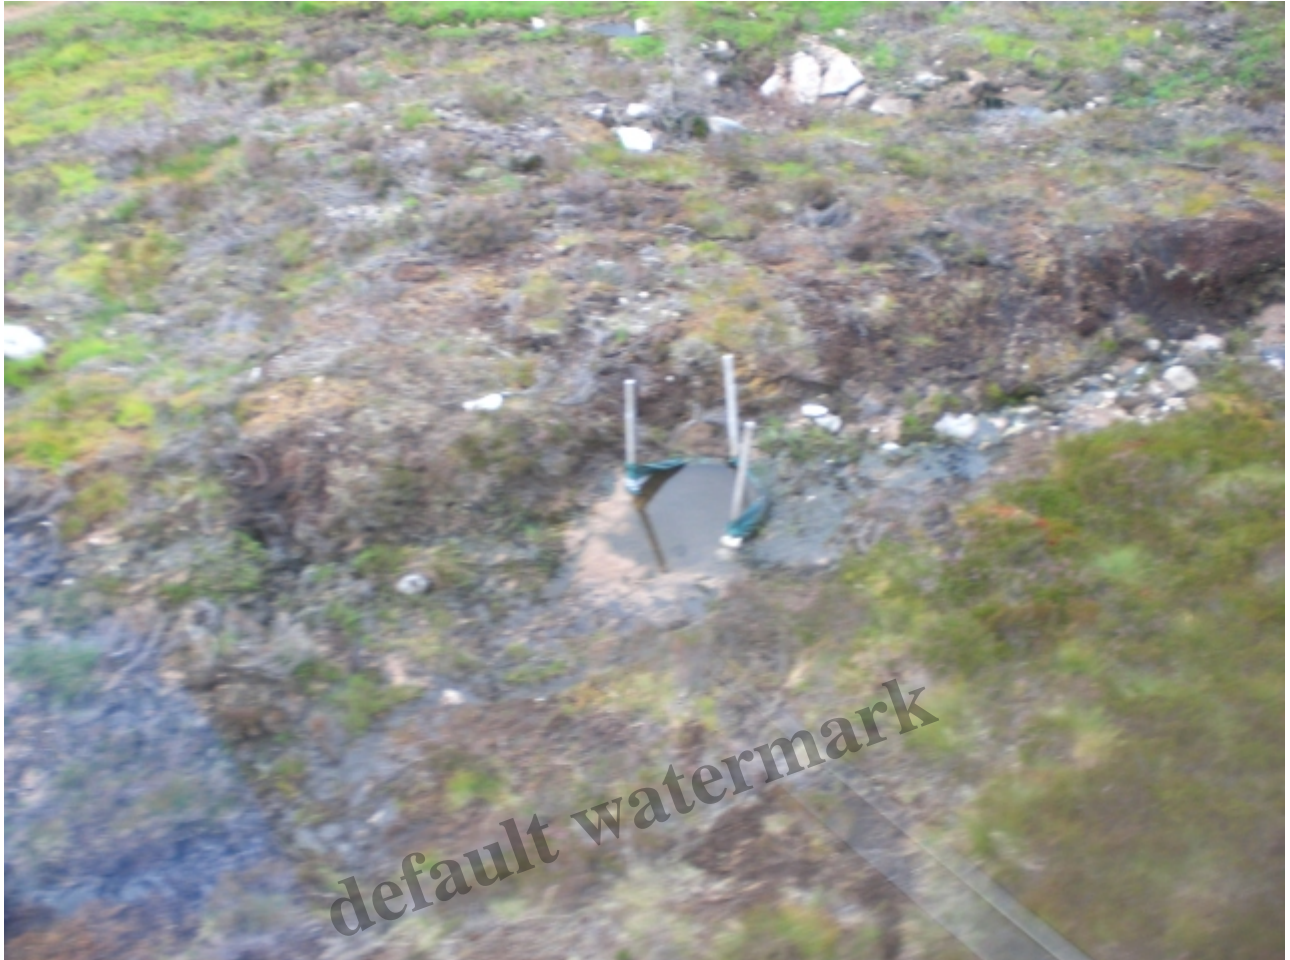
Part of the problem is Natural Retreats has simply failed to empty the silt traps required by the Scottish Environment Protection Agency. Unfortunately SEPA appears to believe Natural Retreats' claims that these are emptied on a daily basis. Photo Credit Alan Bratney.

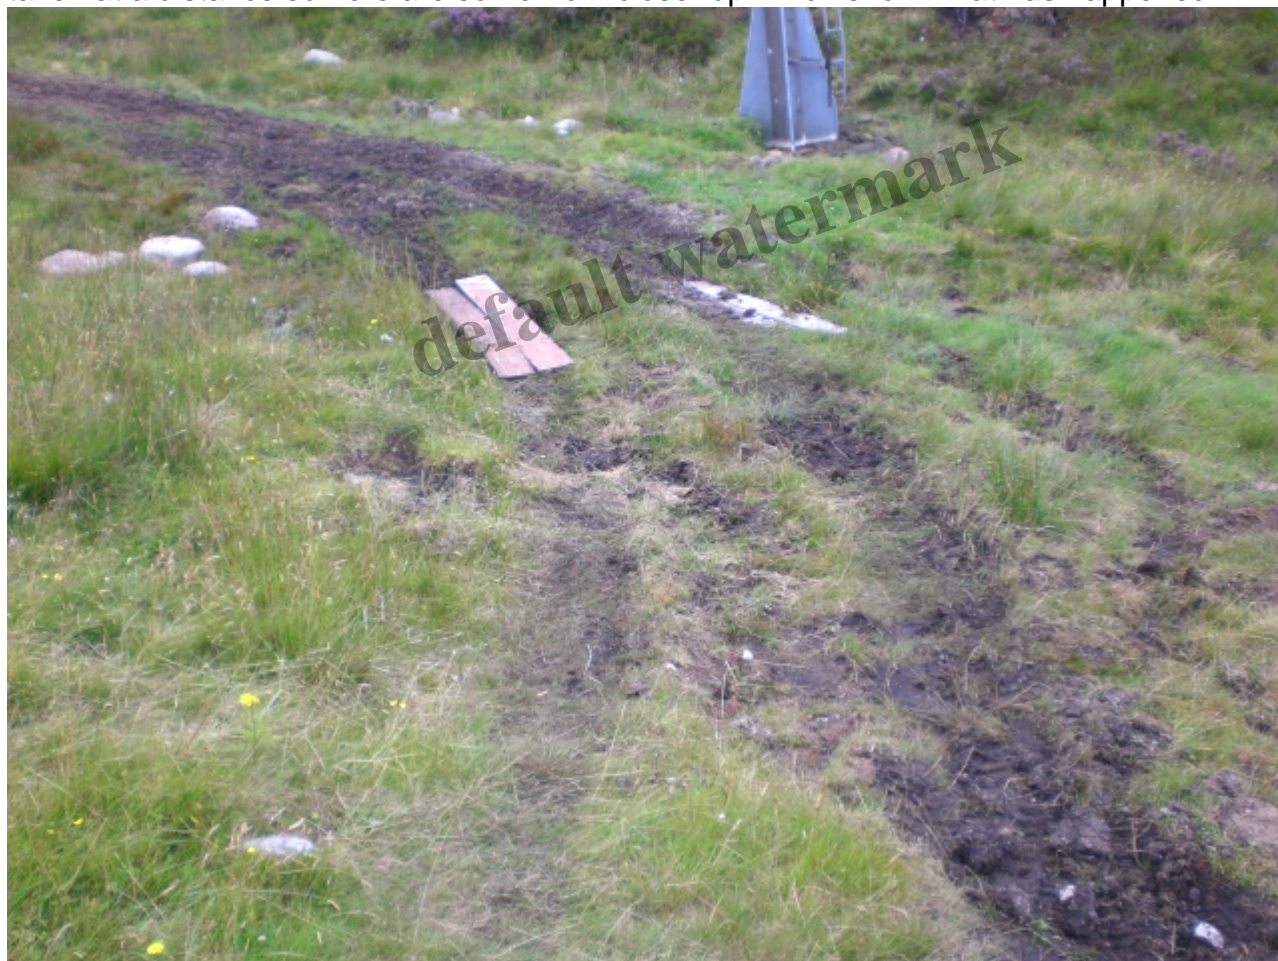
It was easier for Natural Retreats to dump a couple of planks to help their vehicles get across boggy ground rather than use the new track which they claim was needed to prevent this happening! Photo Credit Alan Bratney
