Natural Retreats Cairngorm report card

The Car Park T-Bar

The Coire Cas T-bar gantry works

The Shieling Rope Tow area

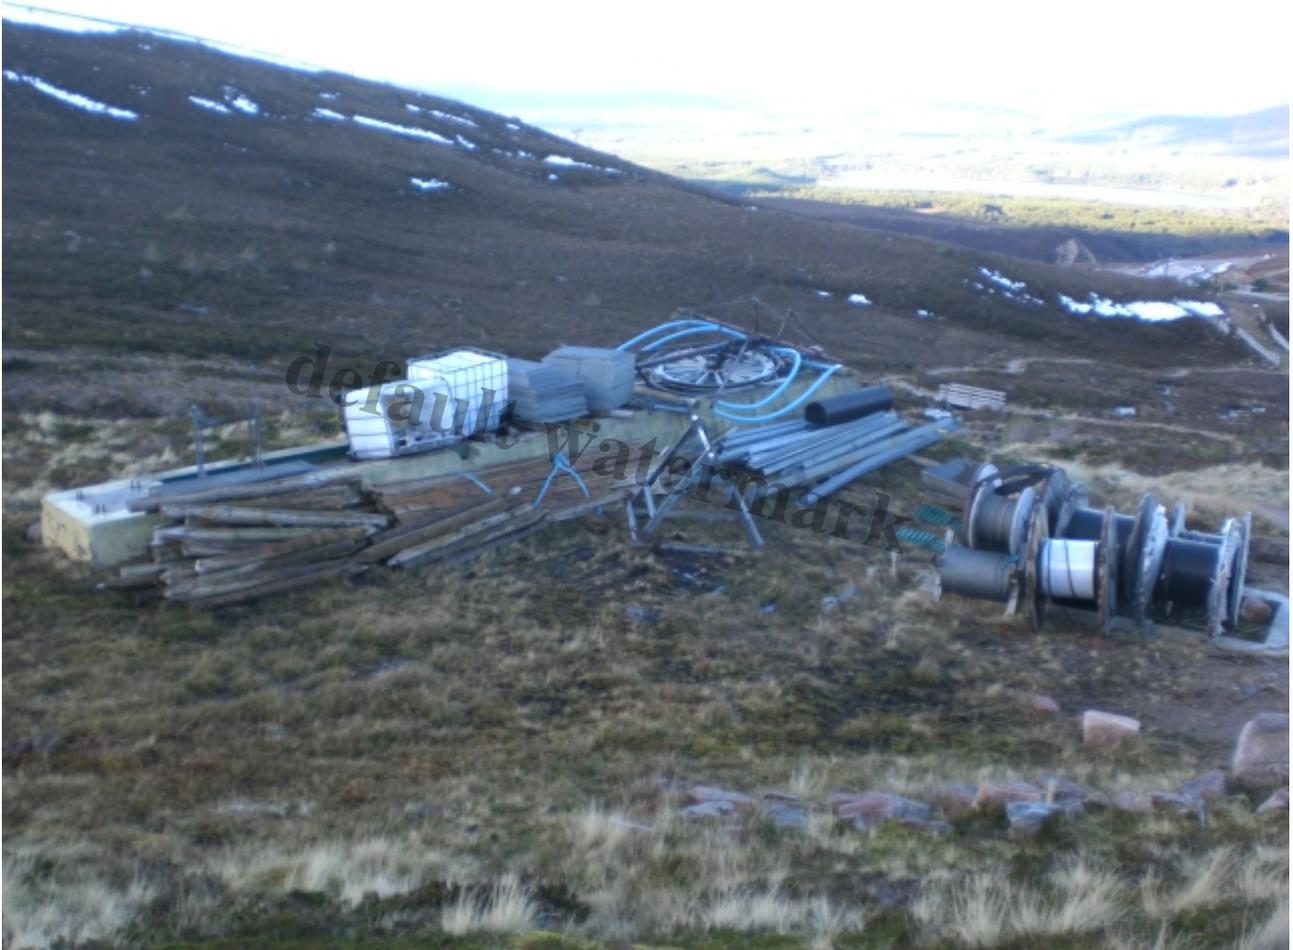
The Fiacaille T-bar dump – photo credit Alan Bratney (all photos featured here by Alan date from 8th January 2017)

Indeed Natural Retreats has claimed that some of the mess – such as that at the unofficial dump they created at the old Fiacaille T-bar base (photo above) would be cleared once the snows arrive. This, they have claimed, is because snow would reduce the impact of vehicles transporting redundant materials out. The trouble with this claim is not just that redundant materials such as the old chestnut fencing which is lying against the new snow fencing get buried as soon as it snows – which may

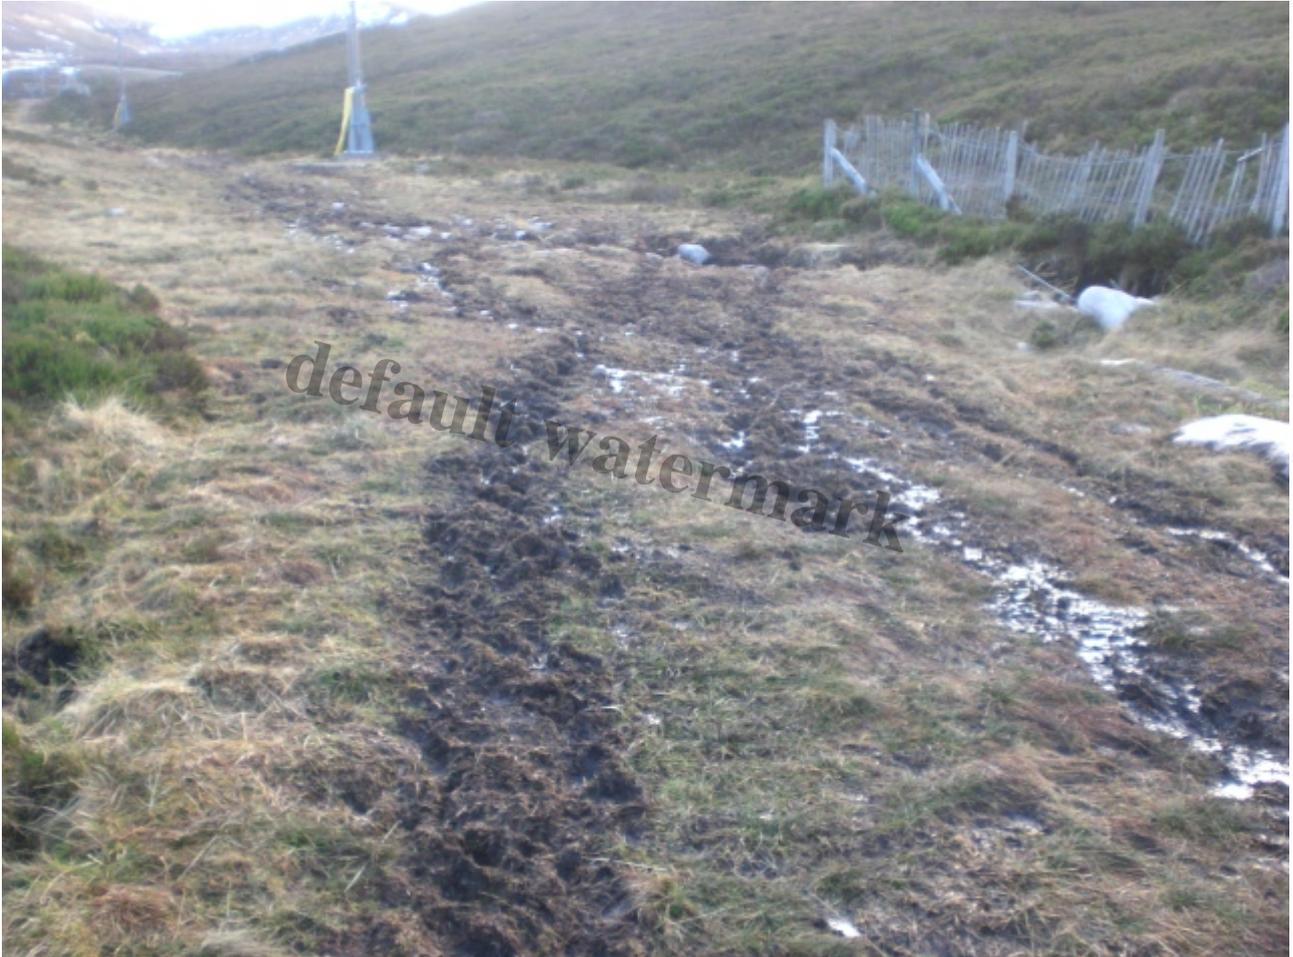
Car Park T bar uptrack vehicle damage â?? Photo Credit Alan Bratney 8/1/17

Parkswatch have previously featured vehicles driving by the Carpark T-bar uptrack and the impact of that is clearly evident. The vegetation has been seriously damaged and the ground is now being eroded by water.

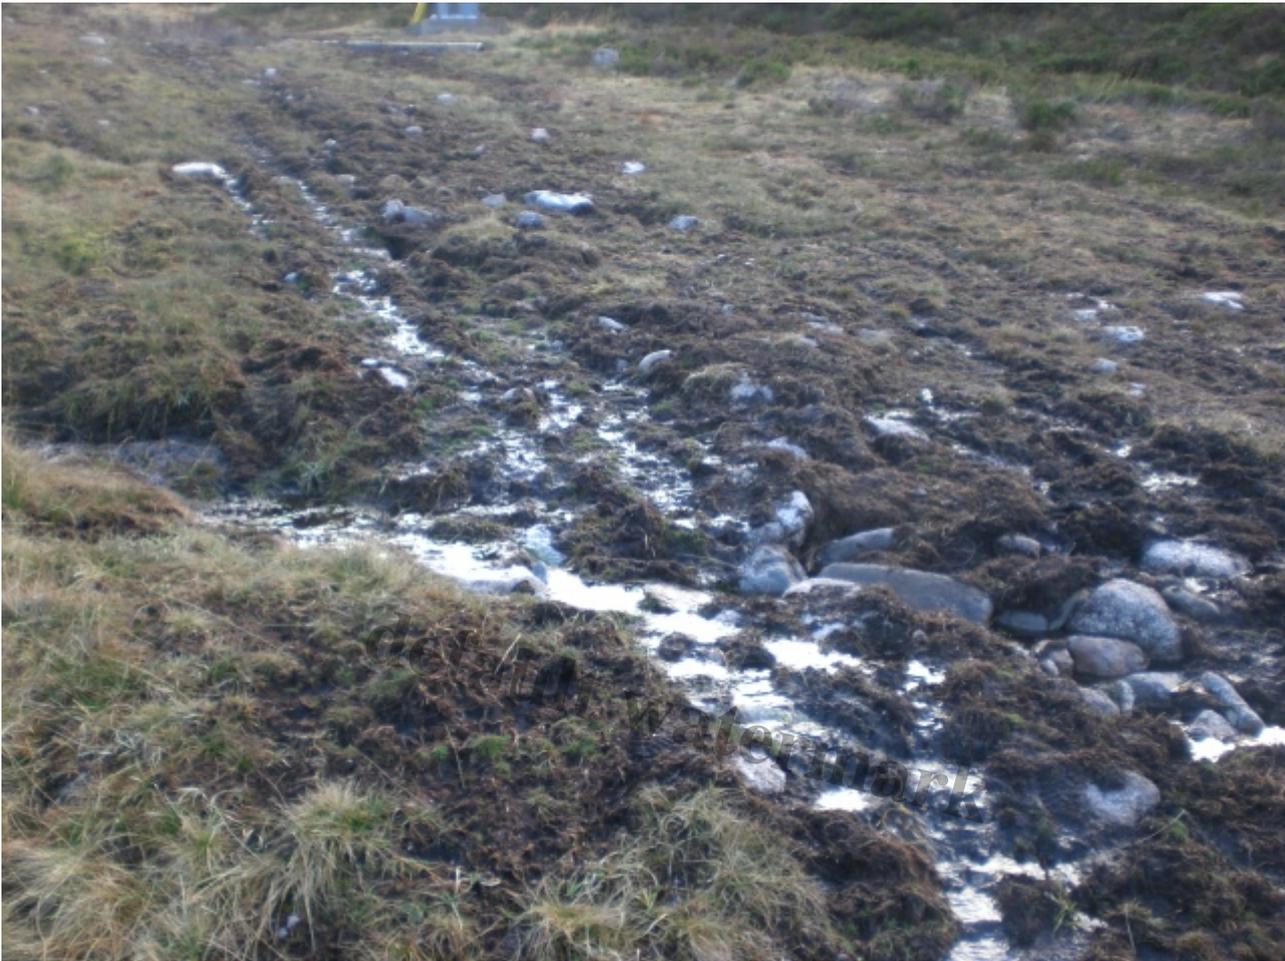
Highland Council approved the laying of new cable along the Car Park T-bar which clearly needed to be done without planning permission as they regarded the works as 'de minimis'. It's clear that the impact of vehicle use here whether for follow up work on the cable laying or for other works has not been 'de minimis'.

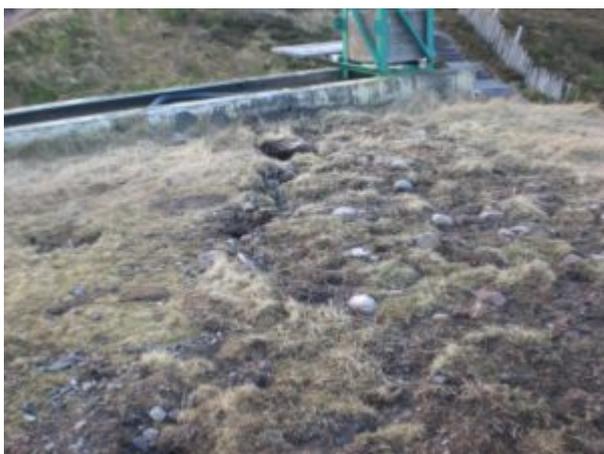
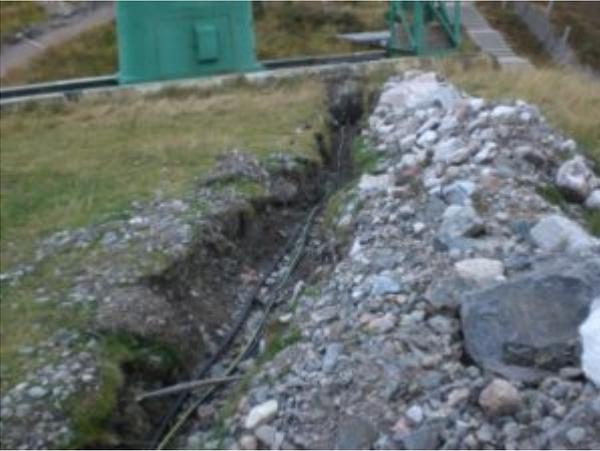
Photo credit Alan Bratney 8/1/16

While the trench for the cabling by the Car Park liffies hut, which had been left open for something like six months (photo left) has now been filled in, the quality of the restoration has been extremely poor. You can still see a trench which will act as a drainage channel. The natural vegetation here had all been highly modified by the high levels of use but in order to help the ground recover and prevent erosion the trench should have been filled in months ago. The most recent good practice guidance all suggests that where trenches are required restoration should take place as the work goes along in order to reduce impacts. Maybe Natural Retreats has is a good explanation for the delay in this case? If so I would be happy to post this on parkswatch.

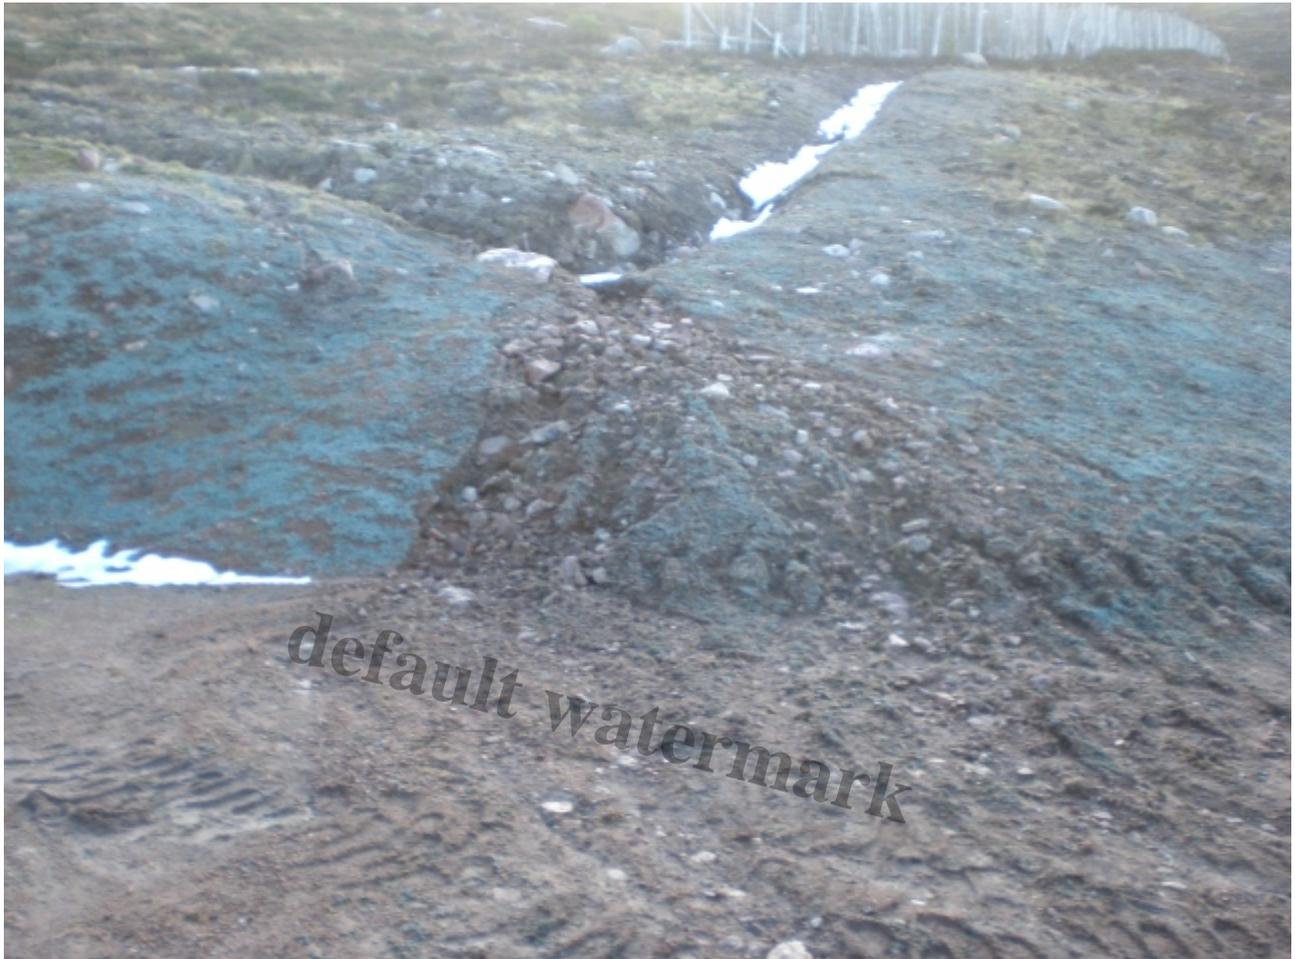
The ground to the right of the gantry, looking uphill showing where the blue revegetation pellets and topsoil have been washed away Photo Credit Alan Bratney 8/1/16

Highland Council agreed to emergency works on the Coire Cas Gantry in 2015 to make it safe for skiing and to "de minimis" groundworks and as a consequence waived the requirement for planning permission. They were informed this last time last year of concerns which they dismissed (see [Letter re Coire Cas Gantry anonymised](#)) and closed the case. I am afraid the recent photos show there has been a dereliction of public duty.

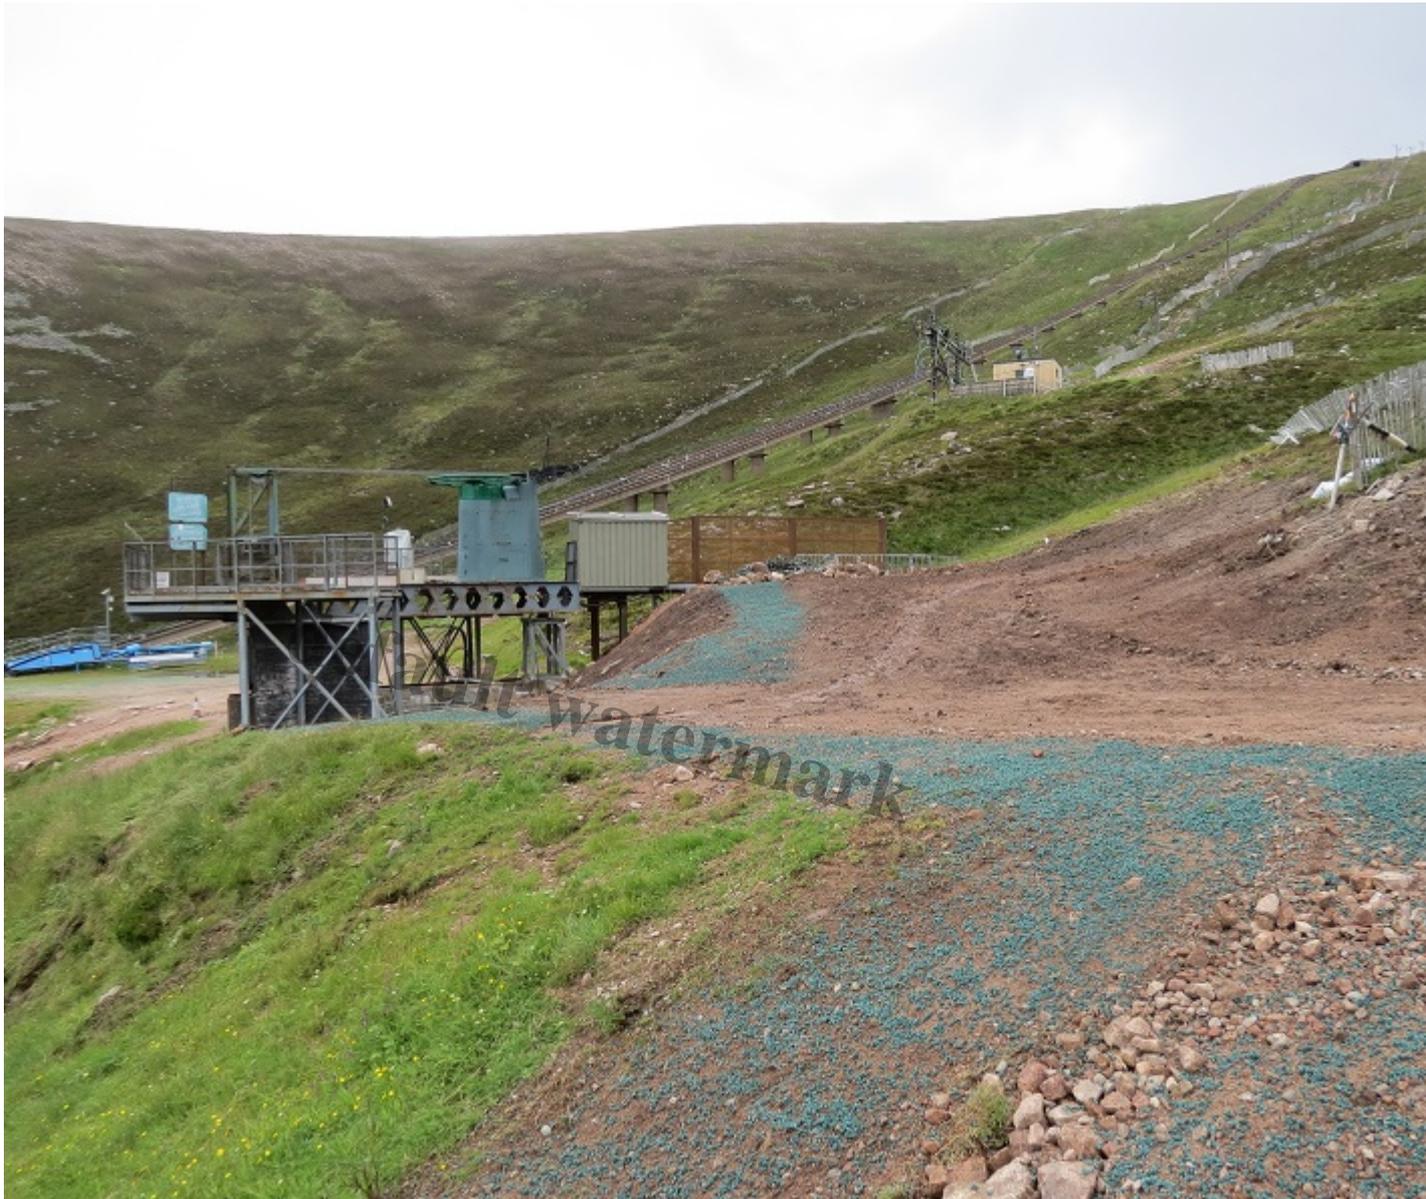
View of the Coire Cas Gantry at the end of July showing the ground featured in the photos above and
Nick Kempe

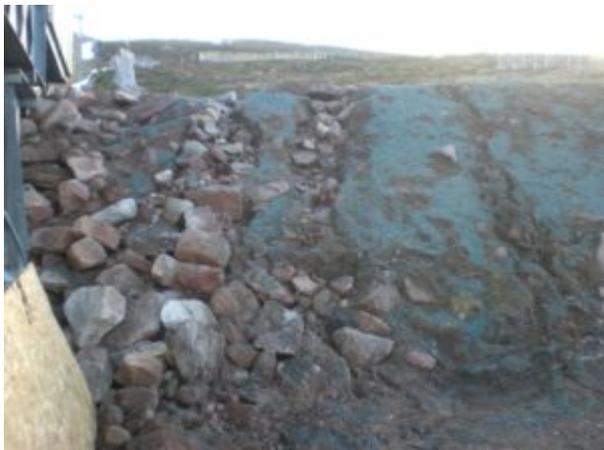
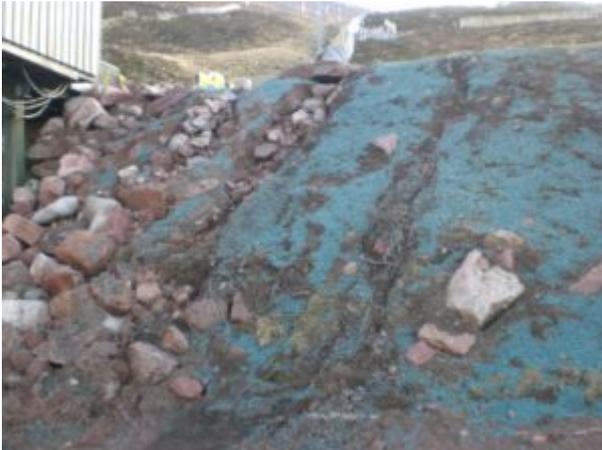
Photo Credit Alan Bratley 8/1/16

And this is how the lower slope adjacent to the gantry looks now

The topsoil is clearly washing out. This is partly a consequence of the steepness of this slope but also of a failure to store vegetation and re-seed the area in the Spring. Its fairly predictable that there will be further significant erosion during the rest of the winter and that the slope will become unstable. Will the Natural Retreats solution be simply to scoop up more material from elsewhere and dump it on the slope? Its time the CNPA talked to Highland Council and they agreed that all works should be required to meet certain standards and that this be enforced. If the only way to do this is to require planning permission whenever that is applicable, then that's what our public authorities should do. All the evidence clearly shows that leaving Natural Retreats to supervise works continues to fail.

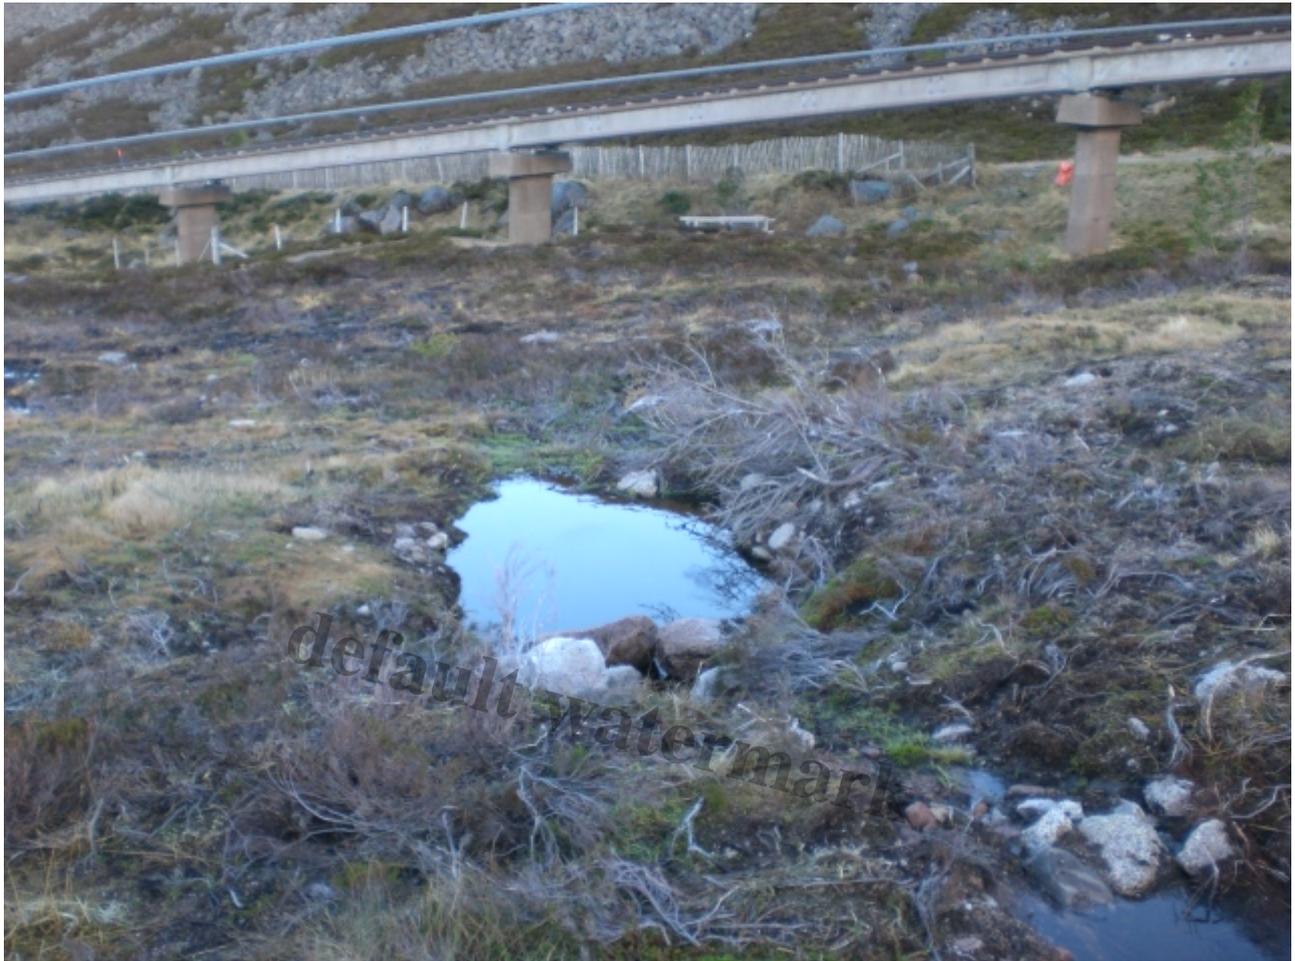
Photo credit Alan Bratley 8/1/16

The places where Natural Retreats's contractors scooped out vegetation with diggers in order to restore the reprofiled Shieling rope tow slope have now predictably filled up with water. In flood prevention terms this may not be a bad thing, as all the other works Natural Retreats has done has had the effect of increasing water run-off, but it has changed the ecology of slope. What's more the efforts to try and minimise the impact of the funicular, by taking extreme care over grounds works, has simply been undone. All this work appears to have been funded by Highlands and Islands Enterprise and I am currently in dialogue with them about exactly what they funded and what if any of the damage has been paid for by Natural Retreats.

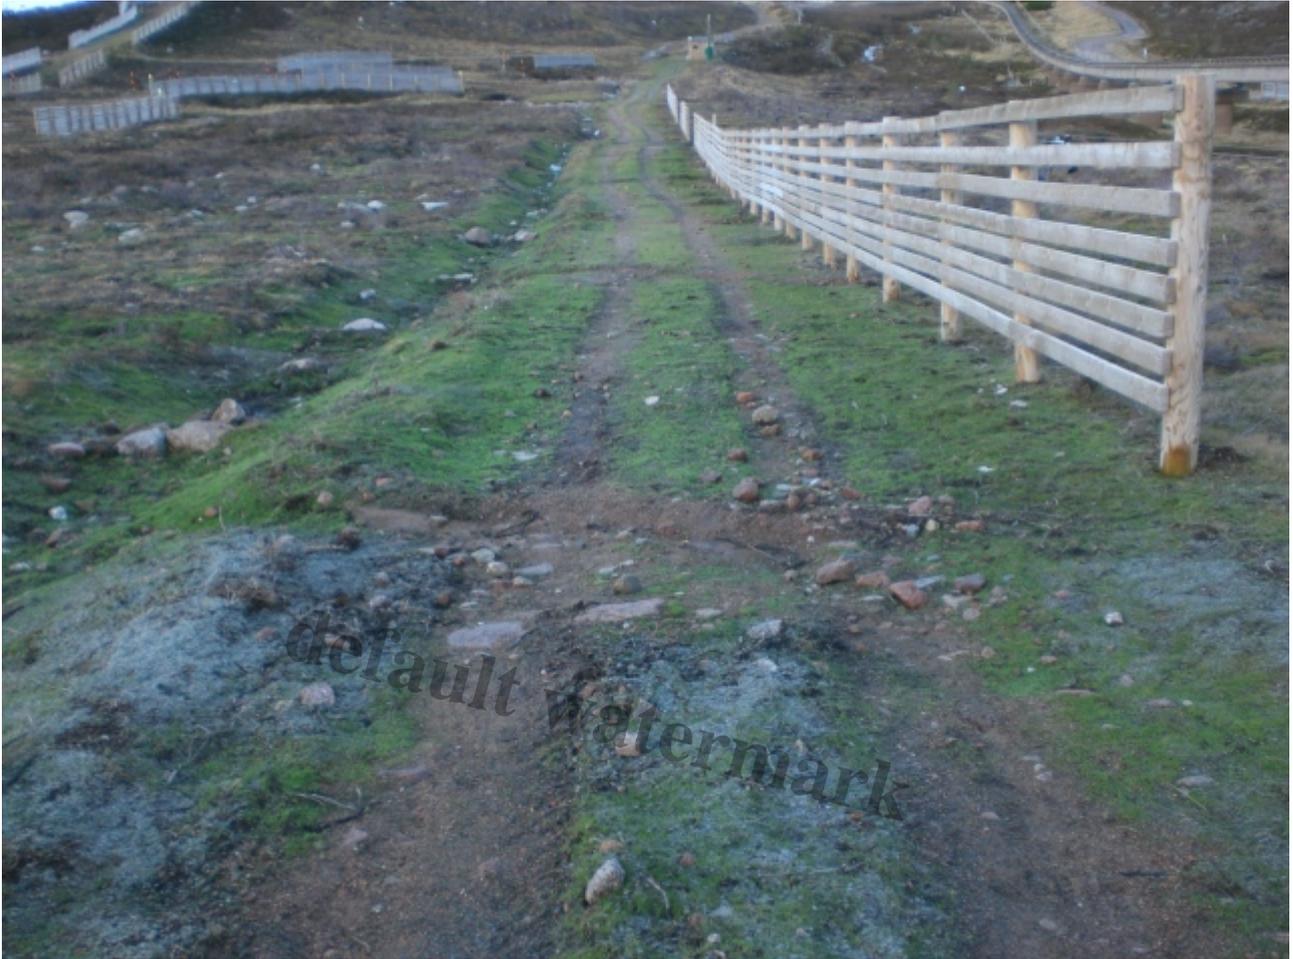
Photo credit Alan Bratney 8/1/16

The unlawful track that Natural Retreats created by the Shielling rope tow is due to be considered by the CNPA planning committee at the end of January. While the seeding has partially established grass along the track, the blue pellets and stones in the foreground indicate that the top of the slope has washed away again. Its too steep and the drainage scoops are unlikely to solve the problem. They are likely to be seriously eroded by the end of the winter.

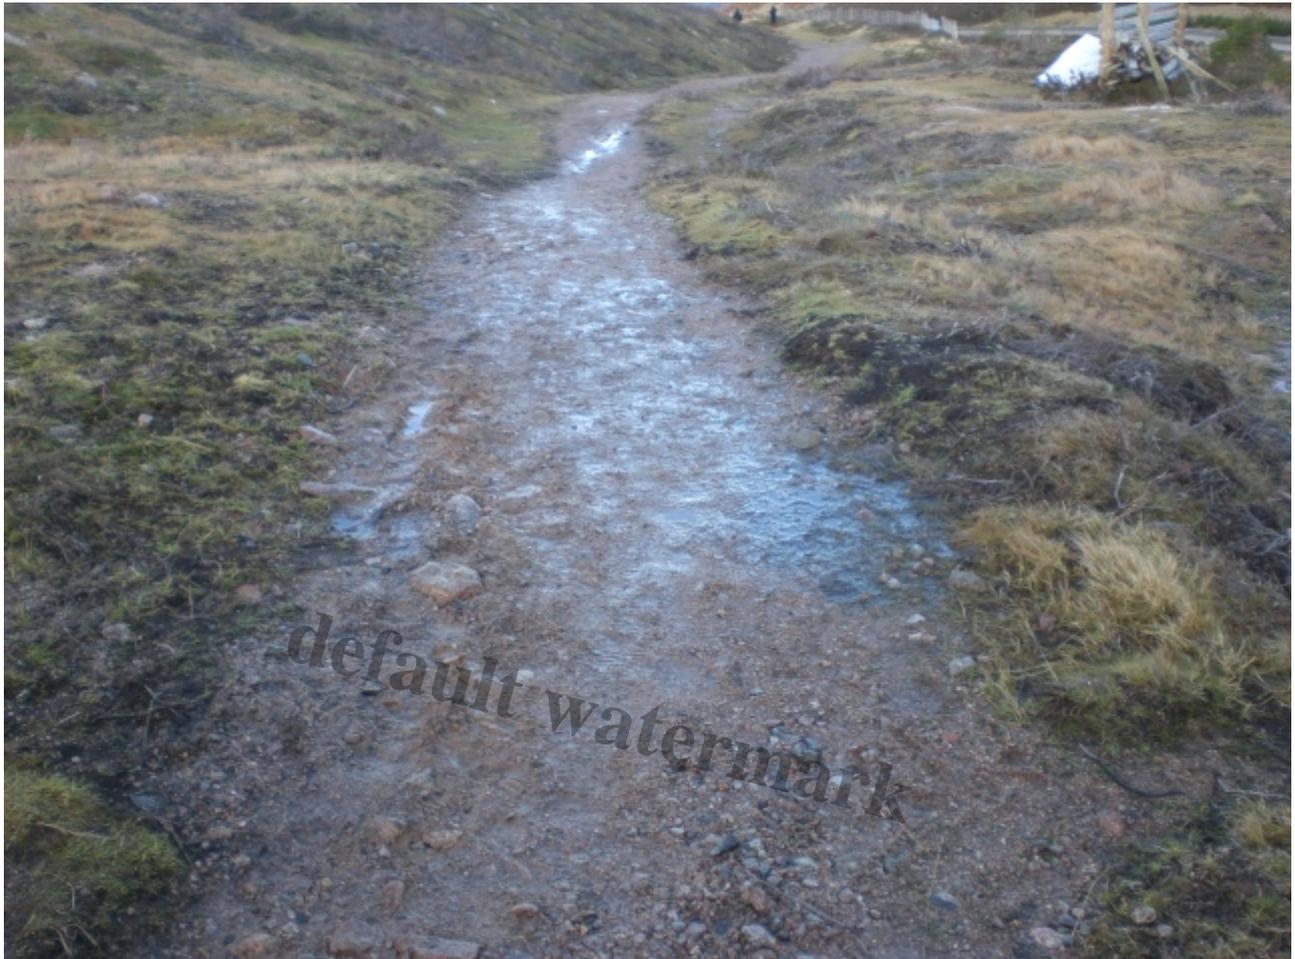
Coire Cas circular path Photo Credit Alan Bratley 8/1/16

The cumulative impact of the destruction of vegetation and increase in water run-off caused by the Shieling Rope tow appears to be impacting on the path below it. The path is now extremely soggy and you can see how lower down its starting to form a burn. I trust that the CNPA consider these issues at Planning Committee and how this fits with the local area flood prevention plan.
