Natural Retreats Cairngorm report card

The Car Park T-Bar

The Coire Cas T-bar gantry works

The Shielling Rope Tow area

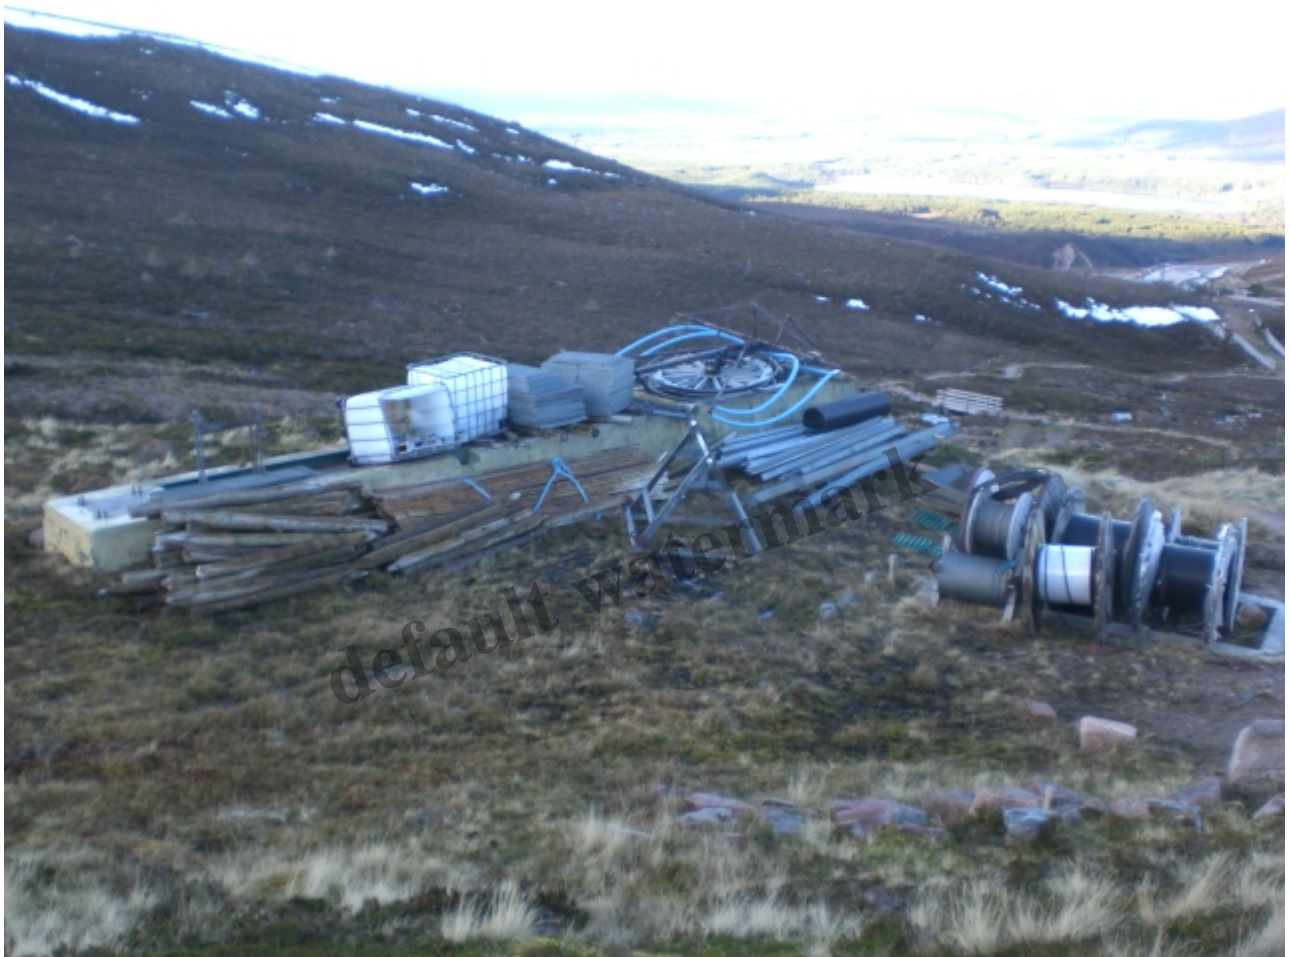
The Fiacail T-bar dump – photo credit Alan Bratney (all photos featured here by Alan date from 8th January 2017)

Indeed Natural Retreats has claimed that some of the mess – such as that at the unofficial dump they created at the old Fiacail T-bar base (photo above) would be cleared once the snows arrive. This, they have claimed, is because snow would reduce the impact of vehicles transporting redundant materials out. The trouble with this claim is not just that redundant materials such as the old chestnut fencing which is lying against the new snow fencing get buried as soon as it snows – which may

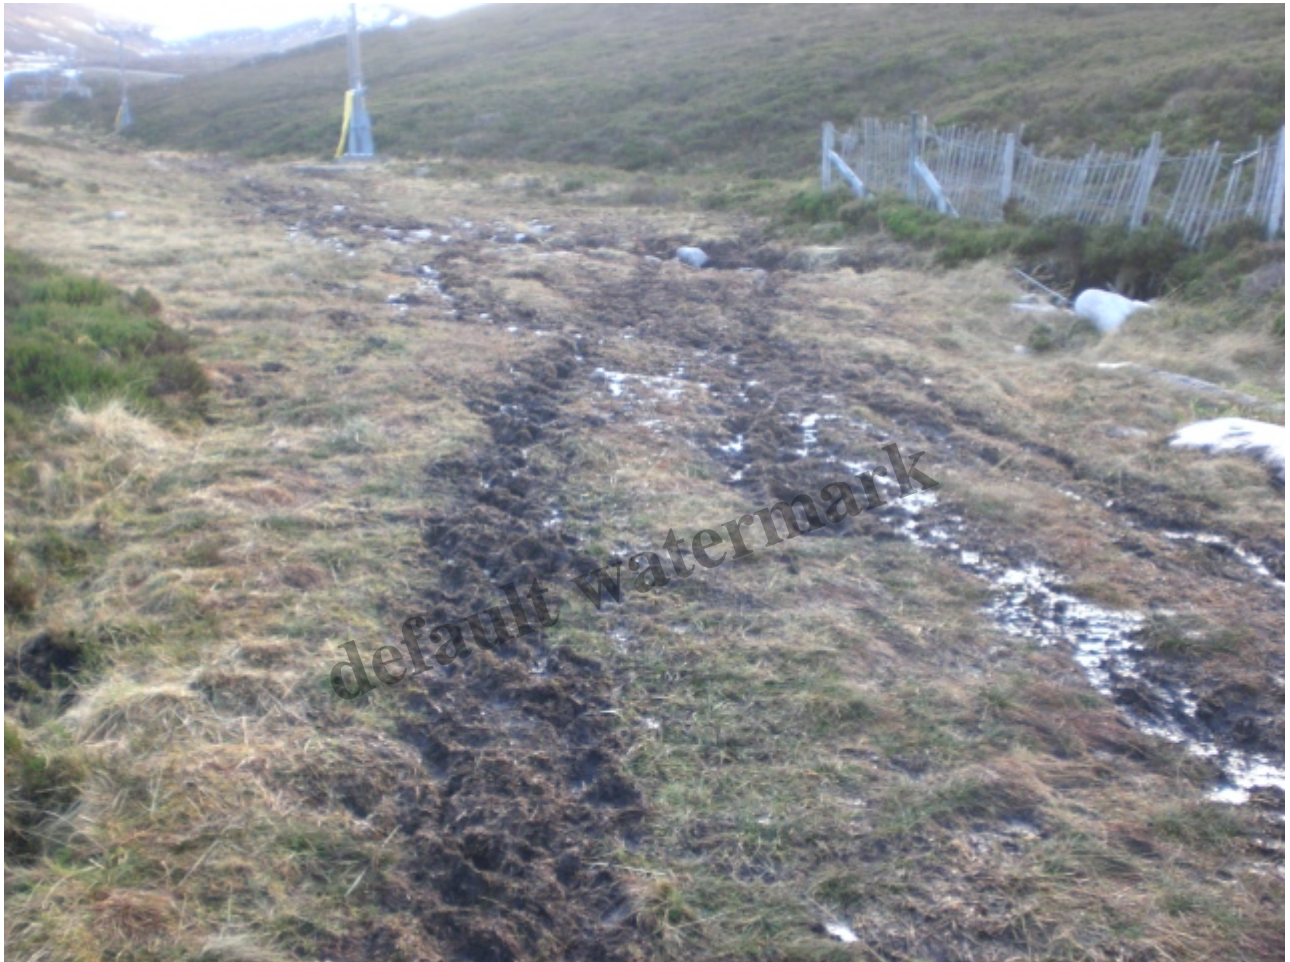
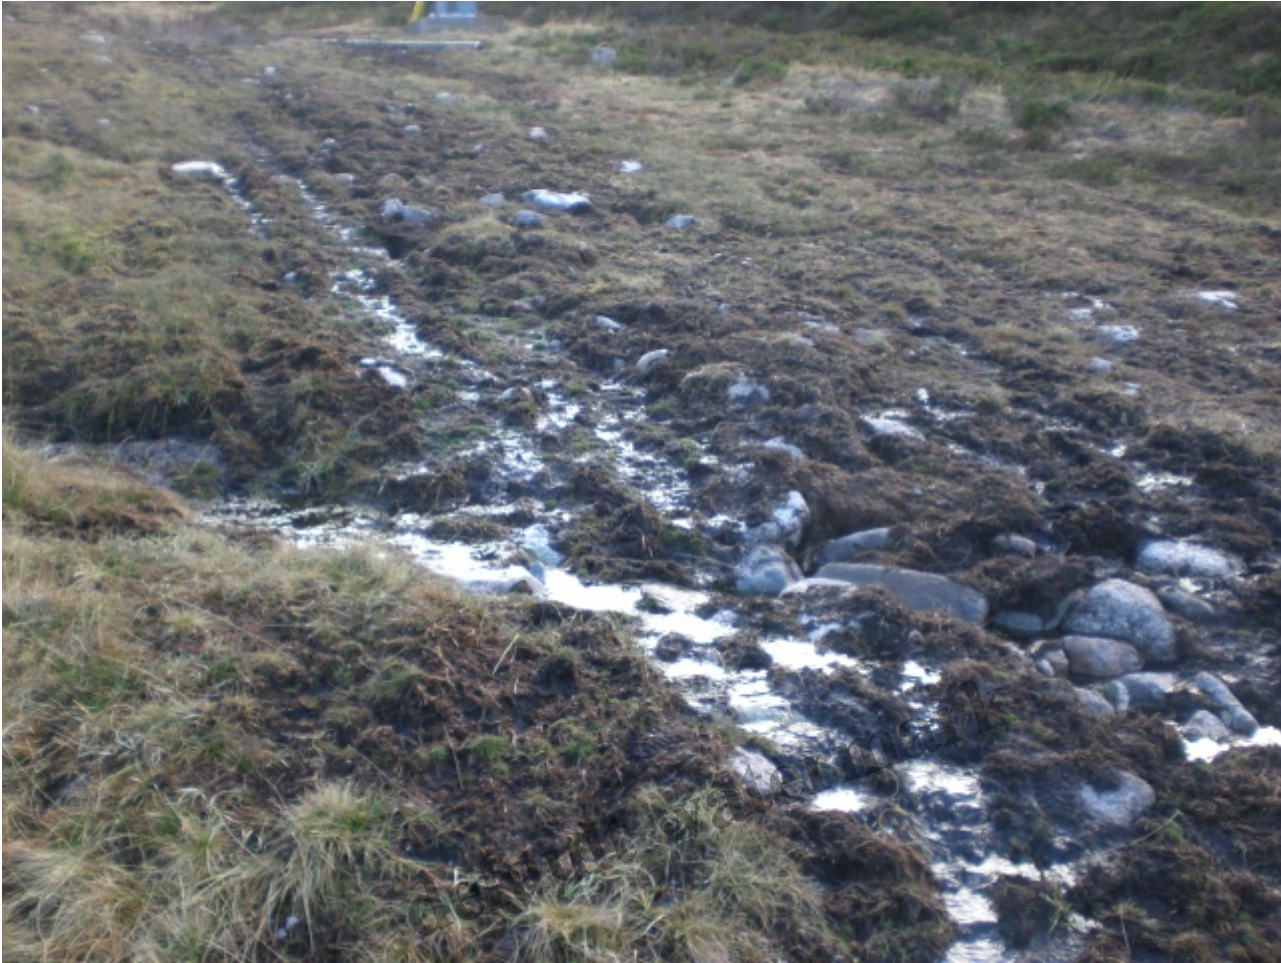
Car Park T bar uptrack vehicle damage – Photo Credit Alan Bratney 8/1/17

Parkswatch have previously featured vehicles driving by the Carpark T-bar uptrack and the impact of that is clearly evident. The vegetation has been seriously damaged and the ground is now being eroded by water.

Highland Council approved the laying of new cable along the Car Park T-bar – which clearly needed to be done – without planning permission as they regarded the works as “de minimis.” Its clear that the impact of vehicle use here – whether for follow up work on the cable laying or for other works – has not been “de minimis”.

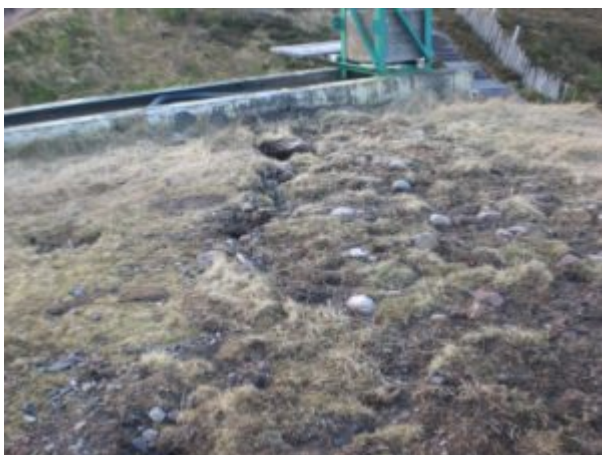
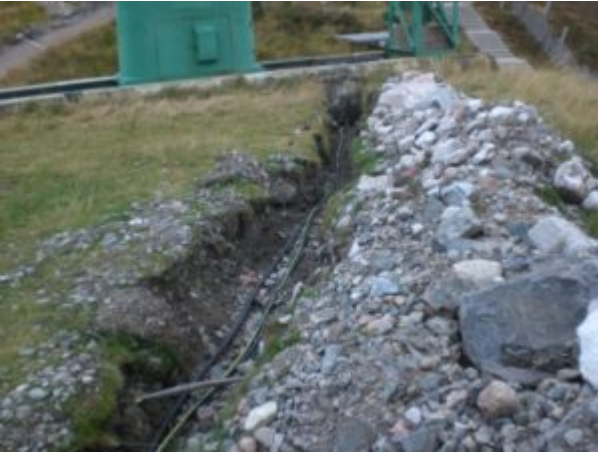
Photo credit Alan Bratney 8/1/16

While the trench for the cabling by the Car Park lifties hut, which had been left open for something like six months (photo left) has now been filled in, the quality of the restoration has been extremely poor. You can still see a trench which will act as a drainage channel. The natural vegetation here had all been highly modified by the high levels of use but in order to help the ground recover and prevent erosion the trench should have been filled in months ago. The most recent good practice guidance all suggests that where trenches are required restoration should take place as the work goes along in order to reduce impacts. Maybe Natural Retreats has is a good explanation for the delay in this case? If so I would be happy to post this on parkswatch.

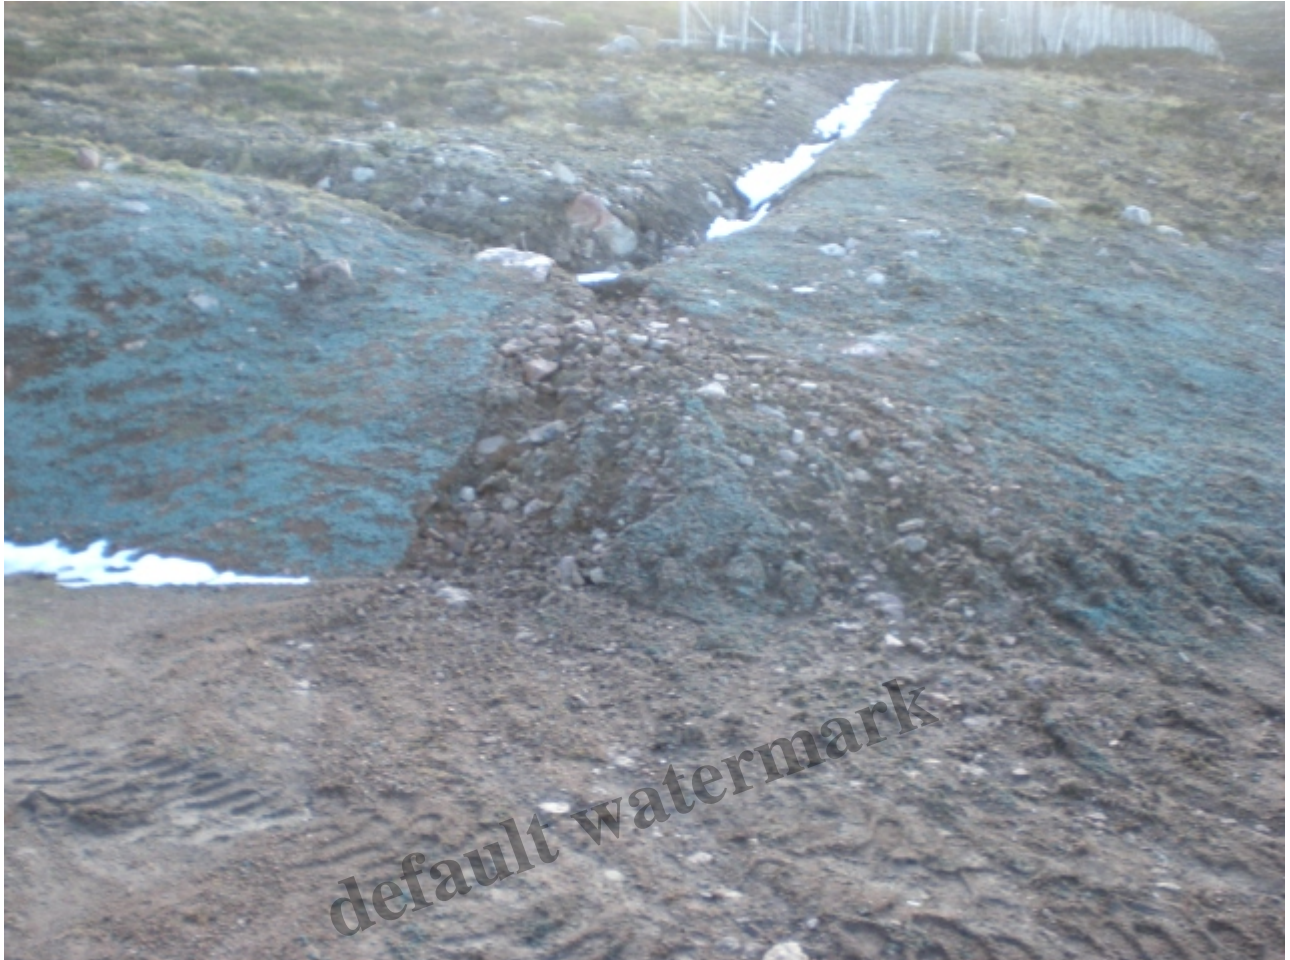
The ground to the right of the gantry, looking uphill showing where the blue revegetation pellets and topsoil have been washed away Photo Credit Alan Bratney 8/1/16

Highland Council agreed to emergency works on the Coire Cas Gantry in 2015 to make it safe for skiing and to “de minimis” groundworks and as a consequence waived the requirement for planning permission. They were informed this last time last year of concerns which they dismissed (see [Letter re Coire Cas Gantry anonymised](#)) and closed the case. I am afraid the recent photos show there has been a dereliction of public duty.

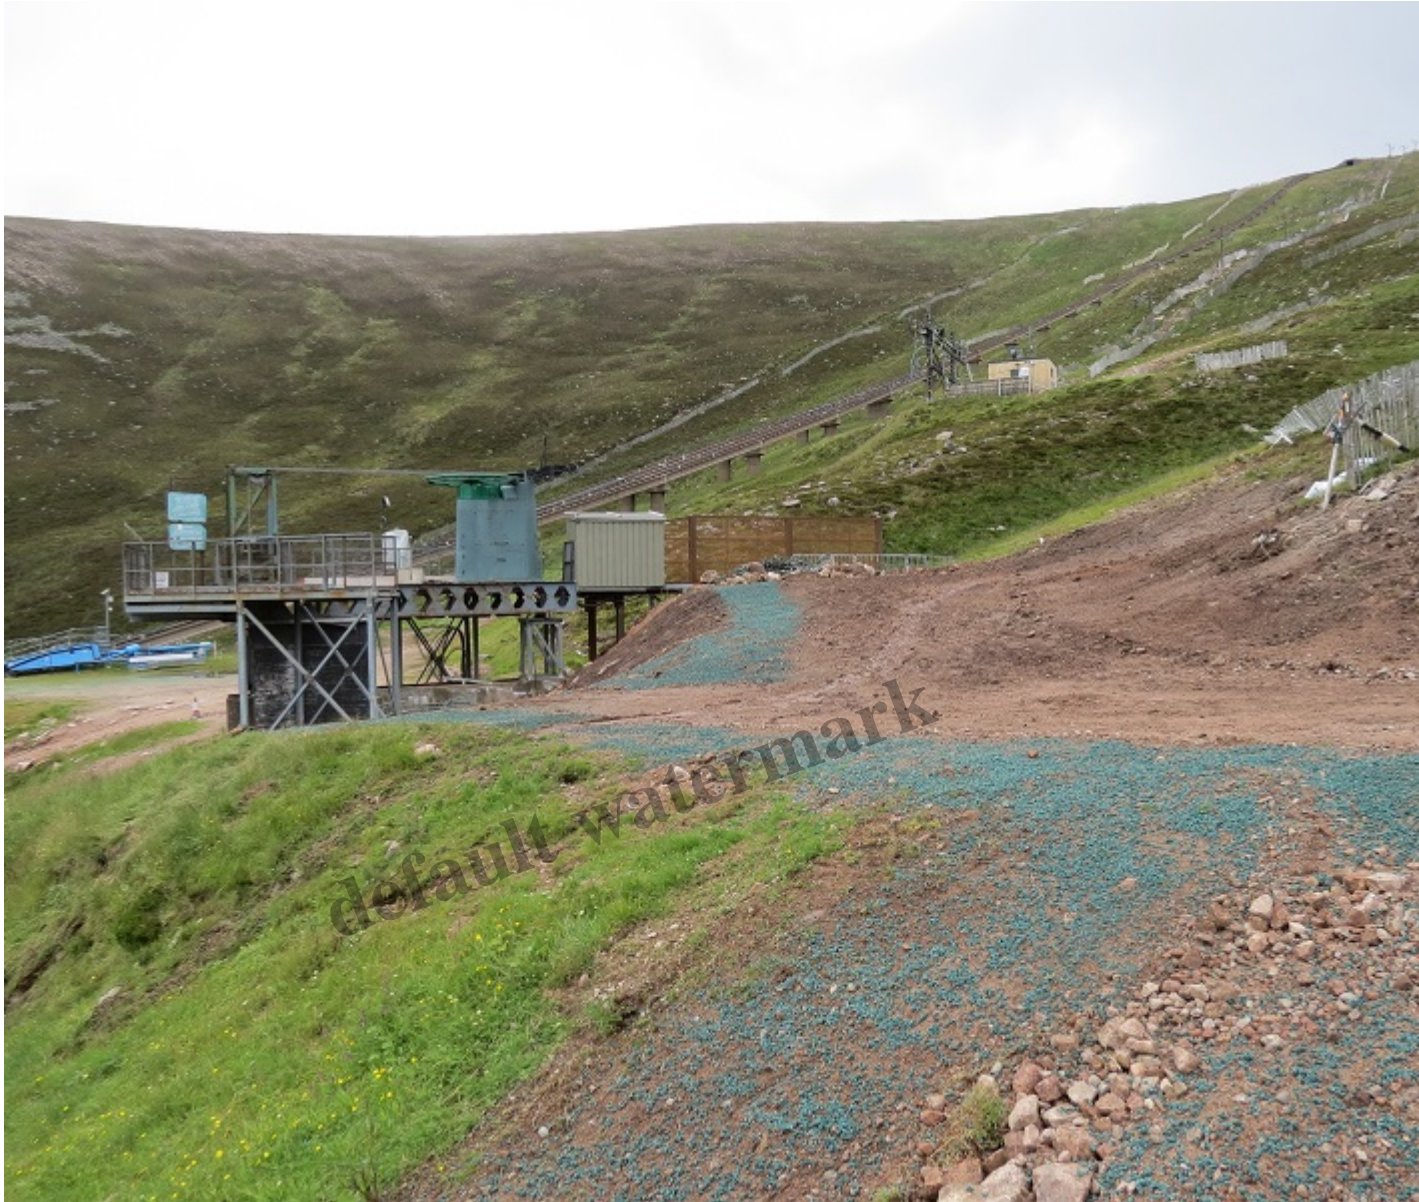
View of the Coire Cas Gantry at the end of July showing the ground featured in the photos above and
Nick Kempe

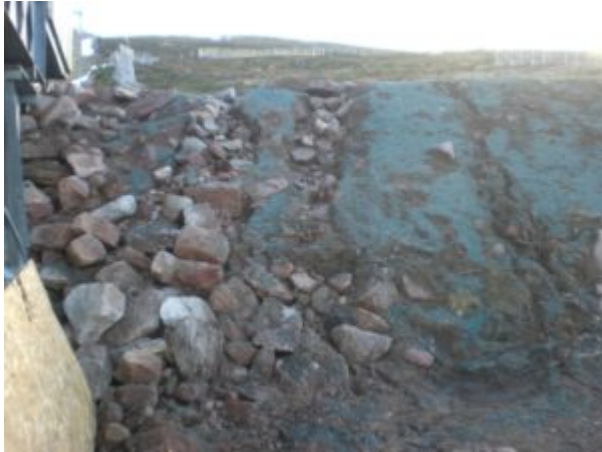
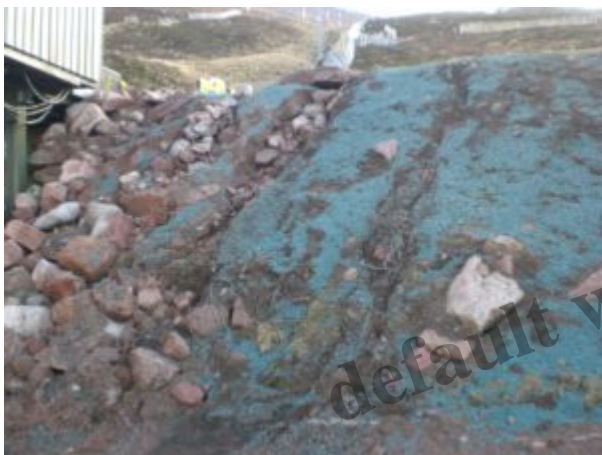
Photo Credit Alan Bratney 8/1/16

And this is how the lower slope adjacent to the gantry looks now

The topsoil is clearly washing out. This is partly a consequence of the steepness of this slope but also of a failure to store vegetation and re-seed the area in the Spring. Its fairly predictable that there will be further significant erosion during the rest of the winter and that the slope will become unstable – will the Natural Retreats solution be simply to scoop up more material from elsewhere and dump it on the slope? Its time the CNPA talked to Highland Council and they agreed that all works should be required to meet certain standards and that this be enforced. If the only way to do this is to require planning permission whenever that is applicable, then that's what our public authorities should do. All the evidence clearly shows that leaving Natural Retreats to supervise works continues to fail.

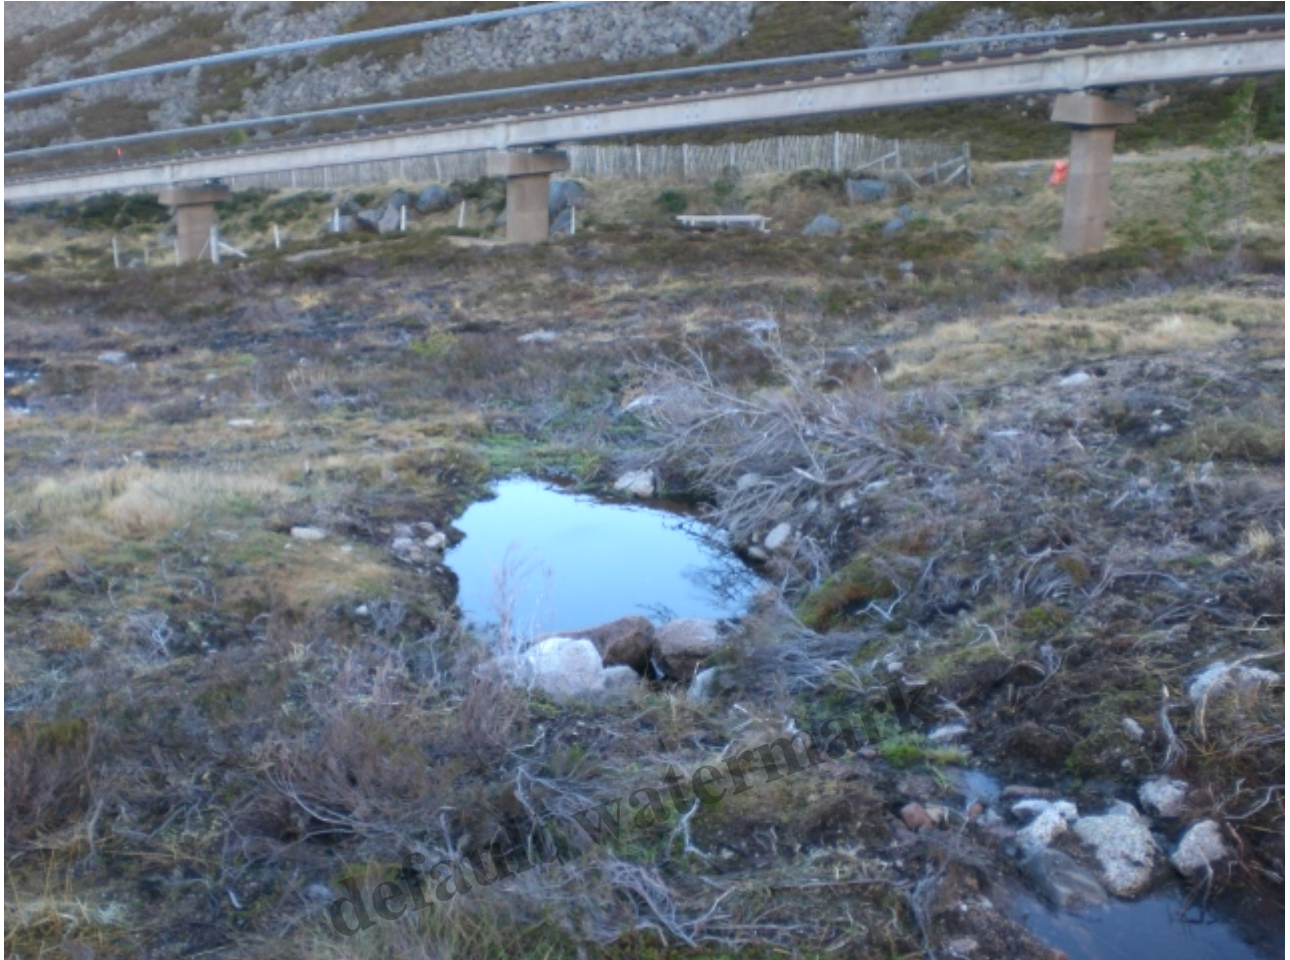
Photo credit Alan Bratney 8/1/16

The places where Natural Retreats' contractors scooped out vegetation with diggers – in order to “restore” the reprofiled Shieling rope tow slope – have now predictably filled up with water. In flood prevention terms this may not be a bad thing, as all the other works Natural Retreats has done has had the effect of increasing water run-off, but it has changed the ecology of slope. What's more the efforts to try and minimise the impact of the funicular, by taking extreme care over grounds works, has simply been undone. All this work appears to have been funded by Highlands and Islands Enterprise and I am currently in dialogue with them about exactly what they funded and what if any of the damage has been paid for by Natural Retreats.

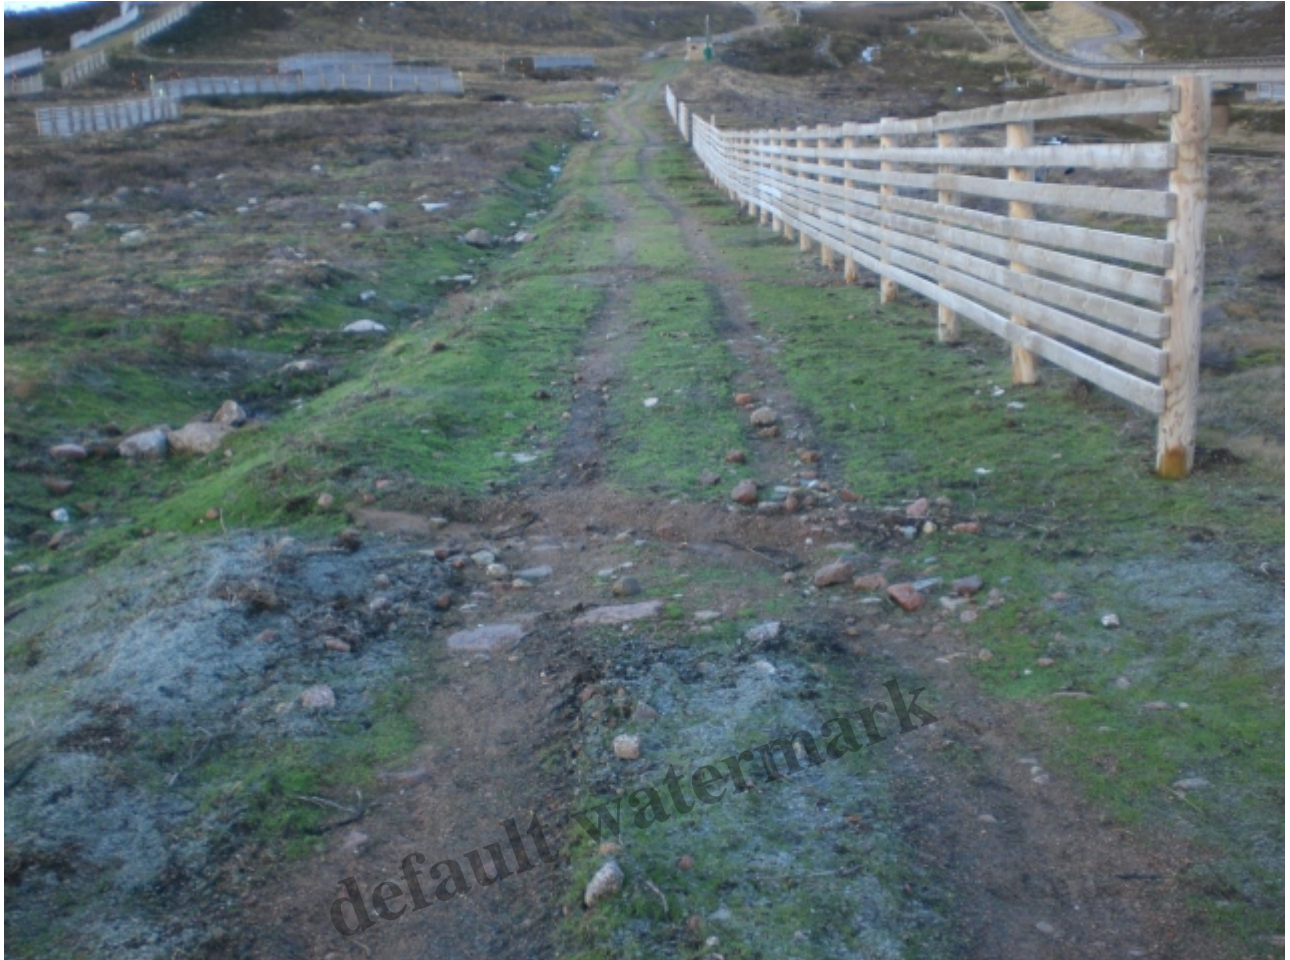
Photo credit Alan Bratney 8/1/16

The unlawful track that Natural Retreats created by the Shielling rope tow is due to be considered by the CNPA planning committee at the end of January. While the seeding has partially established grass along the track, the blue pellets and stones in the foreground indicate that the top of the slope has washed away again. Its too steep and the drainage scoops are unlikely to solve the problem. They are likely to be seriously eroded by the end of the winter.

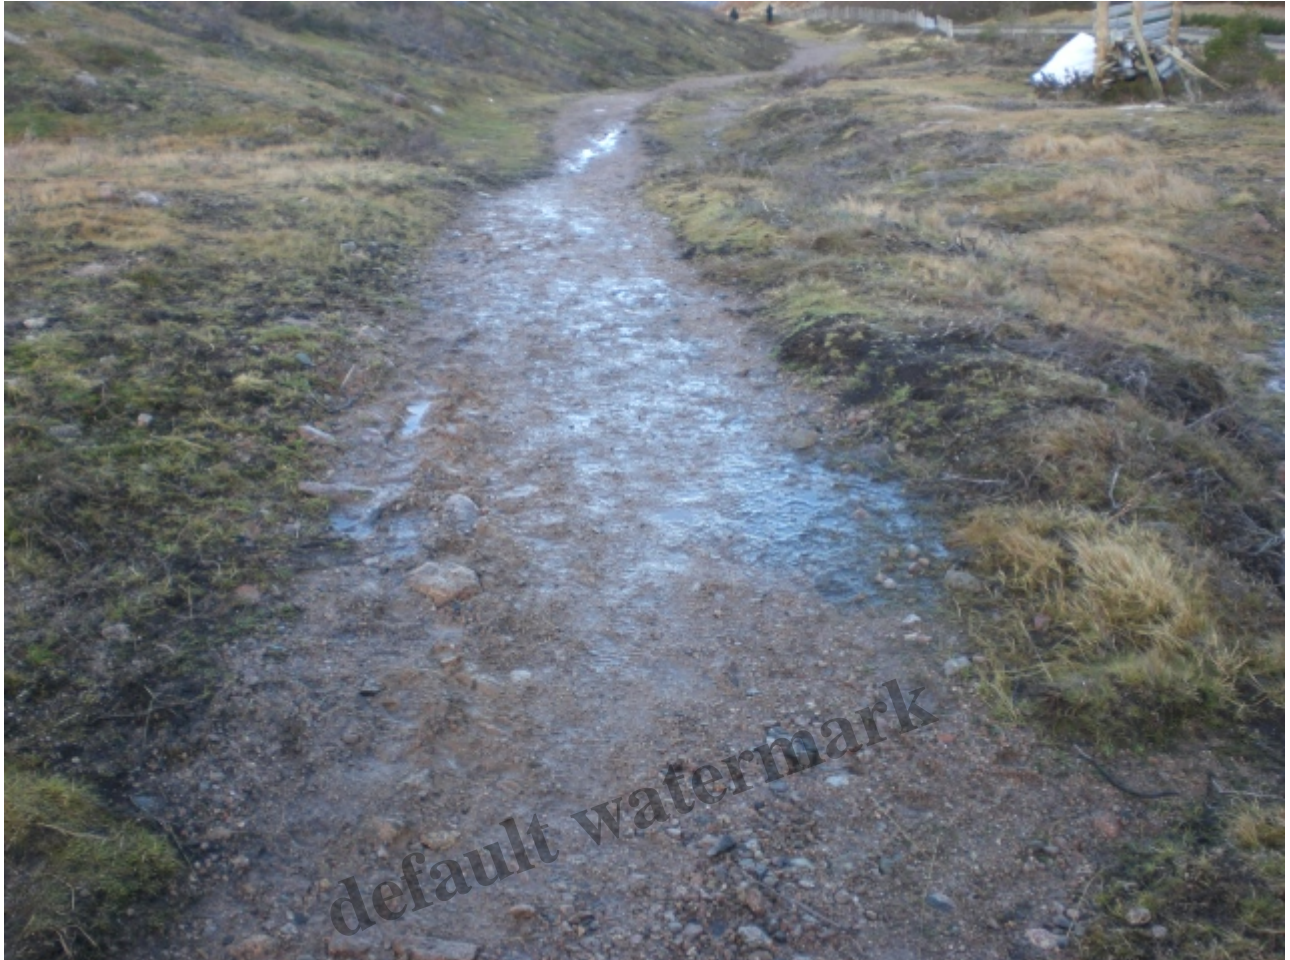
Coire Cas circular path Photo Credit Alan Bratney 8/1/16

The cumulative impact of the destruction of vegetation and increase in water run-off caused by the Shielling Rope tow appears to be impacting on the path below it. The path is now extremely soggy and you can see how lower down its starting to form a burn. I trust that the CNPA consider these issues at Planning Committee and how this fits with the local area flood prevention plan.
