The hill track at Cairngorm – a test case for the National Park (2)

Location and design of the hill track

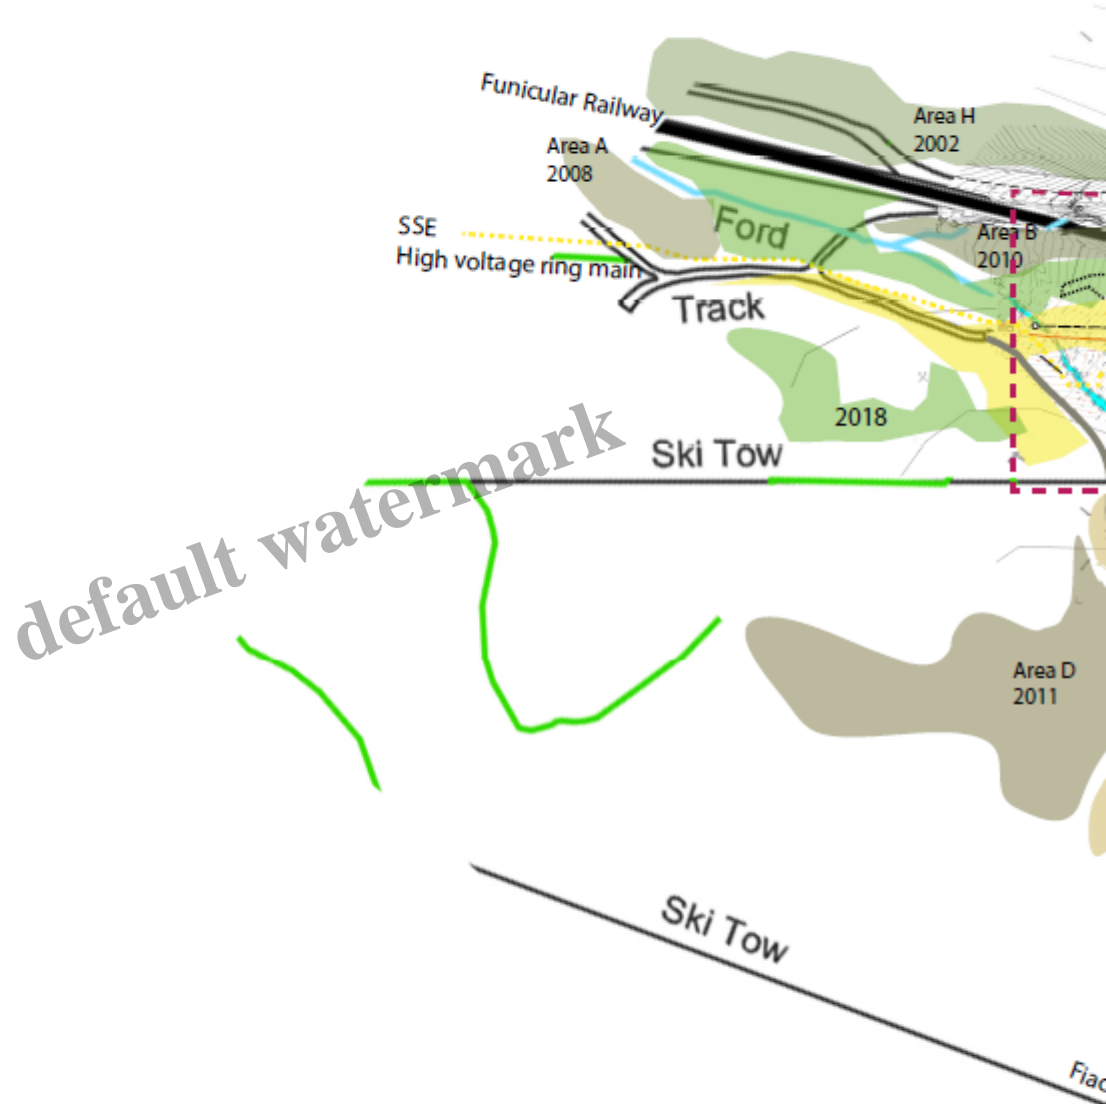
Landscape plan
Drg 4
Scale 1:1000
Printed at 100%

The brown areas are previous plantings, the green is additional planting proposed for 2017-18

The planting will not just hide some of the infrastructure, it should also – though there is no mention of this in the Report – compensate for some of the increased water run-off that has been created by the development. There are some other positive things in the plan, including works around both ends of the ski tow to improve landscaping; the work at the bottom will be done by hand. All of this is good. It should however have all been included in the original planning application, which was sketchy at the very least. Its clear to me that the public pressure has helped (or is it pushed) CNPA staff to take more interest in the development. A lesson here for the CNPA. Well thought out plans properly enforced would avoid lots of problems and public criticism.

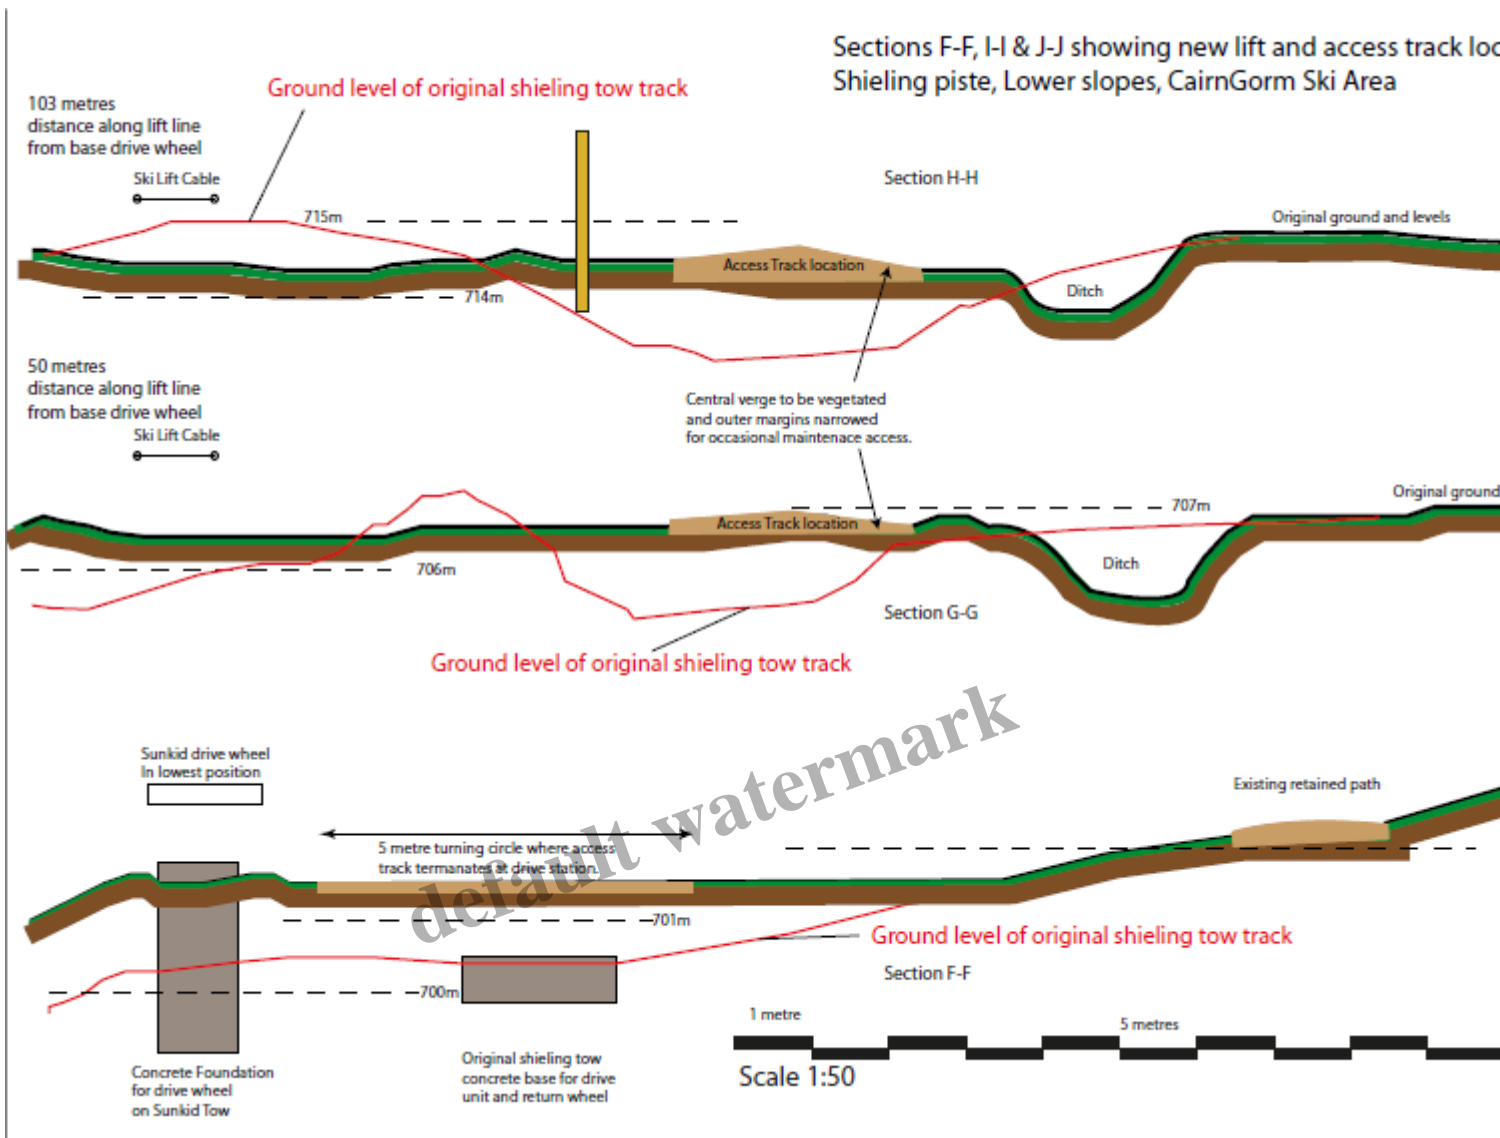
There has been a lot of nonsense talked about the hill track being needed for construction purposes. This diagram from Appendix A to the Committee Report shows that this couldn't have been the case. The elevation of the new track is HIGHER than the previous shieling tow uptrack which sat between two bulldozed banks (section GG). In other words the hill track could only have been created AFTER the slope had been smoothed out (which was agreed in the original planning application). This explains why there is NO evidence of any temporary construction track. There wasn't any. Natural Retreats appears to have confused the original ski uptrack with the new hilltrack in order to make the latter appear more acceptable by implying this had already been agreed on a temporary basis.

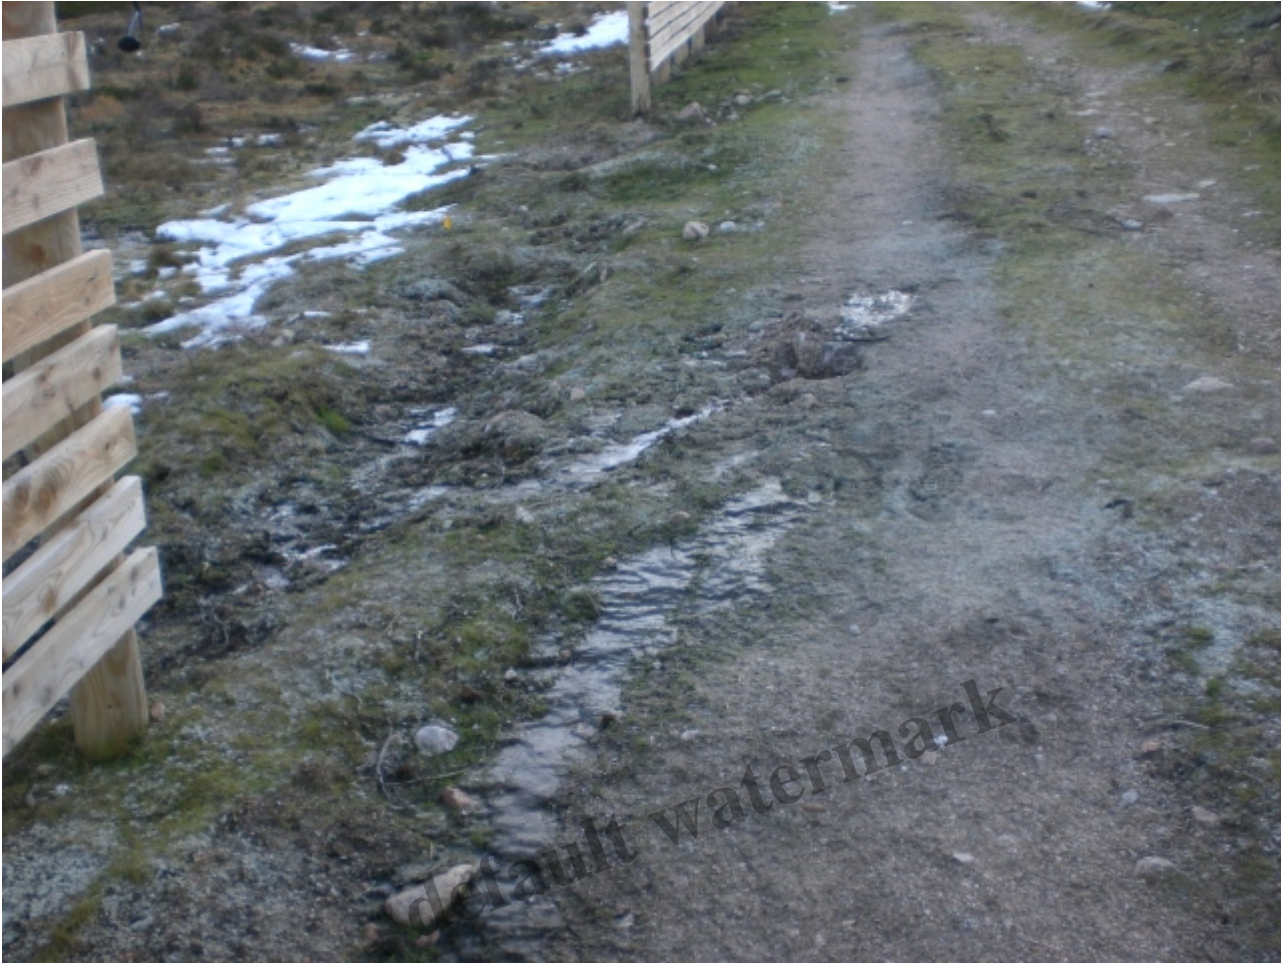
There was no sign of the hole, centre right, when I walked down the track two days before. Two days of freeze thaw and another section of track had been destroyed.

Part of the problem is that the track is too steep, contrary to SNH guidance. Natural Retreats has appears to accept this in its comment that the track “is constrained to existing ground levels” – in other words its fundamentally flawed!

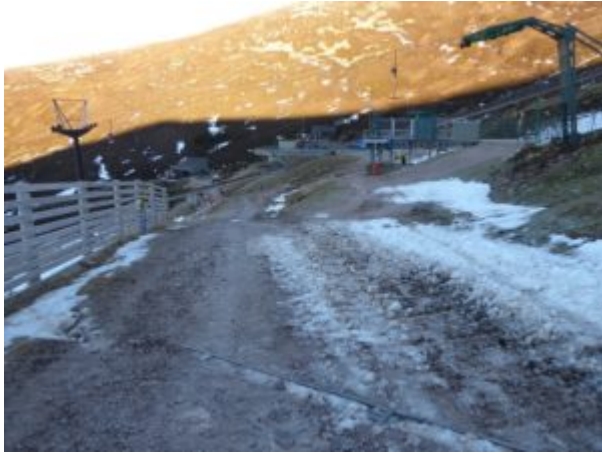
Natural Retreats solution is drainage bars which it says works well. If CNPA officers had walked around Cairngorm at the weekend they would have seen every single steel drainage channel choked with eroded material

Choked steel drainage channel by Cas Gantry

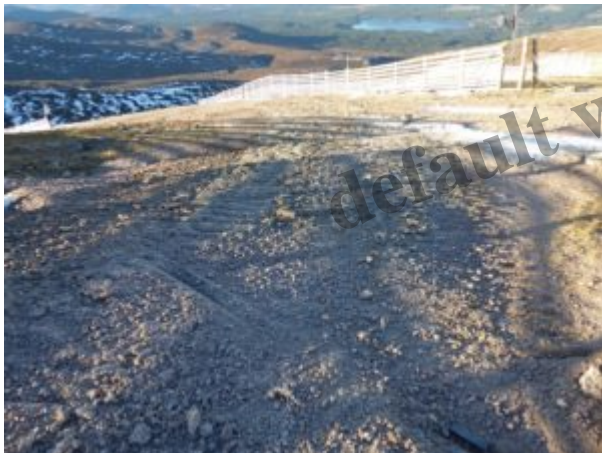
Choked drainage channel below Ptarmigan

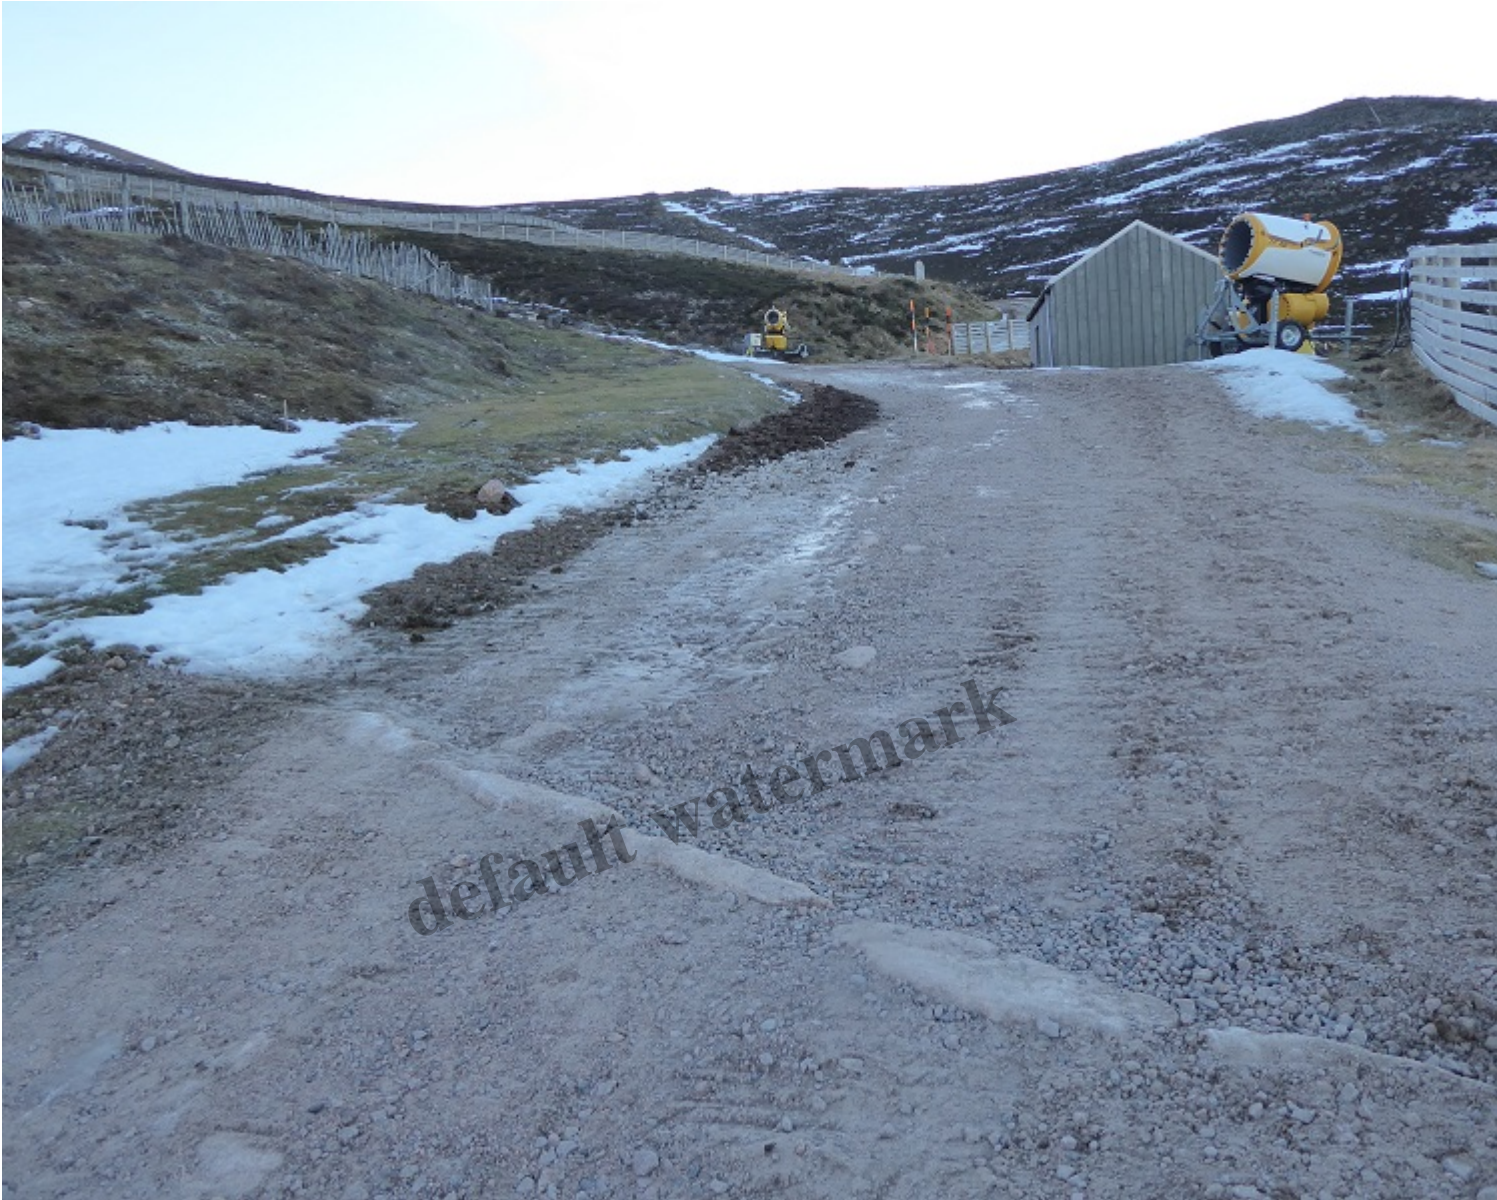
they have not advocated the use of natural materials, as in photo above. Are the granite blocks any less effective in terms of drainage? They are far more in keeping with the natural environment.

The problem which remains though is that the surface materials are too fine and will wash away whatever drainage is installed. The track, as oriented, is simply not sustainable and the Planning Committee needs to consider alternatives.

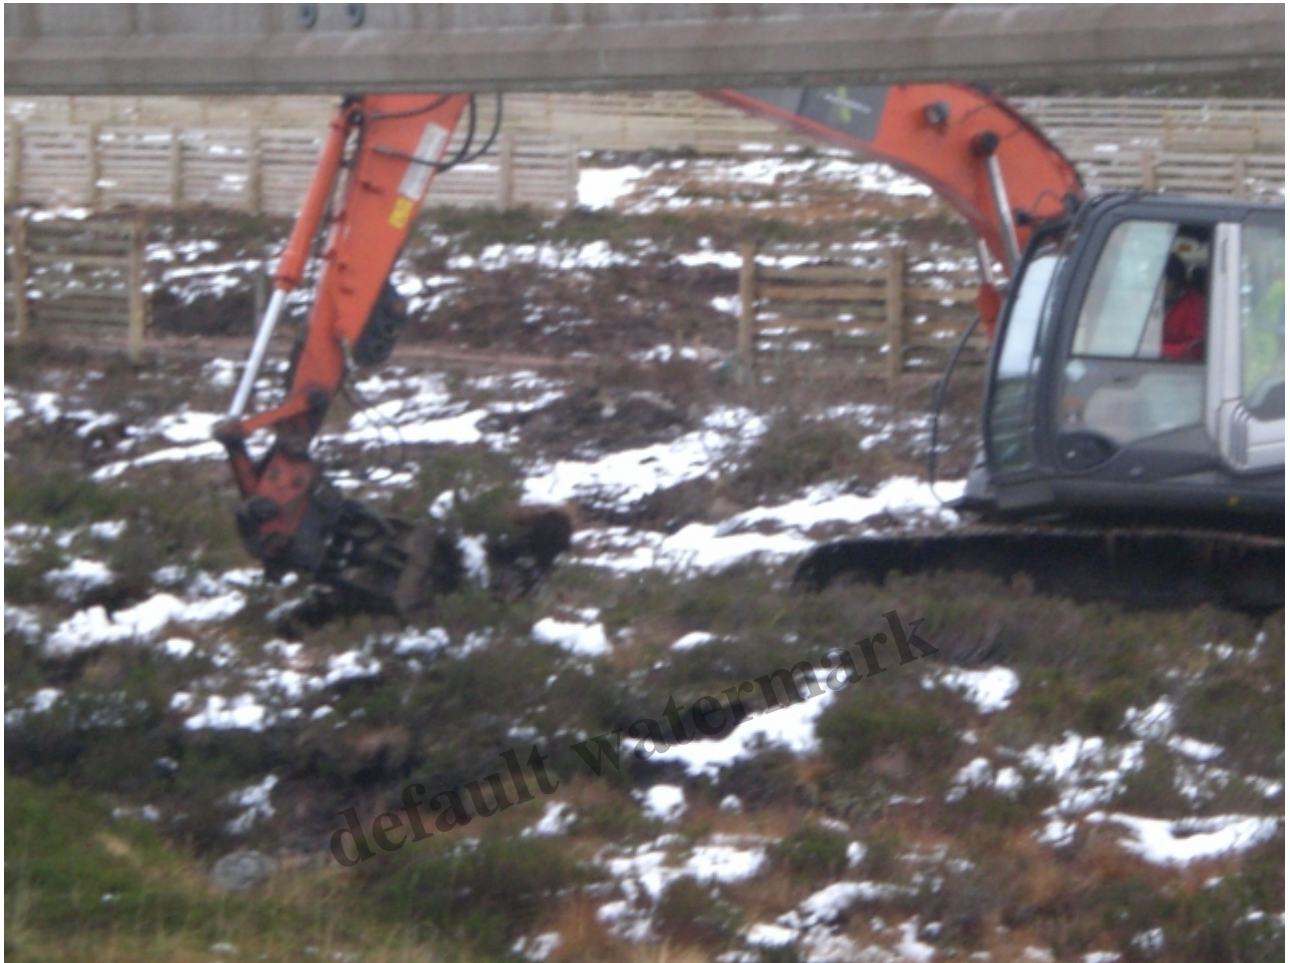
In order to “restore” the damage caused by the works on the Shielling slope, Natural Retreats scooped up vegetation from outside the area granted planning permission.

I had not realised till Saturday that this appears to have been from a far wider area than that immediately adjacent to the shieling slope.

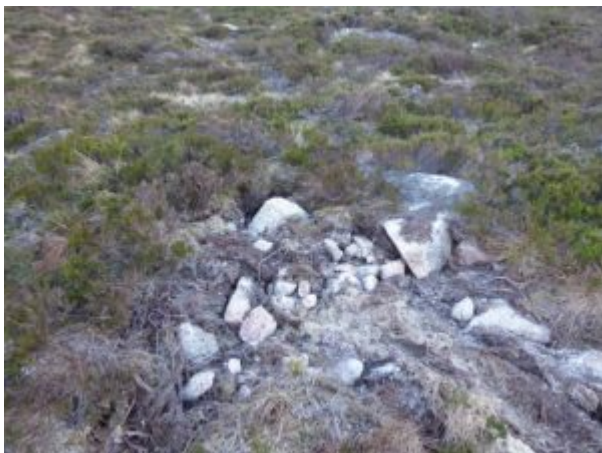
Hole scooped above track to Fiacail dump

The whole of the bank above the track to the Fiacaill dump is full of holes where vegetation has been removed – the most likely explanation appears to be that this was used to replace the vegetation at the Shieling which had not been properly stored.

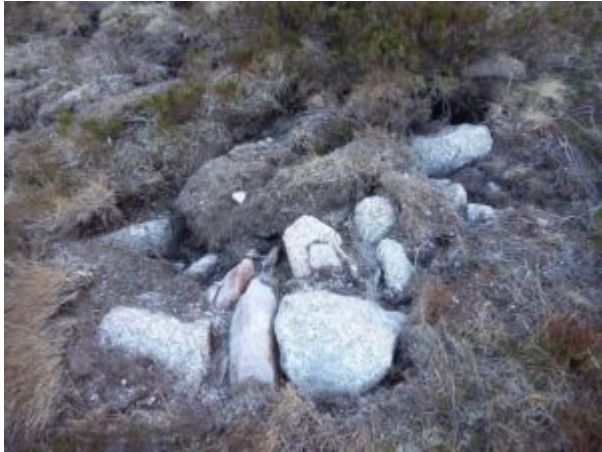
Another hole above track to Fiacaill dump

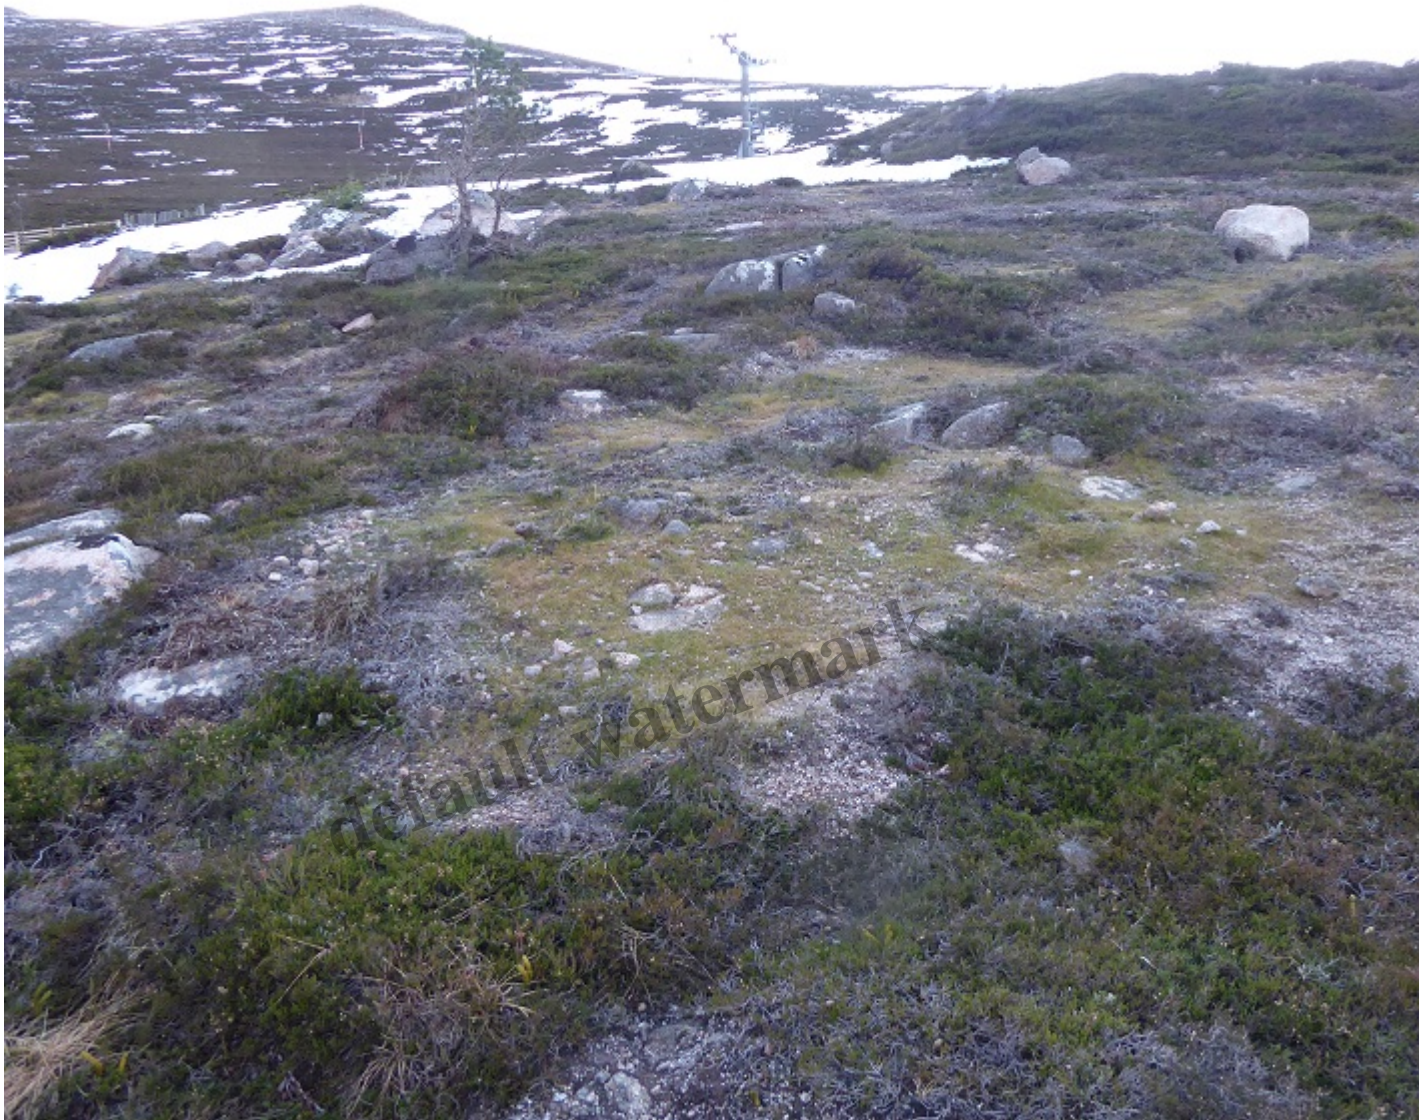
Area of ground above the unlawful works to create a new bank belong the shieling tow. This ground reprofiled and the most likely explanation for the bare ground and re-seeding is that Natural Retreats vegetation from here for use on the Shieling tow.

The CNPA Committee Report makes no attempt to other describe or assess the impact of this destruction. If it had done so, it would help put the remedial measures I described at the beginning of this post in context, as they do not address all of the damage that has been done or assess what impact this might have in the long-term. A proper vegetation assessment should have been undertaken before any decision is made.

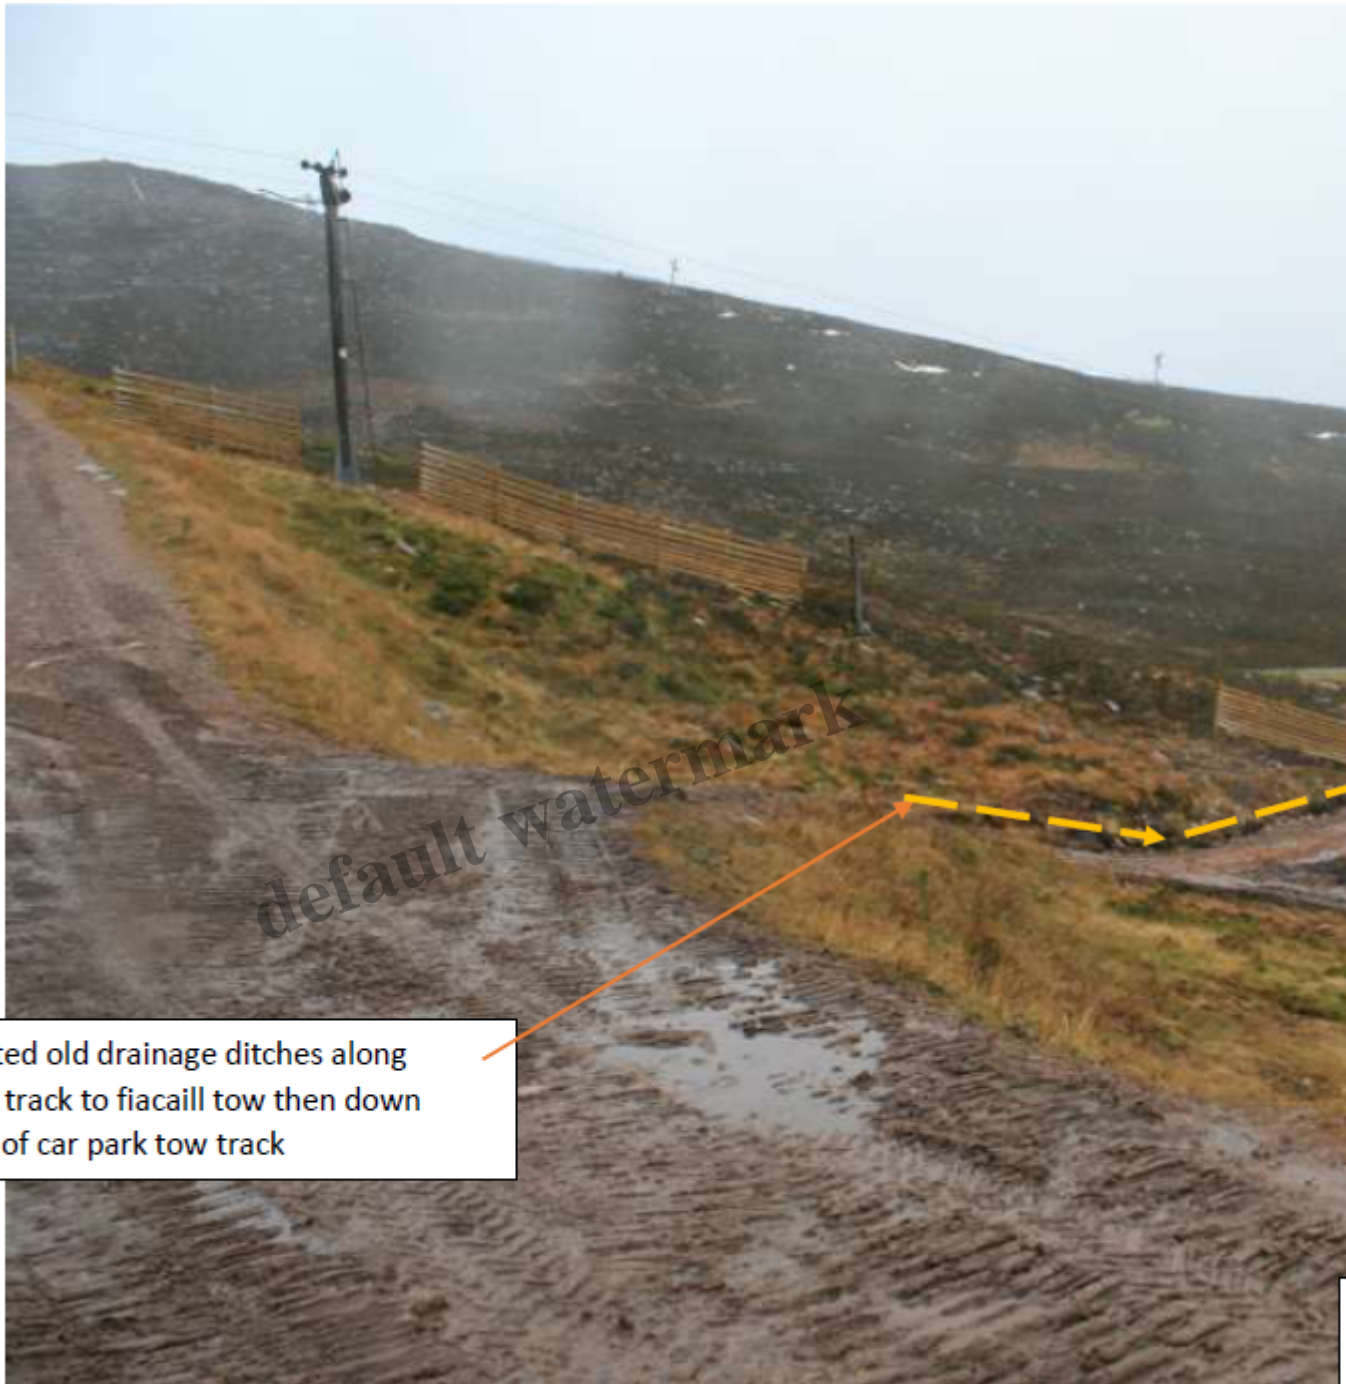
Why a proper assessment is needed is illustrated by these photos. Natural Retreats included the

photo above in their plans showing what they had done.

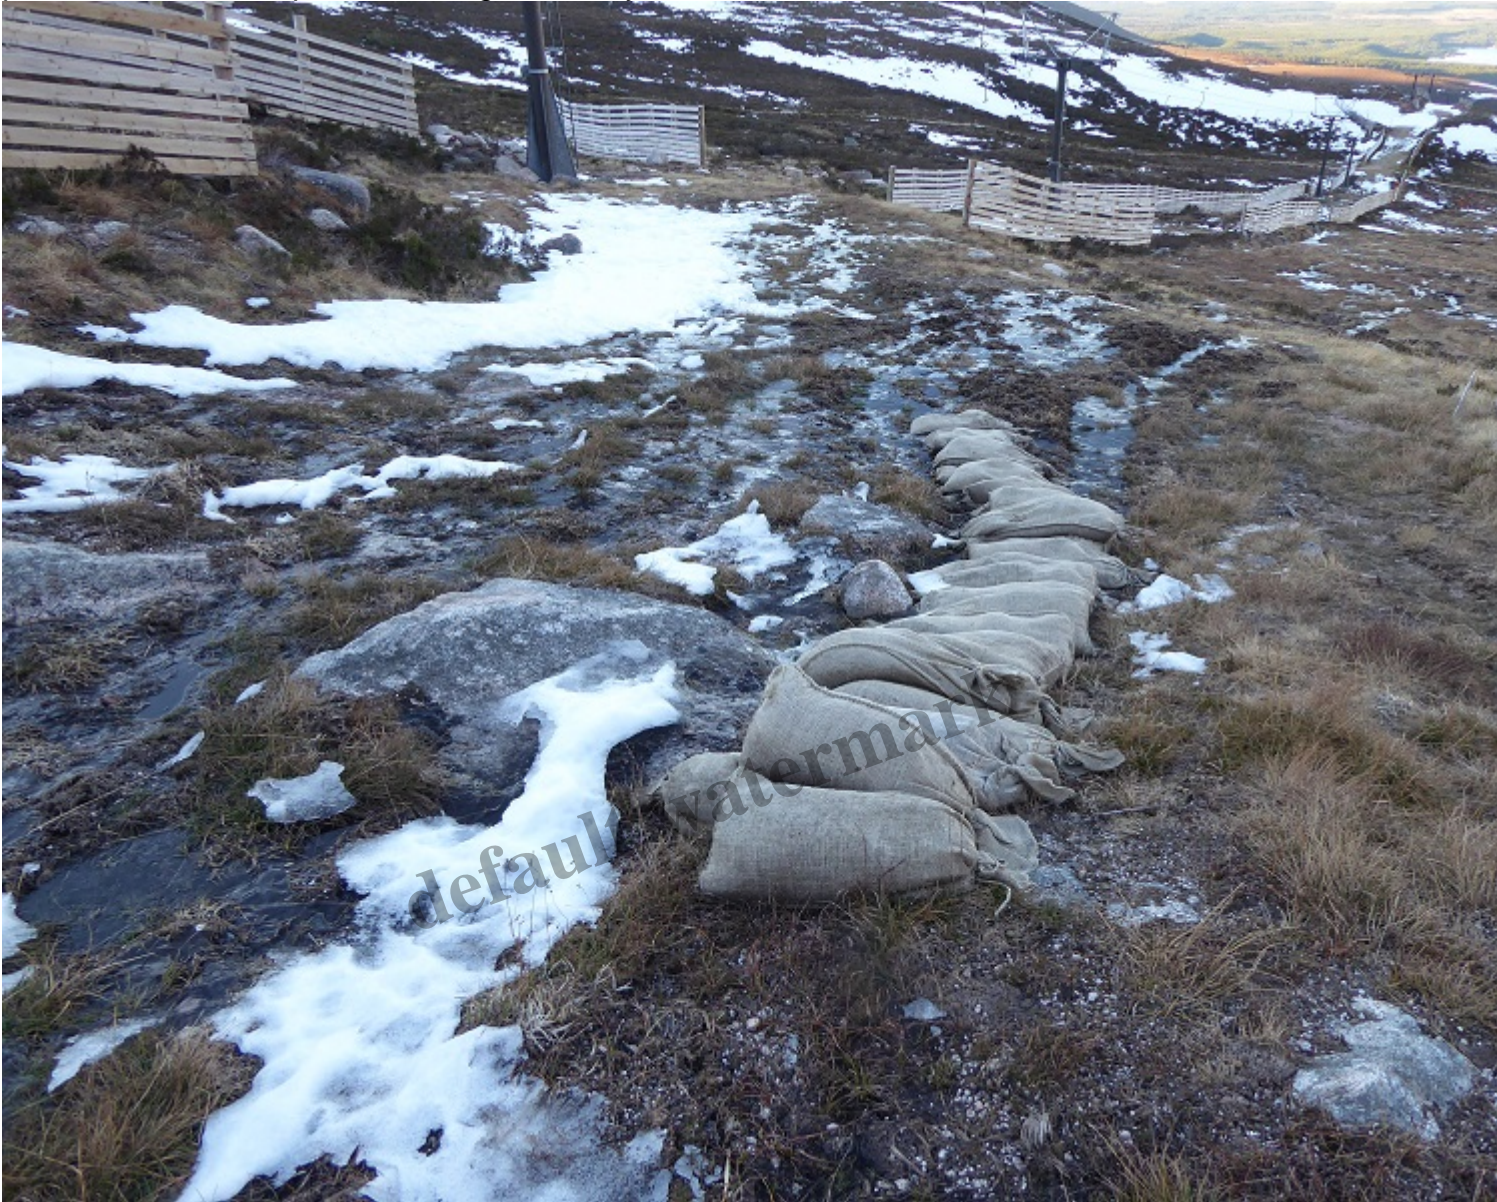
The photo below shows how the area in the distance looked on Saturday. The sandbags are proof that something is not working.

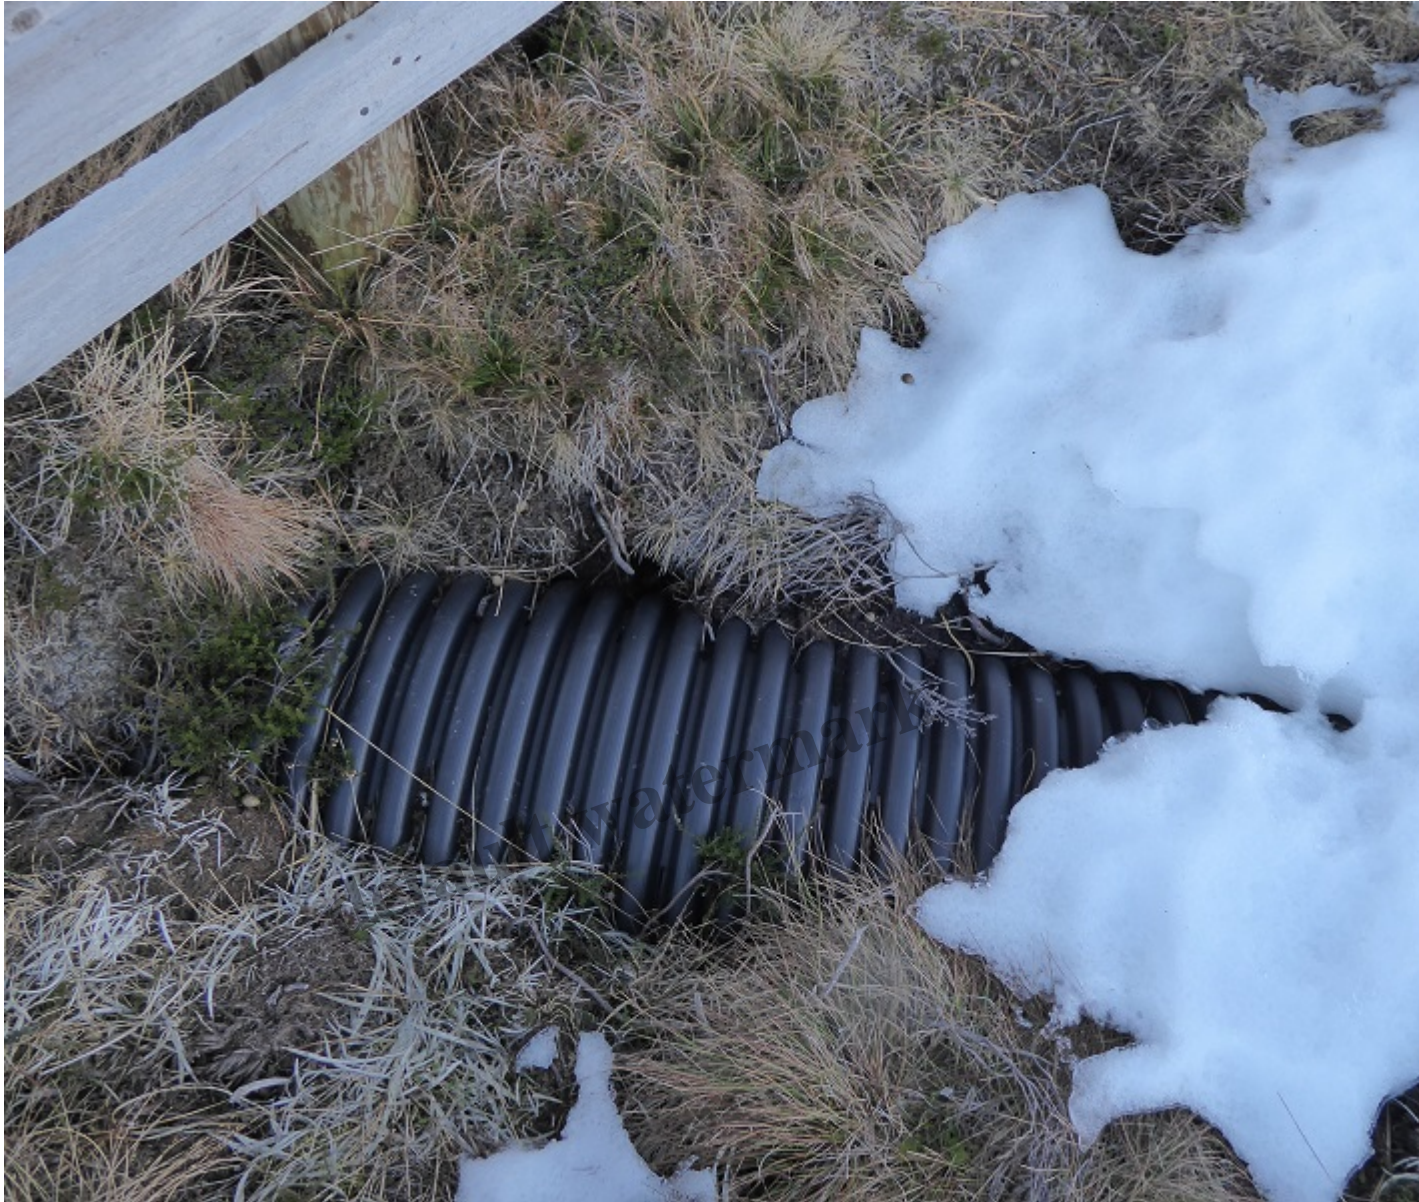
Section of poorly finished culvert crossing ski slope

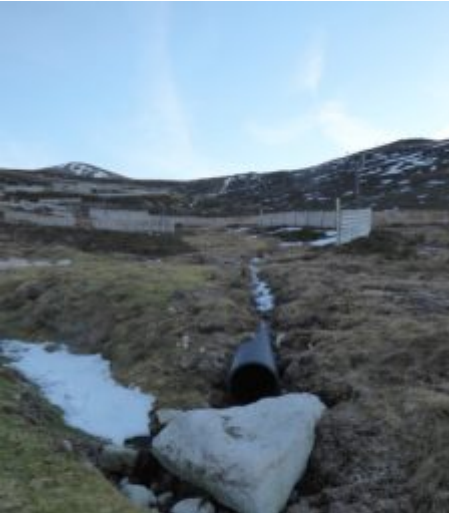
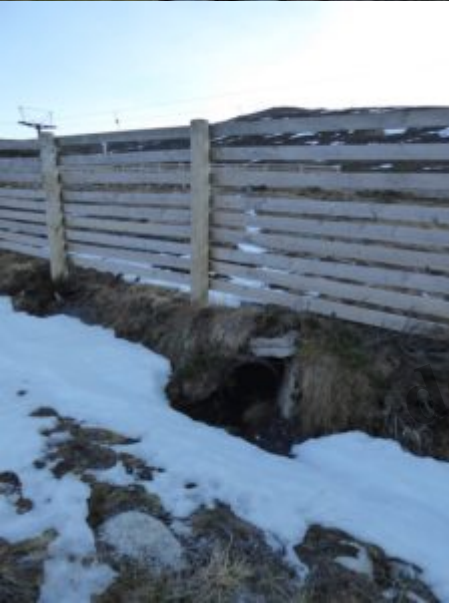
New? and poorly finished culvert at bottom of Shieling slope on left.

There are at least three culverts, none of which have been properly covered, running under the southern of the two shieling slopes (right photo).

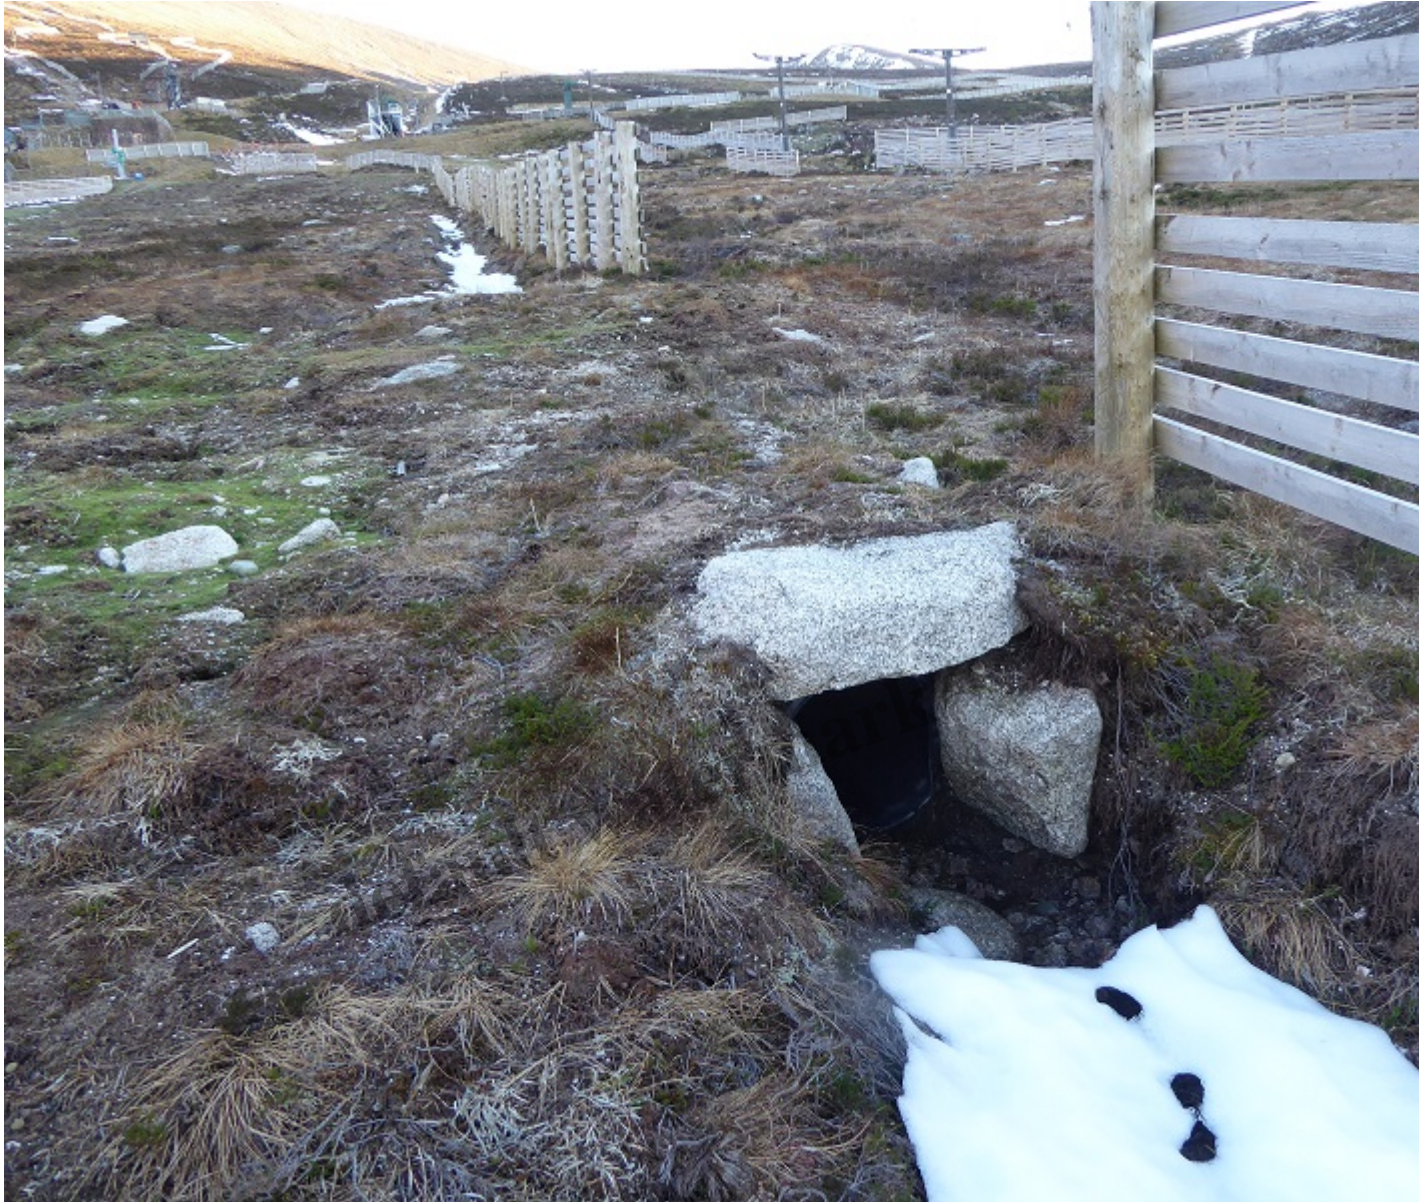
The seeding indicates that this culvert on right side of left shieling slope is new. The drainage line to fence is not mentioned in the Committee Report or accompanying papers.

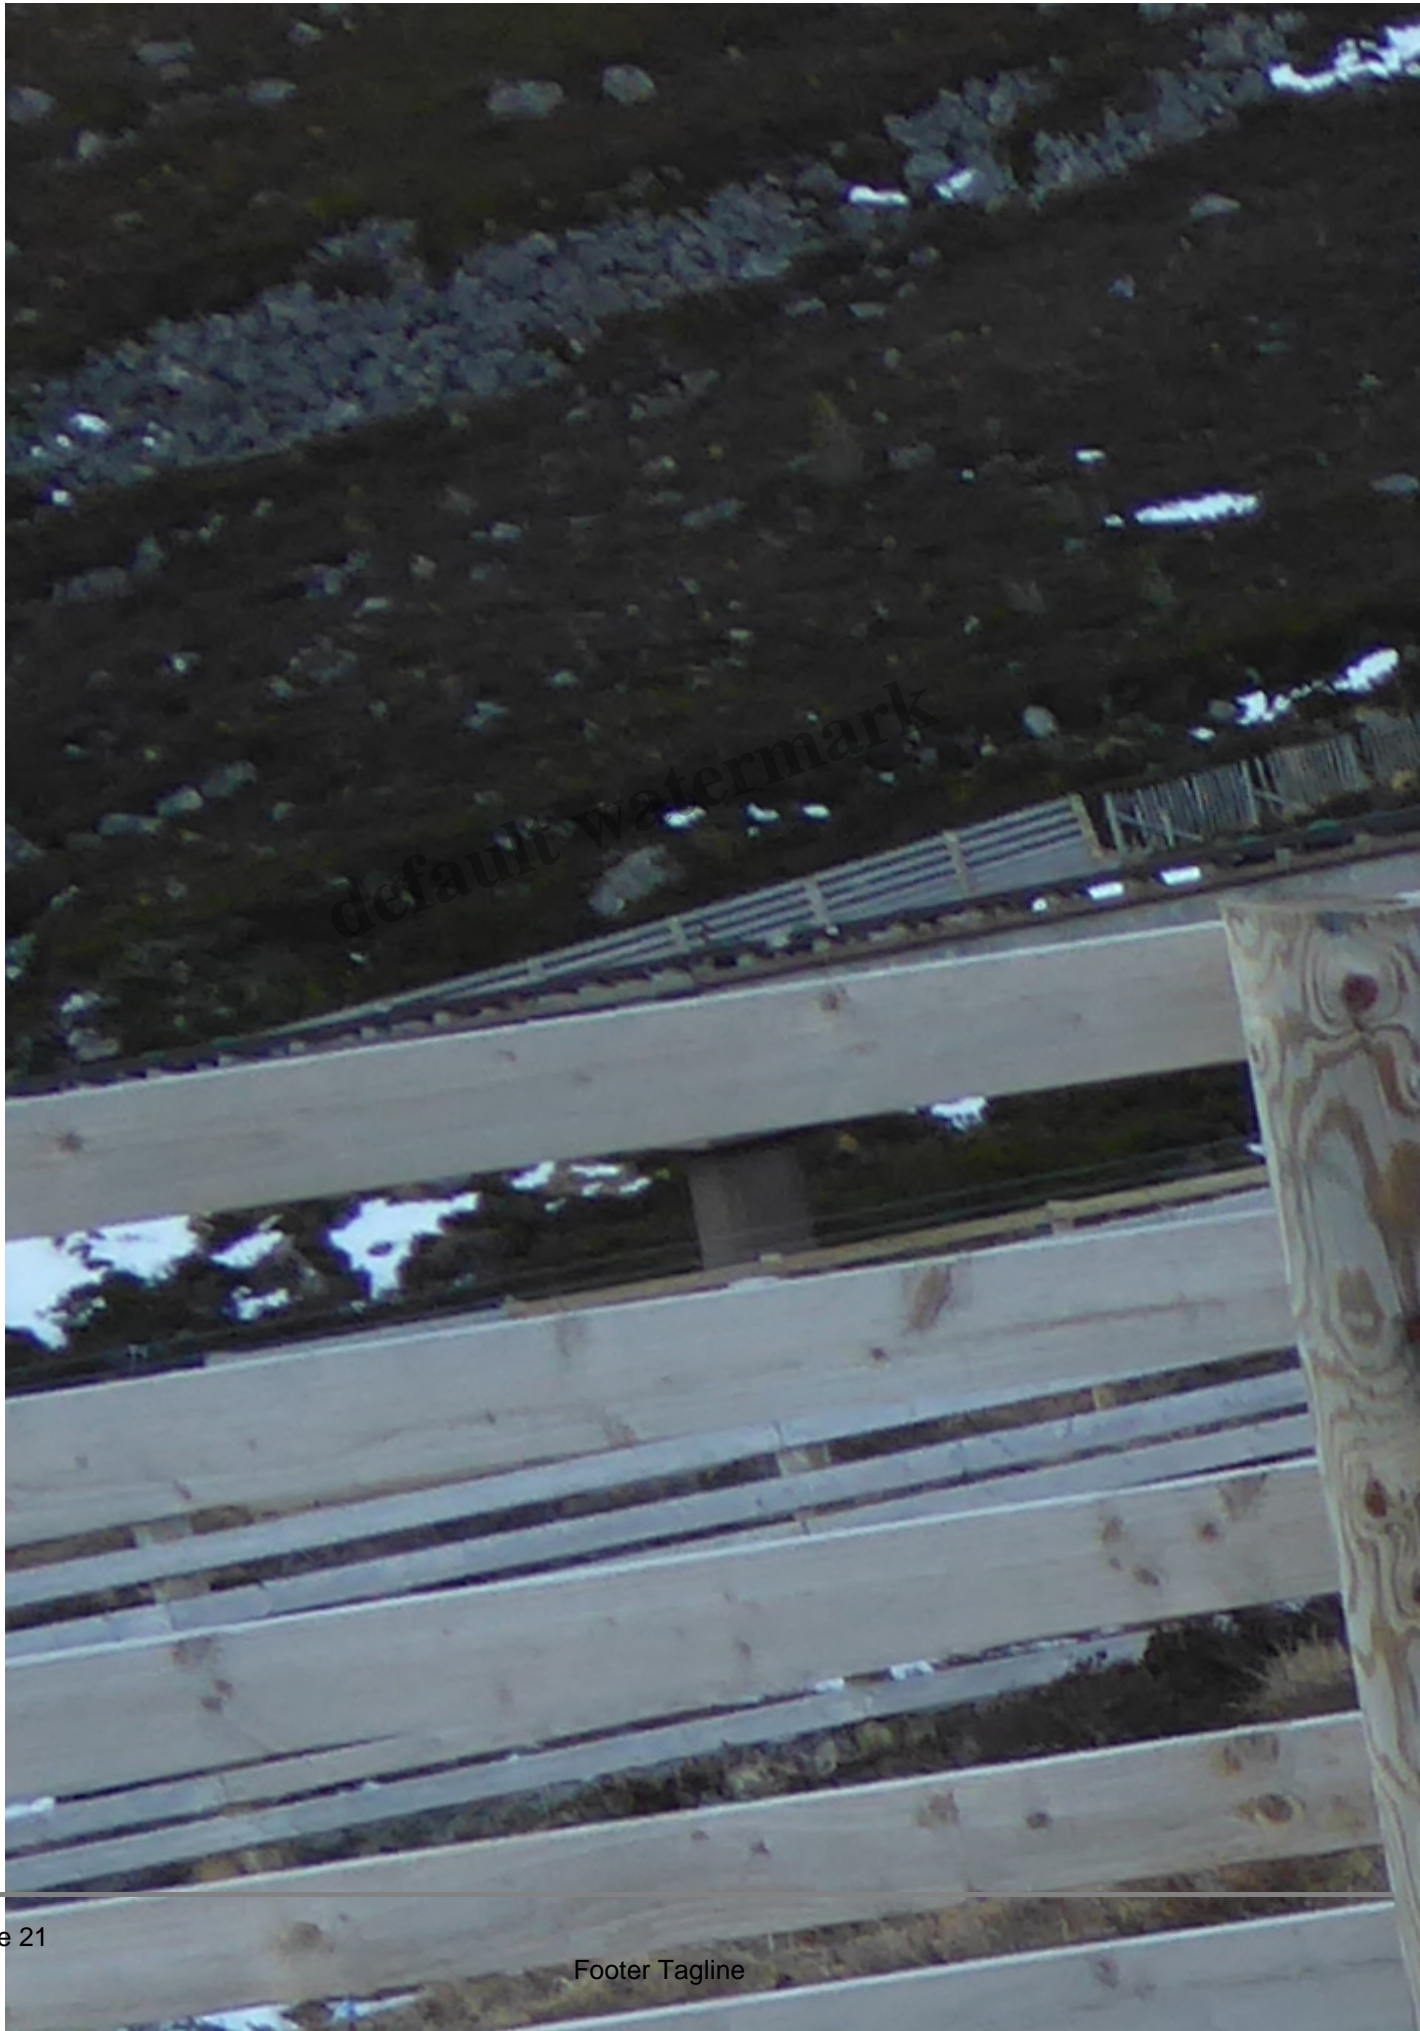
Besides the culverts there are also drainage ditches across the slope

So where is the environmental impact assessment of all this drainage work? What are the implications? We simply don't know. I don't think that is good enough.
