The hill track at Cairngorm – a test case for the National Park (2)

Location and design of the hill track

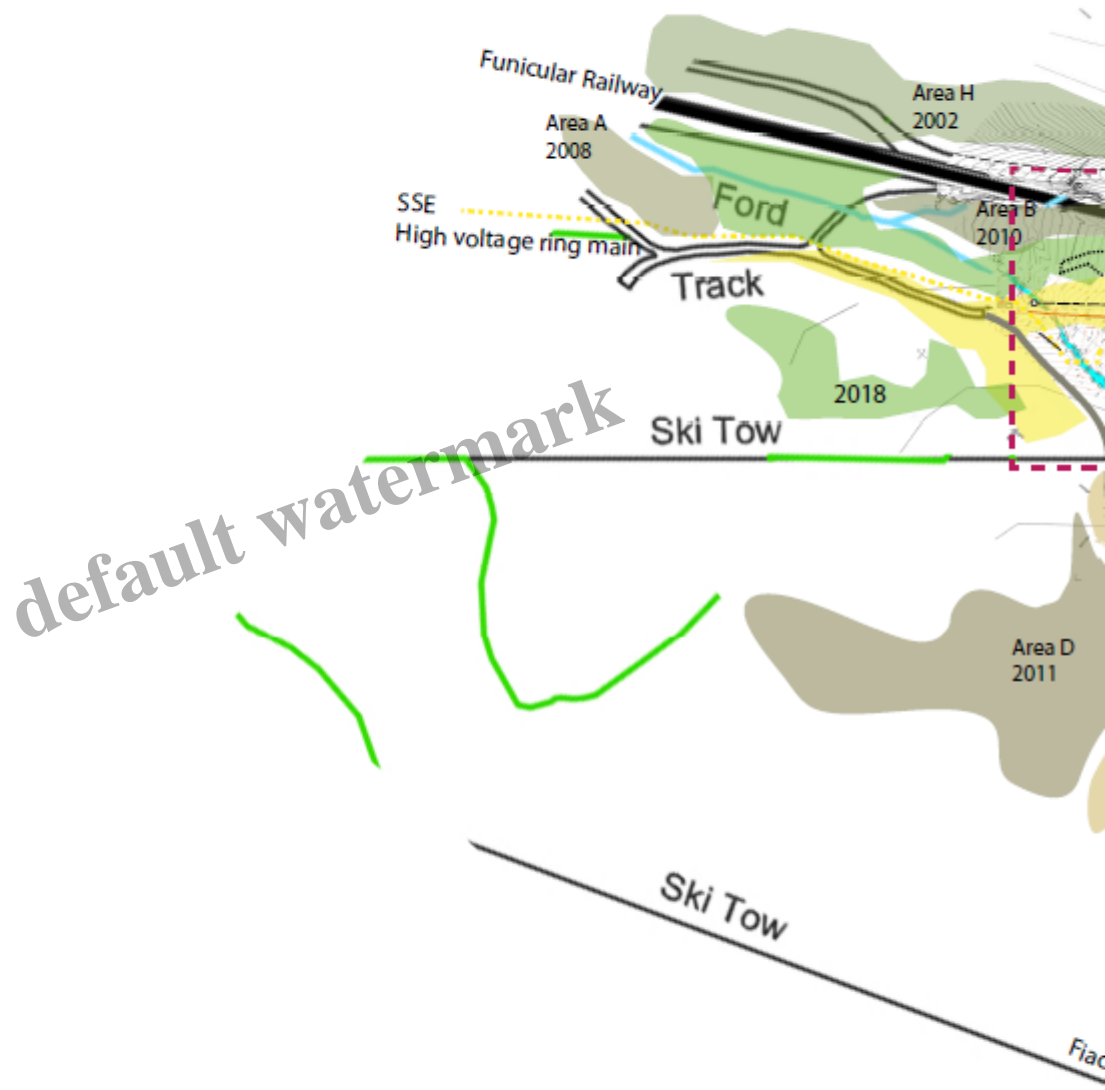
Landscape plan
Drg 4
Scale 1:1000
Printed at 100%

The brown areas are previous plantings, the green is additional planting proposed for 2017-18

The planting will not just hide some of the infrastructure, it should also – though there is no mention of this in the Report – compensate for some of the increased water run-off that has been created by the development. There are some other positive things in the plan, including works around both ends of the ski tow to improve landscaping; the work at the bottom will be done by hand. All of this is good. It should however have all been included in the original planning application, which was sketchy at the very least. Its clear to me that the public pressure has helped (or is it pushed) CNPA staff to take more interest in the development. A lesson here for the CNPA. Well thought out plans properly enforced would avoid lots of problems and public criticism.

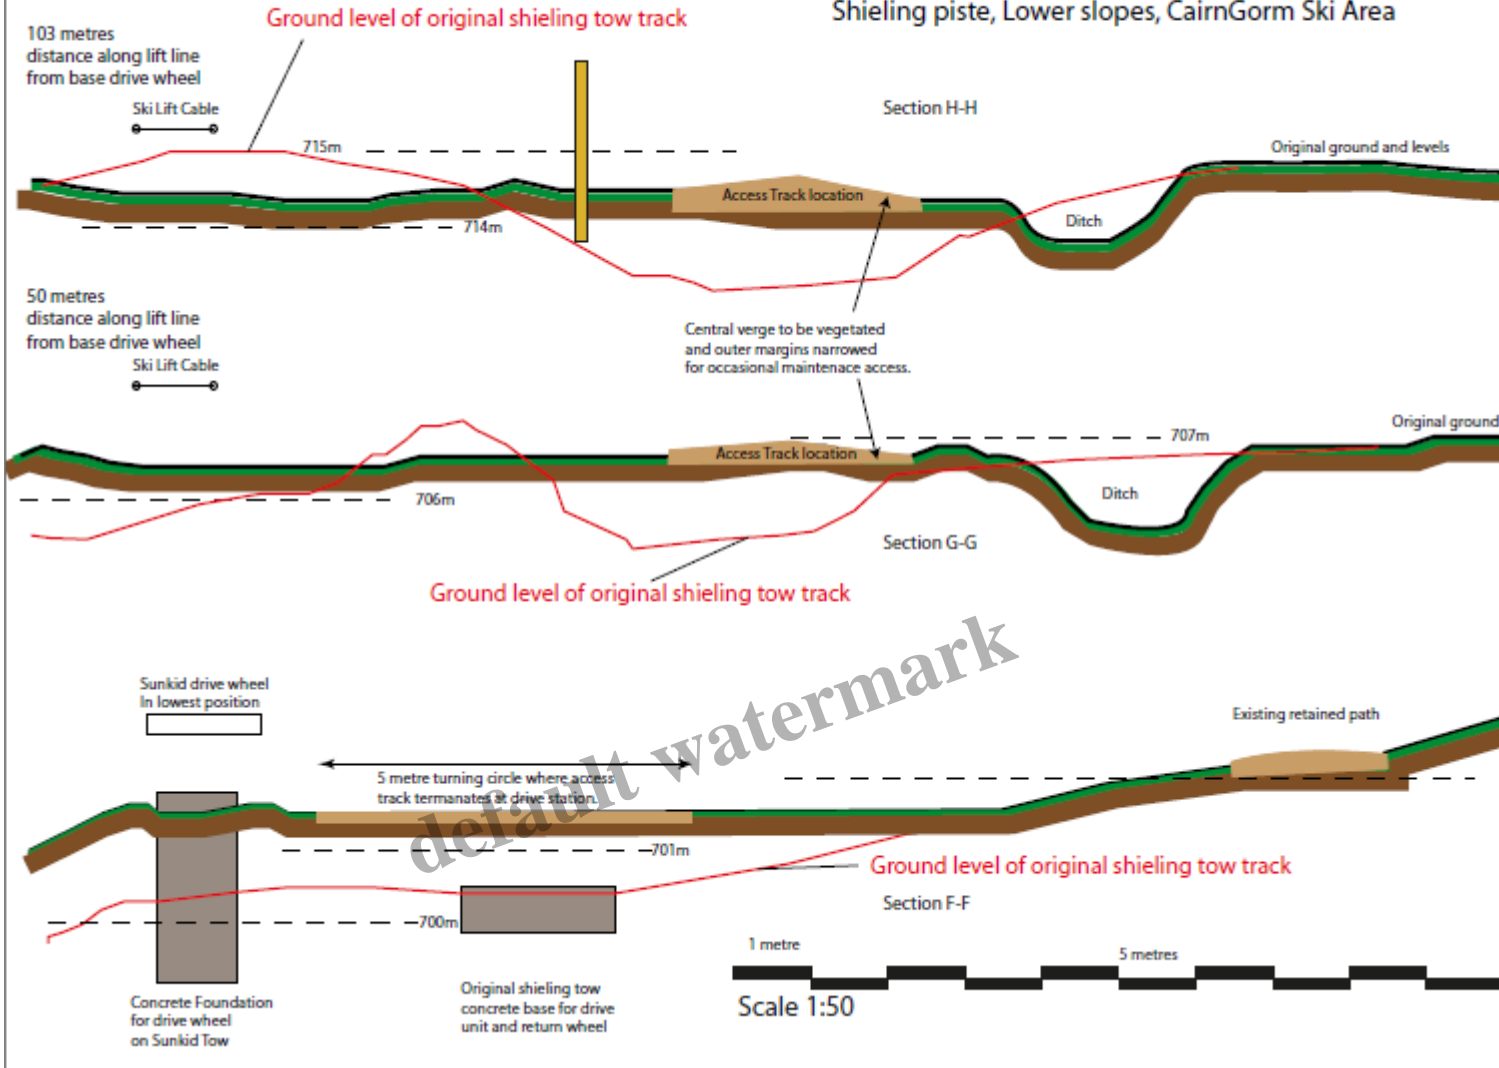
Sections F-F, I-I & J-J showing new lift and access track location
Shielling piste, Lower slopes, CairnGorm Ski Area

There has been a lot of nonsense talked about the hill track being needed for construction purposes. This diagram from Appendix A to the Committee Report shows that this couldn't have been the case. The elevation of the new track is HIGHER than the previous shielling tow uptrack which sat between two bulldozed banks (section GG). In other words the hill track could only have been created AFTER the slope had been smoothed out (which was agreed in the original planning application). This explains why there is NO evidence of any temporary construction track. There wasn't any. Natural Retreats appears to have confused the original ski uptrack with the new hilltrack in order to make the latter appear more acceptable by implying this had already been agreed on a temporary basis.

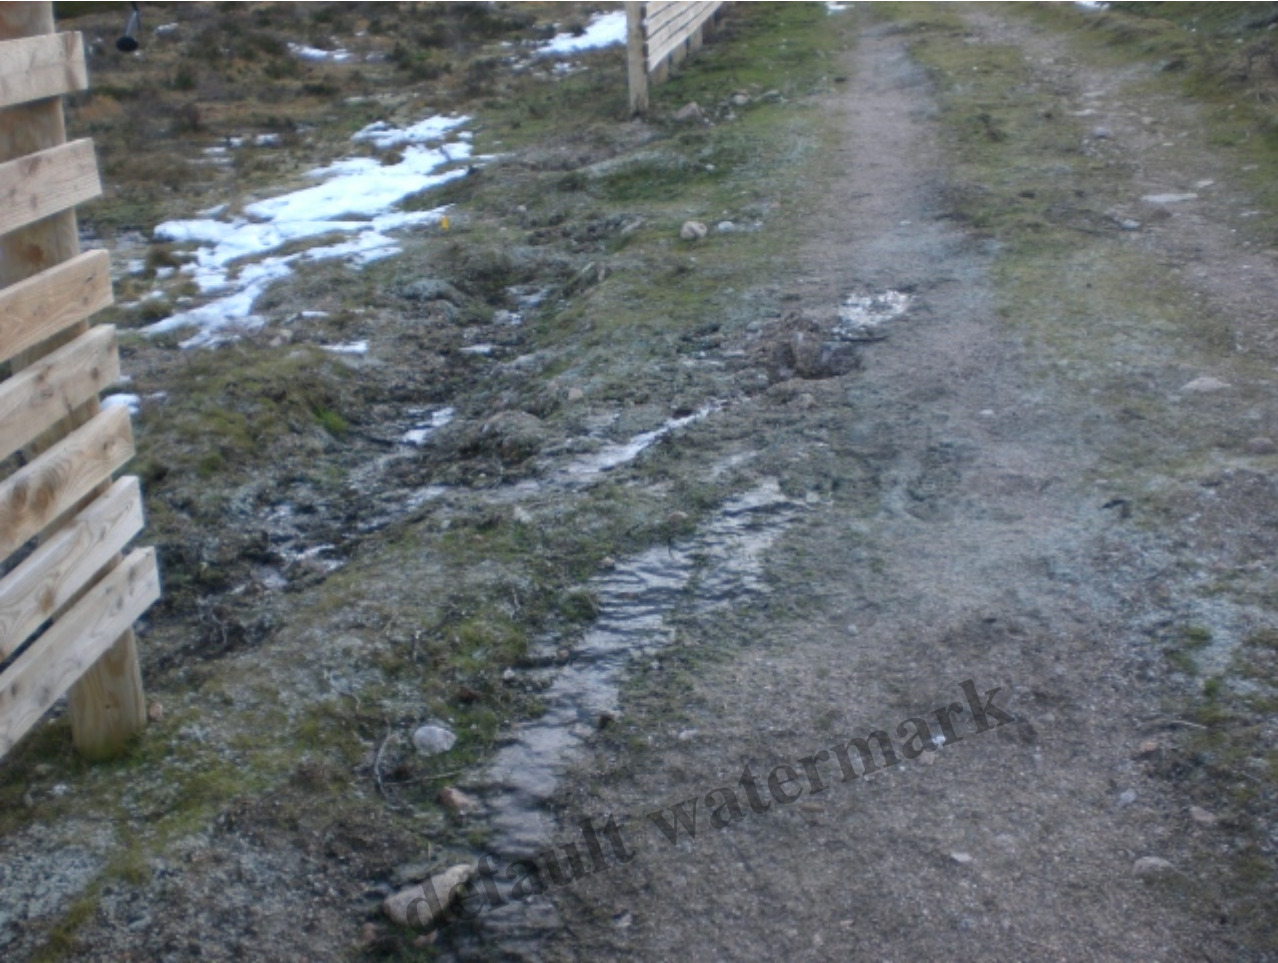
There was no sign of the hole, centre right, when I walked down the track two days before. Two days of freeze thaw and another section of track had been destroyed.

Part of the problem is that the track is too steep, contrary to SNH guidance. Natural Retreats has appears to accept this in its comment that the track “is constrained to existing ground levels” – in other words its fundamentally flawed!

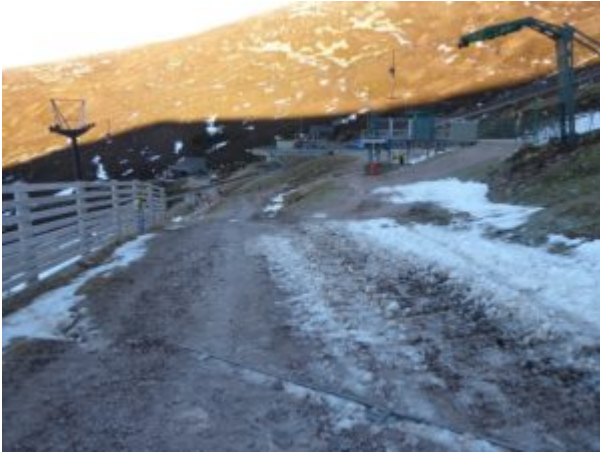
Natural Retreats solution is drainage bars which it says works well. If CNPA officers had walked around Cairngorm at the weekend they would have seen every single steel drainage channel choked with eroded material

Choked steel drainage channel by Cas Gantry

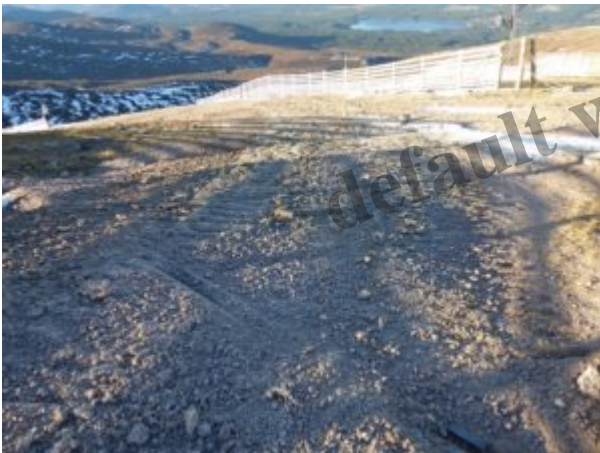
Choked drainage channel below Ptarmigan

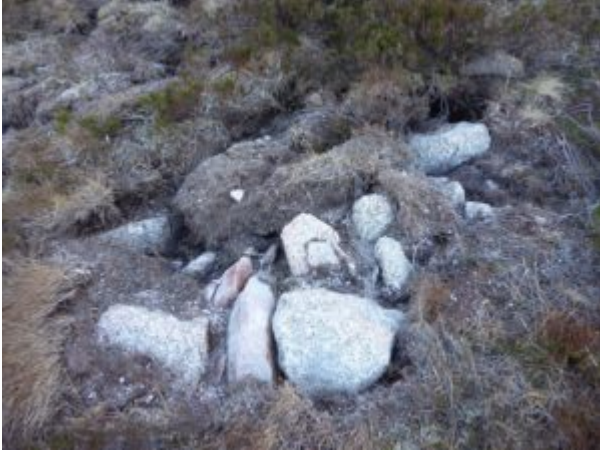
Another hole above track to Fiacail dump

The whole of the bank above the track to the Fiacail dump is full of holes where vegetation has been removed – the most likely explanation appears to be that this was used to replace the vegetation at the Shieling which had not been properly stored.

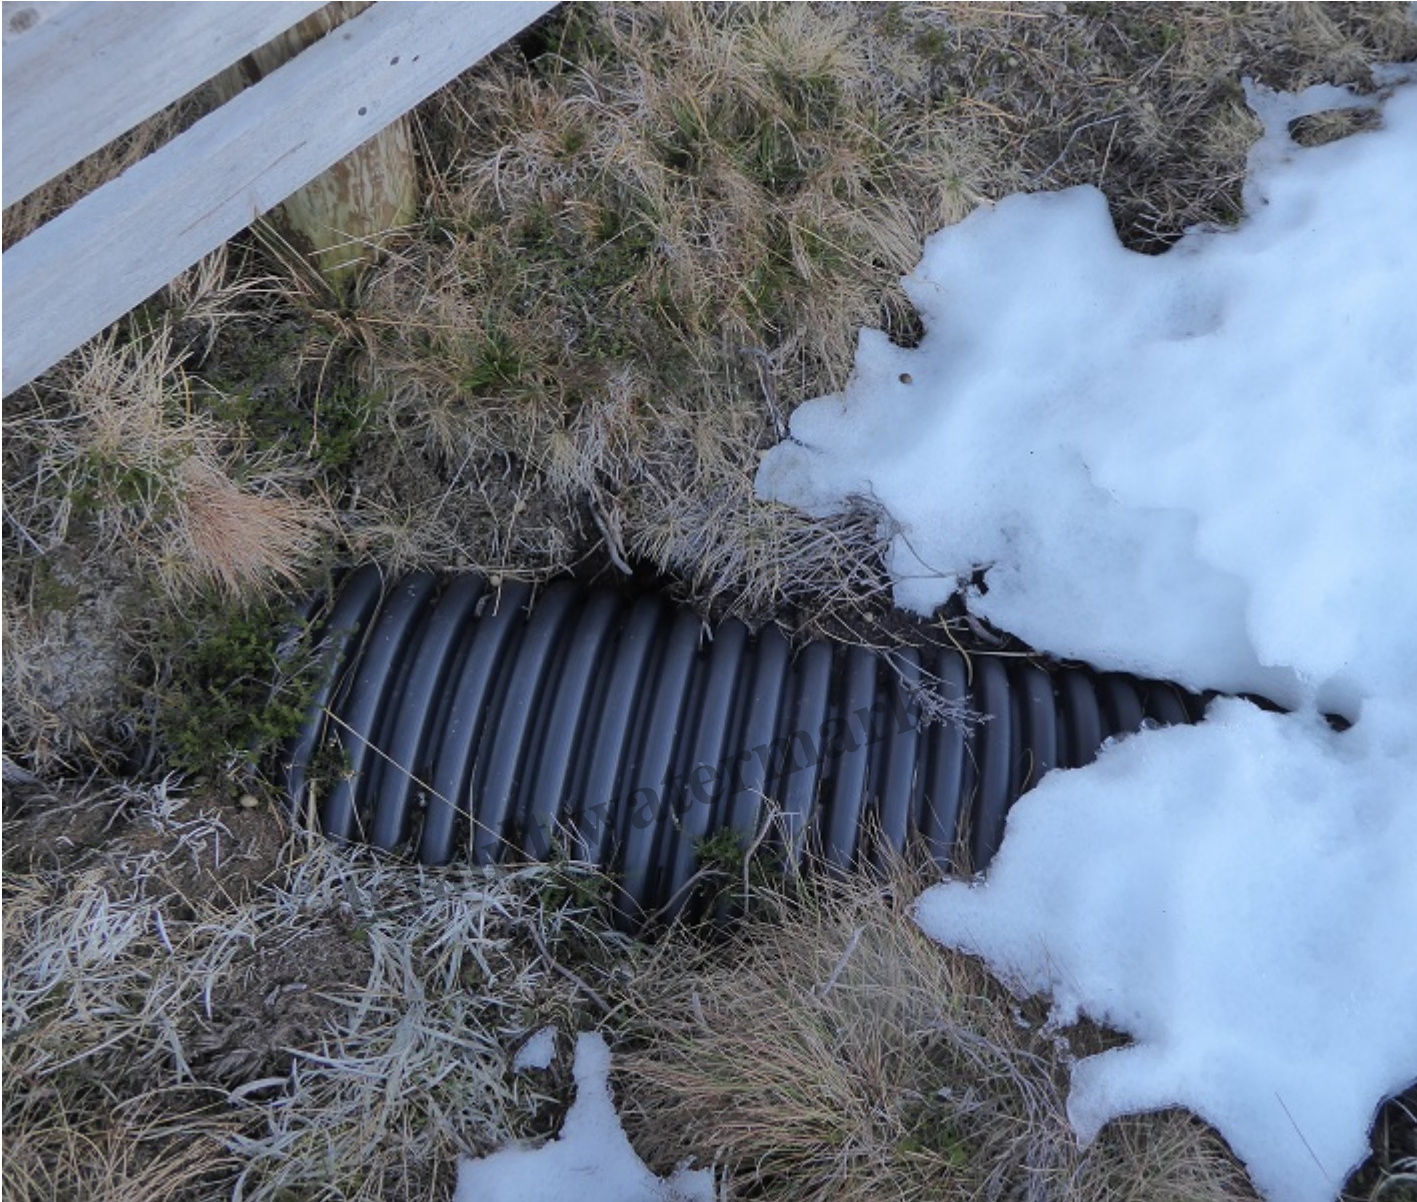
The photo below shows how the area in the distance looked on Saturday. The sandbags are proof that something is not working.

Section of poorly finished culvert crossing ski slope

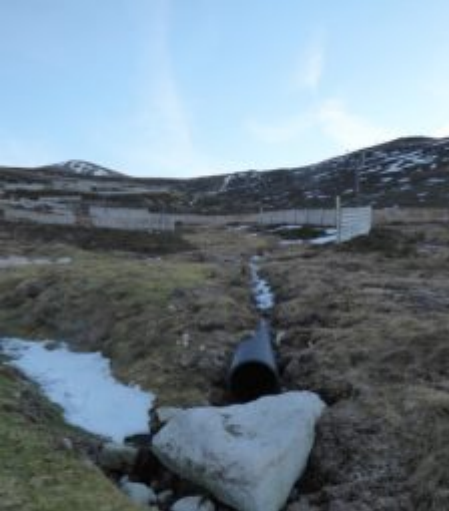
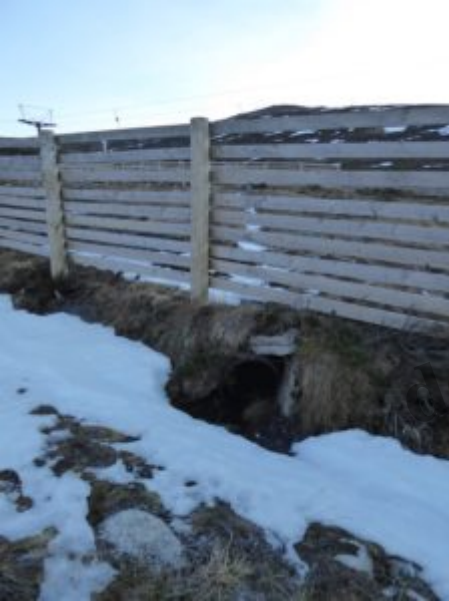
New? and poorly finished culvert at bottom of Shieling slope on left.

There are at least three culverts, none of which have been properly covered, running under the southern of the two shieling slopes (right photo).

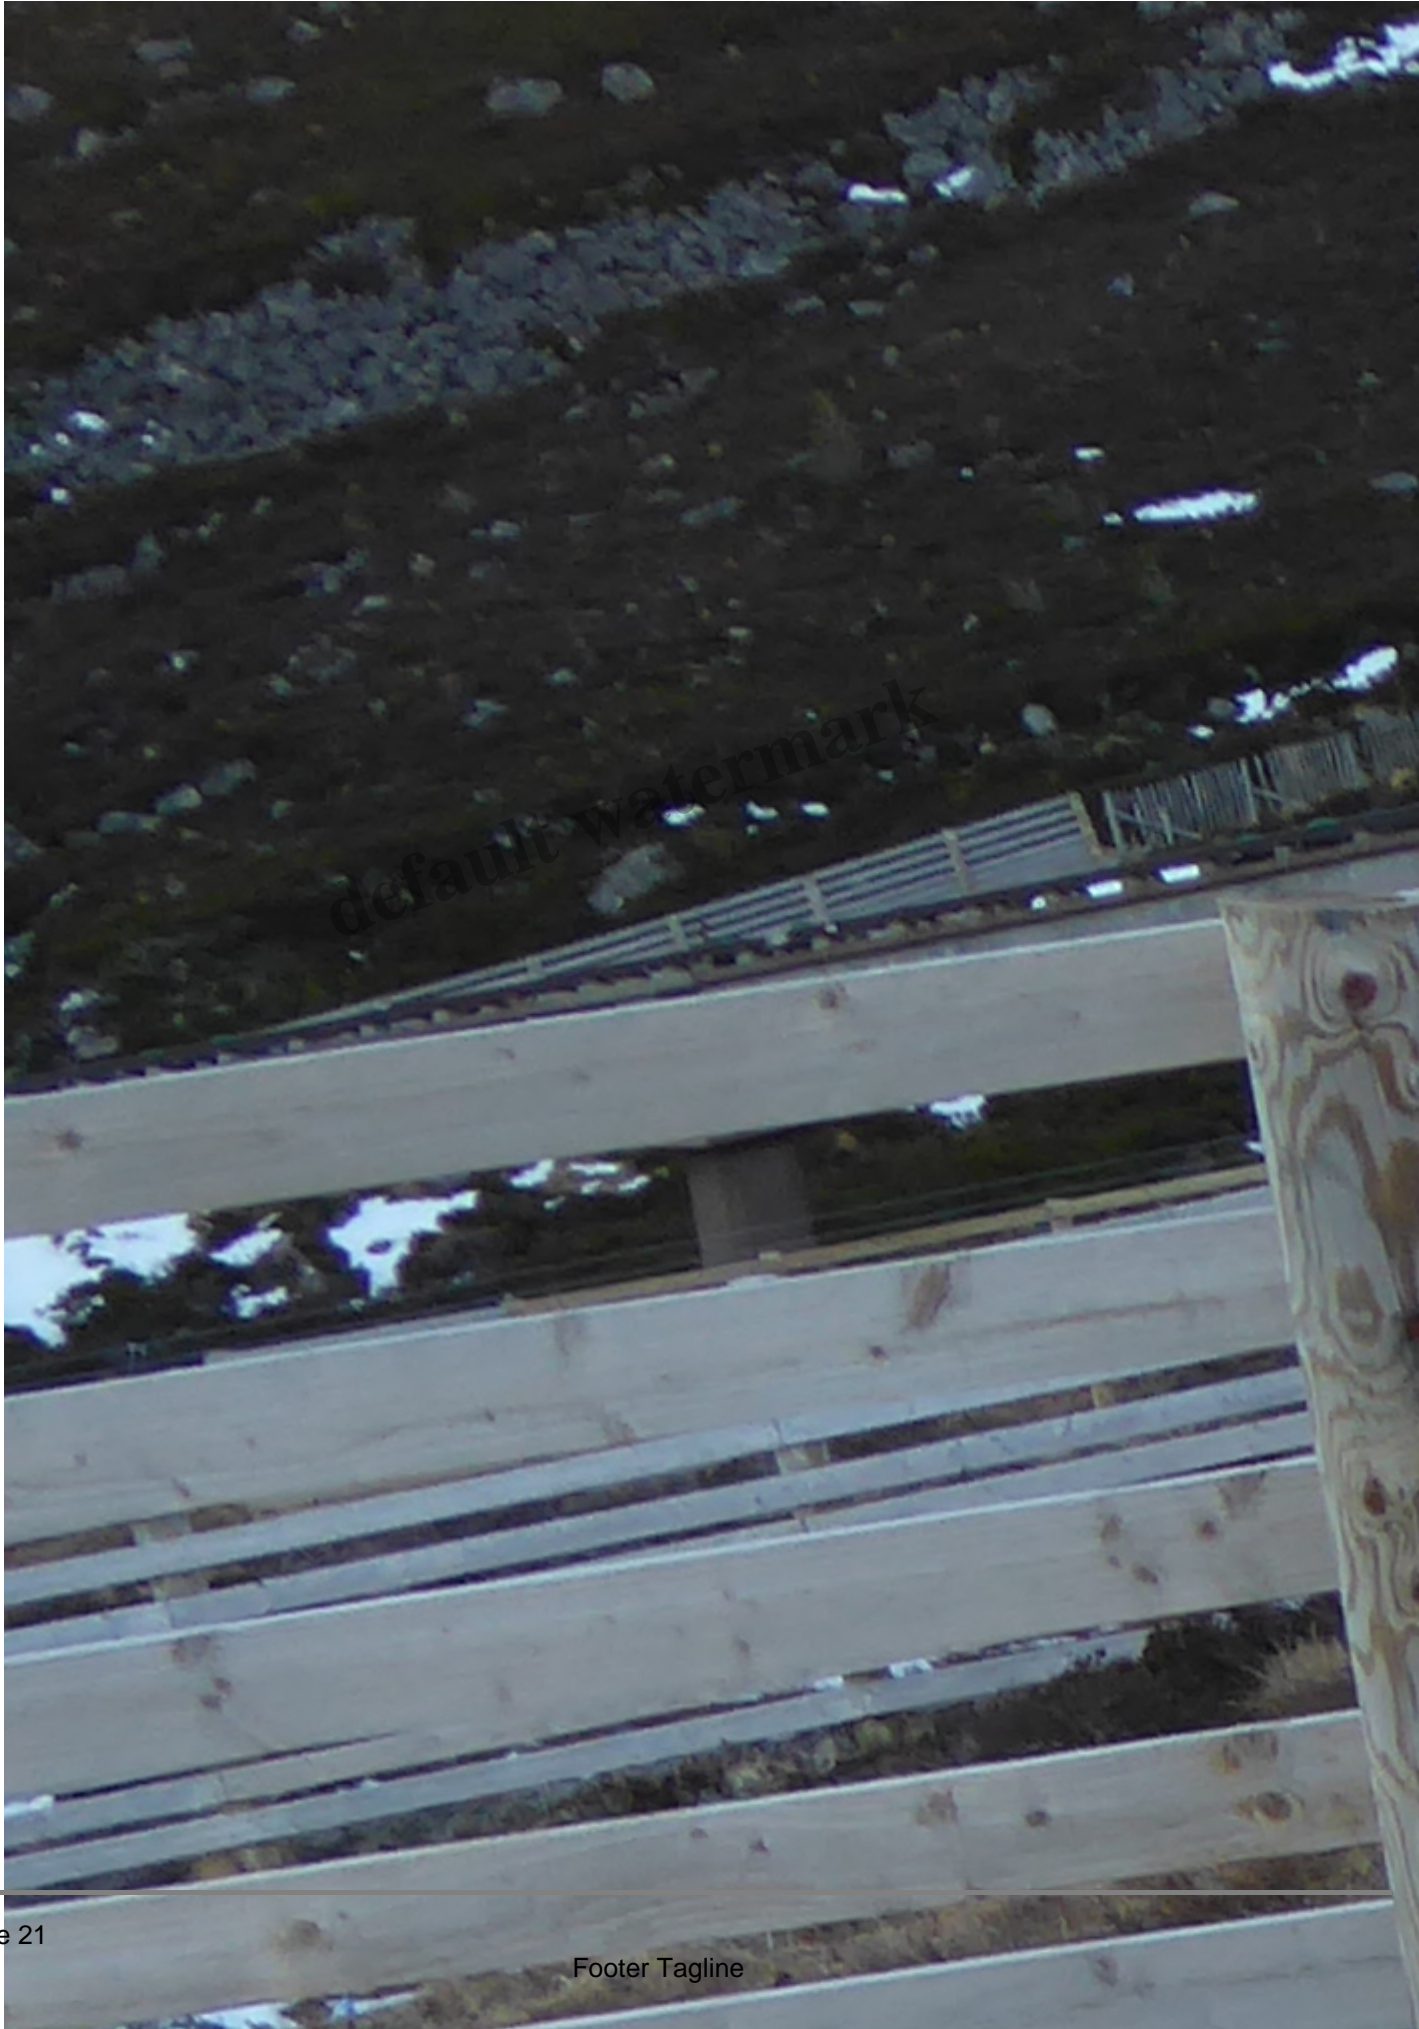
Besides the culverts there are also drainage ditches across the slope

So where is the environmental impact assessment of all this drainage work? What are the implications? We simply don't know. I don't think that is good enough.
