## The hill track at Cairngorm â?? a test case for the National Park (2)

The Officers Report for the Cairngorms National Park Planning Authority meeting on Friday which will consider the hill track at Cairngorm is as interesting for what it leaves out as for what it includes. This is over and above the policy omissions and enforcement failures considered in yesterdayâ??s post.

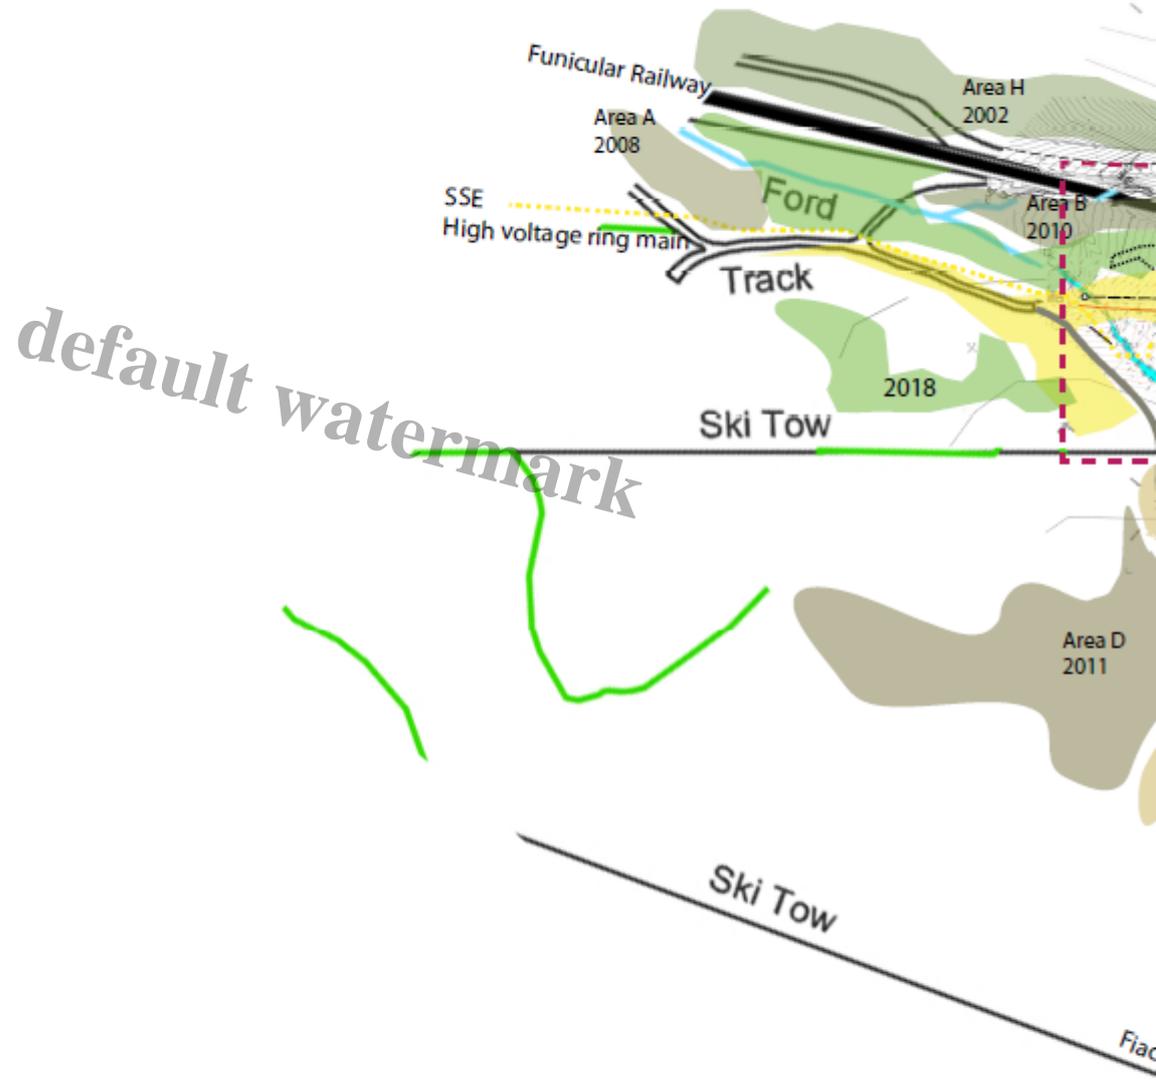
Landscape plan  
Drg 4  
Scale 1:1000  
Printed at 100%

The brown areas are previous plantings, the green is additional planting proposed for 2017-18

The planting will not just hide some of the infrastructure, it should also â?? though there is no mention of this in the Report â?? compensate for some of the increased water run-off that has been created by the development. There are some other positive things in the plan, including works around both ends of the ski tow to improve landscaping; the work at the bottom will be done by hand. All of this is good. It should however have all been included in the original planning application, which was sketchy at the very least. Its clear to me that the public pressure has helped (or is it pushed) CNPA staff to take more interest in the development. A lesson here for the CNPA. Well thought out plans properly enforced would avoid lots of problems and public criticism.

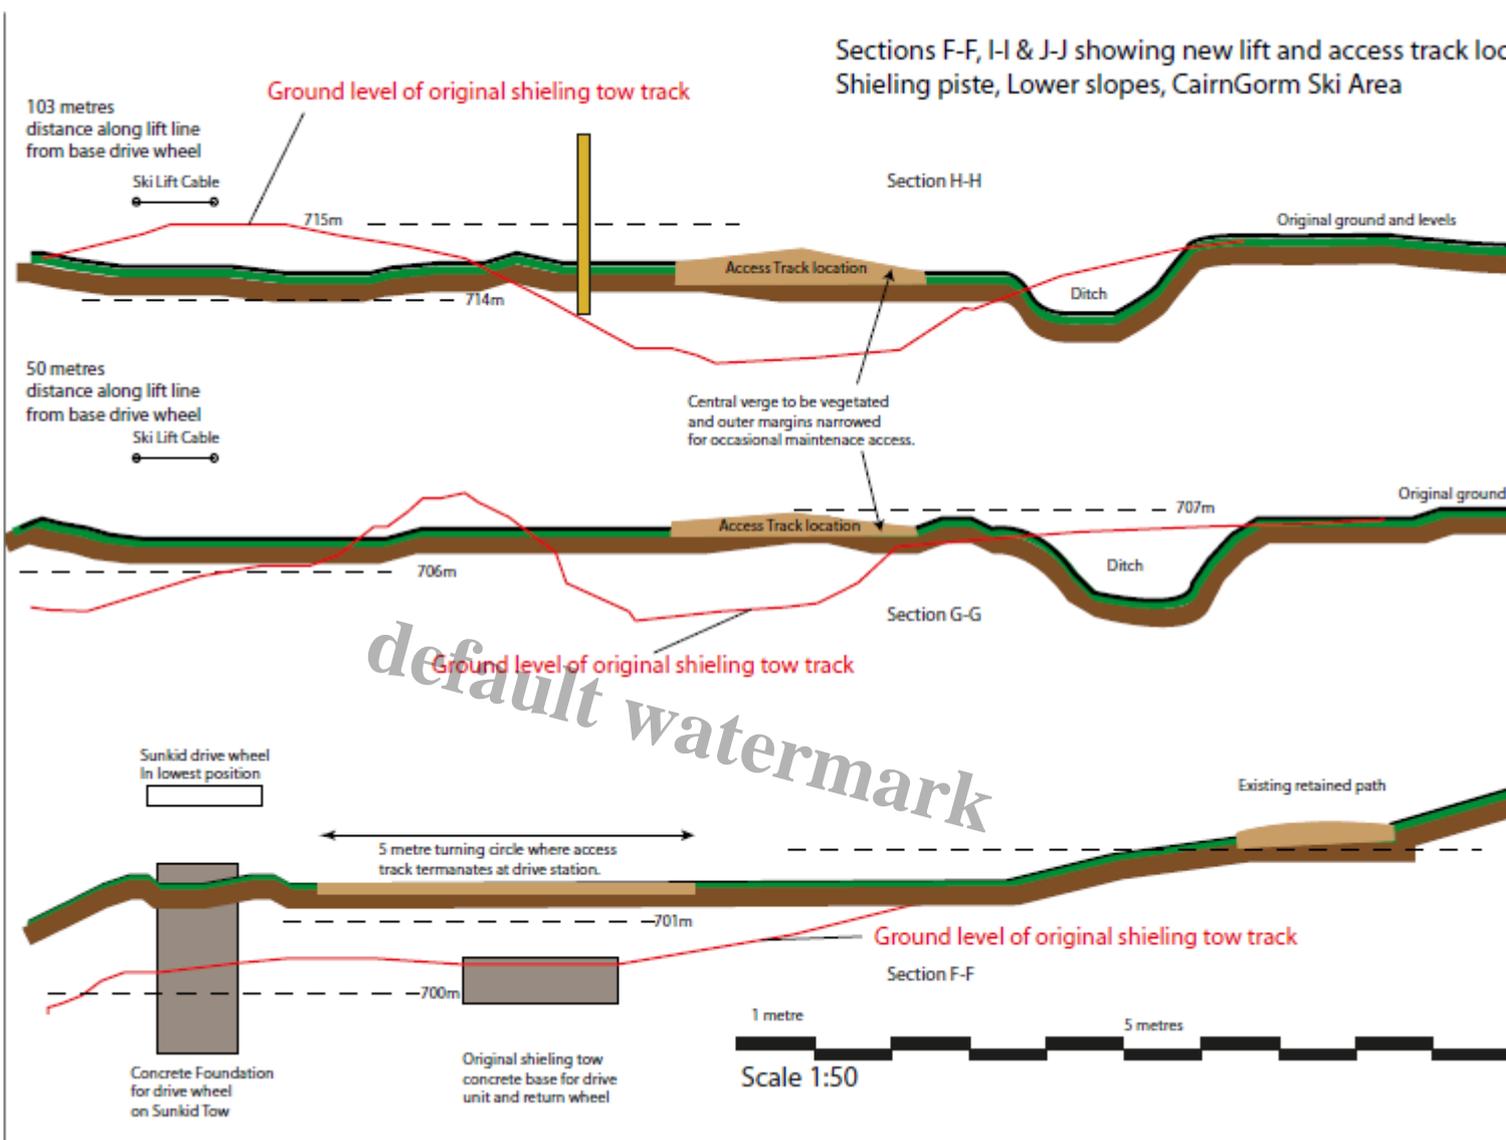
There has been a lot of nonsense talked about the hill track being needed for construction purposes. This diagram from Appendix A to the Committee Report shows that this couldn't have been the case. The elevation of the new track is HIGHER than the previous shieling tow uptrack which sat between two bulldozed banks (section GG). In other words the hill track could only have been created AFTER the slope had been smoothed out (which was agreed in the original planning application). This explains why there is NO evidence of any temporary construction track. There wasn't any. Natural Retreats appears to have confused the original ski uptrack with the new hilltrack in order to make the latter appear more acceptable by implying this had already been agreed on a temporary basis.

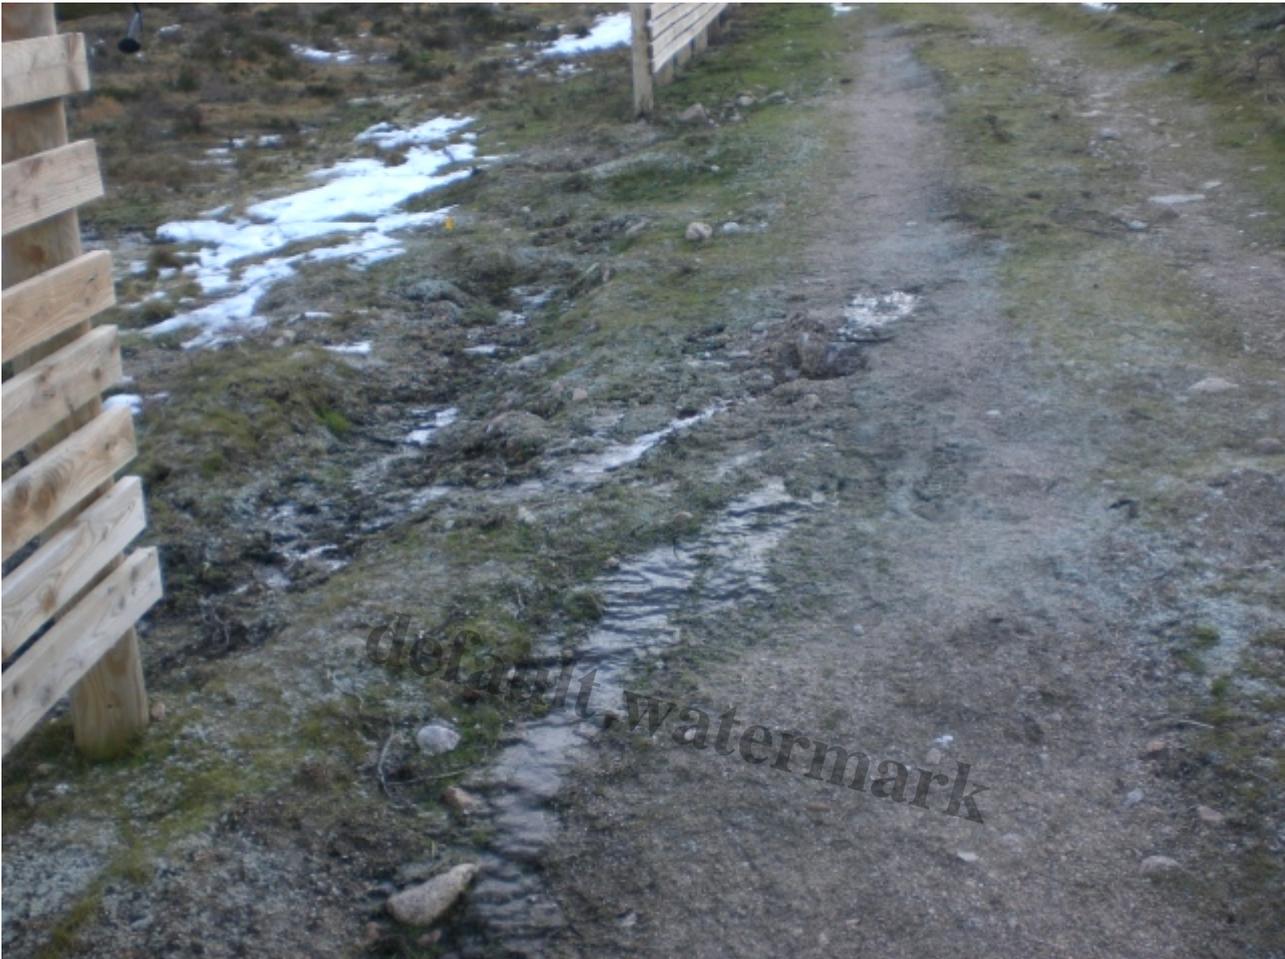
There was no sign of the hole, centre right, when I walked down the track two days before. Two days of freeze thaw and another section of track had been destroyed.

Part of the problem is that the track is too steep, contrary to SNH guidance. Natural Retreats has appears to accept this in its comment that the track "is constrained to existing ground levels" in other words its fundamentally flawed!

The problem which remains though is that the surface materials are too fine and will wash away whatever drainage is installed. The track, as oriented, is simply not sustainable and the Planning Committee needs to consider alternatives.

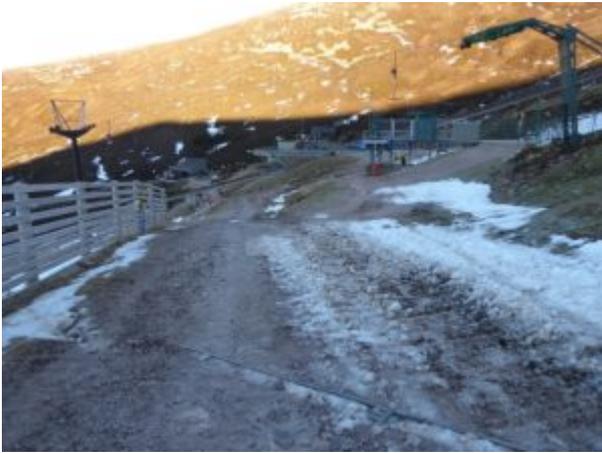
Natural Retreats solution is drainage bars which it says works well. If CNPA officers had walked around Cairngorm at the weekend they would have seen every single steel drainage channel choked with eroded material

Choked steel drainage channel by Cas Gantry

CNPA officers should have questioned the efficacy of steel drainage channels and its interesting why they have not advocated the use of natural materials, as in photo above. Are the granite blocks any

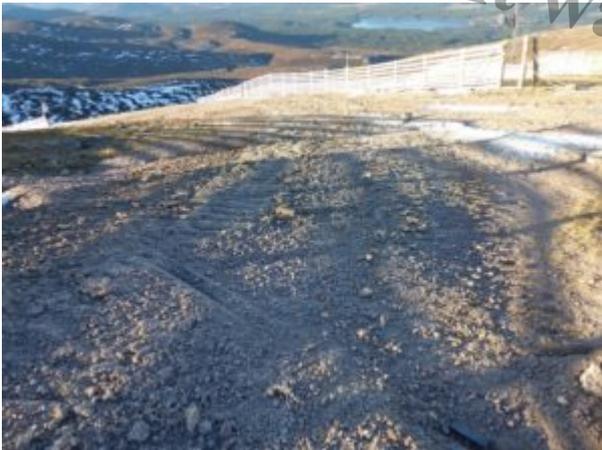
Choked drainage channel below Ptarmigan

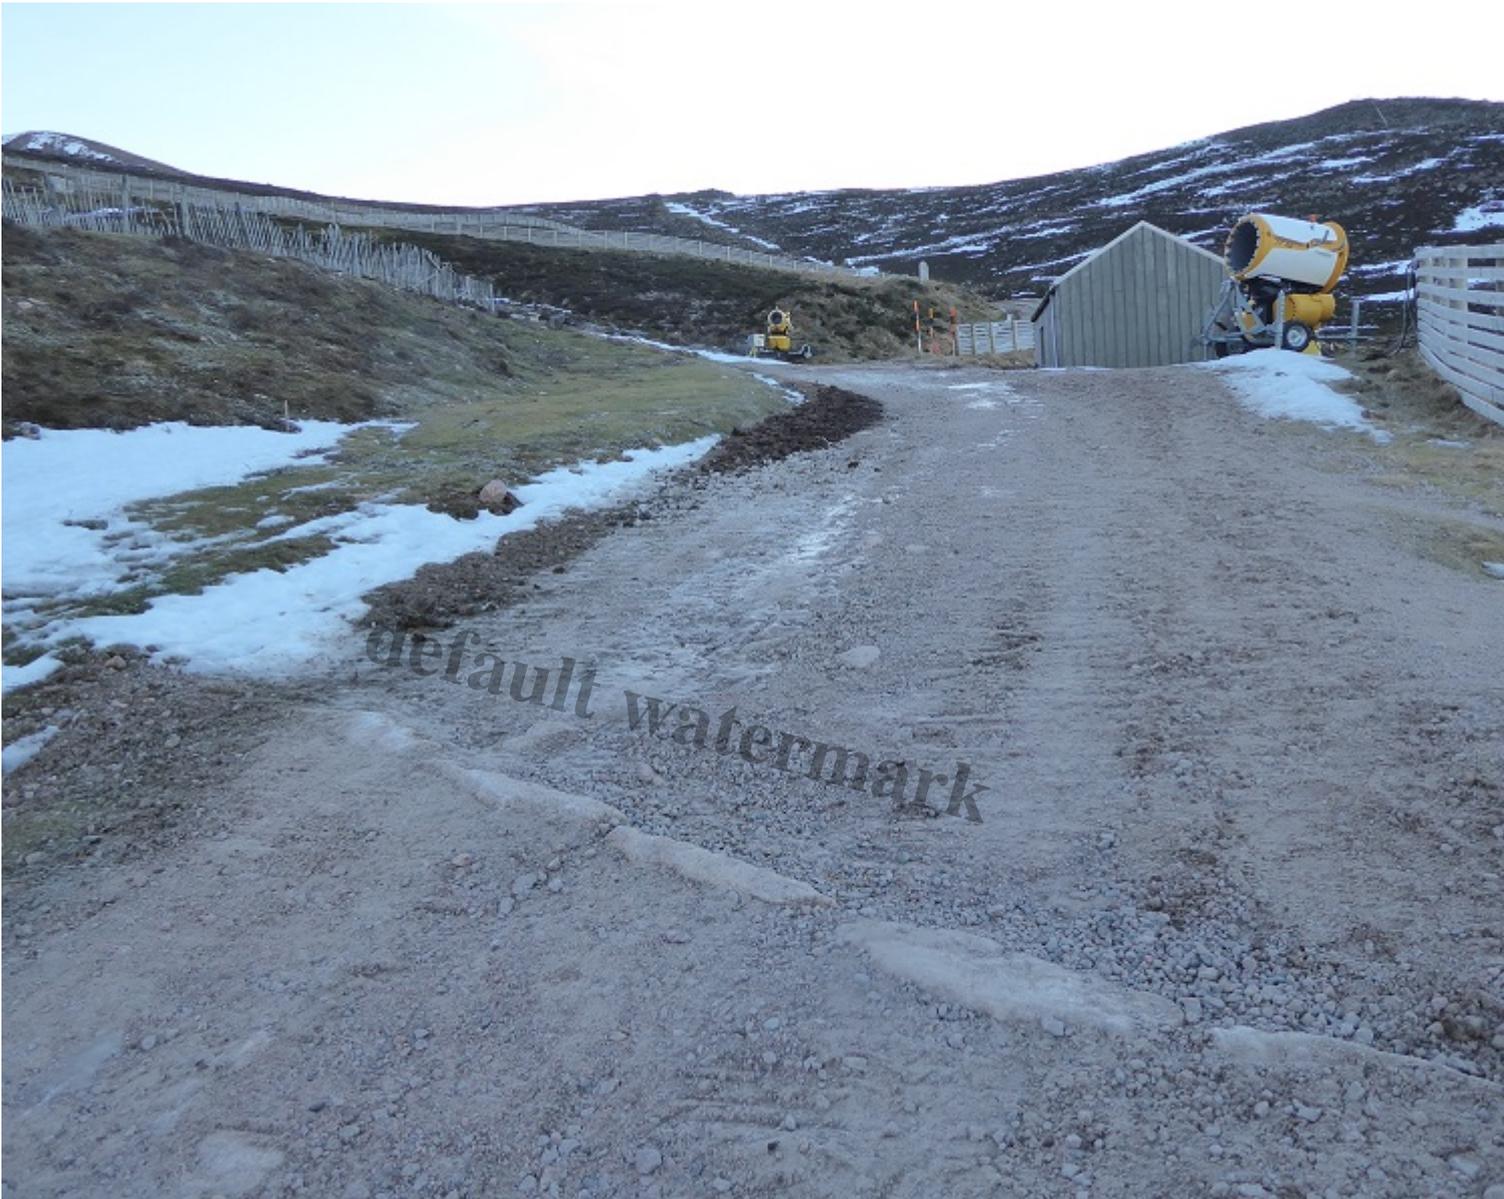
less effective in terms of drainage? They are far more in keeping with the natural environment.

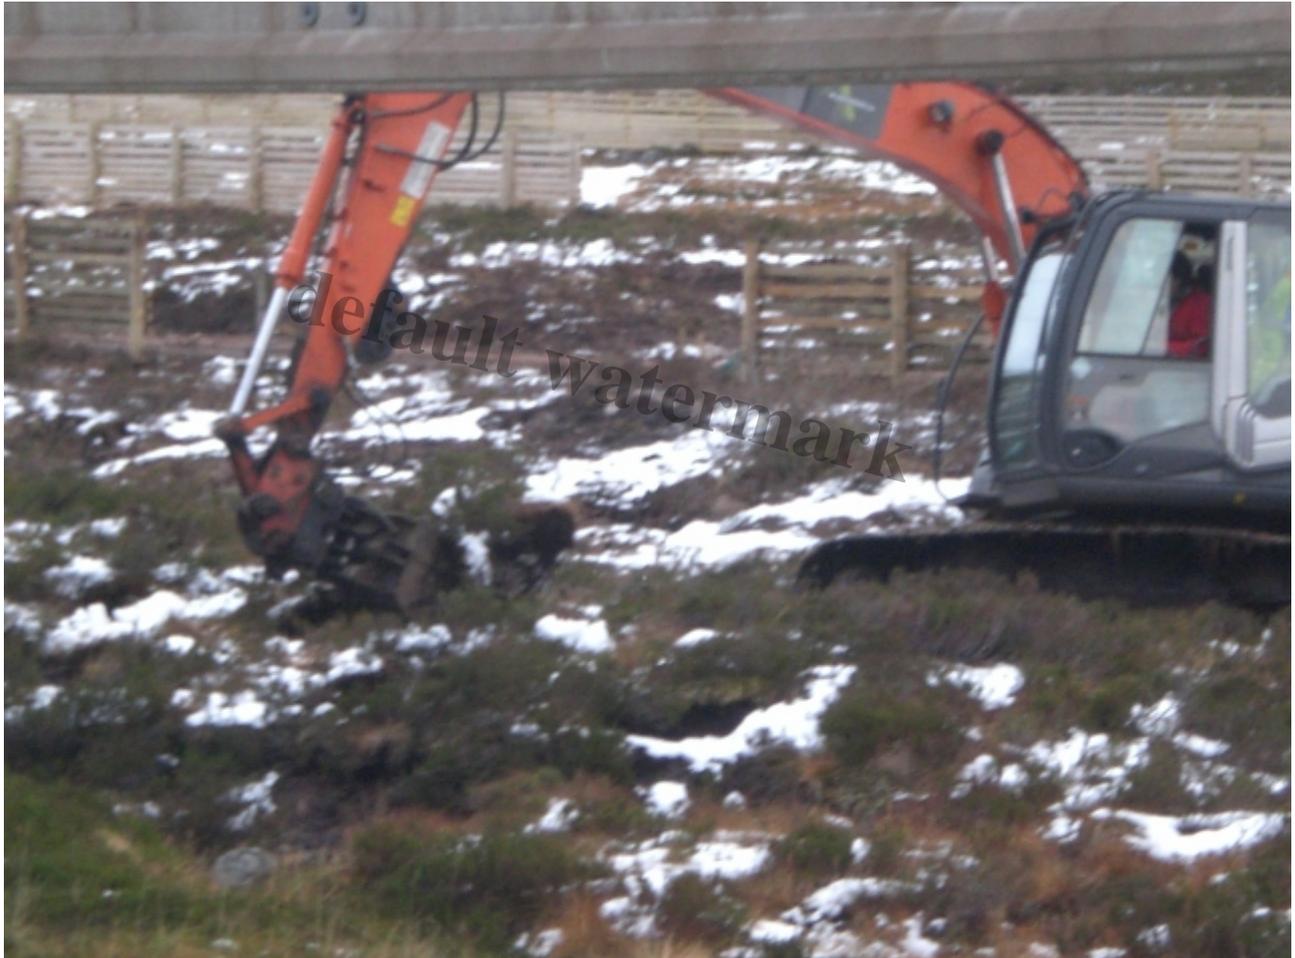
In order to “restore” the damage caused by the works on the Sheiling slope, Natural Retreats scooped up vegetation from outside the area granted planning permission.

I had not realised till Saturday that this appears to have been from a far wider area than that immediately adjacent to the shieling slope.

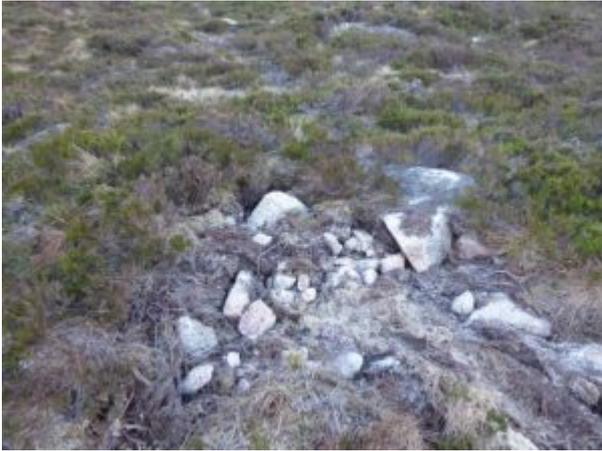
Hole scooped above track to Fiacail dump

The whole of the bank above the track to the Fiacail dump is full of holes where vegetation has been removed – the most likely explanation appears to be that this was used to replace the vegetation at the Shieling which had not been properly stored.

The CNPA Committee Report makes no attempt to other describe or assess the impact of this destruction. If it had done so, it would help put the remedial measures I described at the beginning of this post in context, as they do not address all of the damage that has been done or assess what impact this might have in the long-term. A proper vegetation assessment should have been undertaken before any decision is made.

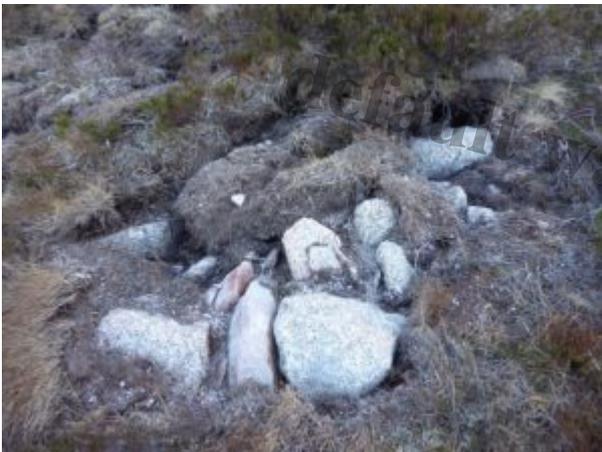
Another hole above track to Fiacail dump

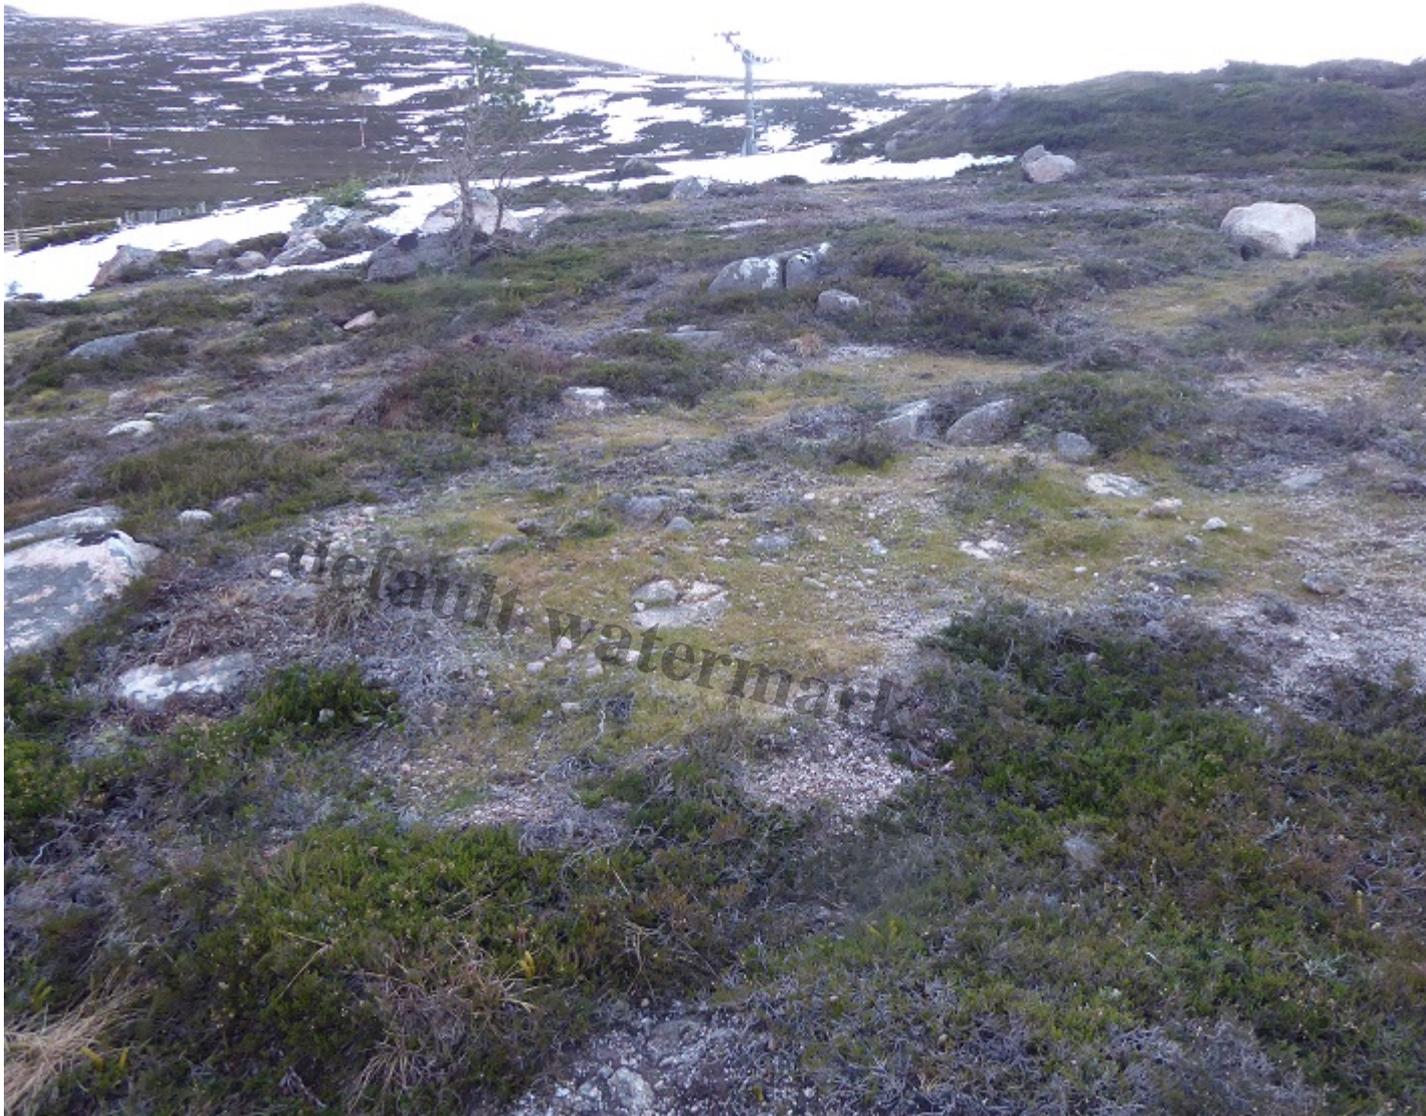
Area of ground above the unlawful works to create a new bank belong the shieling tow. This ground reprofiled and the most likely explanation for the bare ground and re-seeding is that Natural Retreats vegetation from here for use on the Shieling tow.

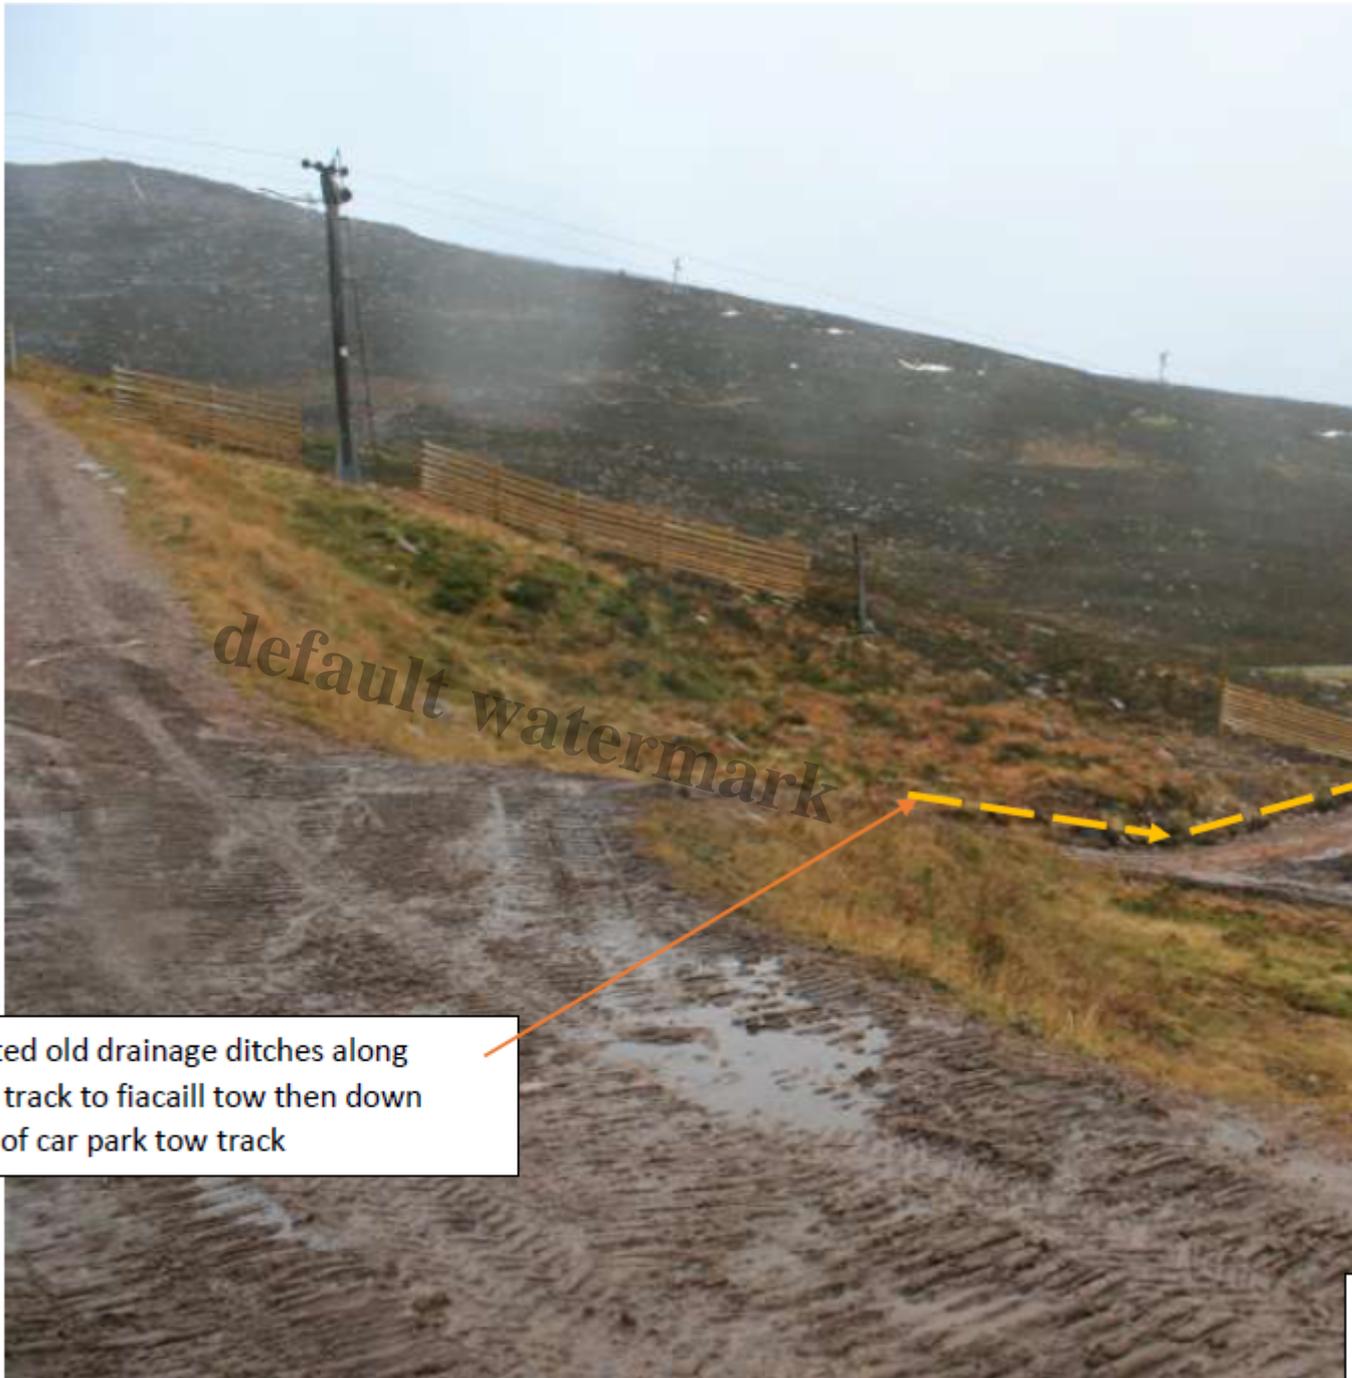
Reinstated old drainage ditches along existing track to fiacaill tow then down outside of car park tow track

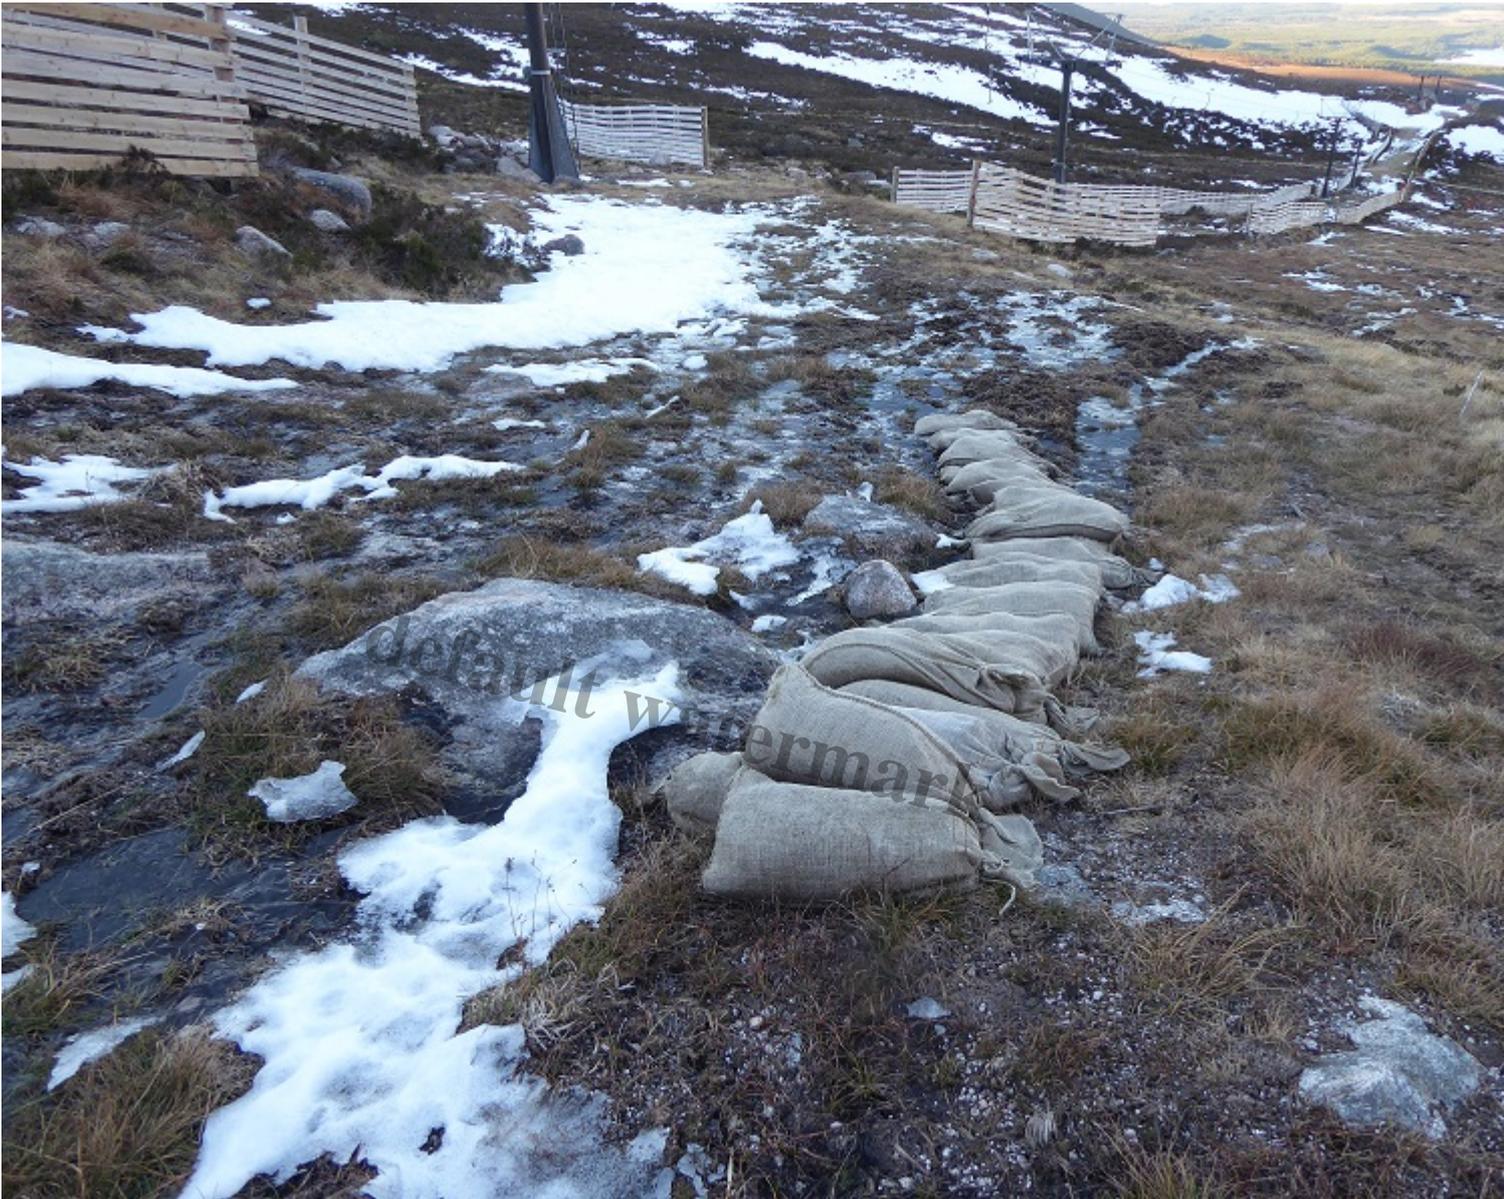
Why a proper assessment is needed is illustrated by these photos. Natural Retreats included the photo above in their plans showing what they had done.

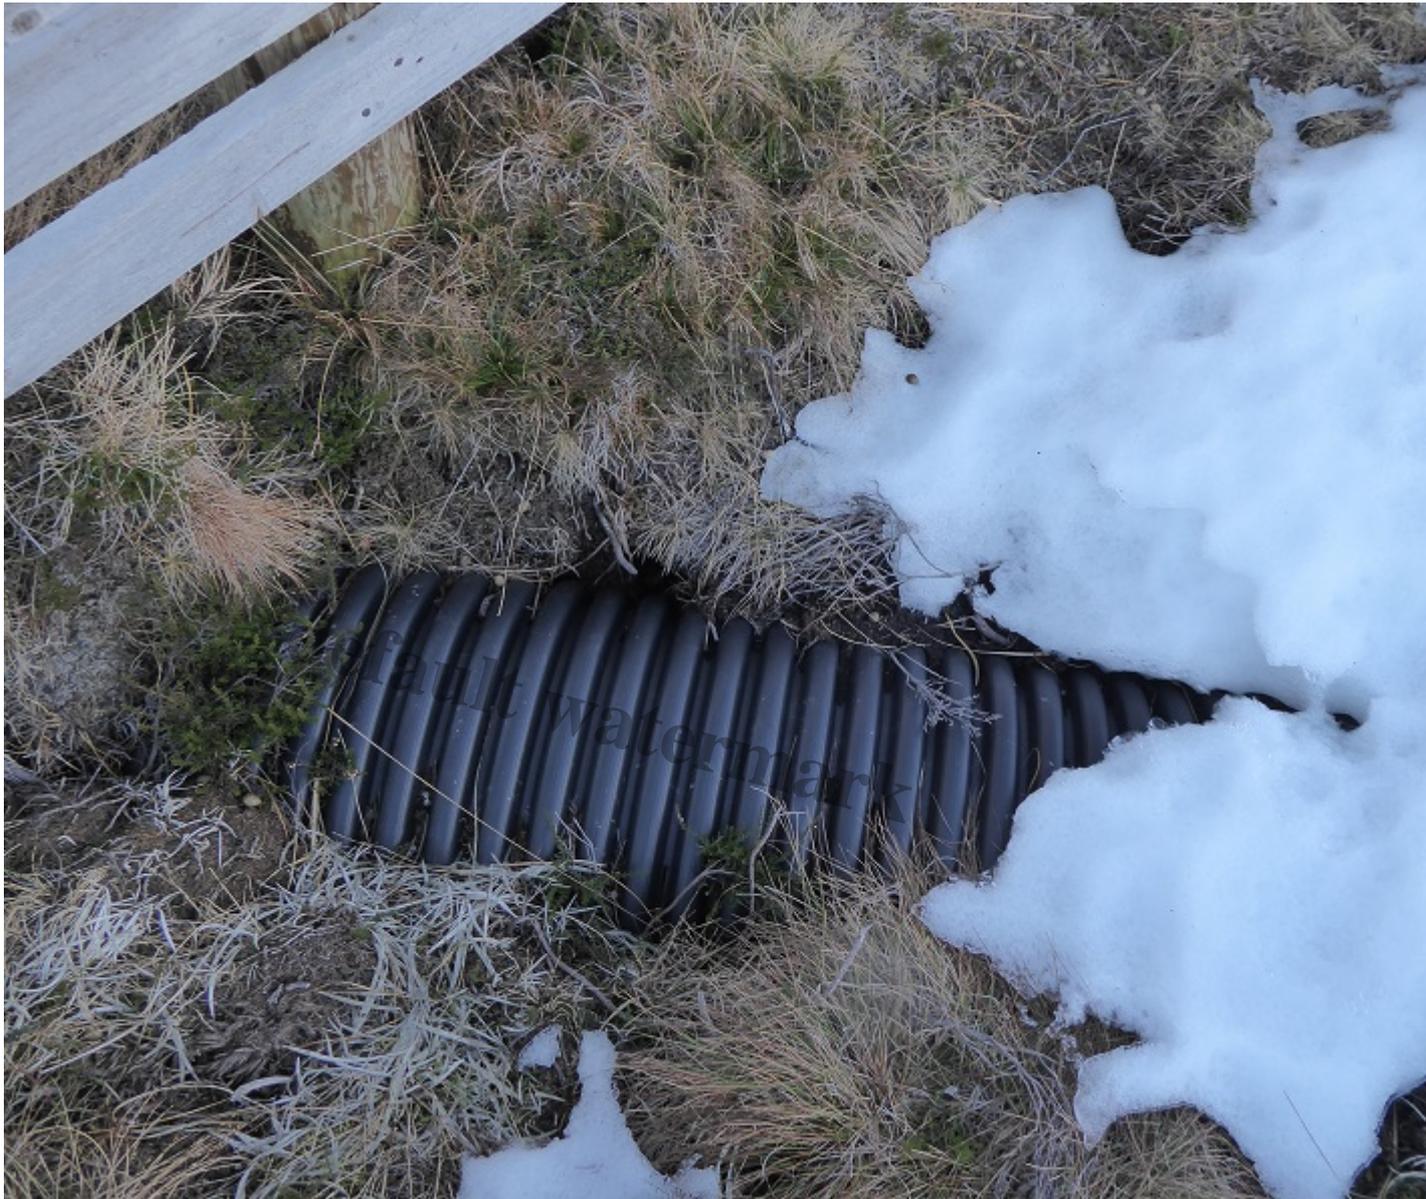
The photo below shows how the area in the distance looked on Saturday. The sandbags are proof that something is not working.

Section of poorly finished culvert crossing ski slope

In fact there are sandbags in several places on the slope – an illustration of problems that the CNPA has simply not considered – and also a significant number of culverts across and along the edge of the ski slopes.

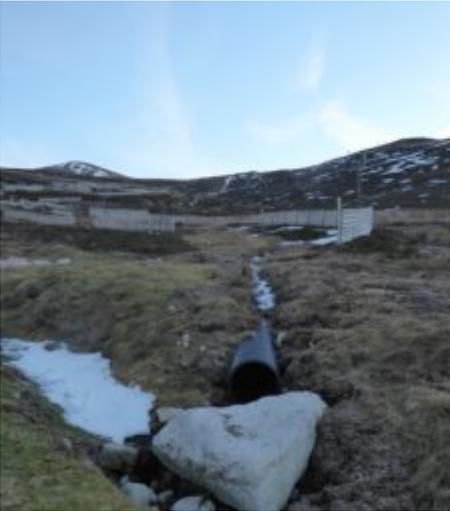
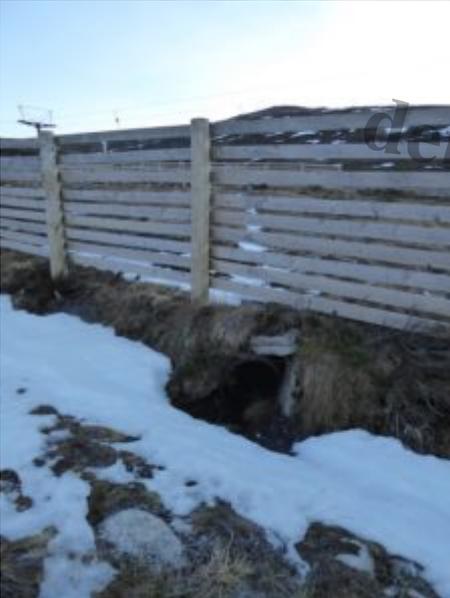
New? and poorly finished culvert at bottom of Shieling slope on left.

There are at least three culverts, none of which have been properly covered, running under the southern of the two shieling slopes (right photo).

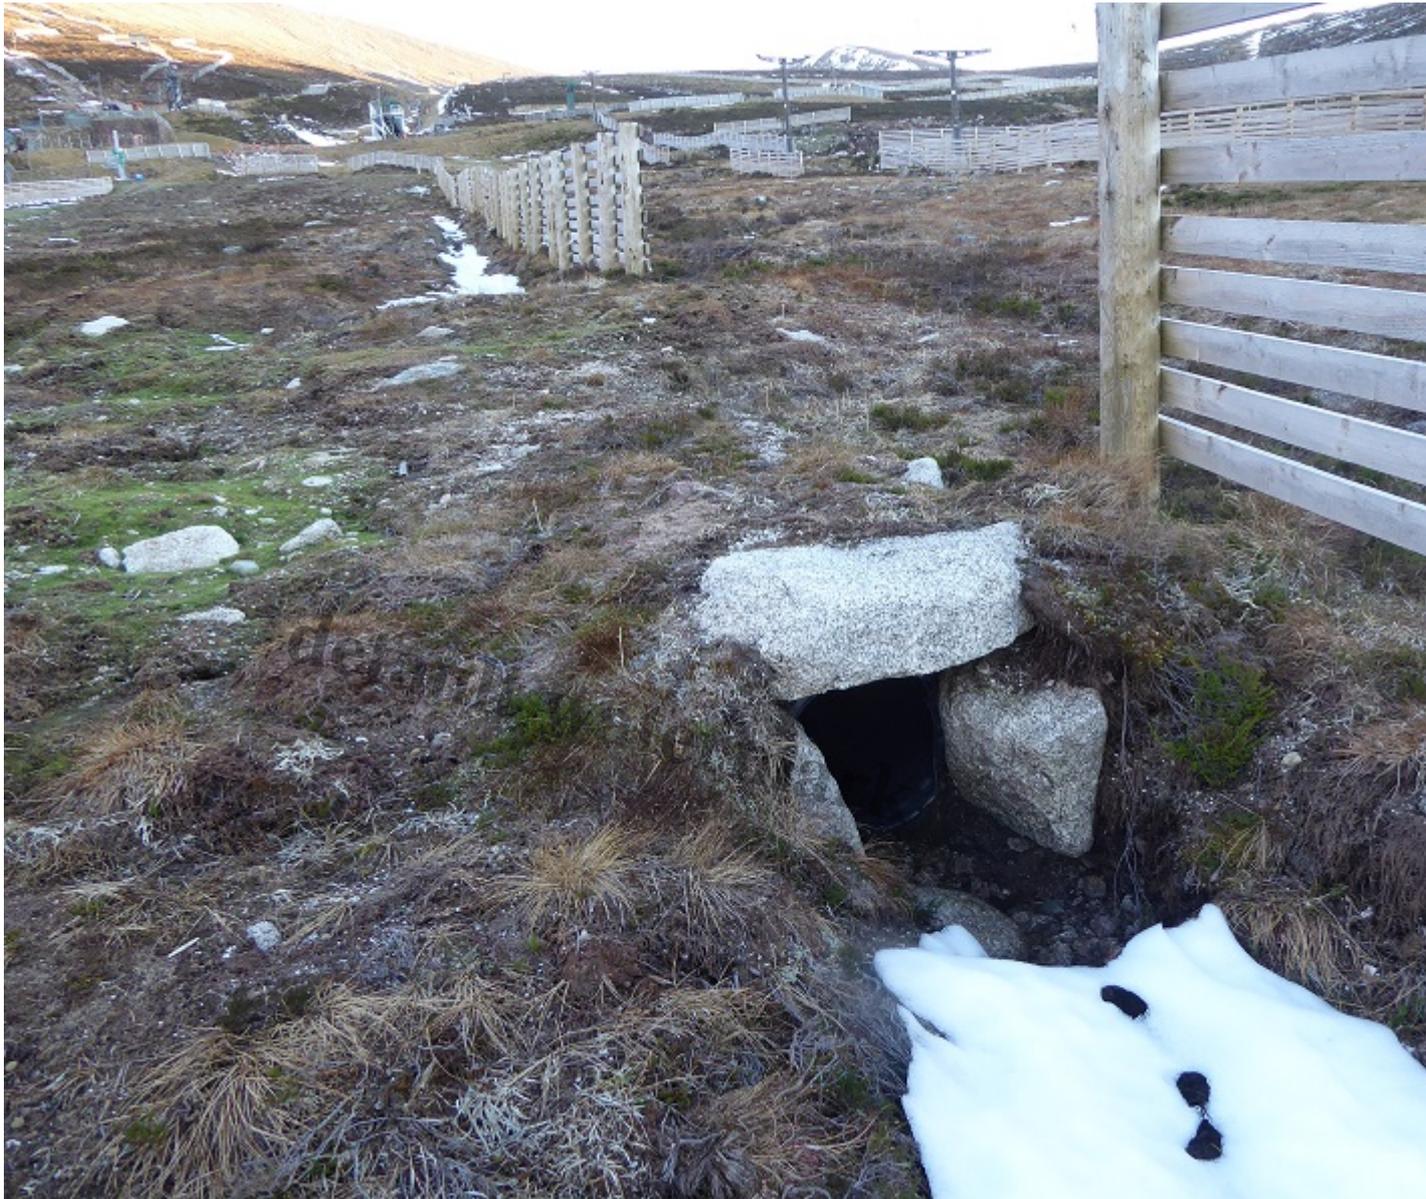
The seeding indicates that this culvert on right side of left shieling slope is new. The drainage line to fence is not mentioned in the Committee Report or accompanying papers.

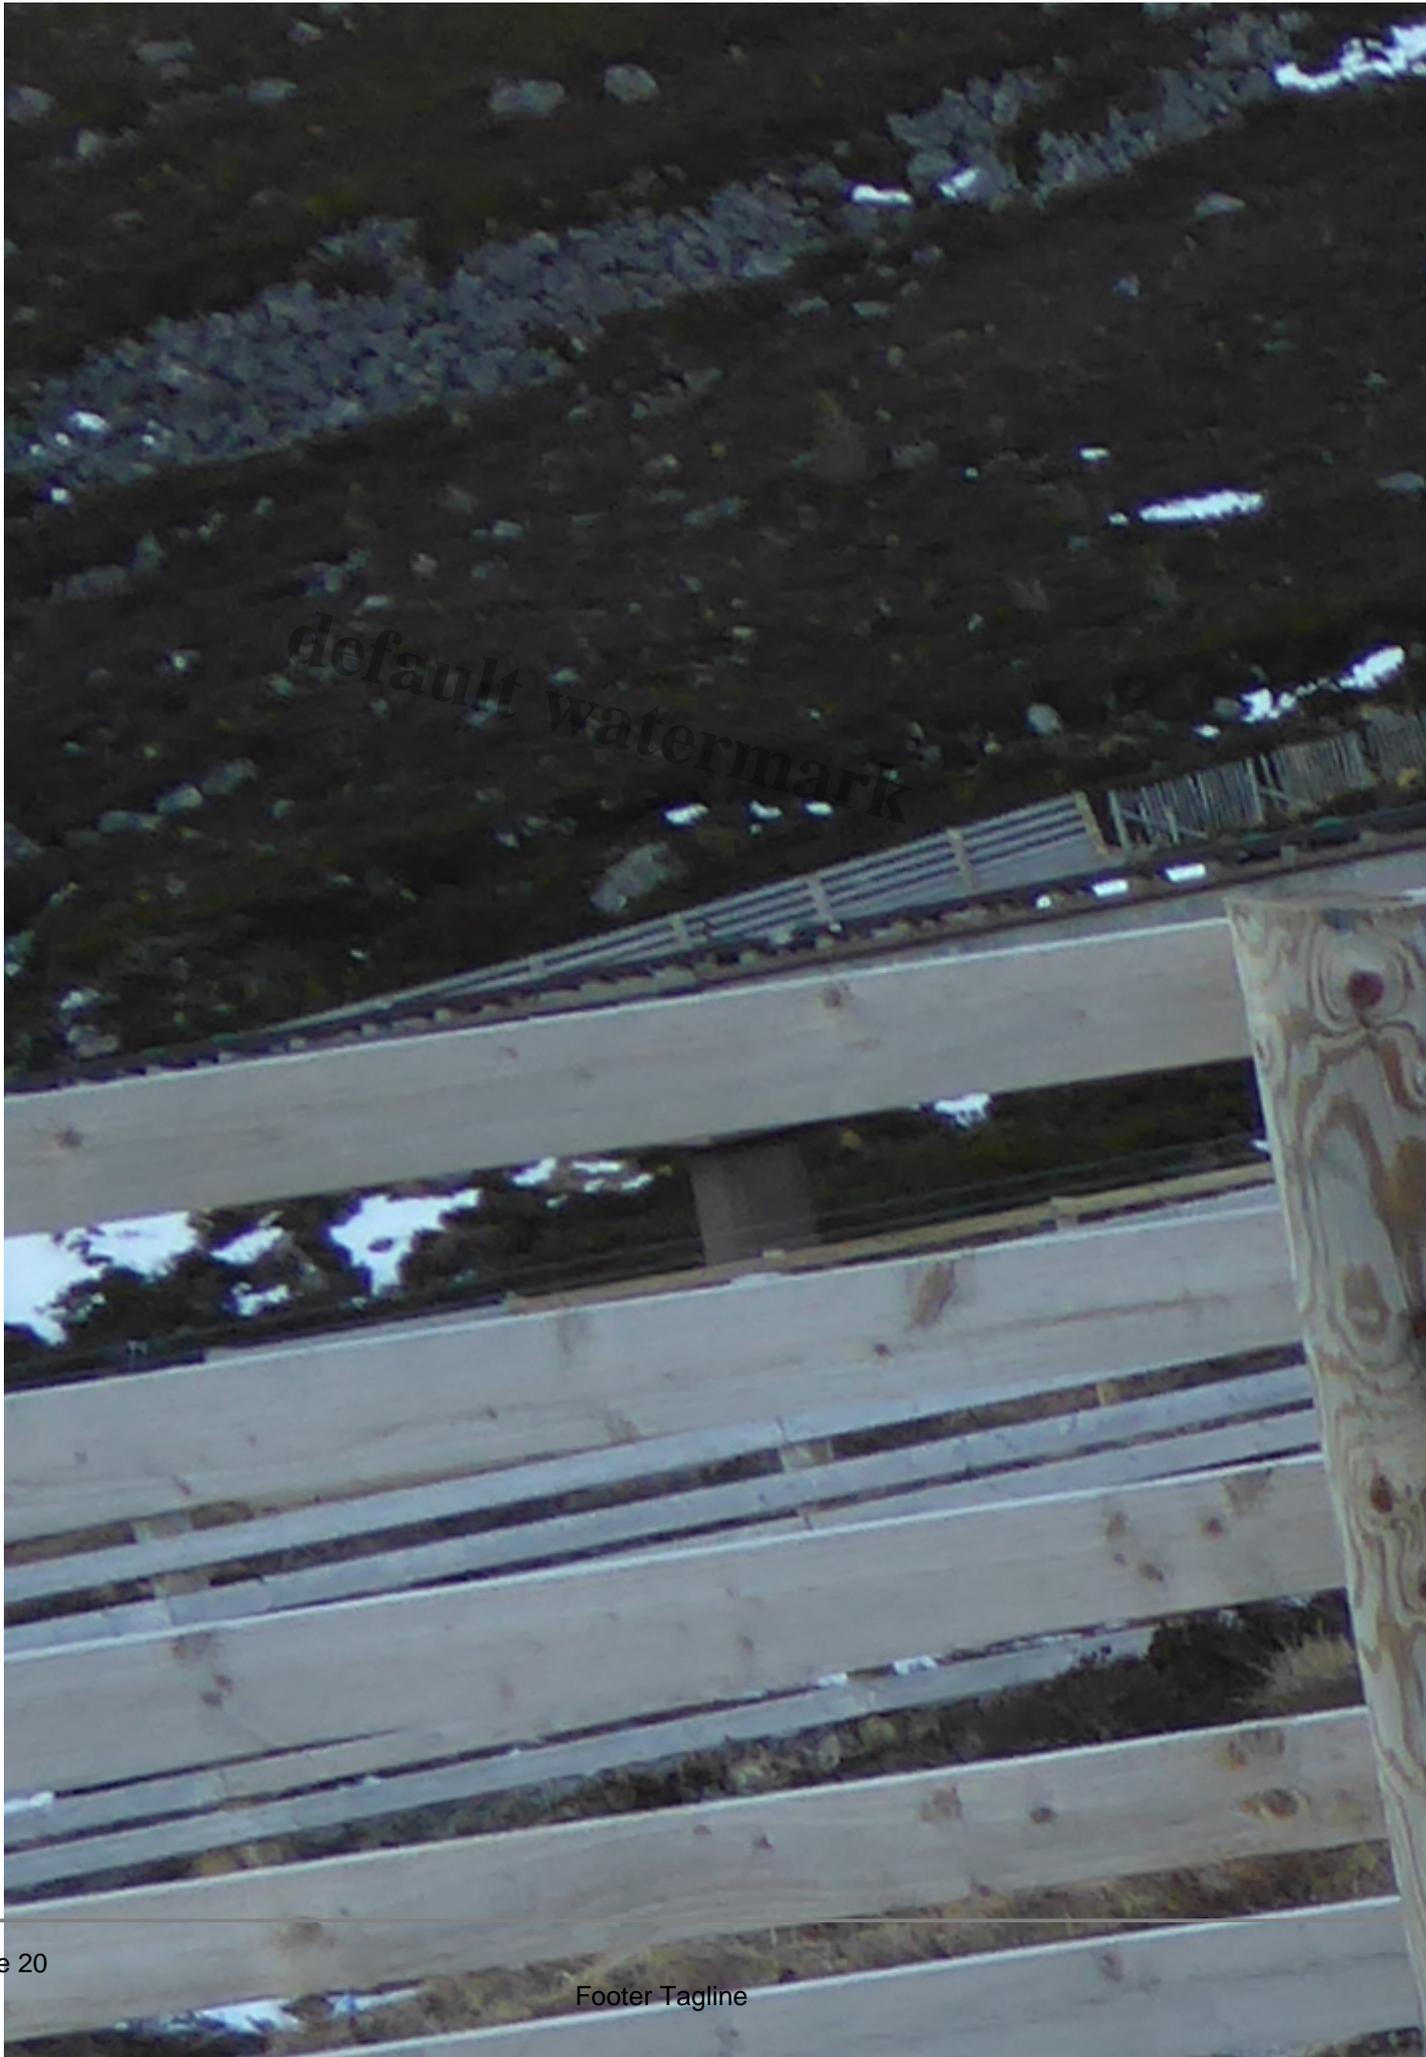
Besides the culverts there are also drainage ditches across the slope

So where is the environmental impact assessment of all this drainage work? What are the implications? We simply don't know. I don't think that is good enough.

The CNPA needs to work out how access could be managed to this site without agreeing to a track which is going to constantly erode, what damage there has been to vegetation outwith the site granted planning permission together with what remedial measures are required and also ensure there is a proper assessment of the likely impact of the drainage works and how this might be mitigated
