Loch Chon campsite â?? all fine and operational according to the Park Board

**By Ross MacBeath**

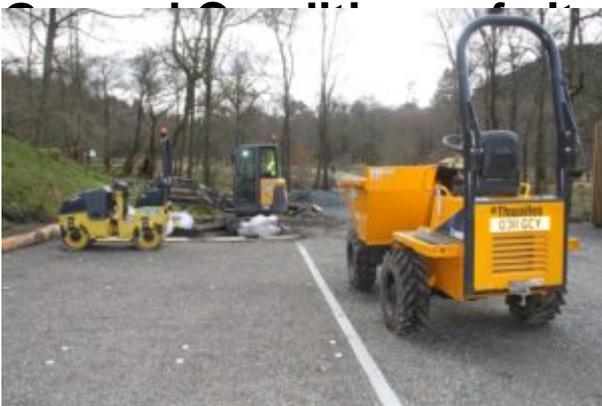
The area remains a building site with tracked vehicles,

tippers and aggregates at one end of the toilet block and an unwelcoming mess at the entrance

container known as the site office and bin store. We are into April and the only pitch that's truly serviceable is pitch 21 which is coincidentally the only pitch on the entire campsite the LLTNPA did not create.

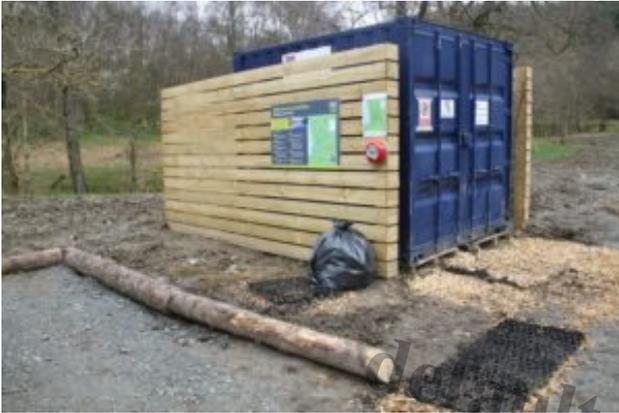
After chastising Campers and Visitors for leaving black bags of rubbish by overflowing bins and handing out penalties, here we have the Park Authority leaving their own bags of rubbish by the bin store, the entrance to which is strewn with various building materials creating a great first impression for visitors.

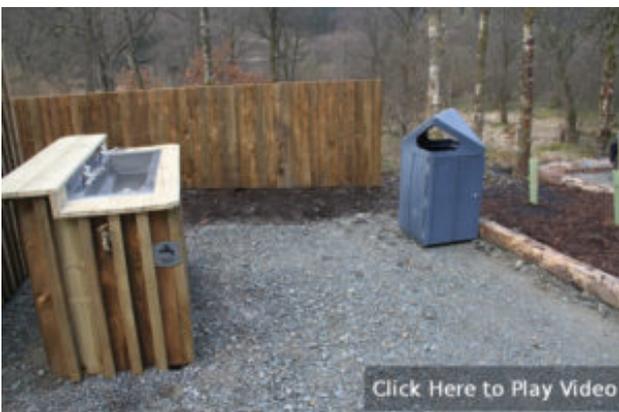
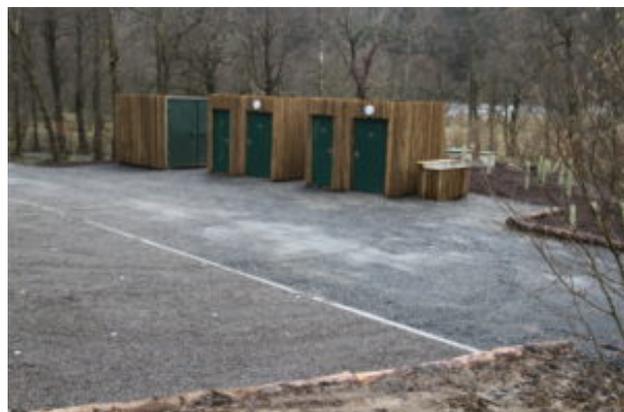
Although the site is claimed to be fully operational, there is no treated drinking water to the external taps, preventing container filling and dish washing. 3 of the 4 toilets remained locked. The 4th is open with flushing cistern and working wash hand basins. I suspect a re-plumbing exercise has diverted the drinking water to the toilet block, though the LLTNPA still insist the issues only lasted a few days despite the almost weekly video reports to the contrary.

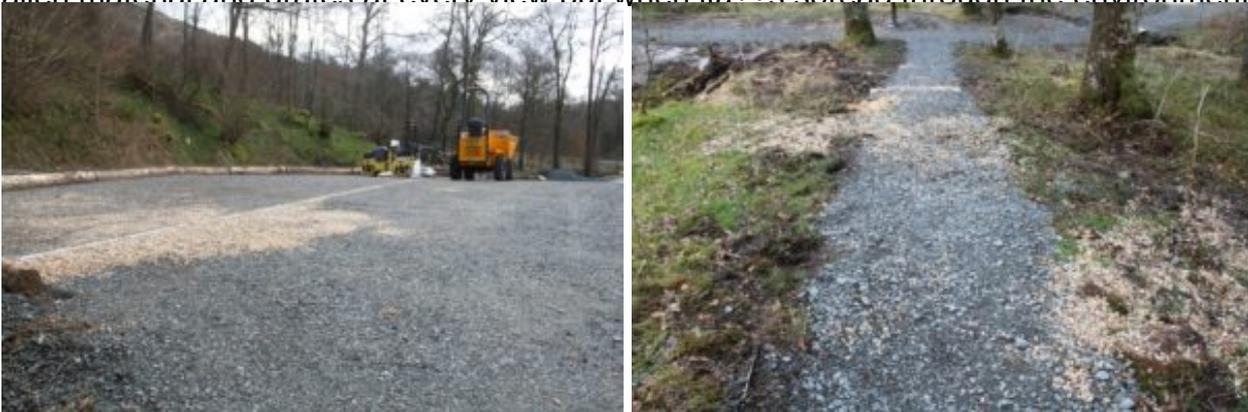
The uncontrolled spread of construction materials beyond the confines of paths and roads is a major concern at this development and this will be the subject of an environmental post shortly. What's going on now is the cross contamination of finished works with a new quartz aggregate material introduced to the site. The use of quartz aggregate in an ancient forest needs to be avoided. It's an alien material and grates at every view but when it's spread through the environment in this manner

How is this possible when there is an appointed clerk of works with responsibility for overseeing all variations to the original planning application and agreeing and documenting all construction work meets environmental standards? The need for a remedy is clear and mixing of this aggregate with vegetation can only be restored by picking it up stone by stone rather than the heavy handed machine operation that has damaged the site unnecessarily in other locations.

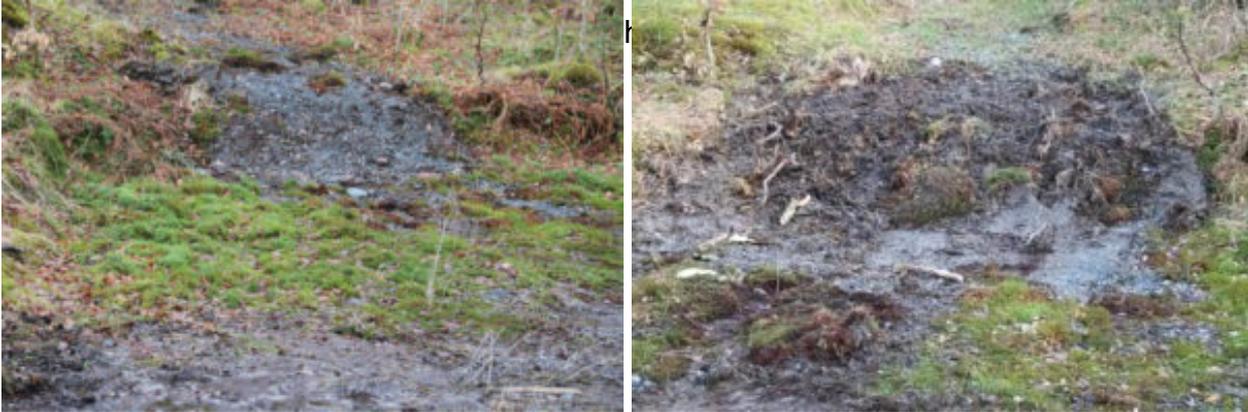
The original contamination on the left and the disastrous attempt to remove it effectively has caused destruction to the hillside in the process. It remains unclear why the hardcore was deposited on vegetation in the first place, given the area, probably a path placement error.

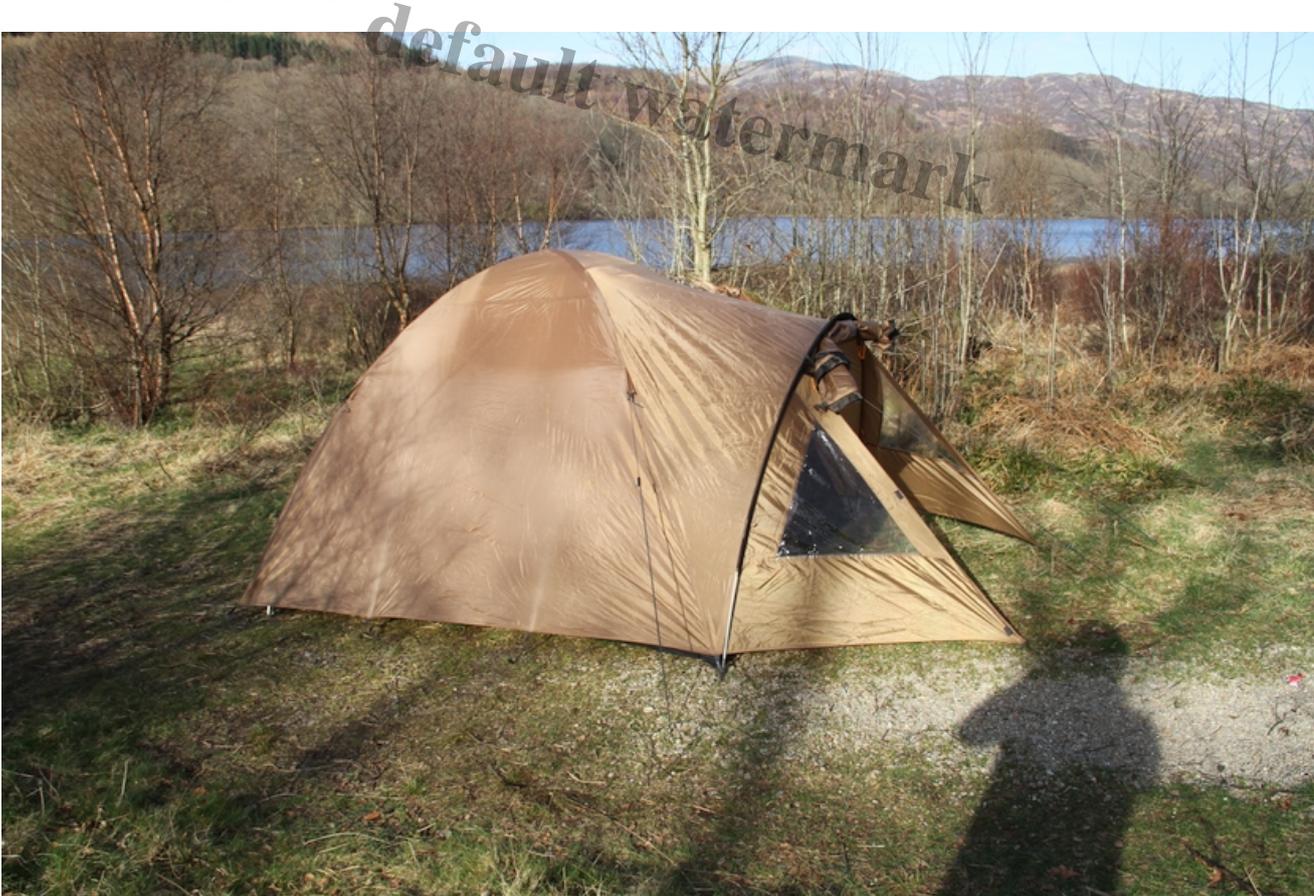
The image below shows a typical and popular loch side camping spot now banned by the bylaws. It's high amenity, provides a level, short grass surface over firm ground, the surface is even with sufficient depth to take tent pegs. it also covers a large area and so provides for cooking and sitting around the tent to eat. The proximity of the loch shore and open areas allow for play and other activities making for a good visitor experience.

This is a former Forestry Commission camping pitch where camping is now banned. It is sited within view of the useless 'Three Lochs Forest Drive Zone' by Loch Achray

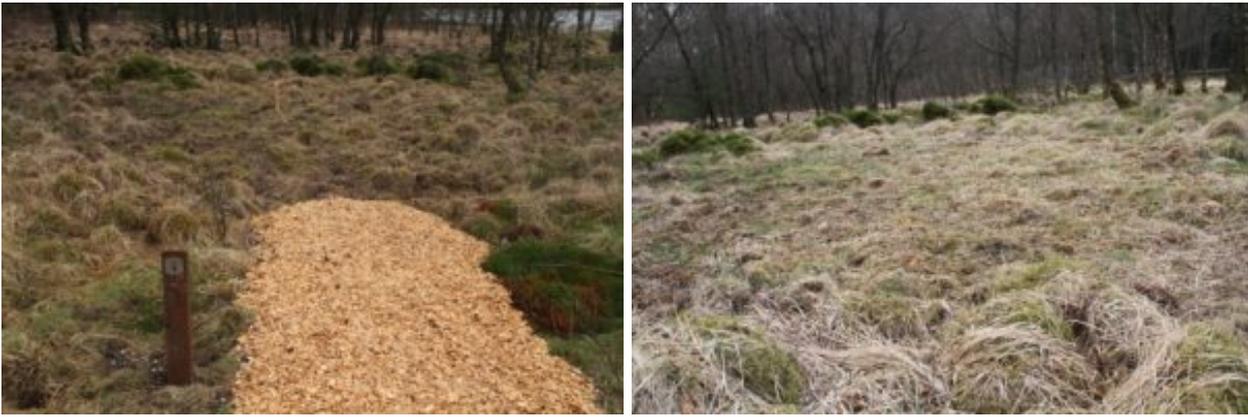
## **Pitch 1 just not up to scratch**

In stark contrast the National Park's paid for replacement is just not suitable. These low lying areas are sited well back from the shore on wild tussock grass which, by its very nature, is unsuitable for camping. It is uncomfortable if not impossible to sleep on. There is no firm ground to light a stove, place a seat or even sit or lie down on a beach towel. Then consider these photographs were taken in the dormant season (March 12th/April 2nd) after winter die back, when new growth takes hold matters will rapidly worsen. The old adage, good campsites are found not made holds true and if you insist in making them they take years to create and require much more work than than a brush over with a strimmer.

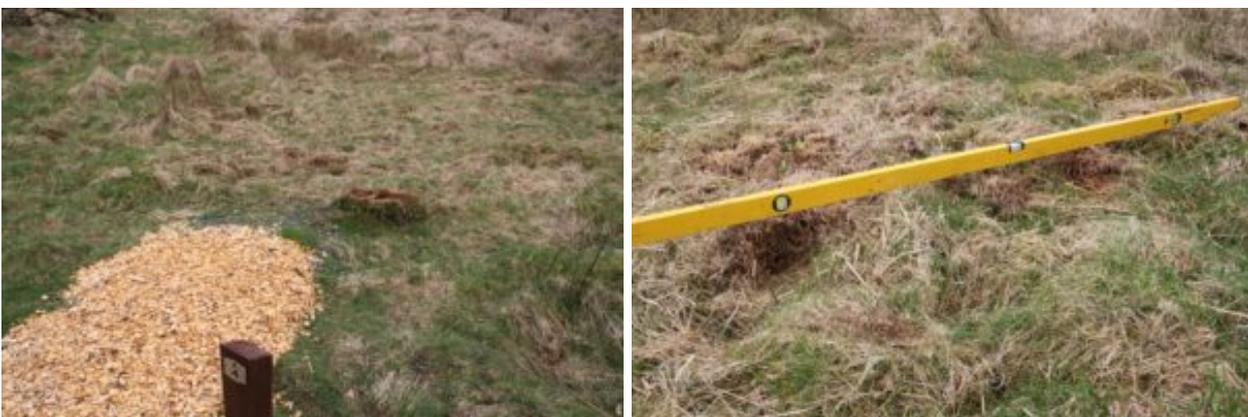
#### **Pitch 4**

Pitch 4 has been trimmed leaving the solid core of tussocks with depressions of 8 to 10 inches the pitch remains unsuitable.

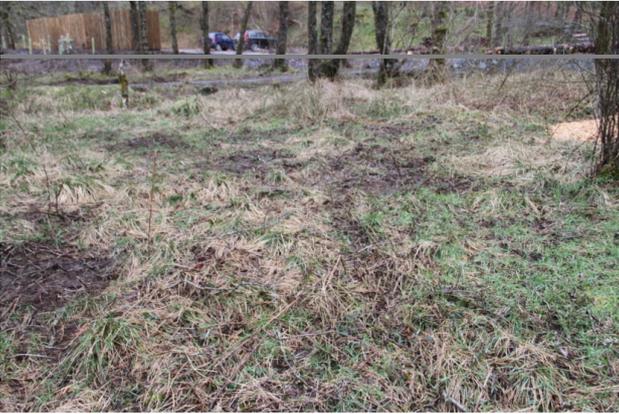
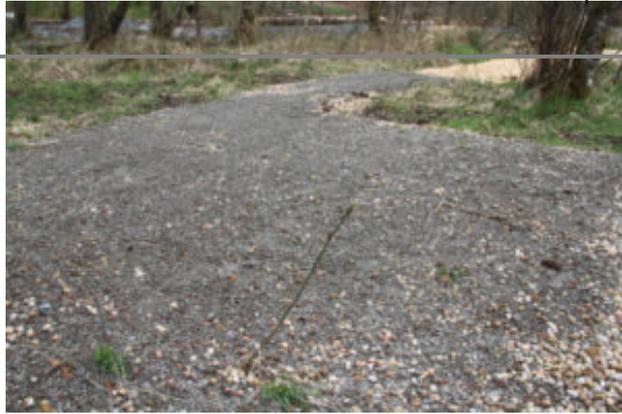
-19th March compared to modified pitch 2nd April

Pitch 6 has been covered with grit. It's not a material you want inside the tent and yet that's exactly what's going to happen here.

A bright quartz aggregate overlaid with a graded building material, it is not constrained at the edges and so is likely to spread out over the adjacent areas. It is also likely that the finer materials will be washed into the aggregate with rain leaving an inappropriate bright quartz aggregate finish to the area. This pitch surface requires to be a natural material in an ancient wood and where works have been carried out that should be grass. This grit is going to cause no end of aggravation to campers as it's carried in to the tent and deposited in the sleeping area, wholly inappropriate.

The evidence of bramble stalks showing through the surface indicates the underlying ground cover of brambles will remain an issue as the removal of a bramble infestation can take up to 2 years of concerted effort of cutting back and digging out roots. Simply burying the problem out of sight will get you through the site handover but they will grow through in a matter of weeks.

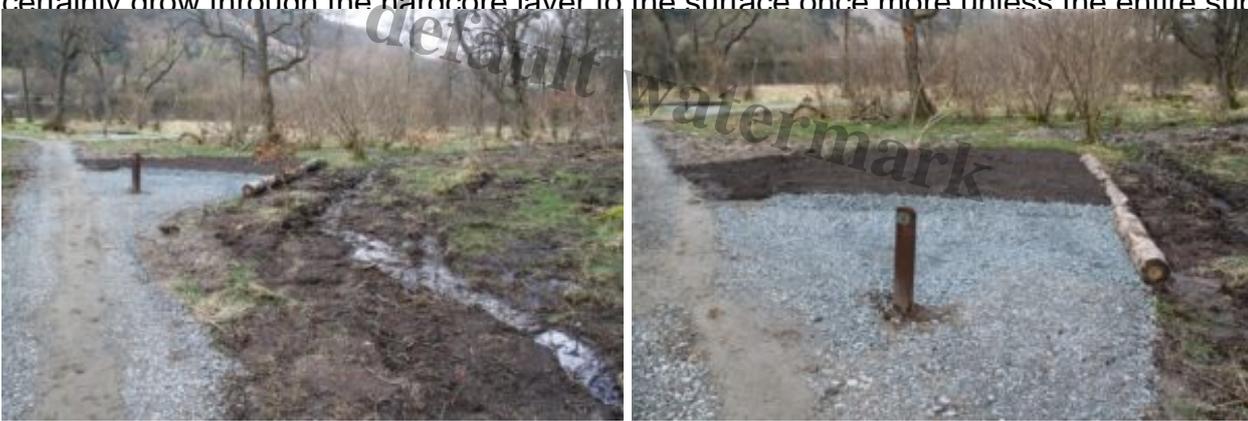
## Disabled sites 8 and 9 have had a makeover

The NP have attempted to constrain and divert the water course around pitch 8 while raising the finished surface of the pitch and that should solve the water problem. It is unclear whether the hardcore layer extends below the entire pitch. If it does we can only hope the soil depth remains around six inches otherwise pegging out the tent base will be an issue. As to the brambles, these will almost certainly grow through the hardcore layer to the surface once more unless the entire subsoil was

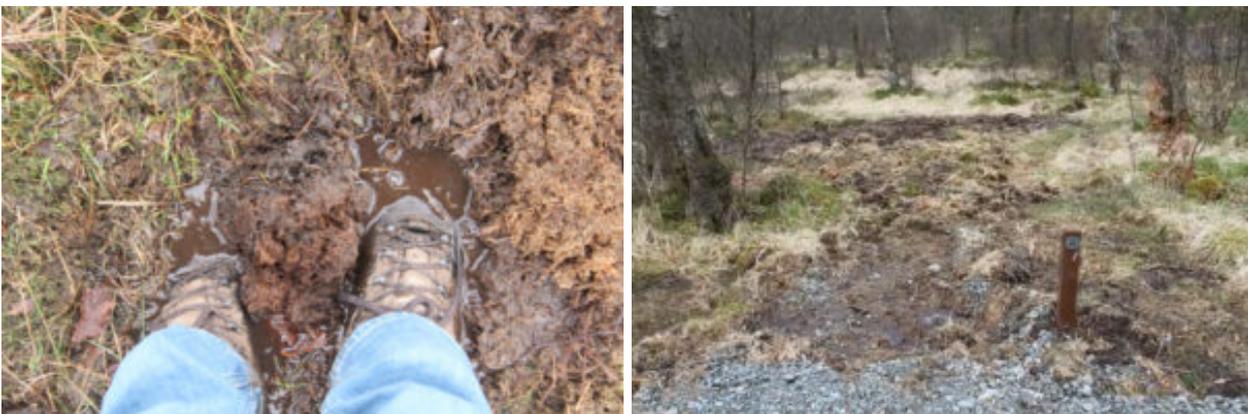
## Park Authority re-sites pitch 10 and Pitch 12

Unbelievable but true, the site of the former pitch 10 was a peat bog. Unfortunately when the Park Authority designates a pitch a mechanical digger drives across it for good measure. The whole area should never have been selected in the first place, it's just incompetence and results in a large area of unnecessary environmental damage.

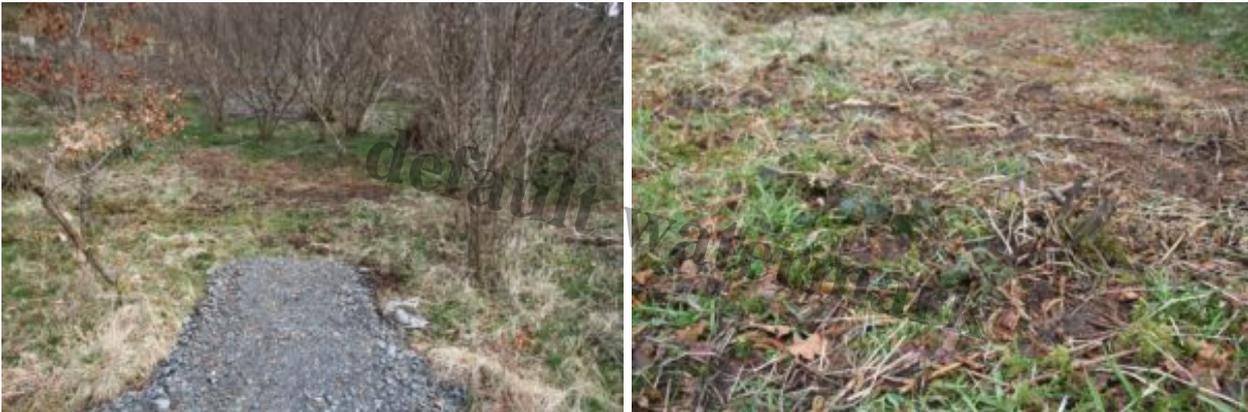
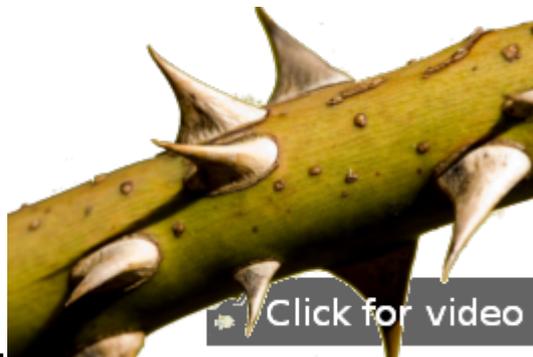
## Pitch 10 re-work

The new pitch is undoubtedly drier but unfortunately in the middle of a bramble patch with the trees to one side and the bog to the other.

While it should be obvious with ground sheet piercing thorns, brambles and tents don't mix and are to be avoided. It is unacceptable to construct a pitch containing or even adjacent to brambles as they will cause both financial loss to the camper and possible injury.

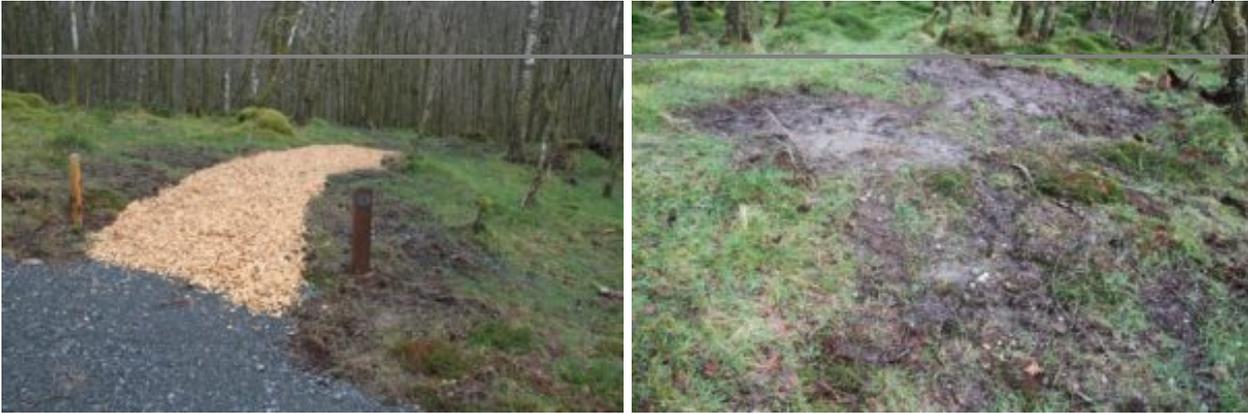
## Pitch 11

Pitch 11 remains an uneven wet mess.

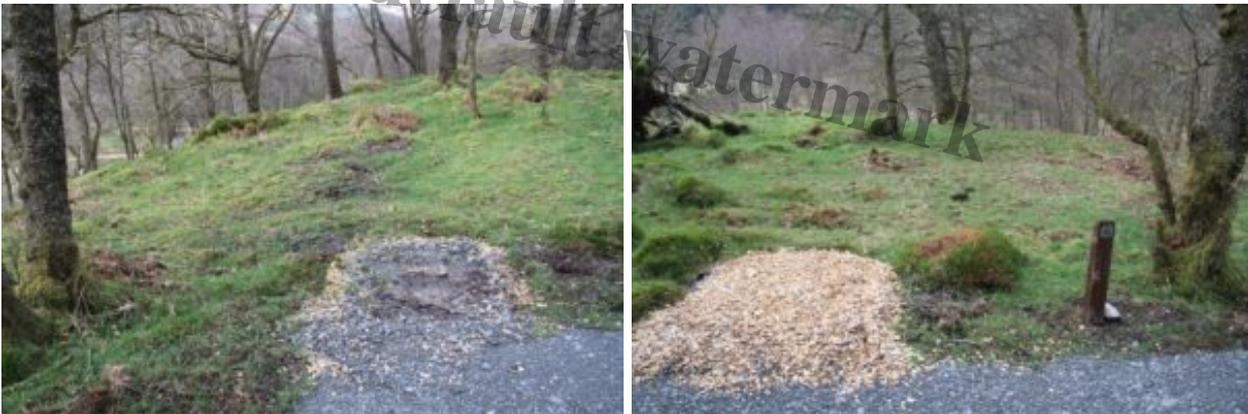
### Pitch 12

Pitch 12 is re-sited from a slope to a more suitable area near by. All that is now required is to reinstate the environmental damage to the old site (see LH image) and trim up the new site removing moss and grass clumps.

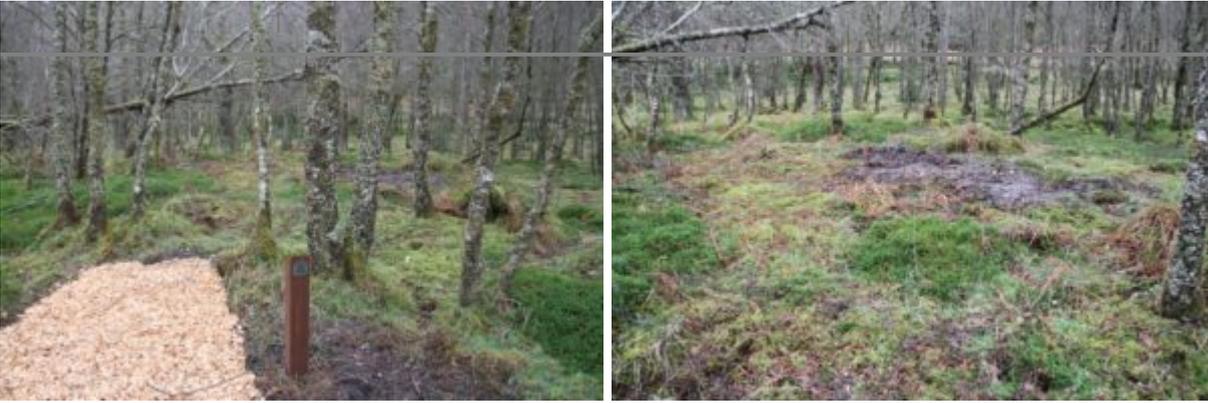
### Pitch 13

Pitch 13 remains unusable even after trimming

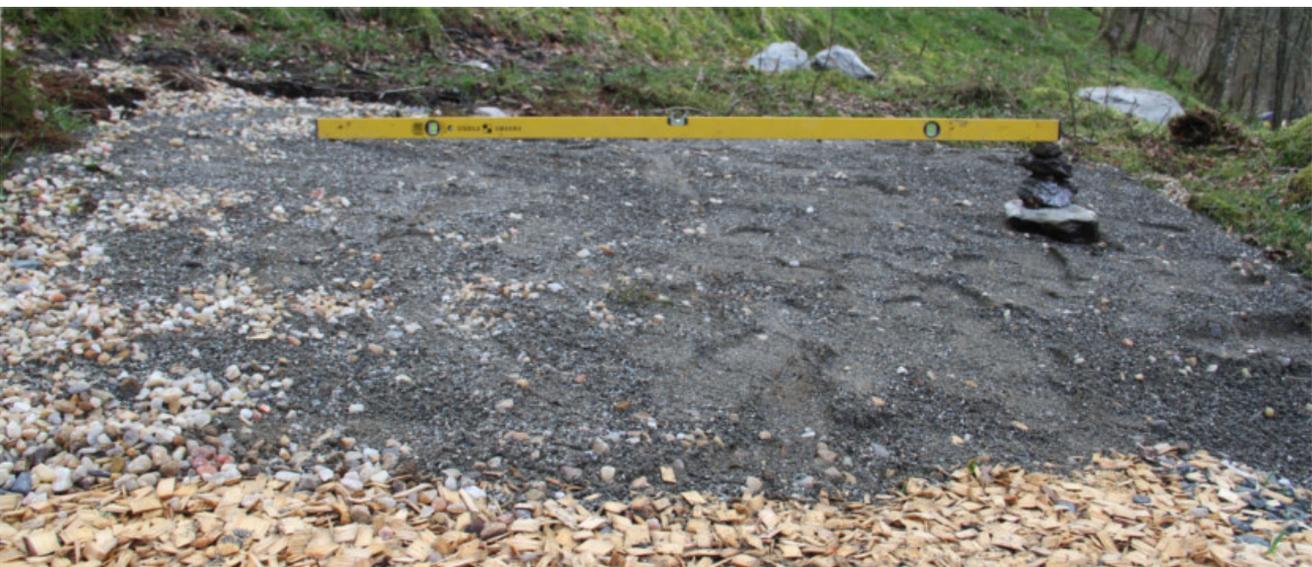
**Pitch 14 re-work includes surfacing with quartz aggregate infilled with fines**

The problem with Pitch 14, as with so many at Loch Chon, is size and the slope. It's just too steep to be a viable camping pitch. In an attempt to make the pitch surface even, the Park Authority have covered the area with their inappropriate quartz aggregate / gravel mix and while it is now even they

have completely failed to correct the slope which is far too steep to be used as a camping pitch. This is a double slope, across the hill and down the hill, and will cause campers to roll into each other and push the tent sides into the fly, letting water penetrate.

The second problem is that the topping used to provide an even surface is not constrained and will inevitably spread out over the surrounding area, reducing effectiveness and contaminating a far greater area.

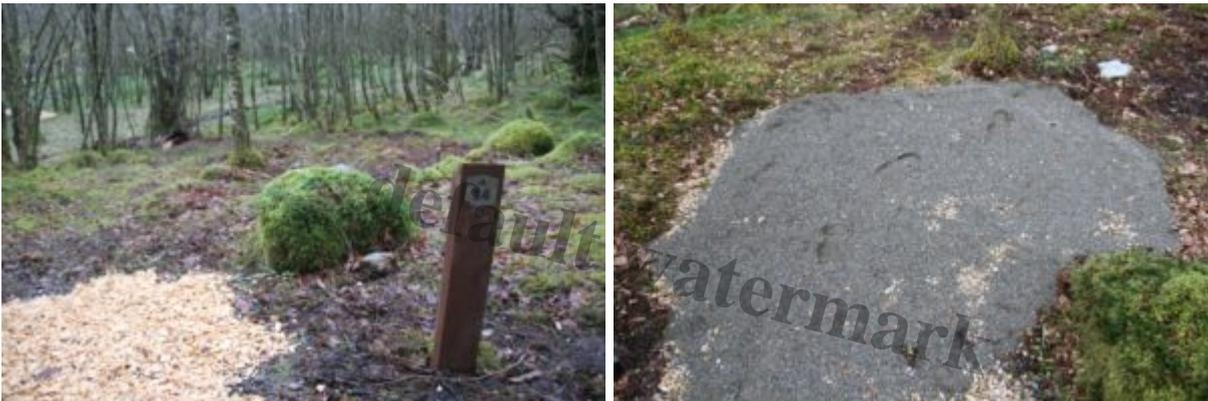
Marked 14 on post in error!

Similar solution to pitch 14 with grit. Recent works have made the pitch level but the surface is not constrained so very quickly the whole of the aggregate will spread down the slope leaving the pitch back where it started. The size of this pitch has been confined to around 5 square metres from the 25 or more square metres available. A tent pitch requires to be at least twice the size of a tent footprint giving a desirable minimum of around 12 square metres and an optimum minimum of 25 square metres for a two/three man tent.

The site selection is again poor with the lower point of the first image in a water course.
