Loch Chon campsite – all fine and operational according to the Park Board

**By Ross MacBeath**

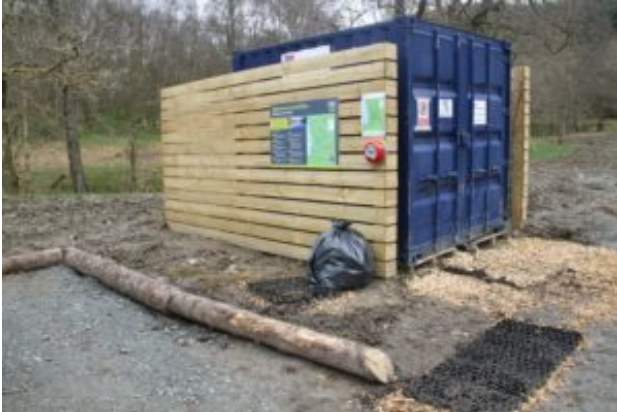
After chastising Campers and Visitors for leaving black bags of rubbish by overflowing bins and handing out penalties, here we have the Park Authority leaving their own bags of rubbish by the bin store, the entrance to which is strewn with various building materials creating a great first impression for visitors.

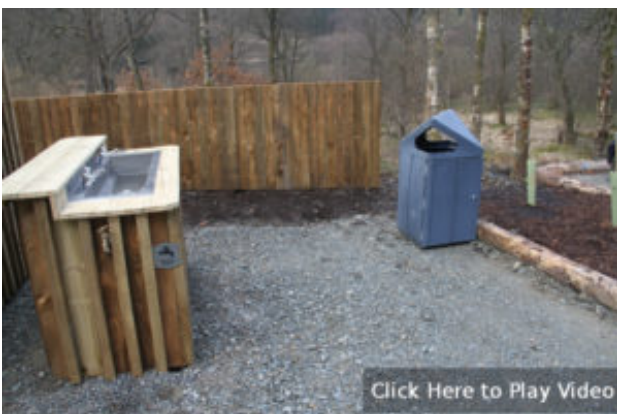
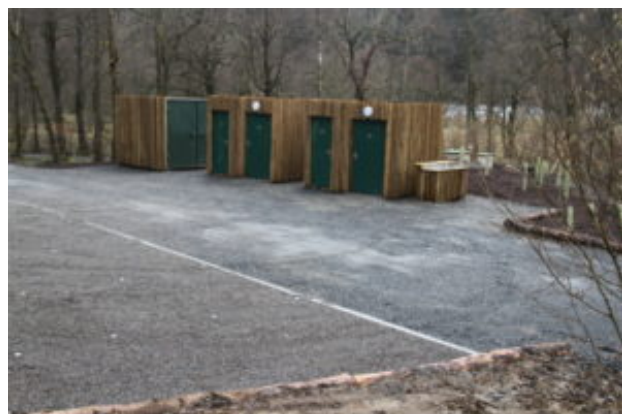
Although the site is claimed to be fully operational, there is no treated drinking water to the external

taps, preventing container filling and dish washing. 3 of the 4 toilets remained locked. The 4th is open with flushing cistern and working wash hand basins. I suspect a re-plumbing exercise has diverted the drinking water to the toilet block, though the LLTNPA still insist the issues only lasted a few days despite the almost weekly video reports to the contrary.

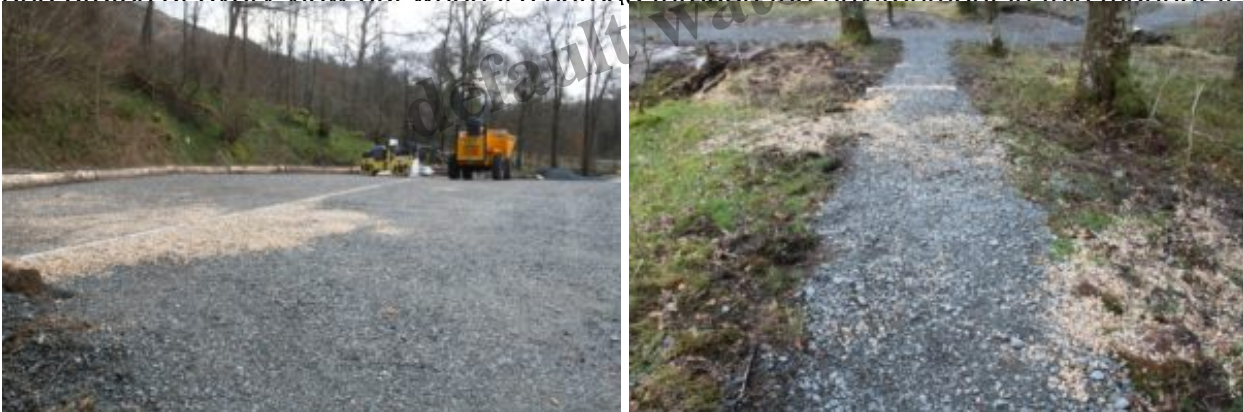
The uncontrolled spread of construction materials beyond the confines of paths and roads is a major concern at this development and this will be the subject of an environmental post shortly. What's going on now is the cross contamination of finished works with a new quartz aggregate material introduced to the site. The use of quartz aggregate in an ancient forest needs to be avoided. It's an alien material and grates at every view but when it's spread through the environment in this manner it should be a

How is this possible when there is an appointed clerk of works with responsibility for overseeing all variations to the original planning application and agreeing and documenting all construction work meets environmental standards? The need for a remedy is clear and mixing of this aggregate with vegetation can only be restored by picking it up stone by stone rather than the heavy handed machine operation that has damaged the site unnecessarily in other locations.

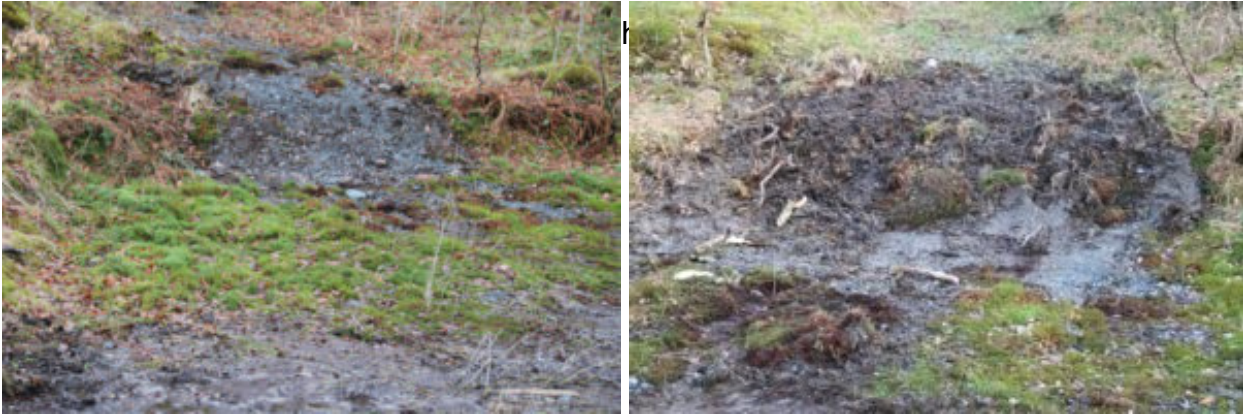
The original contamination on the left and the disastrous attempt to remove it effectively has caused destruction to the hillside in the process. It remains unclear why the hardcore was deposited on vegetation in the first place, given the area, probably a path placement error.

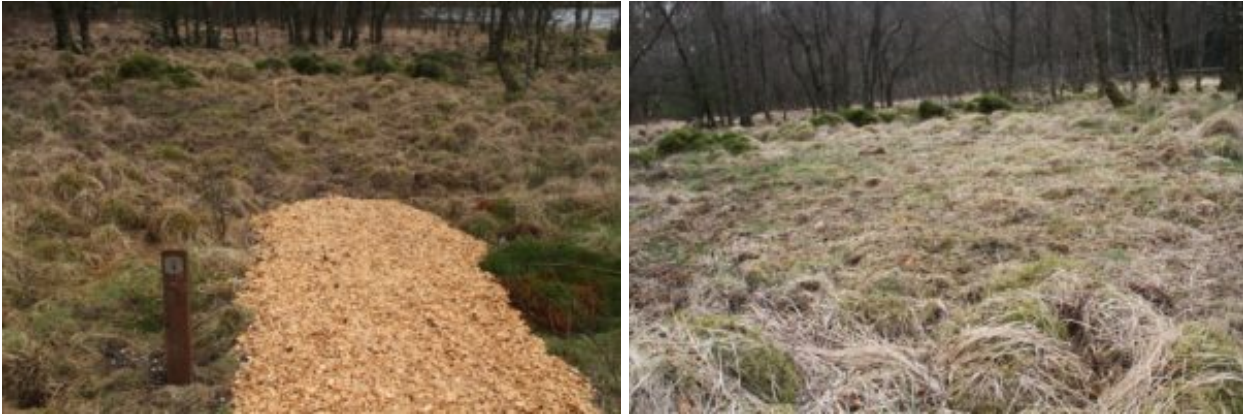
## **Pitch 1 just not up to scratch**

In stark contrast the National Park's paid for replacement is just not suitable. These low lying areas are sited well back from the shore on wild tussock grass which, by it's very nature, is unsuitable for camping. It is uncomfortable if not impossible to sleep on. There is no firm ground to light a stove, place a seat or even sit or lie down on a beach towel. Then consider these photographs were taken in the dormant season (March 12th/April 2nd) after winter die back, when new growth takes hold matters will rapidly worsen. The old adage, good campsites are found not made holds true and if you insist in making them they take years to create and require much more work than than a brush over with a strimmer.

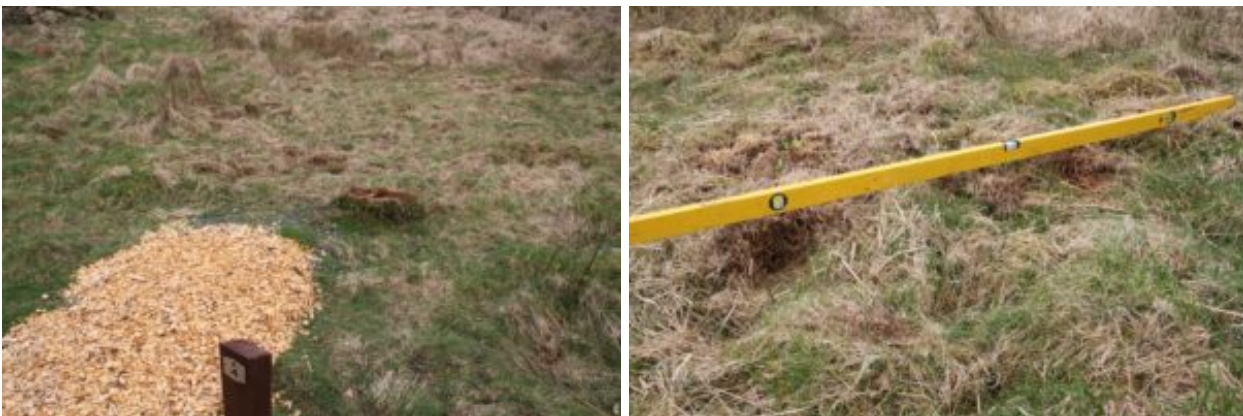
#### **Pitch 4**

Pitch 4 has been trimmed leaving the solid core of tussocks with depressions of 8 to 10 inches the pitch remains unsuitable.

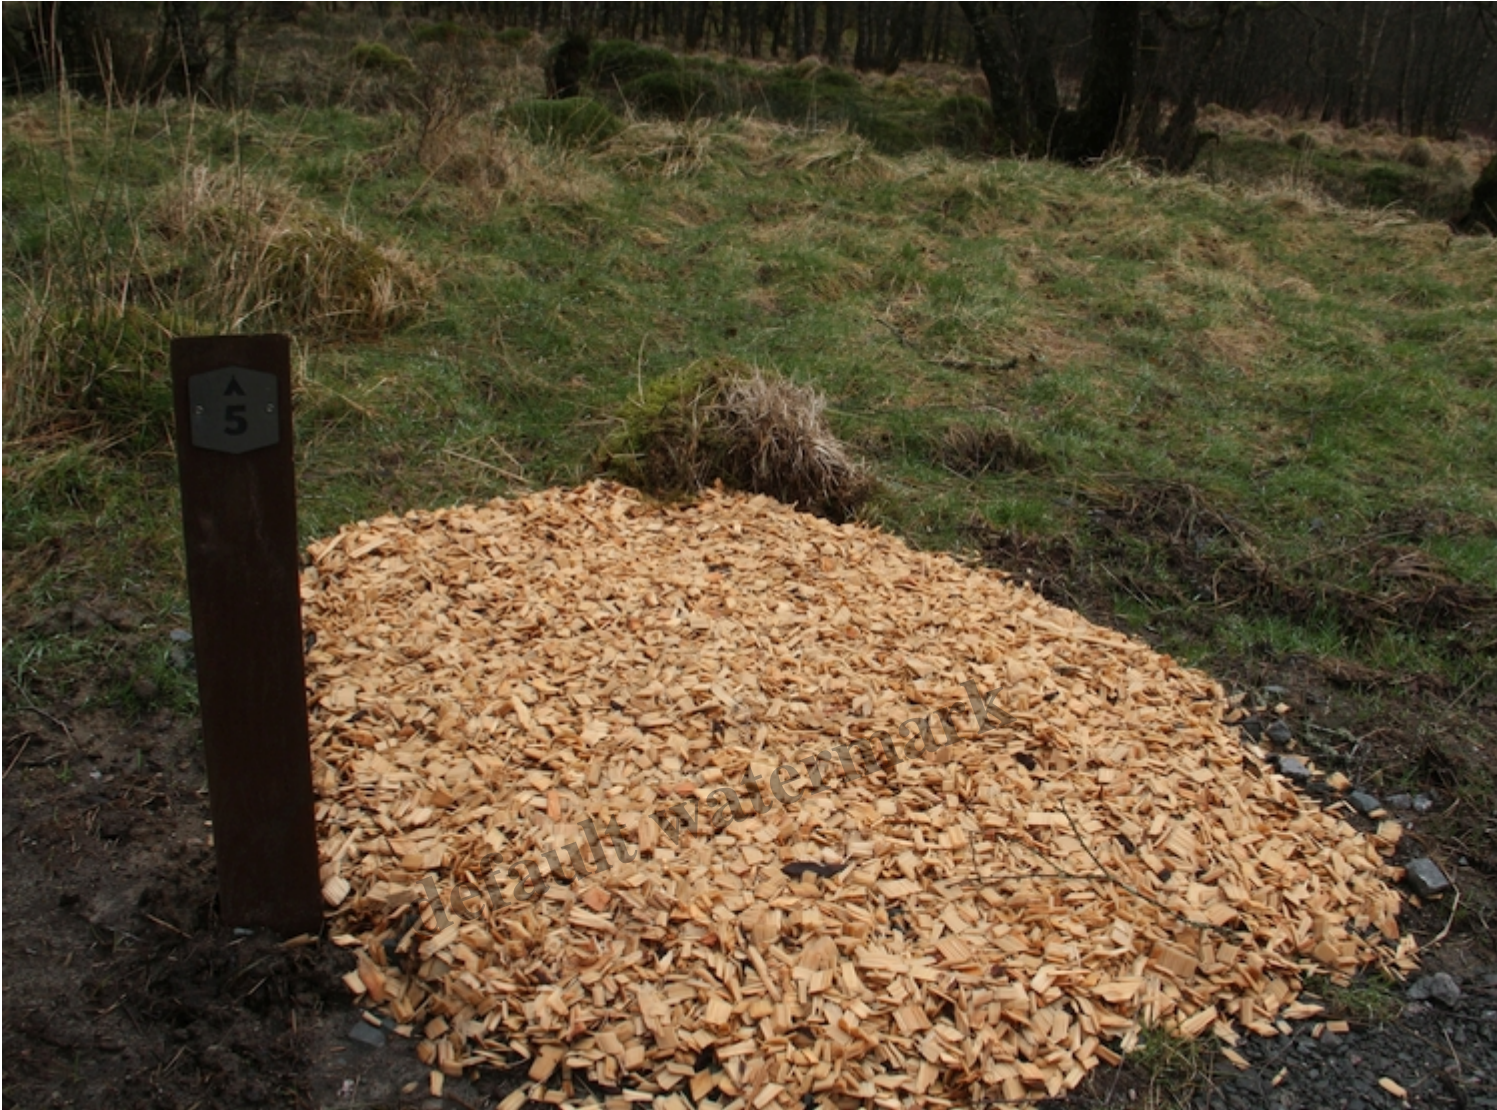
**Pitch 5 fares only slightly better over a confined area.**

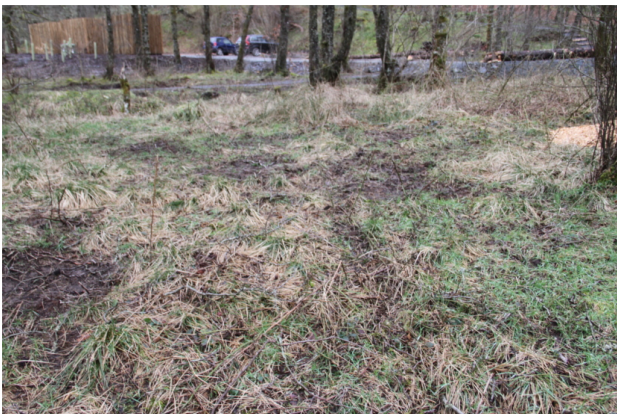
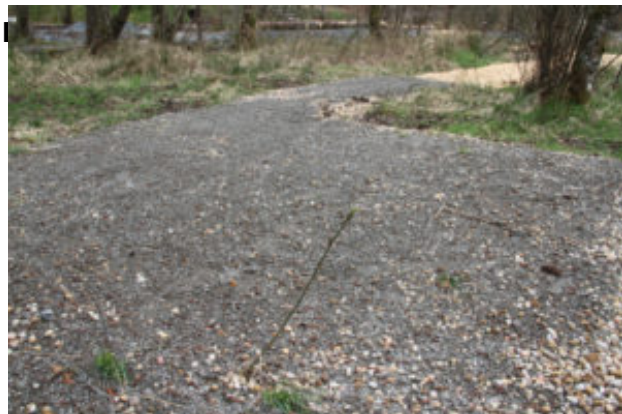
-19th March compared to modified pitch 2nd April

Pitch 6 has been covered with grit. It's not a material you want inside the tent and yet that's exactly what's going to happen here.

A bright quartz aggregate overlaid with a graded building material, it is not constrained at the edges and so is likely to spread out over the adjacent areas. It is also likely that the finer materials will be washed into the aggregate with rain leaving an inappropriate bright quartz aggregate finish to the area. This pitch surface requires to be a natural material in an ancient wood and where works have been carried out that should be grass. This grit is going to cause no end of aggravation to campers as it's carried in to the tent and deposited in the sleeping area, wholly inappropriate.

The evidence of bramble stalks showing through the surface indicates the underlying ground cover of brambles will remain an issue as the removal of a bramble infestation can take up to 2 years of concerted effort of cutting back and digging out roots. Simply burying the problem out of sight will get you through the site handover but they will grow through in a matter of weeks.

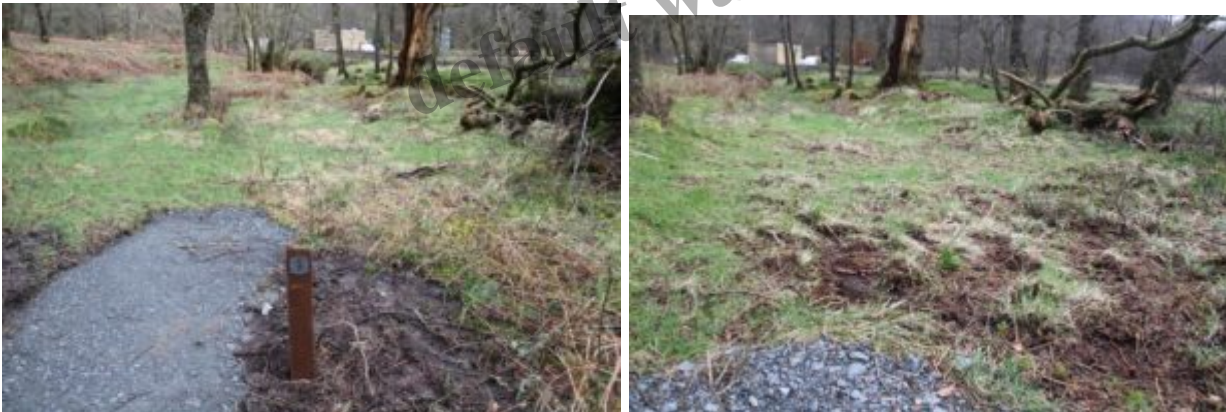
Pitch 7 has been reworked

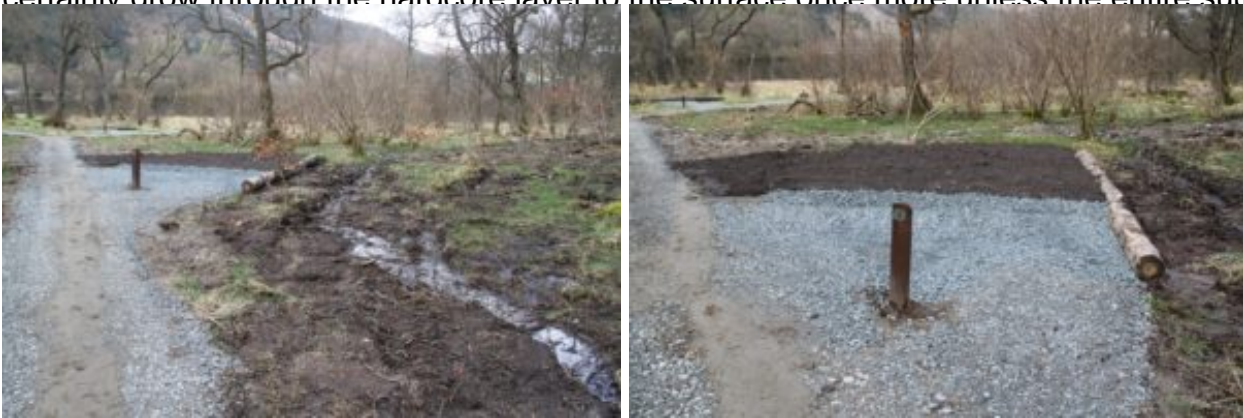
The NP have attempted to constrain and divert the water course around pitch 8 while raising the finished surface of the pitch and that should solve the water problem. It is unclear whether the hardcore layer extends below the entire pitch. If it does we can only hope the soil depth remains around six inches otherwise pegging out the tent base will be an issue. As to the brambles, these will almost certainly grow through the hardcore layer to the surface once more unless the entire subsoil was

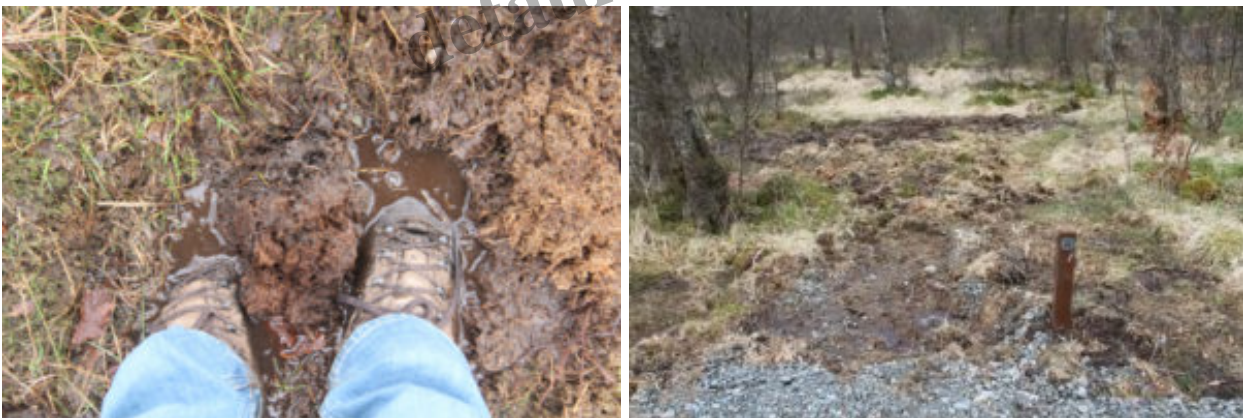
Unbelievable but true, the site of the former pitch 10 was a peat bog. Unfortunately when the Park Authority designates a pitch a mechanical digger drives across it for good measure. The whole area should never have been selected in the first place, it's just incompetence and results in a large area of unnecessary environmental damage.

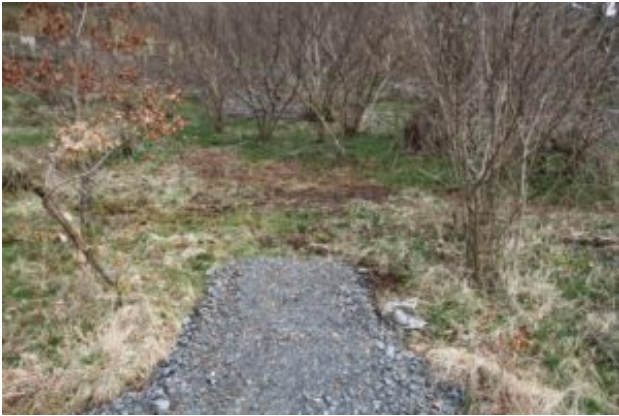
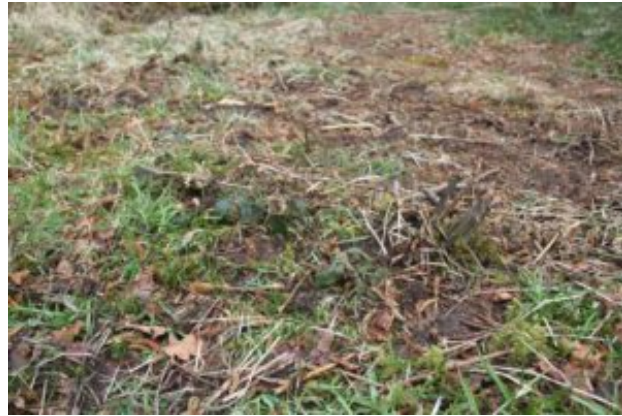
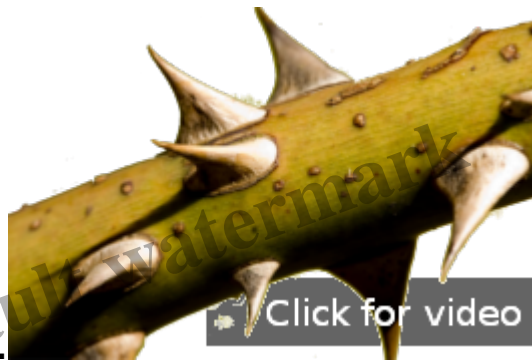
### **Pitch 10 re-work**

The new pitch is undoubtedly drier but unfortunately in the middle of a bramble patch with the trees to

one side and the bog to the other.

While it should be obvious with ground sheet piercing thorns, brambles and tents don't mix and are to be avoided. It is unacceptable to construct a pitch containing or even adjacent to brambles as they will cause both financial loss to the camper and possible injury.

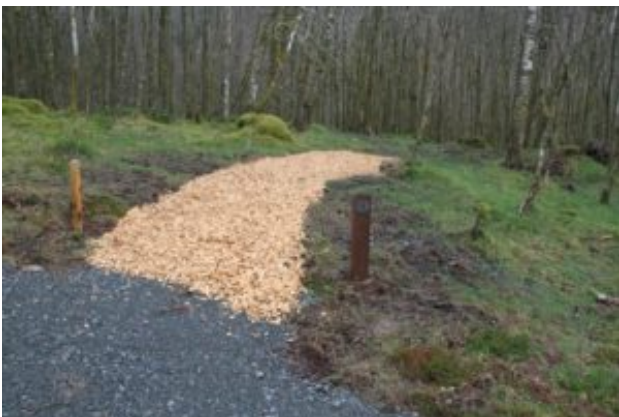
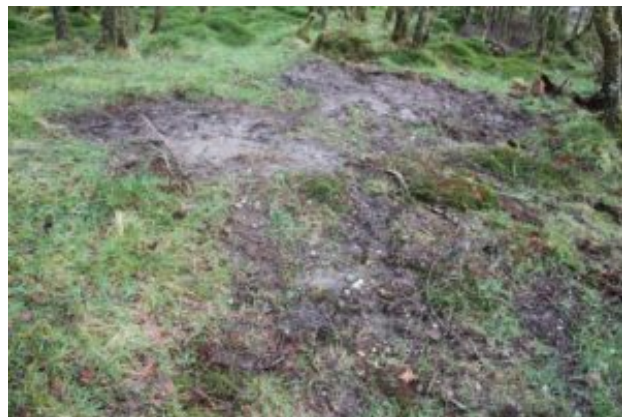
## **Pitch 11**

Pitch 11 remains an uneven wet mess.

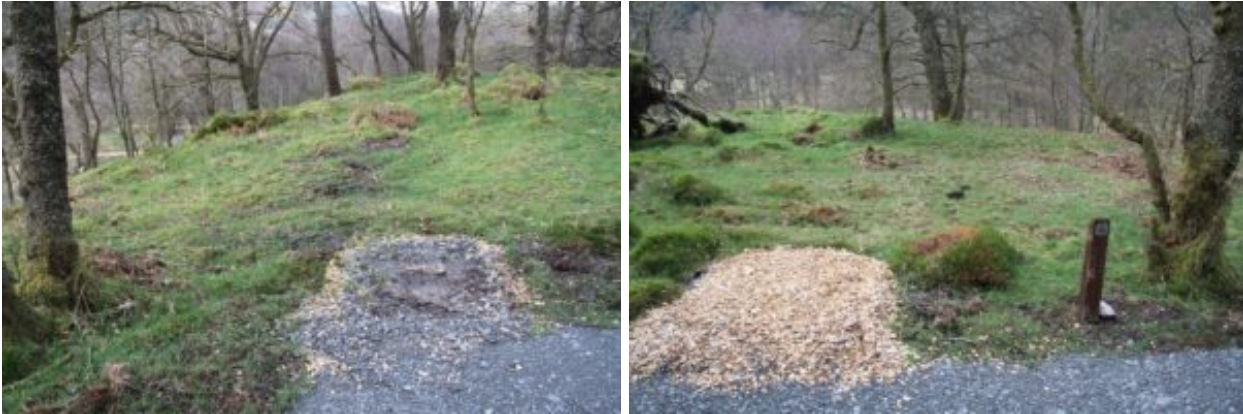
## Pitch 12

Pitch 12 is re-sited from a slope to a more suitable area near by. All that is now required is to reinstate the environmental damage to the old site (see LH image) and trim up the new site removing moss and grass clumps.

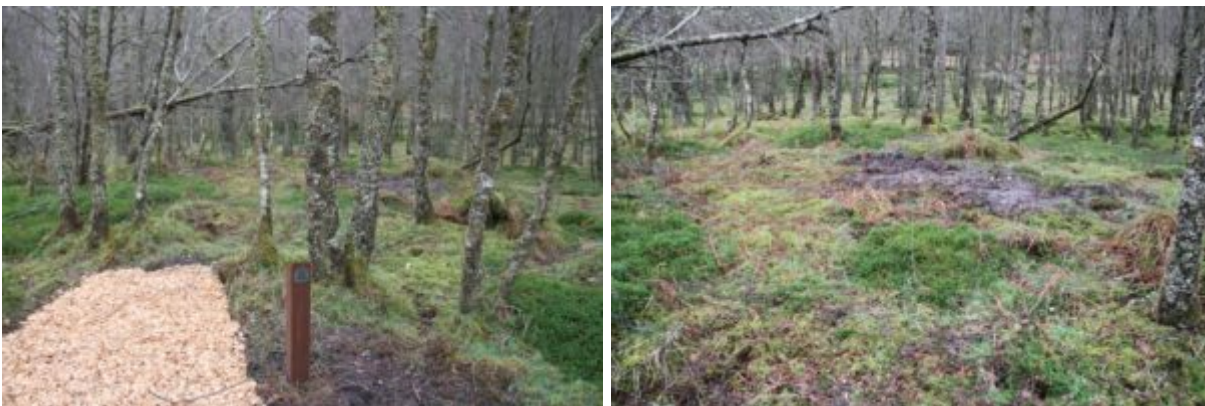
Pitch 13 remains unusable even after trimming

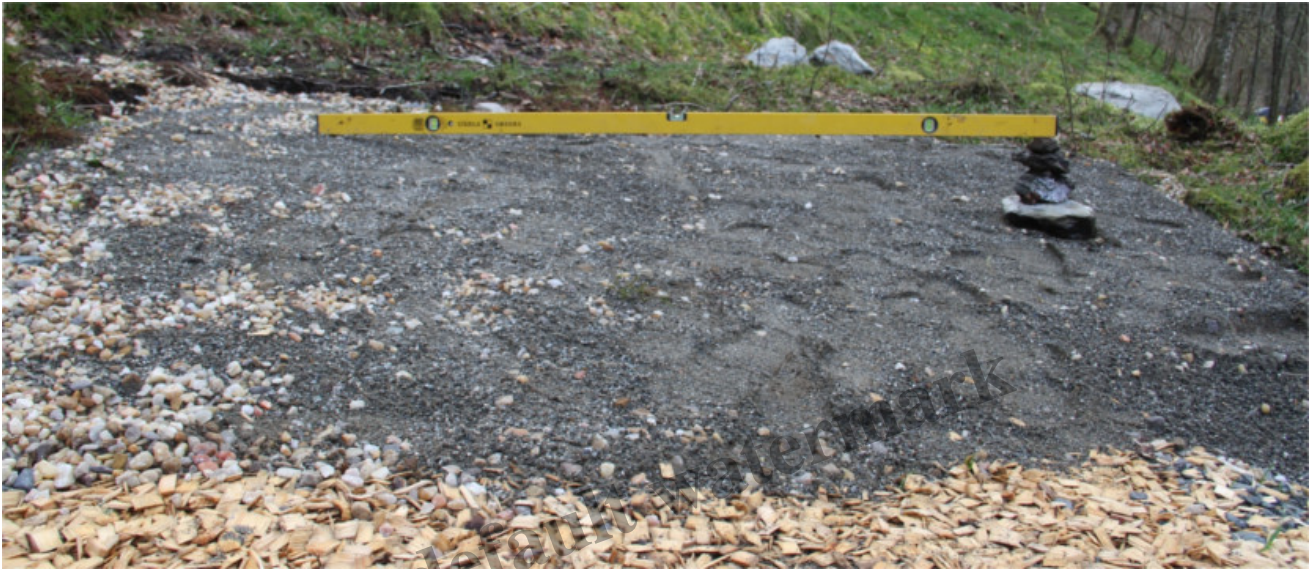
**Pitch 14 re-work includes surfacing with quartz aggregate infilled with fines**

The problem with Pitch 14, as with so many at Loch Chon, is size and the slope. It's just too steep to be a viable camping pitch. In an attempt to make the pitch surface even, the Park Authority have covered the area with their inappropriate quartz aggregate / gravel mix and while it is now even they have completely failed to correct the slope which is far too steep to be used as a camping pitch. This is a double slope, across the hill and down the hill, and will cause campers to roll into each other and push the tent sides into the fly, letting water penetrate.

The second problem is that the topping used to provide an even surface is not constrained and will inevitably spread out over the surrounding area, reducing effectiveness and contaminating a far greater area.

Having decided to do something about the problems at some of the pitches the National Park Authority has still failed to take on board the issues with their camping provision. It's simple. Pitches require to be level, even, dry and able to take tent pegs with area of about 5 m X 5 m as a minimum to allow for cooking and other activities by the tent.

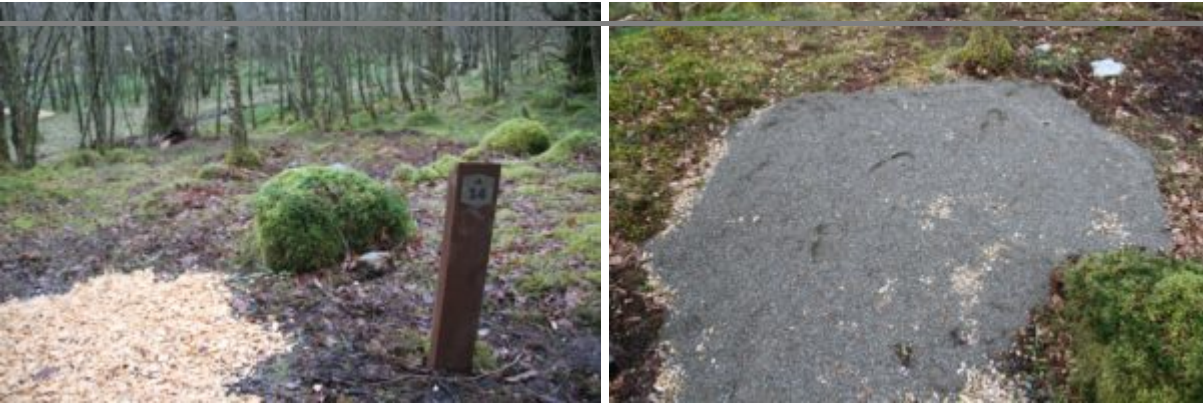
## **Pitch 15**

Marked 14 on post in error!

Similar solution to pitch 14 with grit. Recent works have made the pitch level but the surface is not constrained so very quickly the whole of the aggregate will spread down the slope leaving the pitch back where it started. The size of this pitch has been confined to around 5 square metres from the 25 or more square metres available. A tent pitch requires to be at least twice the size of a tent footprint giving a desirable minimum of around 12 square metres, and an optimum minimum of 25 square metres for a two/three man tent.

The site selection is again poor with the lower point of the first image in a water course.
