Loch Chon campsite – all fine and operational according to the Park Board

By Ross MacBeath

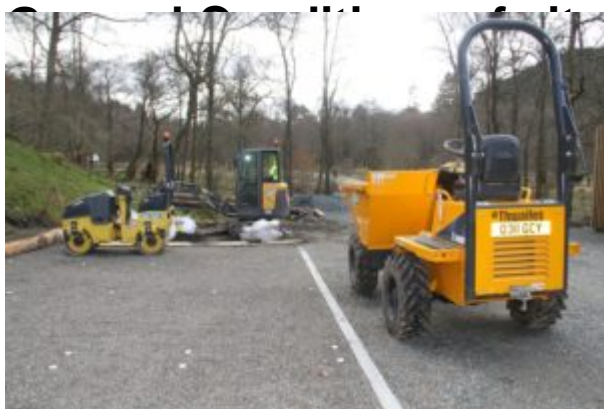
Now, over a full month after Scottish Ministers were promised 300 new pitches were to be provided, allowing the Byelaws to be brought into force, the Loch Chon site has still not been delivered and many of permit zones are unsuitable for camping ([see here](#)) and ([here](#)) for examples. The majority of pitches at Loch Chon remain both unusable or undesirable as camping pitches – as of 2nd April 2017

The area remains a building site with tracked vehicles,

tippers and aggregates at one end of the toilet block and an unwelcoming mess at the entrance container known as the site office and bin store. We are into April and the only pitch that's truly

serviceable is pitch 21 which is coincidentally the only pitch on the entire campsite the LLTNPA did not create.

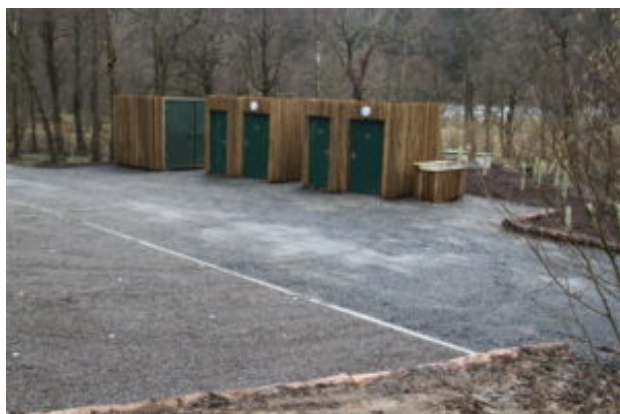
Drinking water issues continue to plague Loch Chon campsite

Although the site is claimed to be fully operational, there is no treated drinking water to the external

taps, preventing container filling and dish washing. 3 of the 4 toilets remained locked. The 4th is open with flushing cistern and working wash hand basins. I suspect a re-plumbing exercise has diverted the drinking water to the toilet block, though the LLTNPA still insist the issues only lasted a few days despite the almost weekly video reports to the contrary.

The promised sympathetic integration of containers into the site has been greatly exaggerated, this solution for buildings in a National Park is just tacky, it's not appropriate for a National Park and ruins the aesthetic of the entire development.

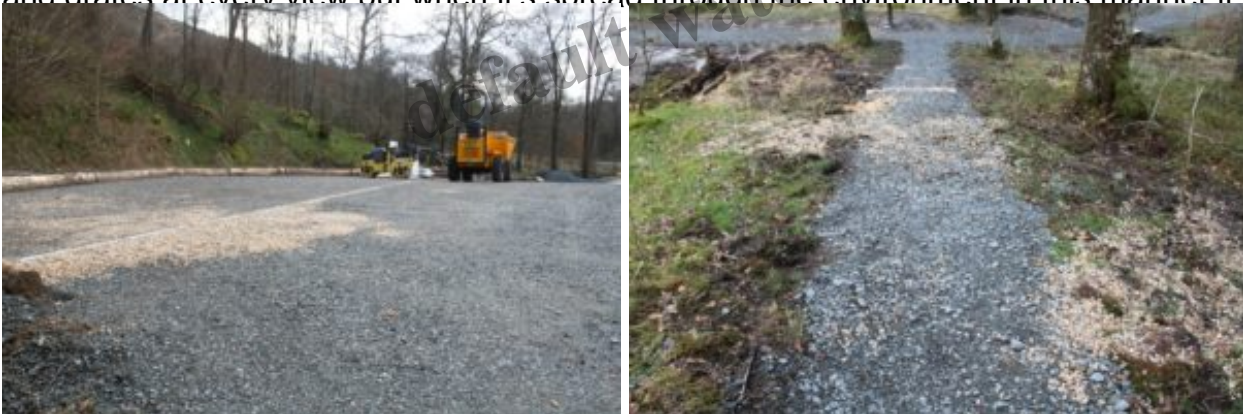
Cross contamination of materials used on site.

The uncontrolled spread of construction materials beyond the confines of paths and roads is a major concern at this development and this will be the subject of an environmental post shortly. What's going on now is the cross contamination of finished works with a new quartz aggregate material introduced to the site. The use of quartz aggregate in an ancient forest needs to be avoided. It's an alien material and grates at every view but when it's spread through the environment in this manner it should be a

How is this possible when there is an appointed clerk of works with responsibility for overseeing all variations to the original planning application and agreeing and documenting all construction work meets environmental standards? The need for a remedy is clear and mixing of this aggregate with vegetation can only be restored by picking it up stone by stone rather than the heavy handed machine operation that has damaged the site unnecessarily in other locations.

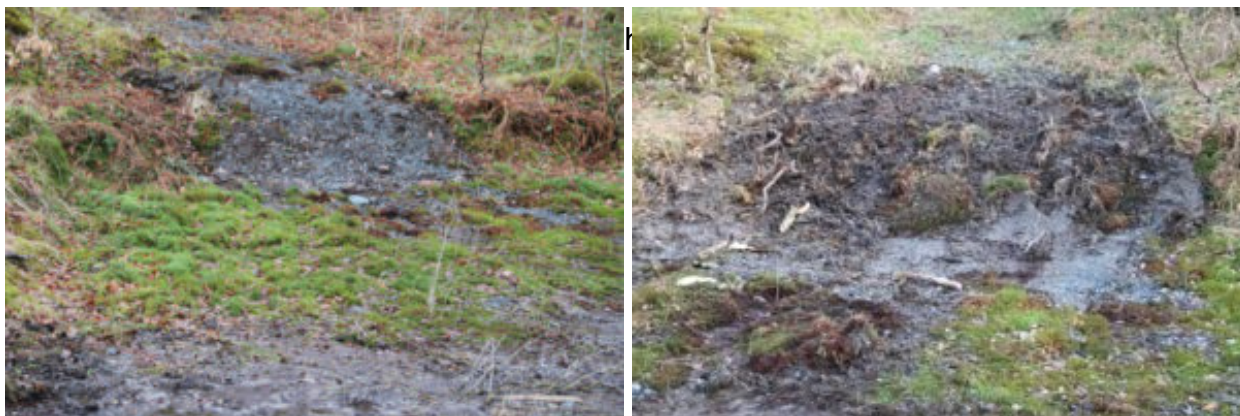
Environmental Damage created through attempting to clear contamination by alien materials

The original contamination on the left and the disastrous attempt to remove it effectively has caused destruction to the hillside in the process. It remains unclear why the hardcore was deposited on vegetation in the first place, given the area, probably a path placement error.

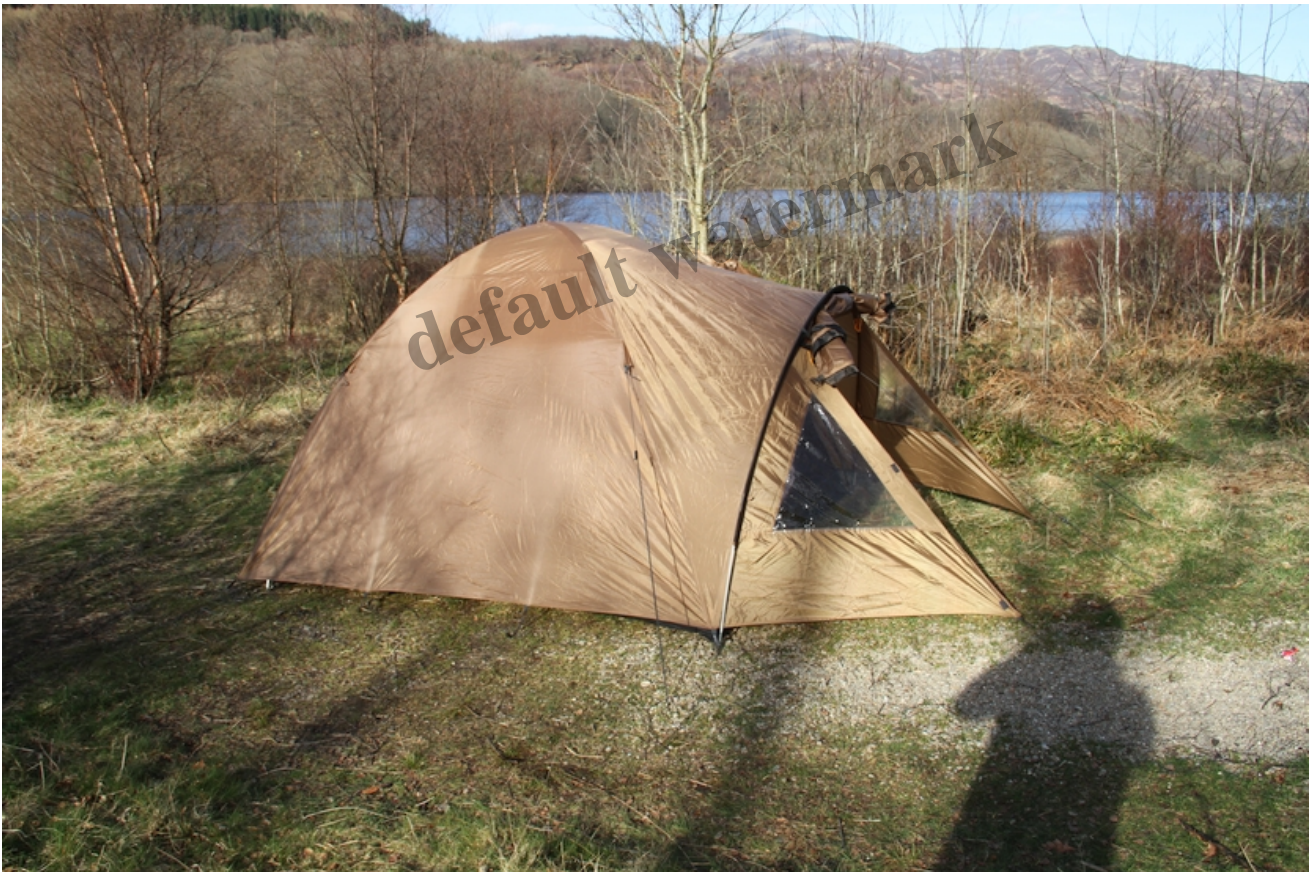
The image below shows a typical and popular loch side camping spot now banned by the bylaws. It's high amenity, provides a level, short grass surface over firm ground, the surface is even with sufficient depth to take tent pegs. it also covers a large area and so provides for cooking and sitting around the tent to eat. The proximity of the loch shore and open areas allow for play and other activities making for a good visitor experience.

This is a former Forestry Commission camping pitch where camping is now banned. It is sited within view of the useless 'Three Lochs Forest Drive Zone L' by Loch Achray

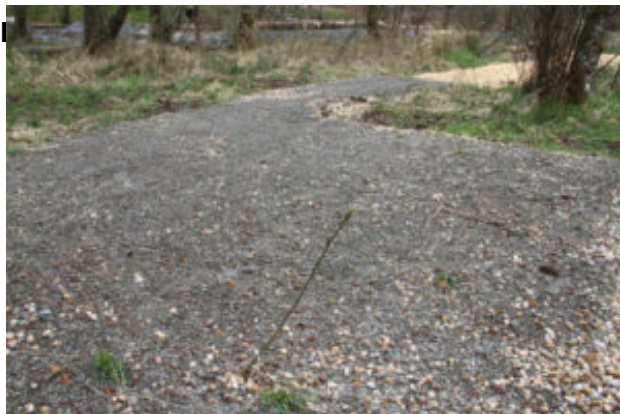
-19th March compared to modified pitch 2nd April

Pitch 6 has been covered with grit. It's not a material you want inside the tent and yet that's exactly what's going to happen here.

A bright quartz aggregate overlaid with a graded building material, it is not constrained at the edges and so is likely to spread out over the adjacent areas. It is also likely that the finer materials will be washed into the aggregate with rain leaving an inappropriate bright quartz aggregate finish to the area. This pitch surface requires to be a natural material in an ancient wood and where works have been carried out that should be grass. This grit is going to cause no end of aggravation to campers as it's carried in to the tent and deposited in the sleeping area, wholly inappropriate.

The evidence of bramble stalks showing through the surface indicates the underlying ground cover of brambles will remain an issue as the removal of a bramble infestation can take up to 2 years of concerted effort of cutting back and digging out roots. Simply burying the problem out of sight will get you through the site handover but they will grow through in a matter of weeks.

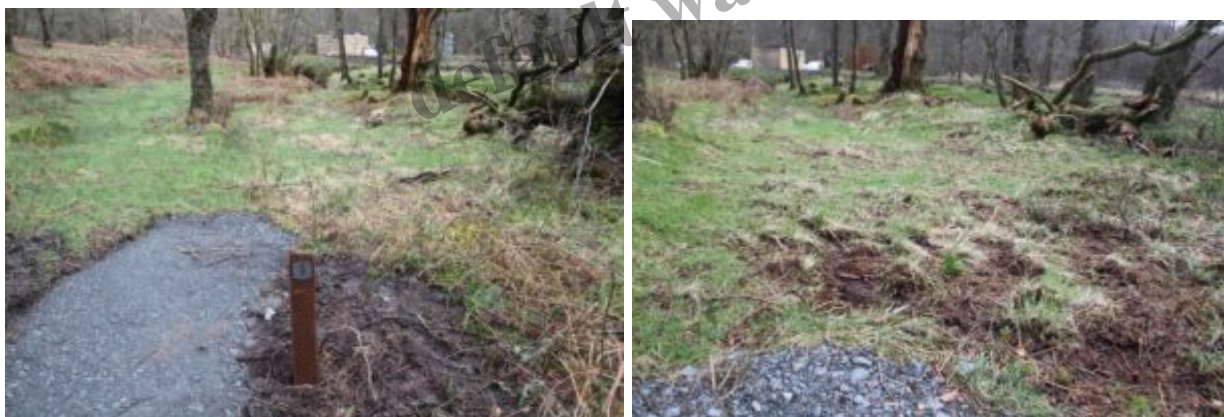
Pitch 7 has been reworked

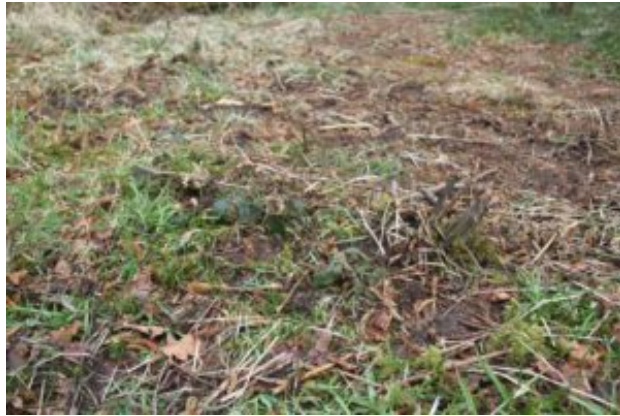
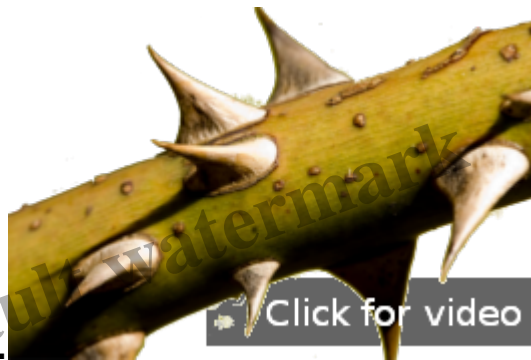
Pitch 10 re-work

The new pitch is undoubtedly drier but unfortunately in the middle of a bramble patch with the trees to

one side and the bog to the other.

Brambles, an invasive species.

While it should be obvious with ground sheet piercing thorns, brambles and tents don't mix and are to be avoided. It is unacceptable to construct a pitch containing or even adjacent to brambles as they will cause both financial loss to the camper and possible injury.

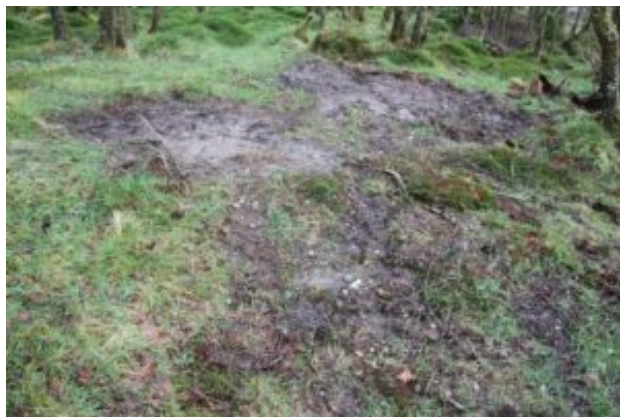
Pitch 11 remains an uneven wet mess.

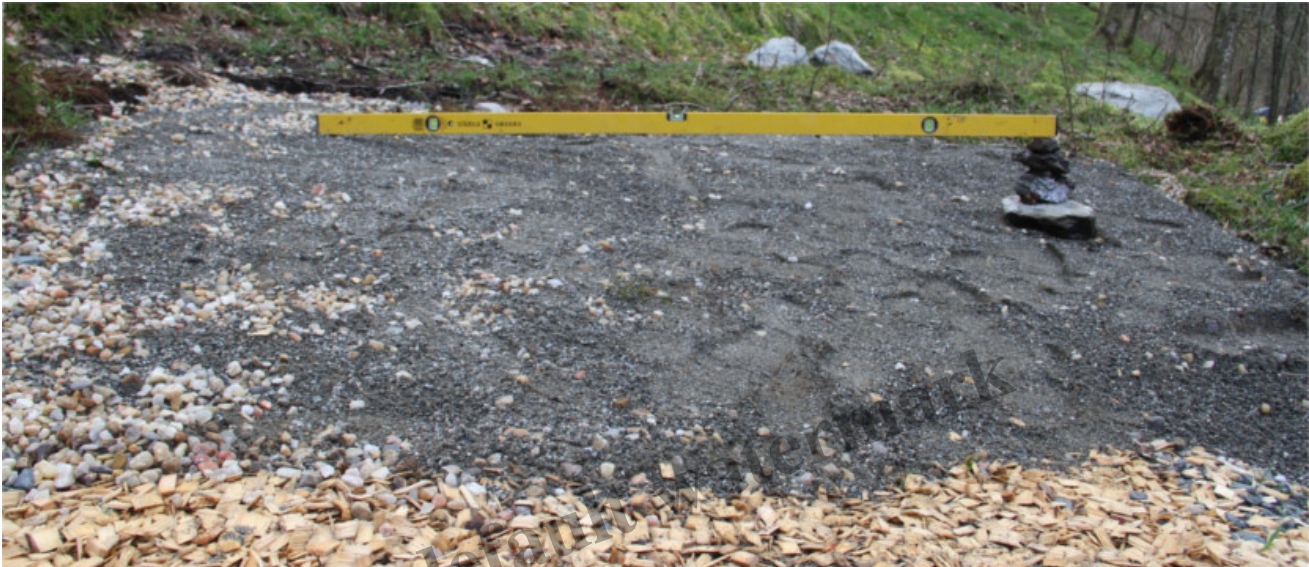
Pitch 14 re-work includes surfacing with quartz aggregate infilled with fines

The problem with Pitch 14, as with so many at Loch Chon, is size and the slope. It's just too steep to be a viable camping pitch. In an attempt to make the pitch surface even, the Park Authority have covered the area with their inappropriate quartz aggregate / gravel mix and while it is now even they have completely failed to correct the slope which is far too steep to be used as a camping pitch. This is a double slope, across the hill and down the hill, and will cause campers to roll into each other and push the tent sides into the fly, letting water penetrate.

The second problem is that the topping used to provide an even surface is not constrained and will inevitably spread out over the surrounding area, reducing effectiveness and contaminating a far greater area.

Having decided to do something about the problems at some of the pitches the National Park Authority has still failed to take on board the issues with their camping provision. It's simple. Pitches require to be level, even, dry and able to take tent pegs with area of about 5 m X 5 m as a minimum to allow for cooking and other activities by the tent.

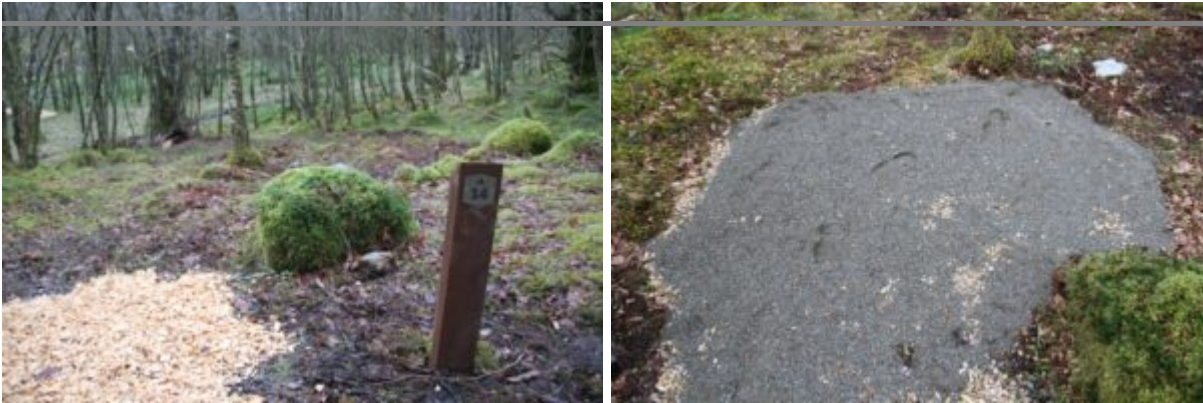
Pitch 15

Marked 14 on post in error!

Similar solution to pitch 14 with grit. Recent works have made the pitch level but the surface is not constrained so very quickly the whole of the aggregate will spread down the slope leaving the pitch back where it started. The size of this pitch has been confined to around 5 square metres from the 25 or more square metres available. A tent pitch requires to be at least twice the size of a tent footprint giving a desirable minimum of around 12 square metres and an optimum minimum of 25 square metres for a two/three man tent.

The site selection is again poor with the lower point of the first image in a water course.
