Loch Chon campsite – all fine and operational according to the Park Board

By Ross MacBeath

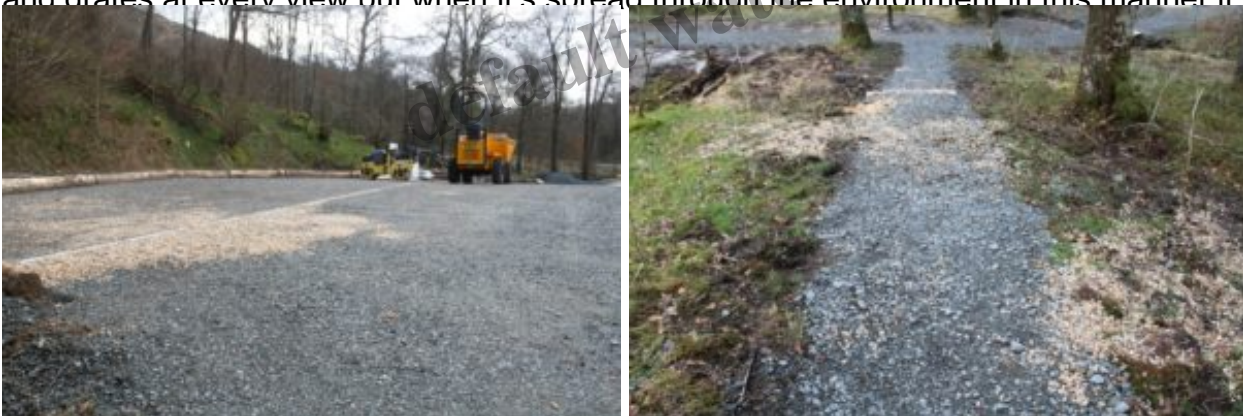
Cross contamination of materials used on site.

The uncontrolled spread of construction materials beyond the confines of paths and roads is a major concern at this development and this will be the subject of an environmental post shortly. What's going on now is the cross contamination of finished works with a new quartz aggregate material introduced to the site. The use of quartz aggregate in an ancient forest needs to be avoided. It's an alien material and grates at every view but when it's spread through the environment in this manner it should be a

How is this possible when there is an appointed clerk of works with responsibility for overseeing all variations to the original planning application and agreeing and documenting all construction work meets environmental standards? The need for a remedy is clear and mixing of this aggregate with vegetation can only be restored by picking it up stone by stone rather than the heavy handed machine operation that has damaged the site unnecessarily in other locations.

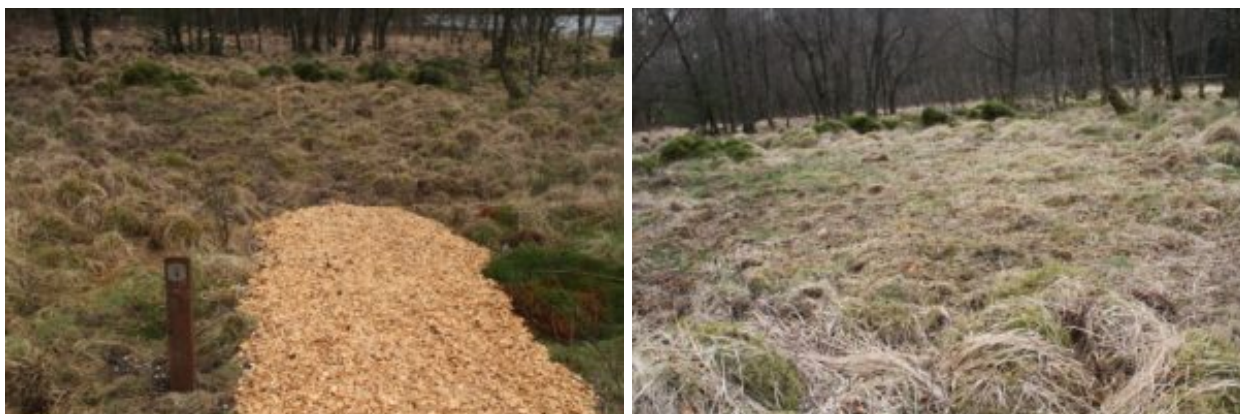
Pitch 1 just not up to scratch

In stark contrast the National Park's paid for replacement is just not suitable. These low lying areas are sited well back from the shore on wild tussock grass which, by it's very nature, is unsuitable for camping. It is uncomfortable if not impossible to sleep on. There is no firm ground to light a stove, place a seat or even sit or lie down on a beach towel. Then consider these photographs were taken in the dormant season (March 12th/April 2nd) after winter die back, when new growth takes hold matters will rapidly worsen. The old adage, good campsites are found not made holds true and if you insist in making them they take years to create and require much more work than than a brush over with a strimmer.

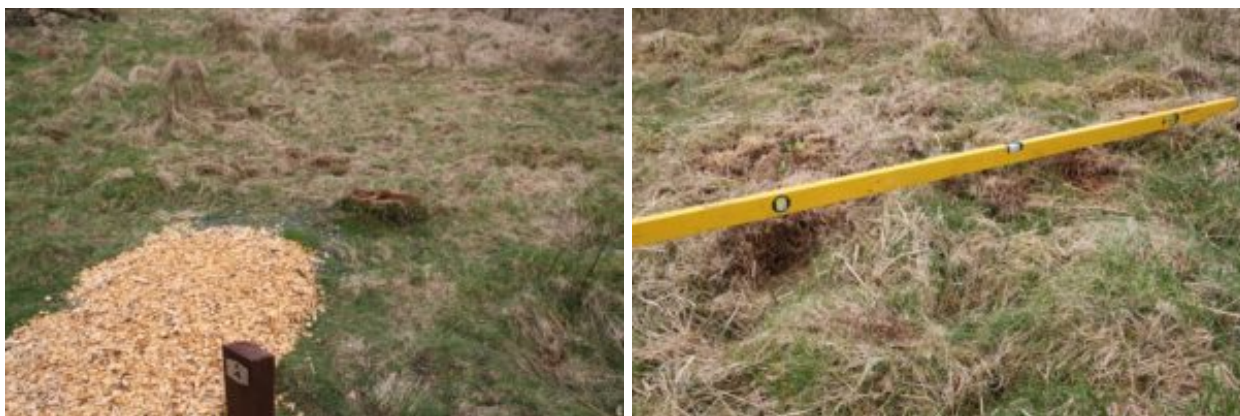
Pitch 4 has been trimmed leaving the solid core of tussocks with depressions of 8 to 10 inches the pitch remains unsuitable.
