Loch Chon campsite – all fine and operational according to the Park Board

By Ross MacBeath

On the 13th March at the Board Meeting at the Loch Lomond and Trossachs National Park HQ in Balloch, the Your Park update report ([see here](#)) stated the “*Loch Chon campsite is on course for completion and handover.....for 1st March*”. At the end of the meeting, in what appeared to be an orchestrated statement, it was reported that the Board had made a site visit and all was found to be in order. It will be interesting to see if this is recorded in the minutes when they eventually appear. Having visited the campsite on the 12th March '17, the day before the board meeting, I knew the statement to be untrue and have published [over a hundred photographs](#) which are proof of this fact. Its very worrying that Board Members who visited appear to have so little knowledge of camping that they were oblivious to the multitude of obvious problems and then that senior staff and the entire board have colluded to hide the fact that all was not in order with the completion and handover of the development at Loch Chon.

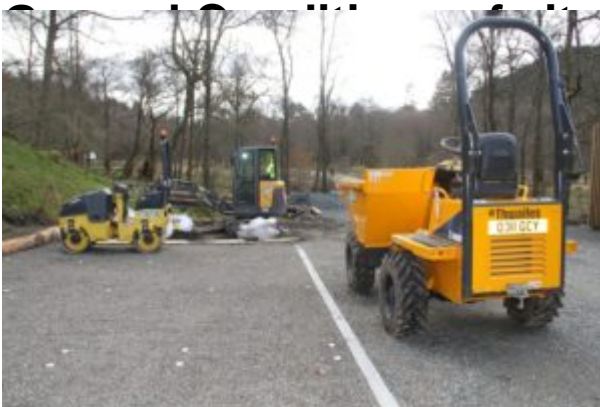
Now, over a full month after Scottish Ministers were promised 300 new pitches were to be provided, allowing the Byelaws to be brought into force, the Loch Chon site has still not been delivered and many of permit zones are unsuitable for camping ([see here](#)) and ([here](#)) for examples. The majority of pitches at Loch Chon remain both unusable or undesirable as camping pitches – as of 2nd April 2017

The area remains a building site with tracked vehicles,

tippers and aggregates at one end of the toilet block and an unwelcoming mess at the entrance container known as the site office and bin store. We are into April and the only pitch that's truly

serviceable is pitch 21 which is coincidentally the only pitch on the entire campsite the LLTNPA did not create.

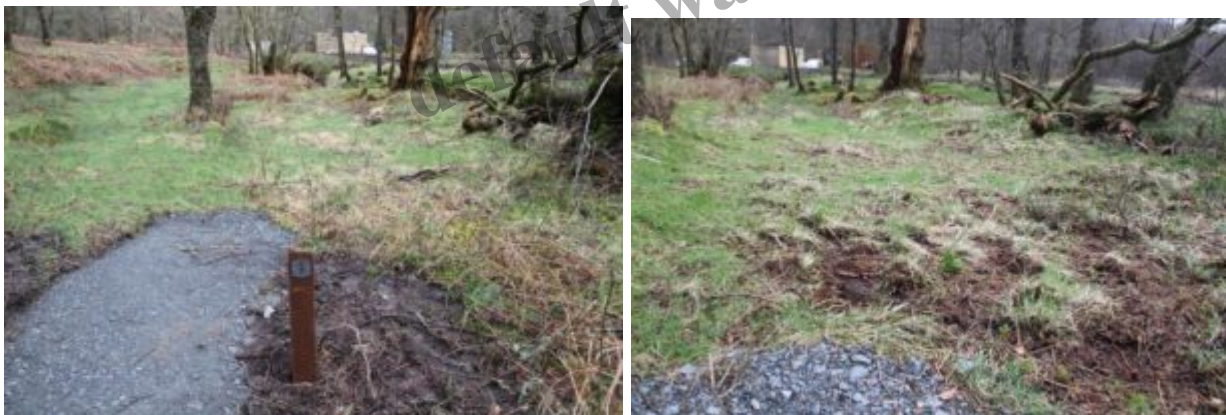
Pitch 7 has been reworked

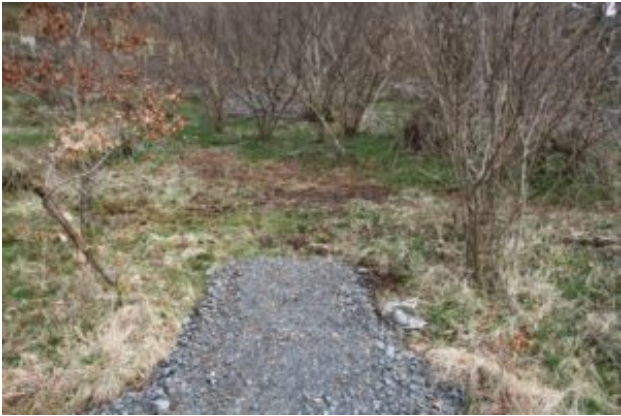
Pitch 10 re-work

The new pitch is undoubtedly drier but unfortunately in the middle of a bramble patch with the trees to

one side and the bog to the other.

Brambles, an invasive species.

While it should be obvious with ground sheet piercing thorns, brambles and tents don't mix and are to be avoided. It is unacceptable to construct a pitch containing or even adjacent to brambles as they will cause both financial loss to the camper and possible injury.

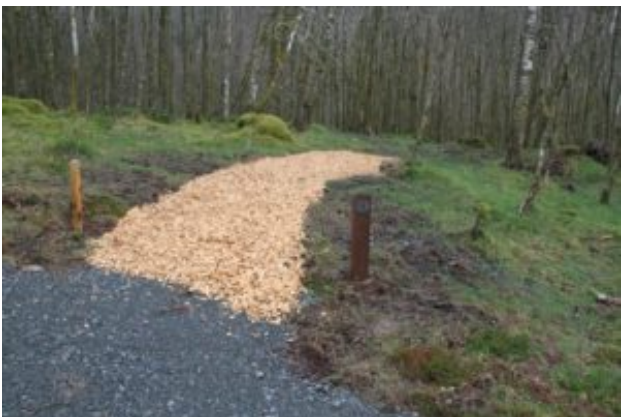
Pitch 11 remains an uneven wet mess.

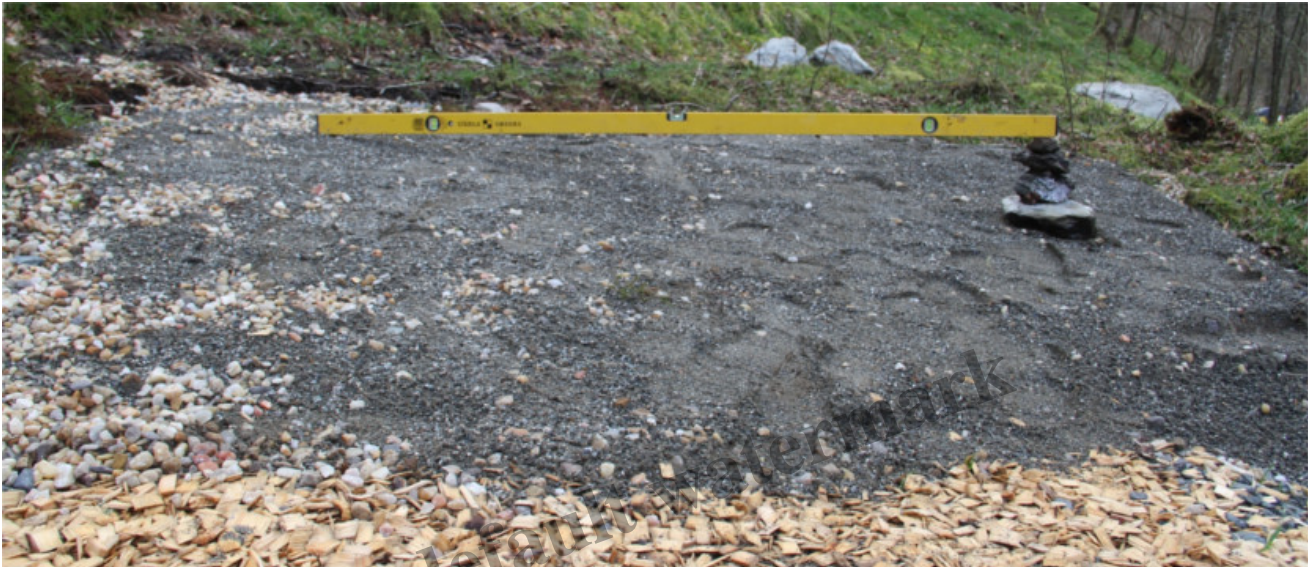
Pitch 14 re-work includes surfacing with quartz aggregate infilled with fines

The problem with Pitch 14, as with so many at Loch Chon, is size and the slope. It's just too steep to be a viable camping pitch. In an attempt to make the pitch surface even, the Park Authority have covered the area with their inappropriate quartz aggregate / gravel mix and while it is now even they have completely failed to correct the slope which is far too steep to be used as a camping pitch. This is a double slope, across the hill and down the hill, and will cause campers to roll into each other and push the tent sides into the fly, letting water penetrate.

The second problem is that the topping used to provide an even surface is not constrained and will inevitably spread out over the surrounding area, reducing effectiveness and contaminating a far greater area.

Having decided to do something about the problems at some of the pitches the National Park Authority has still failed to take on board the issues with their camping provision. It's simple. Pitches require to be level, even, dry and able to take tent pegs with area of about 5 m X 5 m as a minimum to allow for cooking and other activities by the tent.
