## Loch Chon campsite – the water supply failure and cover-up

## **The reasons why the water supply at Loch Chon is defective**

## **Peak water flow and the LLTNPA Loch Chon water supply**

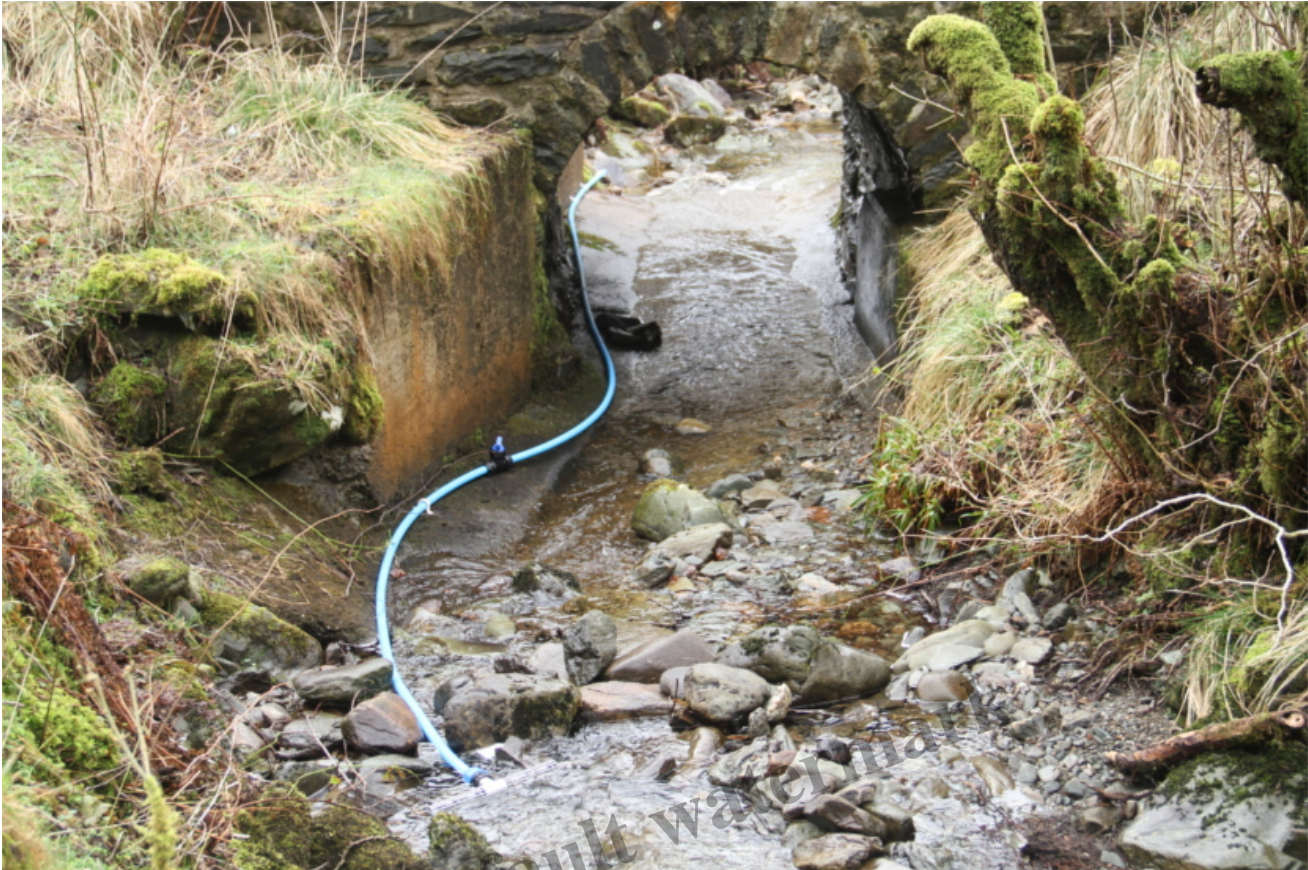
An unsightly installation with loops in blue water pipe makes a poor impression. When taken together with the positioning of the intake manifold, which is partially out of the water, unsecured and likely to be dislodged the first time the stream is in spate, it provides a rather damning but realistic indication of what was initially installed.

Just while we're looking at this image, you can see that the concrete floor of the culvert under the bridge is smooth and curved. This is done intentionally to stop materials collecting on the surface. When the stream is in spate, large boulders are transported in the torrent of water and the smooth culvert base ensures they can roll right through preventing them from causing an obstruction under the bridge. We will see why this is important later in the article.

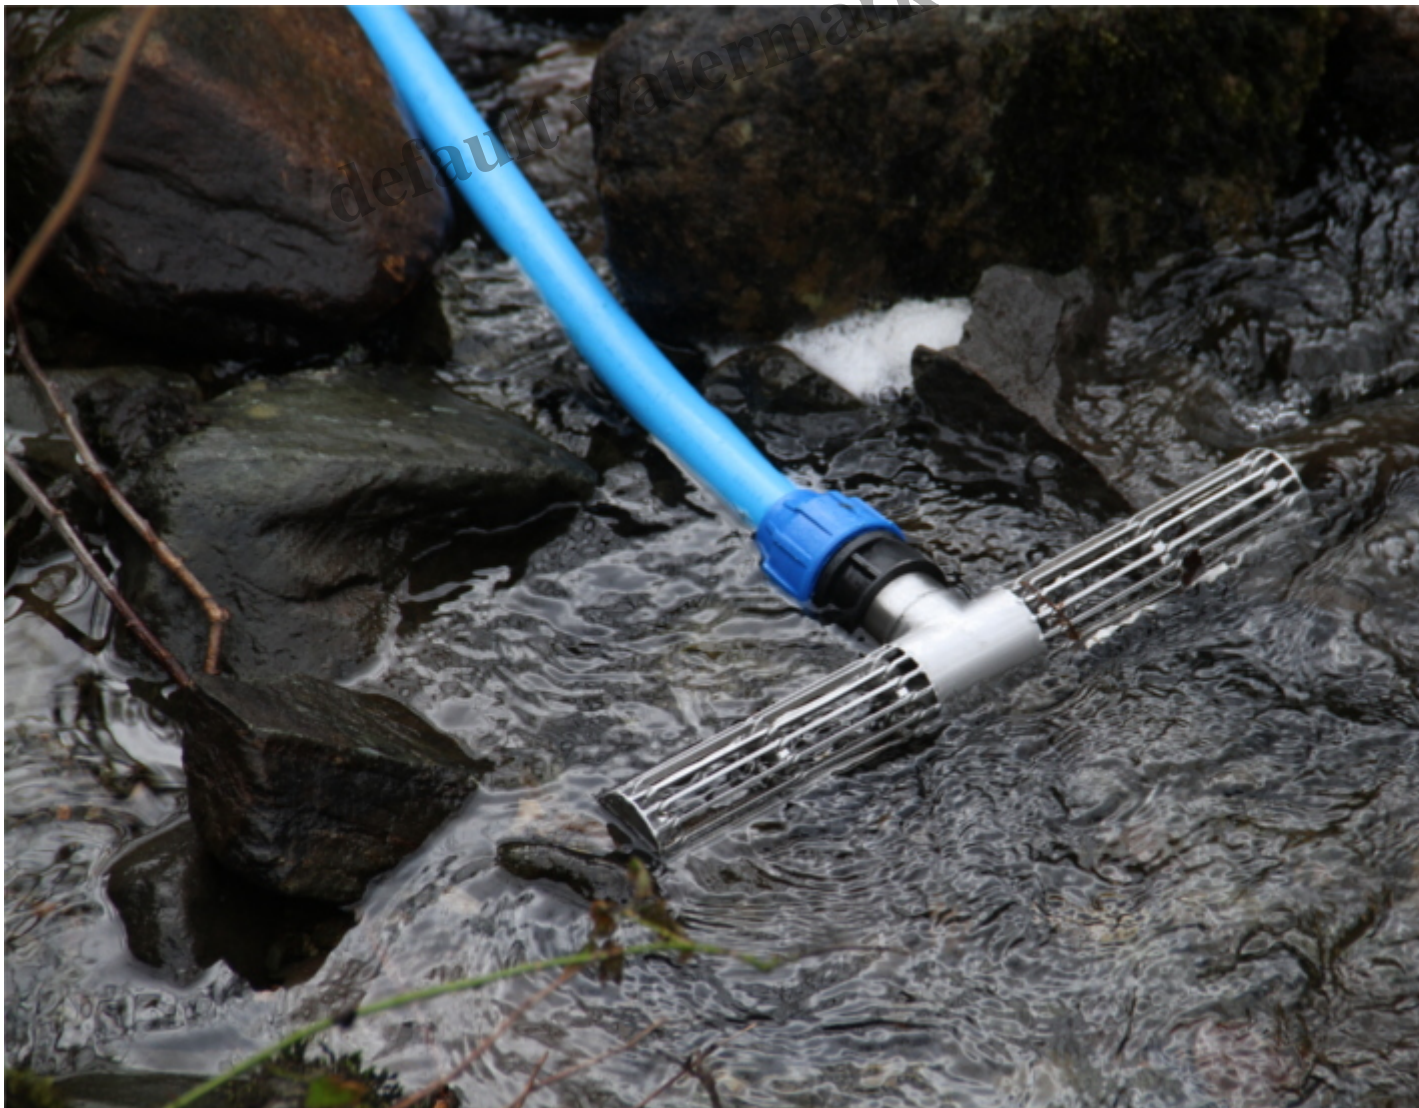
You would think that making sure the intake manifold is always under water would be a given. Yet here we are at Loch Chon on the 12th March 2017 with the manifold almost completely uncovered drawing air into the system.

Image 12th March 2017 lying on surface at water level

The problem is clear that the stream does not have sufficient water flow in dry periods. This was evident during a dry spell starting before March 1st and through 12th March when the water supply failed intermittently when the intake pipe was not fully submerged causing air to be drawn into the system. In this location there is sufficient depth of water the intake is just not positioned properly.

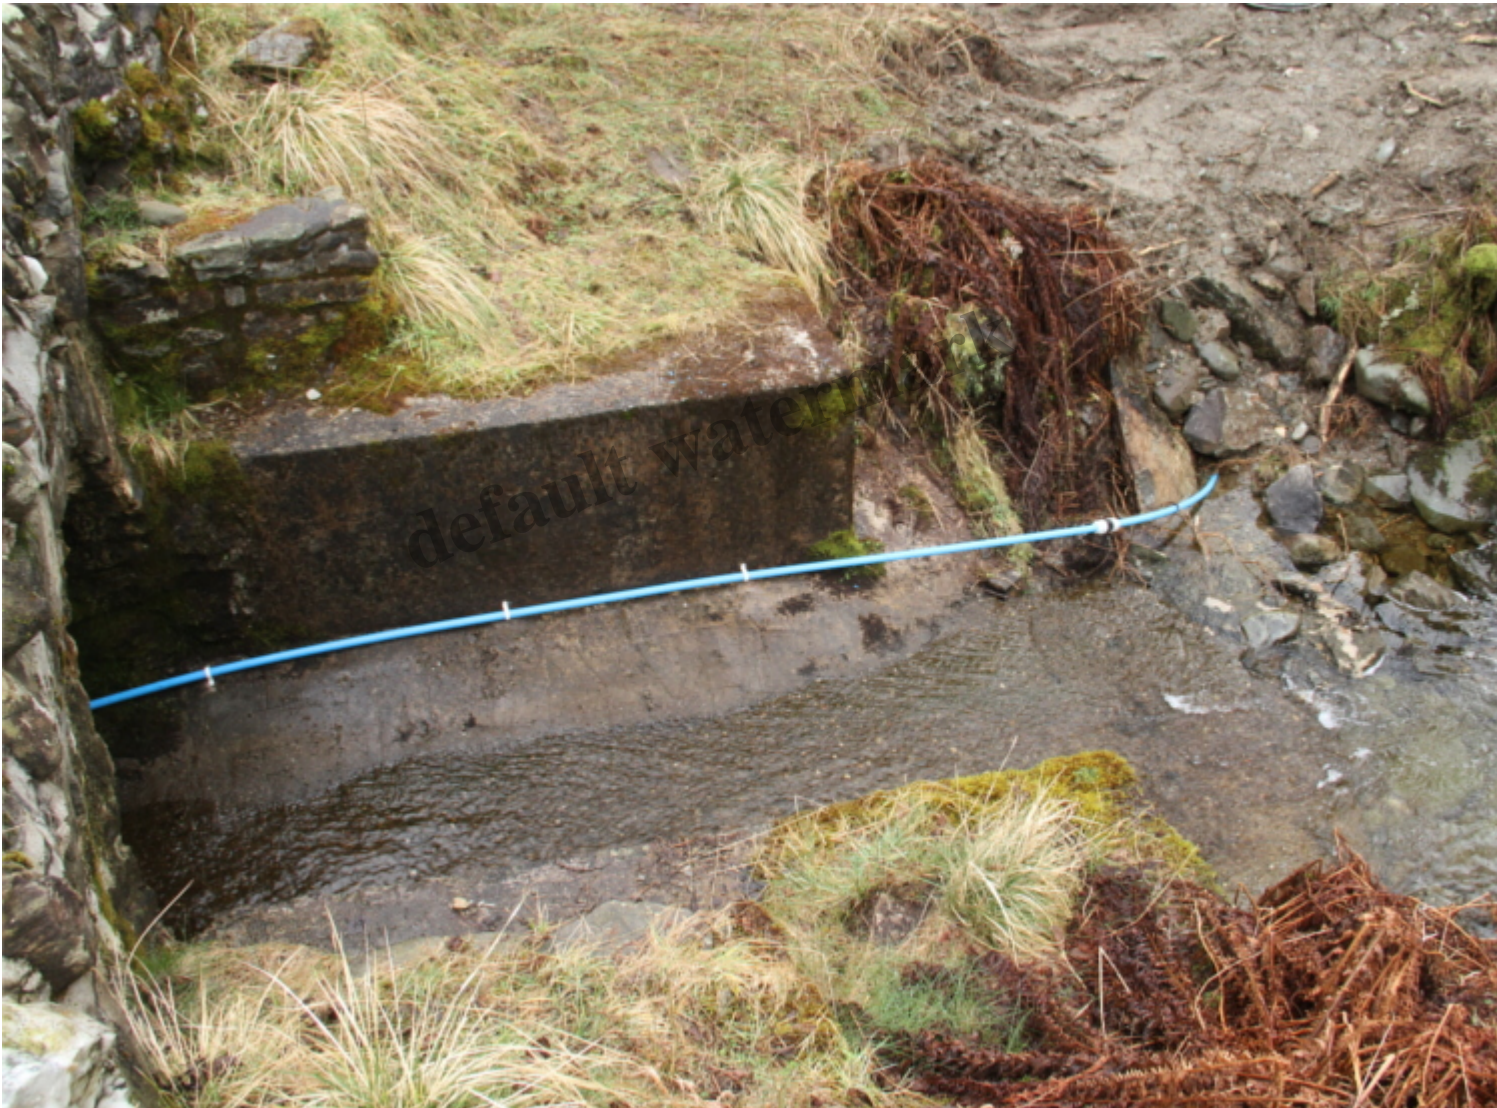
Of course once the air lock is in the system it won't self clear easily as water won't flow up hill. So many basic principles have just been overlooked cumulatively resulting in poor system design. This is a contributory factor together with the failure of staff, the clerk of works and the contractor to understand the basic requirements for implementing such a water supply.

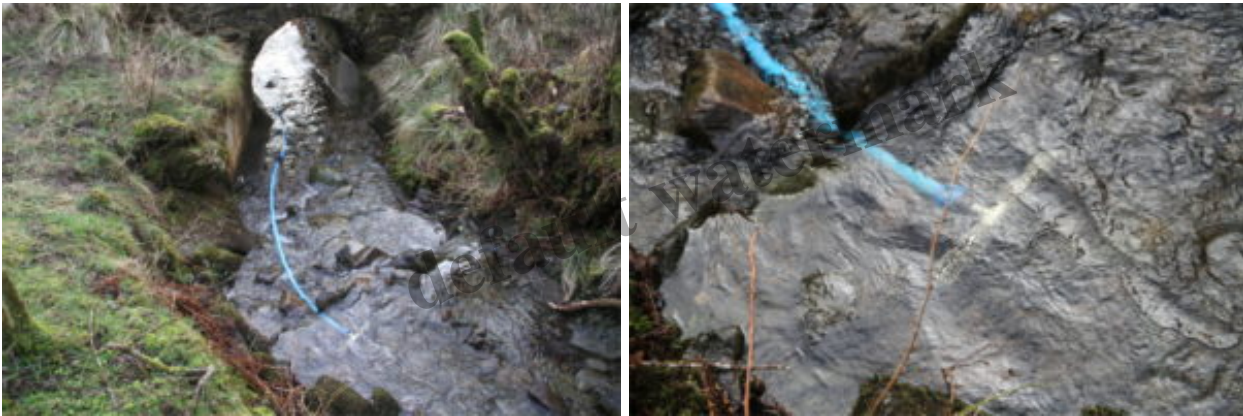
One week later on the 19th March 2017 the intake pipe was submerged once more, after some rainfall, however the water to the toilets and wash hand basins was still off. You can see here the pipe had been removed from the clips removing the ridiculous upward loops in the water feed pipe.

The water supply was still causing issues, drinking water was available but toilet flushing was not.

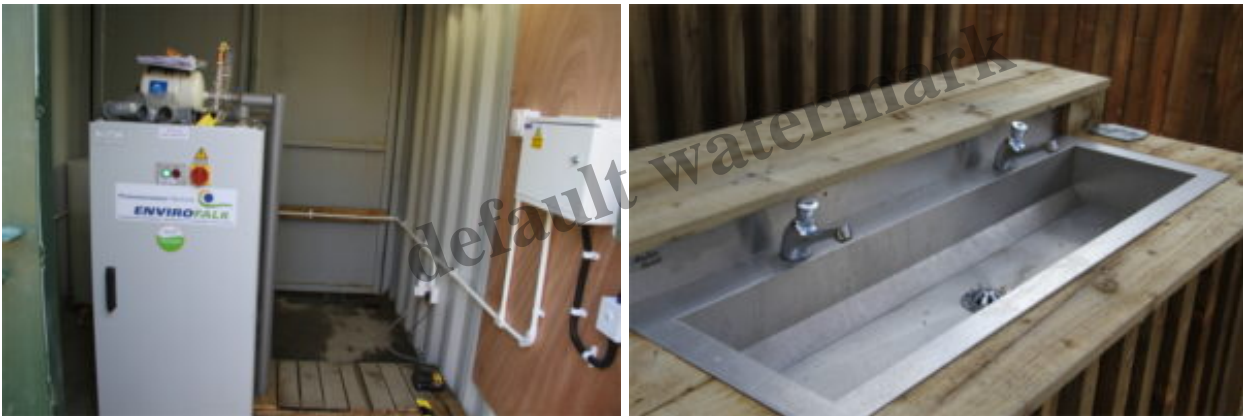
The engineers were working on the system when I arrived and allowed an opportunity to see what's inside the container next to the toilet block. It does look like there is a leak in the container roof.

The confusion over the hot and cold taps had also been sorted and there were now neutered tap tops both supplying cold water.

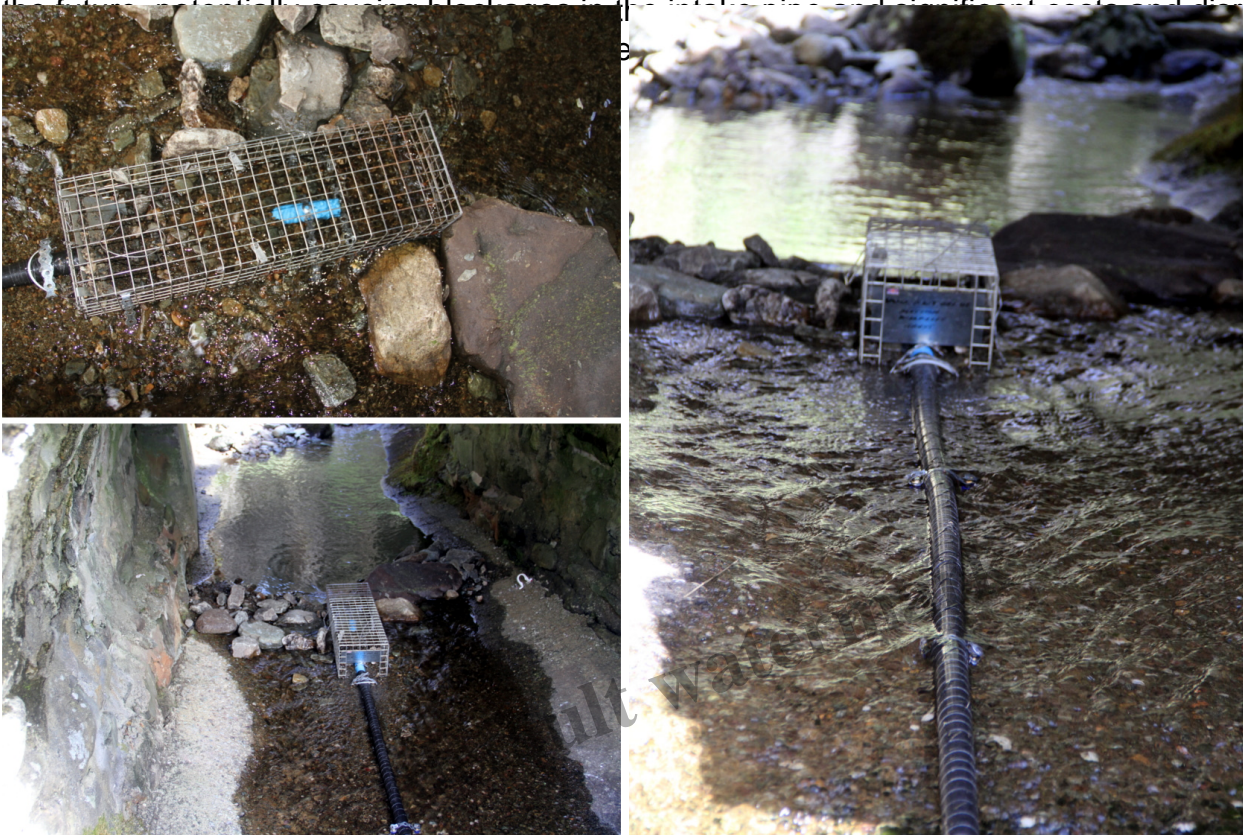
My visit on the 10th of April 2017 showed some changes. The main visible differences one week on were up by the intake manifold. They had cut the pipe back and fitted a black sheath which is far less

intrusive. The had also removed the old stainless steel manifold and fitted a cage to cover the end of the pipe. However the pipe end is open and directly facing into the water flow with nothing to prevent pebbles and smaller items being transported down the stream from finding their way into the system, so anything smaller than the mesh can also enter the intake pipe. I think this may pose a problem for the future as it will be necessary to have a regular maintenance schedule to prevent any significant water supply disruption to clear

The second and most important is the placement of the intake port on to the surface of the culvert, these images are very telling considering the recent weather has been wet followed by a short dry spell, the level here has dropped 20 cm since last checked.3 weeks ago.

**This indicates the Peak flow of the stream may be very small in dry weather.**

The problem is clear, the peak flow of the stream on dry days is so small that the water level in the culvert is no more than a centimetre or so and doesn't even cover the intake pipe. To solve this a [small dam](#), and I mean small, has been created with stones and gravel where the depth of water behind this is sufficient to cover the intake pipe.

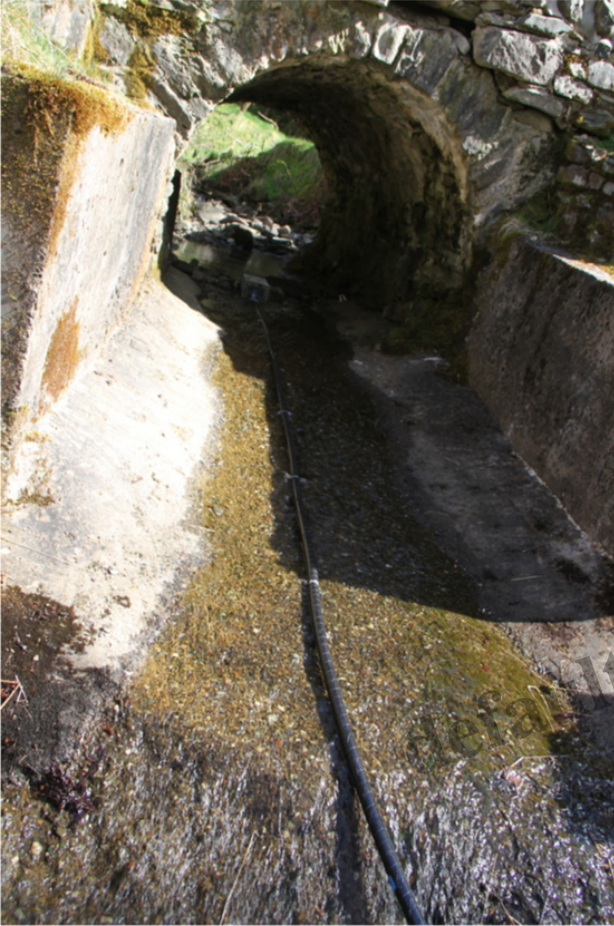
As we discussed already, the smooth curved floor of the culvert is designed to prevent debris collecting in this location. The Debris (dam) (photo above) will be removed by fast water flow.

Even with the current level of water flow the smaller stones and gravel around the intake pipe will be washed away eventually breaking the dam causing the water level to drop below the intake pipe and the water supply to fail.

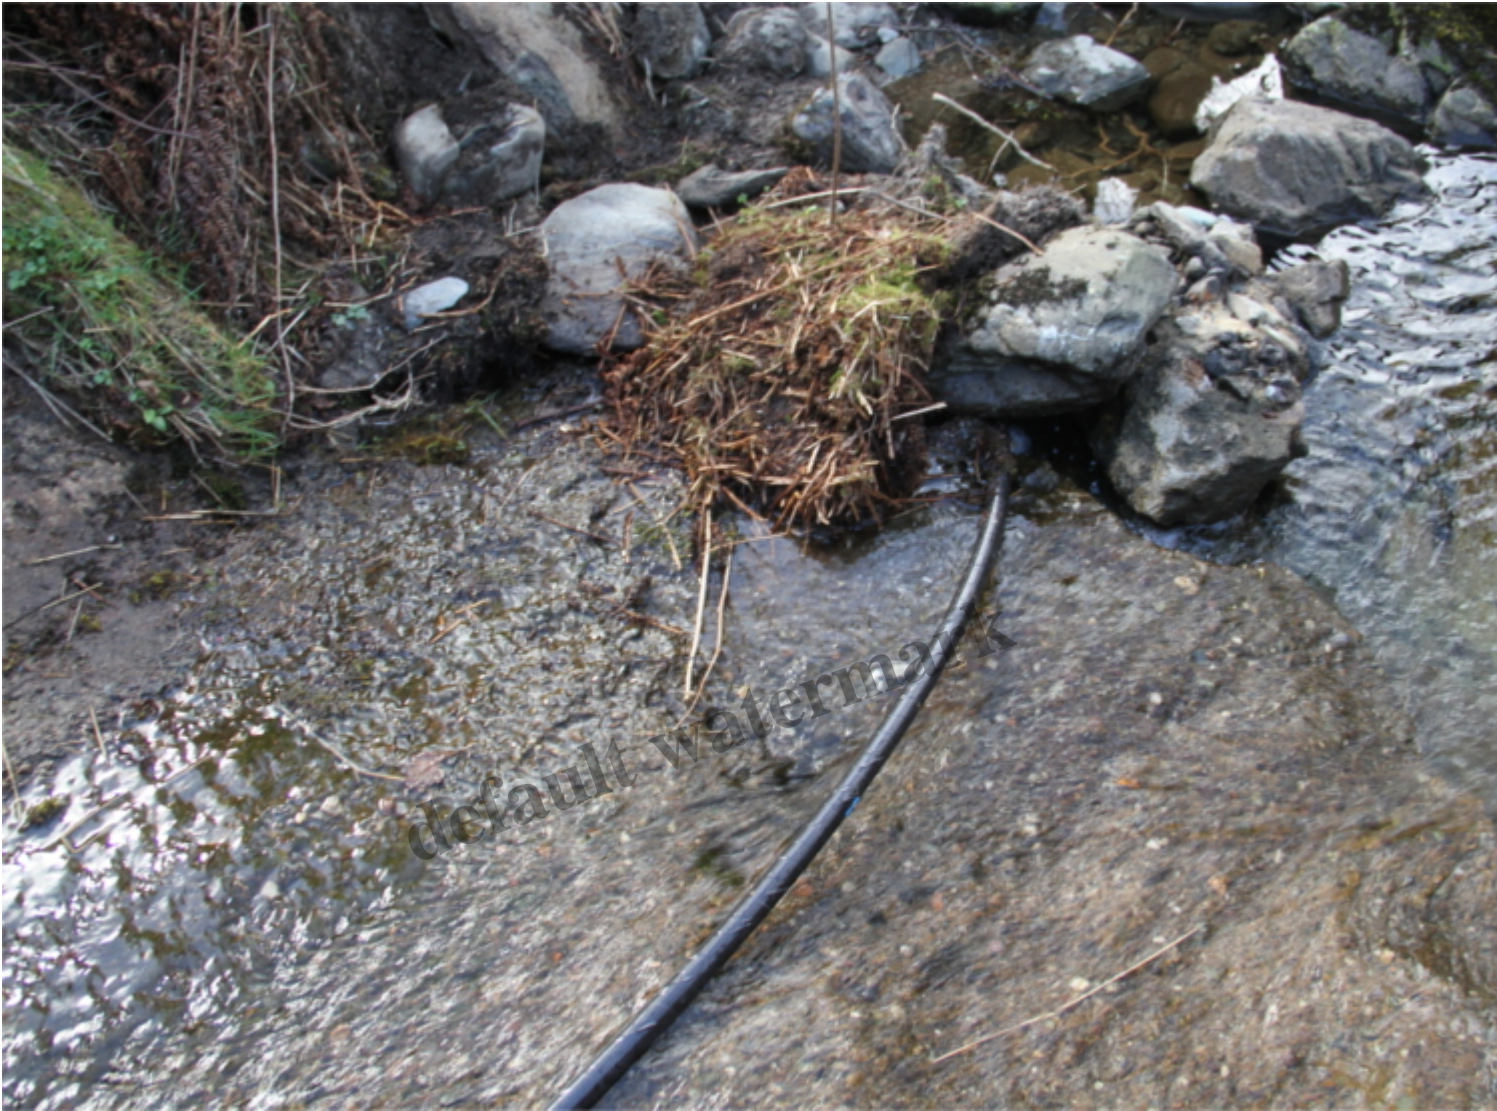
With any heavy rain storm the stream will be in spate, the force of water will clear all of the rocks forming the dam in the culvert. When in spate the stream can also carry branches and fallen trees down through the culvert but now with the fixed obstruction of the mesh cage there is a possibility that these will damage the cage or more likely get jammed on it causing a build up of debris in the culvert. This is not good practice and I would think it should be avoided.

The arrangement of the pipe has changed, now entering the river bank at a much lower level, the pipe is not secured on it's traverse across the culvert and the gap underneath will most likely collect sticks and other vegetation then a build up of debris will possibly occur.
