Loch Chon campsite – the water supply failure and cover-up

The reasons why the water supply at Loch Chon is defective

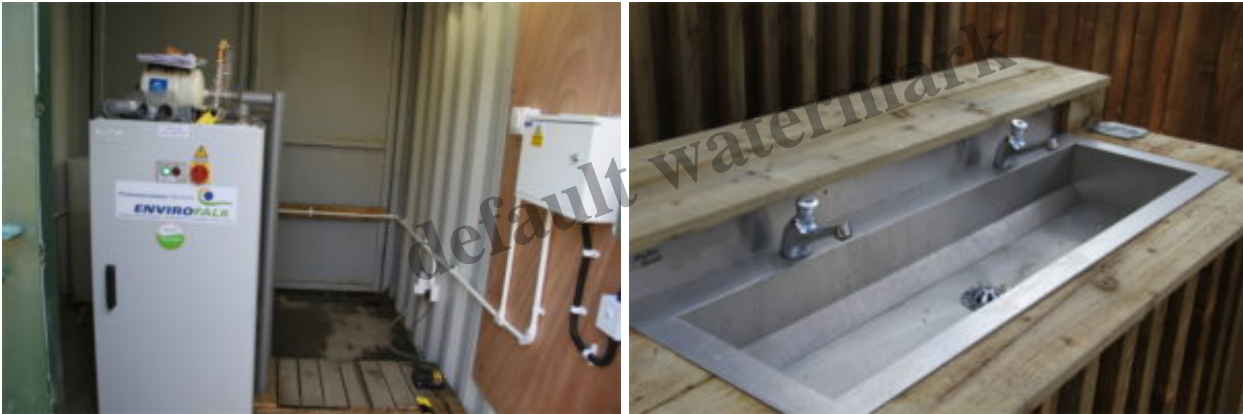
The engineers were working on the system when I arrived and allowed an opportunity to see what's inside the container next to the toilet block. It does look like there is a leak in the container roof.

The confusion over the hot and cold taps had also been sorted and there were now neutered tap tops both supplying cold water.
