Loch Chon campsite â?? the water supply failure and cover-up

The reasons why the water supply at Loch Chon is defective

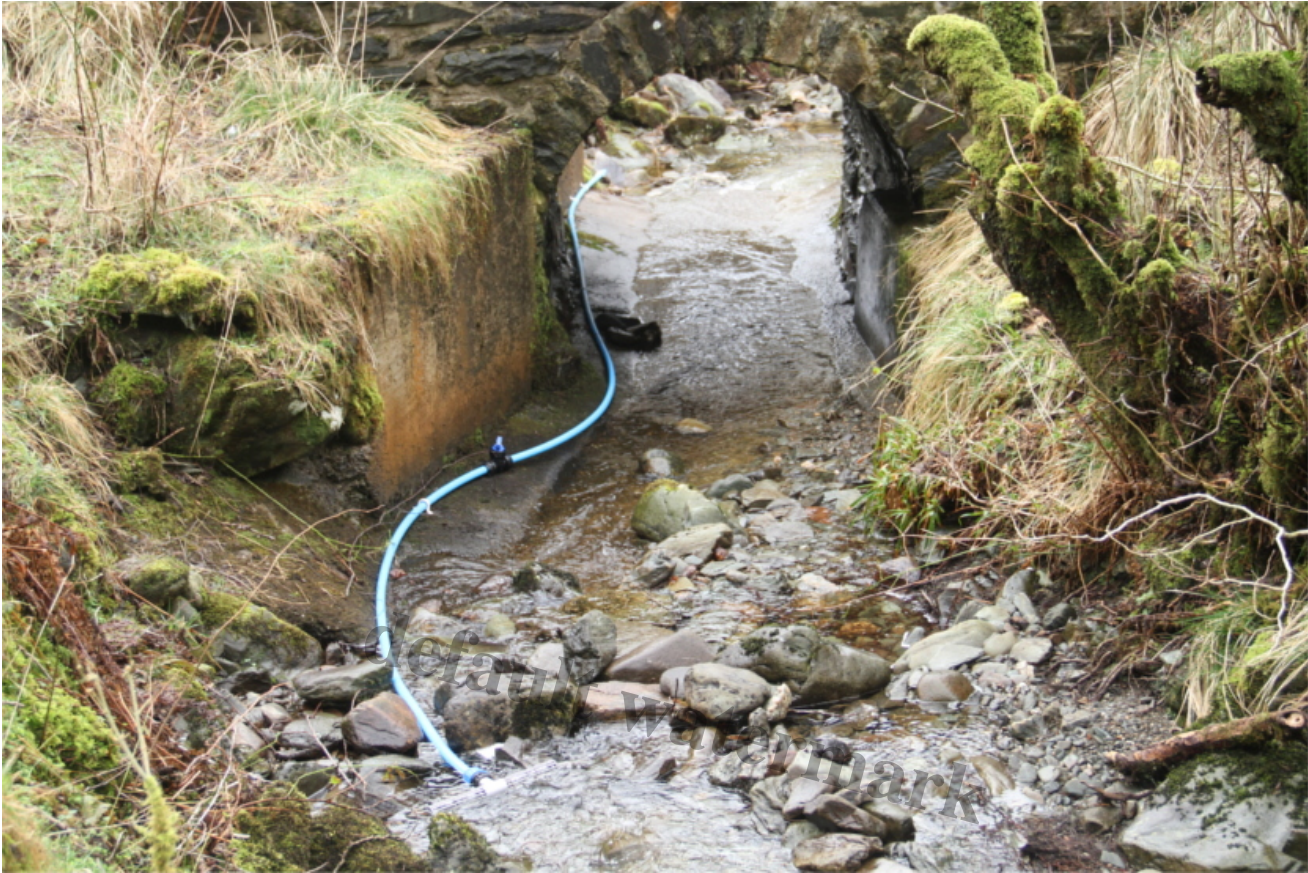
An unsightly installation with loops in blue water pipe makes a poor impression. When taken together with the positioning of the intake manifold, which is partially out of the water, unsecured and likely to be dislodged the first time the stream is in spate, it provides a rather damning but realistic indication of what was initially installed.

Just while weâ??re looking at this image, you can see that the concrete floor of the culvert under the bridge is smooth and curved. This is done intentionally to stop materials collecting on the surface. When the stream is in spate, large boulders are transported in the torrent of water and the smooth culvert base ensures they can roll right through preventing them from causing an obstruction under the bridge. We will see why this is important later in the article.

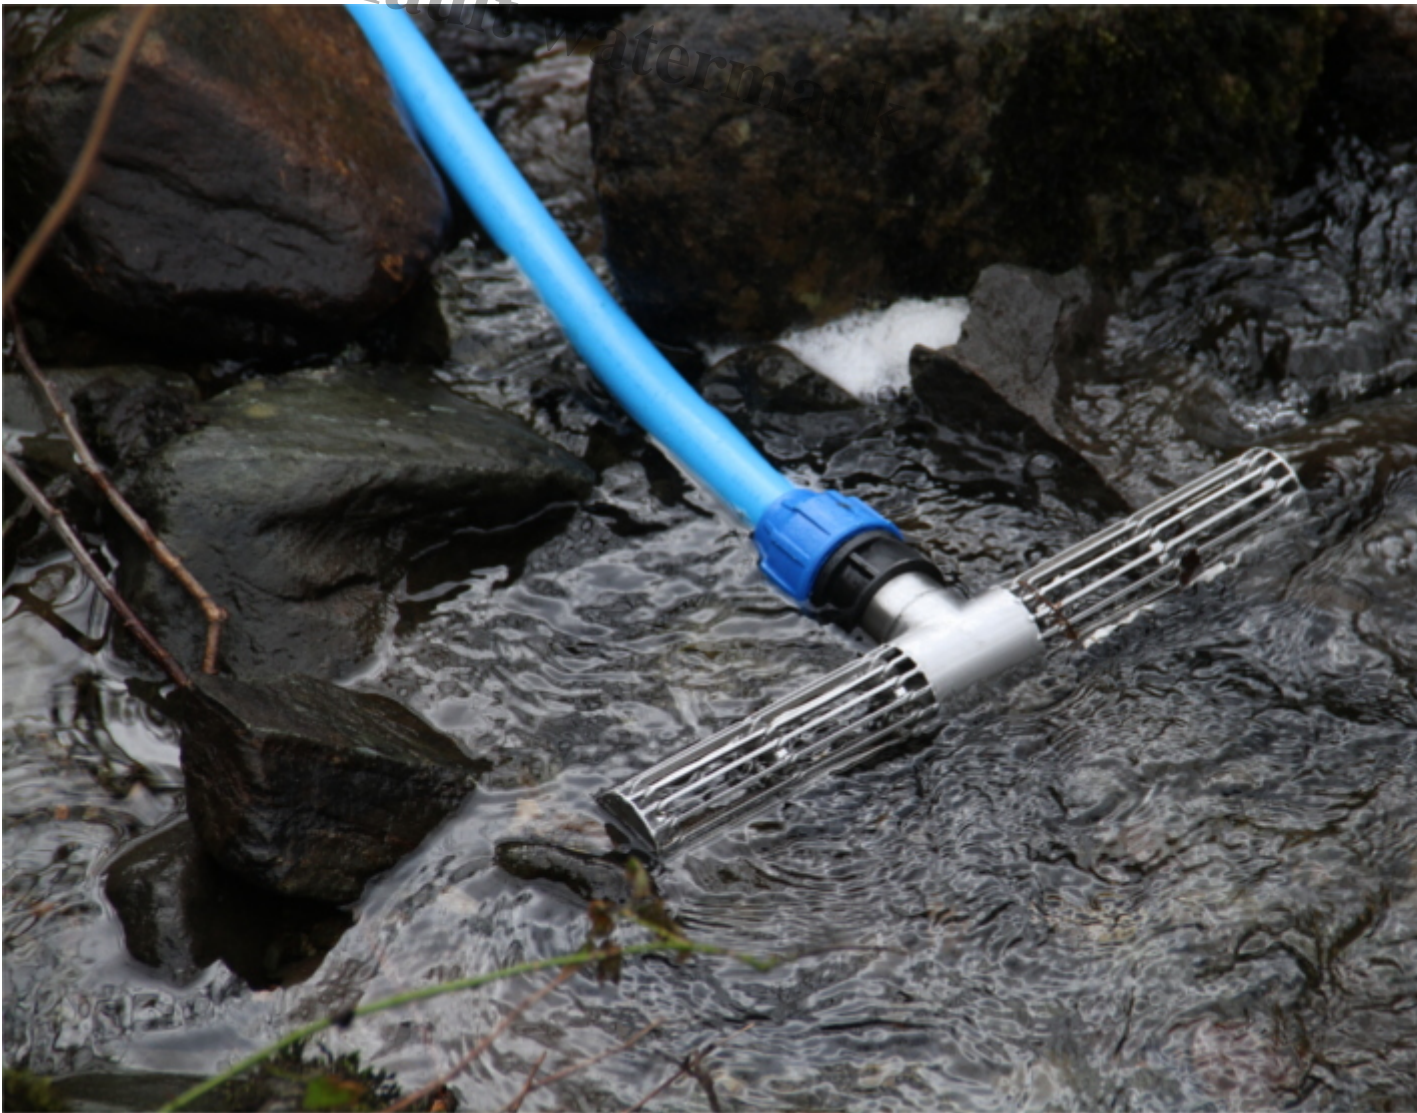
Image 12th March 2017 lying on surface at water level

You would think that making sure the intake manifold is always under water would be a given. Yet here we are at Loch Chon on the 12th March 2017 with the manifold almost completely uncovered drawing air into the system.

The problem is clear that the stream does not have sufficient water flow in dry periods. This was evident during a dry spell starting before March 1st and through 12th March when the water supply failed intermittently when the intake pipe was not fully submerged causing air to be drawn into the system. In this location there is sufficient depth of water the intake is just not positioned properly.

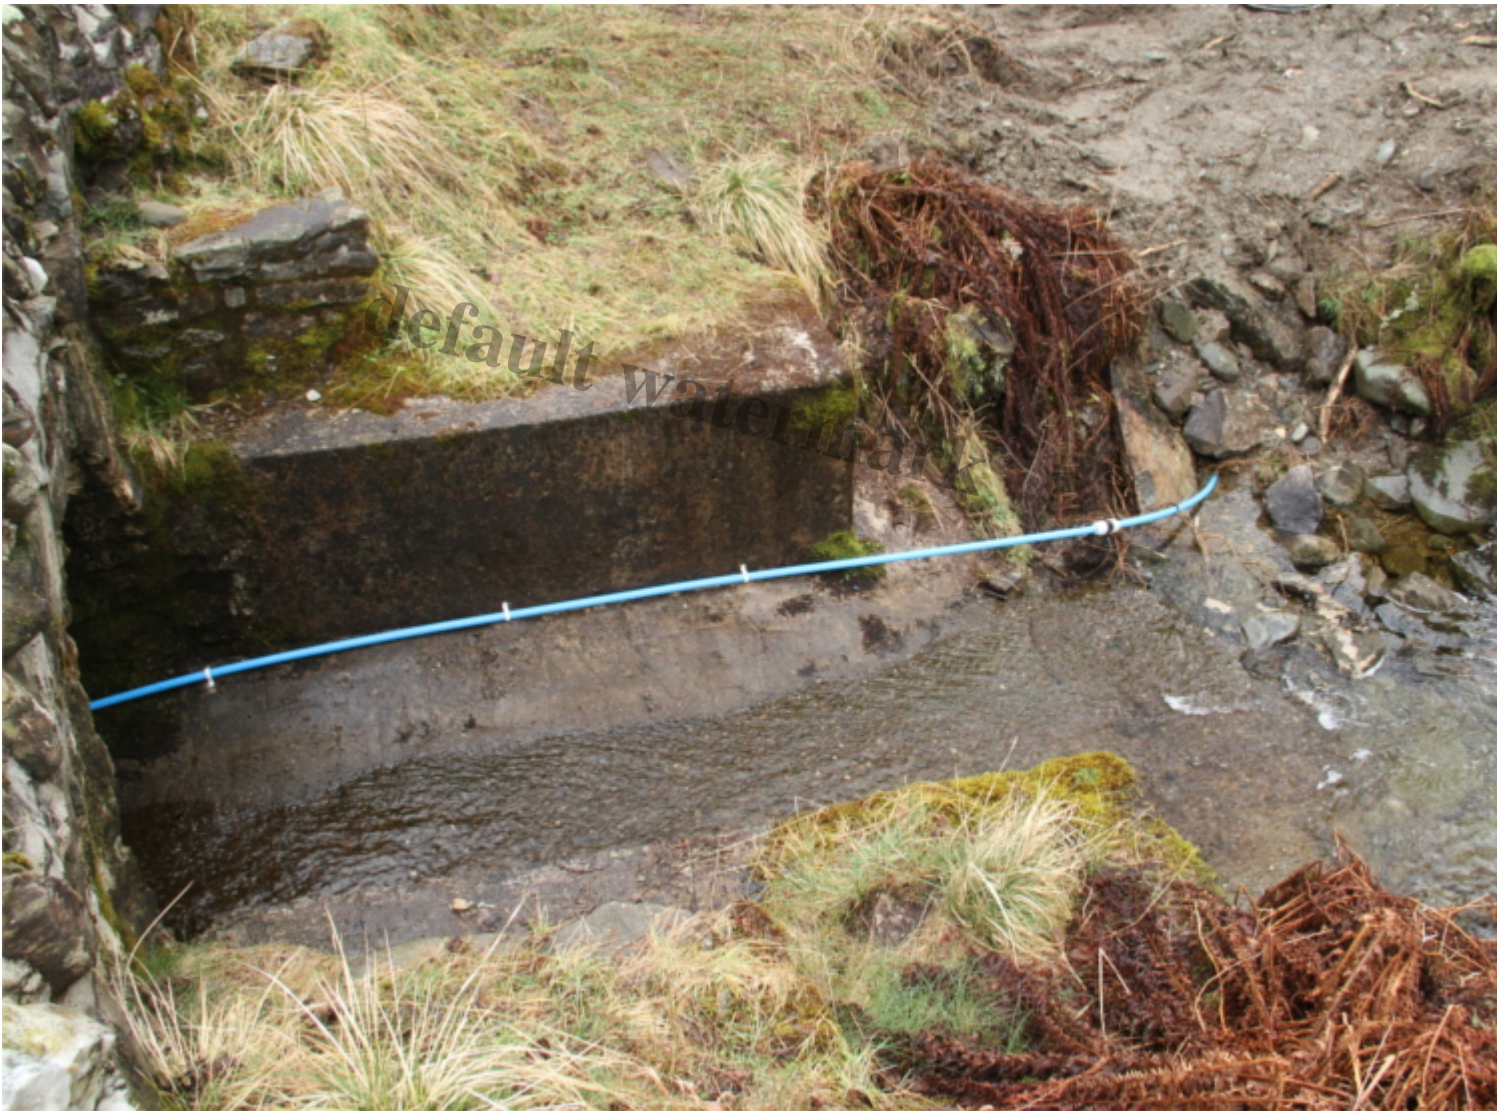
Of course once the air lock is in the system it won't self clear easily as water won't flow up hill. So many basic principles have just been overlooked cumulatively resulting in poor system design. This is a contributory factor together with the failure of staff, the clerk of works and the contractor to understand the basic requirements for implementing such a water supply.

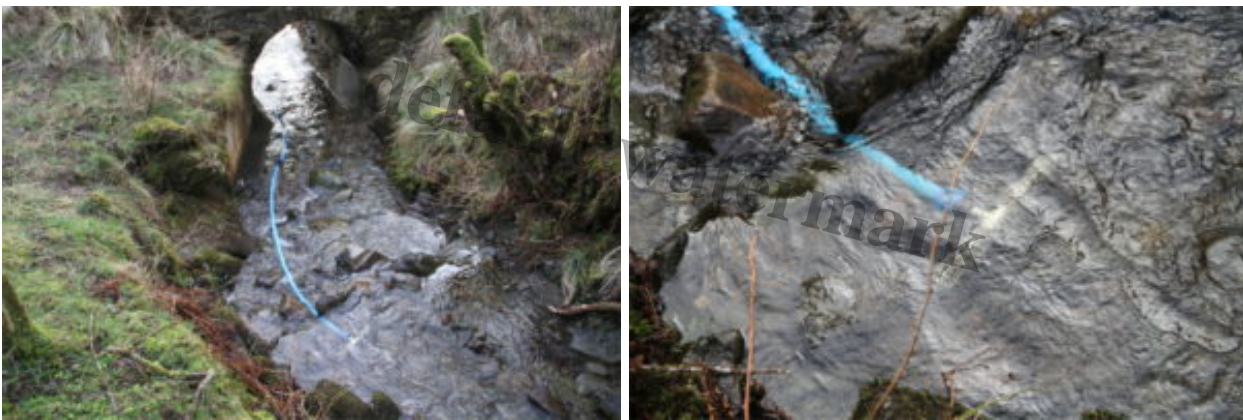
One week later on the 19th March 2017 the intake pipe was submerged once more, after some rainfall, however the water to the toilets and wash hand basins was still off. You can see here the pipe had been removed from the clips removing the ridiculous upward loops in the water feed pipe.

The water supply was still causing issues, drinking water was available but toilet flushing was not.

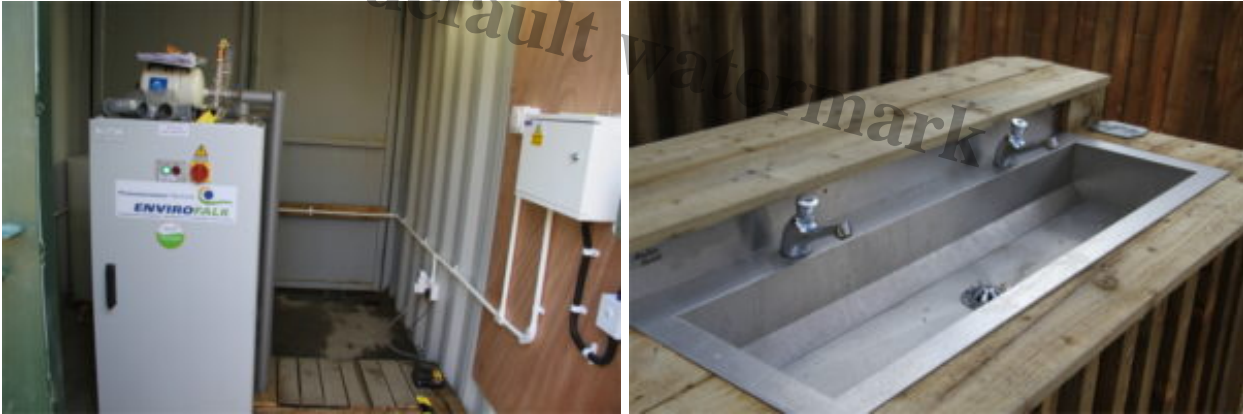
The engineers were working on the system when I arrived and allowed an opportunity to see whats inside the container next to the toilet block. It does look like there is a leak in the container roof.

The confusion over the hot and cold taps had also been sorted and there were now neutered tap tops both supplying cold water.

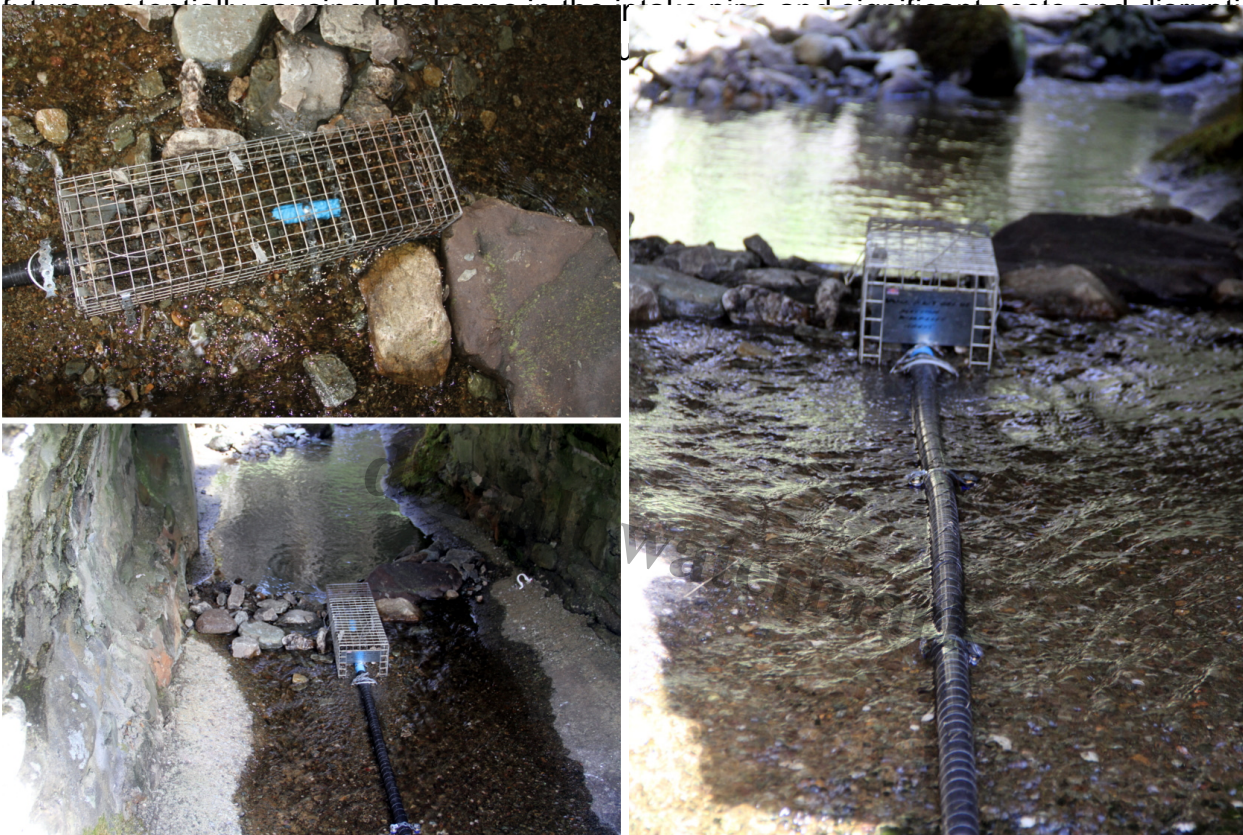
My visit on the 10th of April 2017 showed some changes. The main visible differences one week on were up by the intake manifold. They had cut the pipe back and fitted a black sheath which is far less

intrusive. The had also removed the old stainless steel manifold and fitted a cage to cover the end of the pipe. However the pipe end is open and directly facing into the water flow with nothing to prevent pebbles and smaller items being transported down the stream from finding their way into the system, so anything smaller than the mesh can also enter the intake pipe. I think this may pose a problem for the future, especially considering the high maintenance and difficult access and location to clear it.

The second and most important is the placement of the intake port on to the surface of the culvert, these images are very telling considering the recent weather has been wet followed by a short dry spell, the level here has dropped 20 cm since last checked.3 weeks ago.

This indicates the Peak flow of the stream may be very small in dry weather.

The problem is clear, the peak flow of the stream on dry days is so small that the water level in the culvert is no more than a centimetre or so and doesn't even cover the intake pipe. To solve this a [small dam](#), and I mean small, has been created with stones and gravel where the depth of water behind this is sufficient to cover the intake pipe.

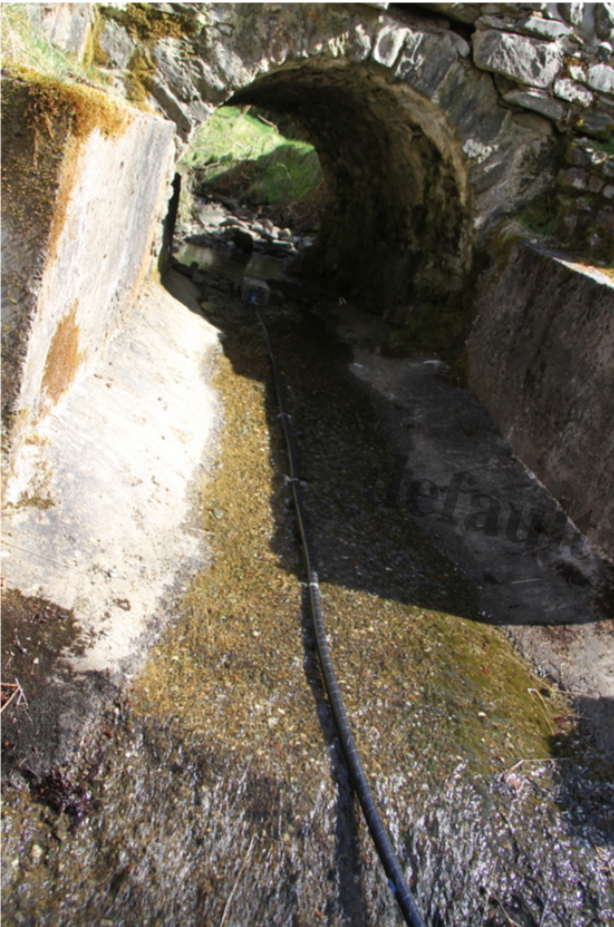
As we discussed already, the smooth curved floor of the culvert is designed to prevent debris collecting in this location. The Debris (dam) (photo above) will be removed by fast water flow.

Even with the current level of water flow the smaller stones and gravel around the intake pipe will be washed away eventually breaking the dam causing the water level to drop below the intake pipe and the water supply to fail.

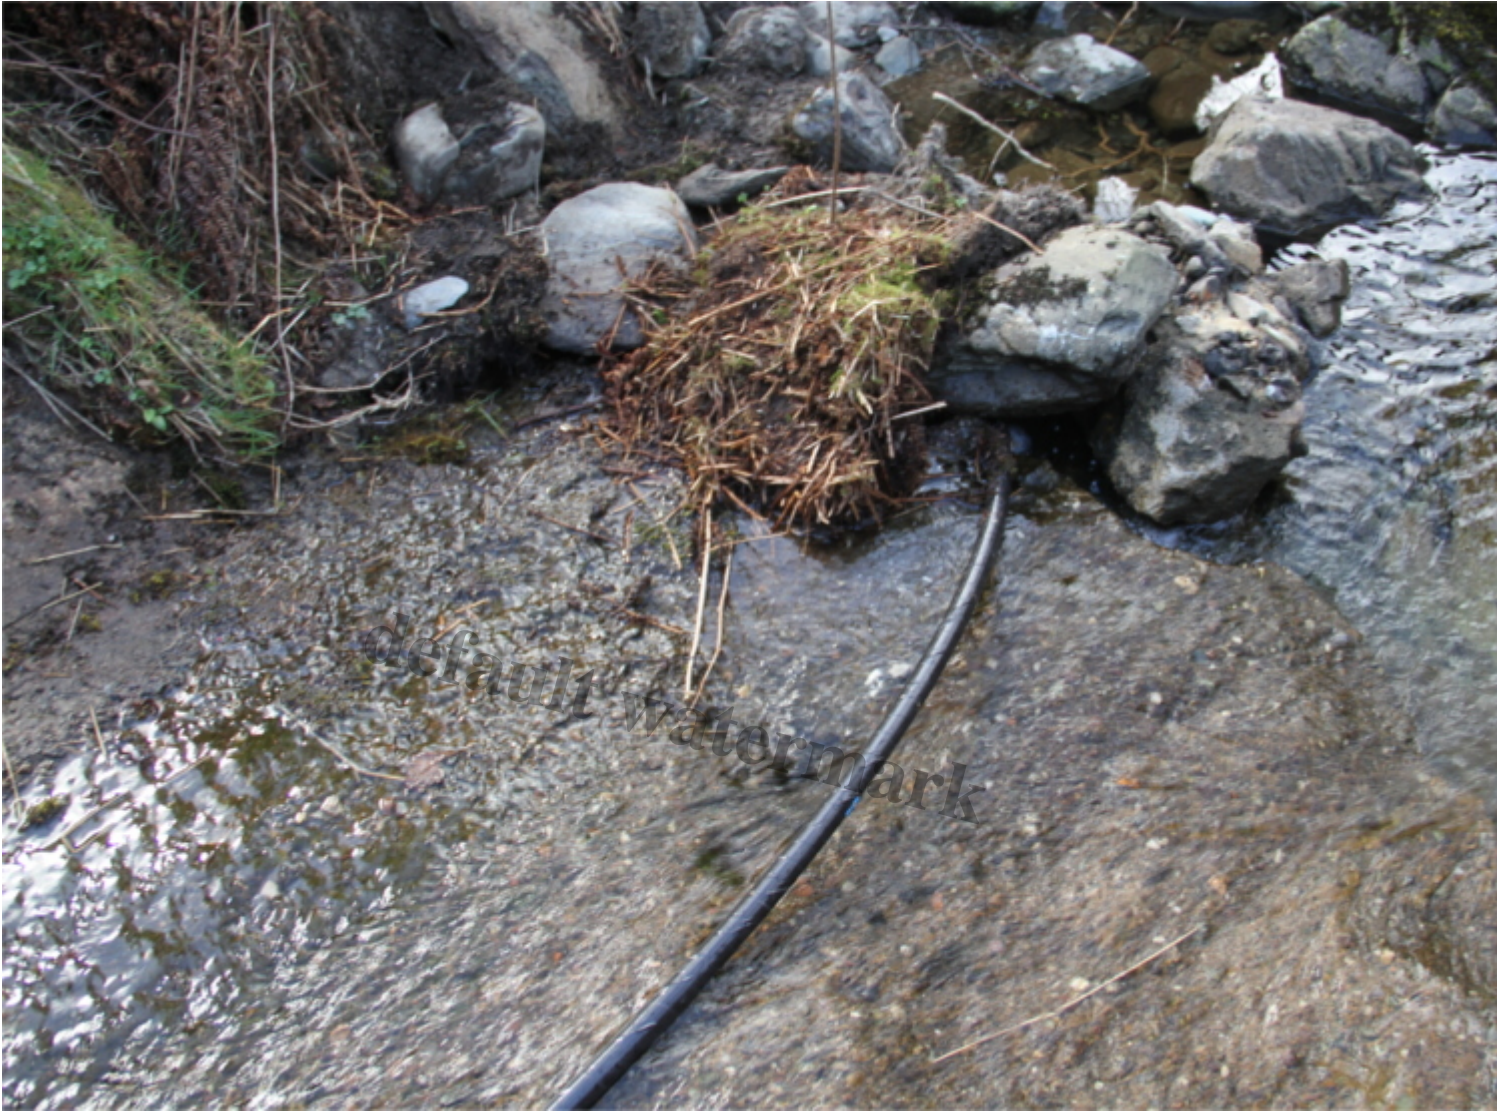
With any heavy rain storm the stream will be in spate, the force of water will clear all of the rocks forming the dam in the culvert. When in spate the stream can also carry branches and fallen trees down through the culvert but now with the fixed obstruction of the mesh cage there is a possibility that these will damage the cage or more likely get jammed on it causing a build up of debris in the culvert. This is not good practice and I would think it should be avoided.

The arrangement of the pipe has changed, now entering the river bank at a much lower level, the pipe is not secured on its traverse across the culvert and the gap underneath will most likely collect sticks and other vegetation then a build up of debris will possibly occur.
