Loch Chon campsite – the water supply failure and cover-up

The reasons why the water supply at Loch Chon is defective

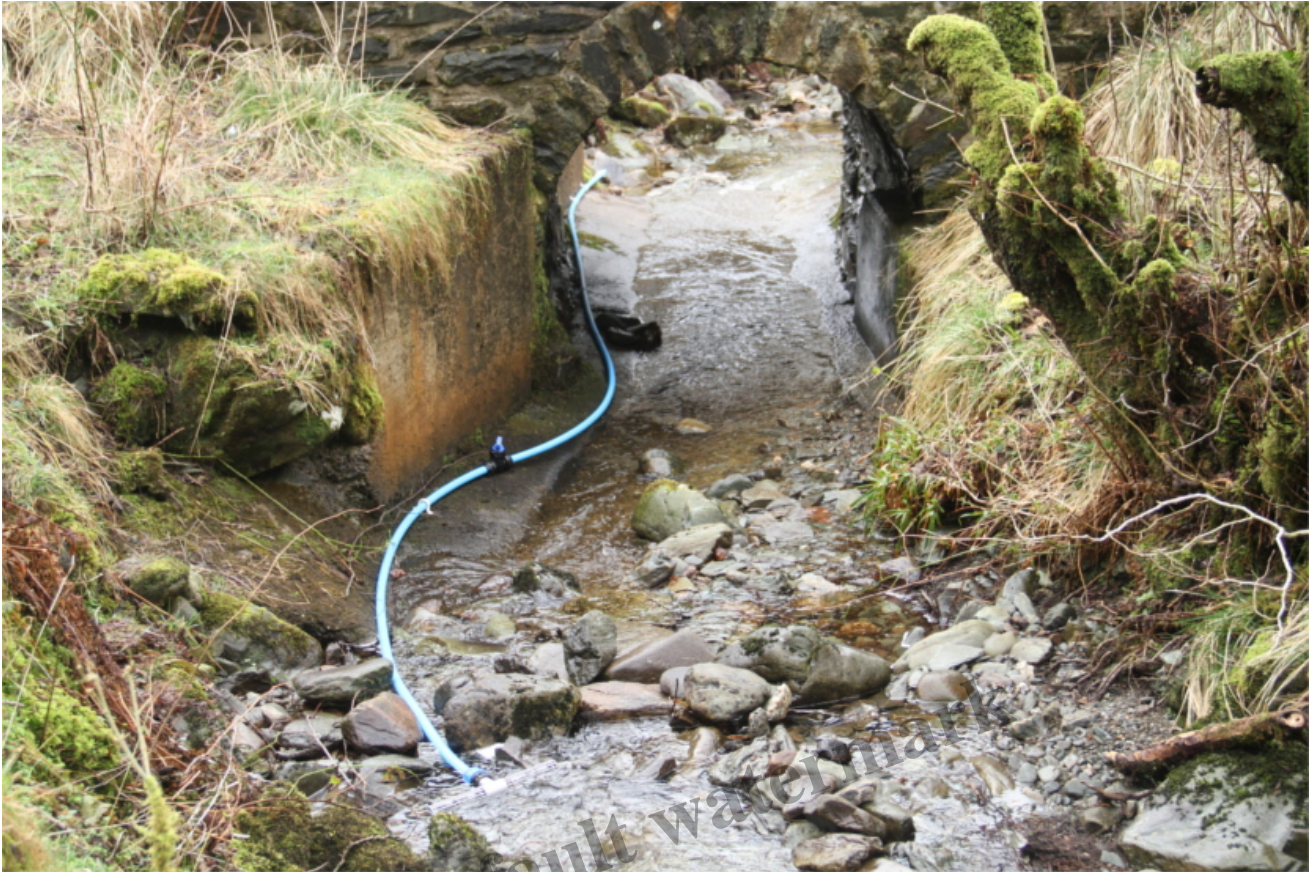
An unsightly installation with loops in blue water pipe makes a poor impression. When taken together with the positioning of the intake manifold, which is partially out of the water, unsecured and likely to be dislodged the first time the stream is in spate, it provides a rather damning but realistic indication of what was initially installed.

Just while we're looking at this image, you can see that the concrete floor of the culvert under the bridge is smooth and curved. This is done intentionally to stop materials collecting on the surface. When the stream is in spate, large boulders are transported in the torrent of water and the smooth culvert base ensures they can roll right through preventing them from causing an obstruction under the bridge. We will see why this is important later in the article.

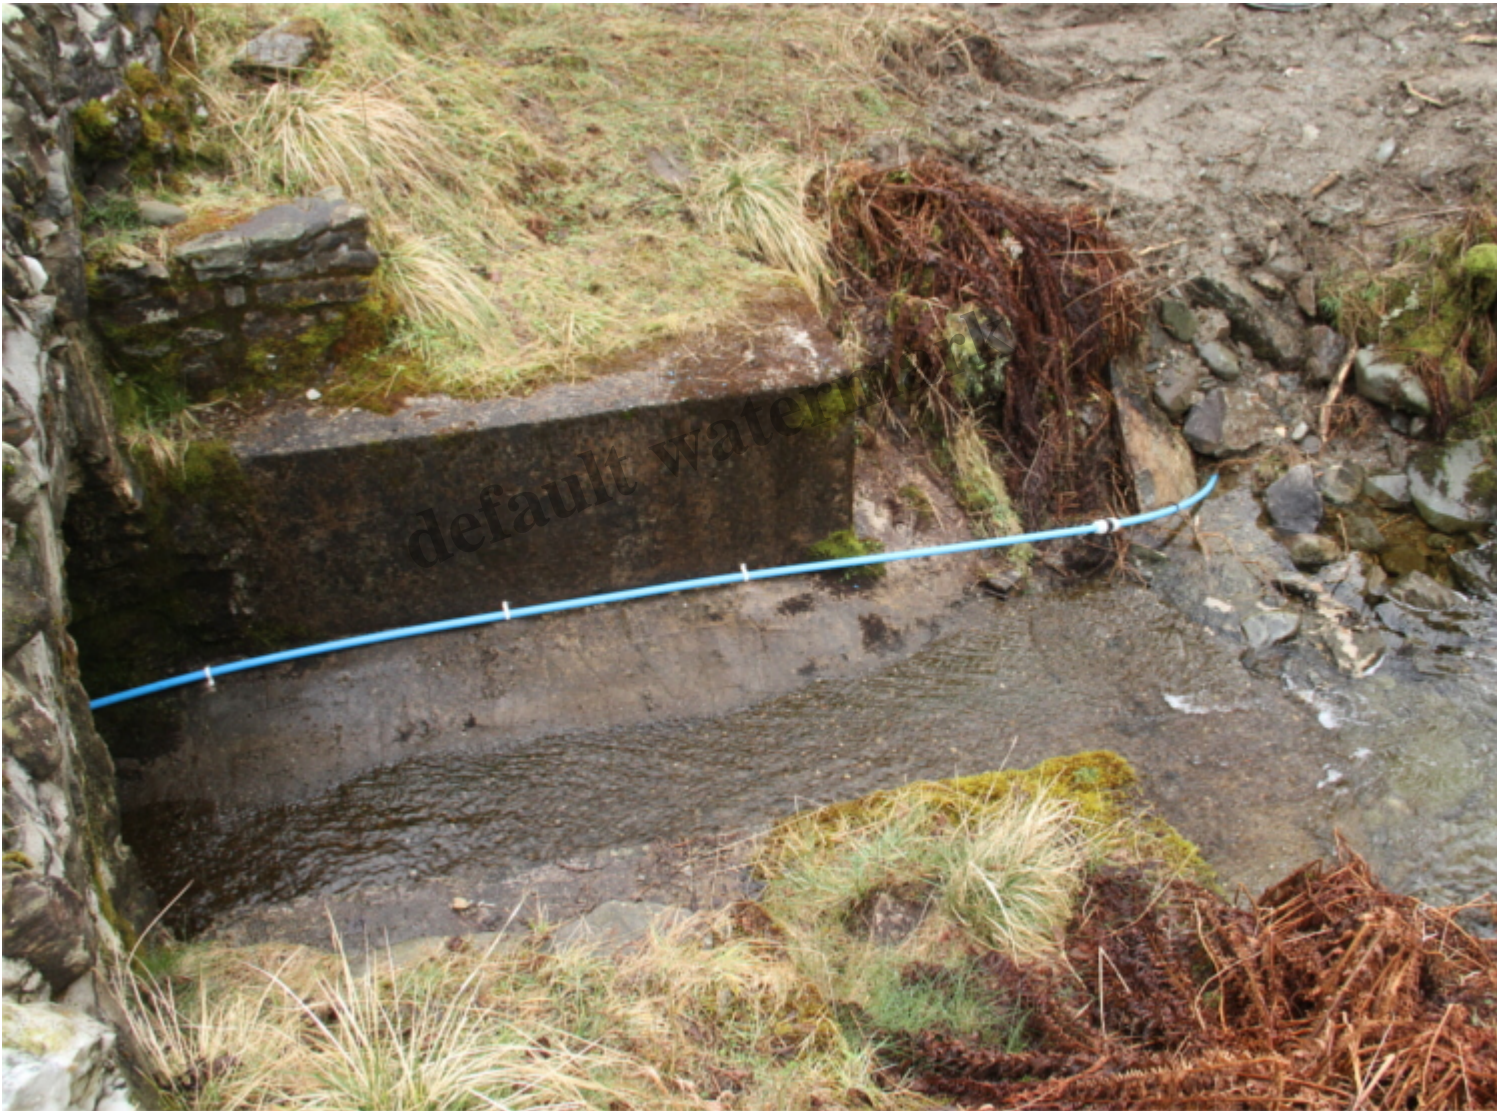
Of course once the air lock is in the system it won't self clear easily as water won't flow up hill. So many basic principles have just been overlooked cumulatively resulting in poor system design. This is a contributory factor together with the failure of staff, the clerk of works and the contractor to understand the basic requirements for implementing such a water supply.

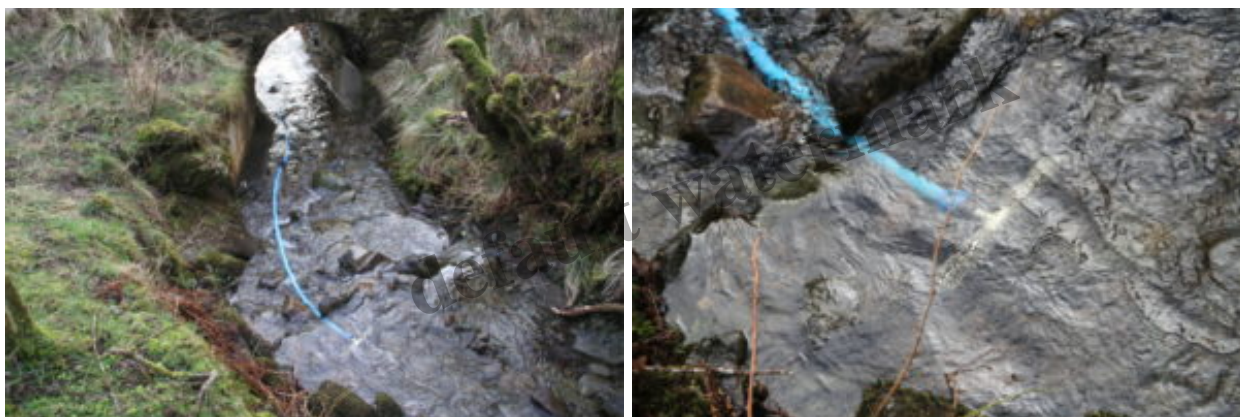
One week later on the 19th March 2017 the intake pipe was submerged once more, after some rainfall, however the water to the toilets and wash hand basins was still off. You can see here the pipe had been removed from the clips removing the ridiculous upward loops in the water feed pipe.

The water supply was still causing issues, drinking water was available but toilet flushing was not.

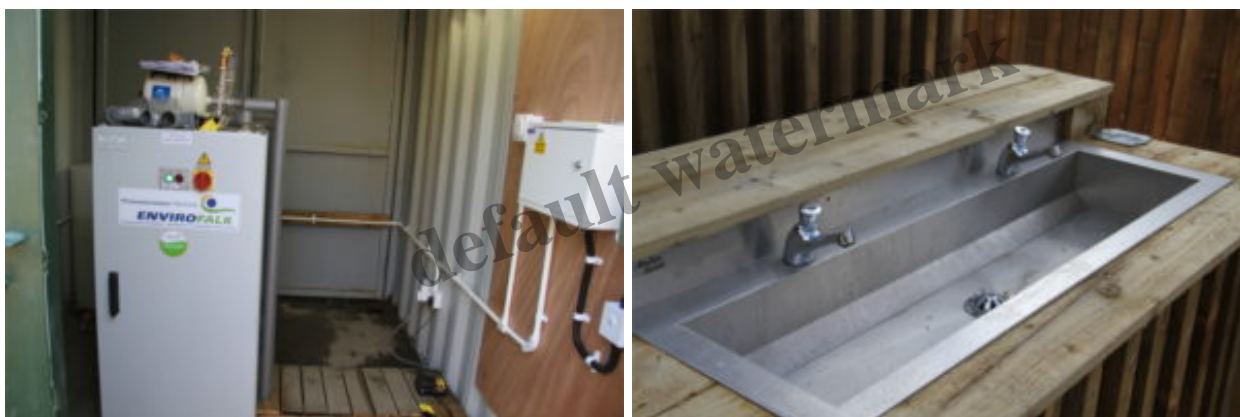
The engineers were working on the system when I arrived and allowed an opportunity to see what's inside the container next to the toilet block. It does look like there is a leak in the container roof.

The confusion over the hot and cold taps had also been sorted and there were now neutered tap tops both supplying cold water.

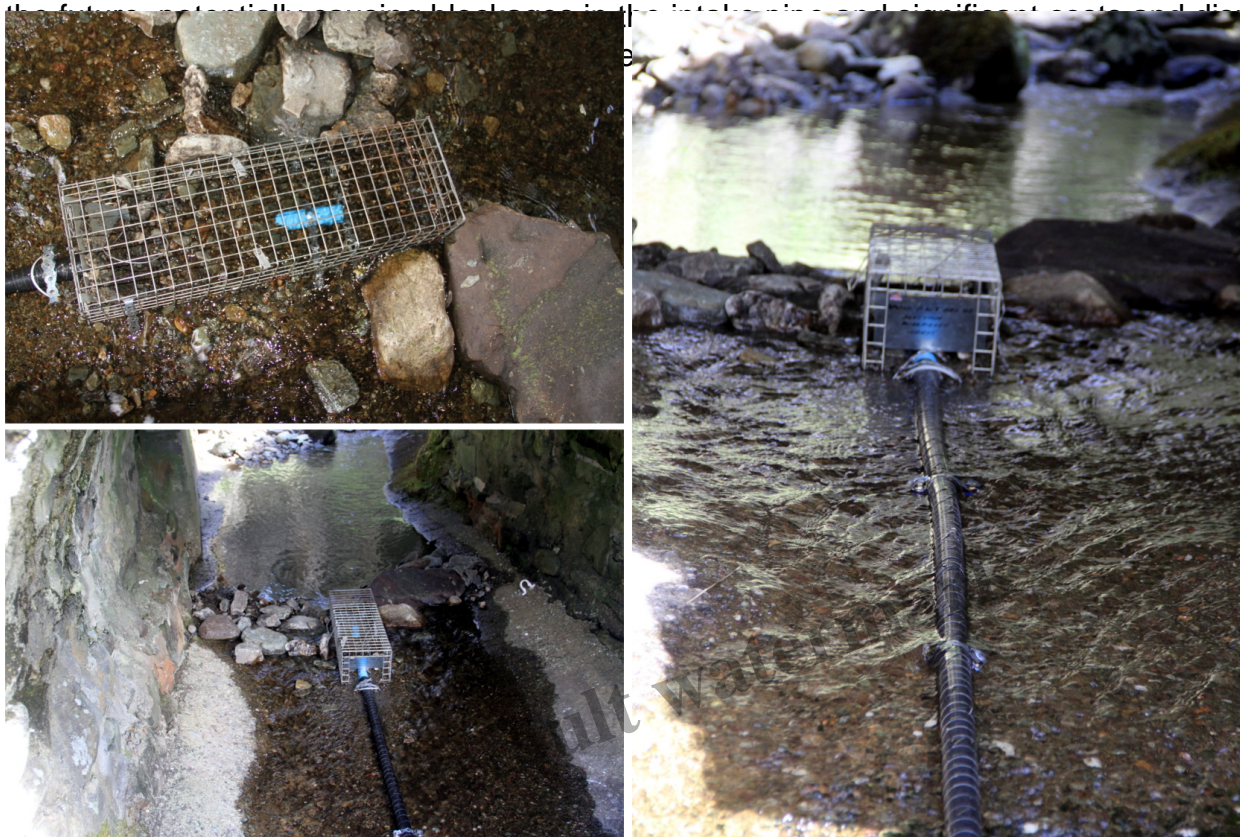
My visit on the 10th of April 2017 showed some changes. The main visible differences one week on were up by the intake manifold. They had cut the pipe back and fitted a black sheath which is far less

intrusive. The had also removed the old stainless steel manifold and fitted a cage to cover the end of the pipe. However the pipe end is open and directly facing into the water flow with nothing to prevent pebbles and smaller items being transported down the stream from finding their way into the system, so anything smaller than the mesh can also enter the intake pipe. I think this may pose a problem for the future maintenance required to keep the intake pipe and sufficient system disruption to clear

The second and most important is the placement of the intake port on to the surface of the culvert, these images are very telling considering the recent weather has been wet followed by a short dry spell, the level here has dropped 20 cm since last checked.3 weeks ago.

This indicates the Peak flow of the stream may be very small in dry weather.

The problem is clear, the peak flow of the stream on dry days is so small that the water level in the culvert is no more than a centimetre or so and doesn't even cover the intake pipe. To solve this a [small dam](#), and I mean small, has been created with stones and gravel where the depth of water behind this is sufficient to cover the intake pipe.

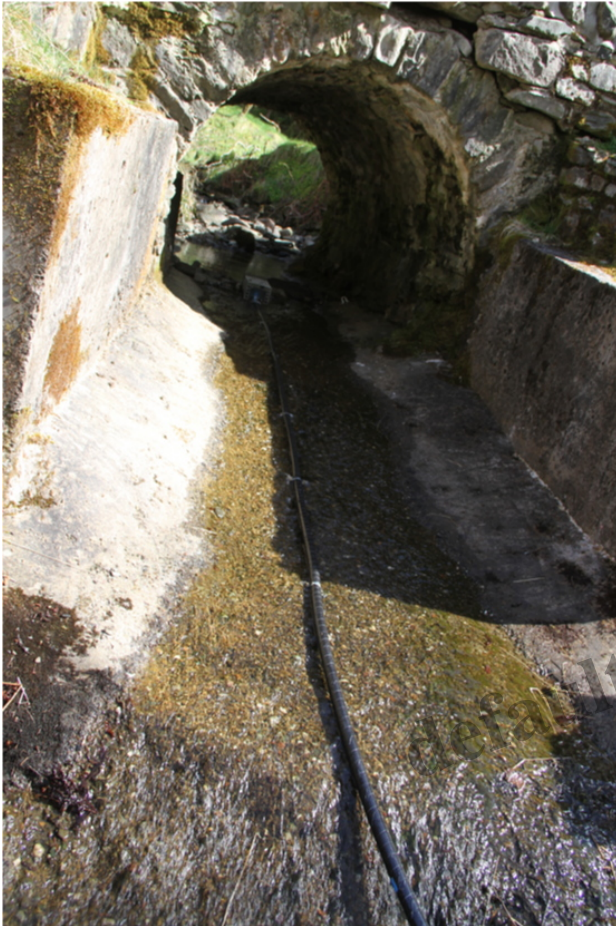
As we discussed already, the smooth curved floor of the culvert is designed to prevent debris collecting in this location. The Debris (dam) (photo above) will be removed by fast water flow.

Even with the current level of water flow the smaller stones and gravel around the intake pipe will be washed away eventually breaking the dam causing the water level to drop below the intake pipe and the water supply to fail.
