## LLTNPA inflict unwarranted damage to the environment at Loch Chon

#### By Ross MacBeath

### Two new vehicle tracks have been created that are not on the plans

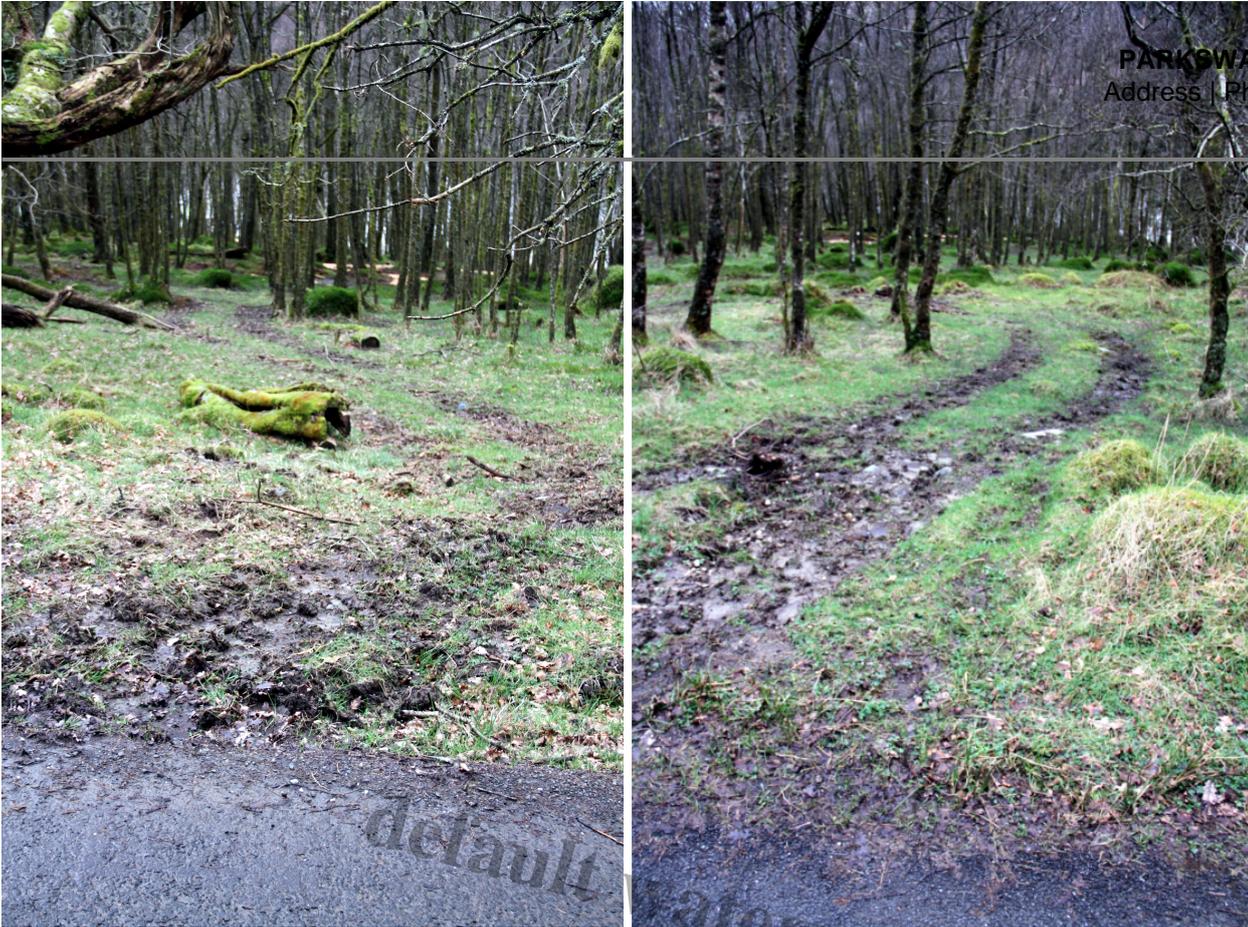
The creation of these tracks by the unwarranted use of vehicles has disrupted a long swathe of the ecosystem stretching down the the entire hillside forming some deep channels encouraging water to flow down the hill and creating new water courses in the process. What should happen is that the Planning Authority should intervene and instruct the applicant to restore these areas to their original state. However, the National Park Authority, as the body which applied for planning permission, have not set aside vegetation for restoration works as was stipulated as a planning requirement. So it will be interesting to see how the Gordon Watson the Chief Executive of the Planning Authority will enforce the restoration on Gordon Watson the Chief Executive of the Park Authority. How can there be anything other than a conflict of interest in this unhealthy arrangement.

The image on the left shows Vehicle track 1 which runs down the entire slope to the lower transverse path by the shore.

The image and track on the right side continues down to the path between pitch 19 and 20, a tree has been lopped off to clear the way for vehicles to pass.

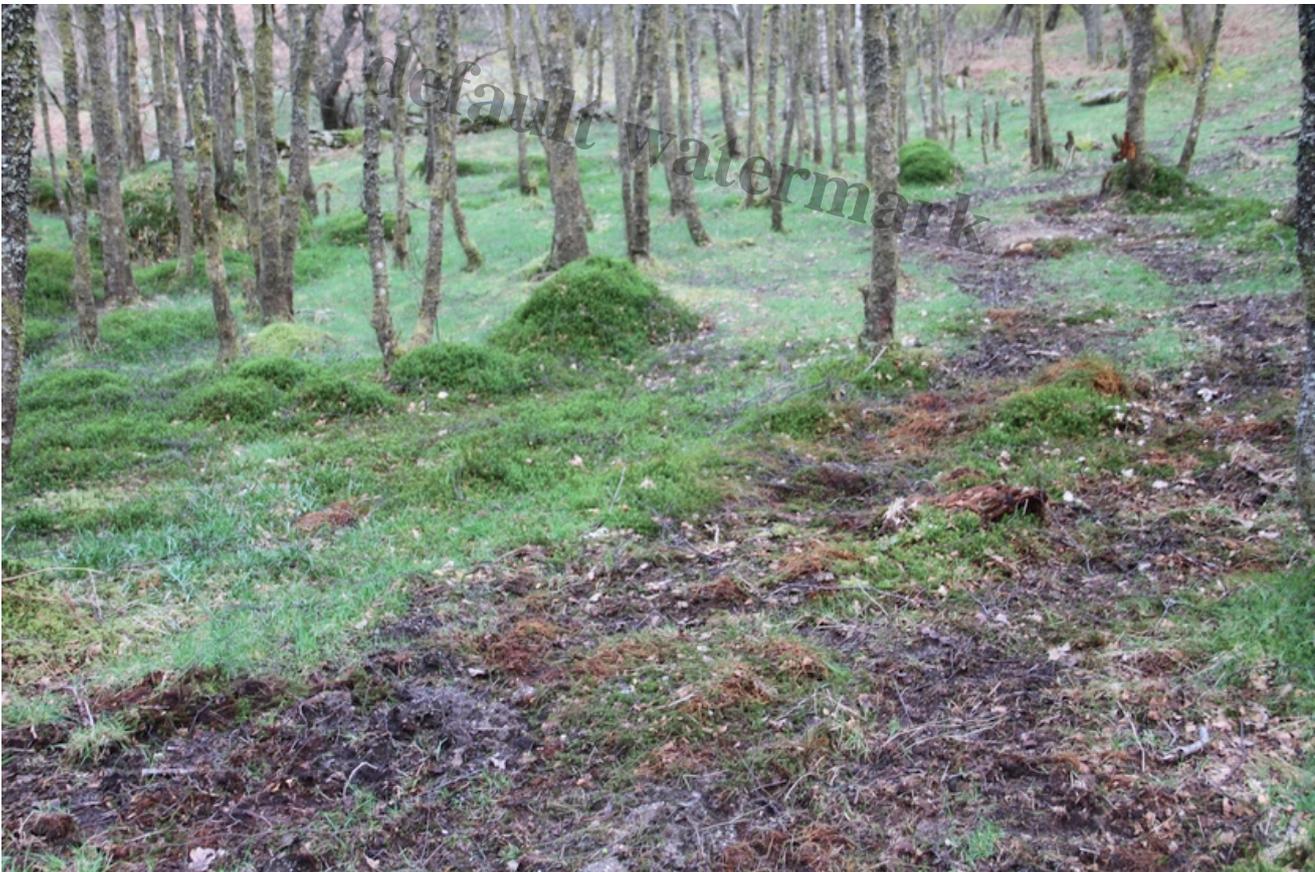
The disruption to the vegetation and underlying peat structure at root level is evident.

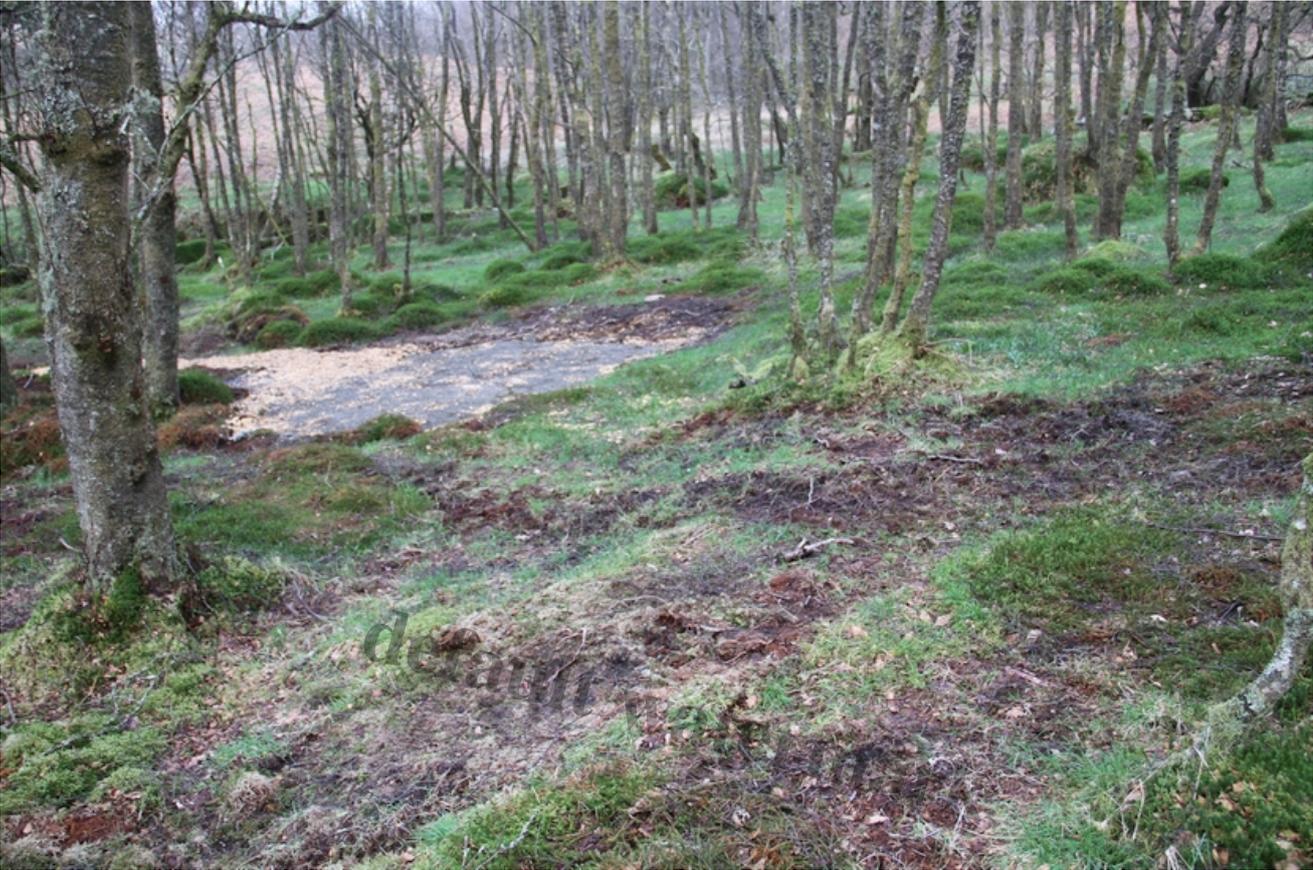
**Vehicle track 1 branches off to the top of pitch 19**

At each branch, or turn of the vehicle, a more intensive area of damage is found. The major problem this creates is not limited to the scars that will take years to heal but the creation of vertical groves that will allow water to enter and move more rapidly down the hill in new channels with a danger of forming new water courses. This poses real risk to the soils and may wash them down the hillside forming a new stream..

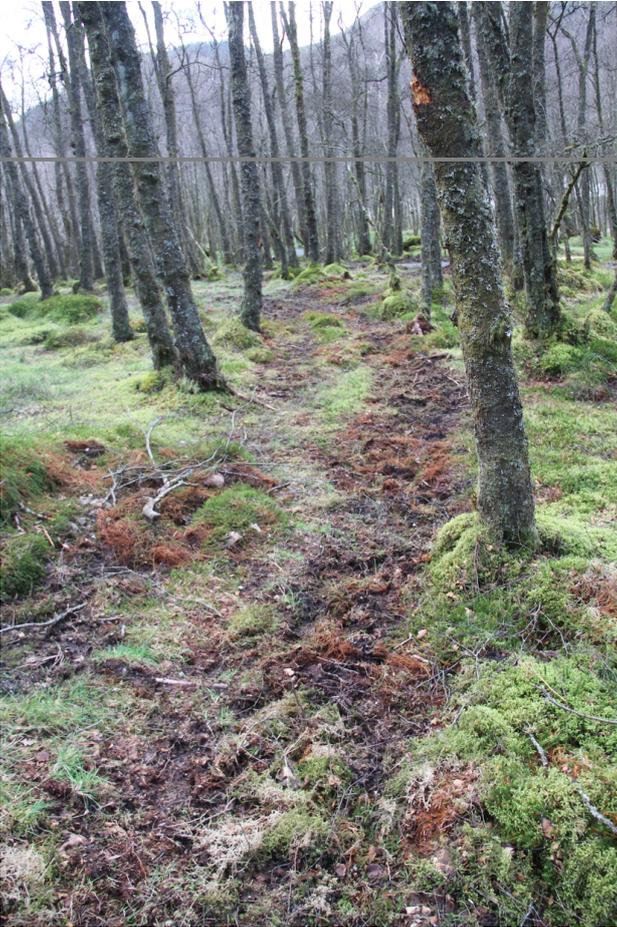
**Looking down Hill track 1 to the transverse â??high pathâ?•**

construction of pitches 19 and 20, as well as the paths used to access them, and other areas at this end of the campsite. In fact track 1 continues further down the slope to the path running along the shore. It appears the vehicle tracks are being used to deliver materials for modifications to pitch surfaces, which were unsuitable for camping, and in the process inevitably causing more damage.

There appears to have been no attempt either to protect the vegetation and little if any attempt to restore the damage.

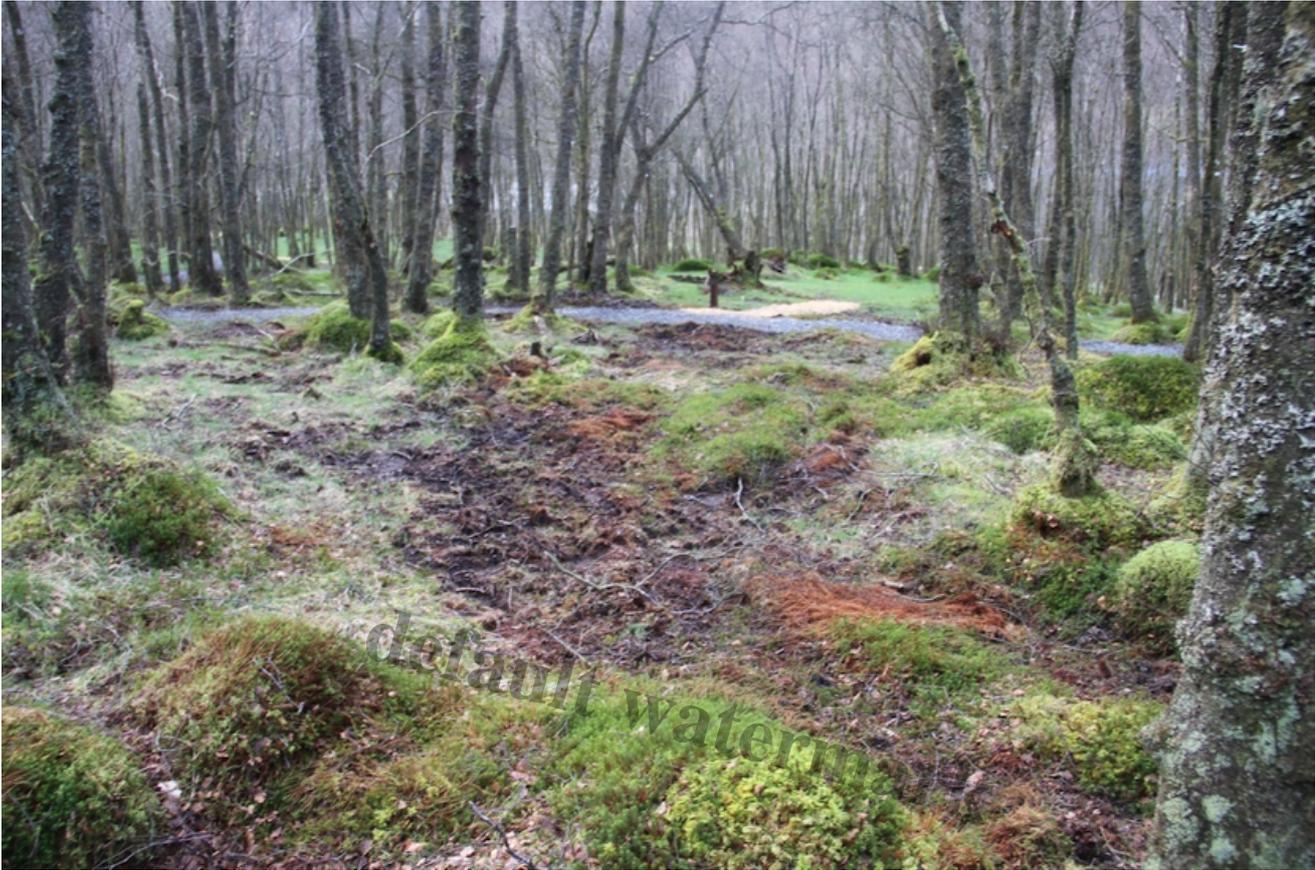
### **Looking down the track from above pitch 19**

The environmental damage is easily traced by the disturbed peat and the rust coloured remains of damaged mosses deprived of their water supply due to mechanical disturbance. and the churned up peat now waterlogged in many places. This is causing water to flow on the surface to collect in many locations where it did not do so before.

The track at this point diverges. The branch straight ahead crosses the new transverse path and continues downhill. The other branch, veering off to the left of the image above, is to the corner of the path where the vegetation and ecosystem around the corner has been churned up. This has formed a collection basin for water which flows both under, across and down the sides of the path. making the path unstable (spongy) and diverting water from the natural water course down the sides of the path.

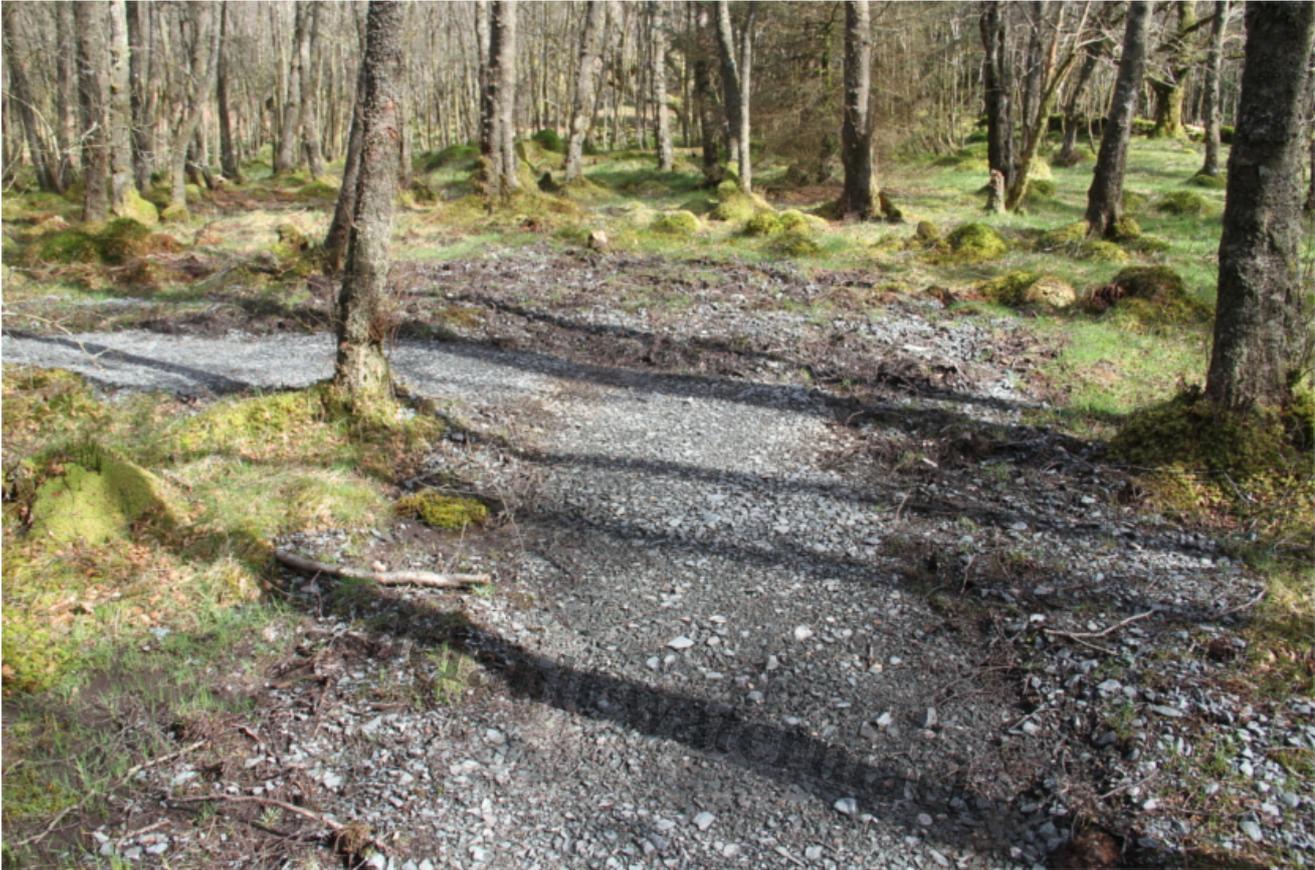
There is also evidence here of another tree being sacrificed to allow the vehicle to pass as well as cross contamination of materials on the path sides, which extends far beyond the specified width of the path.

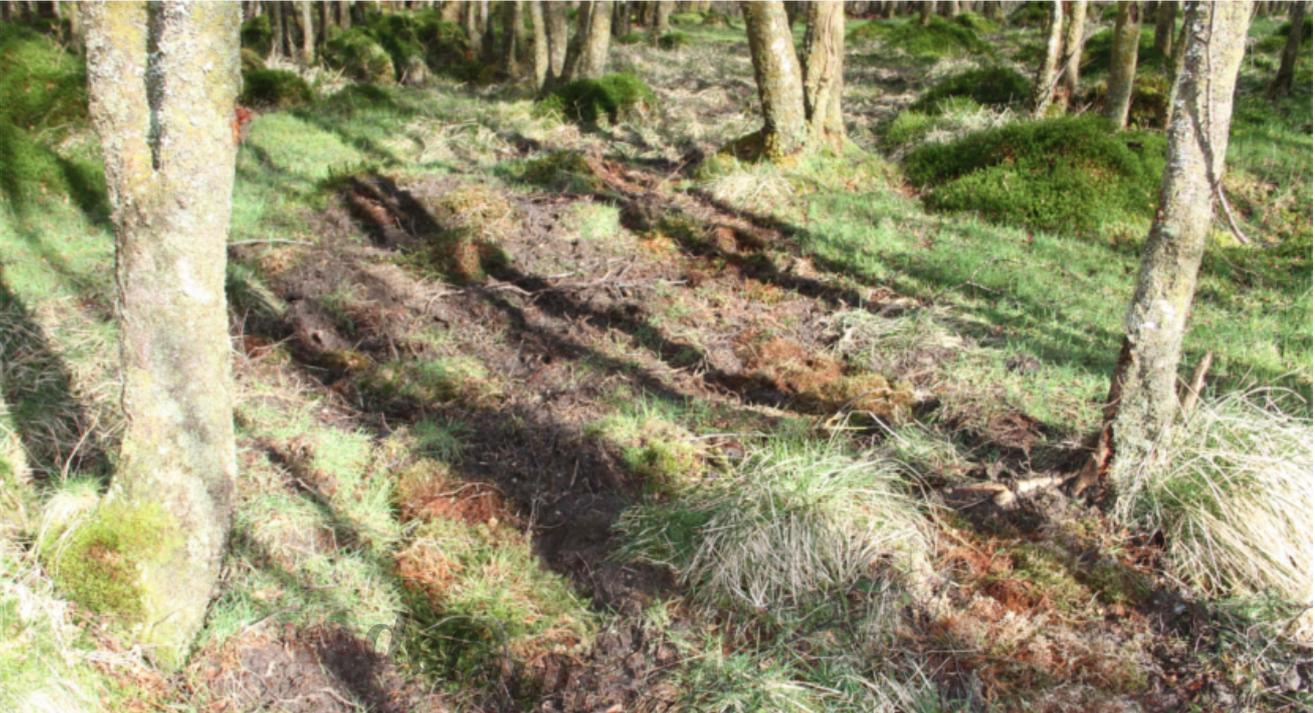
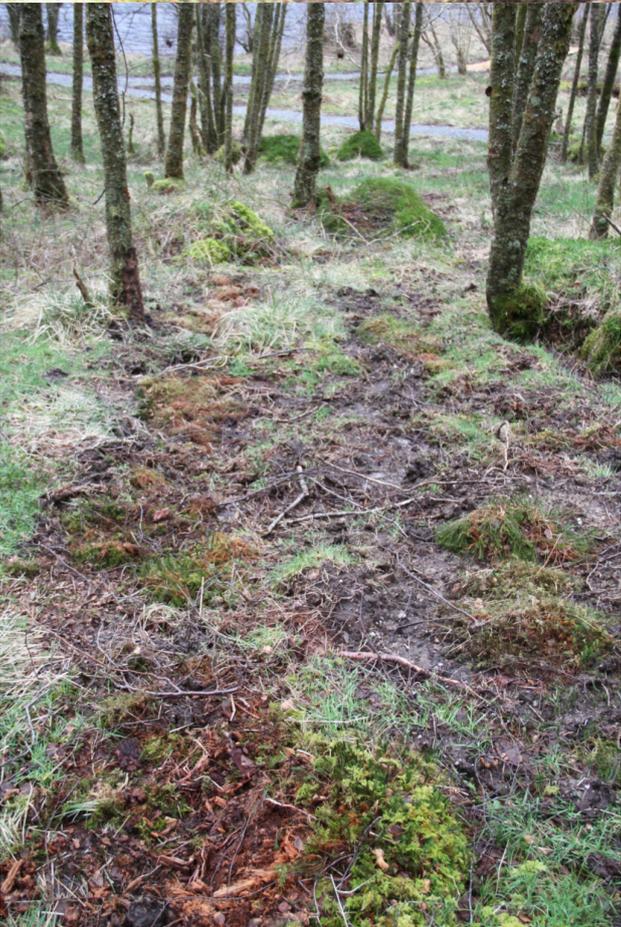
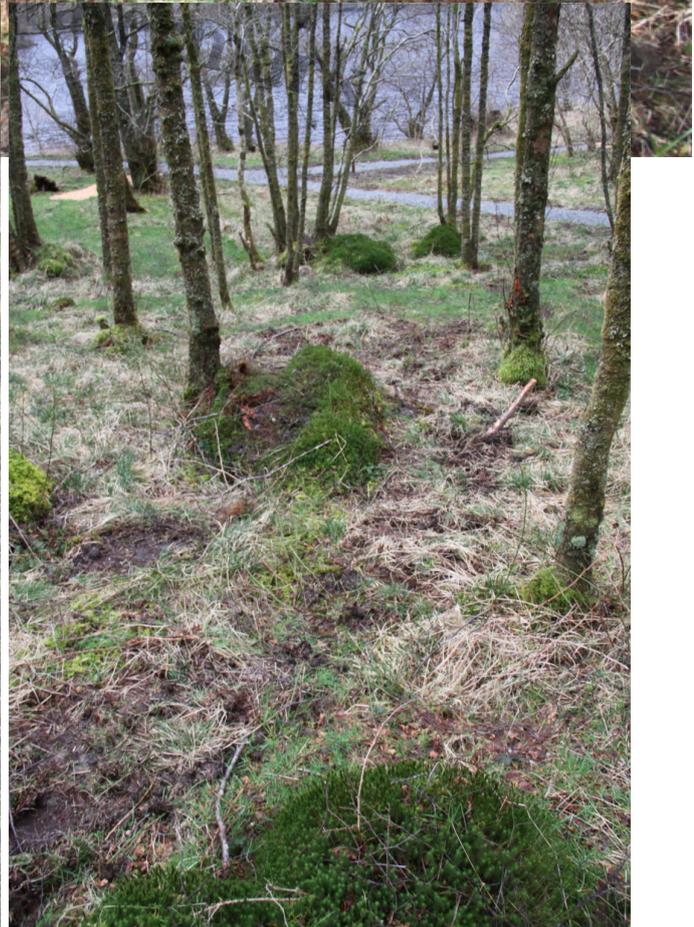
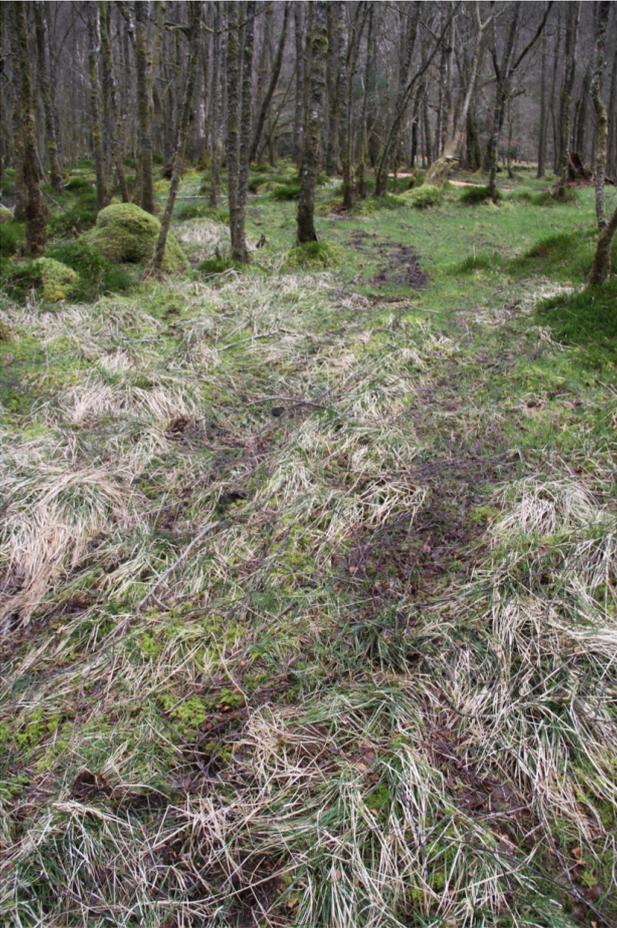
**The vehicle track crosses over the path and continues on downhill**

This environmental damage should have been avoided in the first place and it is obvious that the National Parks has failed in its duty of care. I wonder what the National Park, as Planning Authority, will do to enforce the reinstatement of the environmental damage created by the National Park itself?

When you build a transverse path across the hillside, this disrupts the natural flow of water downhill, with the potential to disrupt the whole ecosystem further down the slope. Evidence of this redirection will be covered in a future Post on paths.

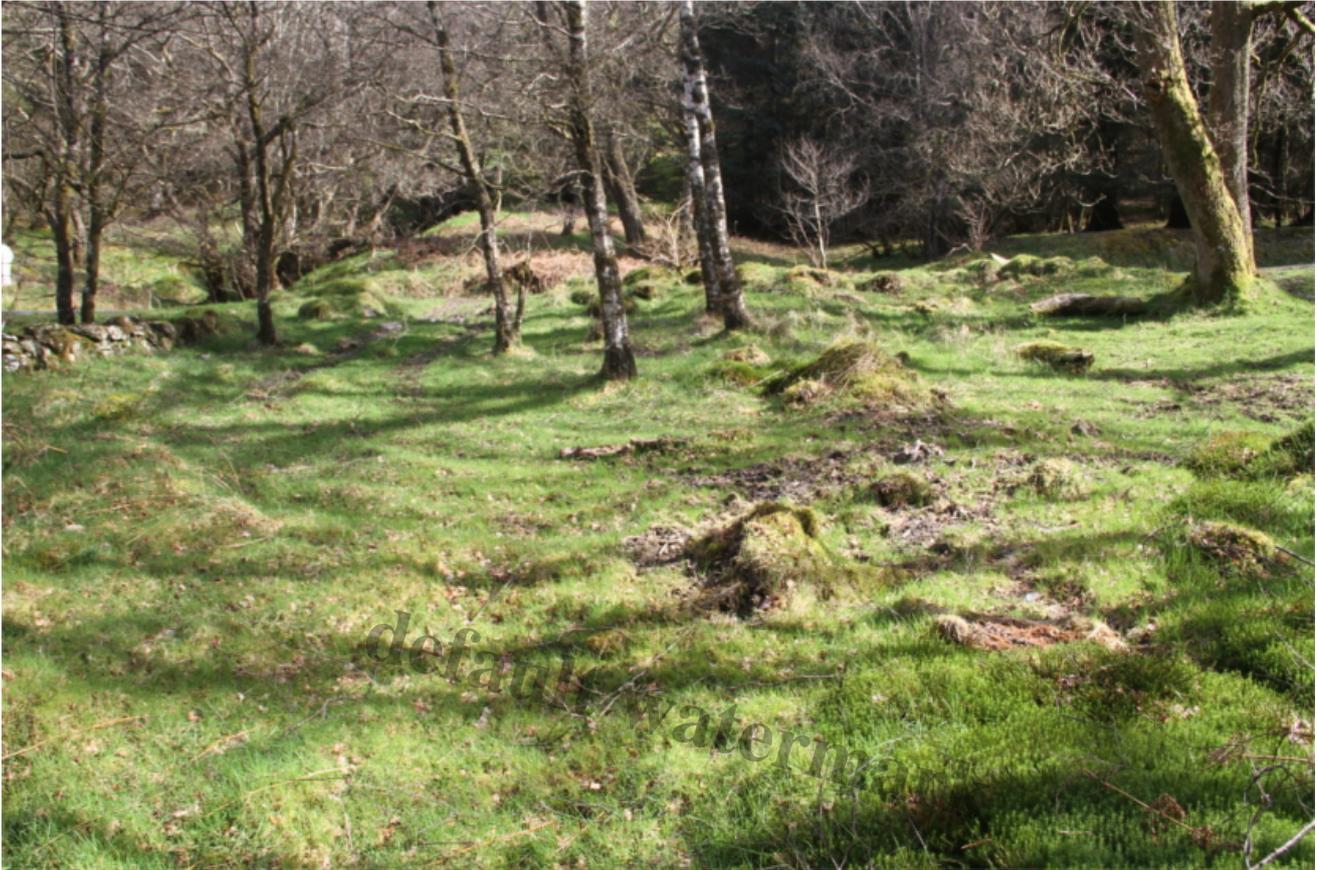
Vehicle Track 2 again starts from the B829 above the site and travels down hill to the junction below the road. Track 2 then cuts off to the North side. The impact appears slight at first (top photo).

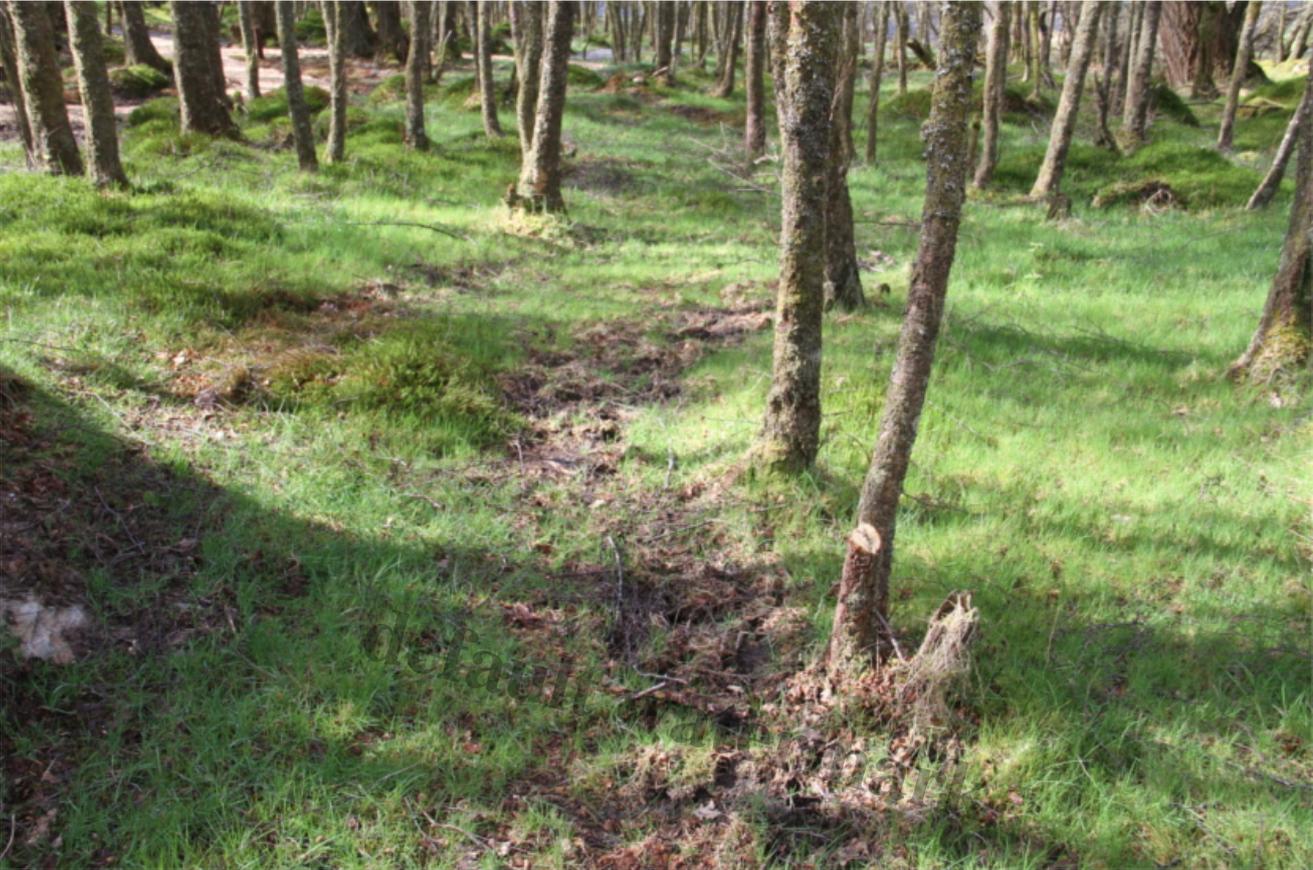
As the ground gets wetter the impact increases.

The tree in the foreground has been lopped of to allow the vehicle to pass. contravening planning and environmental protection conditions. Its fine apparently that the National Park and its contractors chop down trees but not if occasional rogue campers do this.

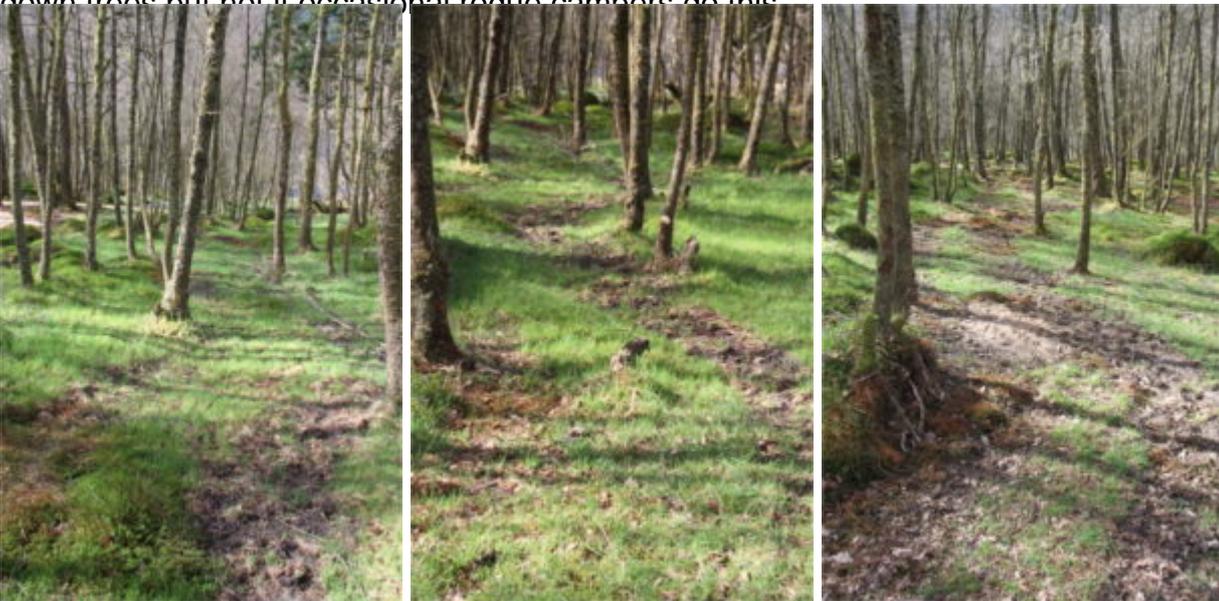
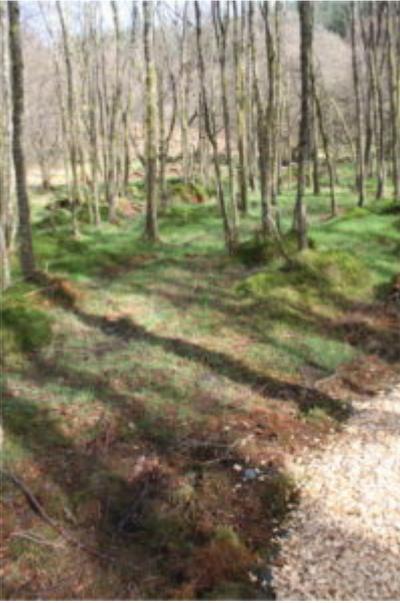
Hill track 2 meets up with the path between pitch 19 and 20.

The track has had a significant impact on the vegetation and the boggy soils within the woodland. There is something very wrong about a National Park Authority, which is supposed to be protecting the environment and who claim to have procedures in place to prevent such damage, have caused this damage themselves. The NPA appear to be incapable of setting up effective damage prevention procedures even where its paying for the works and the photos show vehicles have driven around the site at will.

There is now a distinct possibility that there will be follow on problems with changes to the ecosystem caused by diversion of water courses by these tracks and other LLTNPA created water channels.
