Dishing the Dirt, A Tale of Dirty dishes and Dirt for the disabled.

By Ross MacBeath

Loch Chon infrastructure

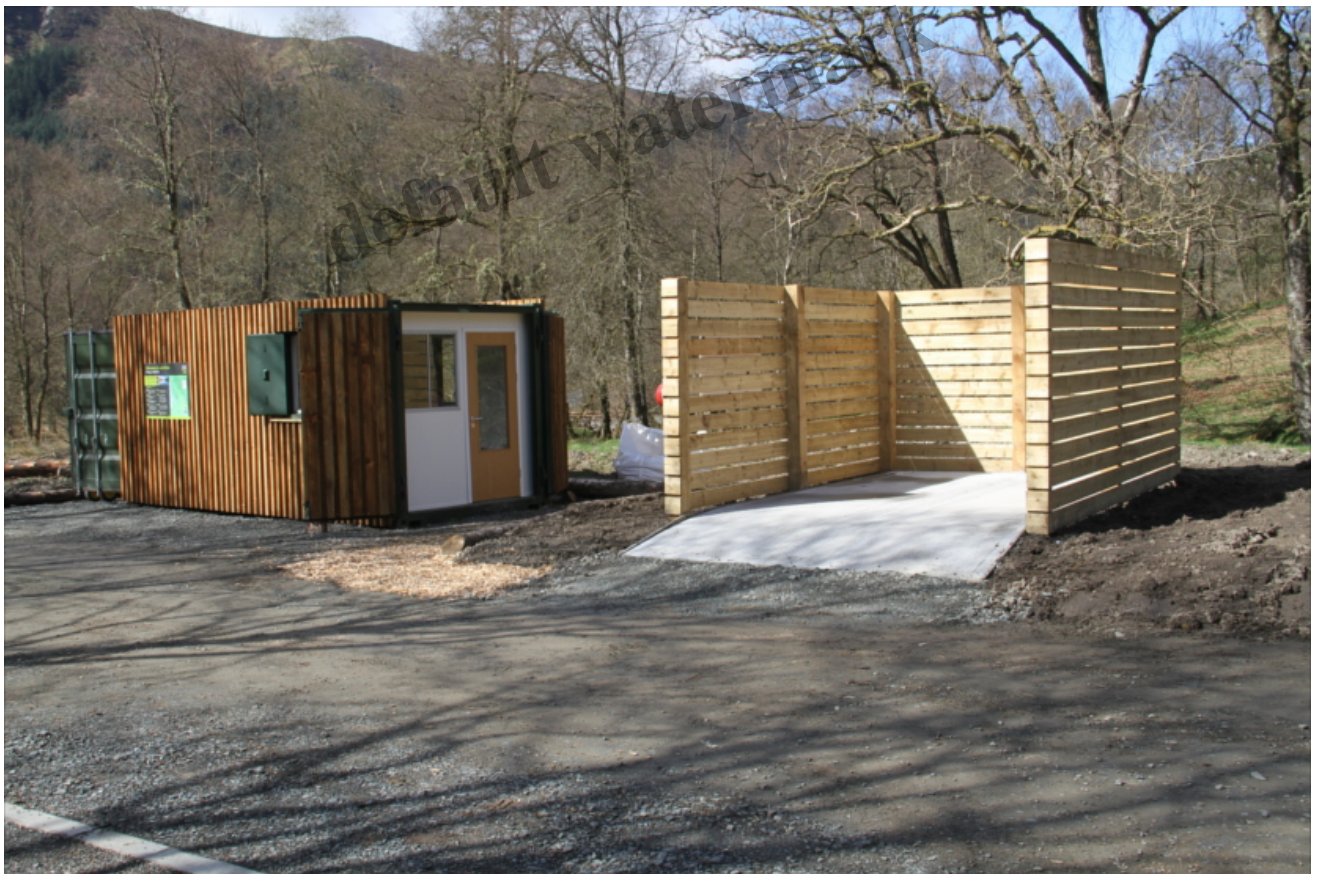
The good news is the bin store is complete, the bad news is its a 2.7 metre high structure which dominates the vista. It doesn't even have a maze to hide the 6 or so bins now in place, remaining in full view from the car park opposite. This is bin overkill, even if the Park's projected 90% occupancy of the campsite should ever prove to be true, its too high, and an unnecessary intrusion in this natural setting.

This image was taken 10th April 2017, Note:green bins now in store, 13/05/2017

It would have made so much more sense to position the bins beside the toilets (rather than the office), where they would be more convenient for campsite users, but campers have never been a priority in this development.

Perhaps it's more important for the refuse collectors to save the additional few hundred metres drive than to hide this monstrosity out of the way. It's a disastrous first impression of the site and is not what was discussed at preliminary meetings with the local community.

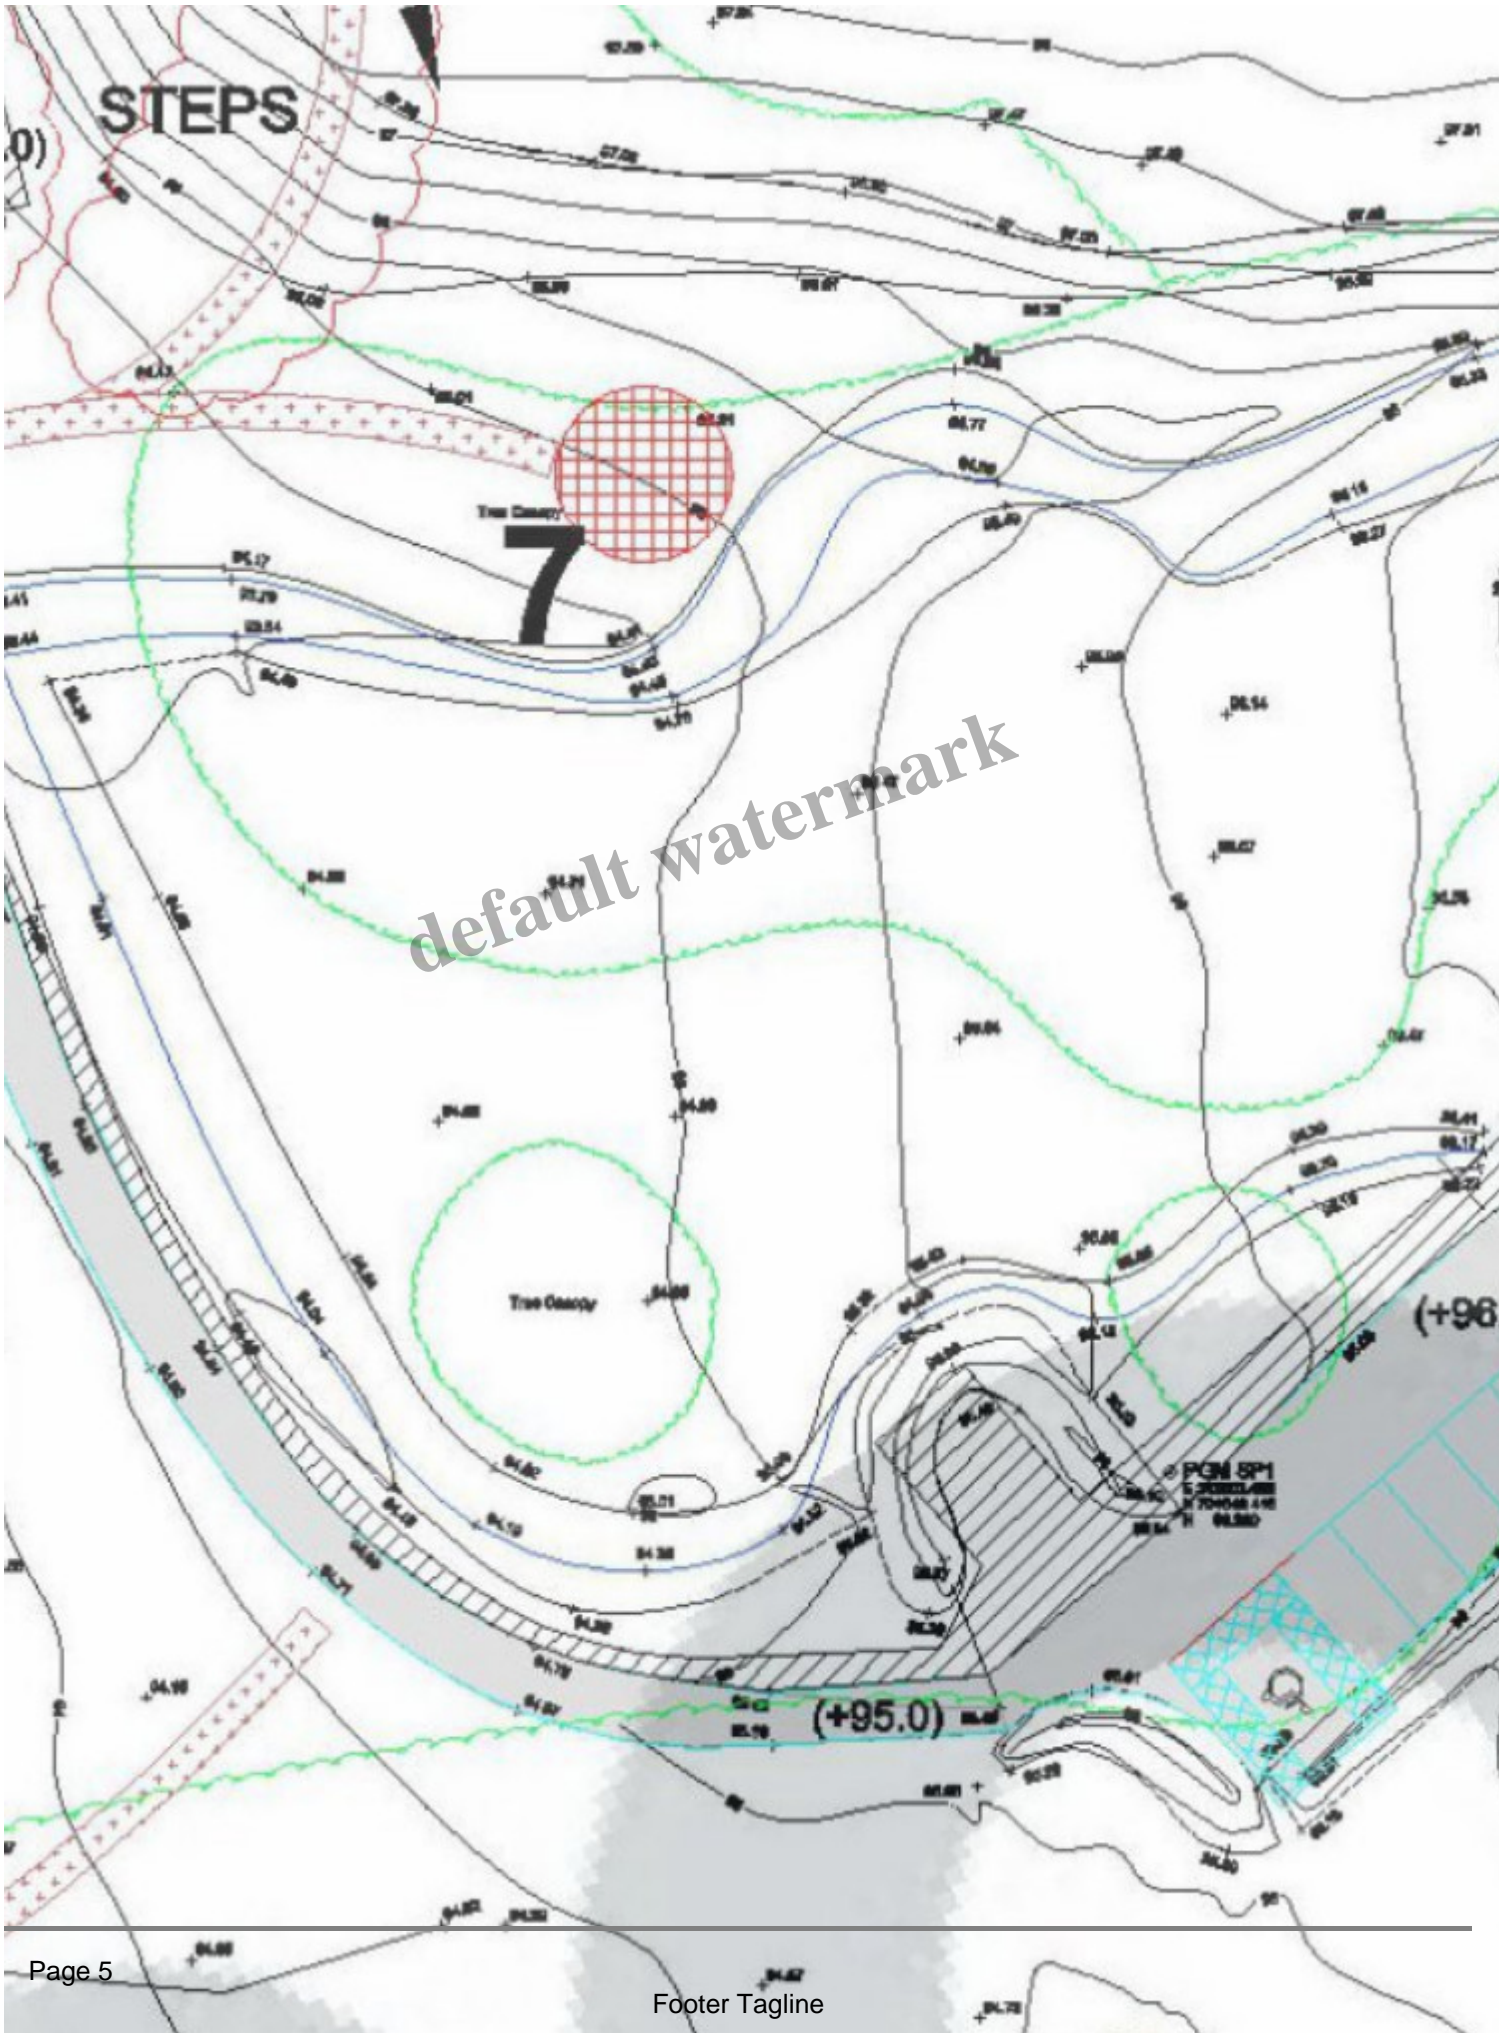
Following the granting of planning permission, National Park planning staff granted a Non Material Variation to the plans. Neither the original plans or the letter mention a bin store or any other structure at this location – the document [NMV decision letter final](#) refers.

The 'S' on the plan indicates the location of the Ranger Base/Store container.

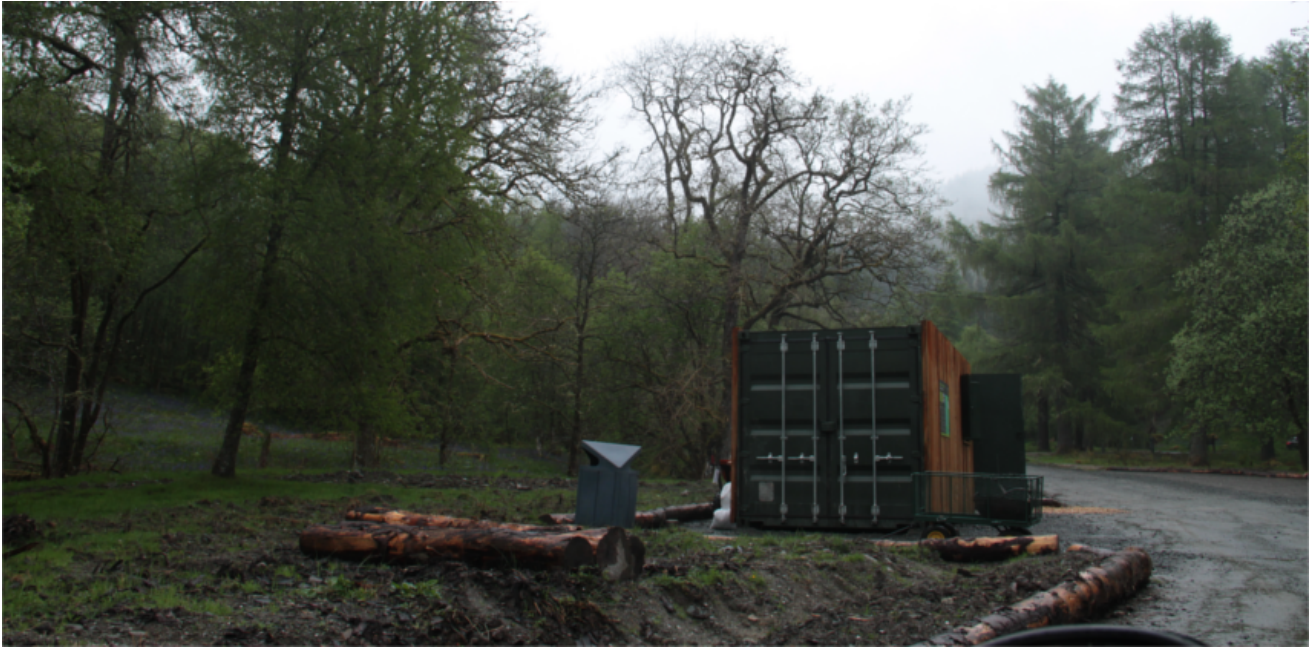
The last memory of your camping experience as you leave this site is this view of the office (below), a shipping container more at home in Tilbury docks, than a sympathetic camping development. It's another one in the eye for the National Park's Marketing Department.

Why are the logs in the image above still lying on site, they interfere with the vegetation regrowth and will result in another bare patch when removed? If they must be stored, do it on hard standing, better still in the Forestry Commission car park along the road.

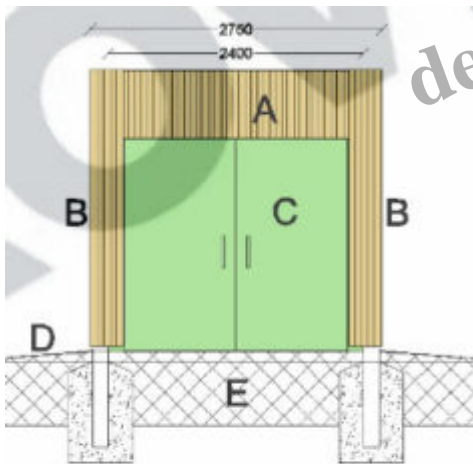
STORE ROOM / RANGER BASE
END ELEVATION 1:50

This end elevation in the photo above is very different to the elevation shown in the engineering drawings for this container contained in the plans. It did seem odd at the time the planning department allowed a drawing to be approved on their system that showed only one end elevation, not both, a very unusual situation. What was not shown is what we see here, a considerably larger and obtrusive industrialised door. The more cynical among us could be forgiven for believing this omission from the plans was not accidental.

Other apparent breaches of the planning consent in respect of the containers include: the construction method of the cladding, which is not mounted as shown in the plans; the omission of the concrete embedded posts from all containers on the site; and the hardcore which has not been graded to form a rise in ground to door level.

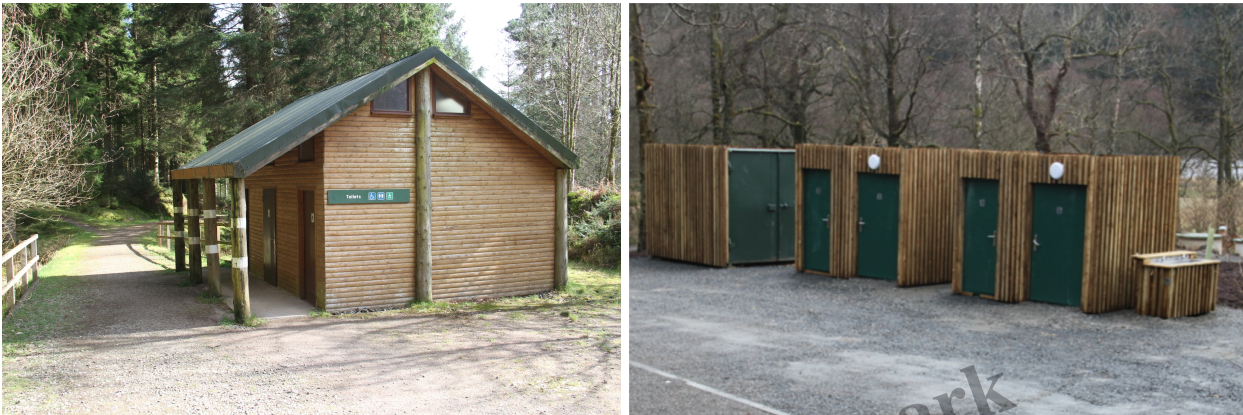
Forestry Commission – Shelter & Charm

LLTNPA – Containers, no shelter no charm

The Forestry Commission's rustic solution to toilet blocks, shown on the left hand image was the preferred style choice at Strathard community meetings and what most people would wish to see in our National Park, in stark contrast to the "industrial" containers the Park Authority favours. It's time the Park Authority started listening to its Partners instead of running roughshod over them.

The toilet blocks are containers like the ranger station, with high security metal doors to each "cell" opening in direct view of the car park opposite, offering no privacy to users. This is surely a breach of regulations.

The inappropriate plastic bulkhead light fittings have been chosen with no consideration of the specification laid out in International Dark-Sky Association guidelines that the National Park claim to be promoting ([see here](#)). The Park Authority are failing to make capital of this ideal site located away from any light pollution except for that of their own making.

Since the toilet block image (above) was taken, the fittings have been recessed into the wood cladding but still fail to comply with the dark skies requirement. Light fittings should shade upward light emissions while other light output should be directed downwards by internal reflectors not flooding the hill side opposite and sky as is the case here.

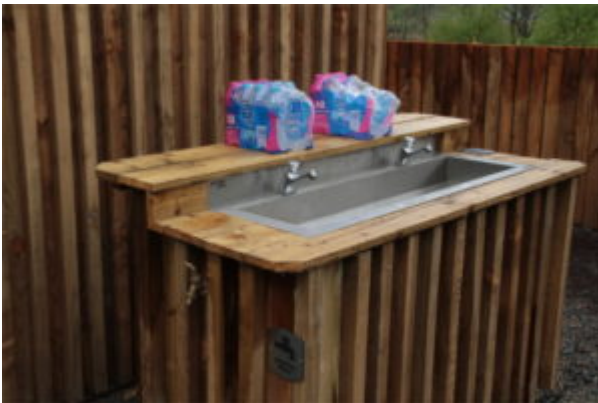
Bottled water for drinking and dish washing? – Water supply faulty – Fail.

The Park have now changed their story to say the contractor provided an external water supply during the period since opening. On the 6 occasions I have personally visited since the site opened, on 4 visits there was no drinking water and on 3 no water in the toilets. On another two occasions where a local resident attended, there was no drinking water. In total this represents 2 months without a contractor supply and 6 weeks without drinking water.

Incredibly on my 6th visit water was being supplied in plastic bottles – which raises the question once more, why? ([see here for recent history of the water issue](#))

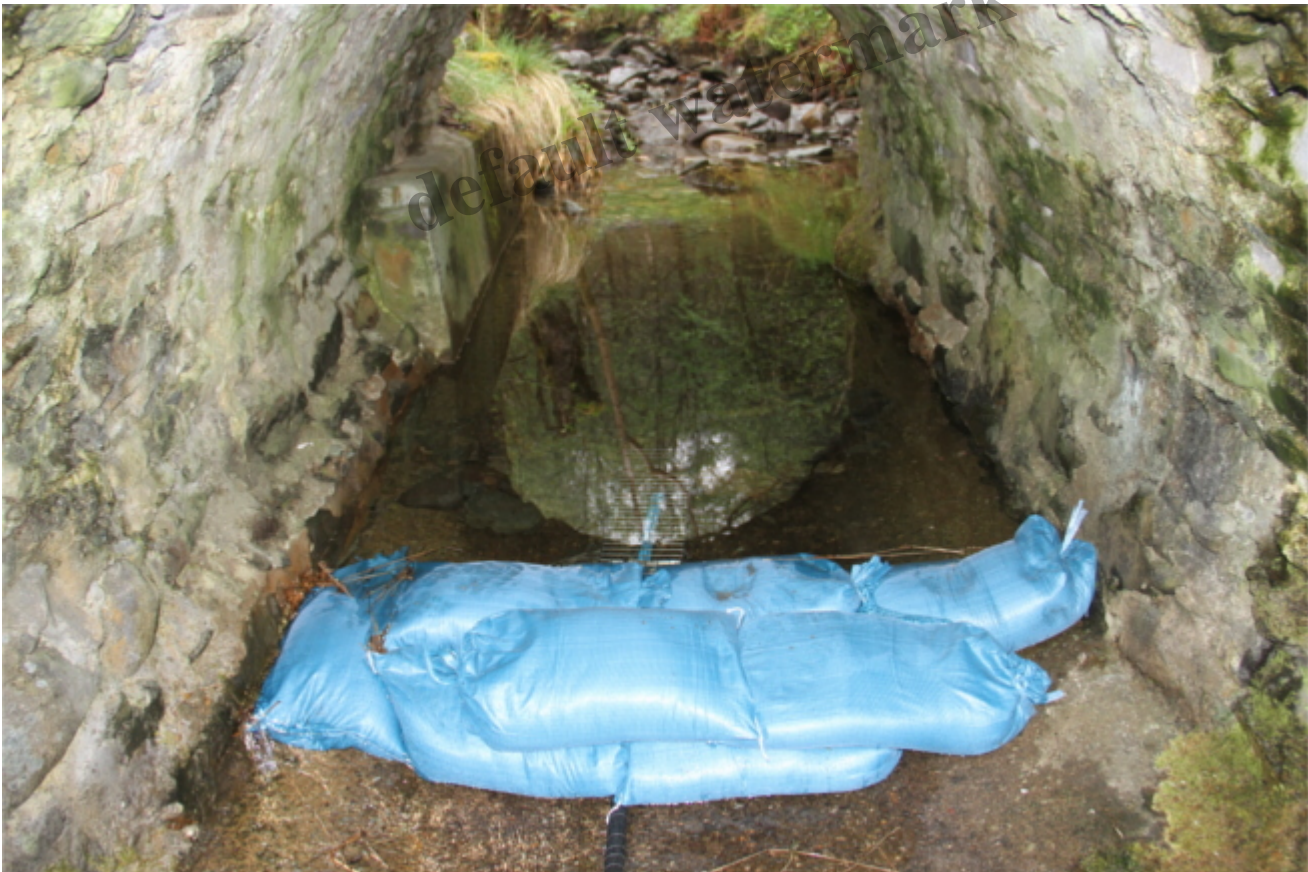
After each visit I have made, I have pointed out the shortcomings to the Park who have then modified the installation to mitigate each issue but as of yet have failed to take on board what is required to be done. After the dry spell at the beginning of May 2017, the water level dropped so low air could be

drawn into the intake pipe. The Park has responded by creating a slightly more substantial dam using sandbags instead of the the pebbles and rocks of the last one. This is getting them through by the skin of their teeth, providing unfiltered water for the toilets and wash hand basins but has not provided the solution to the drinking water problem.

Intake pipe without strainer – Fail

The intake pipe remains open to the flow of water which poses serious risks for debris to enter the system with potential for blockages ([see Solution here](#)).

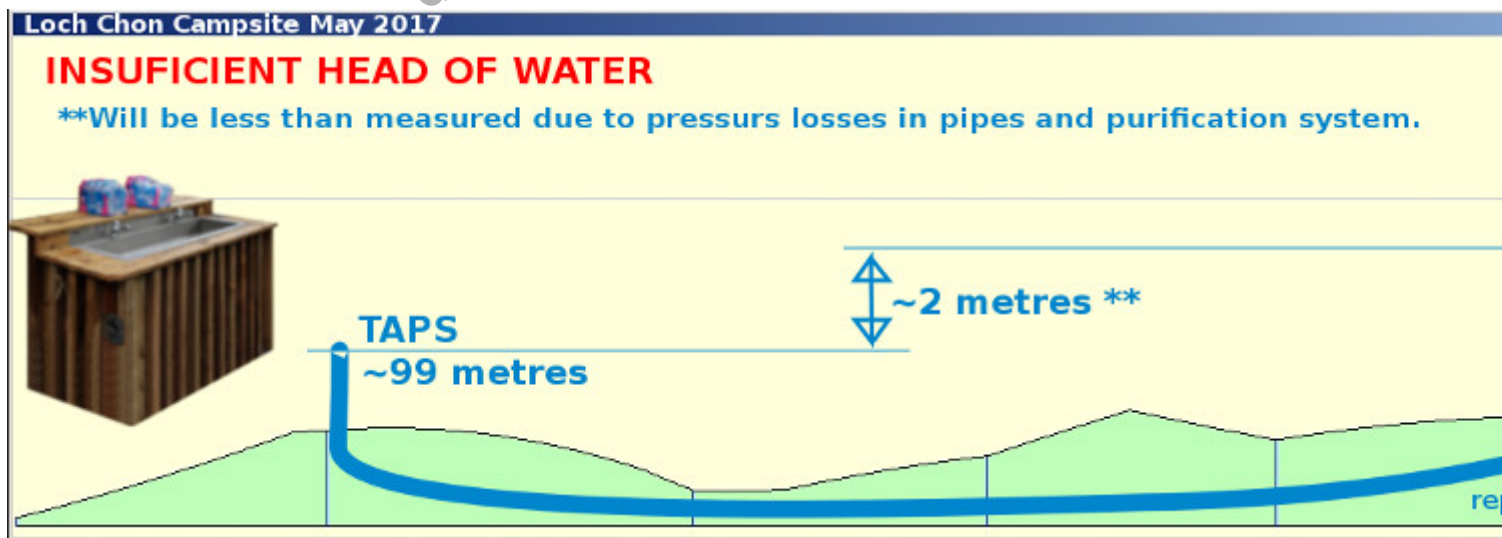
The sandbag issue aside, the problem with the water supply is even more serious, it's a design fault which the Park Authority have been aware of from before the 1st March 2017 but for reasons known only to them have failed to correct. The problem is simple, the intake pipe being below the bridge is effectively underground and the level between the intake and outlet at the taps is too small for water to flow as this diagram explains.

The solution is equally simple, assuming everything else is equal and no damage has been done to the plant through running it without a water feed. Raise the intake pipe level by moving it higher. There is a natural reservoir just upstream at the base of a waterfall, in the form of a pool which provides a natural header tank, something that's required for all such installations to ensure as continuous supply. They could of courses go one better and take the feed from above the waterfall

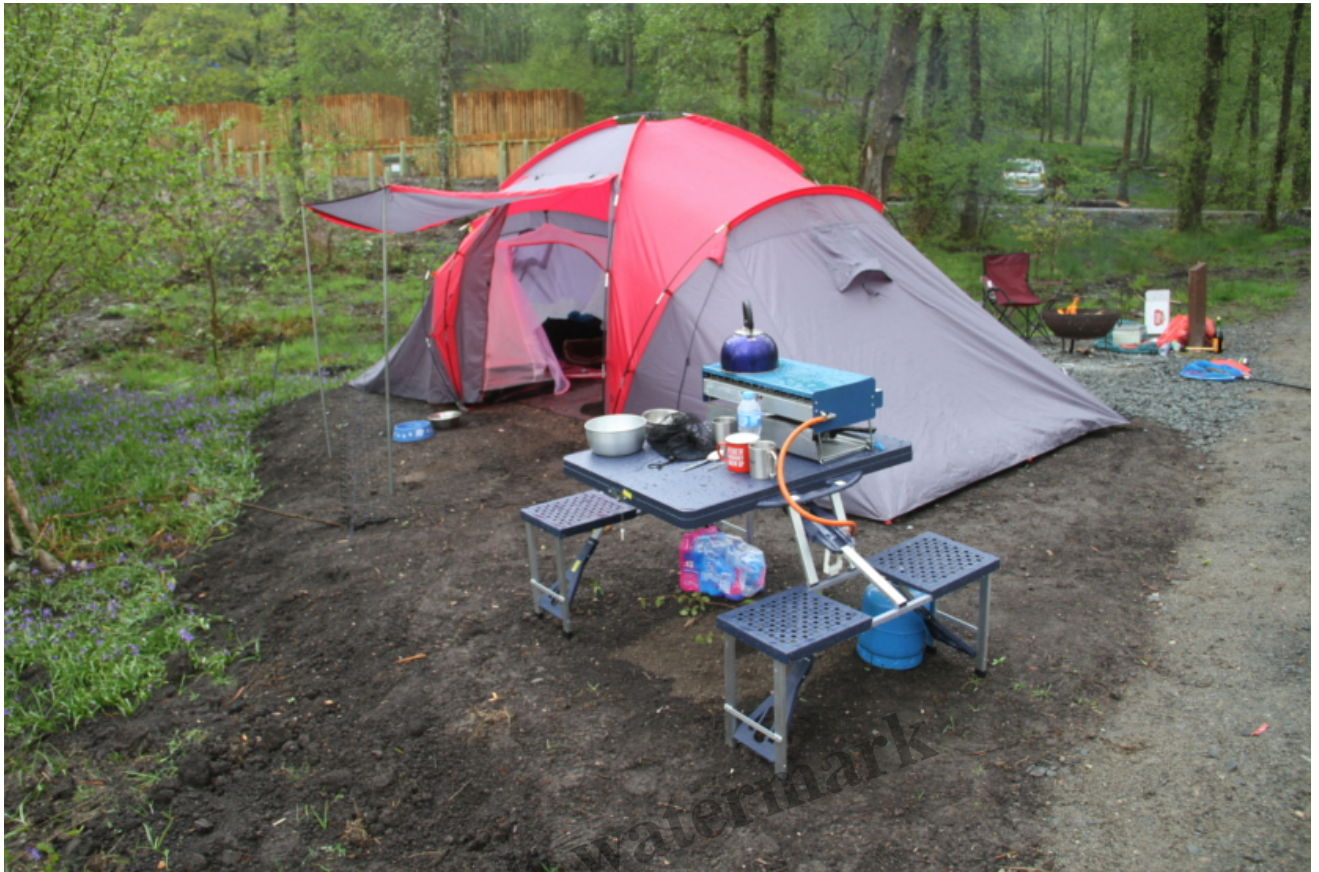
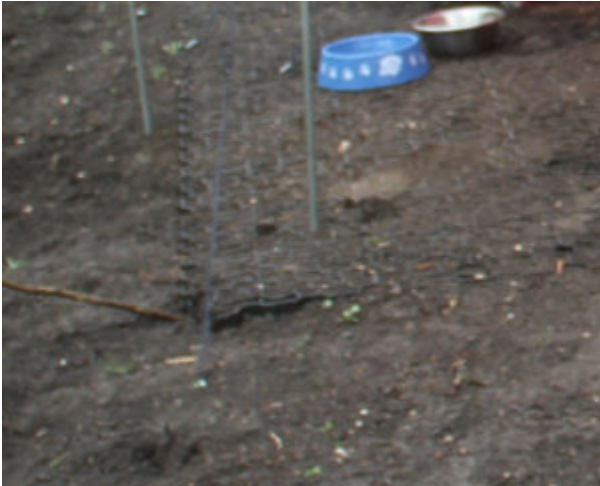
Disabled Pitch 8 13/05/2017, barely able to contain a 3 man tent with unconstrained edges posing hazards

The original state of pitch 8, promoted for disabled use together with pitch 9 due to their accessibility for toilets and car park was disgraceful. ([See Video Here](#)) They were built in a water course cut out from a bramble patch on a wet and muddy area prone to flooding. This modified pitch has been created over the top of that area by building it up on a hardcore plinth with soil covering a hexagonal geo-membrane and provides a marked improvement on the old effort in many ways but fails in an important number of others.

Fail 1: In building up this pitch the edges of the soil should have been constrained to stop any further spread out over the surrounding vegetation. Soil spread is already evident through exposure of the plastic mesh which is creating a trip hazard. Further, the edge of the pitch drops off rapidly close to the tent entrance and again poses a real risk of tripping or falling down the slope.

Fail 2 – as with so many other pitches in this development, this pitch is just too small, for disabled users, some of whom may need a larger tent for access or to take a wheelchair or other aids inside. Here we see a 3 man tent pushed to the back and side edges of the pitch so it will fit and still leave room to get in and out. With table and chairs filling the remainder of the pitch, the fire pan and additional seating have had to go on the path on the other side of the tent. This is effectively the largest tent this pitch will take and even then it is cramped. This makes the pitch useless for a larger tent suitable for families.

Fail 3 – This tent has been erected without the use of guy lines which has only been possible because it's a self supporting tent. Of course not using guy lines is unusual as they are important for the stability of the tent structure and a necessity in the wind where damage to the tent and poles can occur if not tensioned properly with the possibility of the tent being blown away. Fitting guy lines at this pitch is problematic due to the hard core path to the side and front of the tent and the area to the back of the tent is the diverted water course making pegging out difficult if not impossible at times. The other issue of course is that guy lines impede the movement of people around the pitch particularly in the case of a disabled user with a wheel chair or requiring assistance to get in and out of the tent. So the small size of this pitch is of serious concern and brings into questions it's suitability as a easy access pitch for disabled users.

Fail 4: It is now well over a month since this "improved pitch surface" was provided to pitches 8 and 9 and they have not been seeded with the recommended seed mix stated in the planning application, This pitch should have a grass surface not dirt. The occupants of the tent in the above image

explained heavy rain over night and early morning wet the dirt surface resulting in it being carried into the tent on muddy foot wear.

- Urgently correct surface issues on disabled pitches and seed with grass
- Pitch size needs to be increased at many pitches and some surfaces constrained – disabled pitches 8 and 9 are a priority.

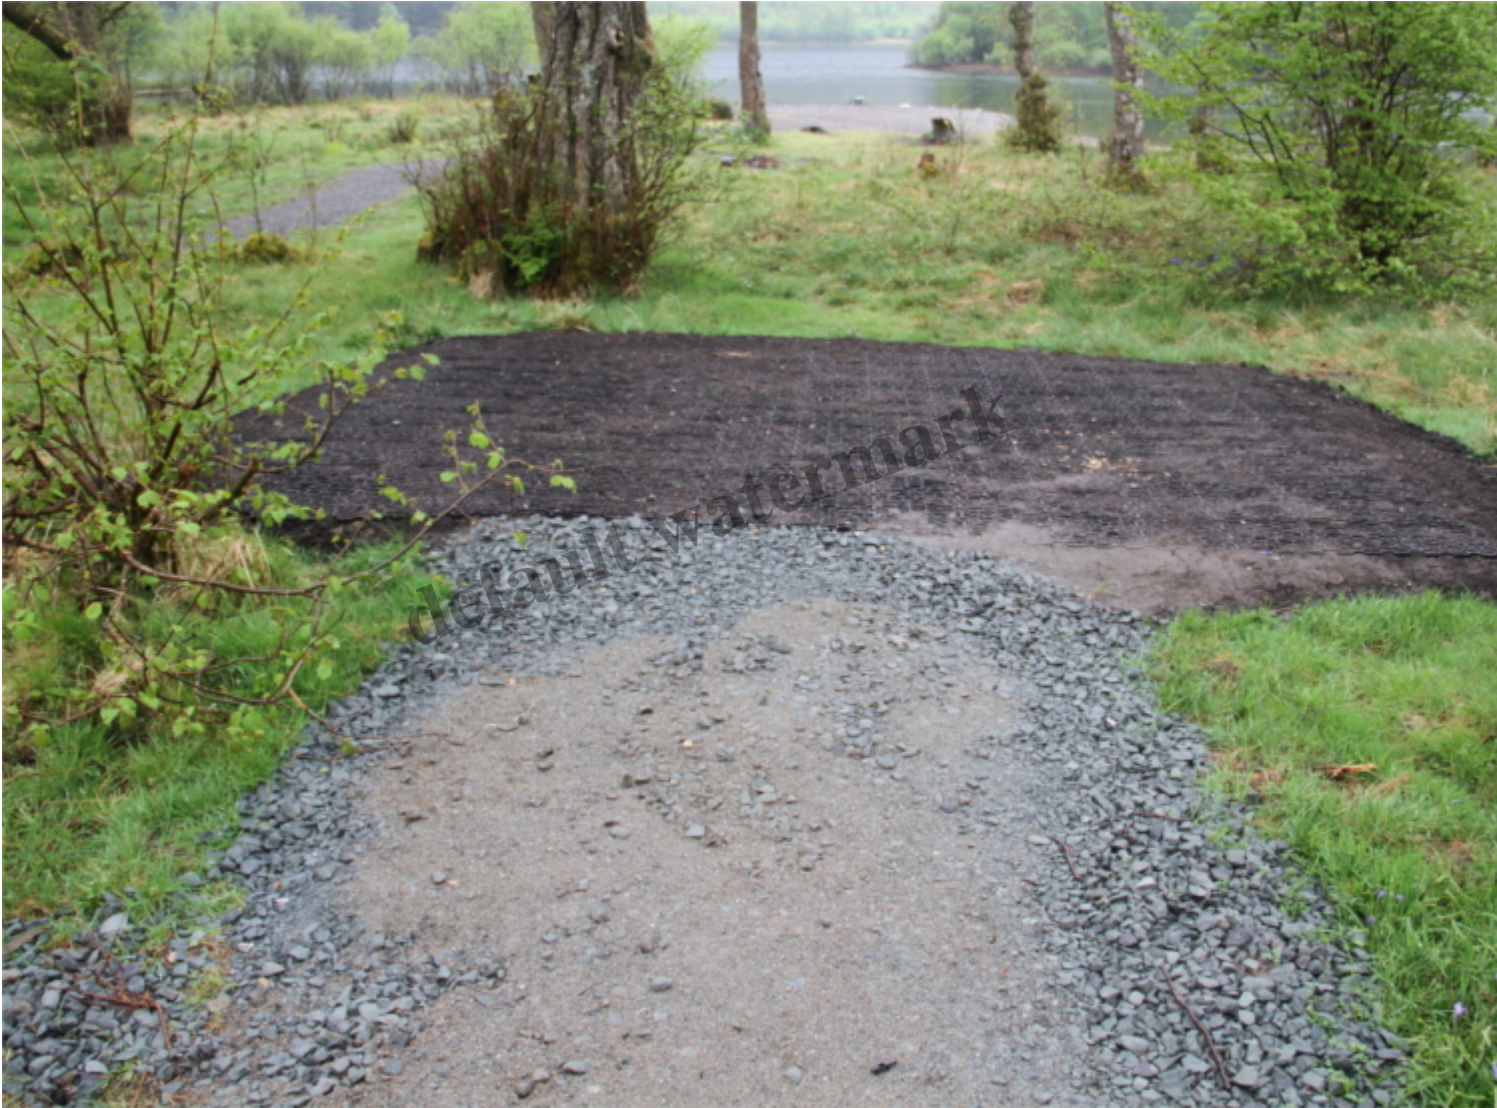
Pitch 9 as the second pitch assigned for disabled and easy access and is only a little better.

Other than the fact it's easier to peg out guy lines as it sits back from the path. The dirt surface remains a problem carrying a muddy mess into the sleeping area in wet weather but has also compressed below the level of the Geo-membrane leaving an unsuitably hard surface for pitching a tent.

Perforation of the tent base is likely while the resultant surface is also very uncomfortable making it

both painful to kneel on this surface and creating a risk of physical injury.

As before the pitch is too small for anything more than a three man tent.mitigated some what by the fact there is other ground around for occupants..

This path also fails to comply with the planning consent, the aggregate should not be spread over vegetation and it should be be bounded by a seeded, graded soil bank to allow it to blend in with the land scape.

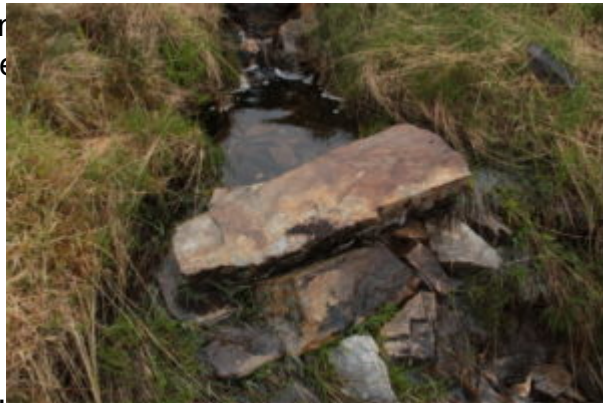
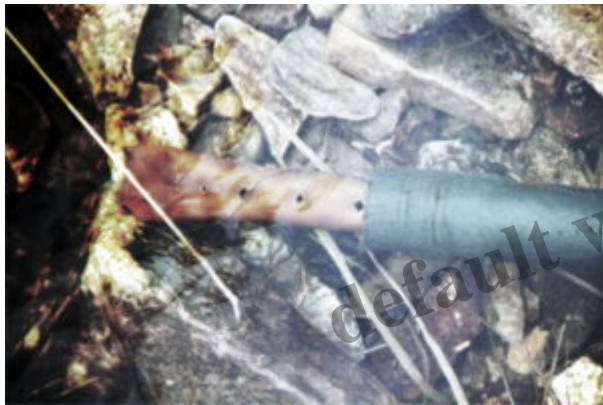
- As a matter of urgency the planning enforcement team need to visit this site and make the applicant comply with the planning consent.
- Complete snagging – the snagging list is sizable.
- Correct water supply as a matter of urgency. A simple solution at the Cononish Goldmine is more than this authority

should be aware of as they sanctioned it.

Note also the strainer on the end of the pipe another fiendishly simple solution, a copper stopper pipe with some nail holes. A strainer requires to be fitted at Loch Chon site to avoid future supply failures.
