Dishing the Dirt, A Tale of Dirty dishes and Dirt for the disabled.

By Ross MacBeath

## Loch Chon infrastructure

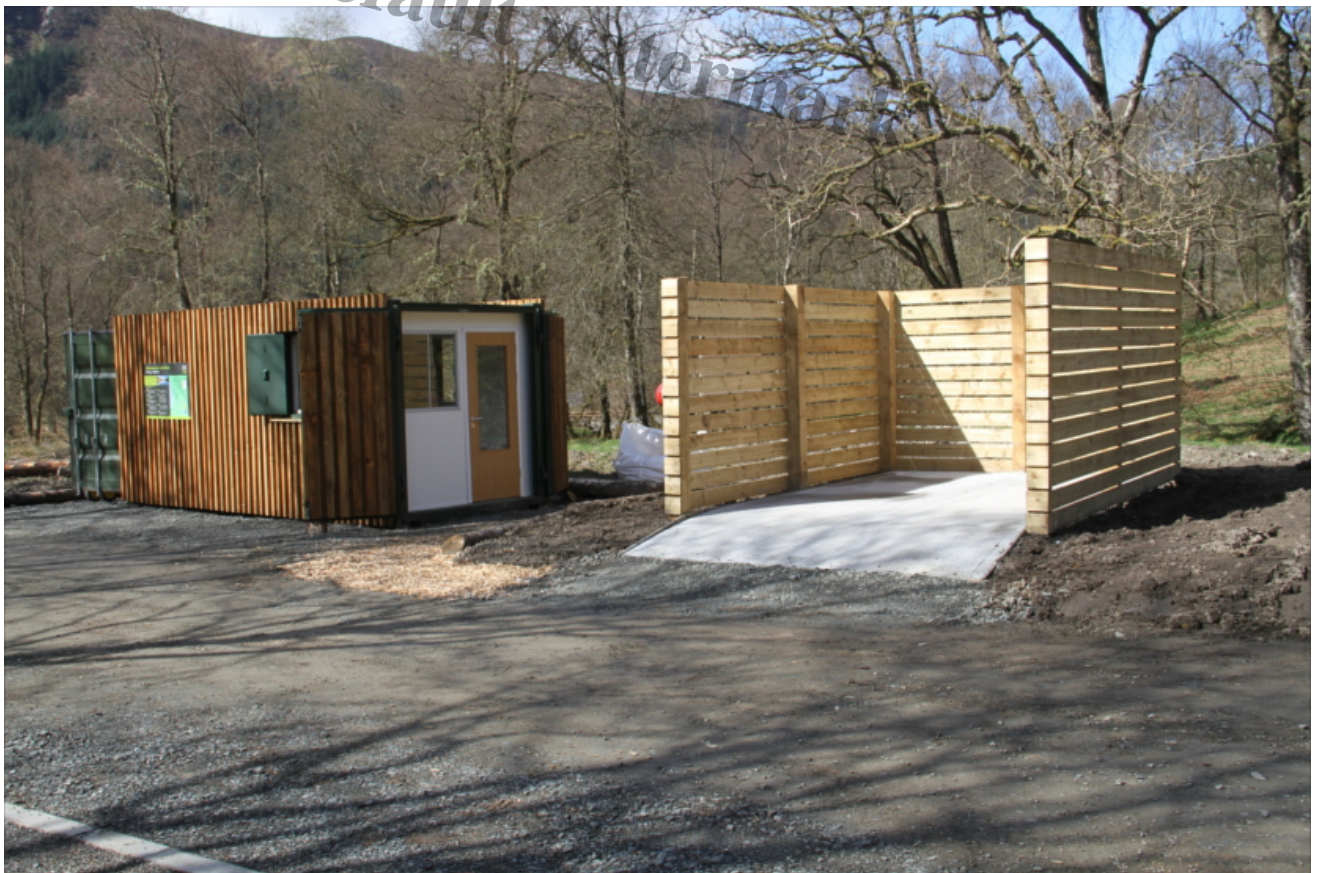
The good news is the bin store is complete, the bad news is its a 2.7 metre high structure which dominates the vista. It doesn't even have a maze to hide the 6 or so bins now in place, remaining in full view from the car park opposite. This is bin overkill, even if the Park's projected 90% occupancy of the campsite should ever prove to be true, its too high, and an unnecessary intrusion in this natural setting.

This image was taken 10th April 2017, Note:green bins now in store, 13/05/2017

It would have made so much more sense to position the bins beside the toilets (rather than the office), where they would be more convenient for campsite users, but campers have never been a priority in this development.

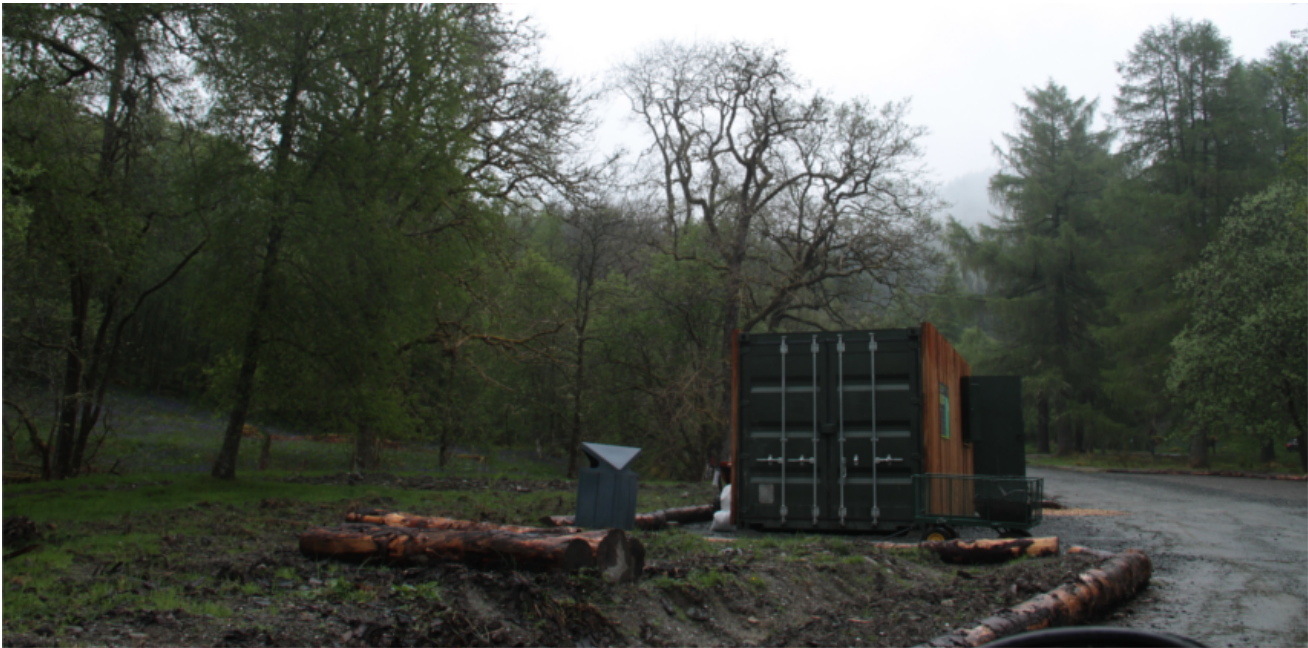
The last memory of your camping experience as you leave this site is this view of the office (below), a shipping container more at home in Tilbury docks, than a sympathetic camping development. It's another one in the eye for the National Park's Marketing Department.

It's another breach in planning consent - Fail

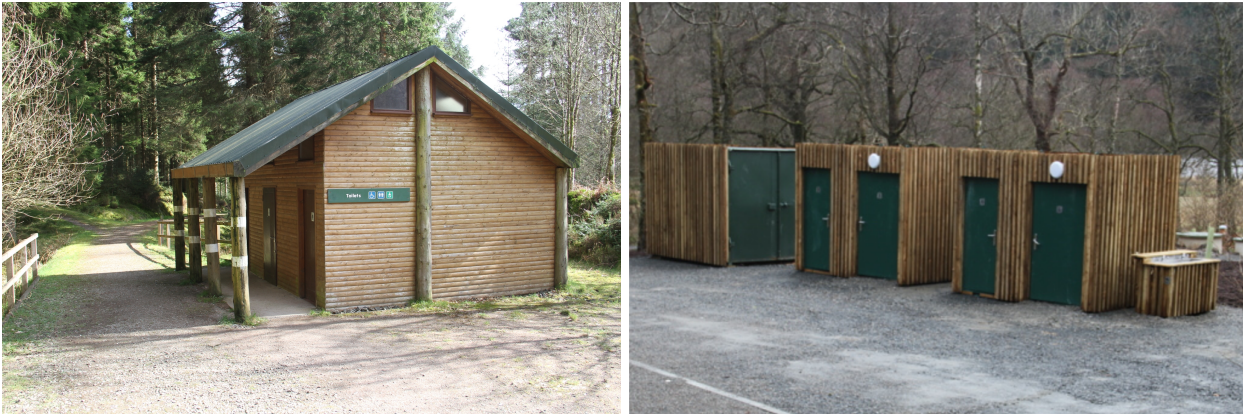
Forestry Commission's Shelter & Charm      LLTNPA's Containers, no shelter no charm

The toilet blocks are containers like the ranger station, with high security metal doors to each cell's opening in direct view of the car park opposite, offering no privacy to users. This is surely a breach of regulations.

Then the Park Authority's failure to provide anything in the way of shelter is a serious design fault. No consideration has been given to the needs of visitors who find themselves caught in the rain when all toilets are occupied, with nowhere to take cover. Getting soaked to the skin is difficult to recover from when camping and should be avoided. At very least a canopy should have been provided across

The inappropriate plastic bulkhead light fittings have been chosen with no consideration of the specification laid out in International Dark-Sky Association guidelines that the National Park claim to be promoting ([see here](#)). The Park Authority are failing to make capital of this ideal site located away from any light pollution except for that of their own making.

Since the toilet block image (above) was taken, the fittings have been recessed into the wood cladding but still fail to comply with the dark skies requirement. Light fittings should shade upward light emissions while other light output should be directed downwards by internal reflectors not flooding the hill side opposite and sky as is the case here.

a widened gap between the two containers but of course what was really required was some forethought and a custom designed visitor toilet block with some visitor friendly features instead of this minimalist offering.

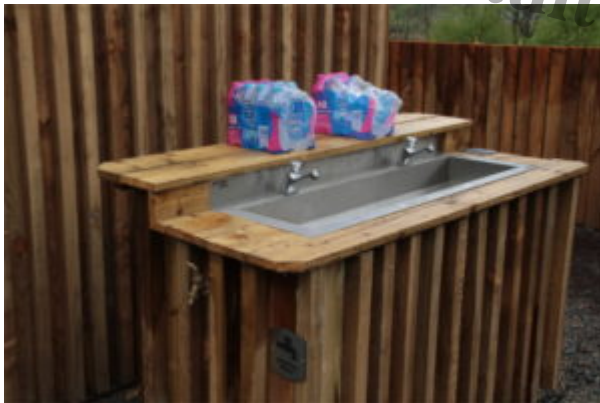
### **Bottled water for drinking and dish washing? â?? Water supply faulty â?? Fail.**

ned the water supply had been working with just a short  
d on our many visits show that to be

untrue.

After each visit I have made, I have pointed out the shortcomings to the Park who have then modified the installation to mitigate each issue but as of yet have failed to take on board what is required to be done. After the dry spell at the beginning of May 2017, the water level dropped so low air could be drawn into the intake pipe. The Park has responded by creating a slightly more substantial dam using sandbags instead of the pebbles and rocks of the last one. This is getting them through by the skin of their teeth, providing unfiltered water for the toilets and wash hand basins but has not provided the solution to the drinking water problem.

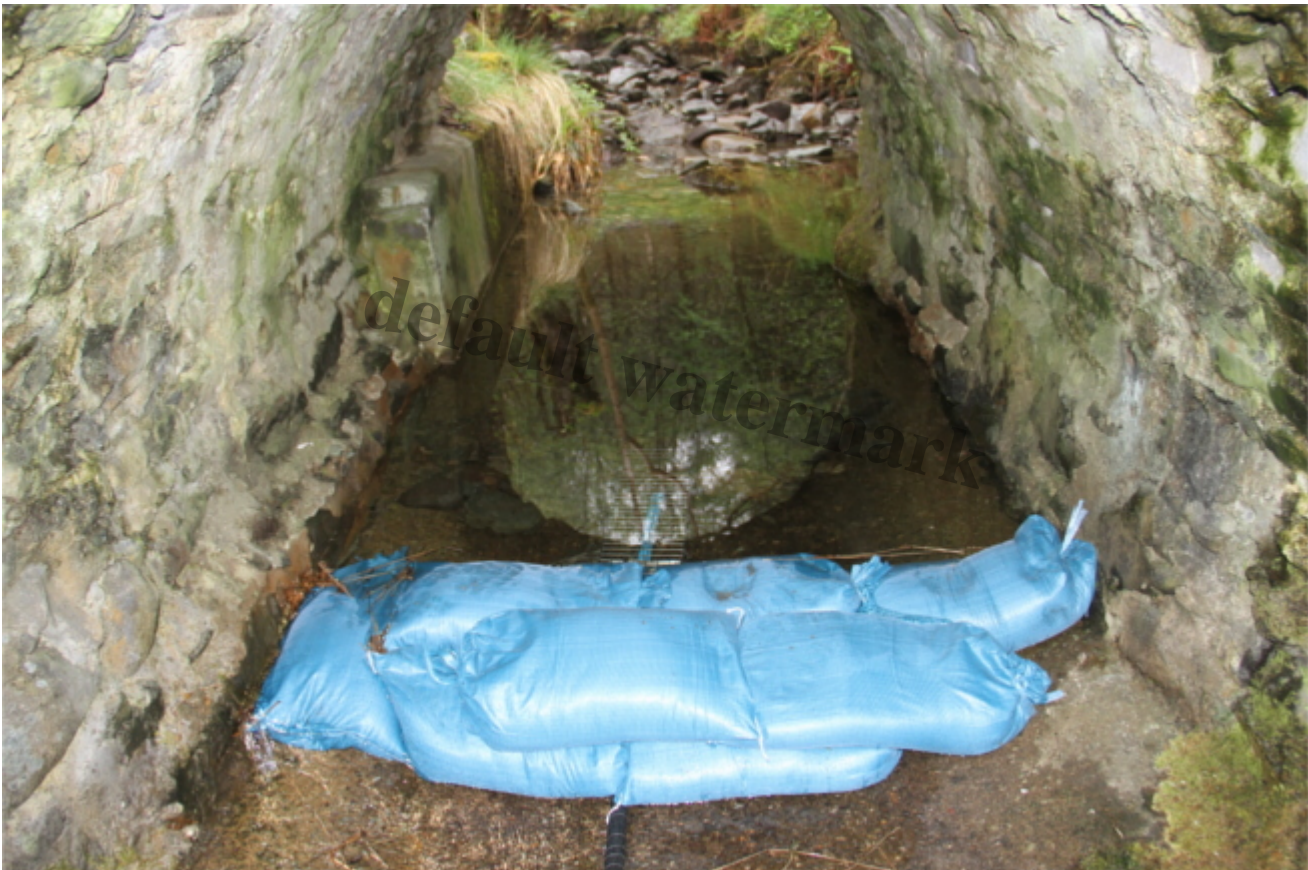
dried up before selecting it as a source. The question needs to be asked why would the planning department grant permission for a campsite without a guaranteed water supply? It's beyond comprehension. In fact when you look at the plans, there is no detail of the water intake design or specification for the size of the header tank, reservoir or pool that would be a requirement for a successful water supply. The upshot has been there is only a trickle of water in the stream in dry spells which goes a long way to explaining the intermittent nature of water supply.

The intake pipe remains open to the flow of water which poses serious risks for debris to enter the system with potential for blockages ([see Solution here](#)).

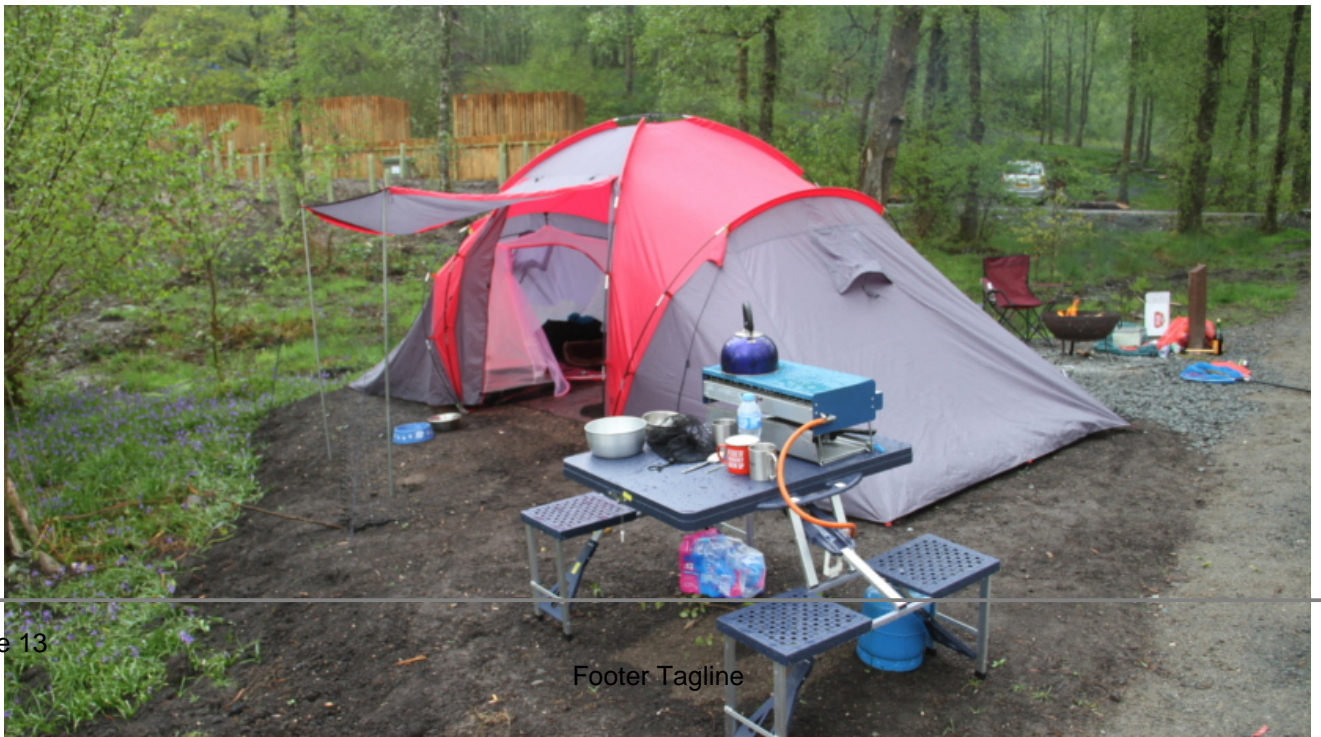
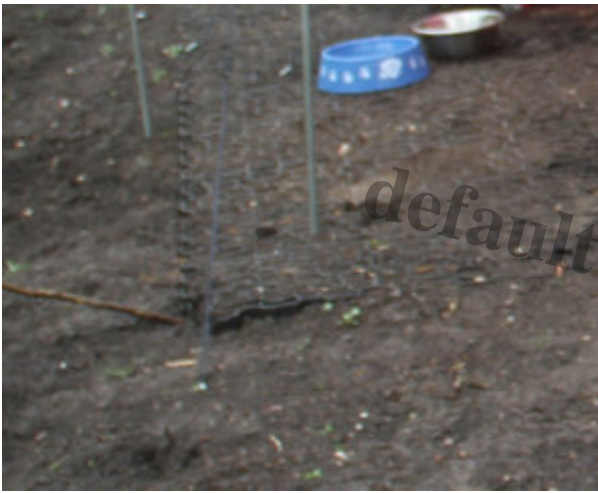
Disabled Pitch 8 13/05/2017, barely able to contain a 3 man tent with unconstrained edges posing hazards

The original state of pitch 8, promoted for disabled use together with pitch 9 due to their accessibility for toilets and car park was disgraceful. ([See Video Here](#)) They were built in a water course cut out from a bramble patch on a wet and muddy area prone to flooding. This modified pitch has been created over the top of that area by building it up on a hardcore plinth with soil covering a hexagonal geo-membrane and provides a marked improvement on the old effort in many ways but fails in an important number of others.

Fail 1: In building up this pitch the edges of the soil should have been constrained to stop any further spread out over the surrounding vegetation. Soil spread is already evident through exposure of the plastic mesh which is creating a trip hazard. Further, the edge of the pitch drops off rapidly close to the tent entrance and again poses a real risk of tripping or falling down the slope.

Fail 2 as with so many other pitches in this development, this pitch is just too small, for disabled users, some of whom may need a larger tent for access or to take a wheelchair or other aids inside. Here we see a 3 man tent pushed to the back and side edges of the pitch so it will fit and still leave room to get in and out. With table and chairs filling the remainder of the pitch, the fire pan and additional seating have had to go on the path on the other side of the tent. This is effectively the largest tent this pitch will take and even then it is cramped. This makes the pitch useless for a larger tent suitable for families.

Fail 3 This tent has been erected without the use of guy lines which has only been possible because its a self supporting tent. Of course not using guy lines is unusual as they are important for the stability of the tent structure and a necessity in the wind where damage to the tent and poles can occur if not tensioned properly with the possibility of the tent being blown away. Fitting guy lines at this pitch is problematic due to the hard core path to the side and front of the tent and the area to the back

of the tent is the diverted water course making pegging out difficult if not impossible at times. The other issue of course is that guy lines impede the movement of people around the pitch particularly in the case of a disabled user with a wheel chair.or requiring assistance to get in and out of the tent So the small size of this pitch is of serious concern and brings into questions itâ??s suitability as a easy access pitch pitch.for disabled users.

Fail 4: It is now well over a month since this â??improved pitch surfaceâ?? was provided to pitches 8 and 9 and they have not been seeded with the recommended seed mix stated in the planning application, This pitch should have a grass surface not dirt. The occupants of the tent in the above image explained heavy rain over night and early morning wet the dirt surface resulting in it being carried into the tent on muddy foot wear.

- Urgently correct surface issues on disabled pitches and seed with grass
- Pitch size needs to be increased at many pitches and some surfaces constrained – disabled pitches 8 and 9 are a priority.
- Where pitch size cannot be increased due to poor site selection, an auxiliary area beside the pitch should be created so campsite users can sit and cook by their tents.  
This would probably require a new planning application and not be a Non Material Variation
- Remove unsuitable pitches from the booking system
- Change booking system and include pitch descriptions and photographs, especially in connection with the size of tent and the number occupants the pitch can accommodate.

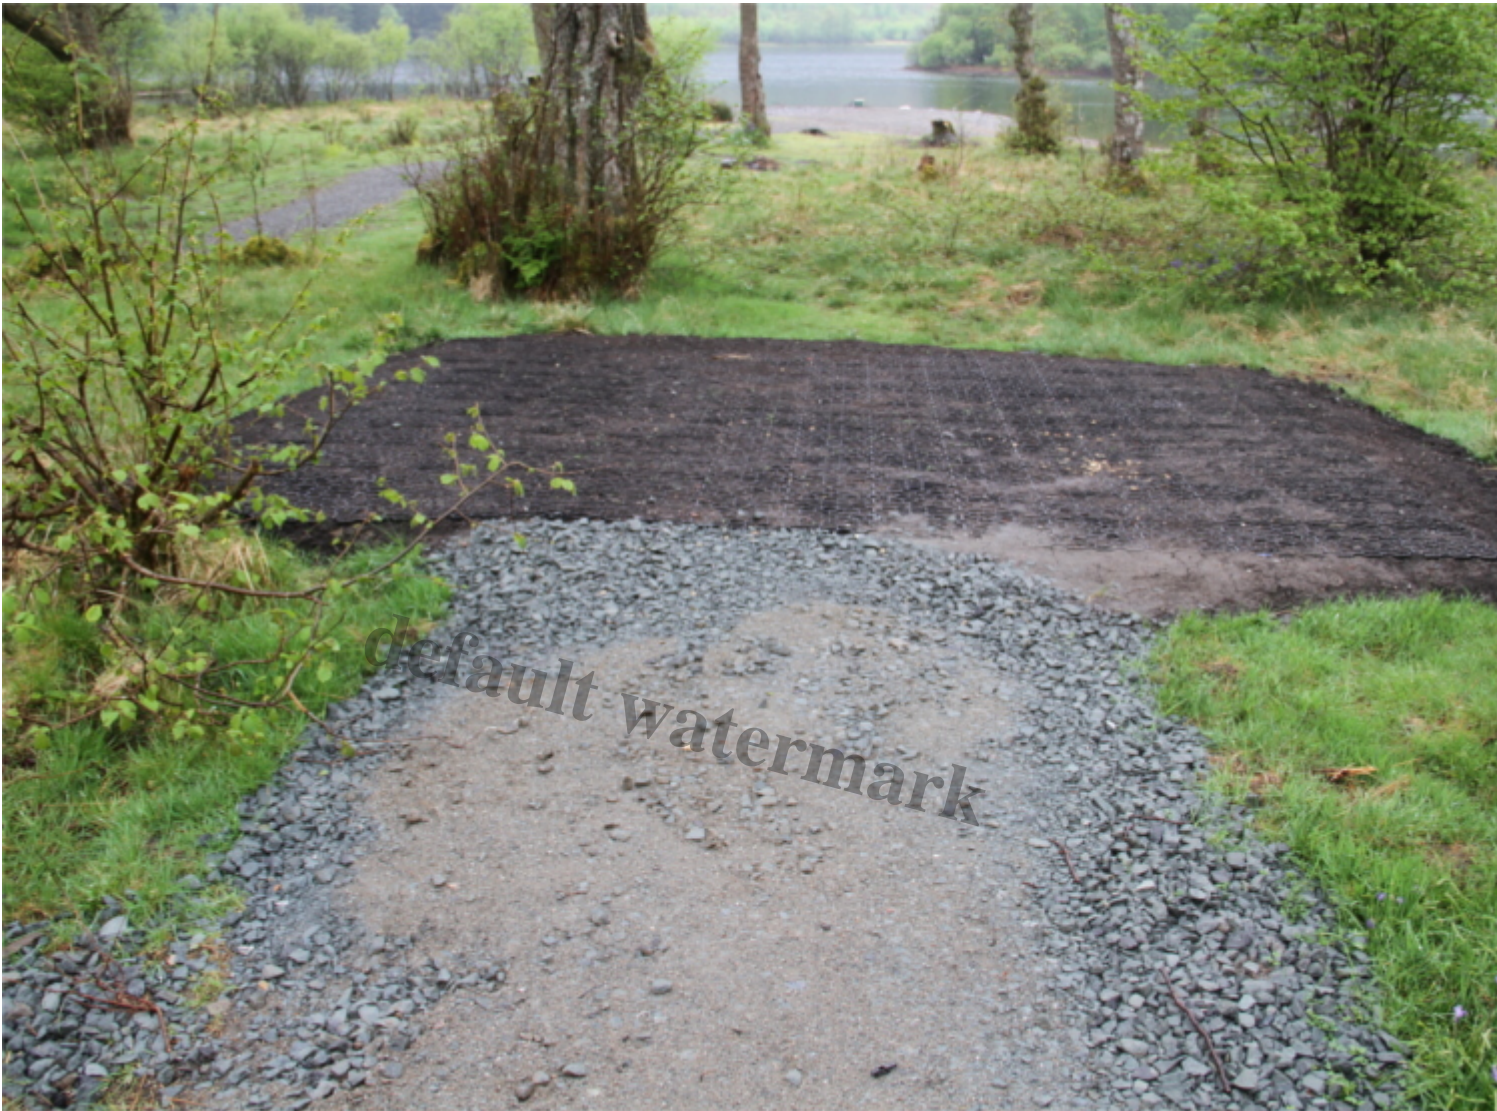
Pitch 9 as the second pitch assigned for disabled and easy access and is only a little better.

Other than the fact it's easier to peg out guy lines as it sits back from the path. The dirt surface remains a problem carrying a muddy mess into the sleeping area in wet weather but has also compressed below the level of the Geo-membrane leaving an unsuitably hard surface for pitching a tent.

Perforation of the tent base is likely while the resultant surface is also very uncomfortable making it both painful to kneel on this surface and creating a risk of physical injury.

As before the pitch is too small for anything more than a three man tent.mitigated some what by the fact there is other ground around for occupants..

This path also fails to comply with the planning consent, the aggregate should not be spread over vegetation and it should be bounded by a seeded, graded soil bank to allow it to blend in with the land scape.

- Complete seeding process so recovery of damaged areas can be achieved this season
- Rethink the use of sand as a pitch surface, it's ridiculous and gets carried into the tent.
- Paths constructed on spongy ground. needs to be dug out and consolidated as per the statement in the planning consent.- 3 locations identified so far.
- Paths need to be brought up to the specification of the planning consent with respect to edge grading and restoration of edges through seeding.

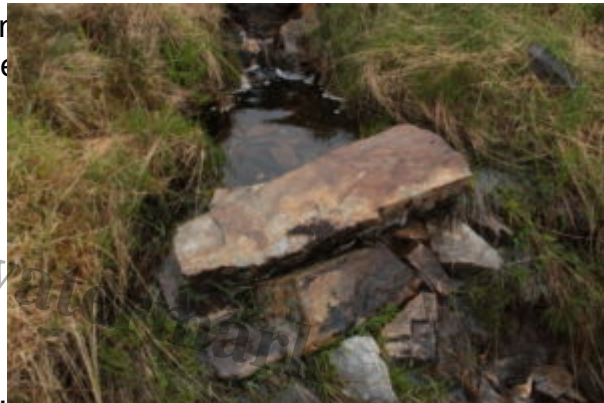
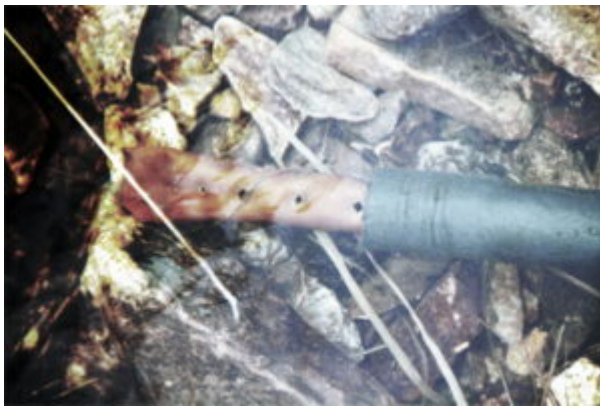
Note also the strainer on the end of the pipe another fiendishly simple solution, a copper stopper pipe with some nail holes. A strainer requires to be fitted at Loch Chon site to avoid future supply failures.

- As a matter of urgency the planning enforcement team need to visit this site and make the applicant comply with the planning consent.
- Complete snagging – the snagging list is sizable.
- Correct water supply as a matter of urgency – a simple solution at the Cononish Goldmine is more than this authority
