Dishing the Dirt, A Tale of Dirty dishes and Dirt for the disabled.

By Ross MacBeath

Loch Chon infrastructure

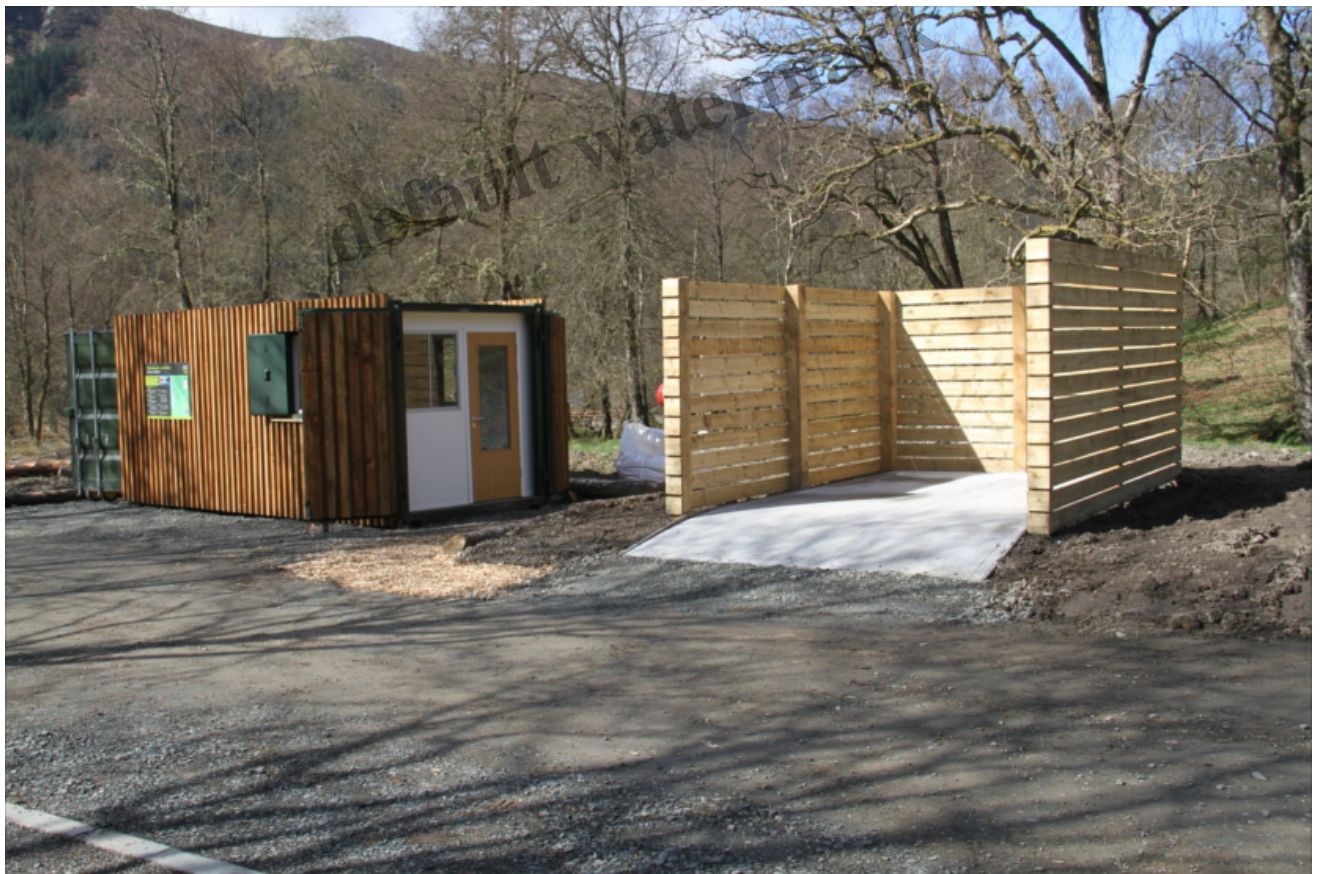
The good news is the bin store is complete, the bad news is its a 2.7 metre high structure which dominates the vista. It doesn't even have a maze to hide the 6 or so bins now in place, remaining in full view from the car park opposite. This is bin overkill, even if the Park's projected 90% occupancy of the campsite should ever prove to be true, its too high, and an unnecessary intrusion in this natural setting.

This image was taken 10th April 2017, Note:green bins now in store, 13/05/2017

It would have made so much more sense to position the bins beside the toilets (rather than the office), where they would be more convenient for campsite users, but campers have never been a priority in this development.

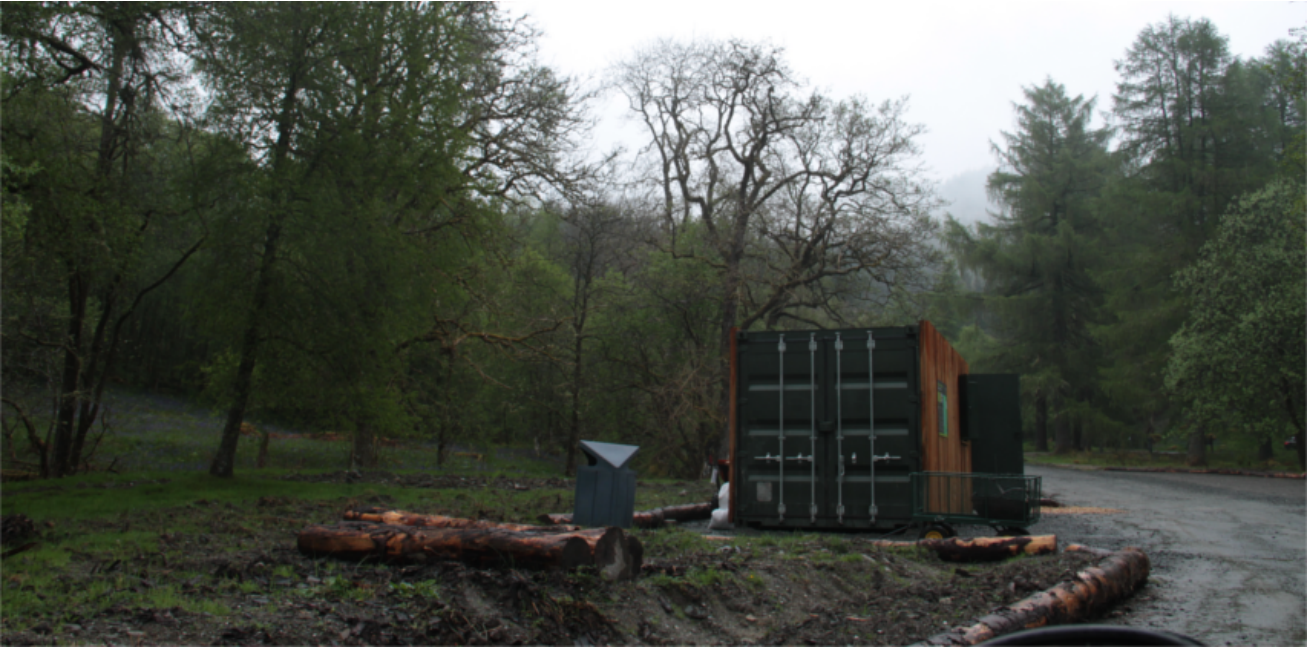
The last memory of your camping experience as you leave this site is this view of the office (below), a shipping container more at home in Tilbury docks, than a sympathetic camping development. It's another one in the eye for the National Park's Marketing Department.

Why are the logs in the image above still lying on site, they interfere with the vegetation regrowth and will result in another bare patch when removed? If they must be stored, do it on hard standing, better still in the Forestry Commission car park along the road.

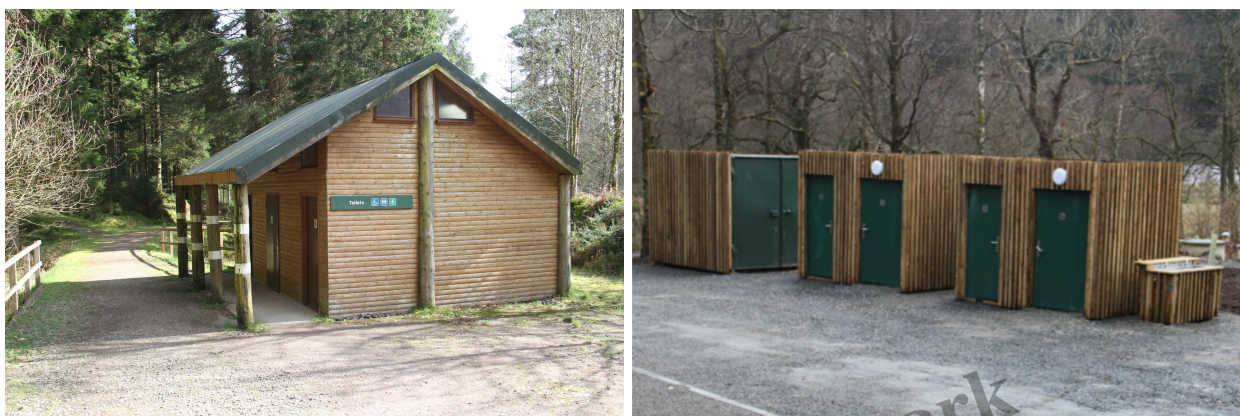
Forestry Commission – Shelter & Charm

LLTNPA – Containers, no shelter no charm

The Forestry Commission's rustic solution to toilet blocks, shown on the left hand image was the preferred style choice at Strathard community meetings and what most people would wish to see in our National Park, in stark contrast to the “industrial” containers the Park Authority favours. It's time the Park Authority started listening to its Partners instead of running roughshod over them.

The toilet blocks are containers like the ranger station, with high security metal doors to each “cell” opening in direct view of the car park opposite, offering no privacy to users. This is surely a breach of regulations.

The inappropriate plastic bulkhead light fittings have been chosen with no consideration of the specification laid out in International Dark-Sky Association guidelines that the National Park claim to be promoting ([see here](#)). The Park Authority are failing to make capital of this ideal site located away from any light pollution except for that of their own making.

Since the toilet block image (above) was taken, the fittings have been recessed into the wood cladding but still fail to comply with the dark skies requirement. Light fittings should shade upward light emissions while other light output should be directed downwards by internal reflectors not flooding the hill side opposite and sky as is the case here.

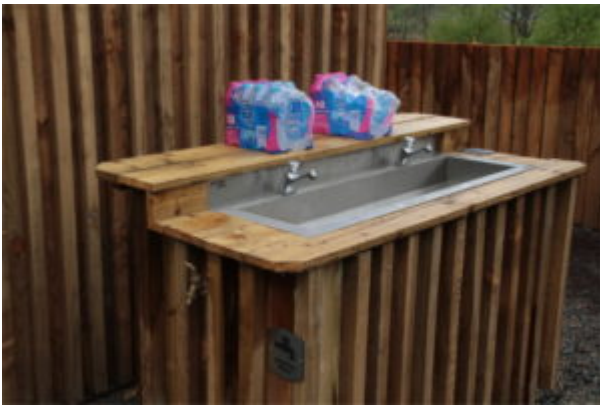
Bottled water for drinking and dish washing? – Water supply faulty – Fail.

The Park have now changed their story to say the contractor provided an external water supply during the period since opening. On the 6 occasions I have personally visited since the site opened, on 4 visits there was no drinking water and on 3 no water in the toilets. On another two occasions where a local resident attended, there was no drinking water. In total this represents 2 months without a contractor supply and 6 weeks without drinking water.

Incredibly on my 6th visit water was being supplied in plastic bottles – which raises the question once more, why? ([see here for recent history of the water issue](#))

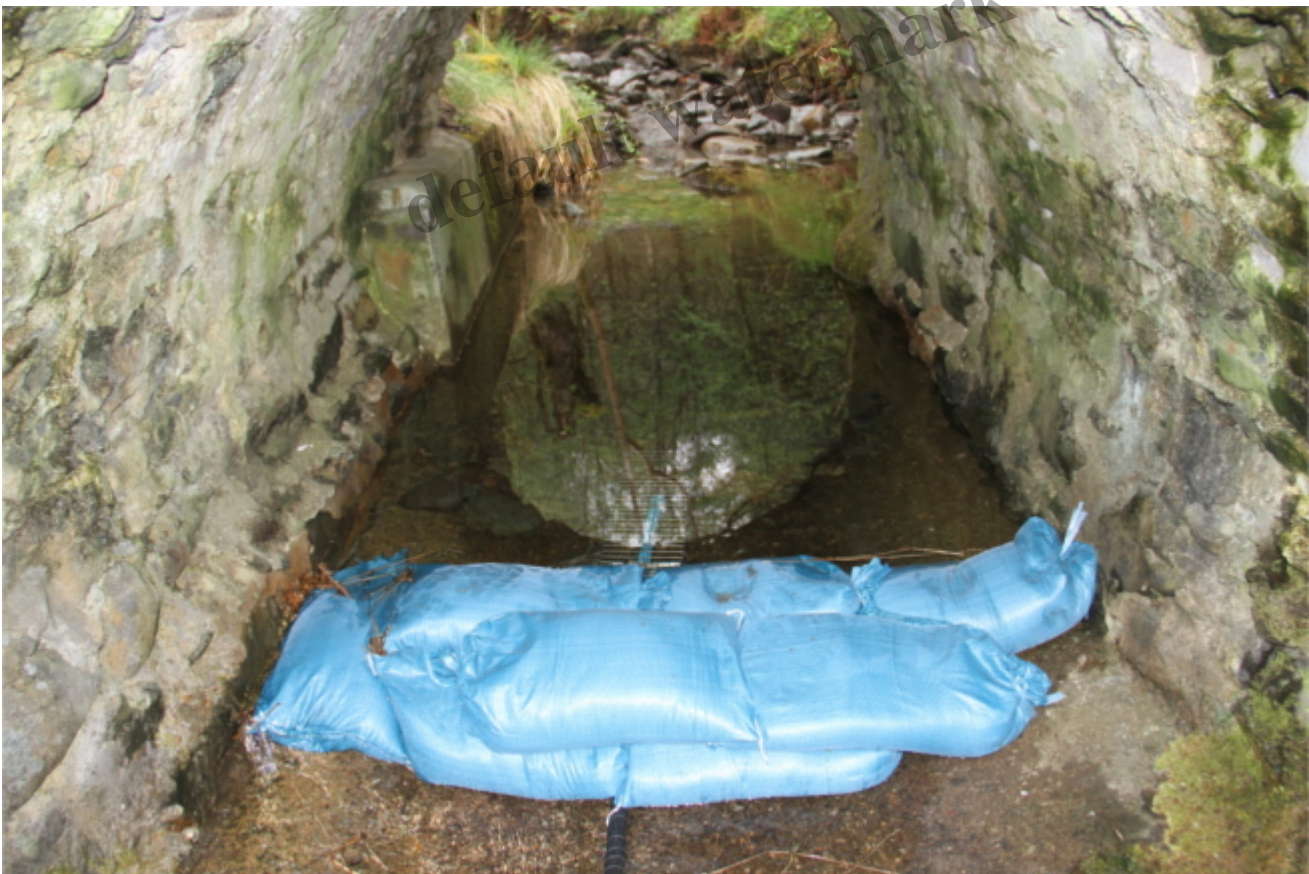
After each visit I have made, I have pointed out the shortcomings to the Park who have then modified the installation to mitigate each issue but as of yet have failed to take on board what is required to be done. After the dry spell at the beginning of May 2017, the water level dropped so low air could be

drawn into the intake pipe. The Park has responded by creating a slightly more substantial dam using sandbags instead of the the pebbles and rocks of the last one. This is getting them through by the skin of their teeth, providing unfiltered water for the toilets and wash hand basins but has not provided the solution to the drinking water problem.

The intake pipe remains open to the flow of water which poses serious risks for debris to enter the system with potential for blockages ([see Solution here](#)).

Note also the strainer on the end of the pipe another fiendishly simple solution, a copper stopper pipe with some nail holes. A strainer requires to be fitted at Loch Chon site to avoid future supply failures.
