Coire Cas report card – the HIE/Natural Retreats restoration and clear-up

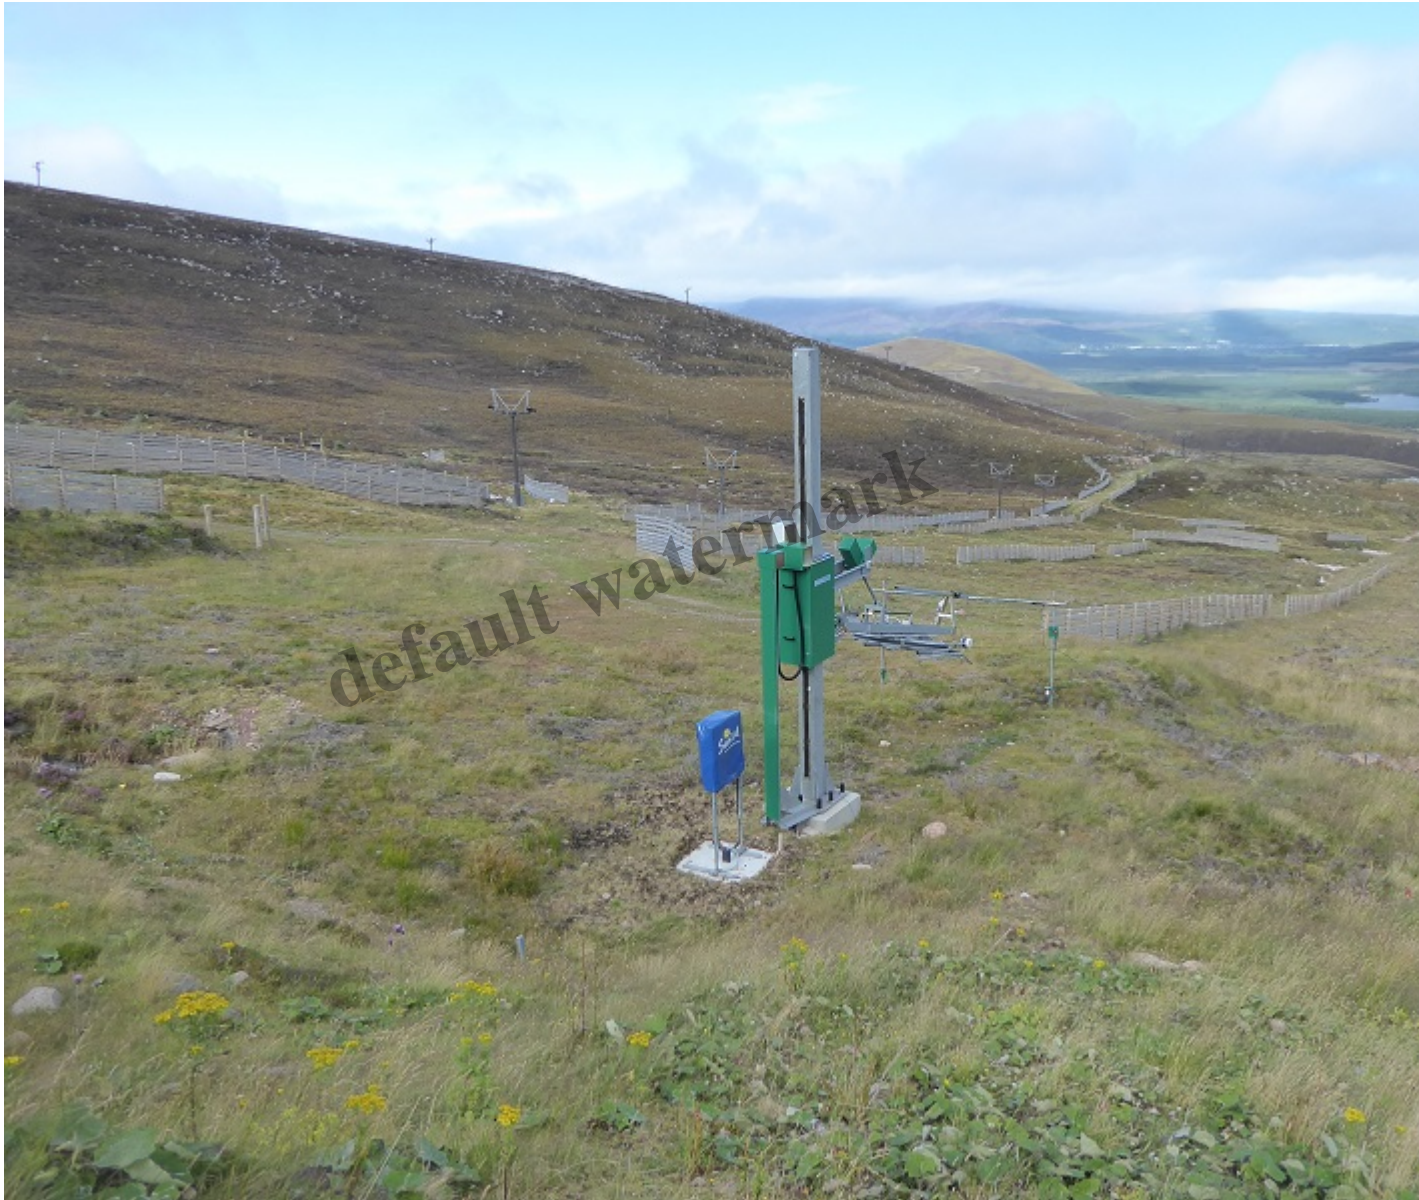
At a landscape scale, the impact of the work that was done to replace the shieling t-bar with a rope t-bar doesn't look too bad, with the most obvious change being the colour of the slope, which has changed from brown to green due to the replacement of heather by grasses. In the foreground you can see ragwort which has grown on the disturbed ground.

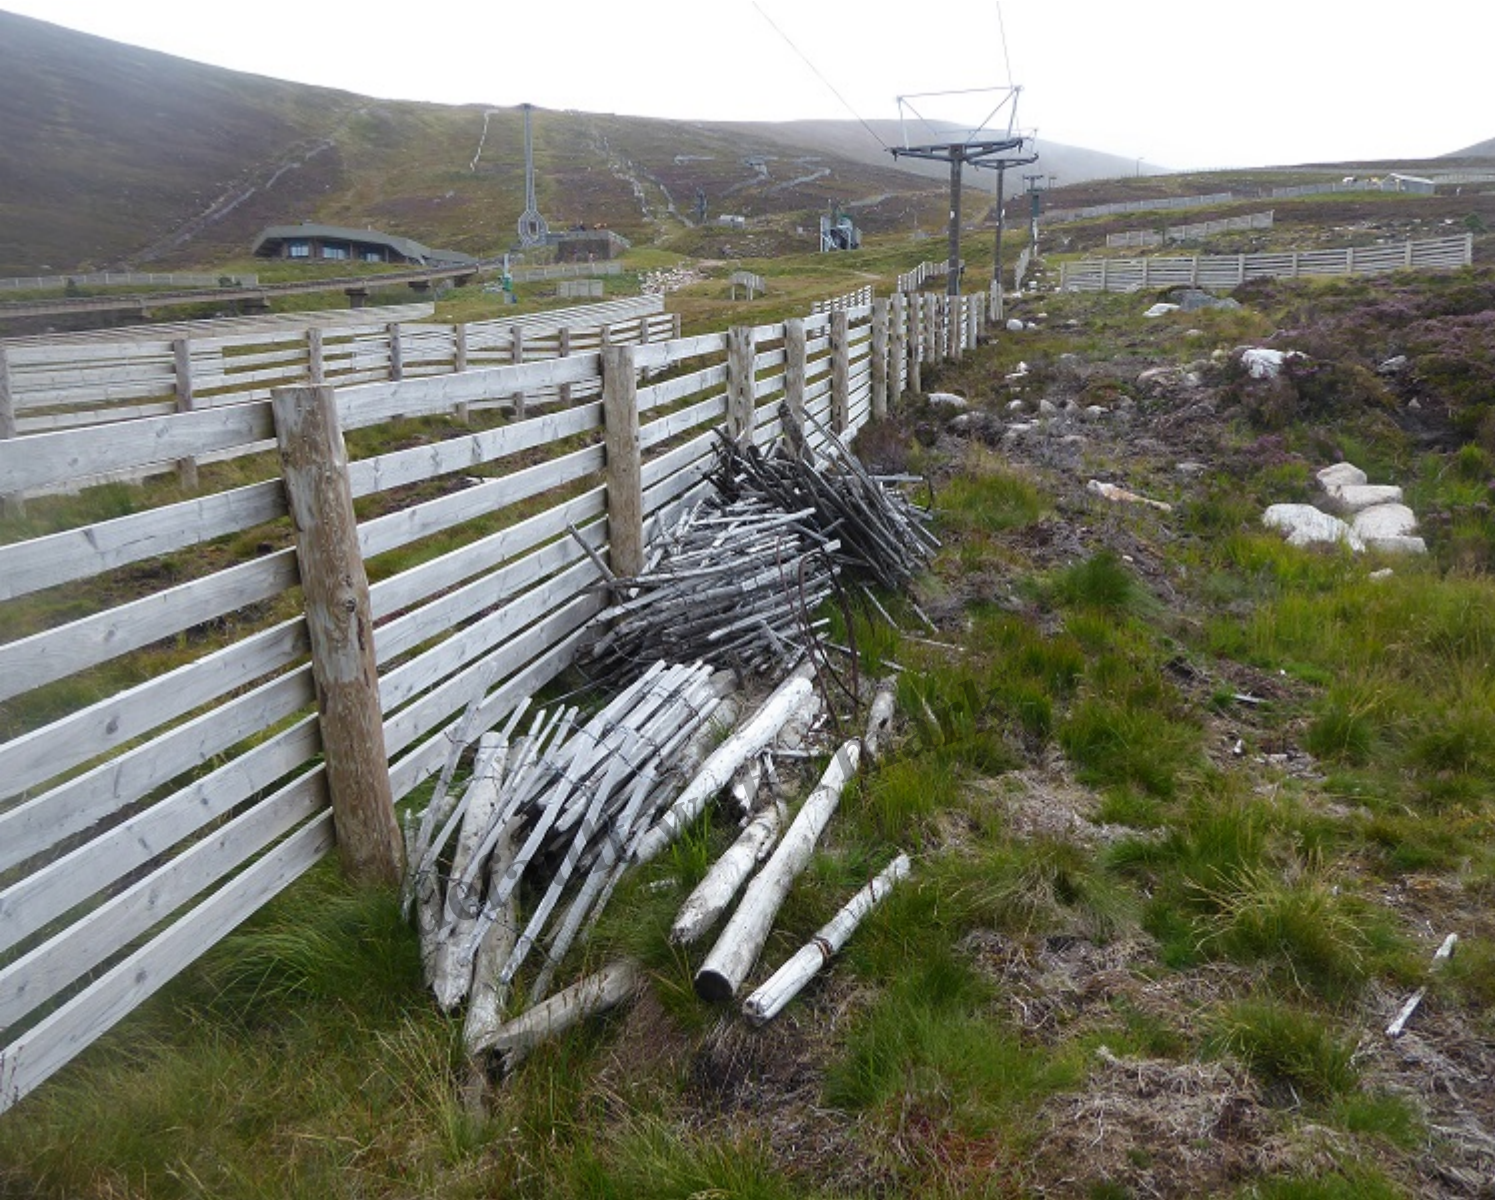
While a fair bit of rubbish has been removed from Coire Cas, including bits of pipe that must have been there 30 years, we did not have to look far to find more. The cynic in me wondered if it had been placed on this side of the fence so it could not be seen by passengers travelling in the funicular!

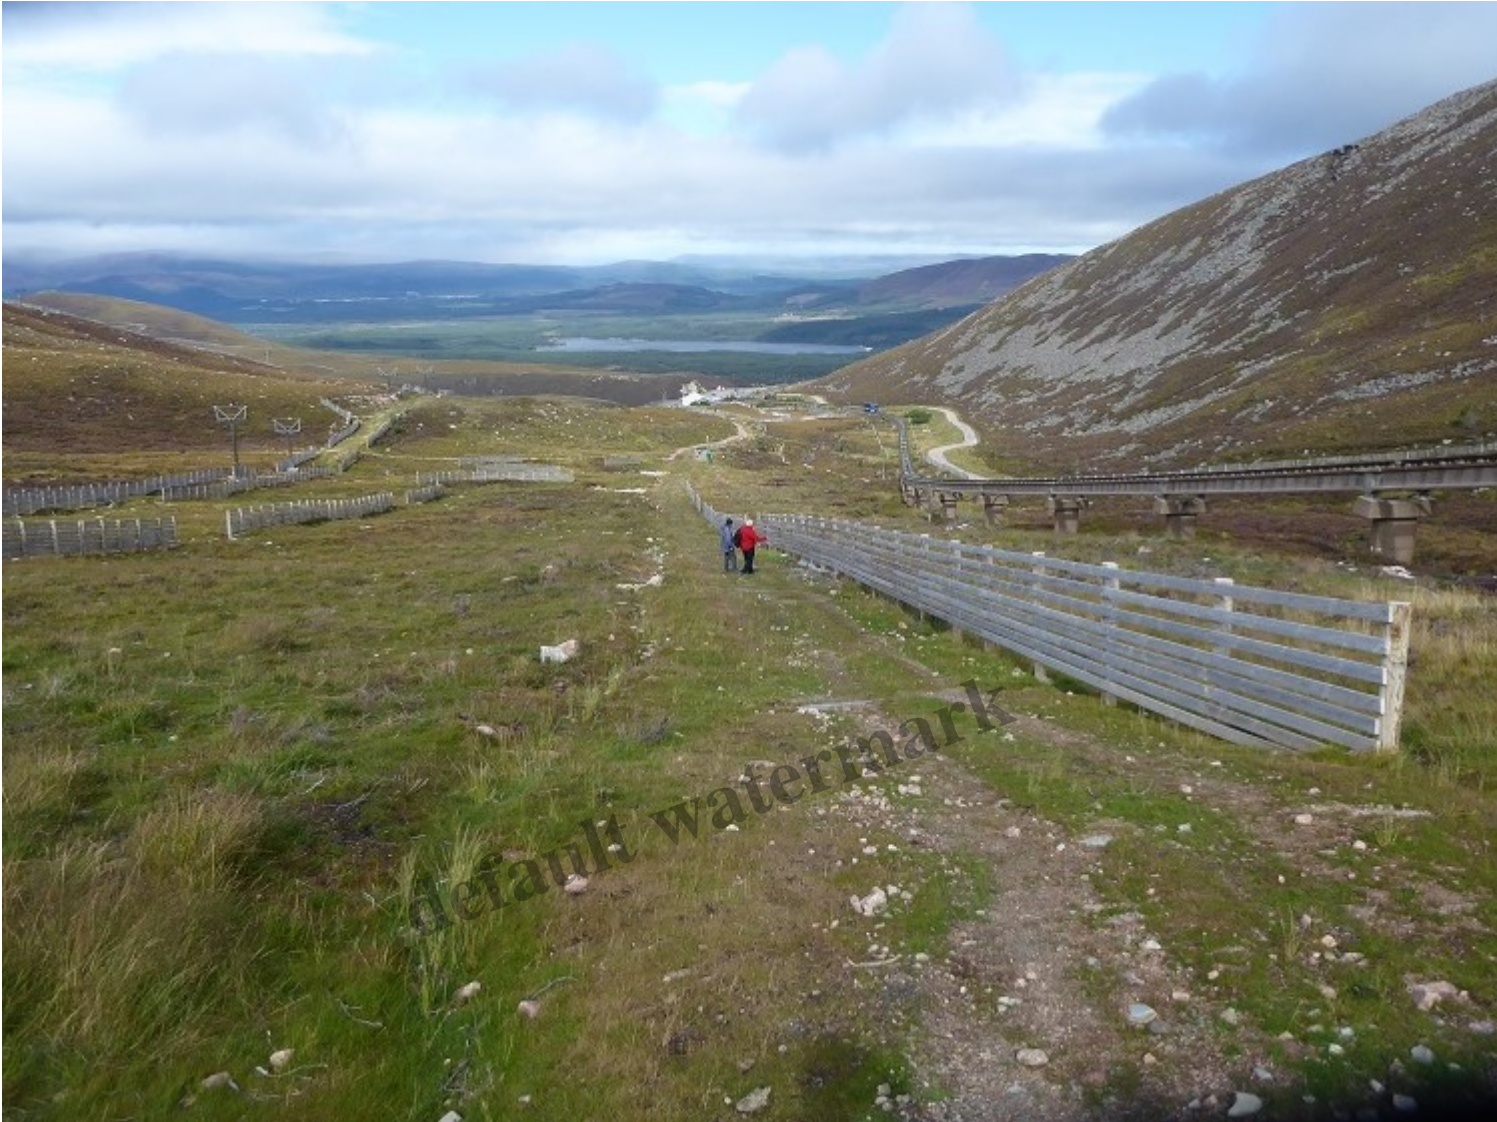
The shieling track, which had been created unlawfully and then granted retrospective planning permission by the Cairngorms National Park Authority ([see here](#)) looked far better than we had expected. The whole track surface, including wheel lanes, had been re-seeded which has helped to stabilise the ground and cross drains installed, as required by the CNPA. So, were conservationists wrong to oppose it? I don't think so. The reason why it looks this good is that it has not been used.. The question is what will happen if and when it does?

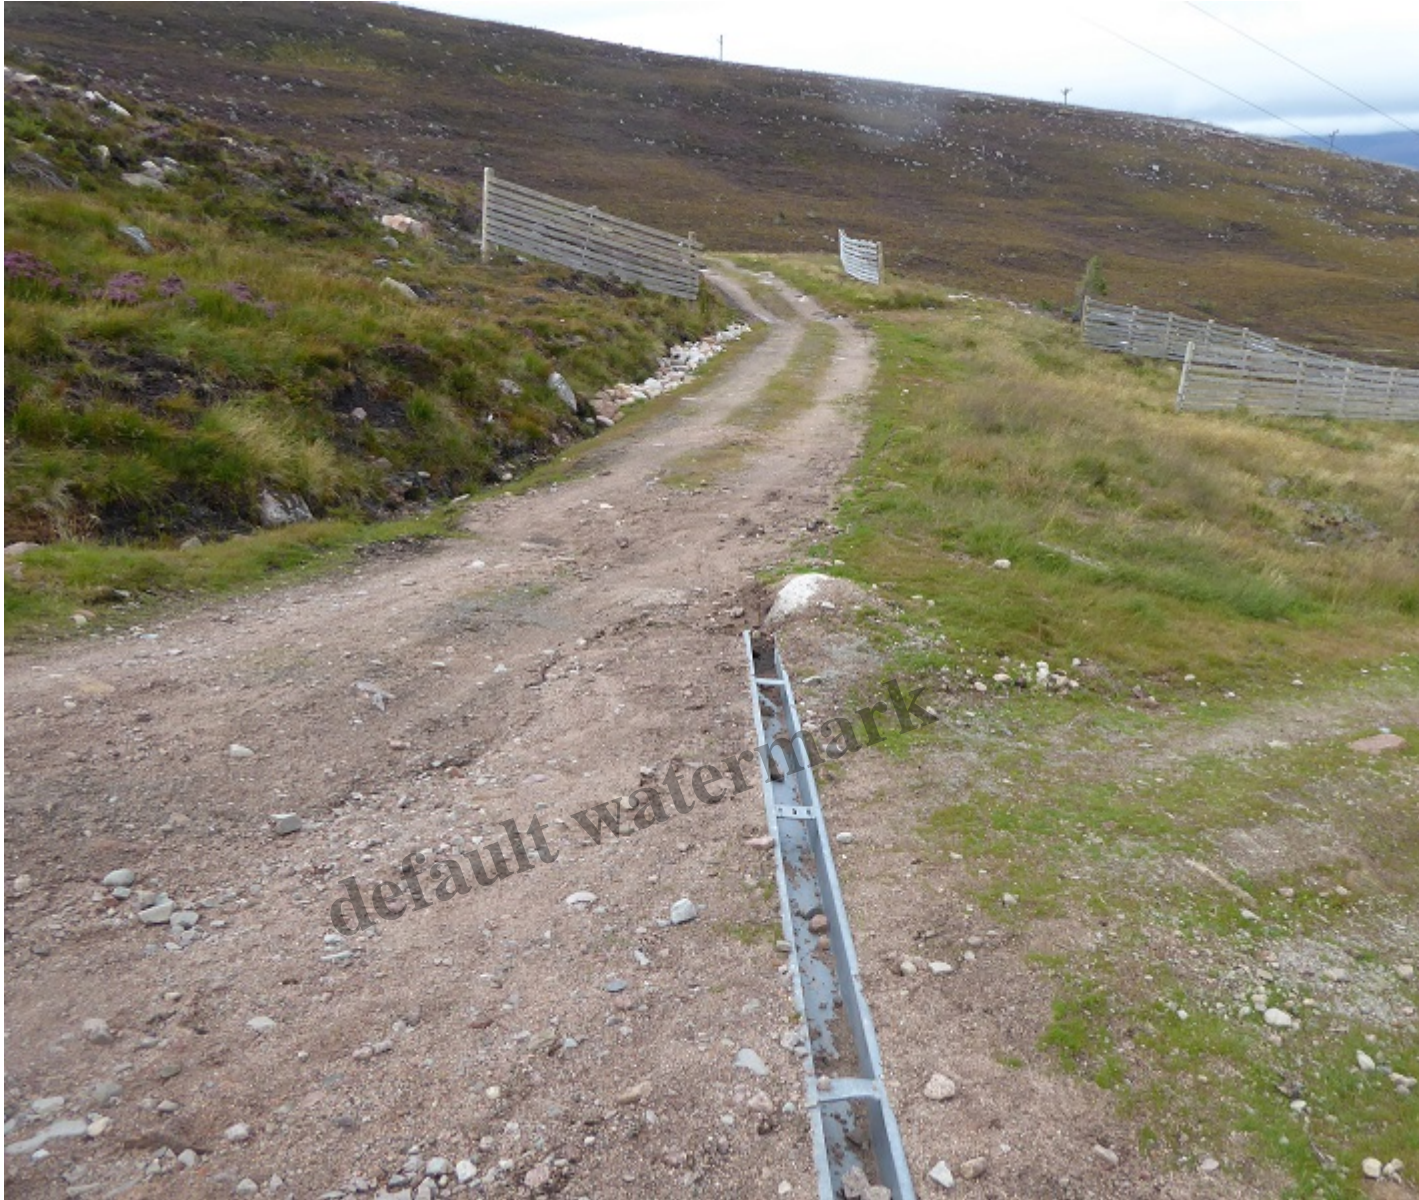
Poor track design. The cross drain empties onto the track beyond and while protecting the top of the shieling track (right) will increase the erosion on the track to the former Fiacail T-bar (left – and which incidentally has never been granted planning permission). Note the rut developing at the end of the track.

There is evidence for what will happen this from the top of the shieling track (the start of the track is to the right of the cross drain in the photo). As soon as vehicles use this ground the re-seeded grass is likely to wear away and the surface of the track erode, as on the left side of photo. Since the shieling track is significantly steeper, exceeding at the top SNH's maximum recommended inclination for hill tracks, the erosion is likely to be worse.

The paradox here is the only way the Shieling track will look

acceptable is if it's not used. Perhaps the CNPA should have followed the advice of the North East Mountain Trust who suggested heather should have been re-established across the entire shieling slope and that the uptrack under the rope tow could have been used for occasional vehicle use?

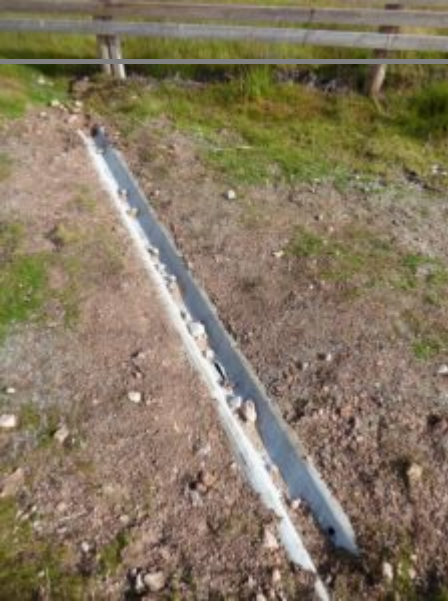
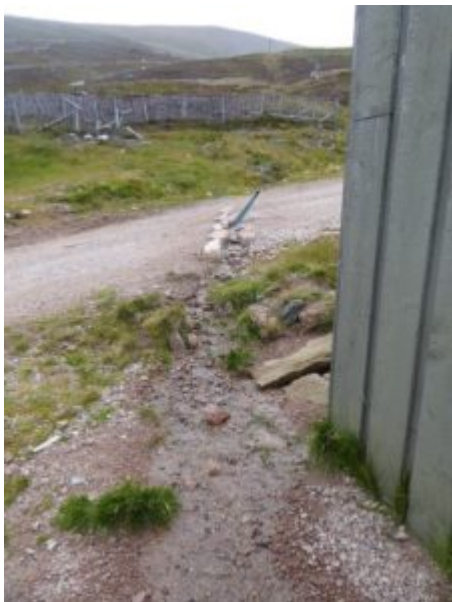
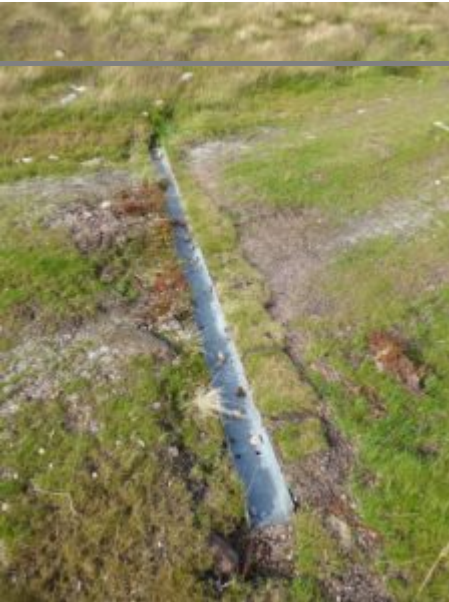
Cross drains have been installed along the Shieling track (left – a recycled Council road barrier is far cheaper than using natural materials) but the re-seeding has not stopped some sediment and stones being washed into them, a sign of continuing erosion.

We did see one example of a cross drain where a significant amount of

care had been taken (left). The turfs should help hold back and filter sediments. By contrast, above, was an example of Natural Retreats' incompetence (right). Water channelled against the wooden sides of the pump house building! Rotten to the core!

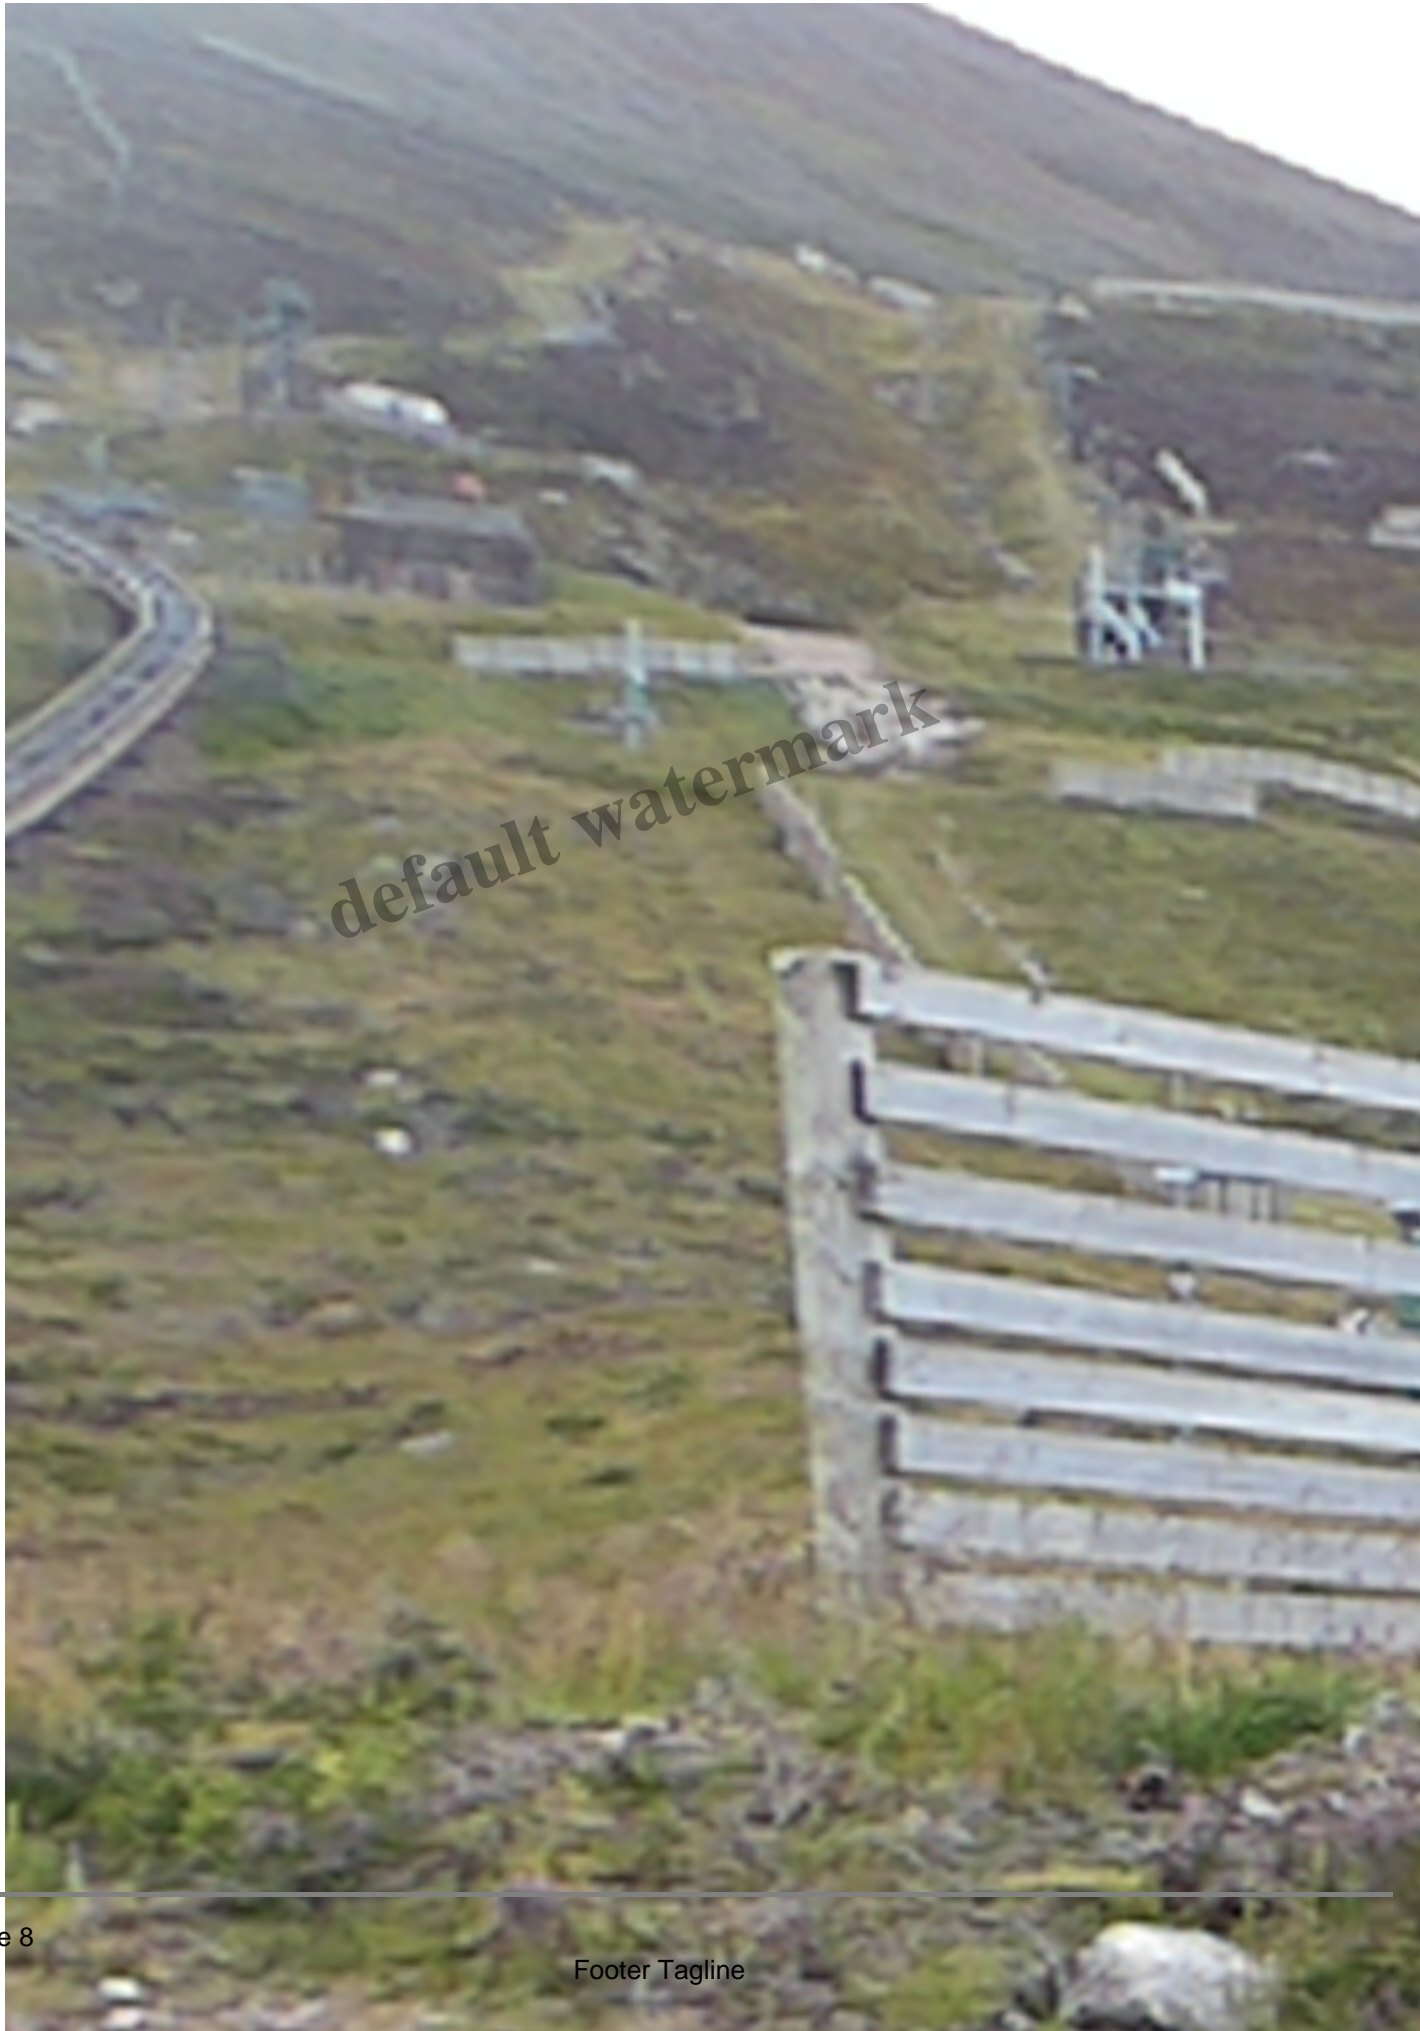
The area below the shieling rope tow outwith the area granted planning permission by the CNPA. The

The photo demonstrates the large area affected by the shieling works and where vegetation and turves were not retained prior to re-instatement, hence all the re-seeding (the green in the photo). While heather should re-colonise this area in time we will need to wait to see other longer term impacts, such as whether invasive species colonise some of the ground. The picture will be complicated because the CNPA required compensatory tree planting as a condition of the retrospective planning permission, although this had not started at the time of our visit and there is no mention of this on Cairngorm Mountain's "Behind the Scenes" blog (Autumn is a good time for planting).

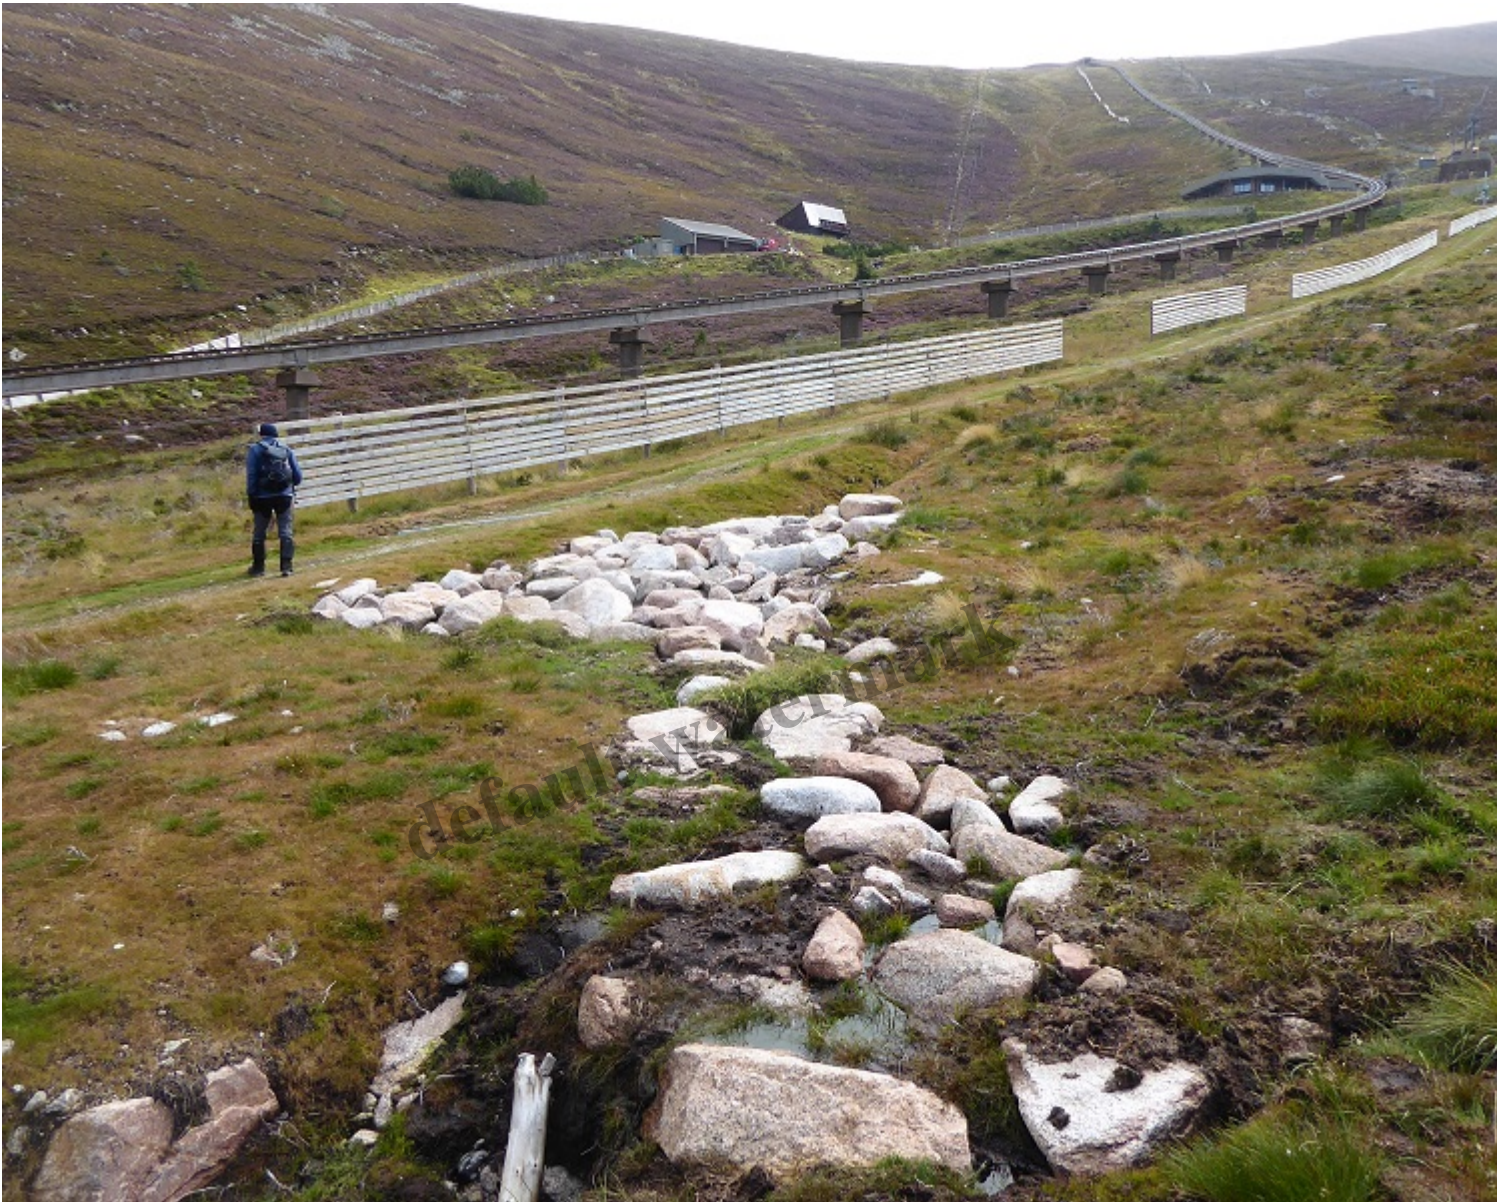
My biggest concern on the day was landscaping. The area with boulders is outwith that granted planning permission but has been subject to extensive engineering works and new drainage. It looks totally out of place and there has been no attempt to restore the slope to how it previously looked.

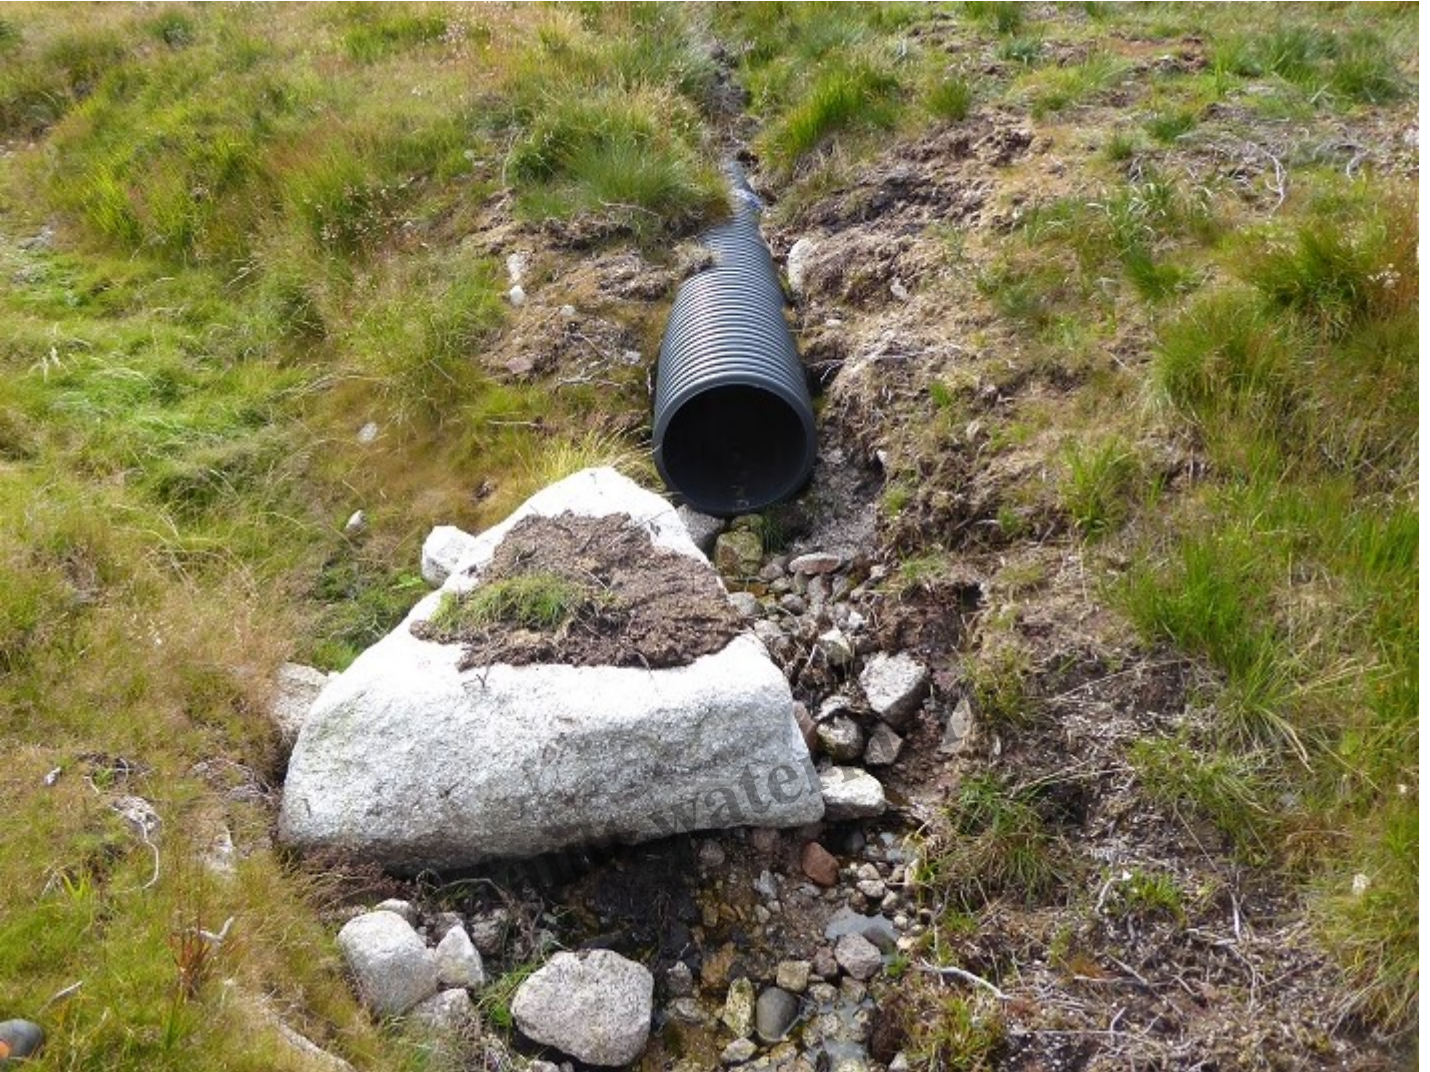
While culverts along the burn at the bottom of the shieling slope – which required permission from the Scottish Environment Protection Agency – have been finished well, other culverts which did have permission from SEPA, are right eyesores.

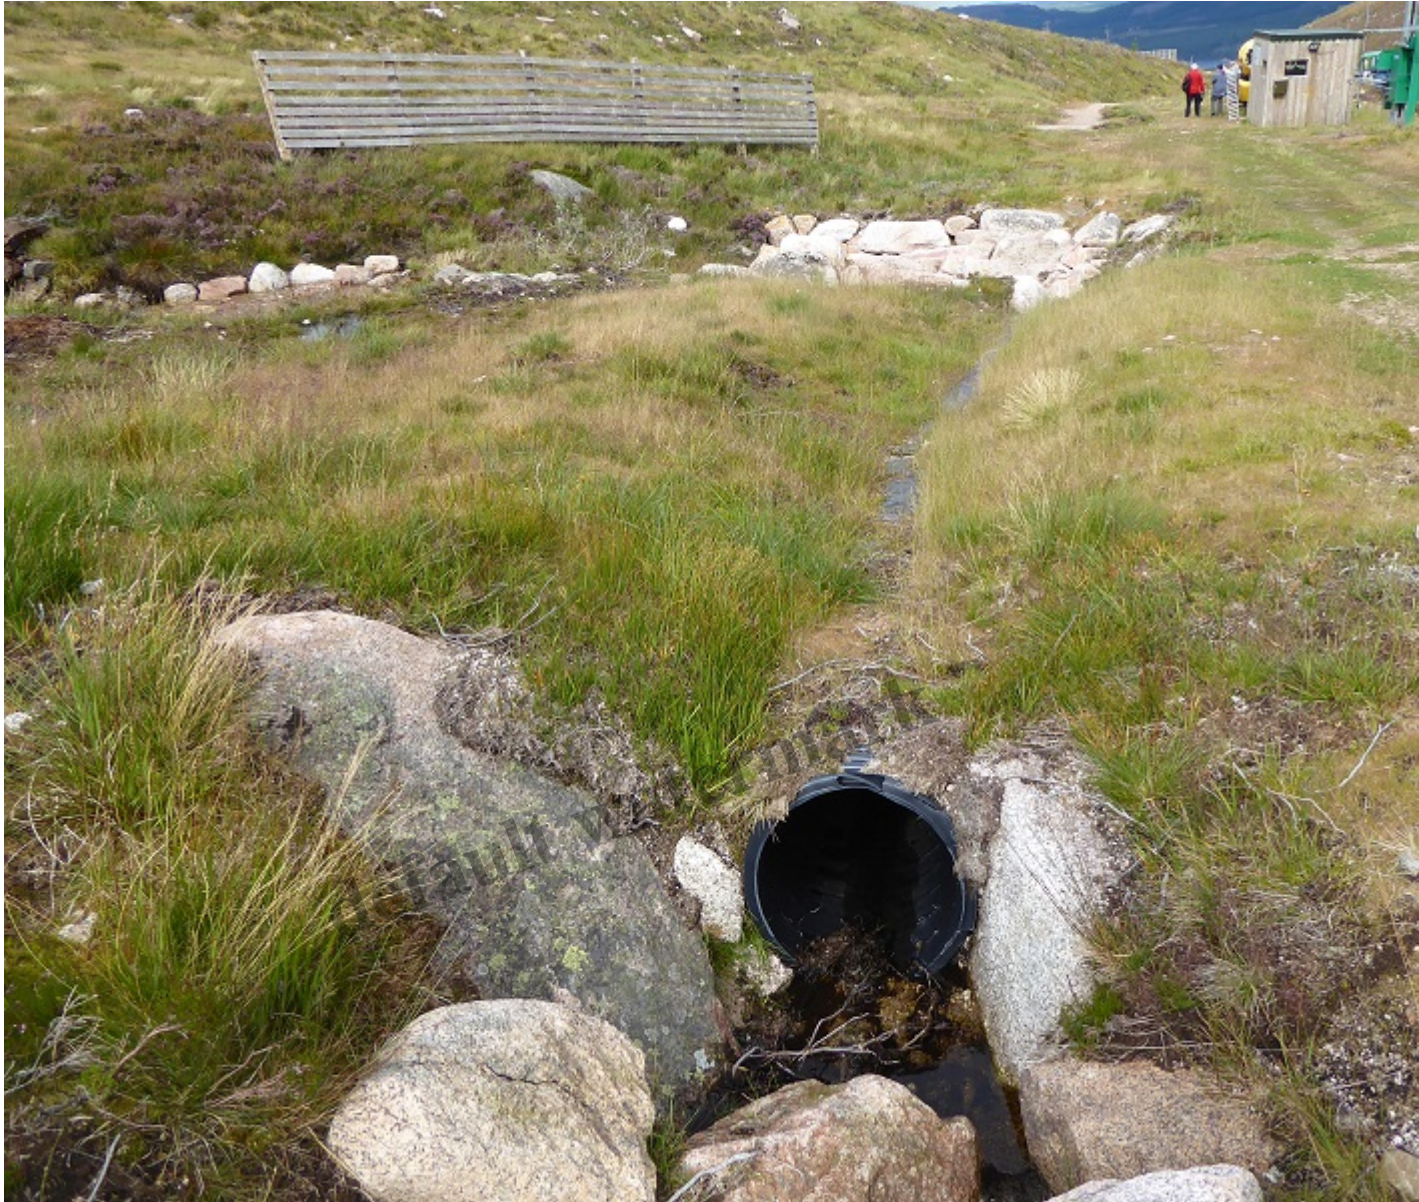
Natural Retreats did not retain enough soil/peat to replace vegetation on top of culvert, required to erode to cross over to the bottom of the new rope tow.

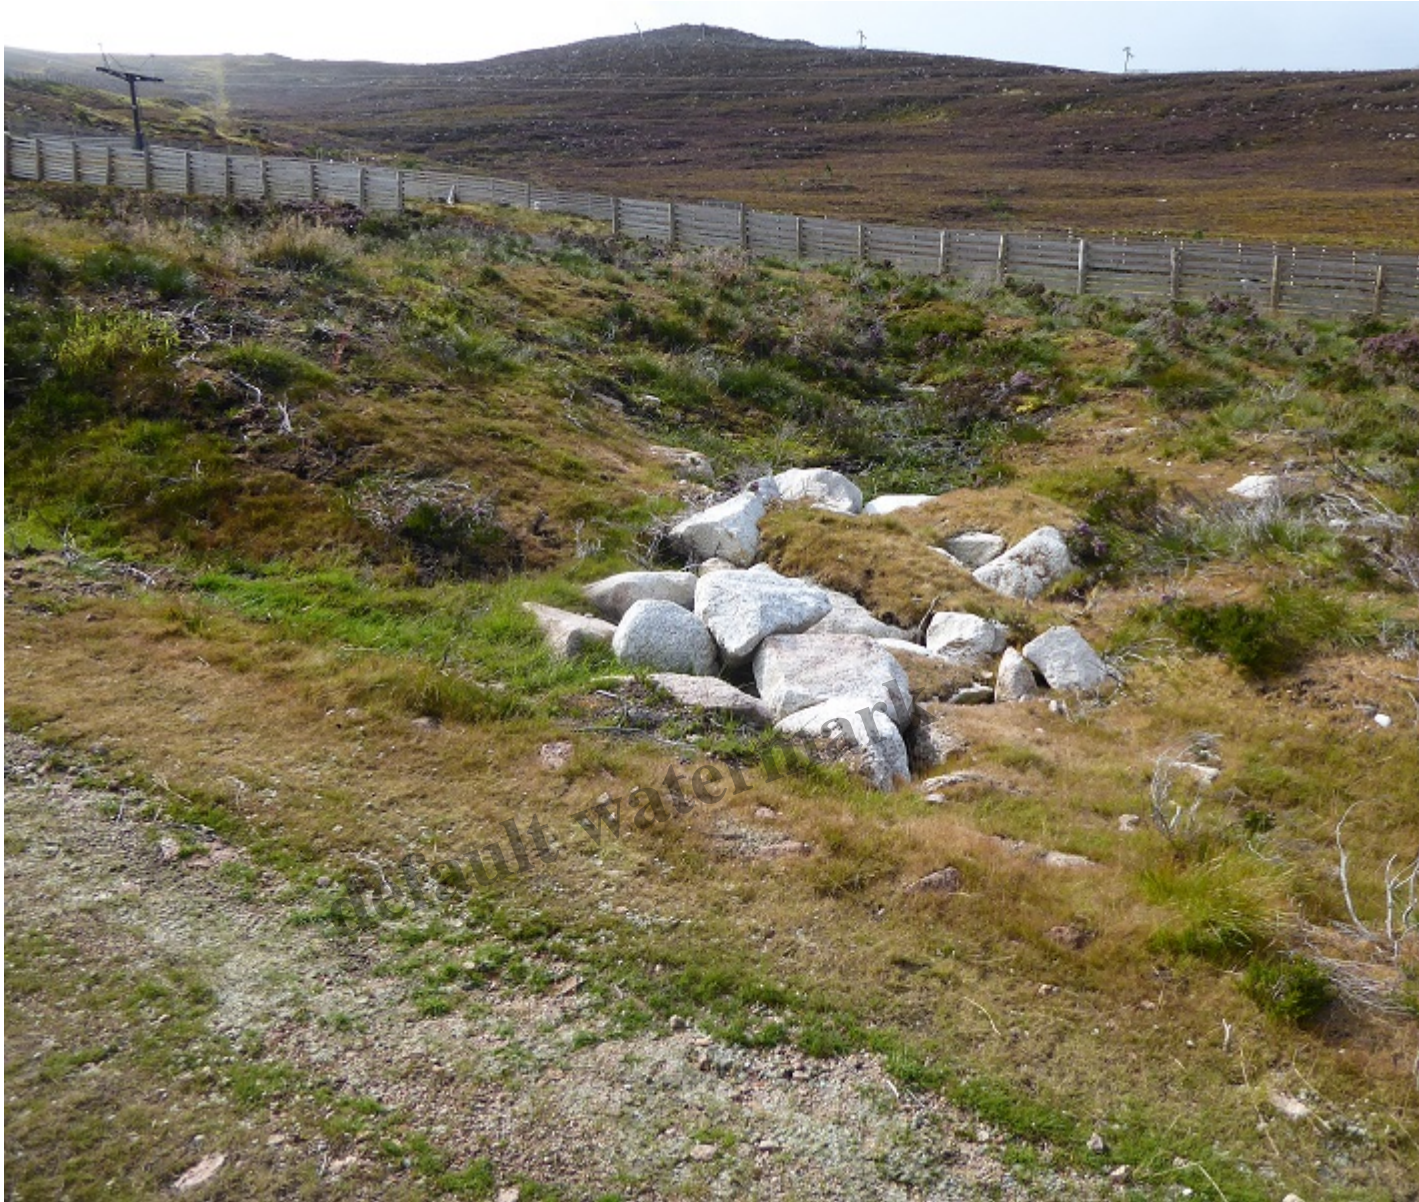
Natural Retreats has made half an attempt to conceal these boulders by the Shieling track

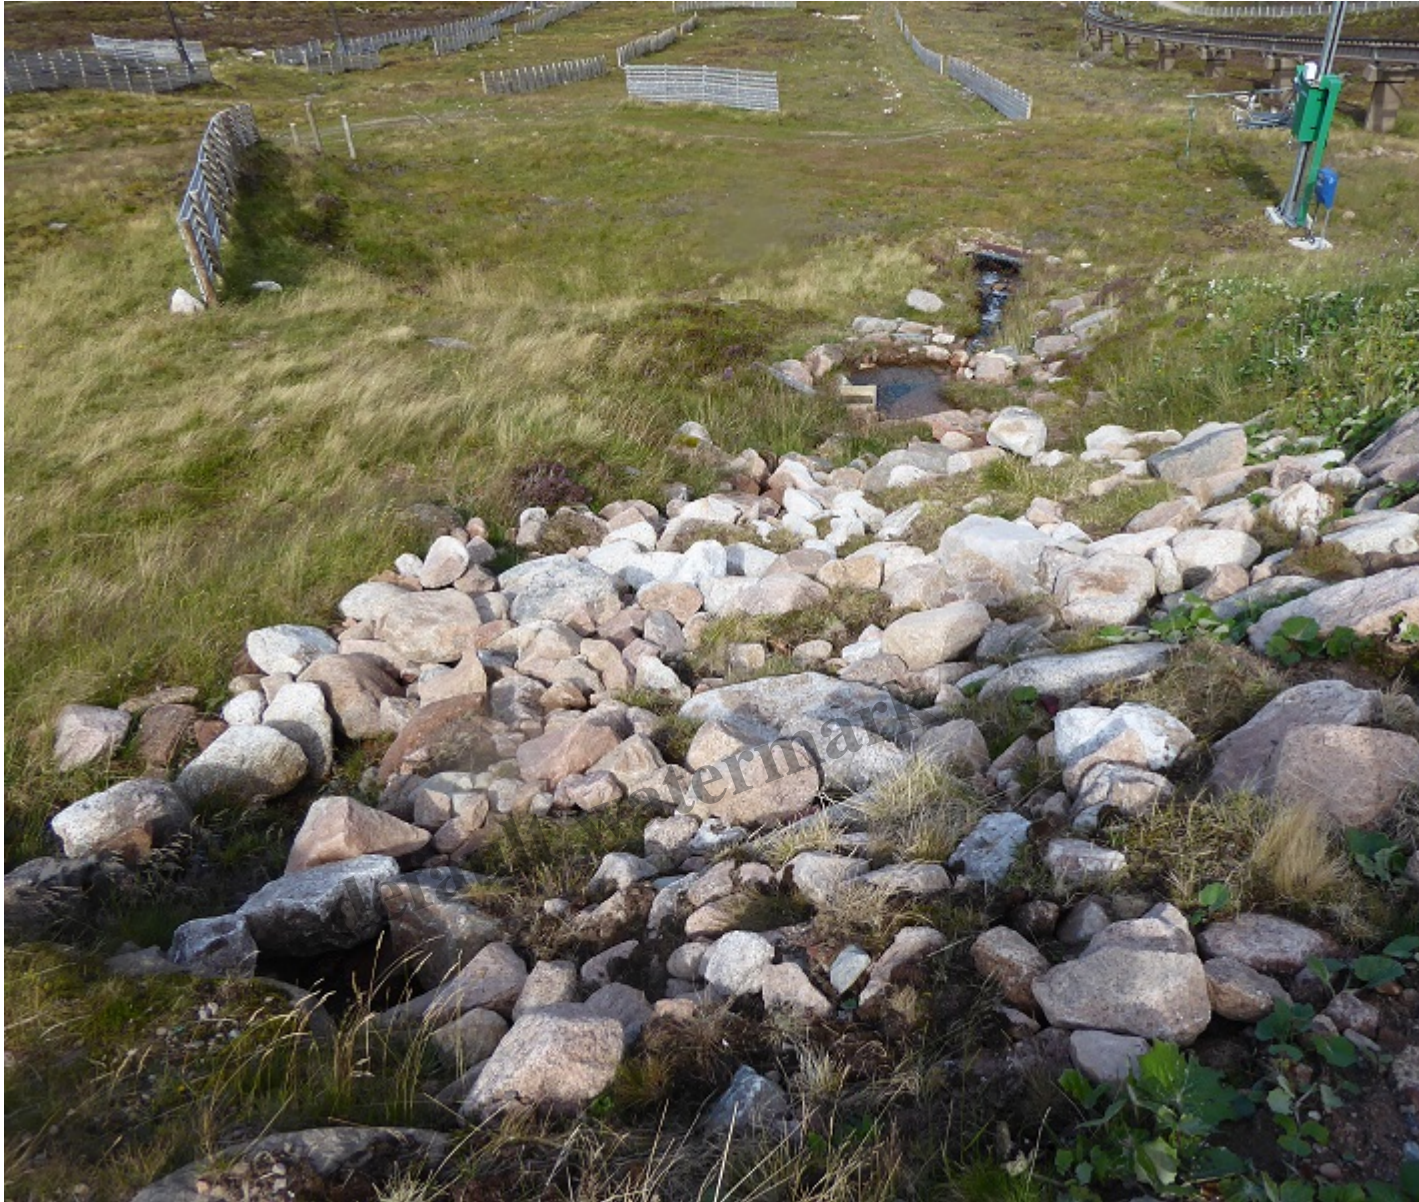
Above the shieling rope tow the boulder dumps are more visible from a distance

The shieling rope tow and surrounds was subject to planning permission from the Cairngorms National Park Authority and they therefore continue to have some influence (legally) on the restoration of this area. The three things I think they need to focus on are: restoration of vegetation, landscaping and the ecological impact of the changed drainage in the area.

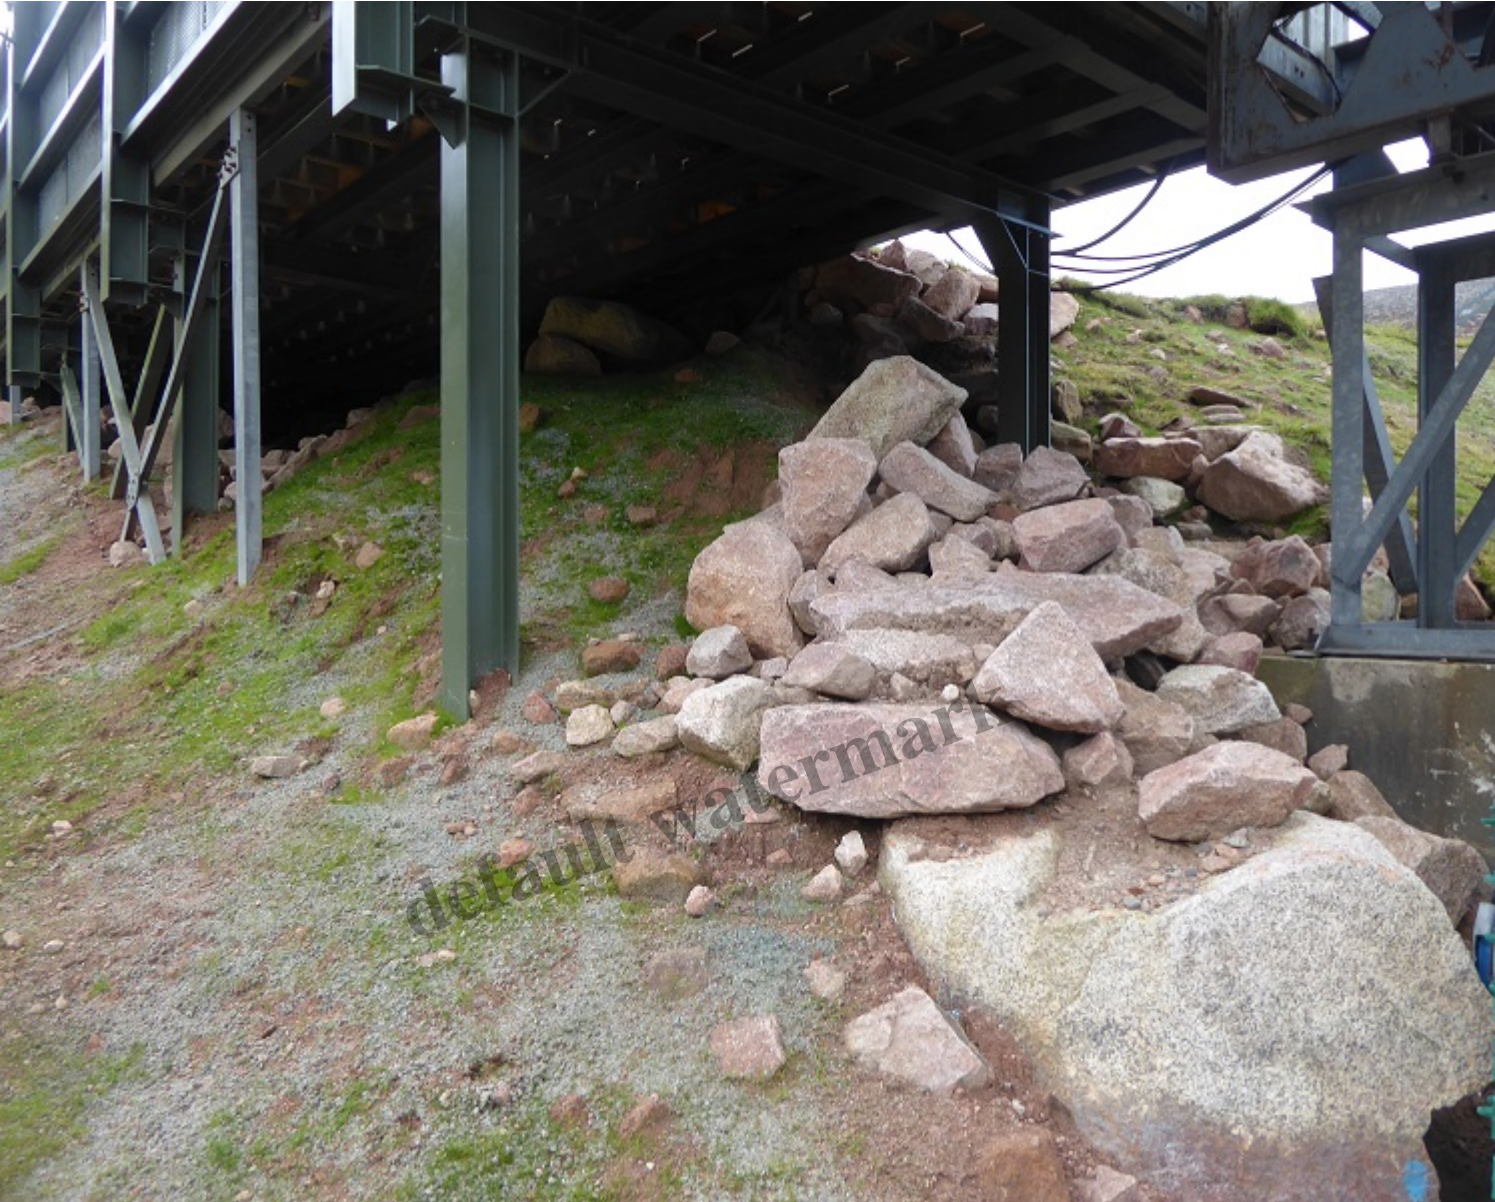
Some, but not all the boulders which were shoved under the gantry as a result of piste widening works (no planning permission) have been restored.
