Coire Cas report card – the HIE/Natural Retreats restoration and clear-up

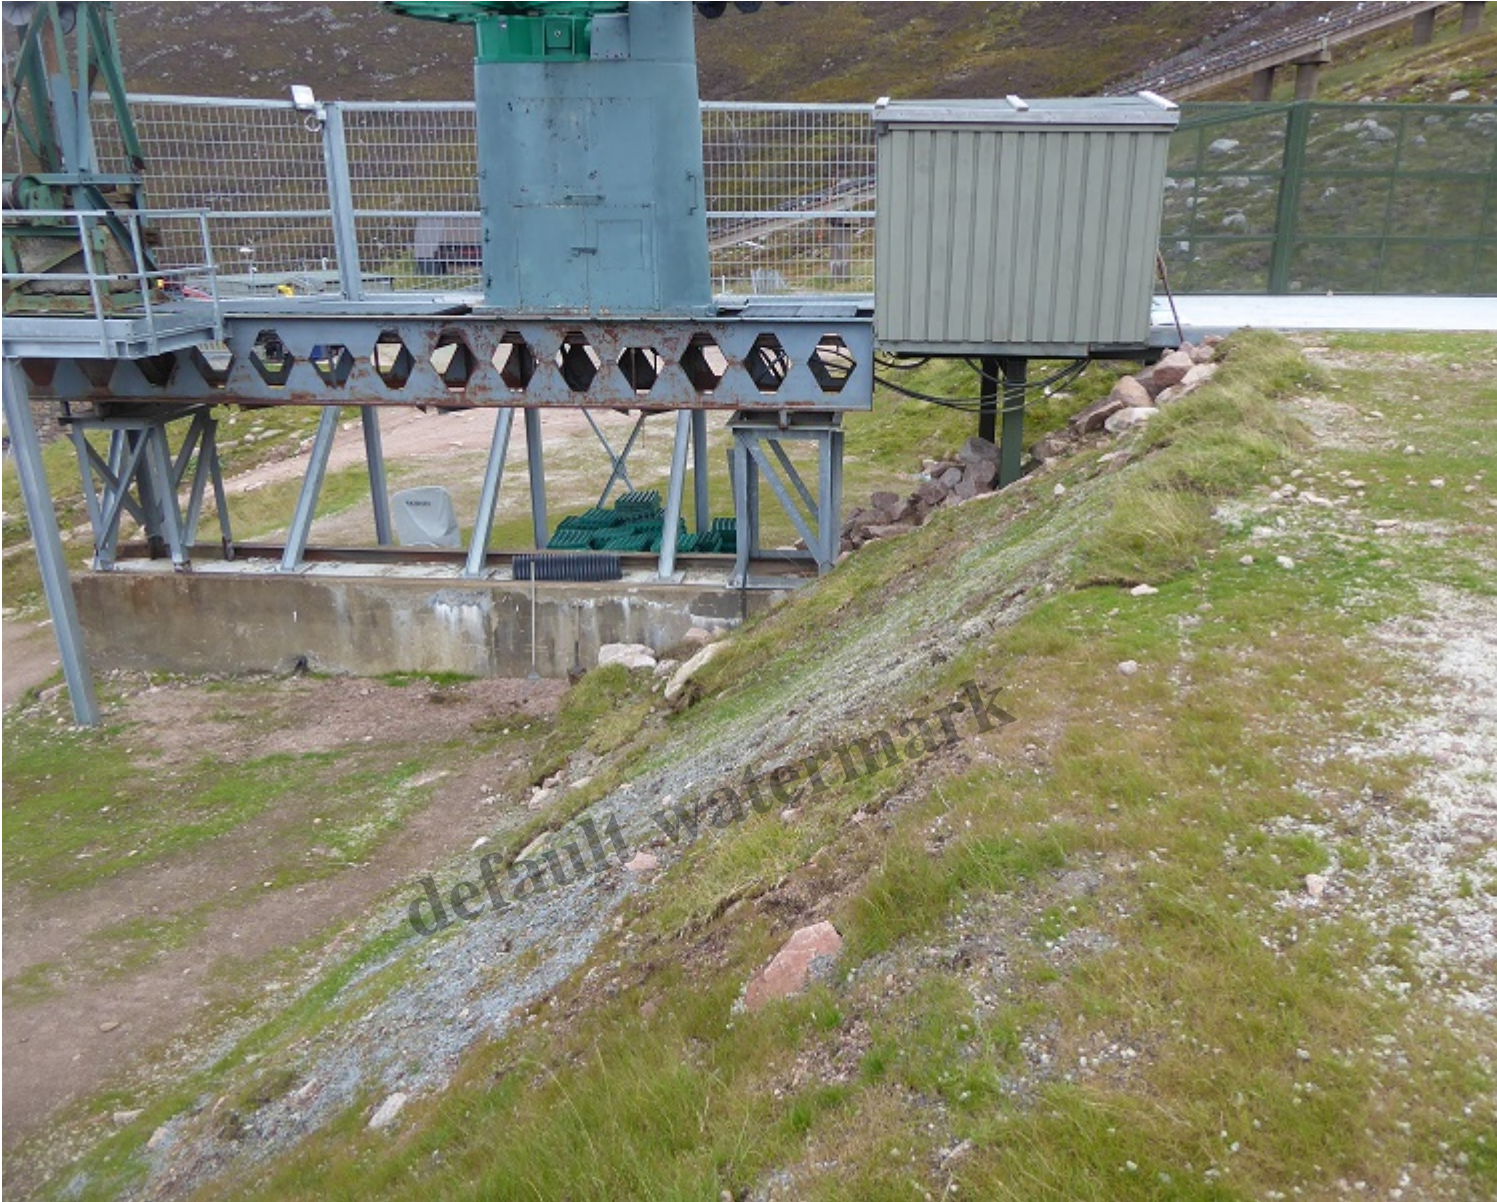
Turf has been placed along top of the slope which Natural Retreats excavated in order to try and prevent water flooding down it. The basic issue is the slope is too steep and no vegetation/turf was retained for restoration purposes. The bluish re-seeding pellets (left foreground) continue to get washed out and the risk is this slope will again be subject to severe erosion this winter.

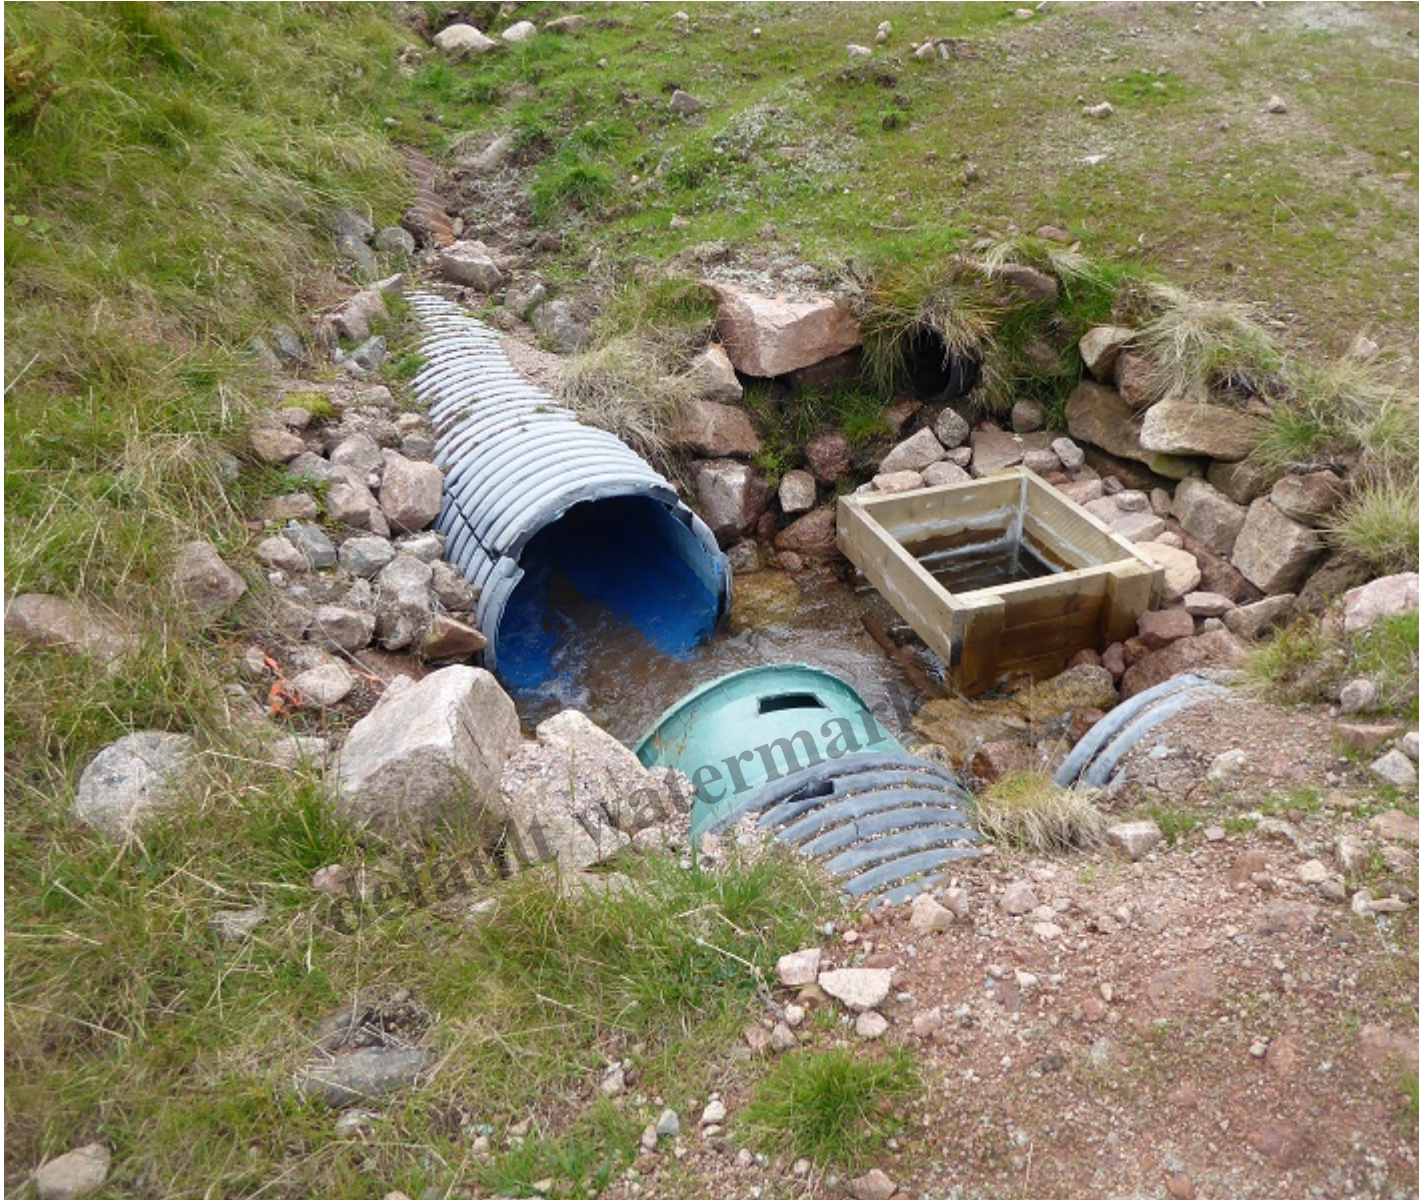
Culvert pipe chopped? to create pool to provide water for snow making machines. I understand the v on the right helps sediment in the water to settle out and prevents the snow making machines becom with silt.

The finishing of the culverts is very poor.

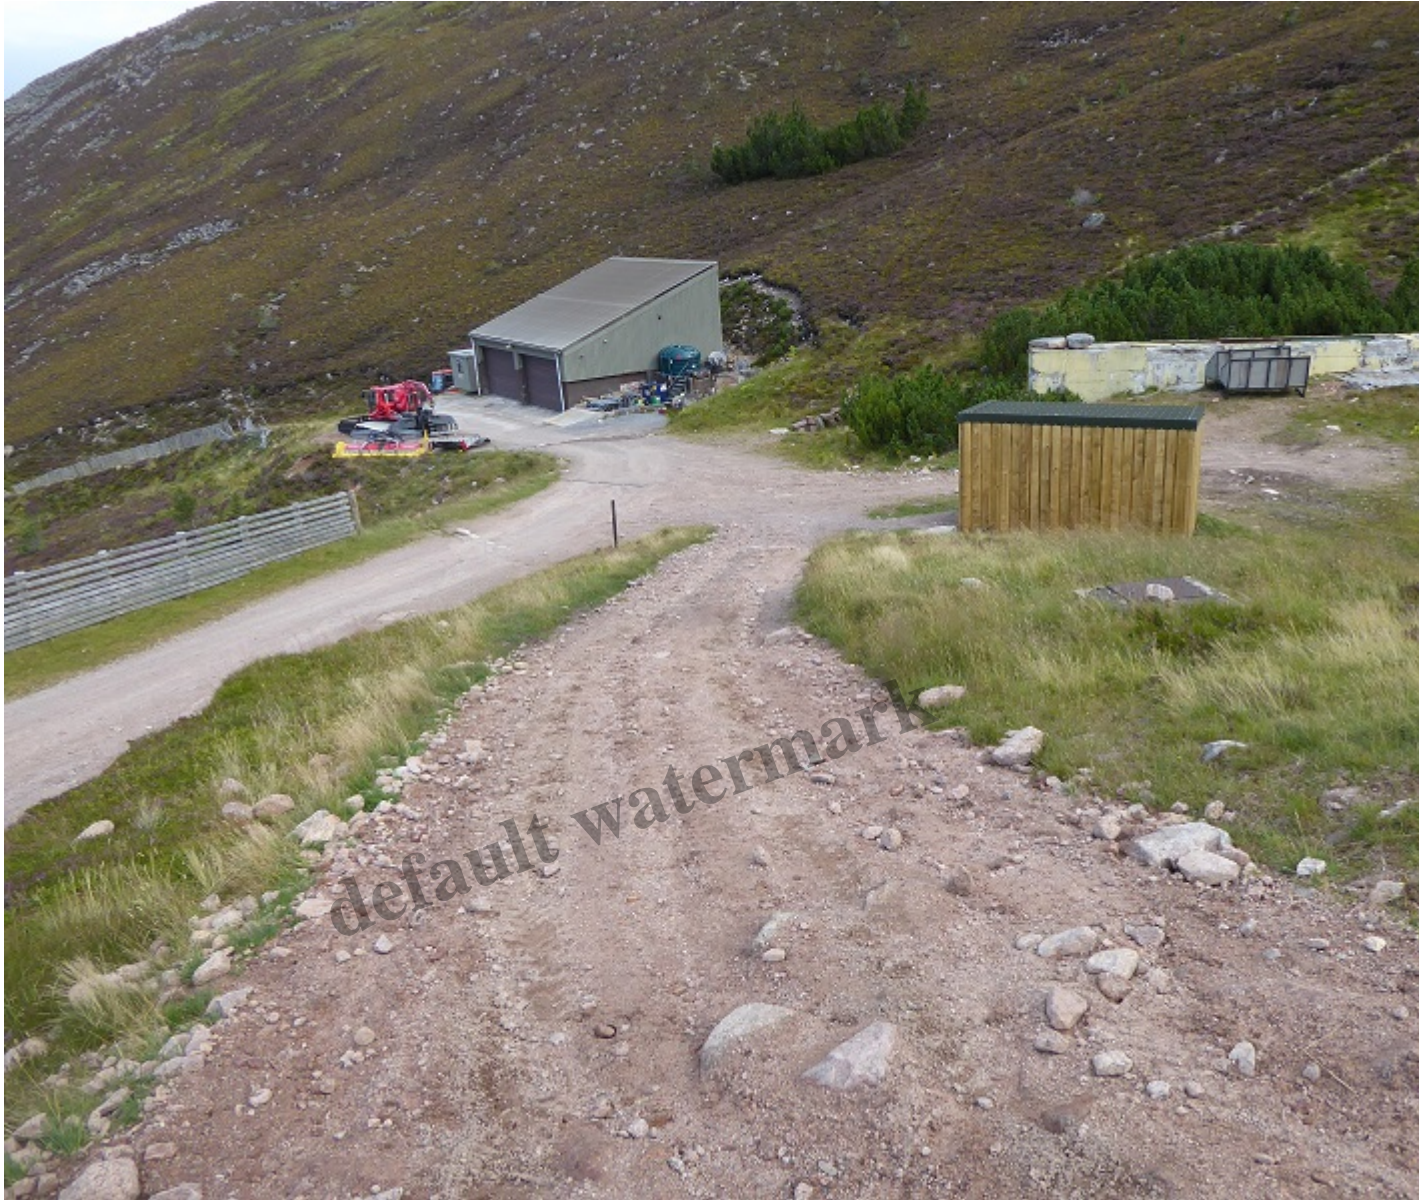
View down “track” from former shieling restaurant to recently renewed former Lifties hut.

Worst of all though is the uncontrolled use of vehicles. The track above never used to be there, has been created through vehicle use, is far too steep and is eroding badly. It has never been granted Planning Permission. Forest Enterprise Scotland provides Prior Notification for new tracks as short as 40m to Planning Authorities so HIE has no excuse for this.

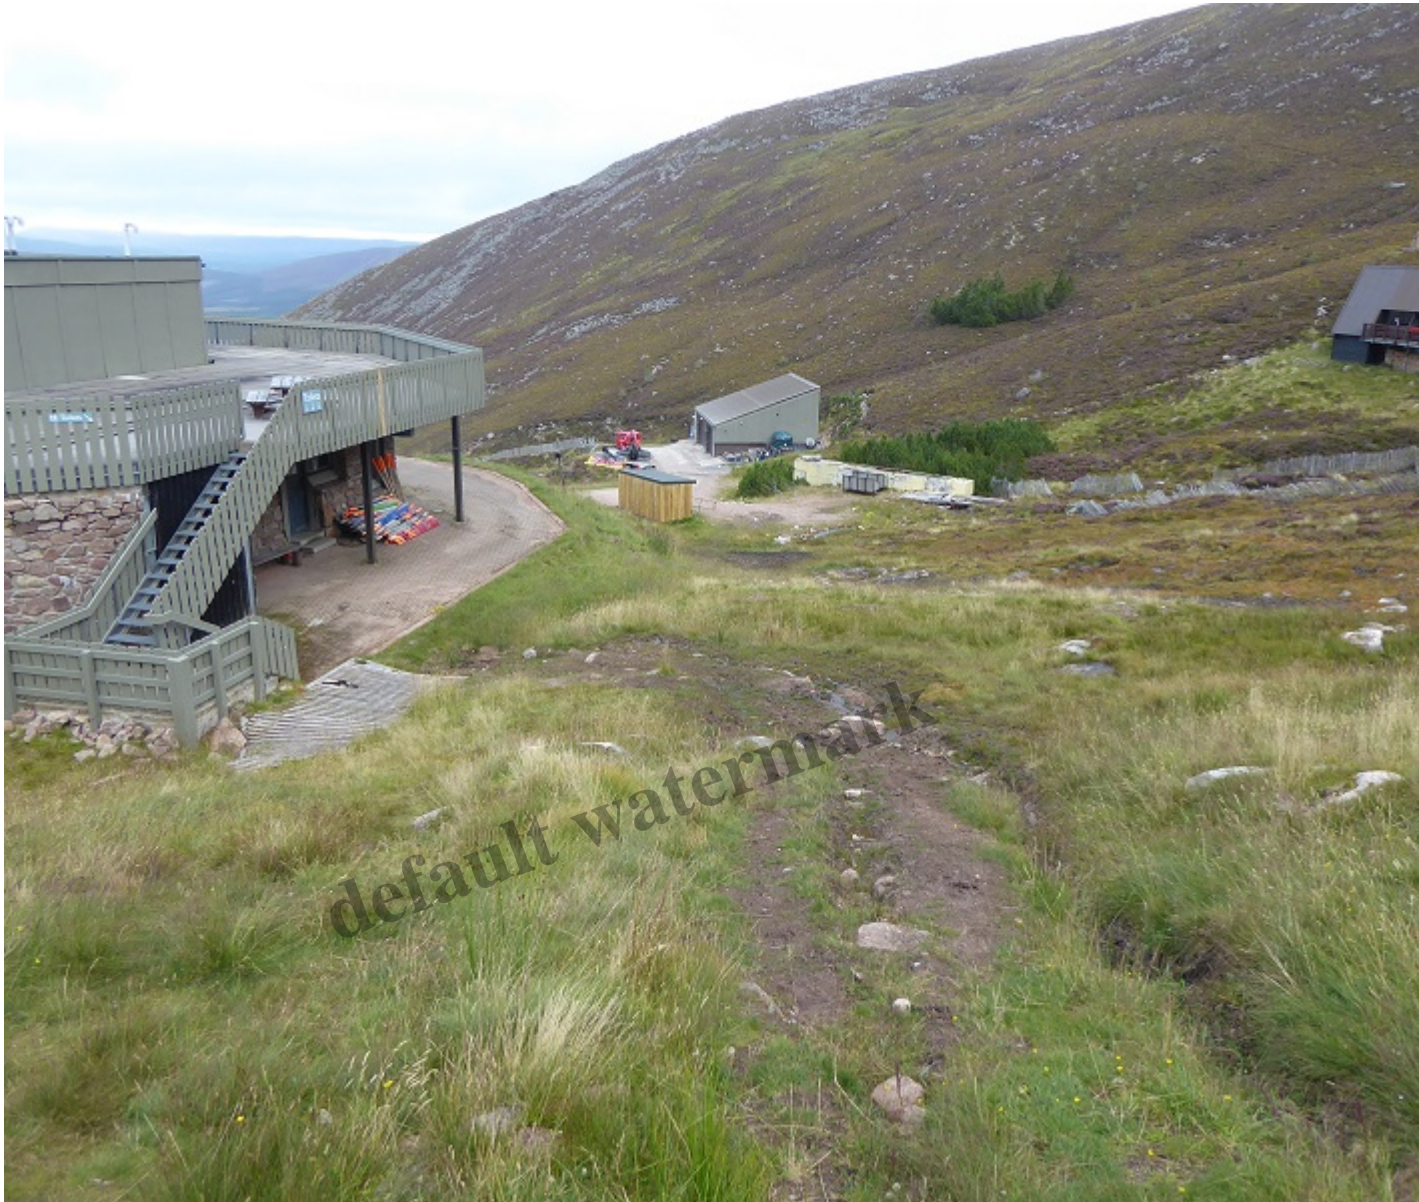
ATV tracks by the former shieling restaurant – there is a second track on the right running parallel to the centre.

Off track use of vehicles at Cairngorm used to be strictly controlled but is now seen as unnecessary bureaucracy.
