## The landscape impact of the Beauly Denny

This post will consider the failure of Scottish and Southern Electric to date to restore the landscape caused by the Beauly Denny construction works in the northern section of the Drumochter.

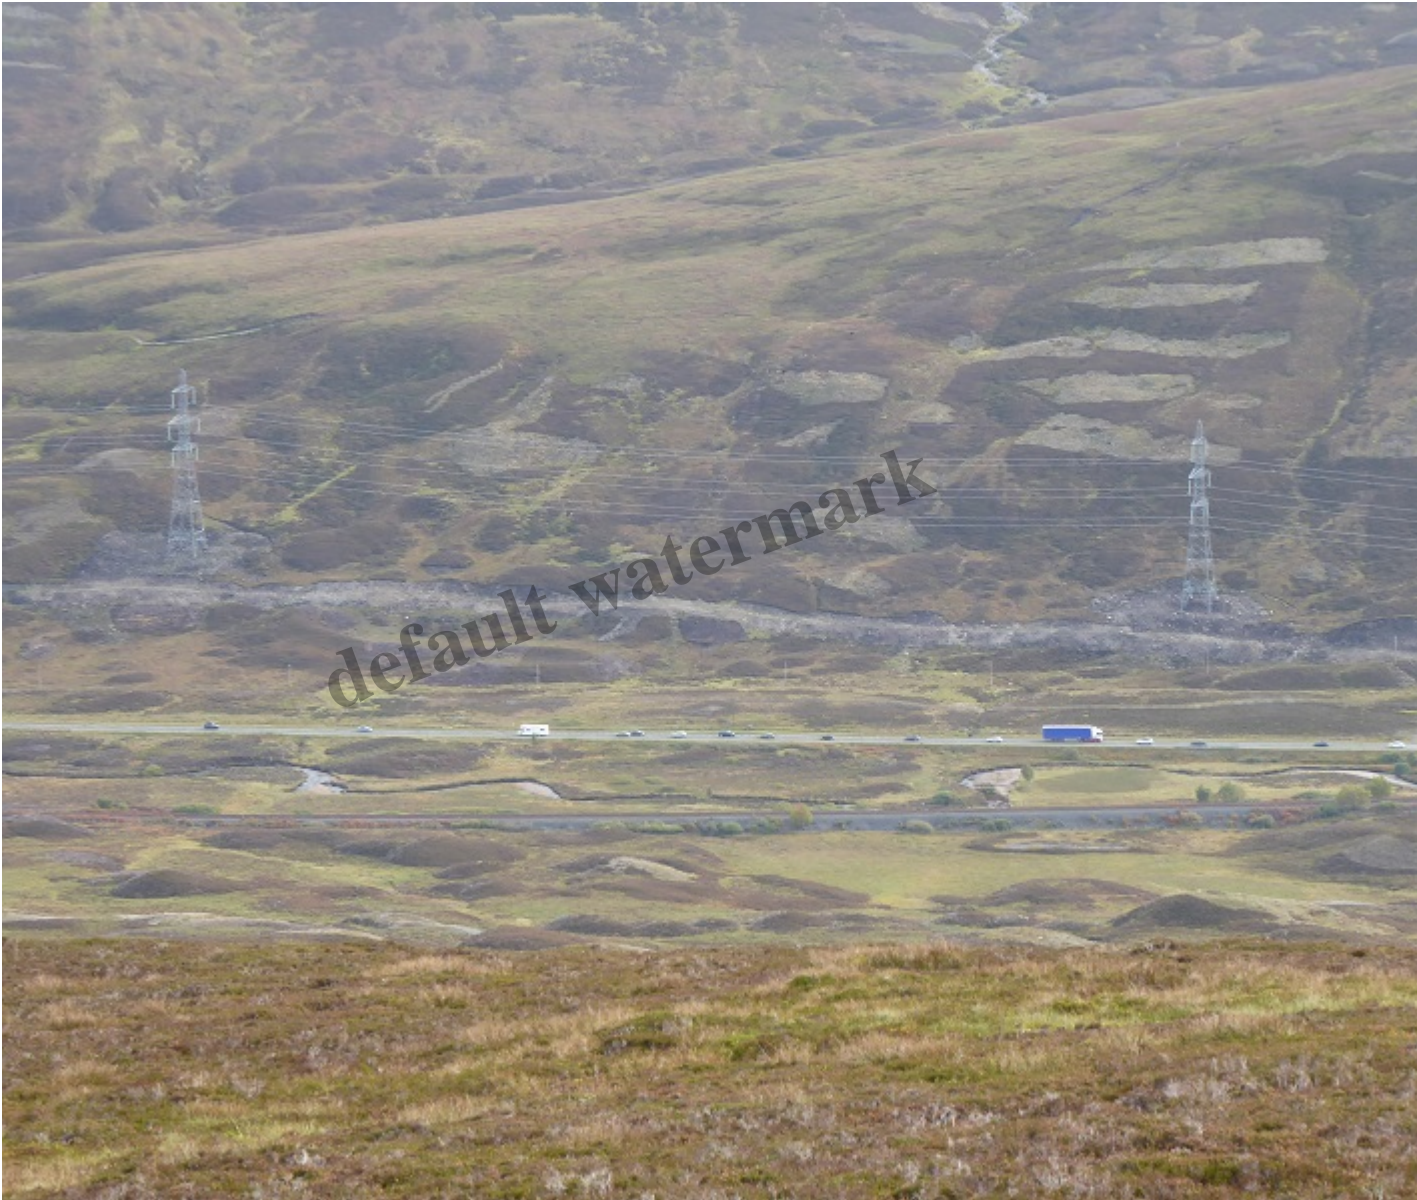
The “restored” construction track just south of Balsporran Cottage forms a gash across the hillside which will remain highly visible even if the vegetation does recover because the “bench” which was created across the hillside by cut and fill construction to provide a flat track has not been re-landscaped.

In my view both CNPA and SNH should now be calling on SSE to produce a proper landscape plan to restore the scar across the hillside caused by the failure to re-landscape the cut and fill track. Such restoration should make off road use of vehicles along the line of the former construction track very difficult, while specific action should be taken to prevent the estate from driving vehicles onto the flatter area of moorland between north Drumochter Lodge and Balsporran Cottages.

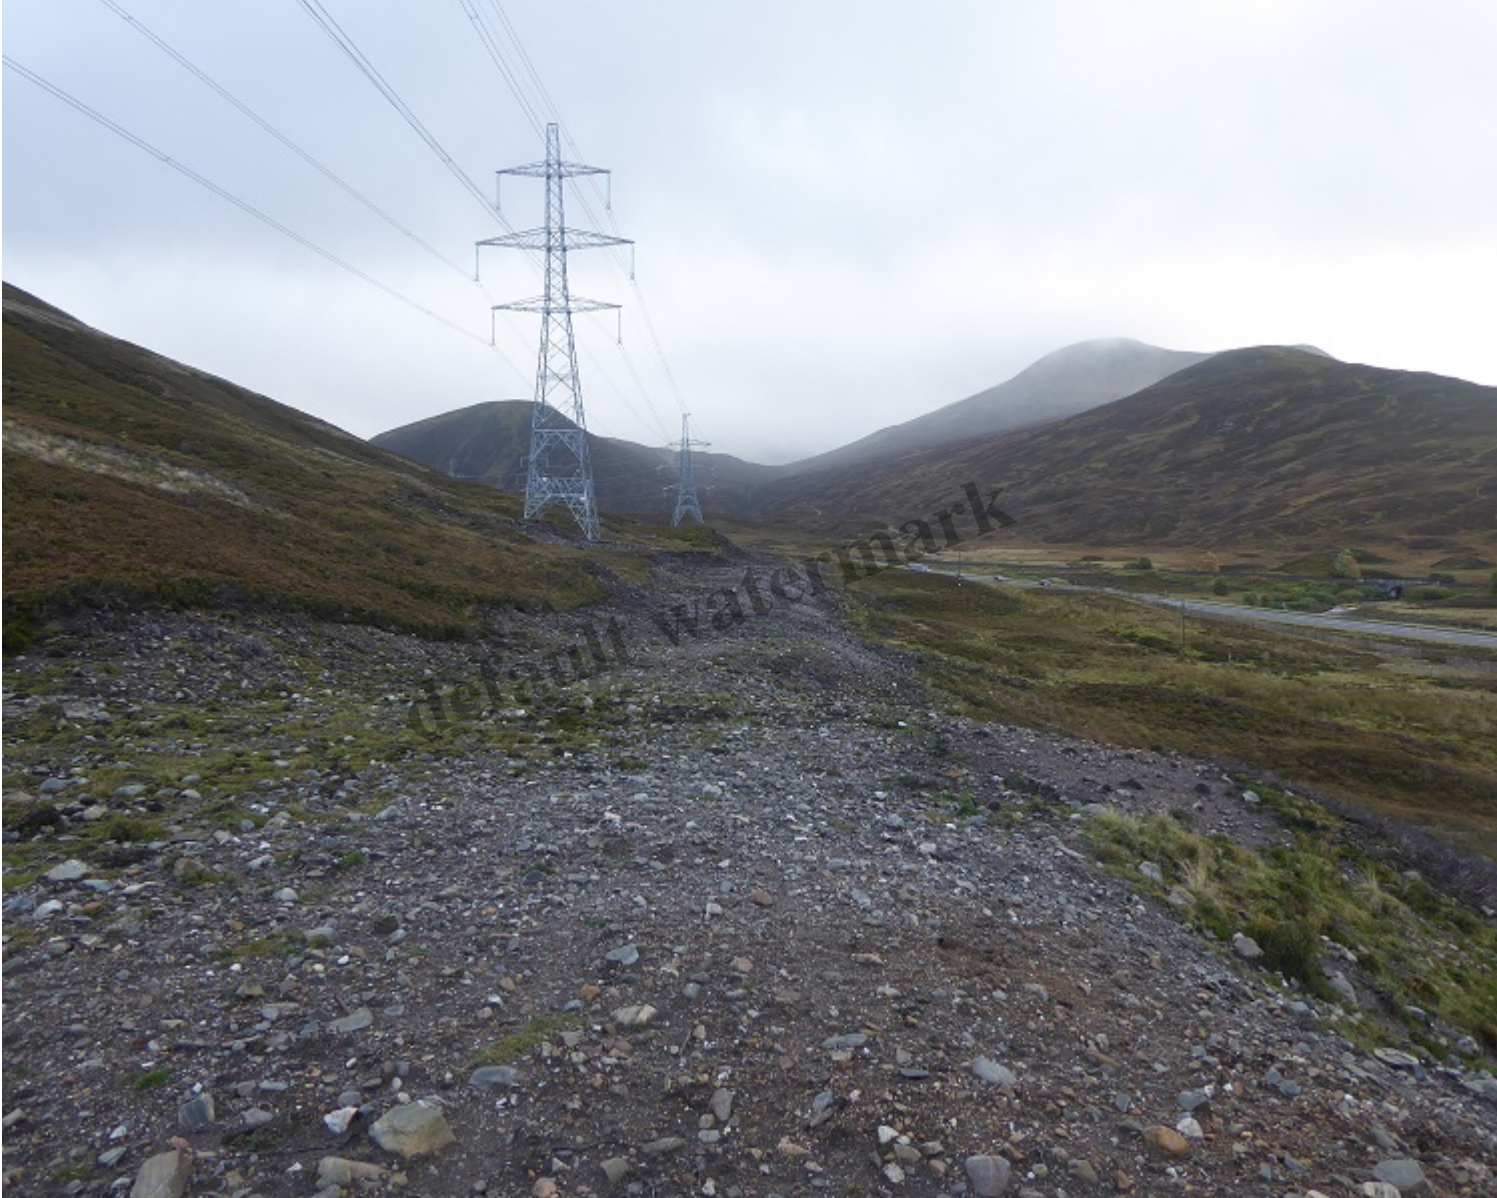
In my view the main reason for this is that the attempt to restore the former access track along this section has been risible. The photo above shows the bench that was cut across the hillside through cut and fill (the upper slope was cut and the lower filled in with the material excavated) remains. In effect the only restoration that has been carried out has been to break up the former track surface. The material which forms the line of the track should have been moulded back to match the contours of the hillside, with the “fill” material shifted uphill to cover the “cut” ground and banks on the upside of the

track.

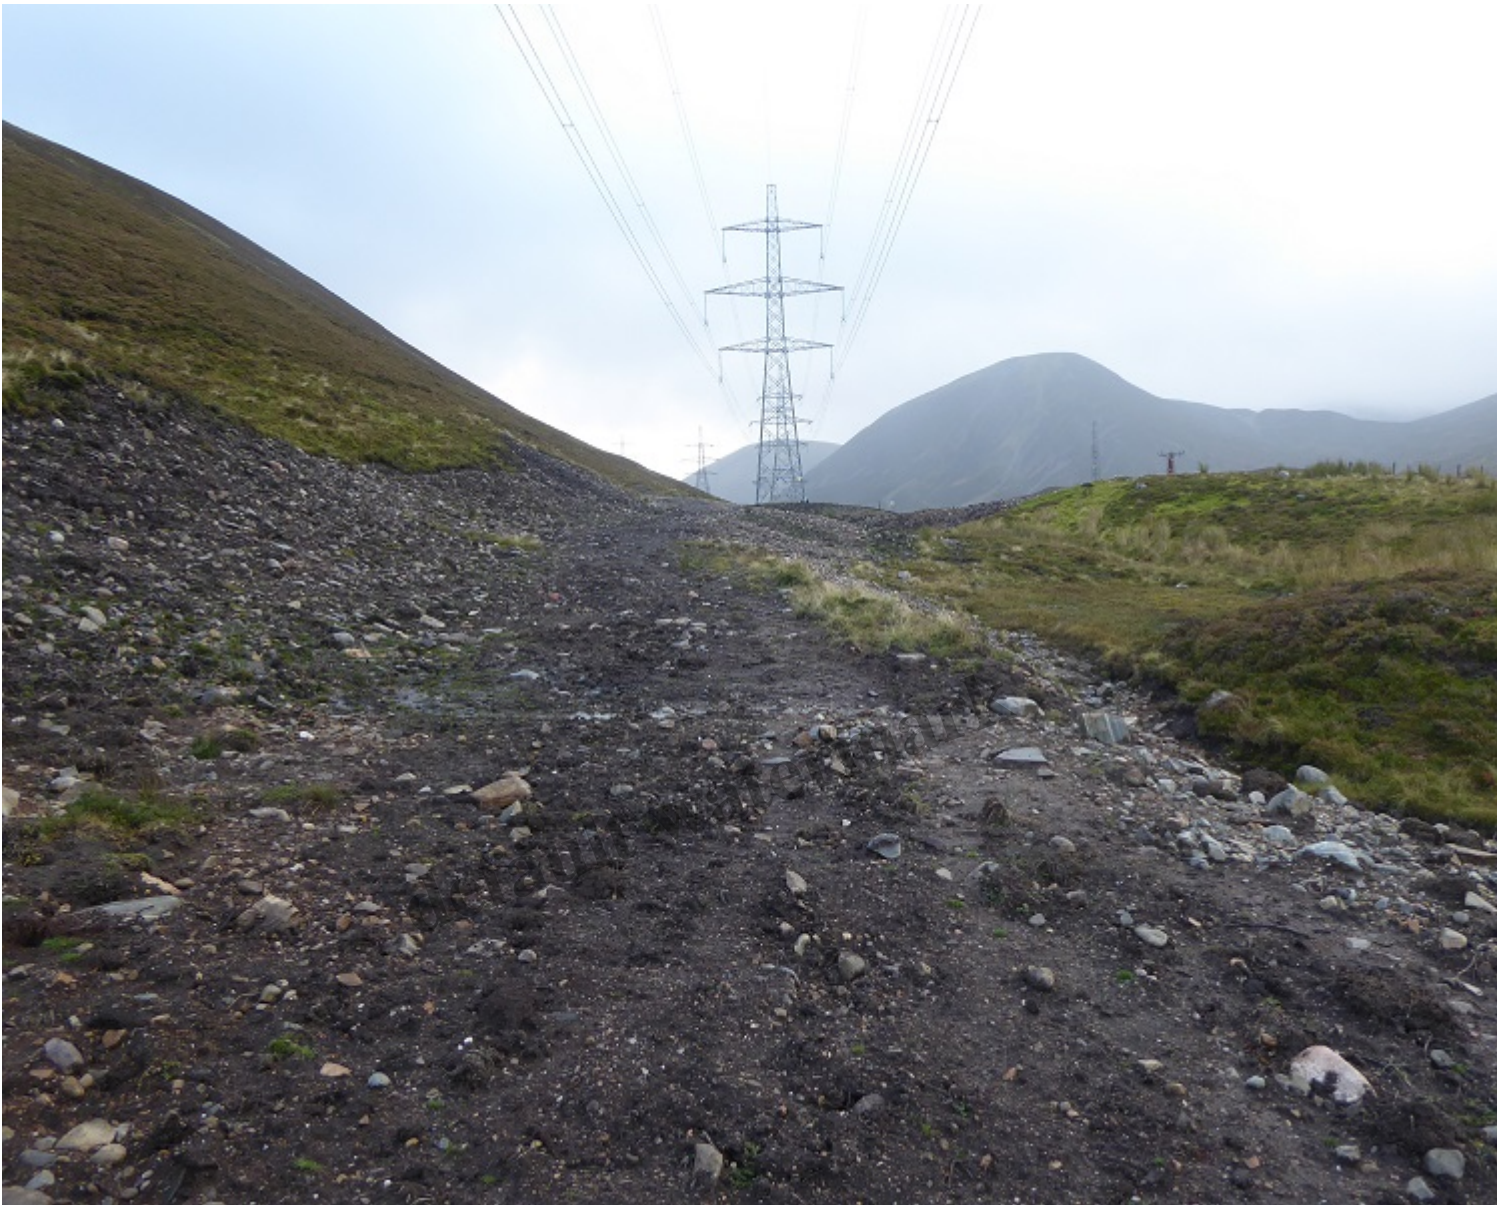
The consequence of leaving the track foundations in place is not only that a permanent line has been left across the hillside but as should have been quite predictable, the North Drumochter Estate has continued to use the line as a track. This will prevent full vegetation recovery even if the current plan, which is to leave restoration up to natural regeneration works.

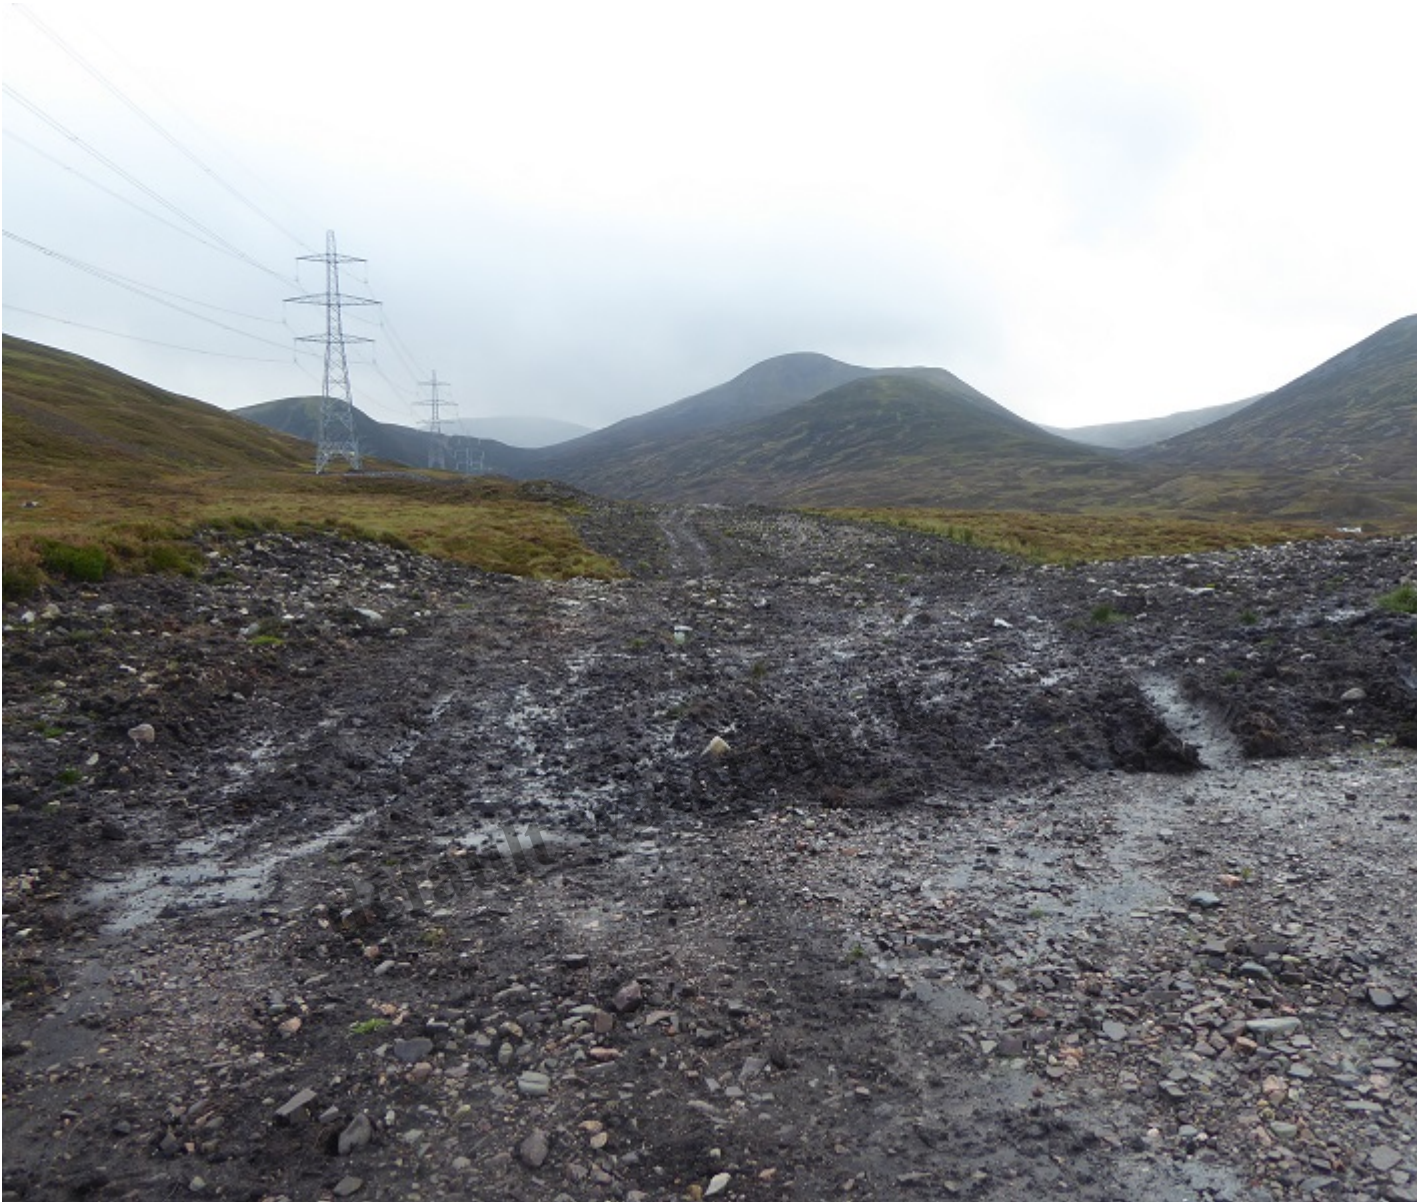
The boundary between the unrestored section of track just south of North Drumochter Lodge policy v and the restored section.

The photos shows vehicles are still being driven from the section of track granted planning permission by the CNPA (which still requires to be narrowed) onto the section “restored” by SSE’s contractors creating a churned up motorway. This “restored” section is in the Drumochter Hills Site of Special Scientific Interest and off-track use of vehicles here needs consent by SNH. (I will ask if it has been granted). Unless the CNPA, SNH and SSE work together to stop vehicles being driven here the vegetation will never recover.

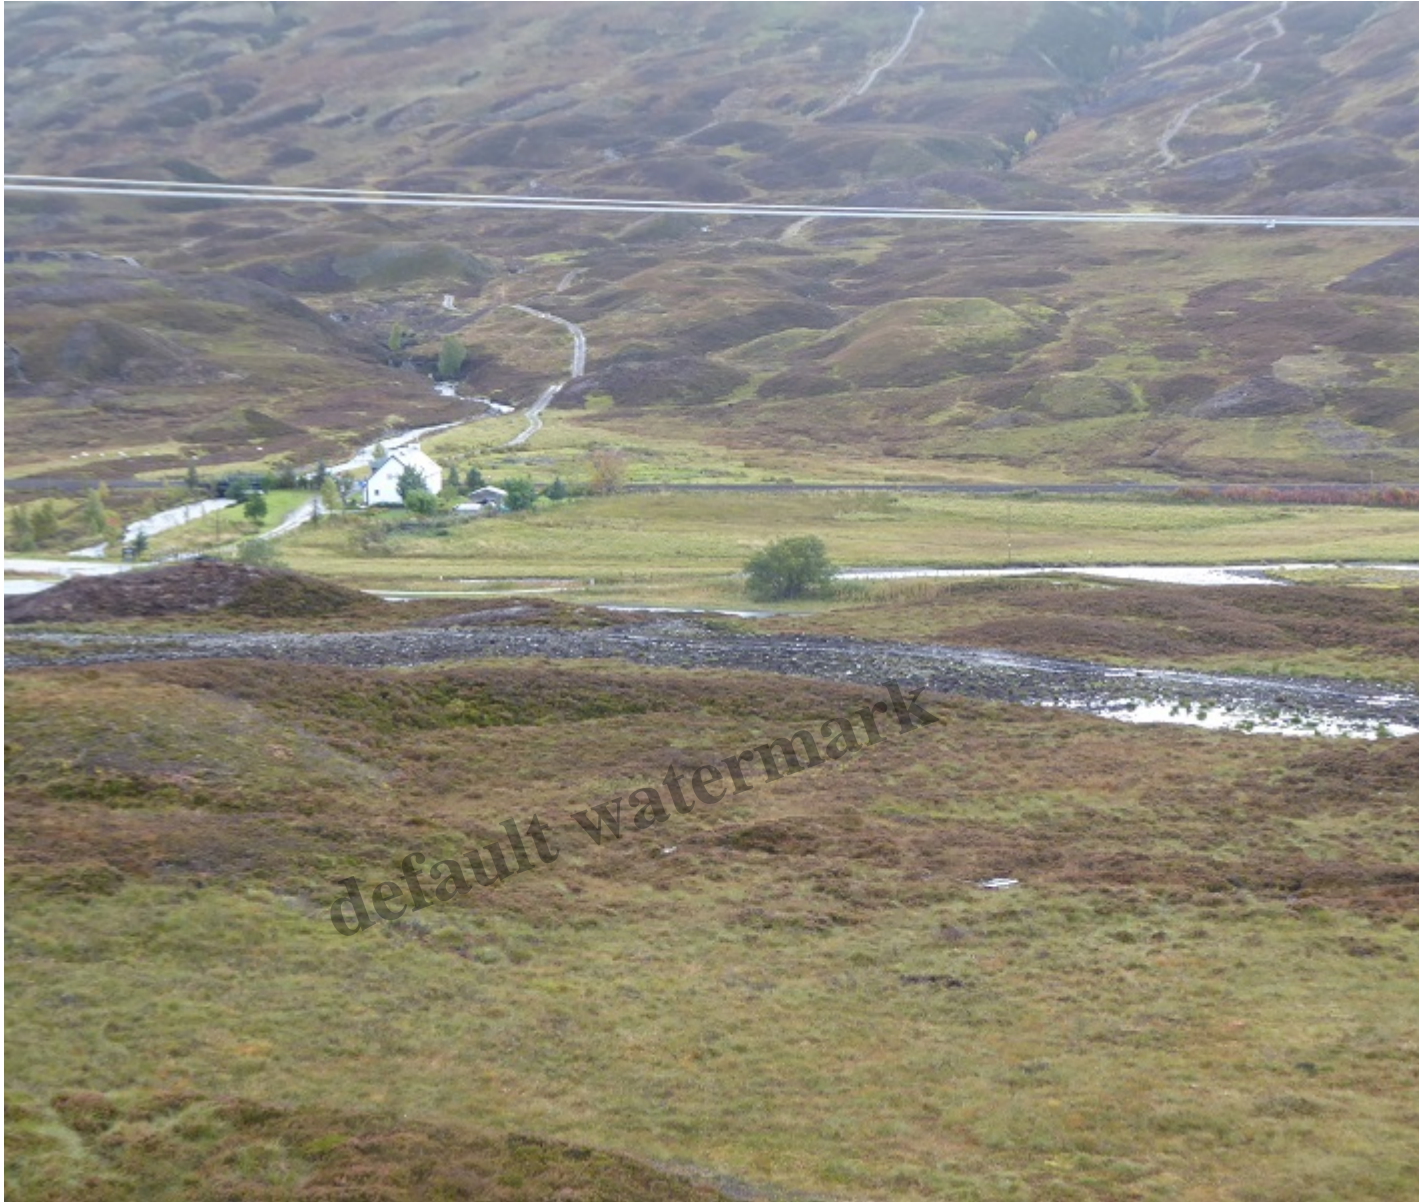
The first section of the restored track opposite Balsporran Cottages is a quagmire due to inappropriate use

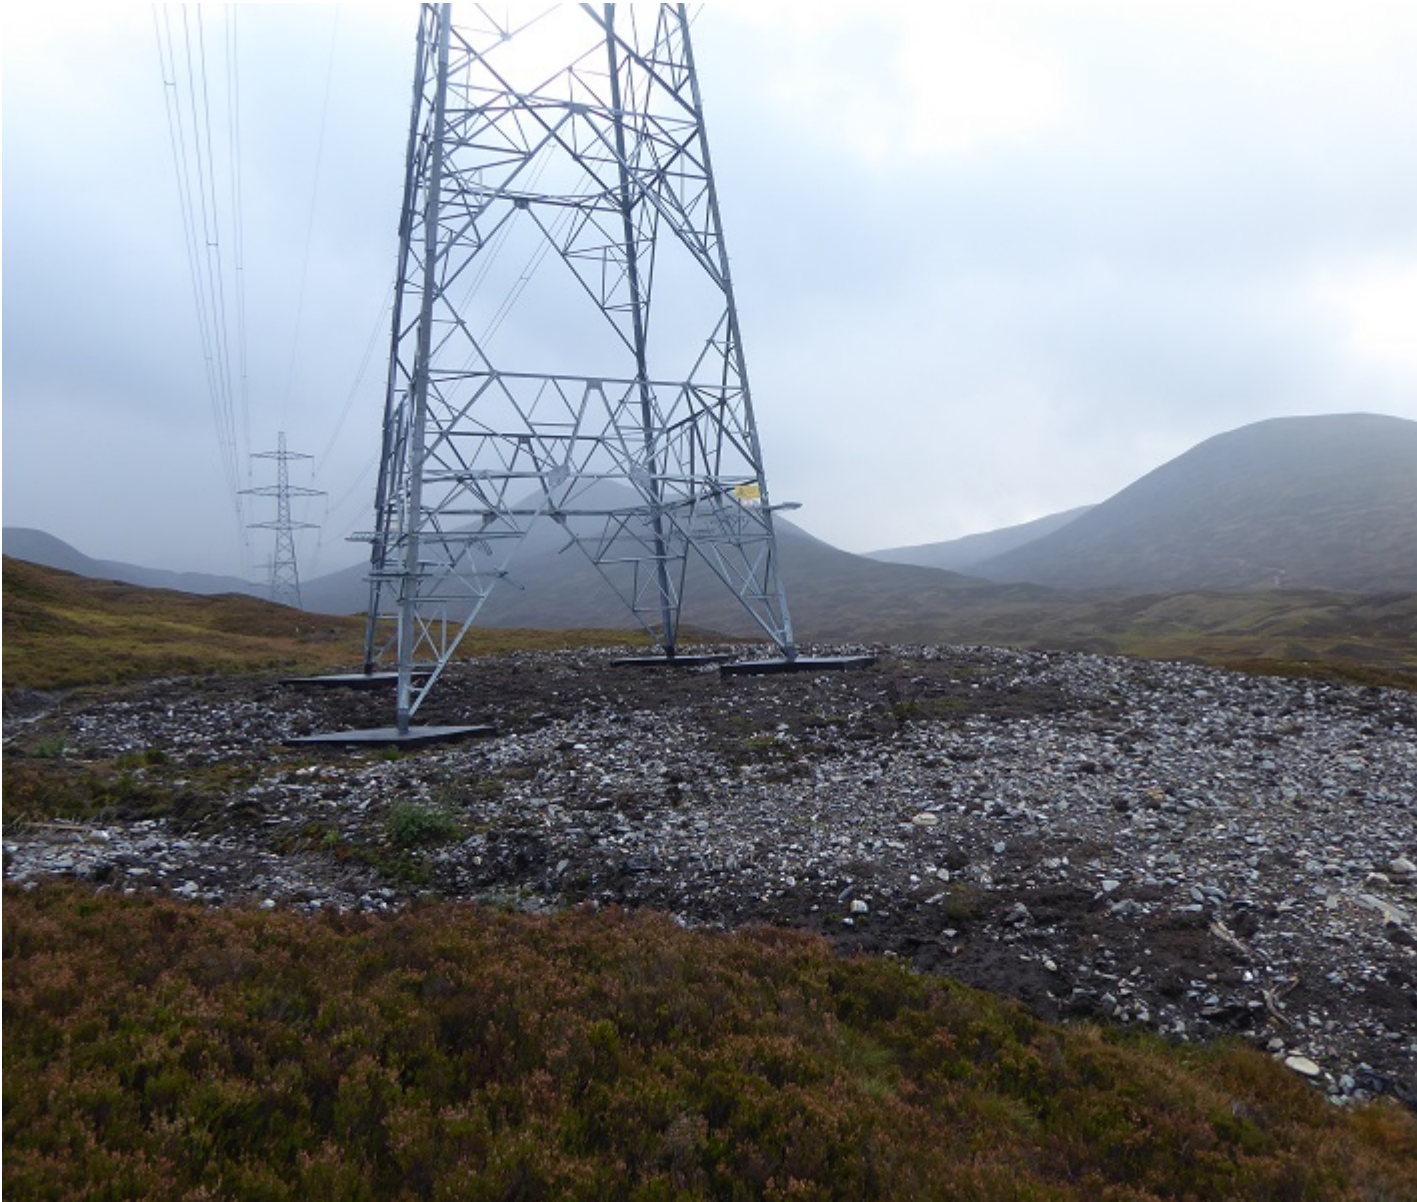
Some peat has been restored around the tower base but a far wider area has been left to “natural re

Some of the poor restoration around the tower bases has been explained by CNPA staff as being a consequence of a failure to store vegetation properly during the construction phase leaving insufficient peat and vegetation to re-cover the area and of inadequate construction method statements [250615trackrestorationSSE \(obtained through FOI\)](#). This appears correct and the result is that more mineral soils are exposed and this will promote natural regeneration by different plant communities. CNPA staff have suggested alternative solutions (see peatland restoration advice in link above) which so far appear to have been resisted by SSE. One suspects the underlying reason for this is SSE does not want to incur more costs.

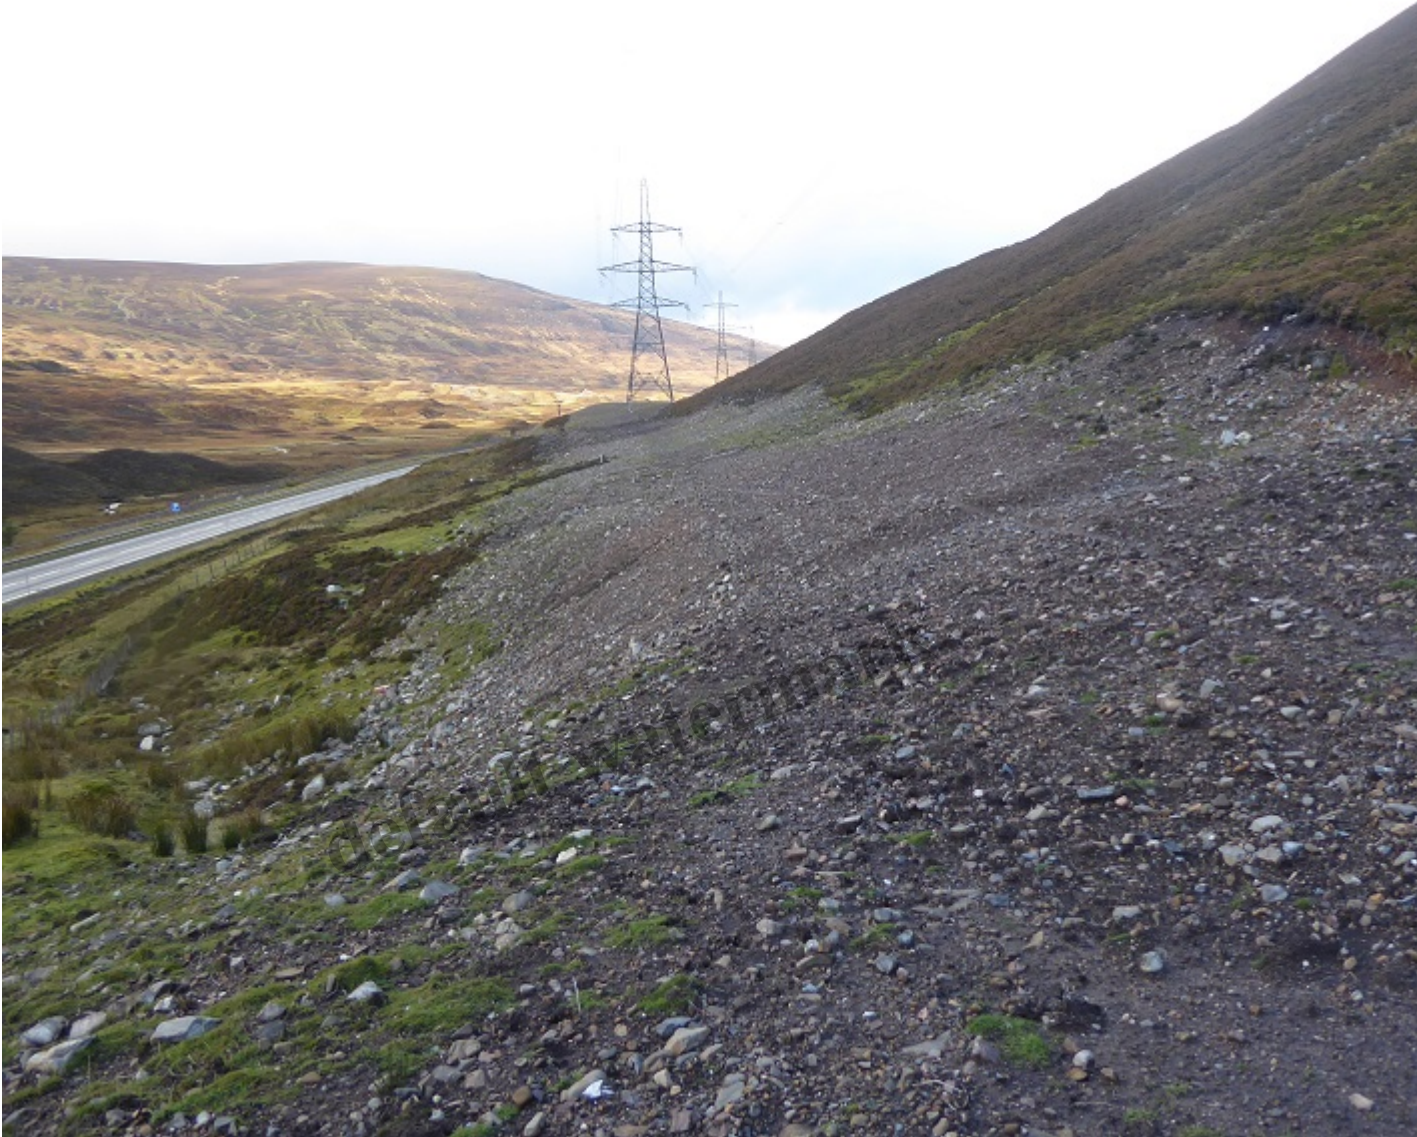
Section south of previous photo looking north

Its only as the former construction track approaches the Drumochter pass that the restoration work has attempted to remove the line of the cut and fill and mould the former track materials into the contours of the hillside. While a short section of bank (on right) has been left exposed, other restoration on this short stretch has been more successful with the horizontal bench across the hillside effectively removed, making it much harder for vehicles to drive here. Unfortunately the failure to store and replace vegetation means it will still form a very visible scar for some time. Vegetation reinstatement, rather than landscaping, is the main issue on this short section of the former construction track.
