## The landscape impact of the Beaully Denny

This post will consider the failure of Scottish and Southern Electric to date to restore the landscape caused by the Beaully Denny construction works in the northern section of the Drumochter.

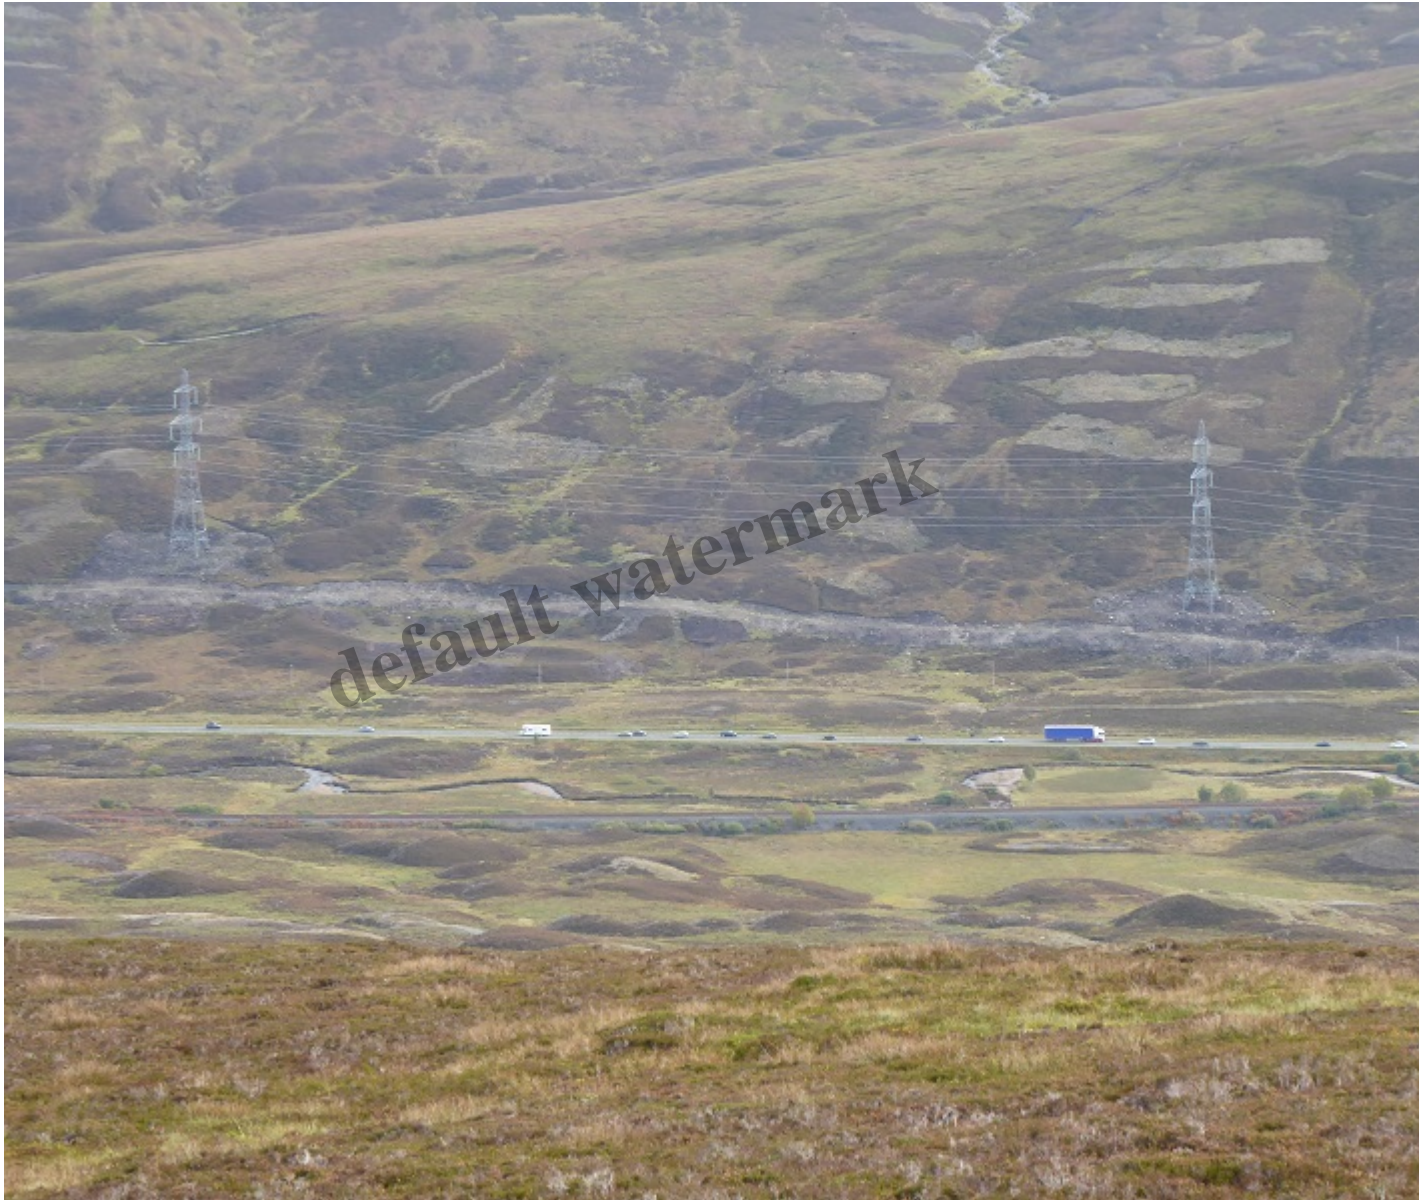
The “restored” construction track just south of Balsporran Cottage forms a gash across the hillside which will remain highly visible even if the vegetation does recover because the “bench” which was created across the hillside by cut and fill construction to provide a flat track has not been re-landscaped.

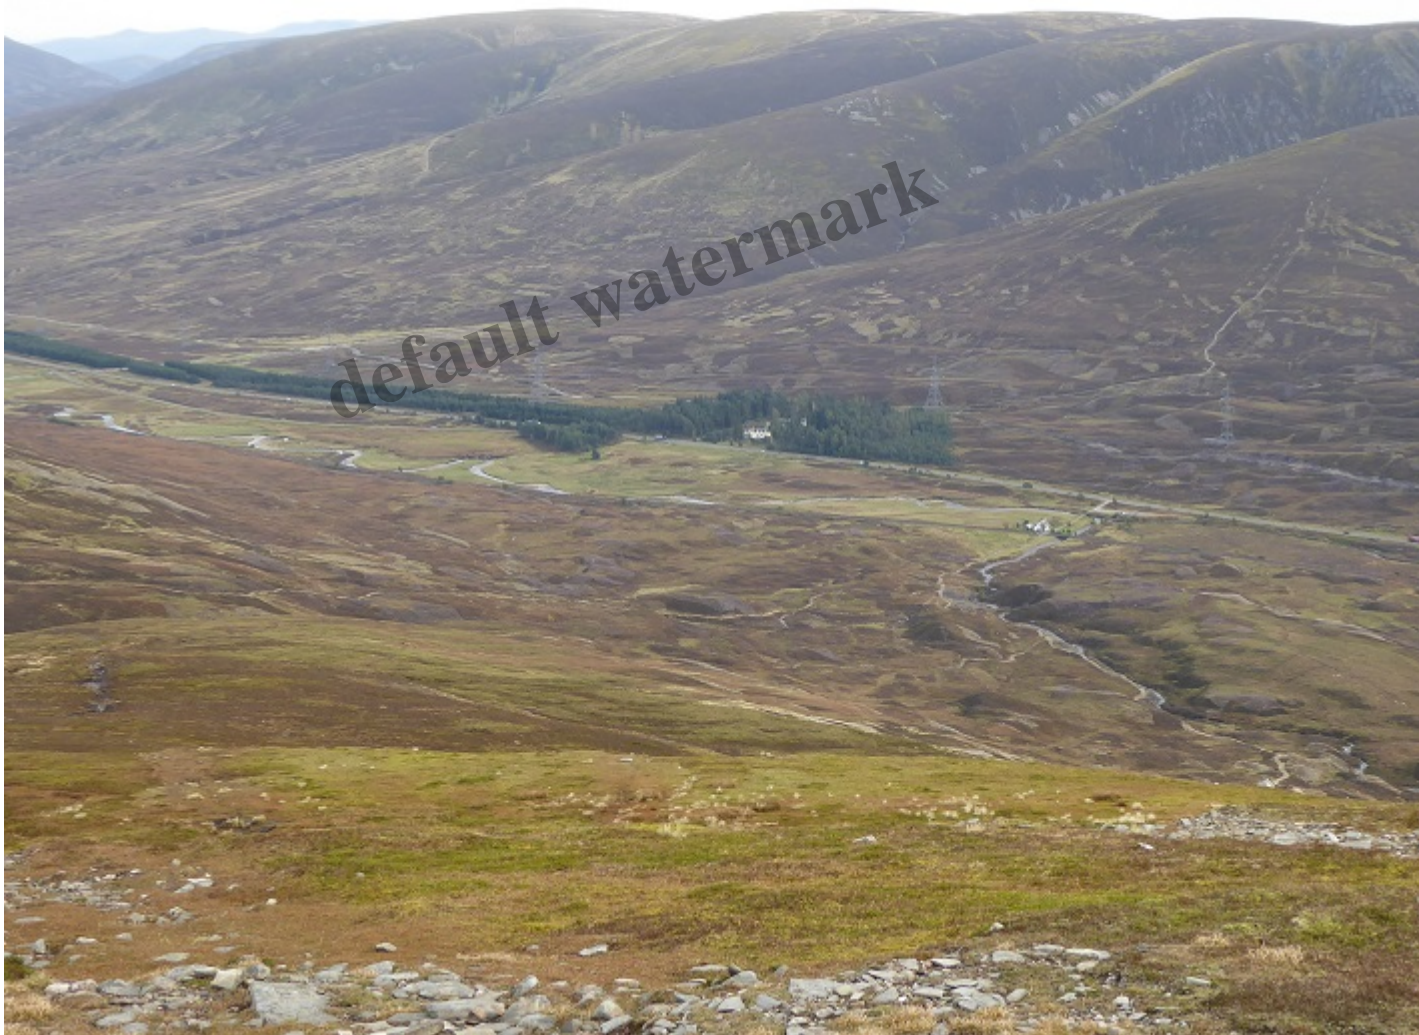
View of north Drumochter Lodge and Beaulieu Denny from Geal Charn.

North Drumochter Estate has subsequently applied to remove the requirement for native woodland planting around it – this will be considered in future post. The section considered in this post, where full restoration is required, lies between the south (right) of the north Drumochter Lodge policy woodlands to Drumochter summit. The line of the former construction track is still clearly visible in the photo above from a distance.

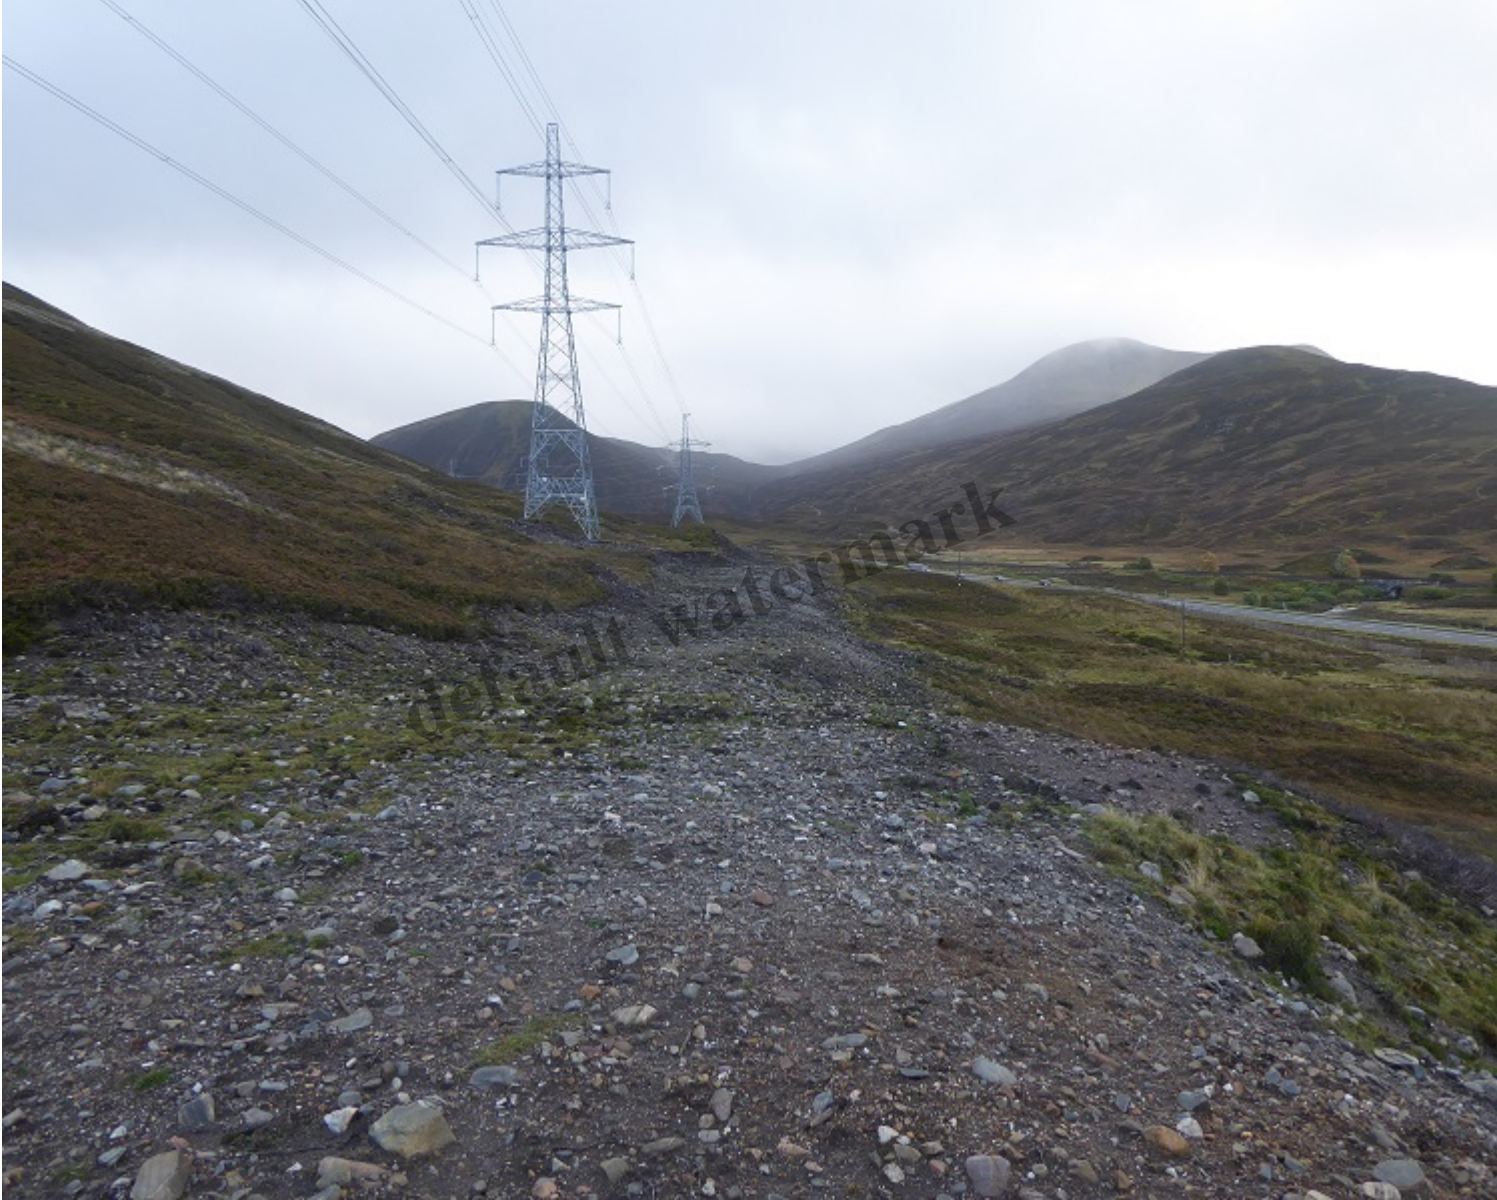
In my view the main reason for this is that the attempt to restore the former access track along this section has been risible. The photo above shows the bench that was cut across the hillside through cut and fill (the upper slope was cut and the lower filled in with the material excavated) remains. In effect the only restoration that has been carried out has been to break up the former track surface. The material which forms the line of the track should have been moulded back to match the contours of the hillside, with the “fill” material shifted uphill to cover the “cut” ground and banks on the upside of the

track.

In my view both CNPA and SNH should now be calling on SSE to produce a proper landscape plan to restore the scar across the hillside caused by the failure to re-landscape the cut and fill track. Such restoration should make off road use of vehicles along the line of the former construction track very difficult, while specific action should be taken to prevent the estate from driving vehicles onto the flatter area of moorland between north Drumochter Lodge and Balsporran Cottages.

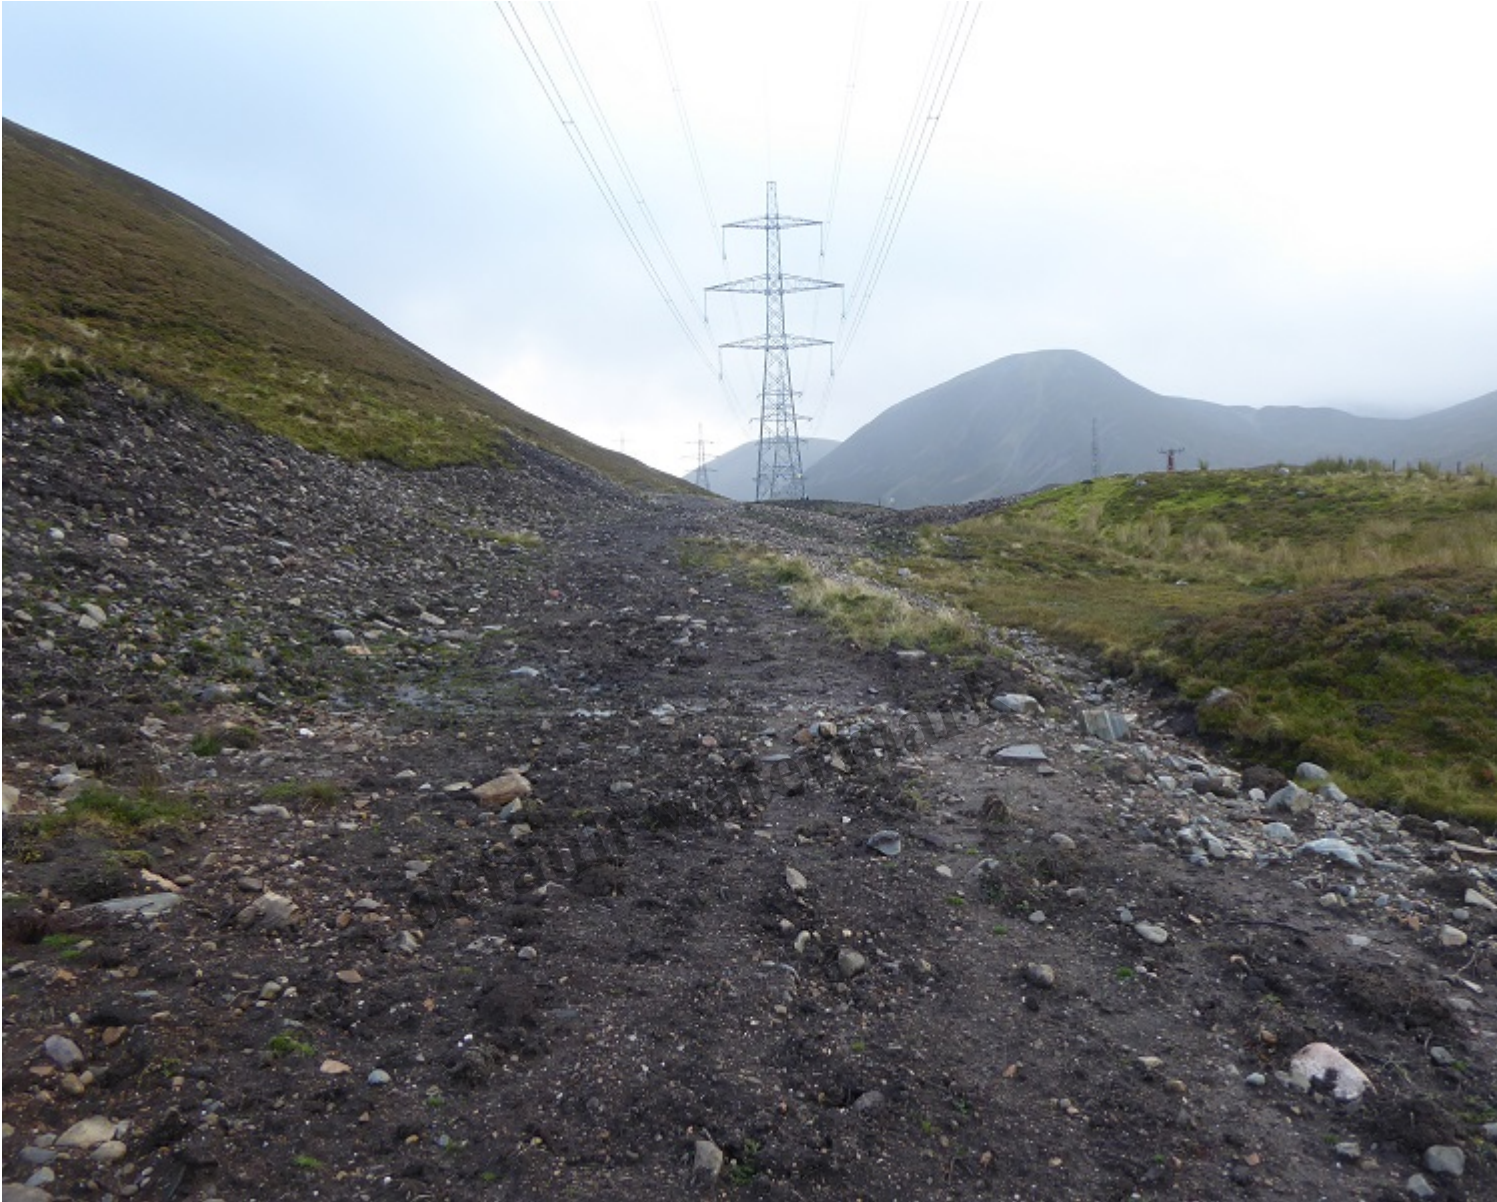
The consequence of leaving the track foundations in place is not only that a permanent line has been left across the hillside but as should have been quite predictable, the North Drumochter Estate has continued to use the line as a track. This will prevent full vegetation recovery even if the current plan, which is to leave restoration up to natural regeneration works.

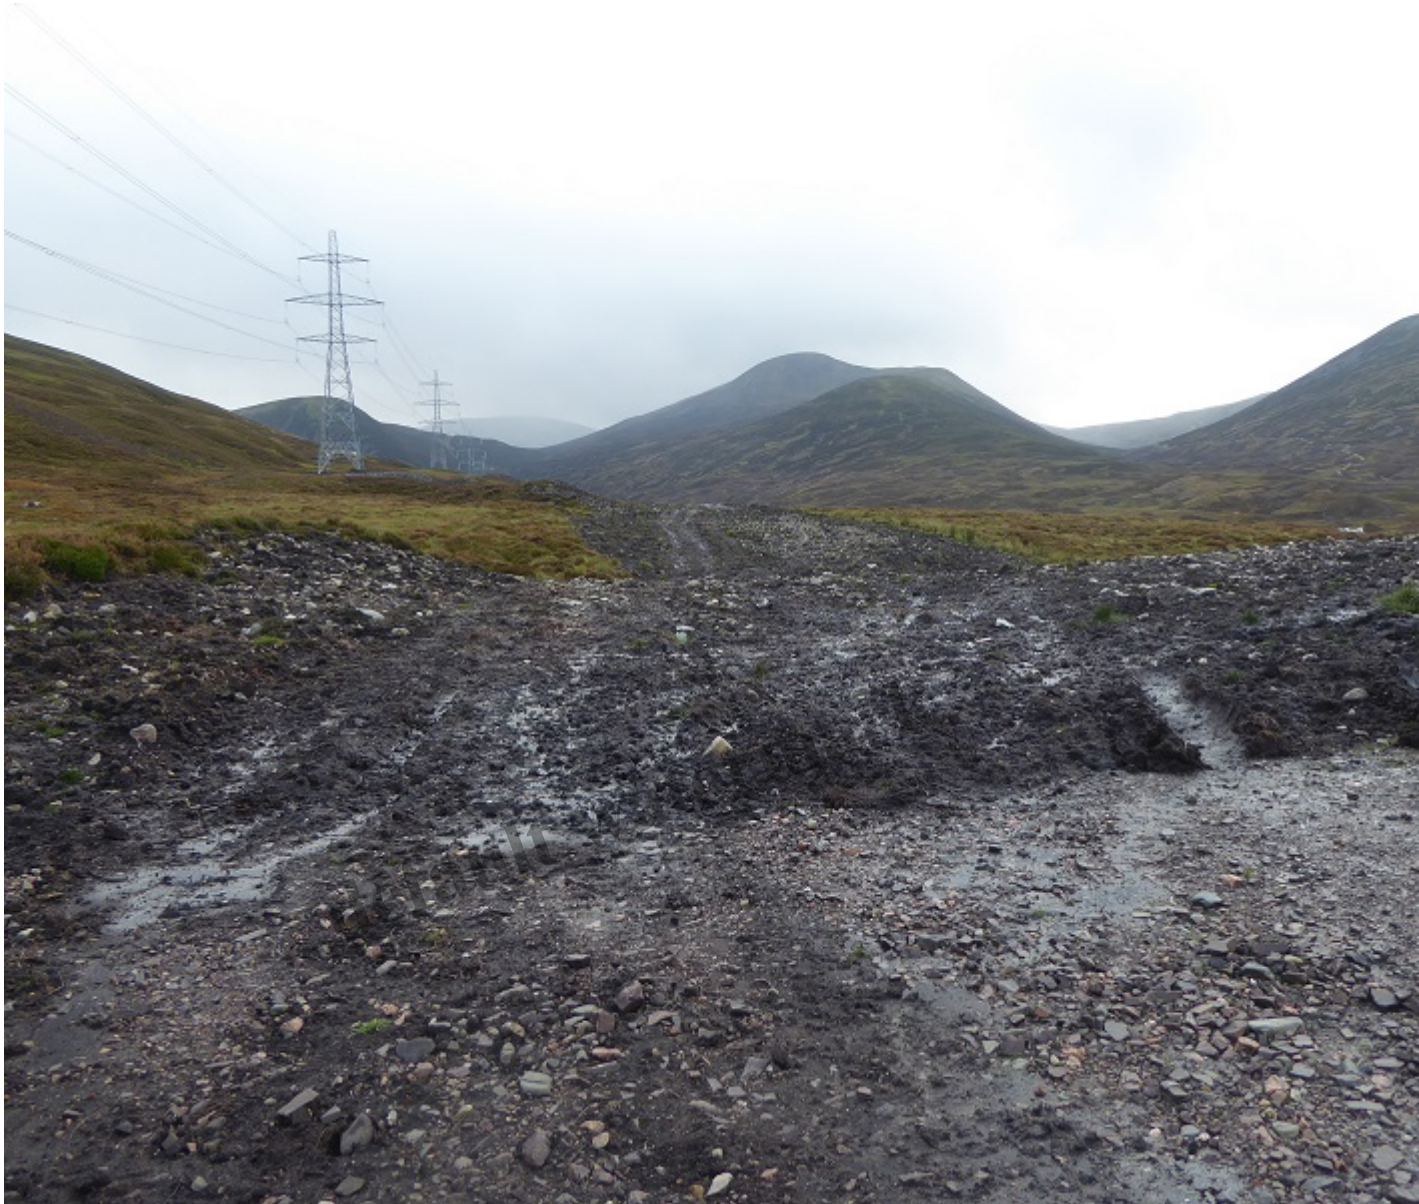
The boundary between the unrestored section of track just south of North Drumochter Lodge policy v and the restored section.

The photos shows vehicles are still being driven from the section of track granted planning permission by the CNPA (which still requires to be narrowed) onto the section “restored” by SSE’s contractors creating a churned up motorway. This “restored” section is in the Drumochter Hills Site of Special Scientific Interest and off-track use of vehicles here needs consent by SNH. (I will ask if it has been granted). Unless the CNPA, SNH and SSE work together to stop vehicles being driven here the vegetation will never recover.

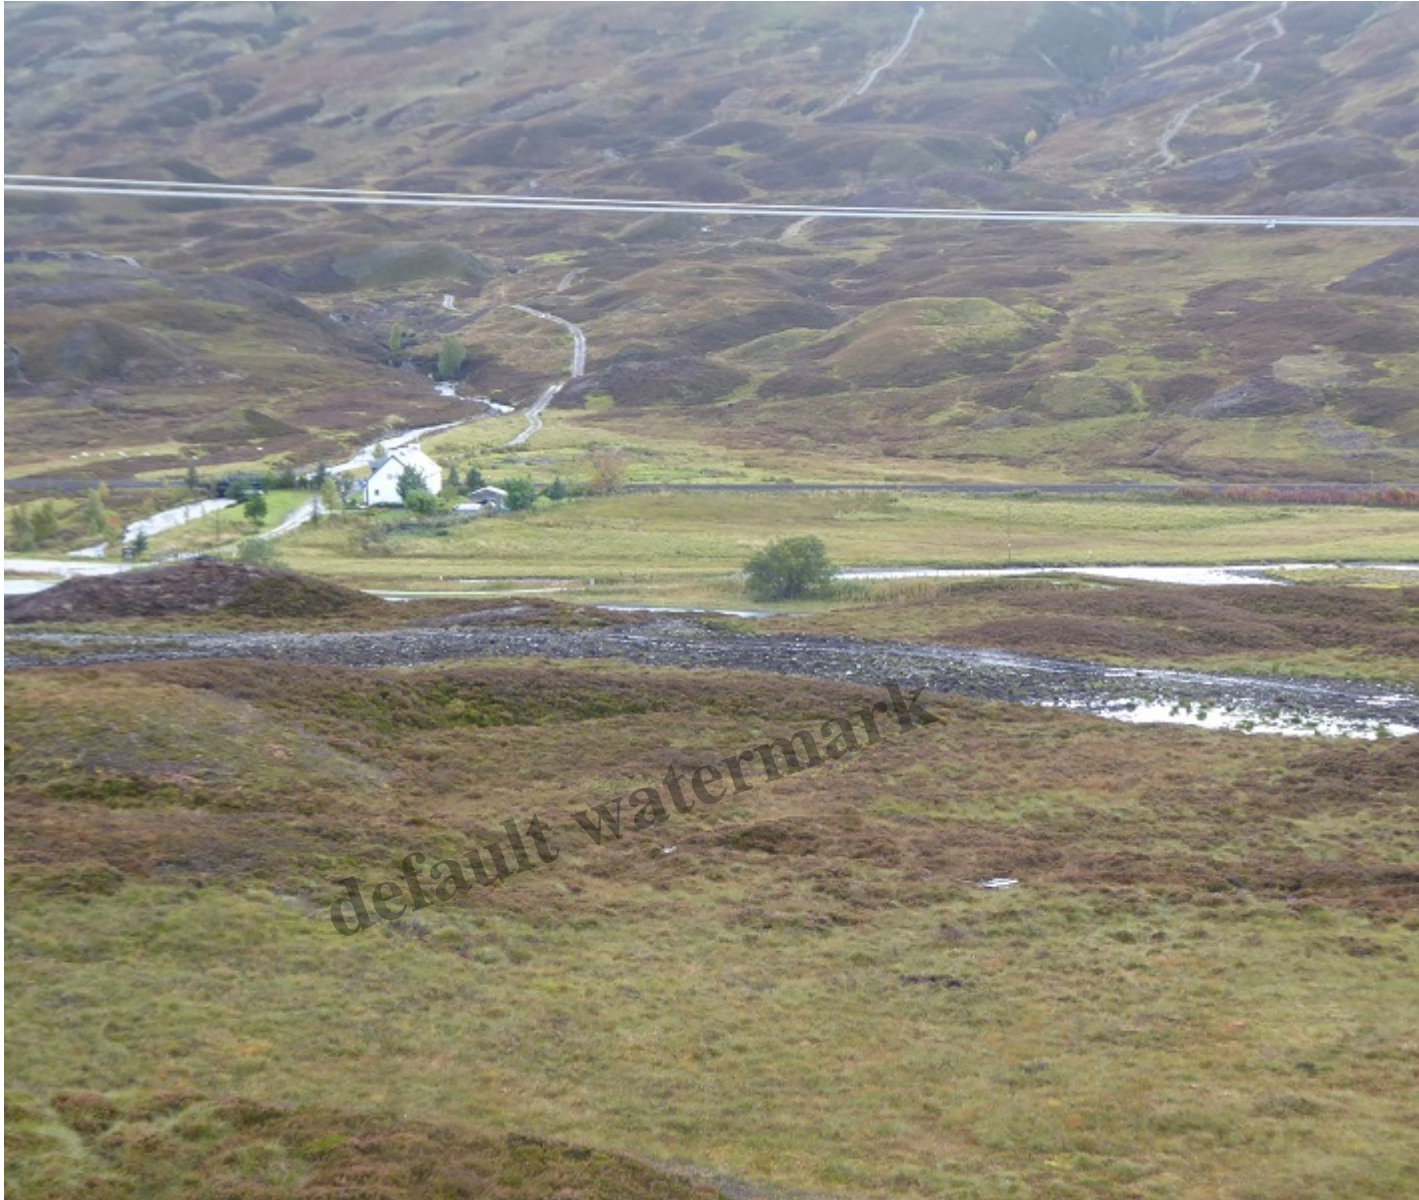
The first section of the restored track opposite Balsporran Cottages is a quagmire due to inappropriate use

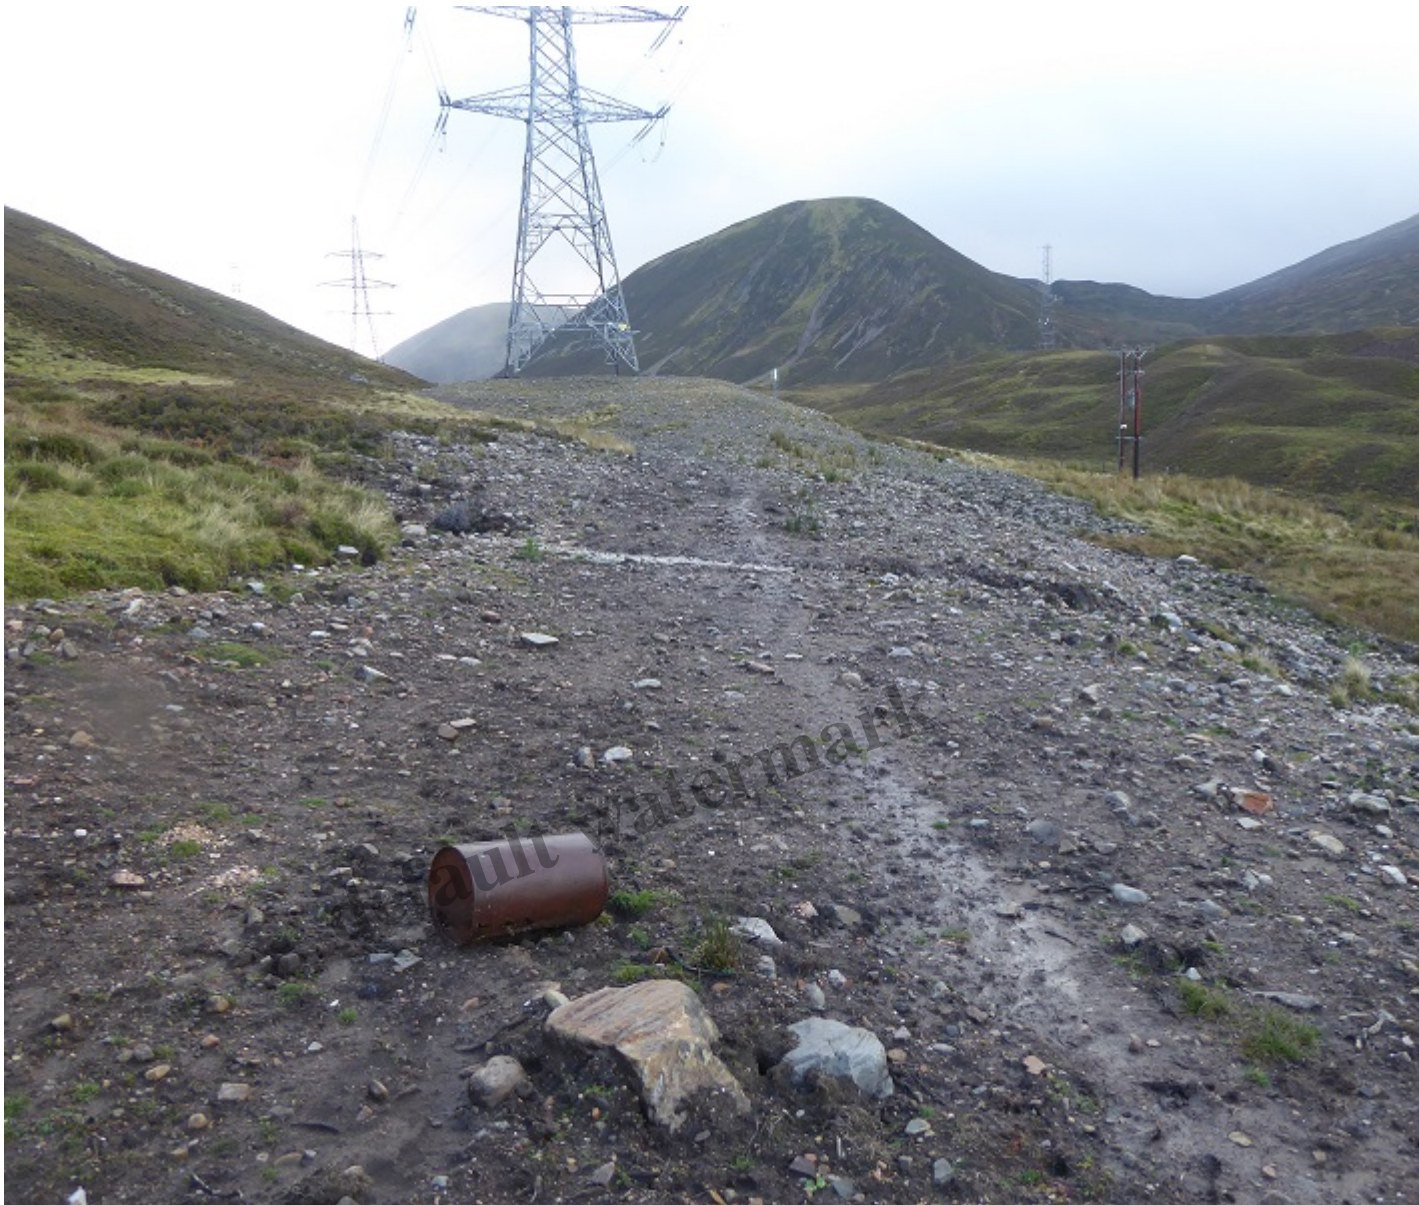
For almost 2.5km there has been no attempt to landscape the ground of the former track into the surrounding hillside with the result that it will form a permanent landscape scar even if vehicle use was stopped

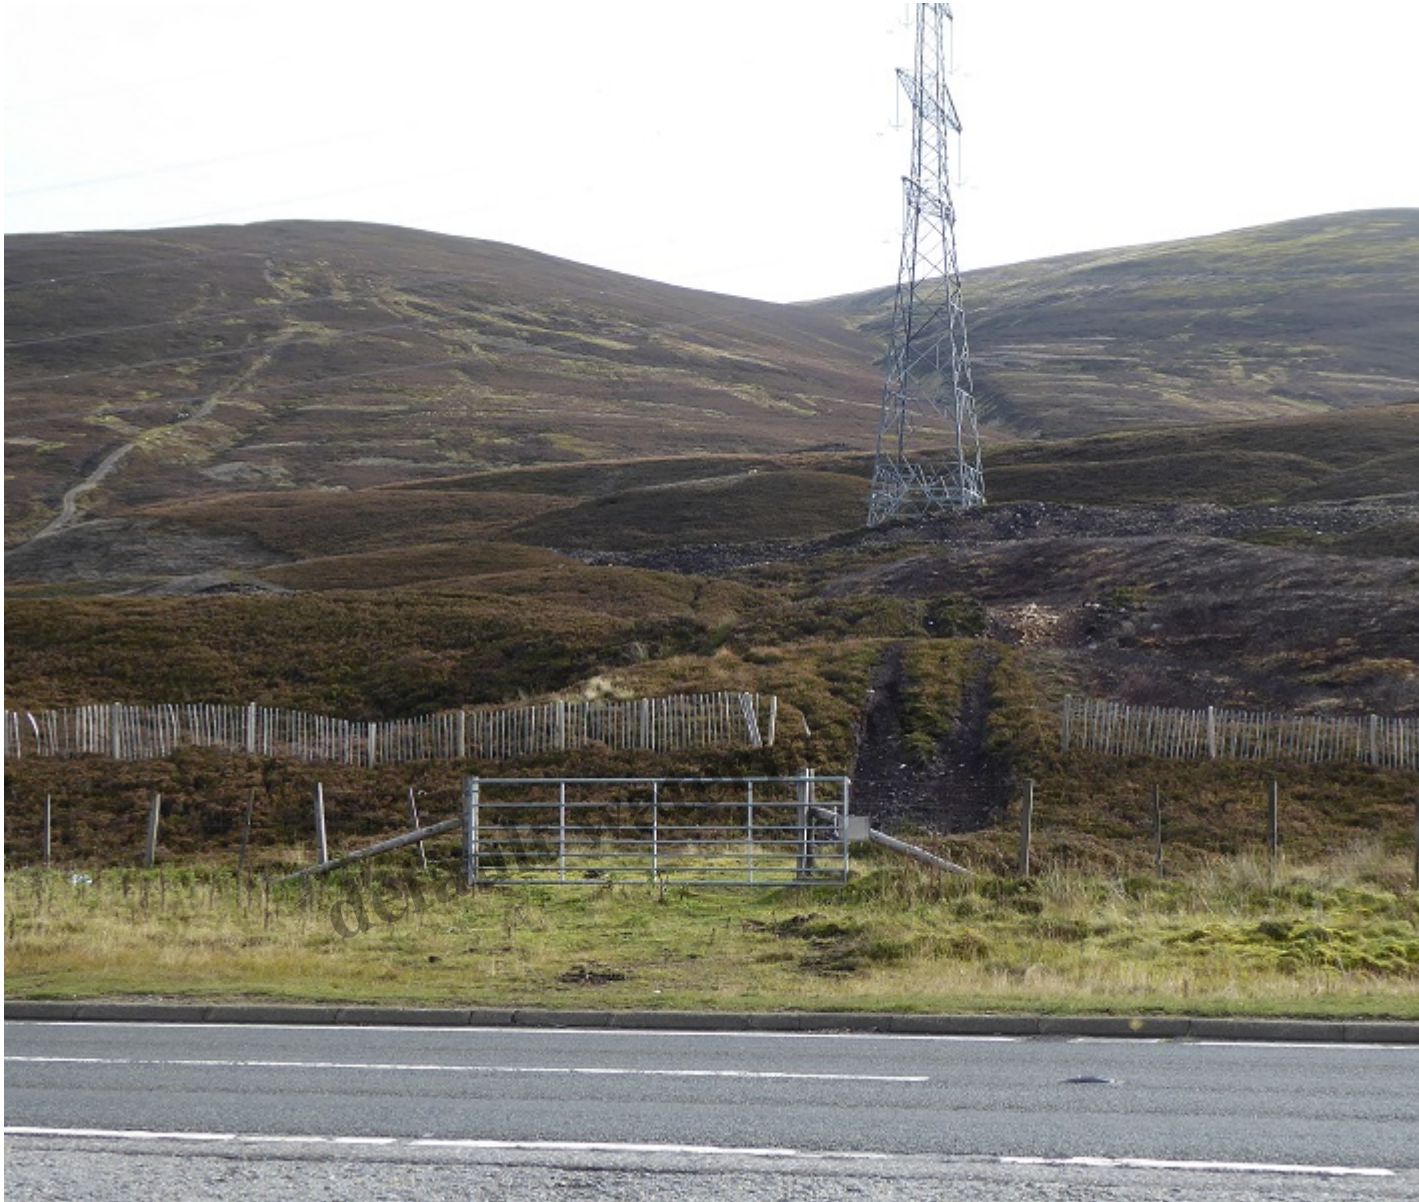
Access point opposite Balsporran Cottages has been used to create a shortcut to North Drumochter

The use of vehicles has been facilitated by the creation of access gates from the A9 enabling vehicles to be driven up onto the line of the Beaully Denny construction track, creating more erosion and

preventing vegetation recovery.

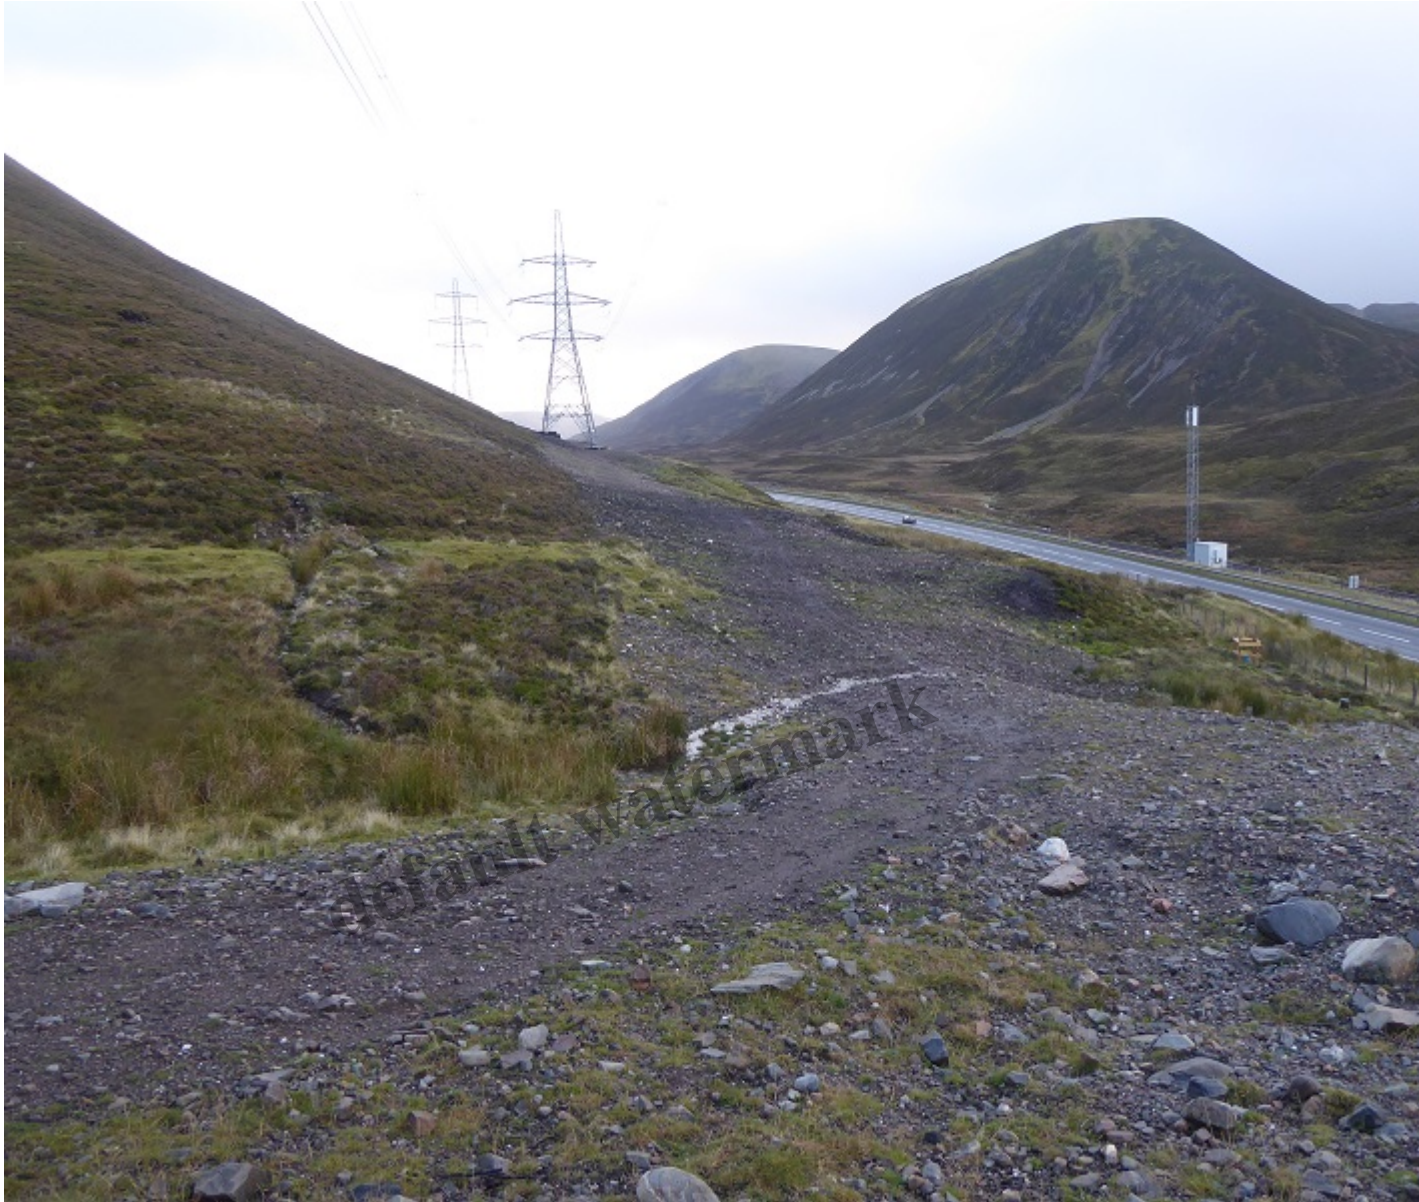
The former track as it approaches the Boar of Badenoch from the north – in what sense is this a “ten track?”

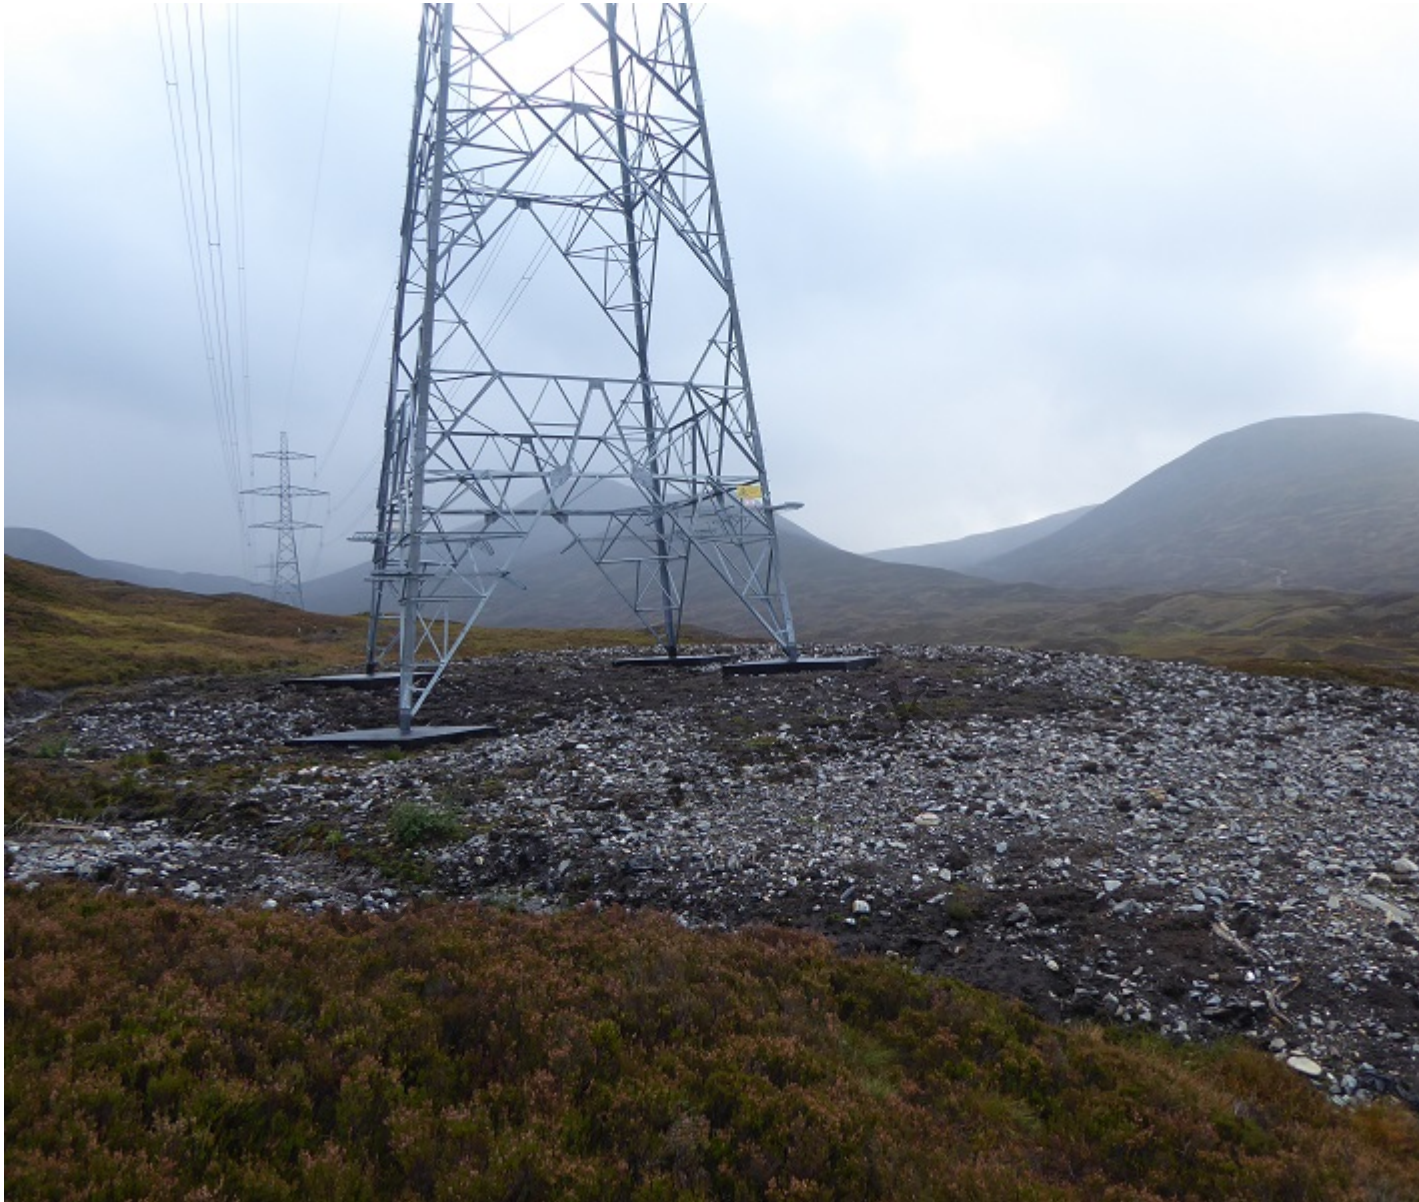
Some peat has been restored around the tower base but a far wider area has been left to “natural re

Some of the poor restoration around the tower bases has been explained by CNPA staff as being a consequence of a failure to store vegetation properly during the construction phase leaving insufficient peat and vegetation to re-cover the area and of inadequate construction method statements [250615trackrestorationSSE \(obtained through FOI\)](#). This appears correct and the result is that more mineral soils are exposed and this will promote natural regeneration by different plant communities. CNPA staff have suggested alternative solutions (see peatland restoration advice in link above) which so far appear to have been resisted by SSE. One suspects the underlying reason for this is SSE does not want to incur more costs.

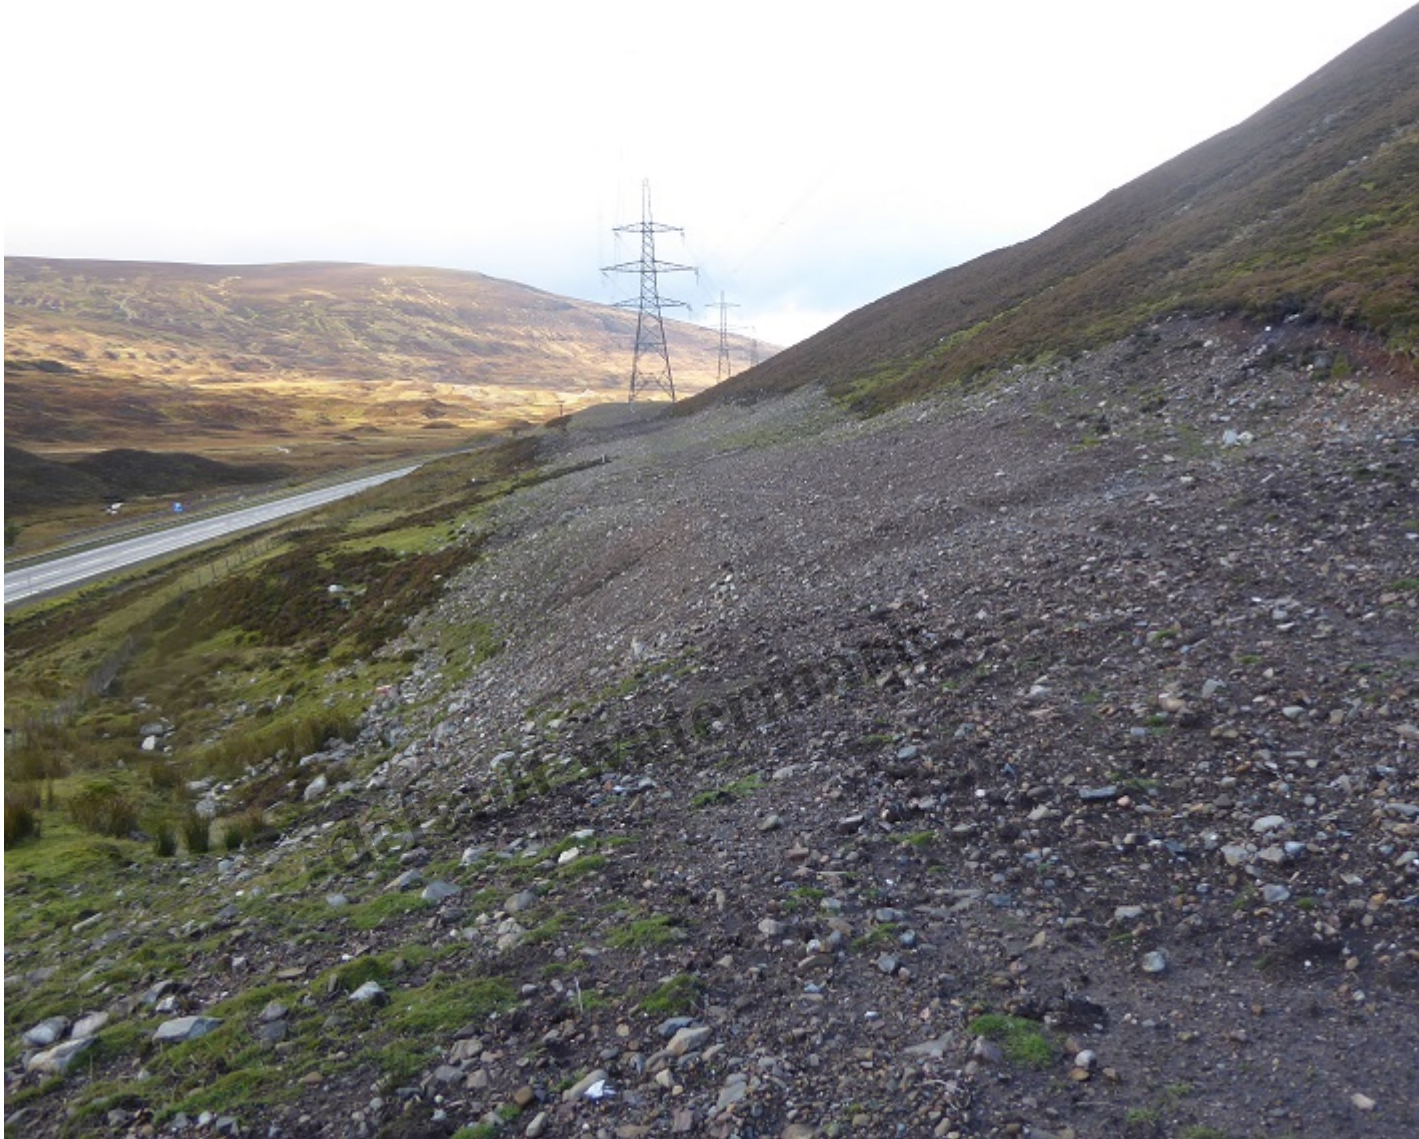
Section south of previous photo looking north

Its only as the former construction track approaches the Drumochter pass that the restoration work has attempted to remove the line of the cut and fill and mould the former track materials into the contours of the hillside. While a short section of bank (on right) has been left exposed, other restoration on this short stretch has been more successful with the horizontal bench across the hillside effectively removed, making it much harder for vehicles to drive here. Unfortunately the failure to store and replace vegetation means it will still form a very visible scar for some time. Vegetation reinstatement, rather than landscaping, is the main issue on this short section of the former construction track.

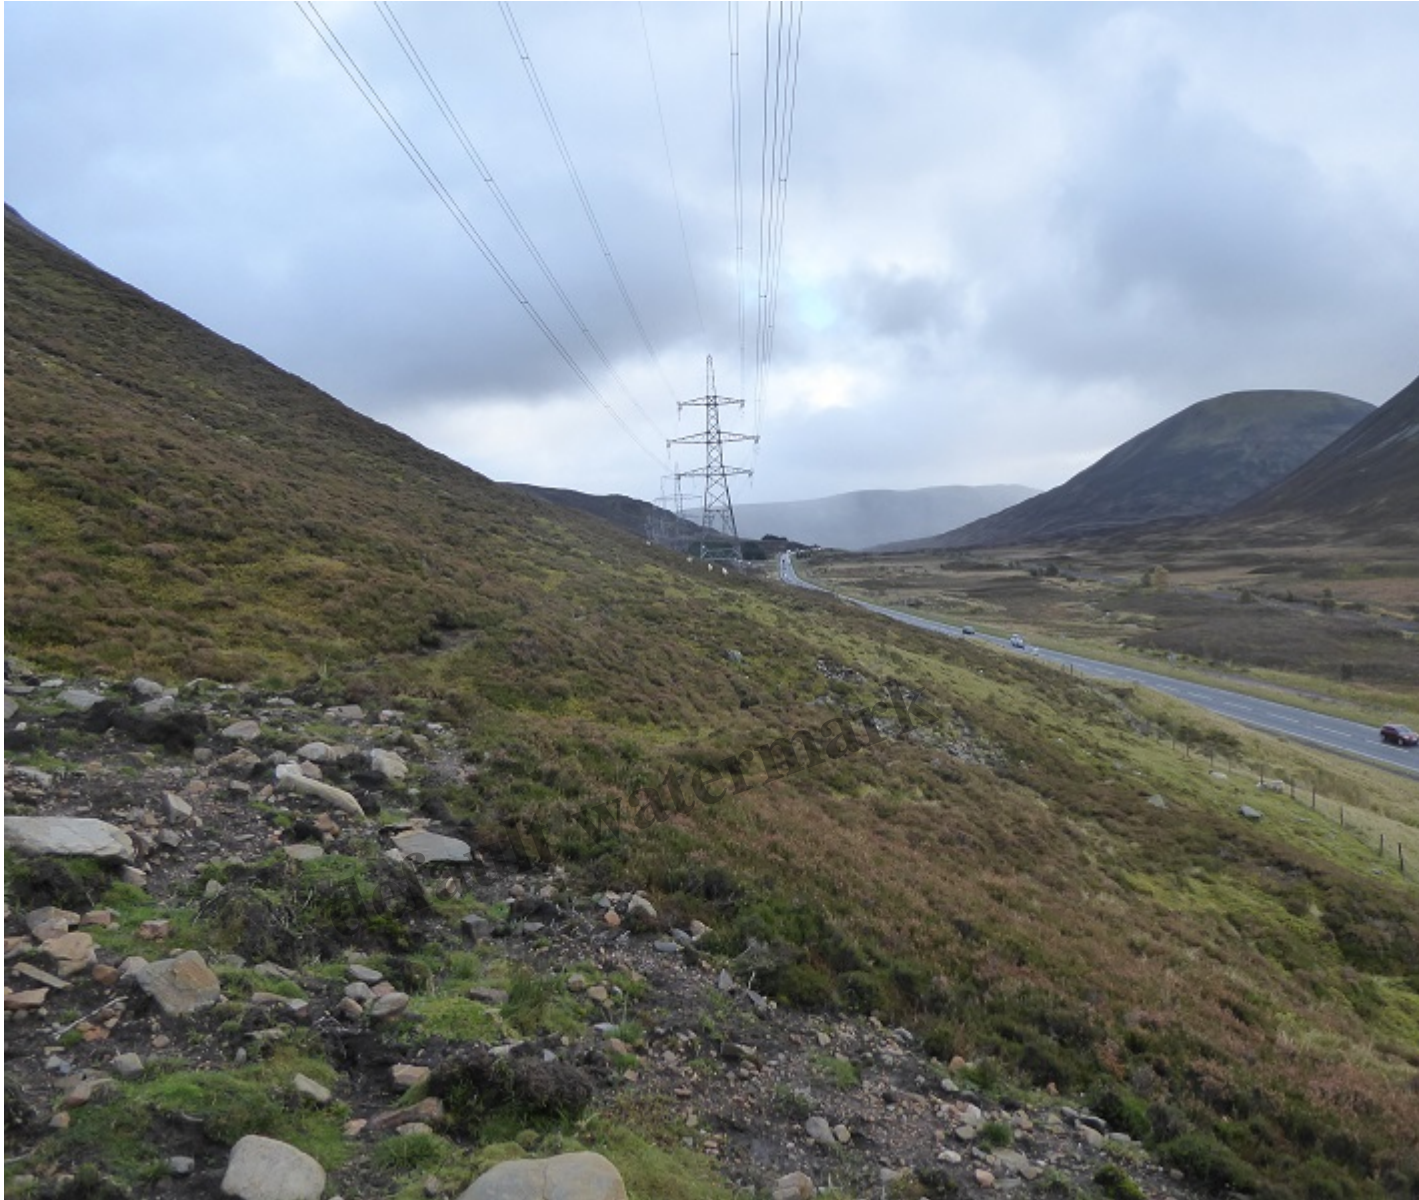
There is one section between pylons near the Boar of Badenoch where no access track was constructed.

This photo shows what the hillside would look like if restored properly and provides a benchmark to judge the restoration.
