The landscape impact of the Beauly Denny

This post will consider the failure of Scottish and Southern Electric to date to restore the landscape caused by the Beauly Denny construction works in the northern section of the Drumochter.

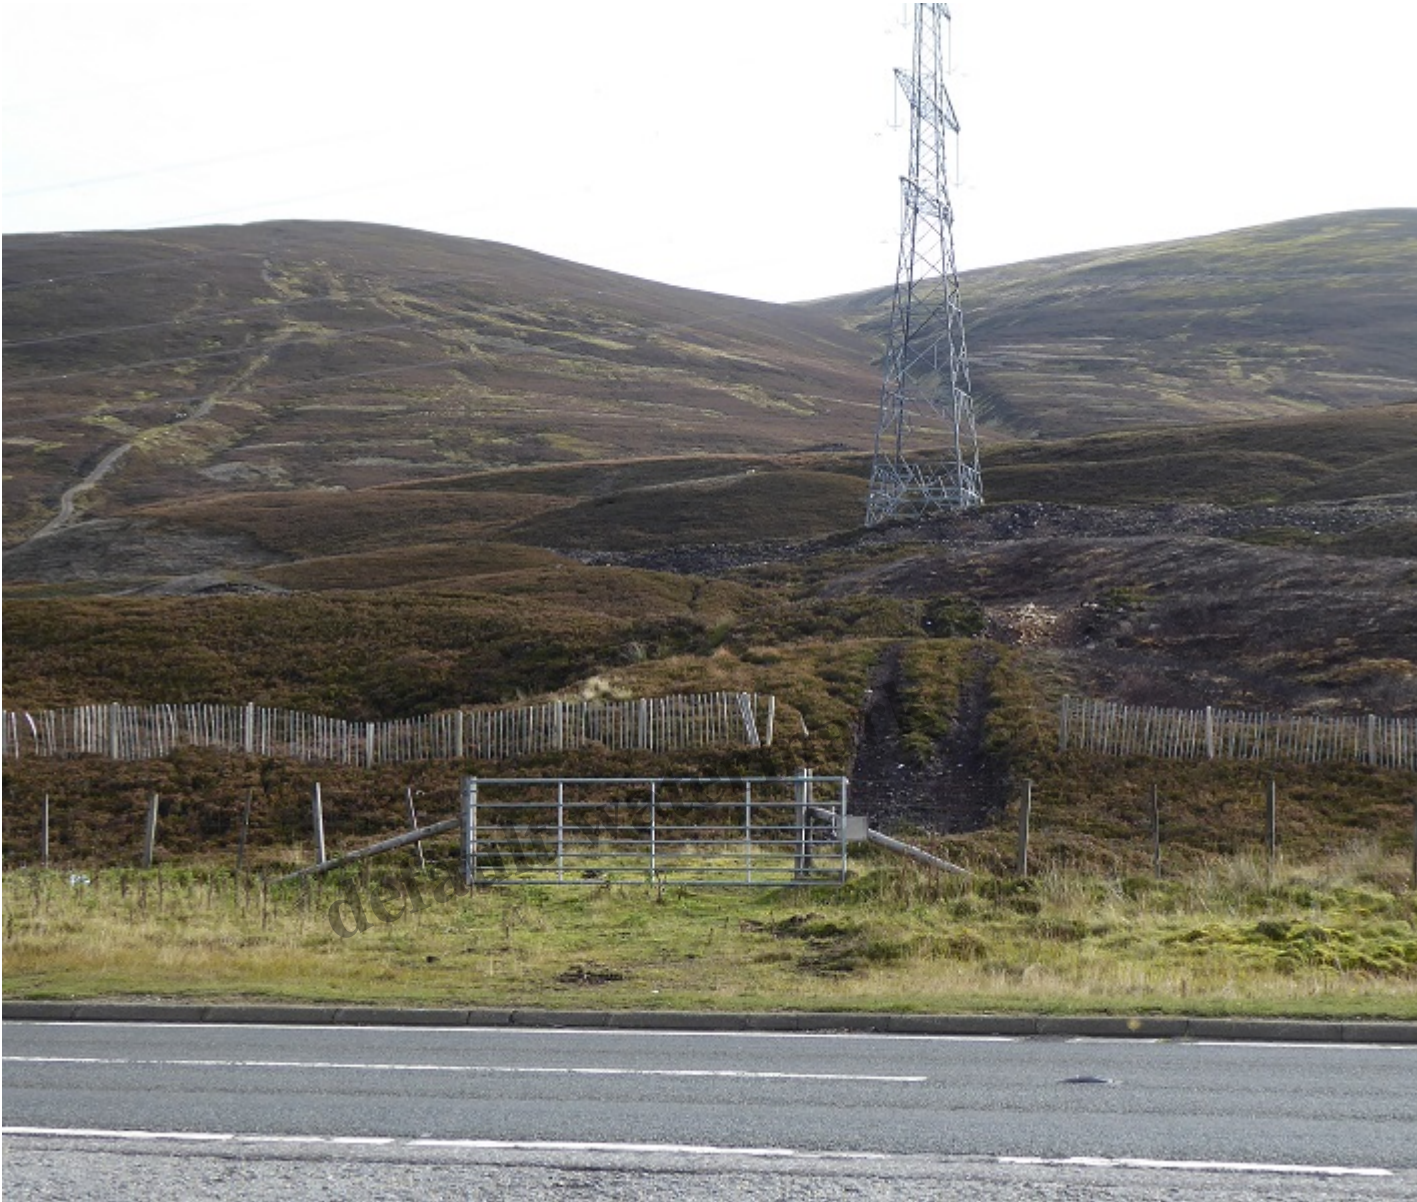
Access point opposite Balsporran Cottages has been used to create a shortcut to North Drumochter

The use of vehicles has been facilitated by the creation of access gates from the A9 enabling vehicles to be driven up onto the line of the Beaully Denny construction track, creating more erosion and

preventing vegetation recovery.
