The landscape impact of the Beauly Denny

This post will consider the failure of Scottish and Southern Electric to date to restore the landscape caused by the Beauly Denny construction works in the northern section of the Drumochter.

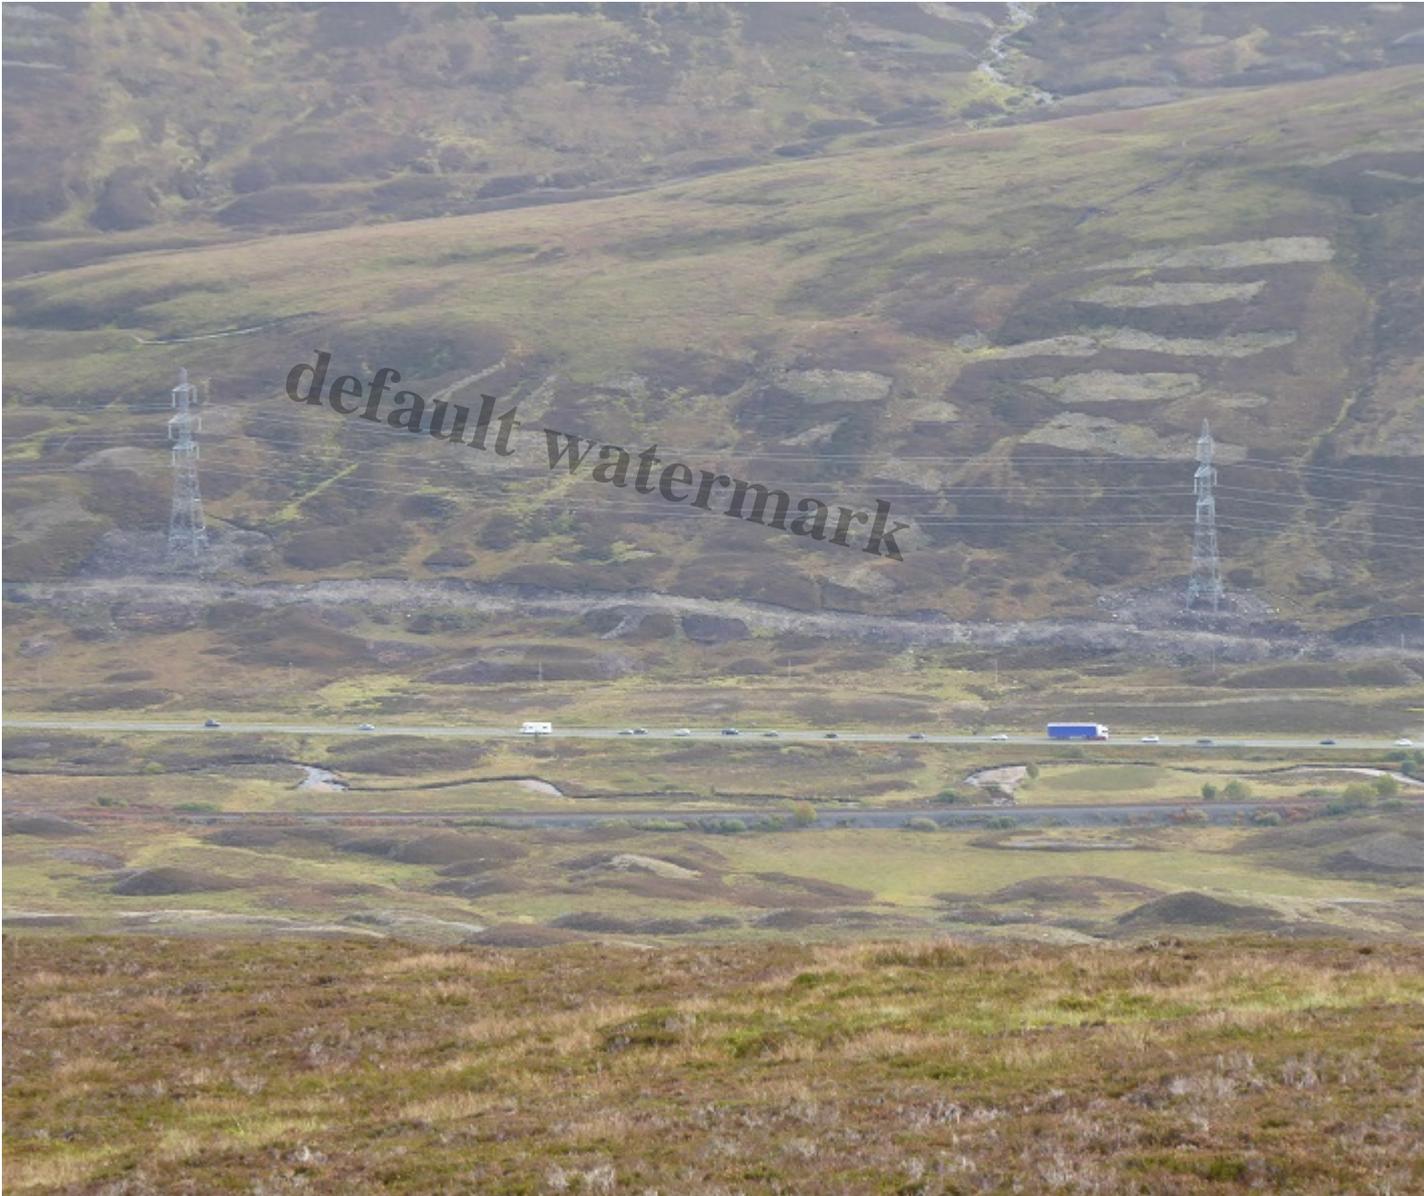
The “restored” construction track just south of Balsporran Cottage forms a gash across the hillsides. The track will remain highly visible even if the vegetation does recover because the “bench” which was cut across the hillside by cut and fill construction to provide a flat track has not been re-landscaped.

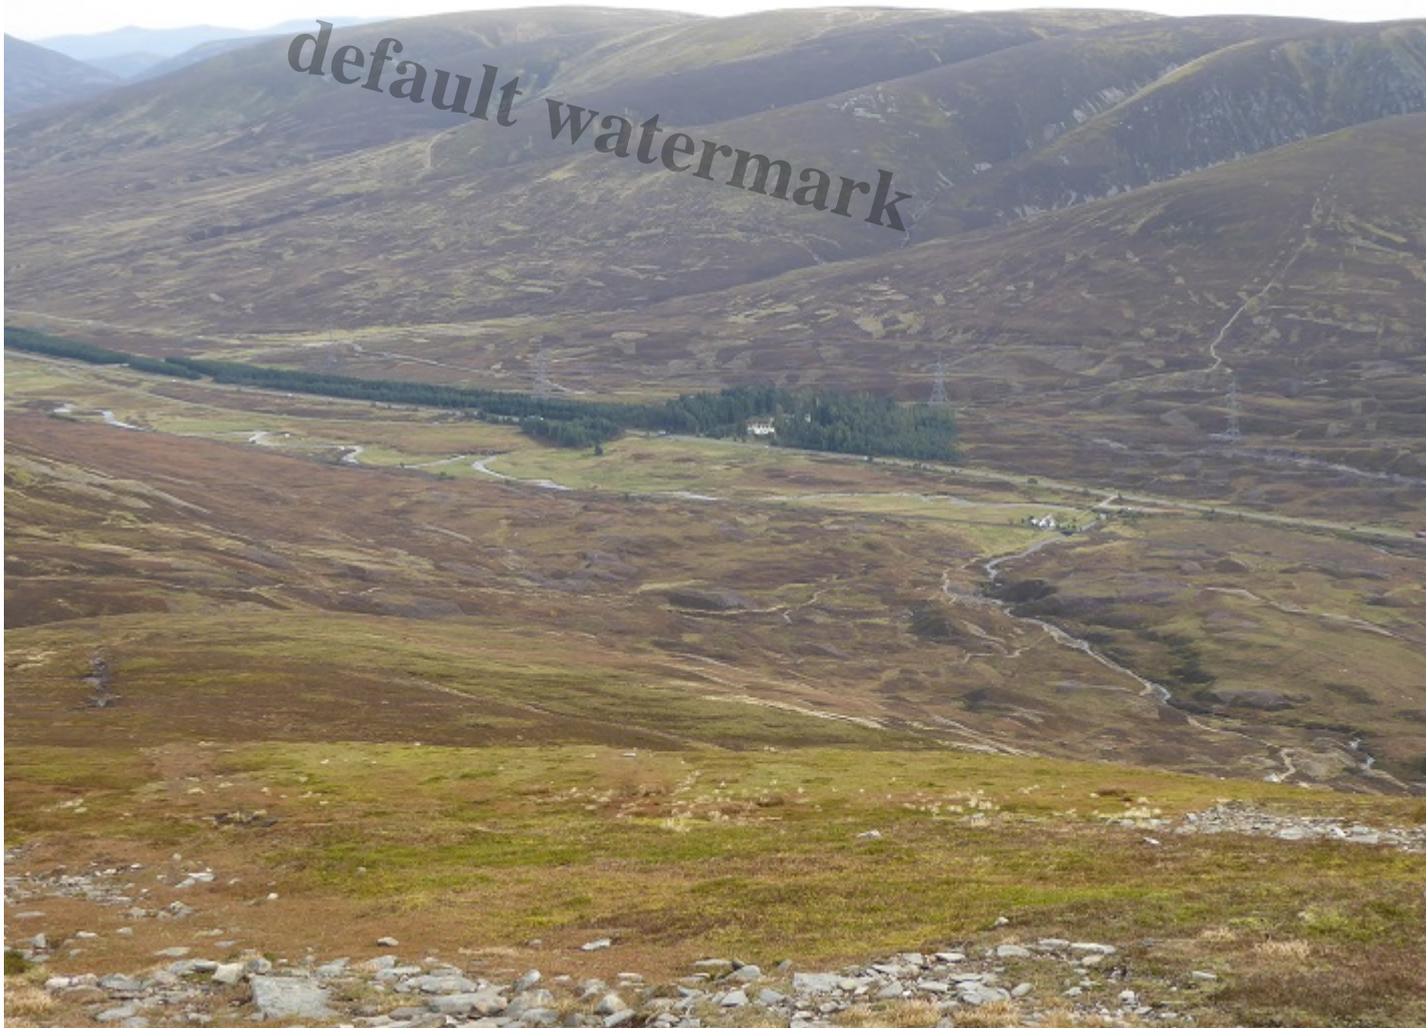
View of north Drumochter Lodge and Beaully Denny from Geal Charn.

[here](#)). The northern part of this track (outside frame of photo) was restored in the summer but the North Drumochter Estate has subsequently applied to remove the requirement for native woodland planting around it – this will be considered in future post. The section considered in this post, where full restoration is required, lies between the south (right) of the north Drumochter Lodge policy woodlands to Drumochter summit. The line of the former construction track is still clearly visible in the photo above from a distance.

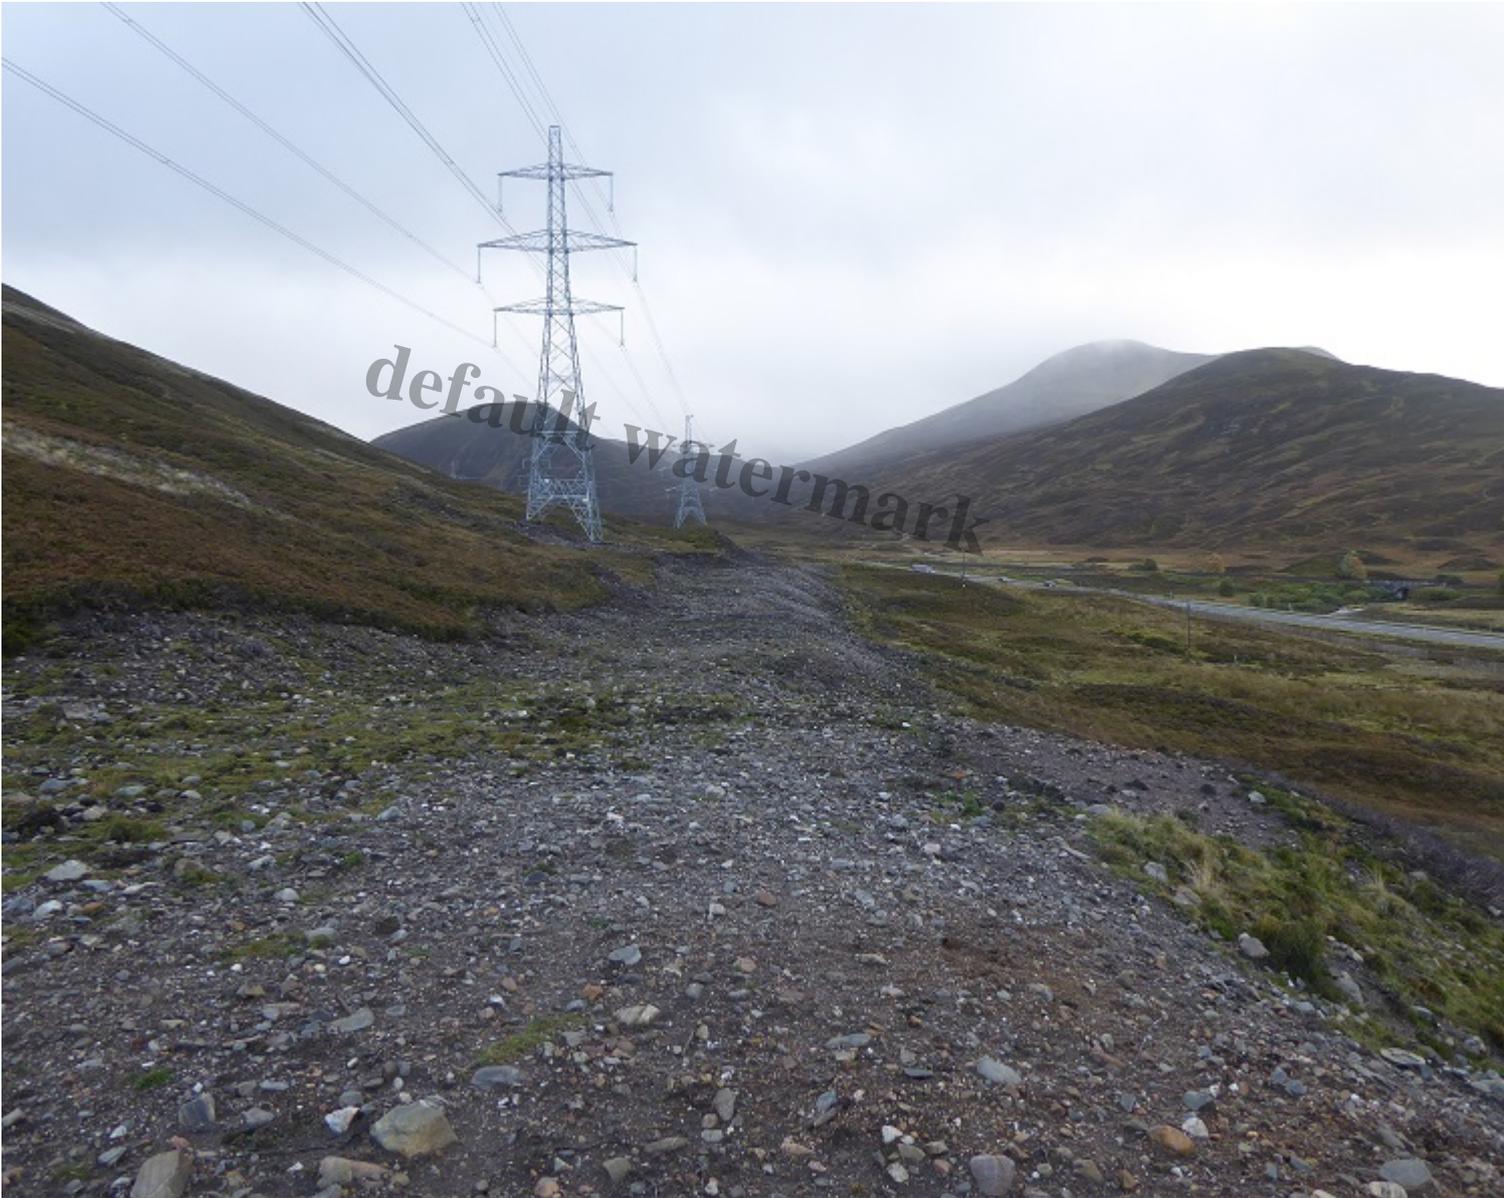
In my view the main reason for this is that the attempt to restore the former access track along this section has been risible. The photo above shows the bench that was cut across the hillside through cut and fill (the upper slope was cut and the lower filled in with the material excavated) remains. In effect the only restoration that has been carried out has been to break up the former track surface. The material which forms the line of the track should have been moulded back to match the contours of the hillside, with the –fill– material shifted uphill to cover the –cut– ground and banks on the upside of the track.

In my view both CNPA and SNH should now be calling on SSE to produce a proper landscape plan to restore the scar across the hillside caused by the failure to re-landscape the cut and fill track. Such restoration should make off road use of vehicles along the line of the former construction track very difficult, while specific action should be taken to prevent the estate from driving vehicles onto the flatter area of moorland between north Drumochter Lodge and Balsporran Cottages.

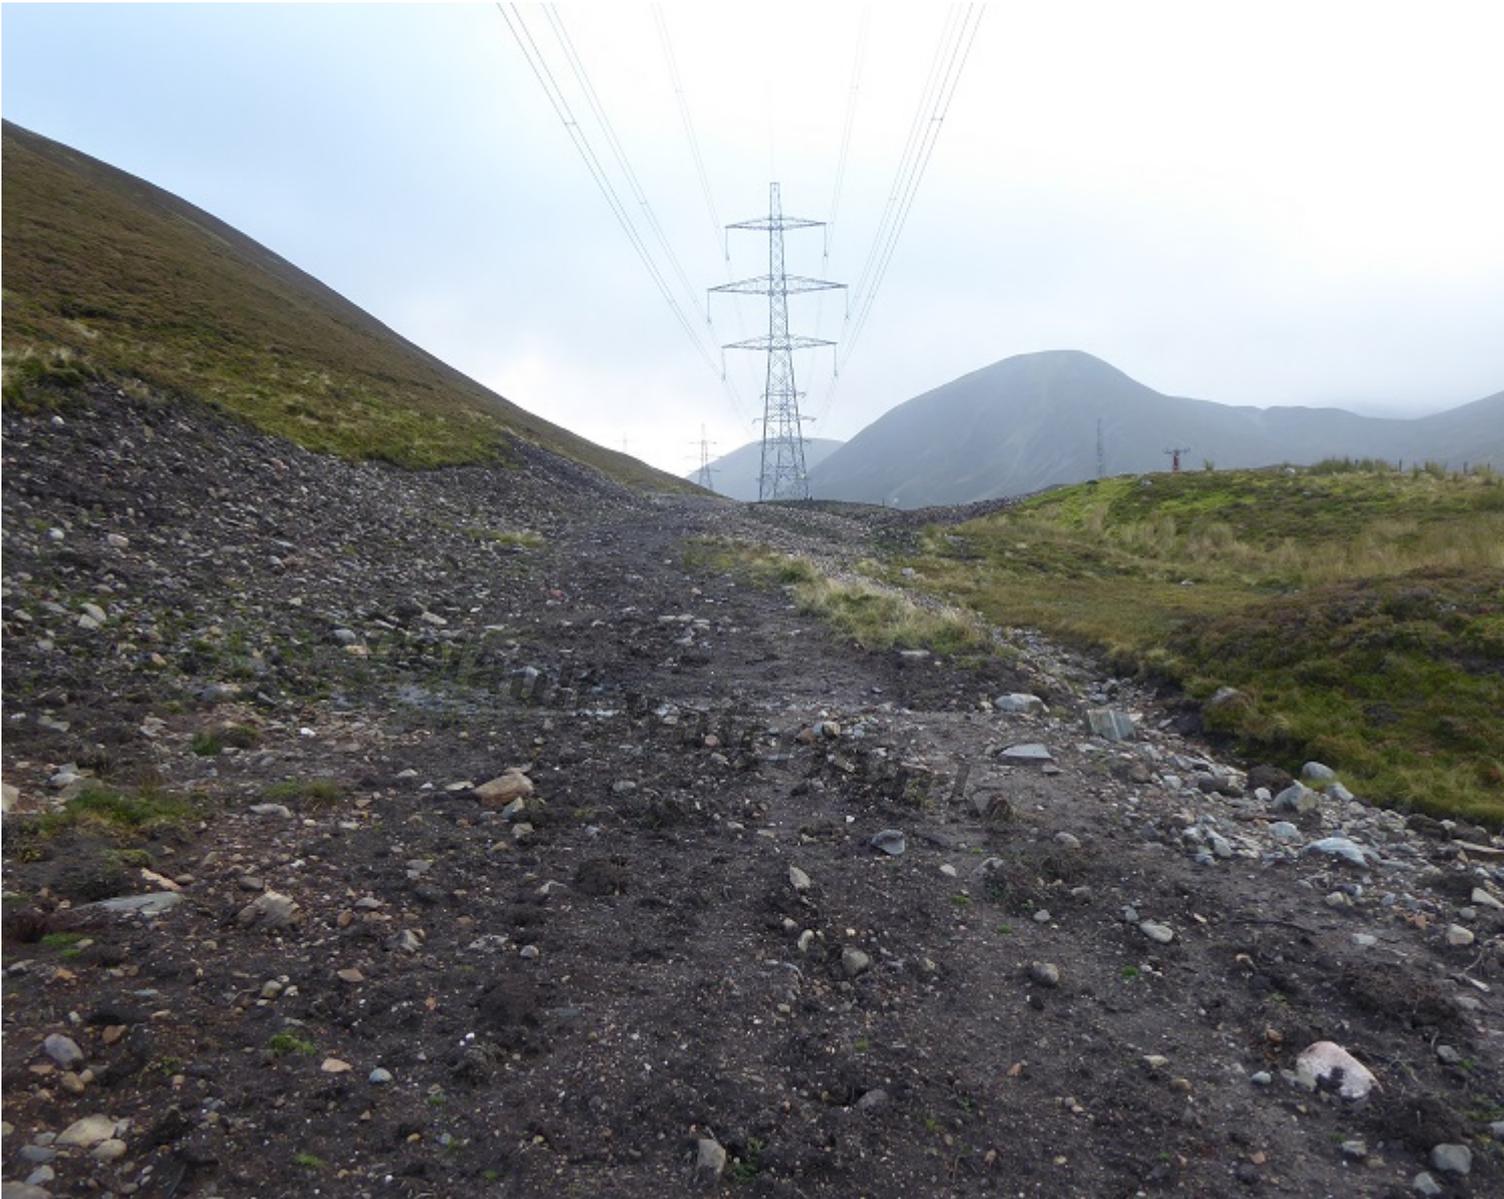
The consequence of leaving the track foundations in place is not only that a permanent line has been left across the hillside but as should have been quite predictable, the North Drumochter Estate has continued to use the line as a track. This will prevent full vegetation recovery even if the current plan, which is to leave restoration up to natural regeneration works.

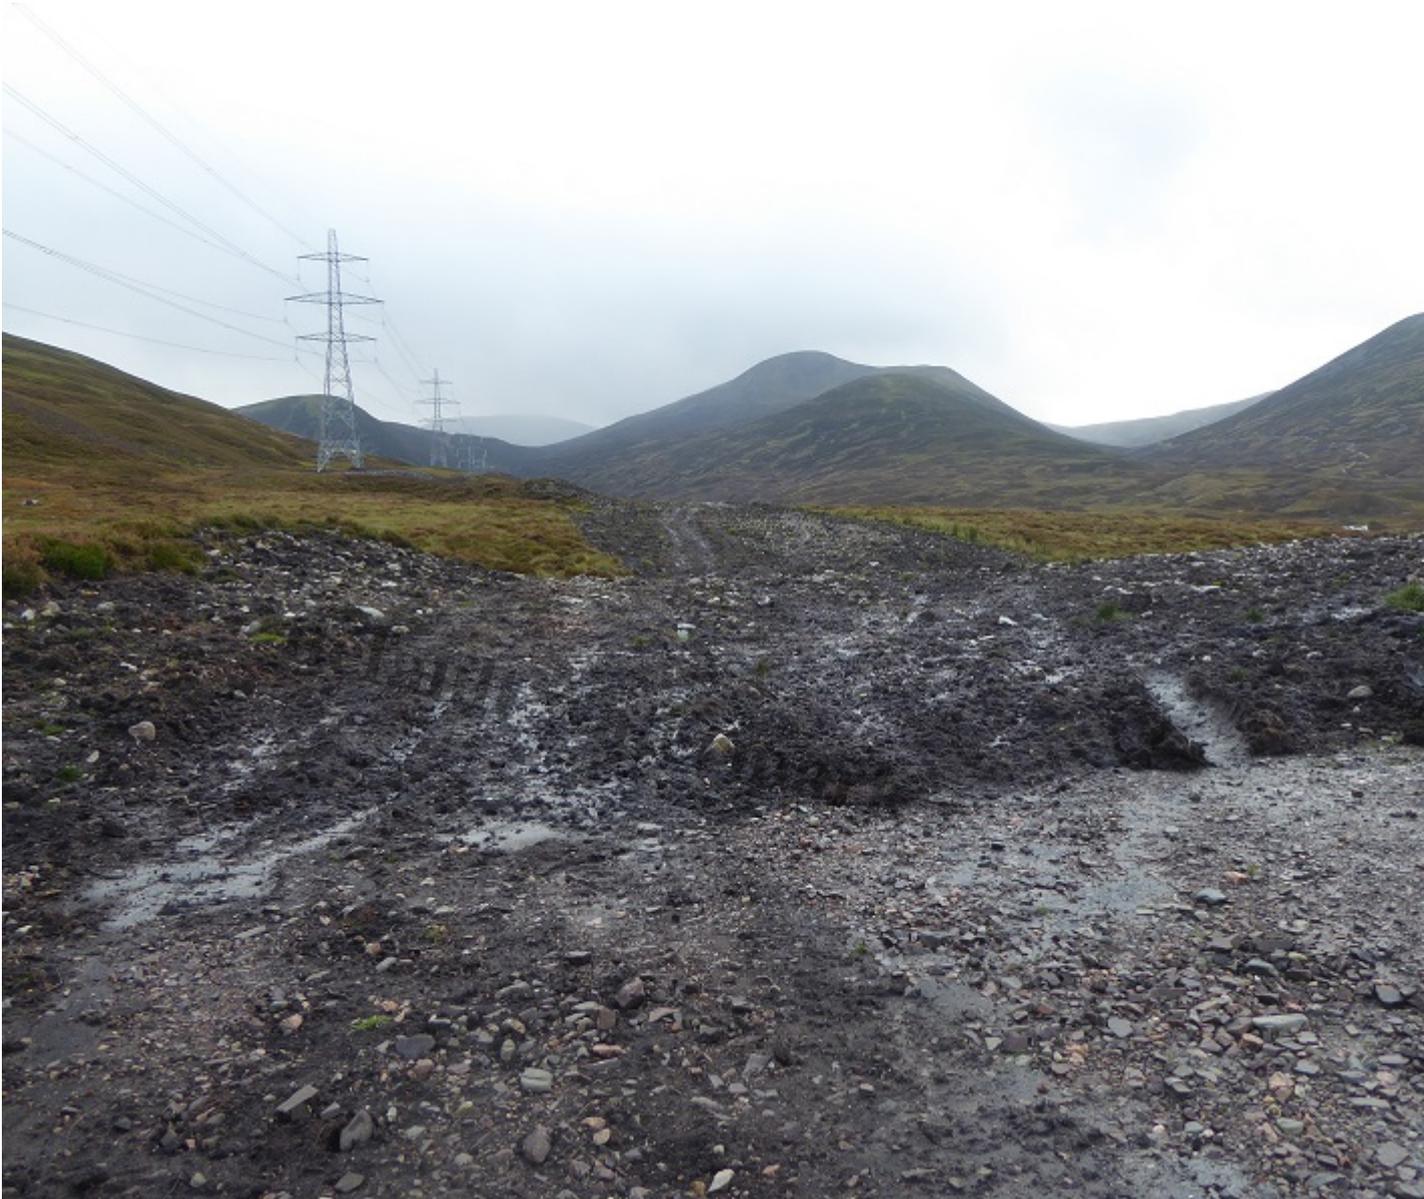
The boundary between the unrestored section of track just south of North Drumochter Lodge policy v and the restored section.

The photos shows vehicles are still being driven from the section of track granted planning permission by the CNPA (which still requires to be narrowed) onto the section “restored” by SSE’s contractors creating a churned up motorway. This “restored” section is in the Drumochter Hills Site of Special Scientific Interest and off-track use of vehicles here needs consent by SNH. (I will ask if it has been granted). Unless the CNPA, SNH and SSE work together to stop vehicles being driven here the vegetation will never recover.

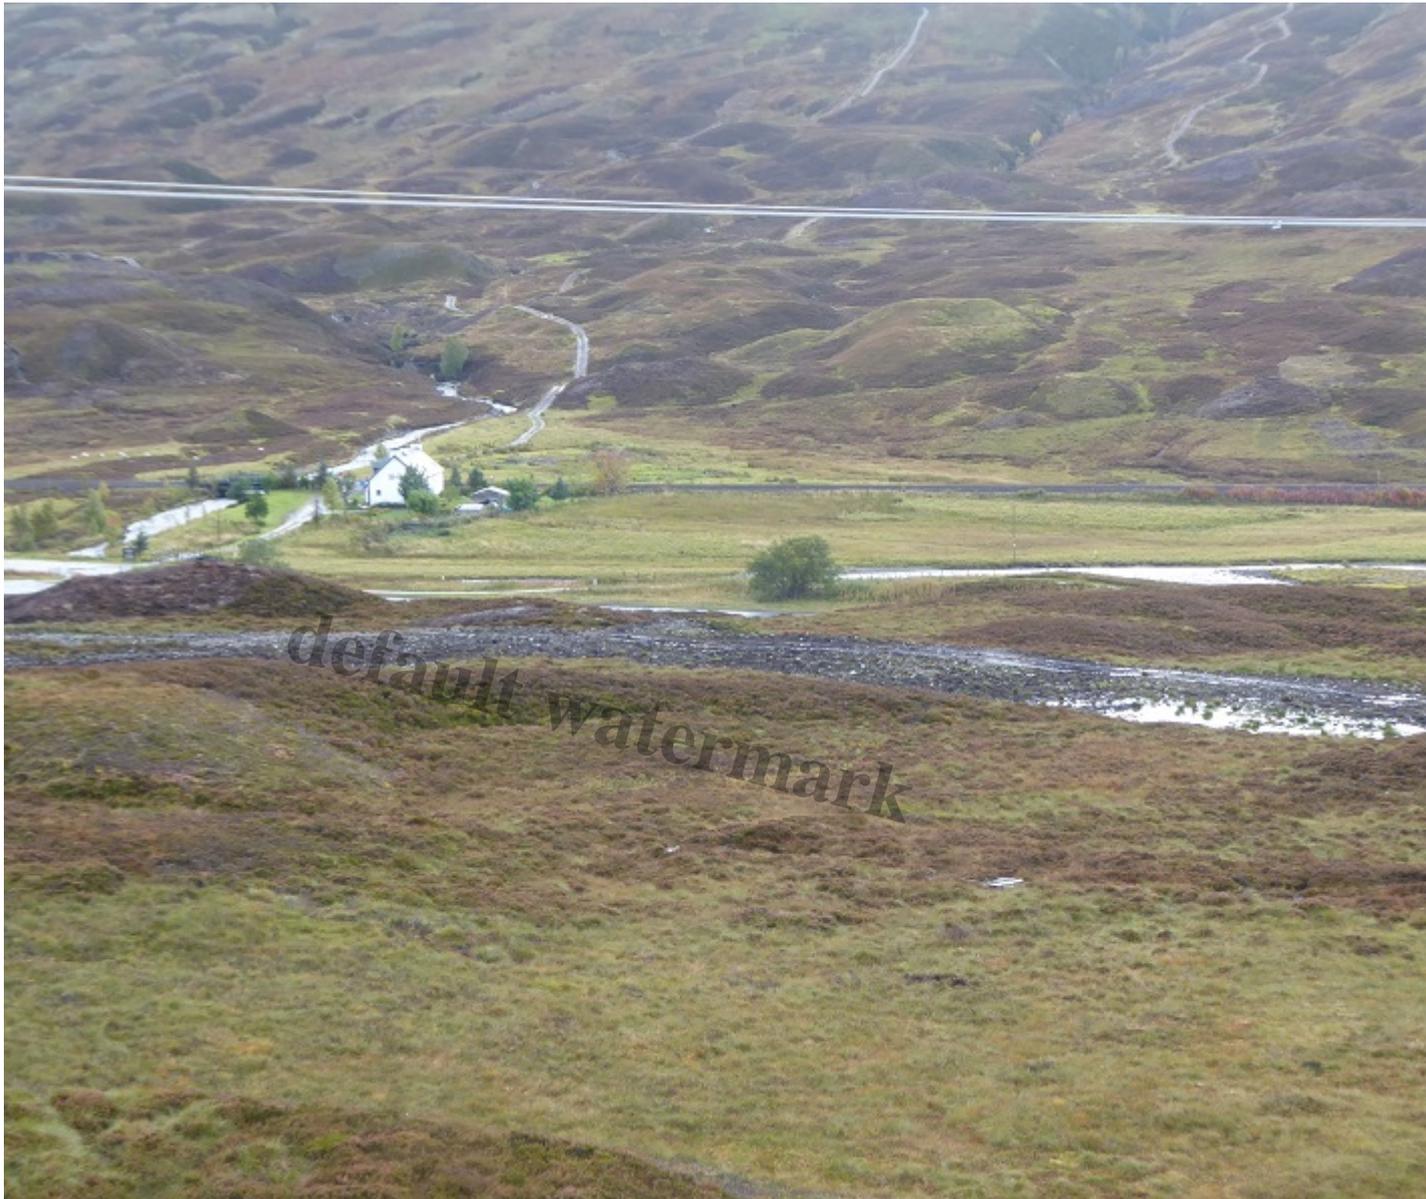
The first section of the restored track opposite Balsporran Cottages is a quagmire due to inappropriate use

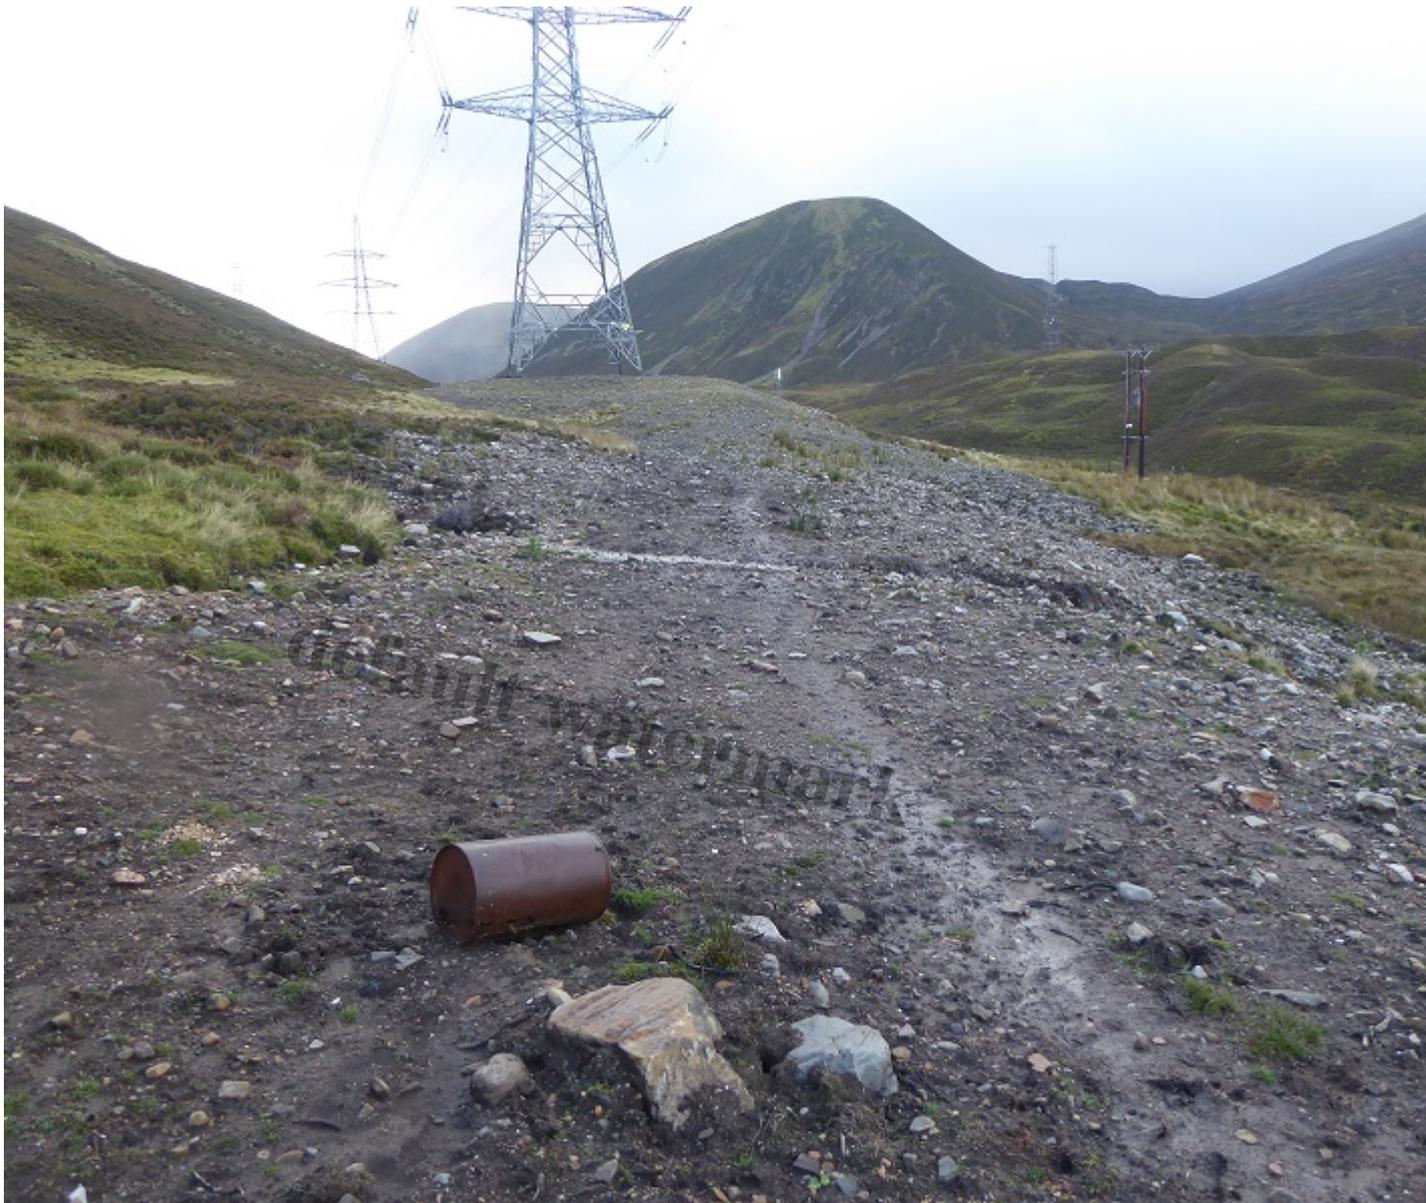
For almost 2.5km there has been no attempt to landscape the ground of the former track into the surrounding hillside with the result that it will form a permanent landscape scar even if vehicle use was stopped

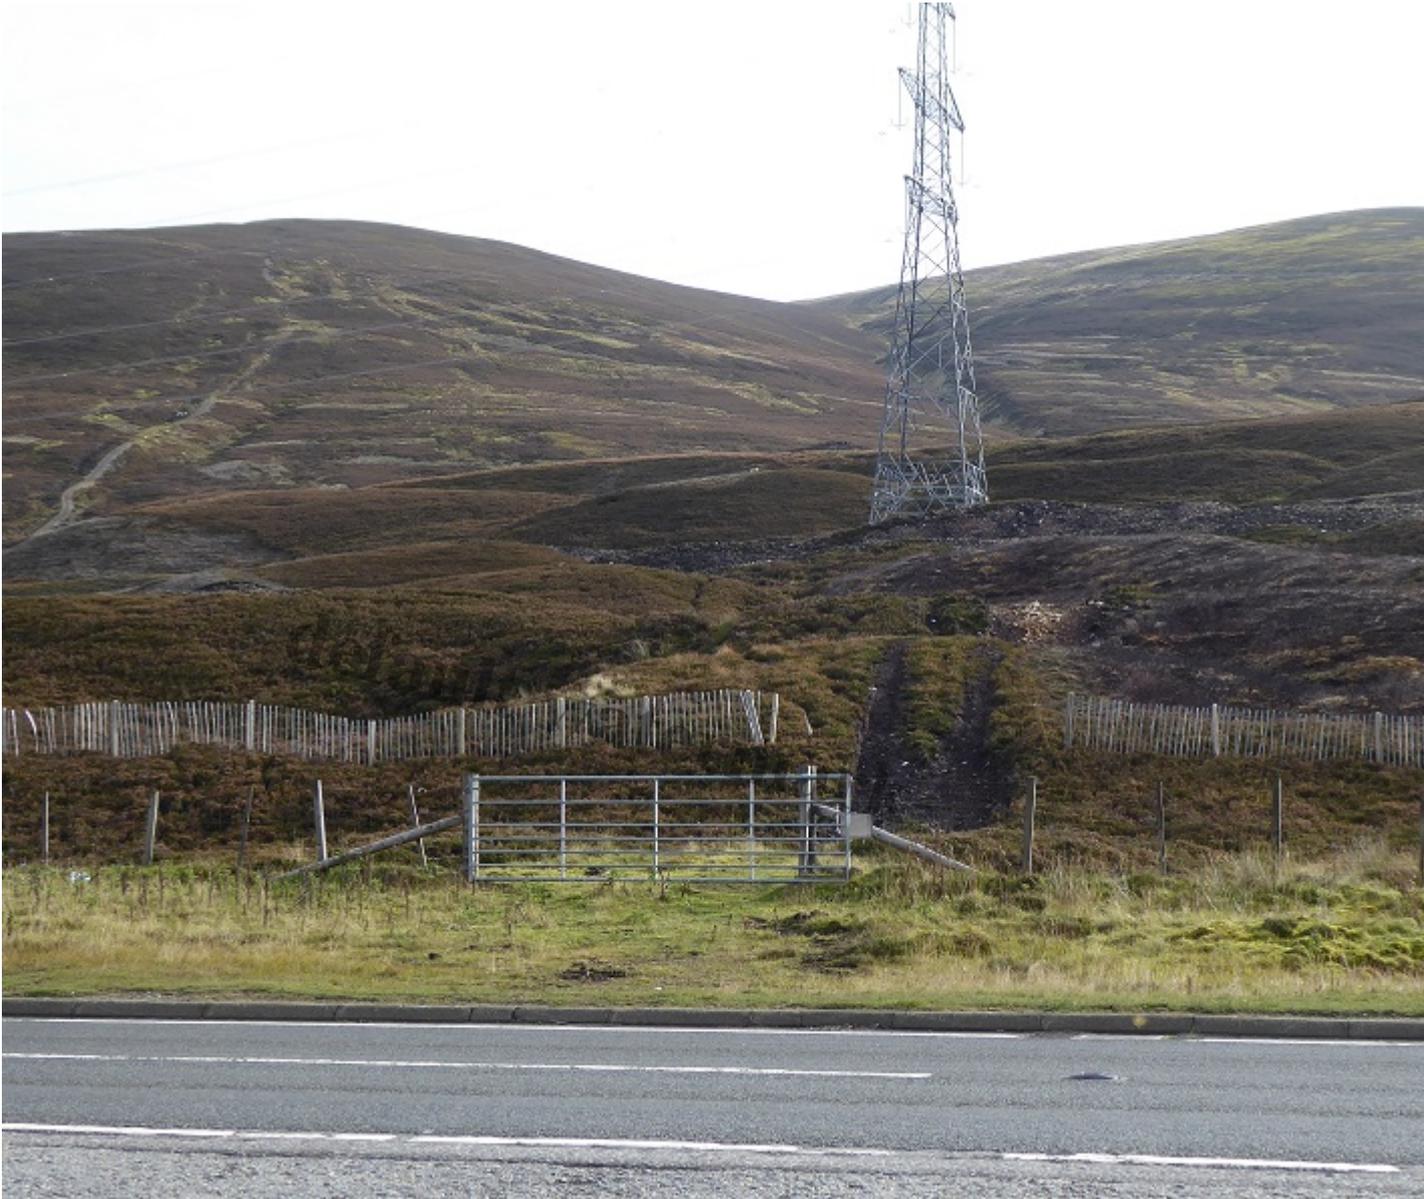
Access point opposite Balsporran Cottages has been used to create a shortcut to North Drumochter

The use of vehicles has been facilitated by the creation of access gates from the A9 enabling vehicles to be driven up onto the line of the Beaully Denny construction track, creating more erosion and preventing vegetation recovery.

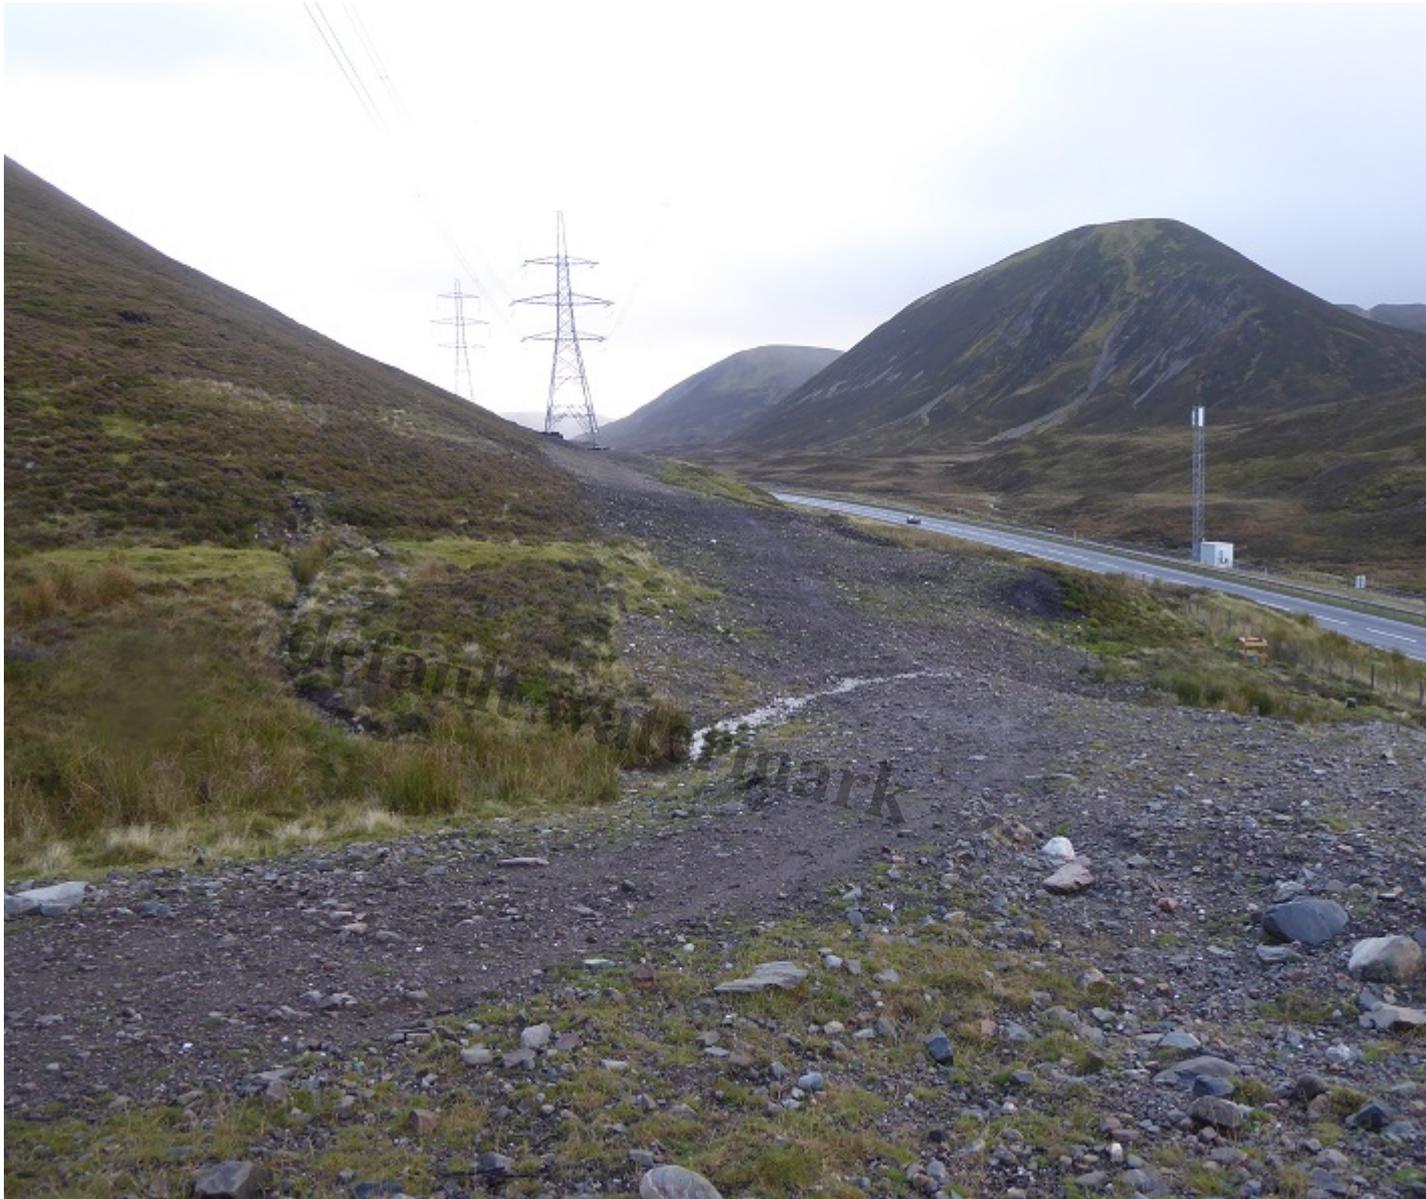
The former track as it approaches the Boar of Badenoch from the north – in what sense is this a temporary track?

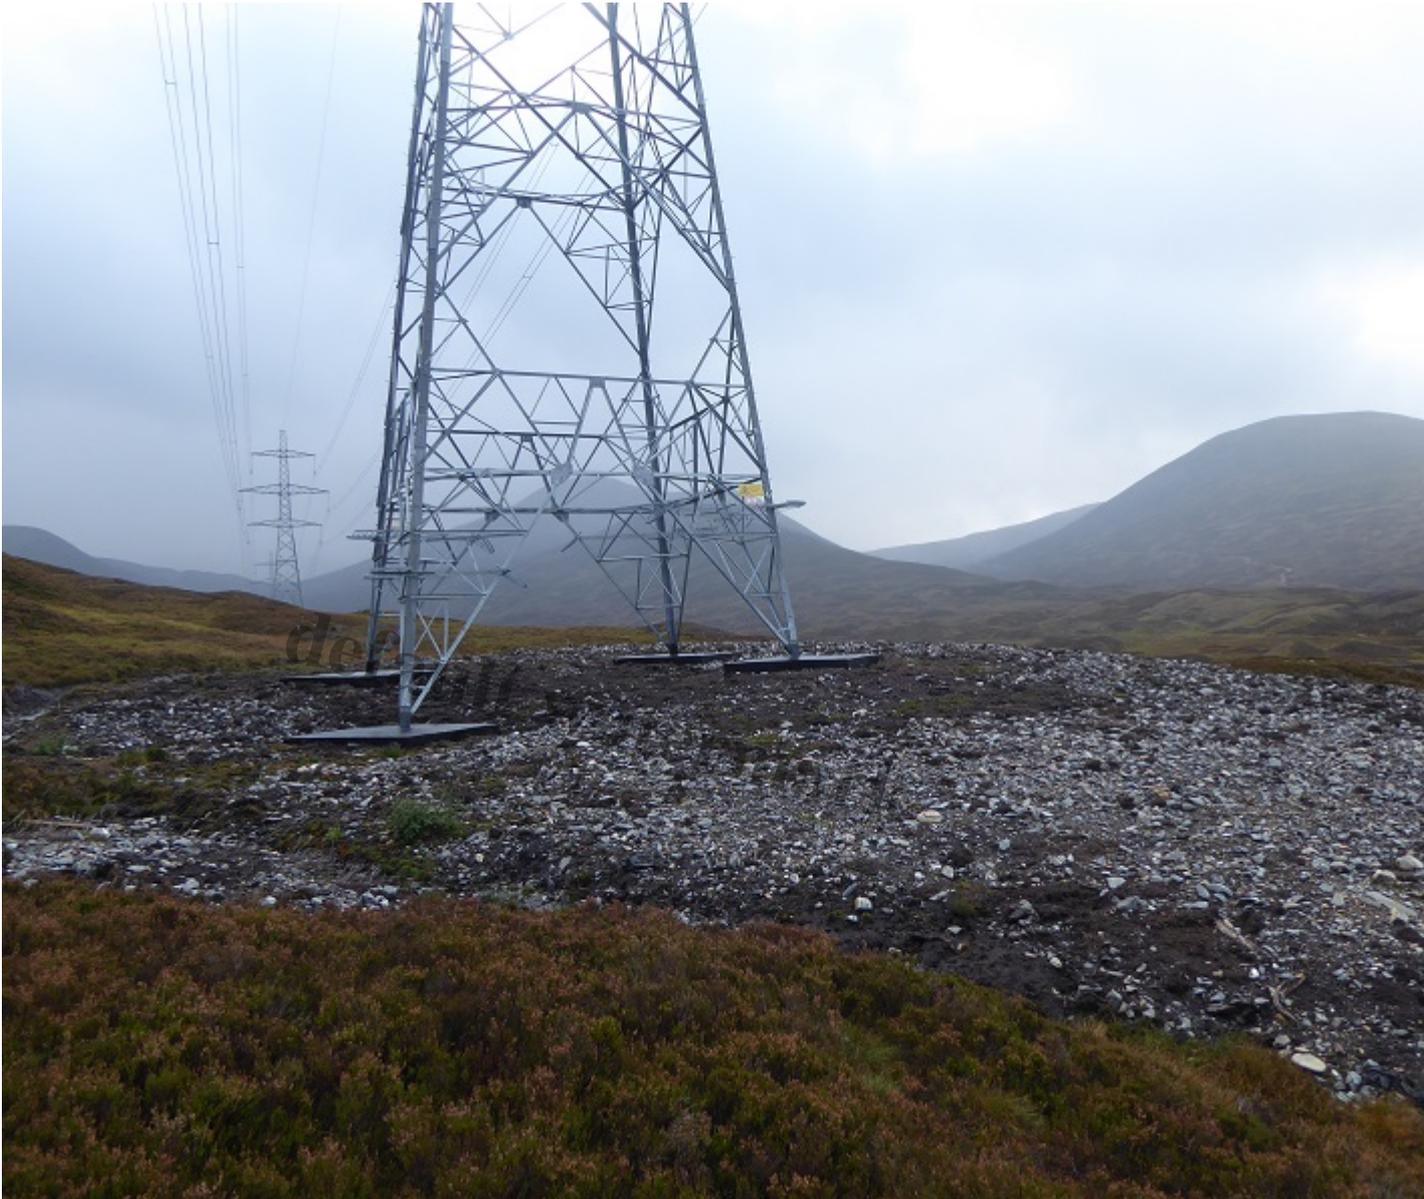
Some peat has been restored around the tower base but a far wider area has been left to “natural regeneration”.

Some of the poor restoration around the tower bases has been explained by CNPA staff as being a consequence of a failure to store vegetation properly during the construction phase leaving insufficient peat and vegetation to re-cover the area and of inadequate construction method statements [250615trackrestorationSSE \(obtained through FOI\)](#). This appears correct and the result is that more mineral soils are exposed and this will promote natural regeneration by different plant communities. CNPA staff have suggested alternative solutions (see peatland restoration advice in link above) which so far appear to have been resisted by SSE. One suspects the underlying reason for this is SSE does not want to incur more costs.

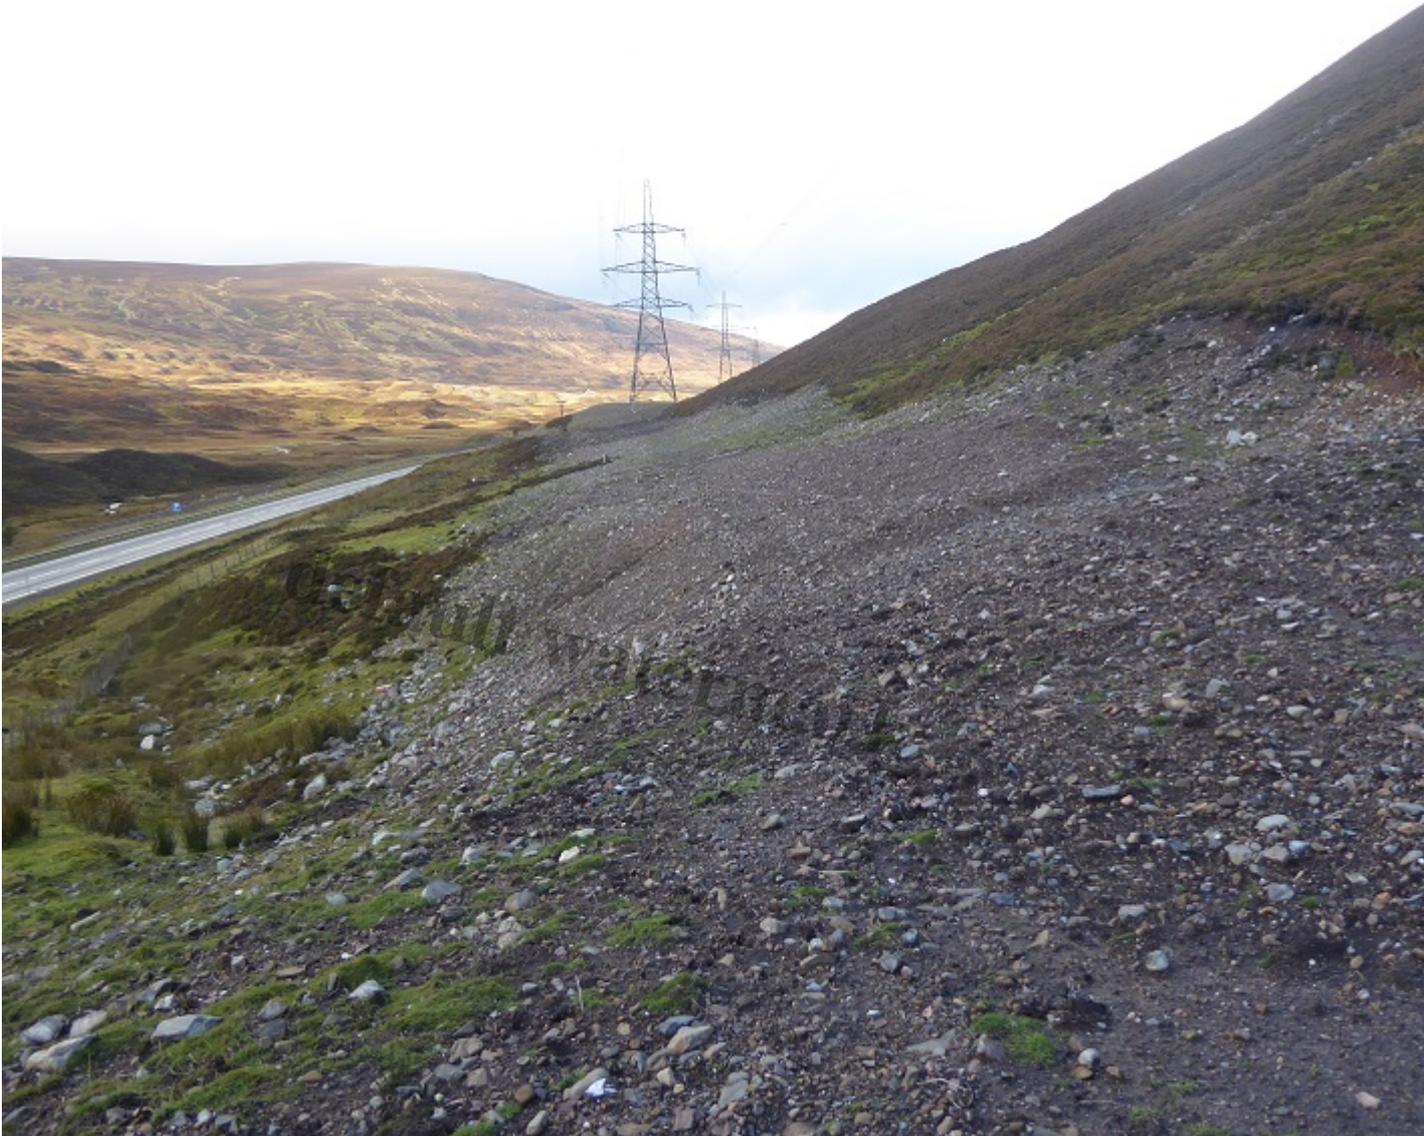
Section south of previous photo looking north

Its only as the former construction track approaches the Drumochter pass that the restoration work has attempted to remove the line of the cut and fill and mould the former track materials into the contours of the hillside. While a short section of bank (on right) has been left exposed, other restoration on this short stretch has been more successful with the horizontal bench across the hillside effectively removed, making it much harder for vehicles to drive here. Unfortunately the failure to store and replace vegetation means it will still form a very visible scar for some time. Vegetation reinstatement, rather than landscaping, is the main issue on this short section of the former construction track.

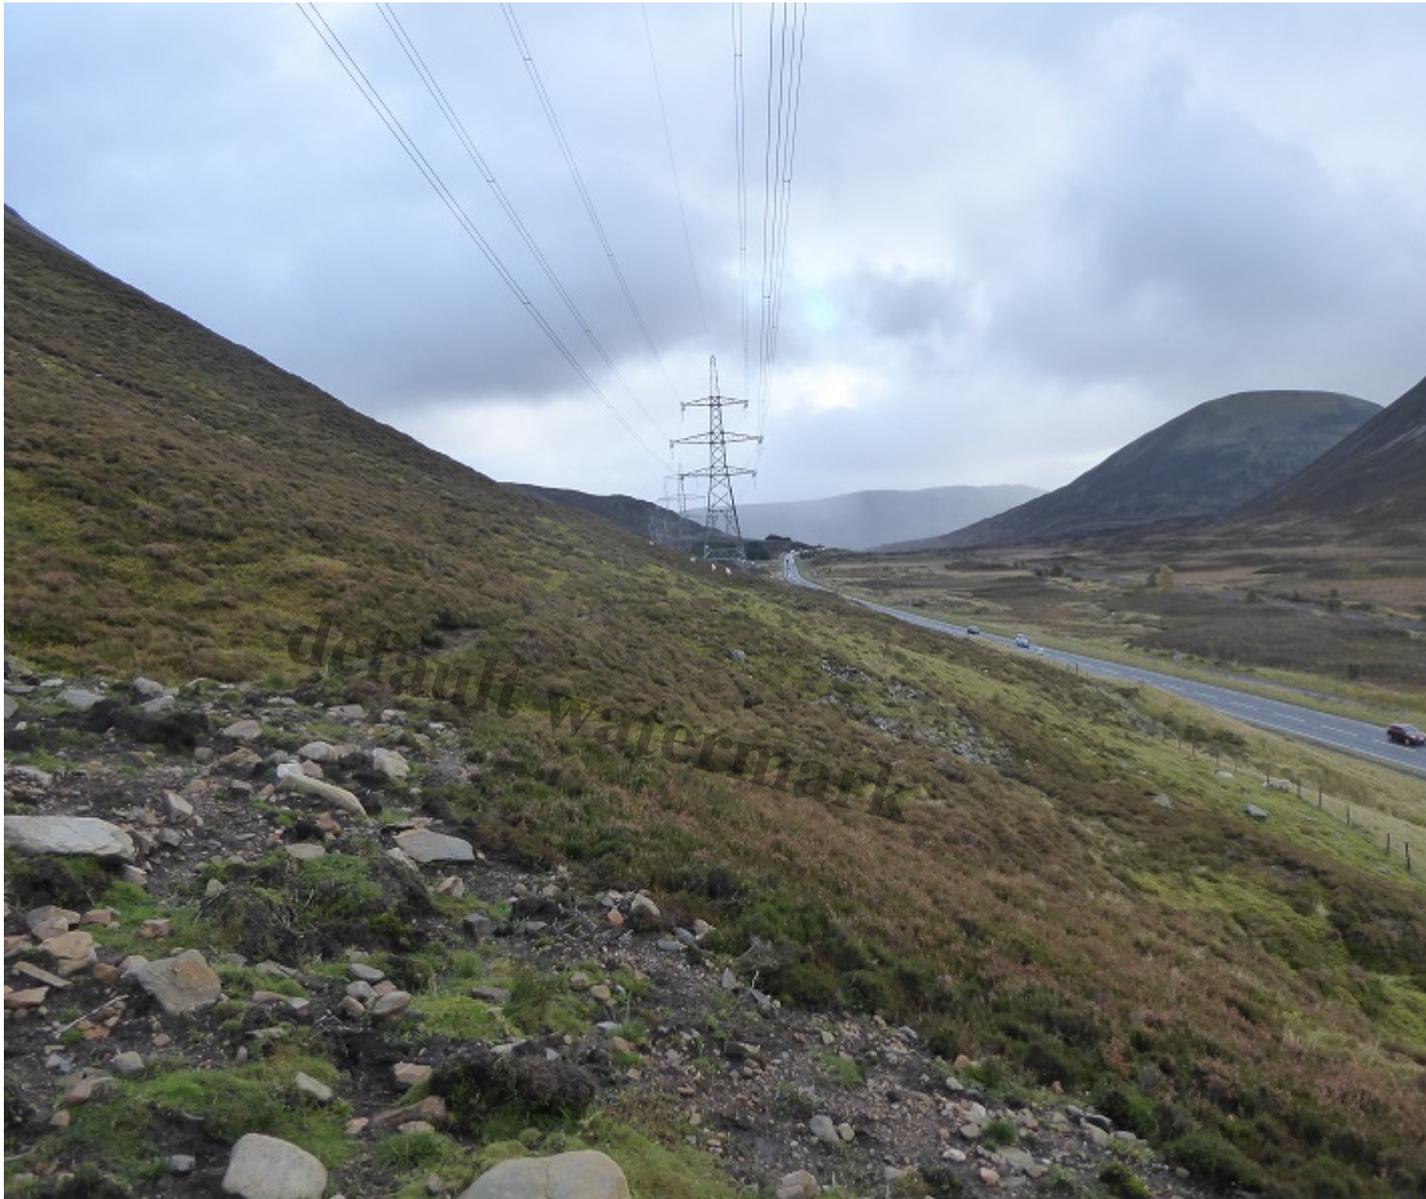
There is one section between pylons near the Boar of Badenoch where no access track was constructed.

This photo shows what the hillside would look like if restored properly and provides a benchmark to judge the restoration.
