The restoration of Glen Bruar

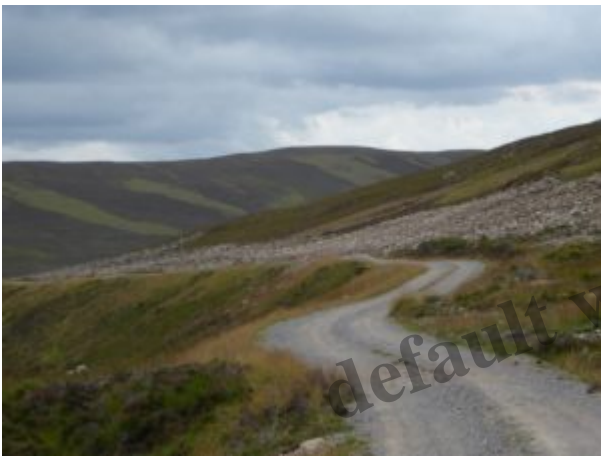
Looking south at the worst section of pipeline scar 2016

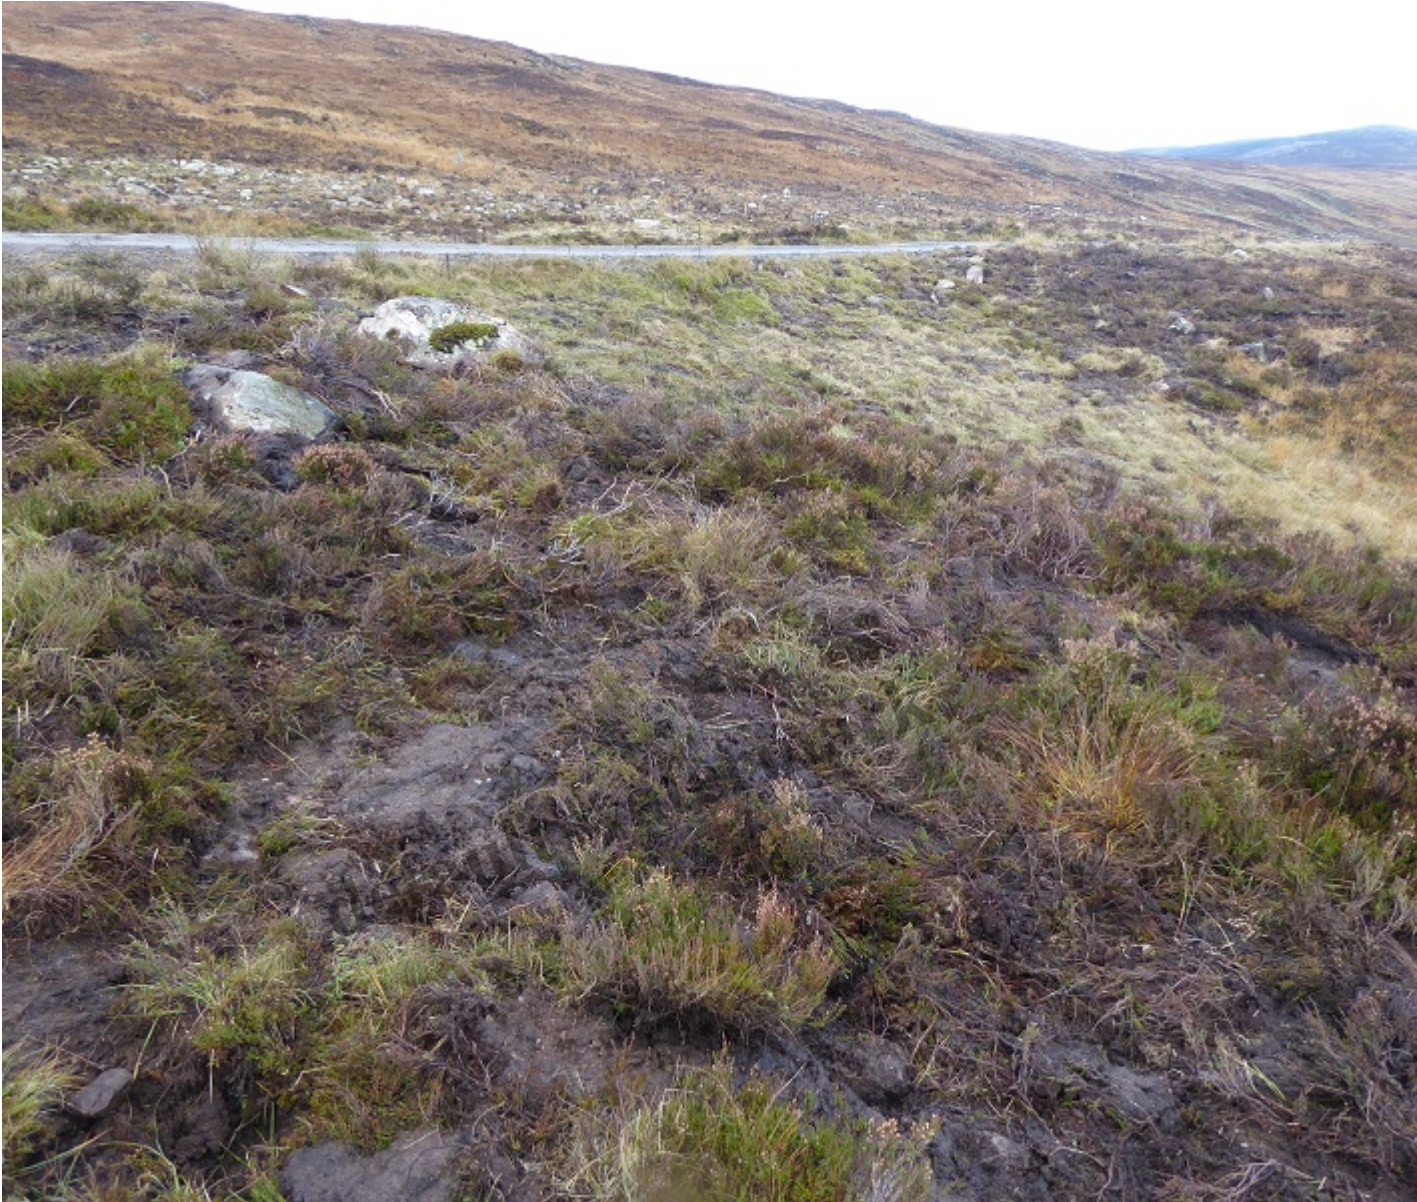
A more typical view of how the ground below the track and pipeline which has been robbed for turves appears

As a consequence the ground which has been “robbed” should recover quite quickly.

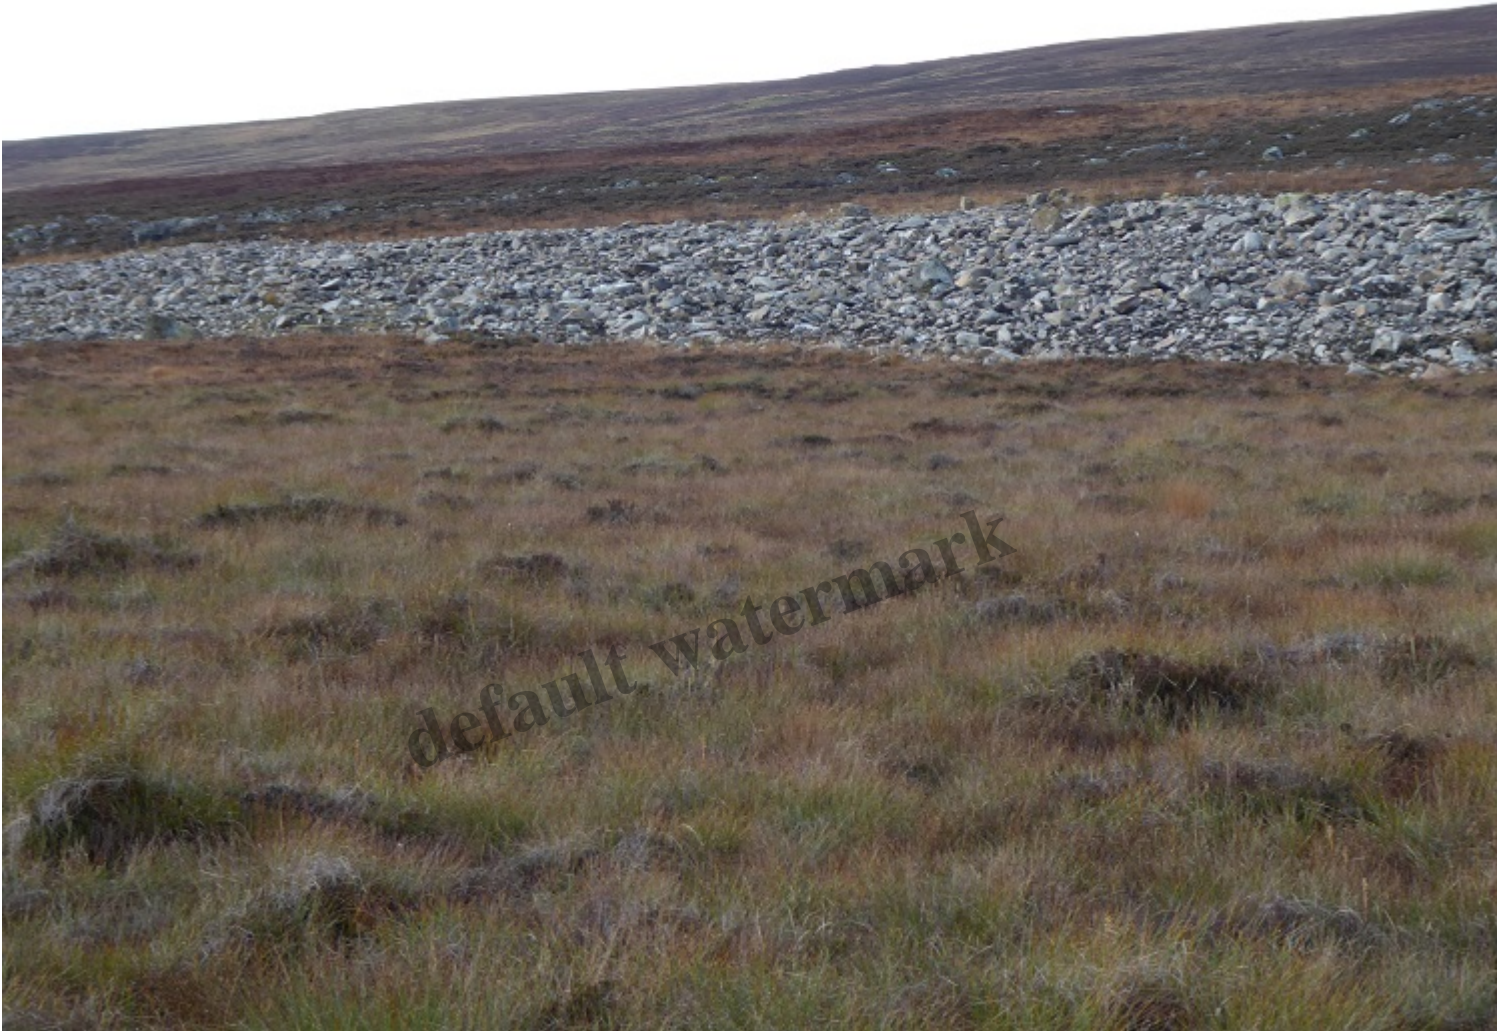
There is also still one area where the landscape scar is prominent, where the pipeline cuts across a slope above an area of deep peat:

At present it looks like very little attempt has been made to restore this.

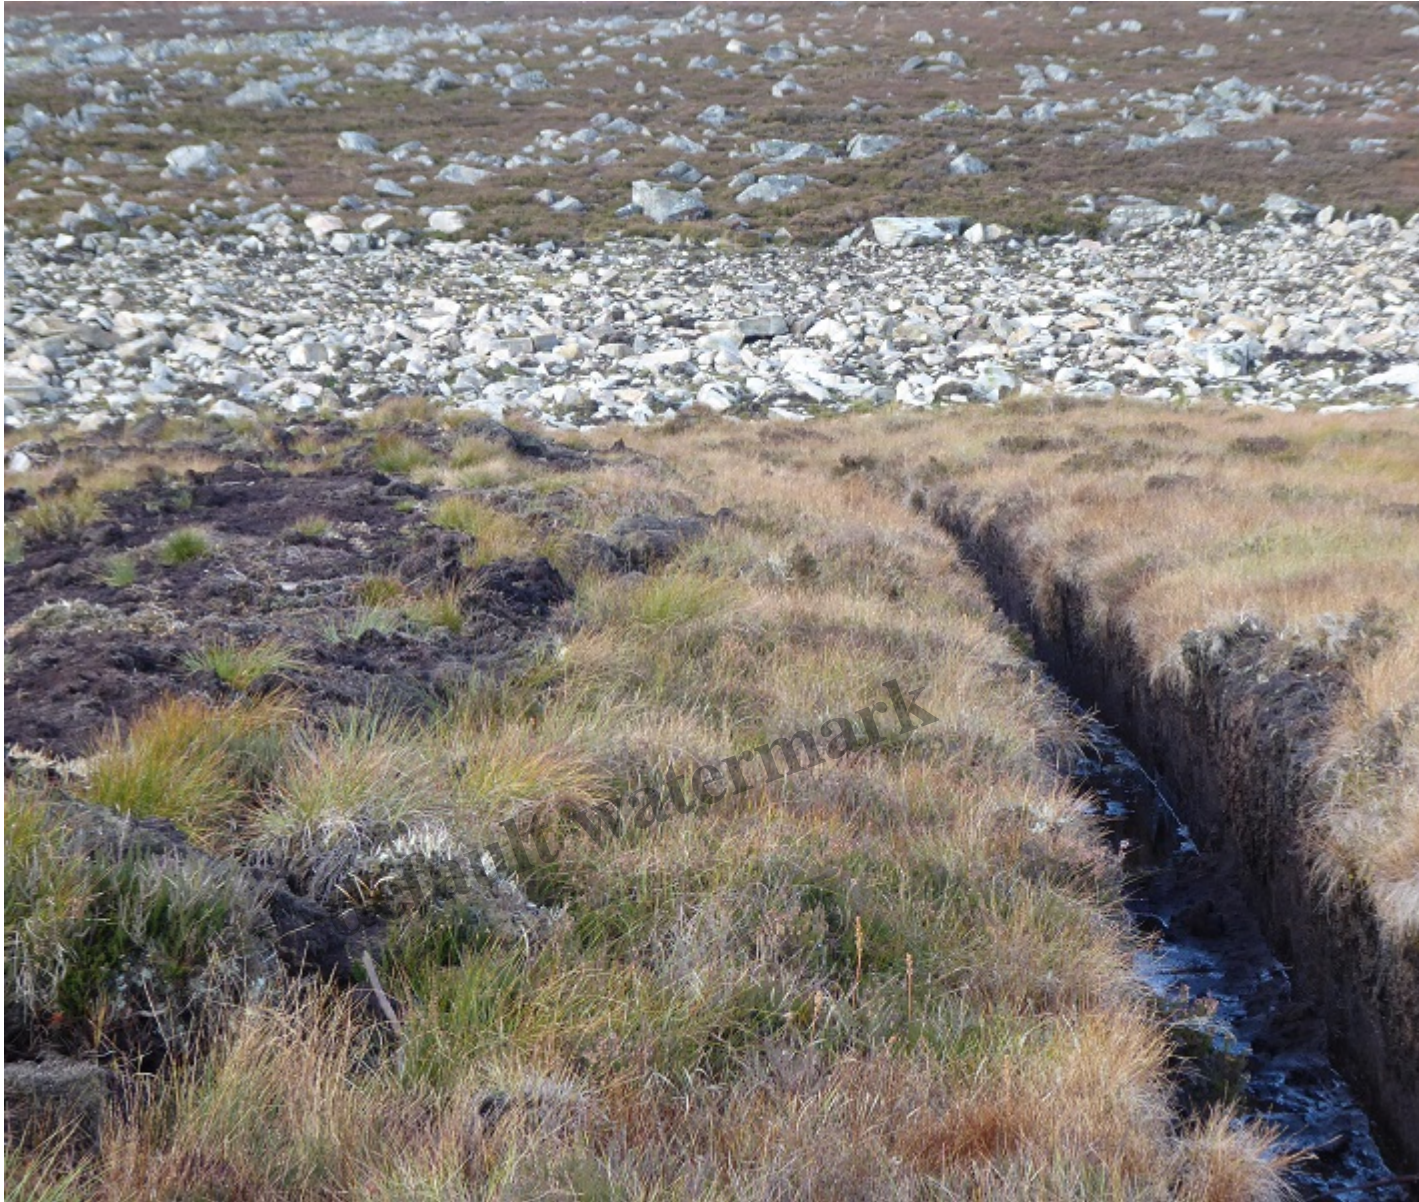
New drainage ditch showing depth of peat. The excavated material has been dumped on left.

There are however some obvious opportunities to do so. The vegetation that has recently been removed to create this ditch could have been used to reinstate part of the boulder band.

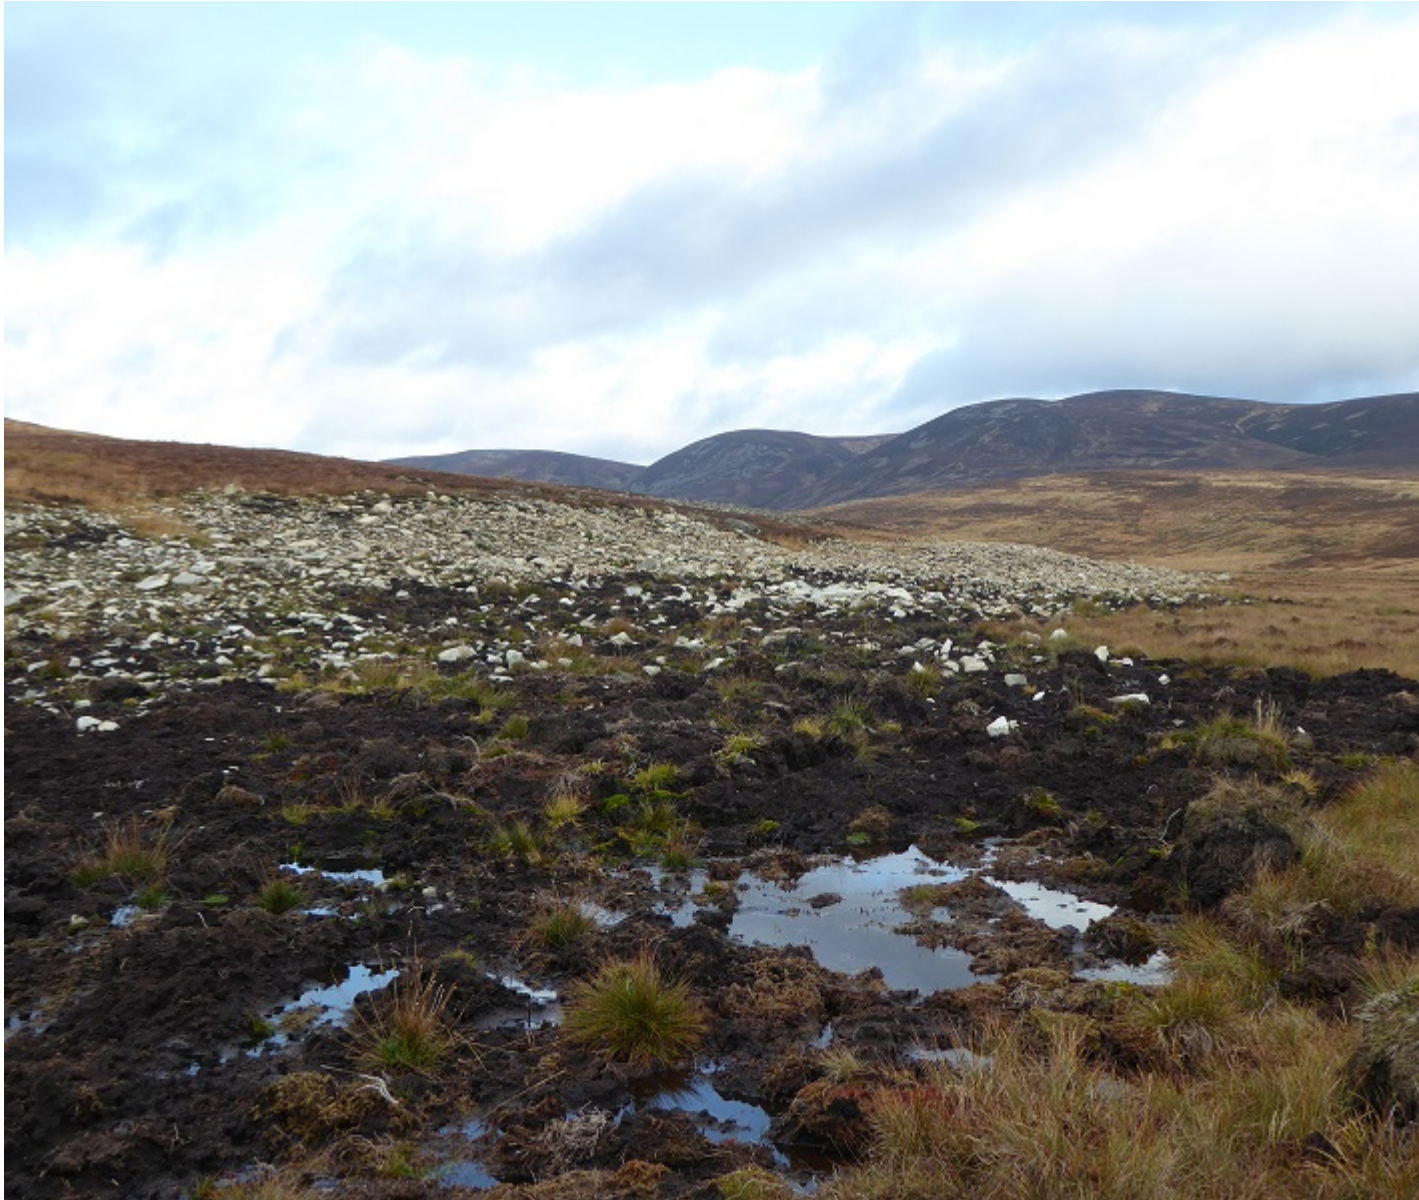
The start of the section of unrestored pipeline marked by the boulder field. Note the large peat turves far right which appear to date from original excavation and have never been used for restoration purposes.
