## The restoration of Glen Bruar

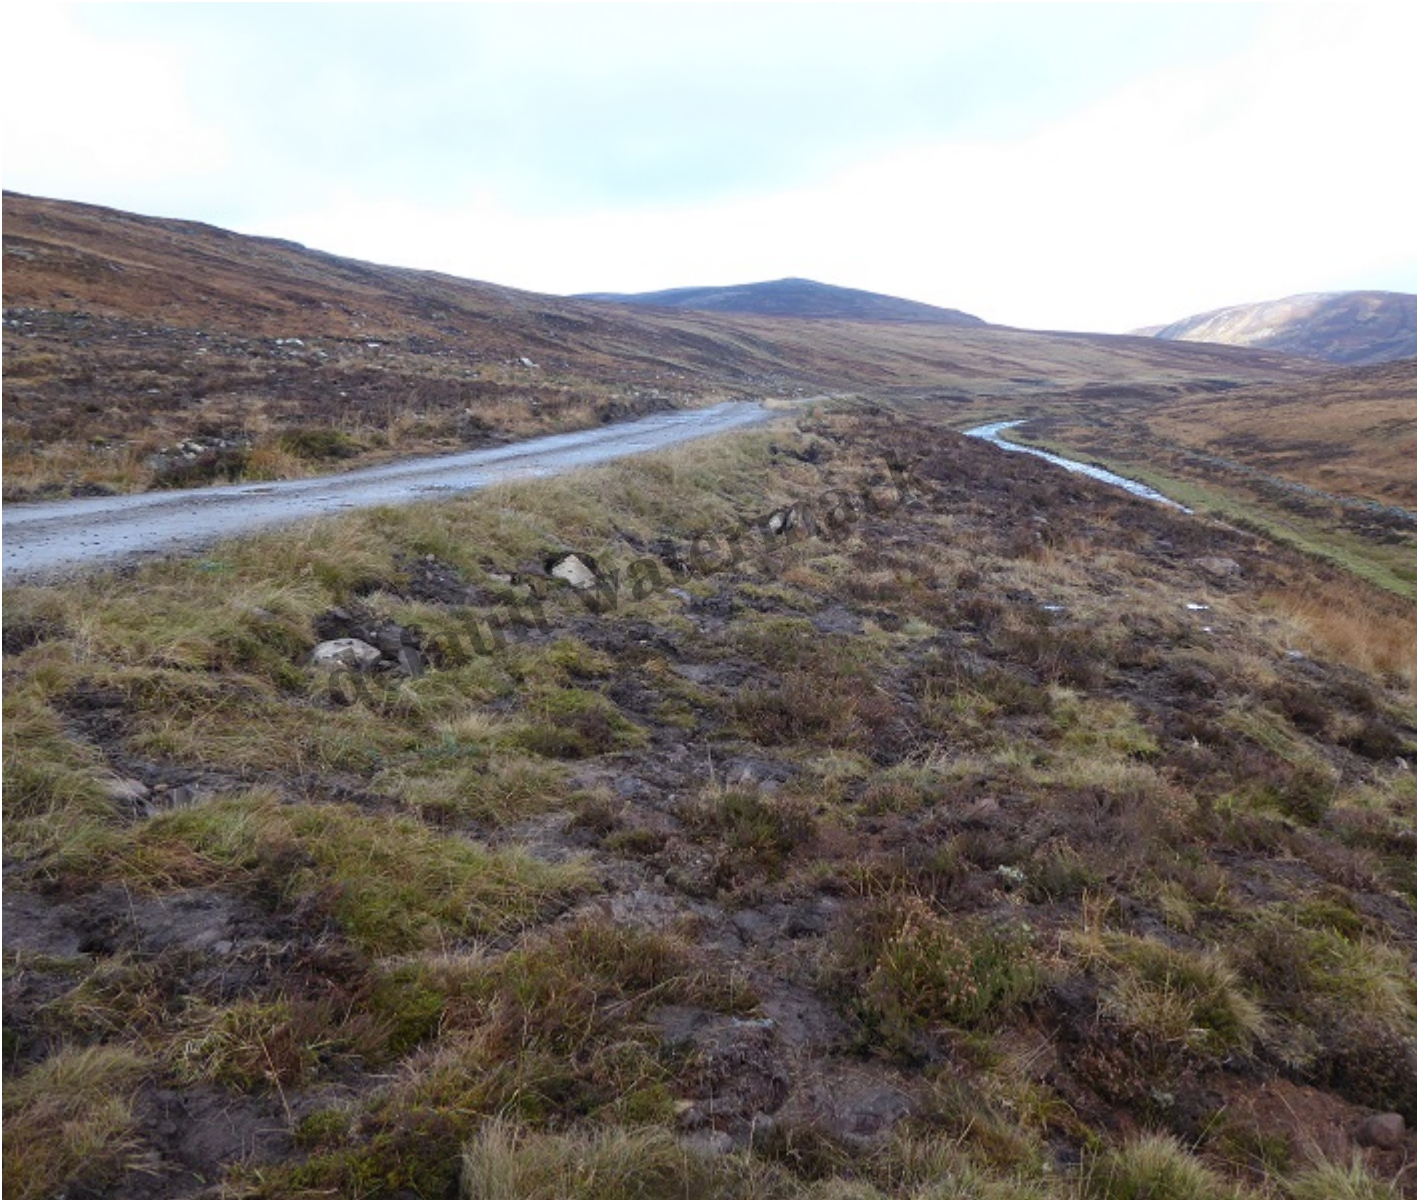
An unexceptional scene? Not when you compare it to how it looked this time last year (see below). The vegetation have been taken from the lower (right) side of track and used to restore the scar on the upper side of the track.

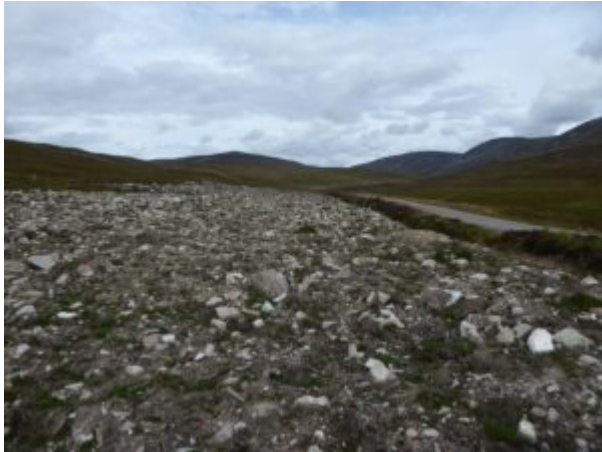
The view in August 2016

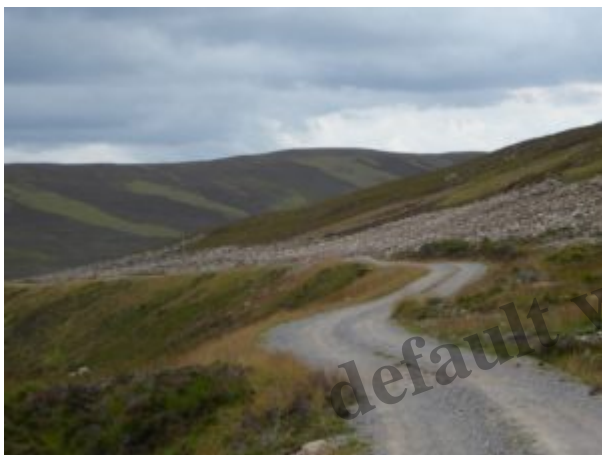
Looking south at the worst section of pipeline scar 2016

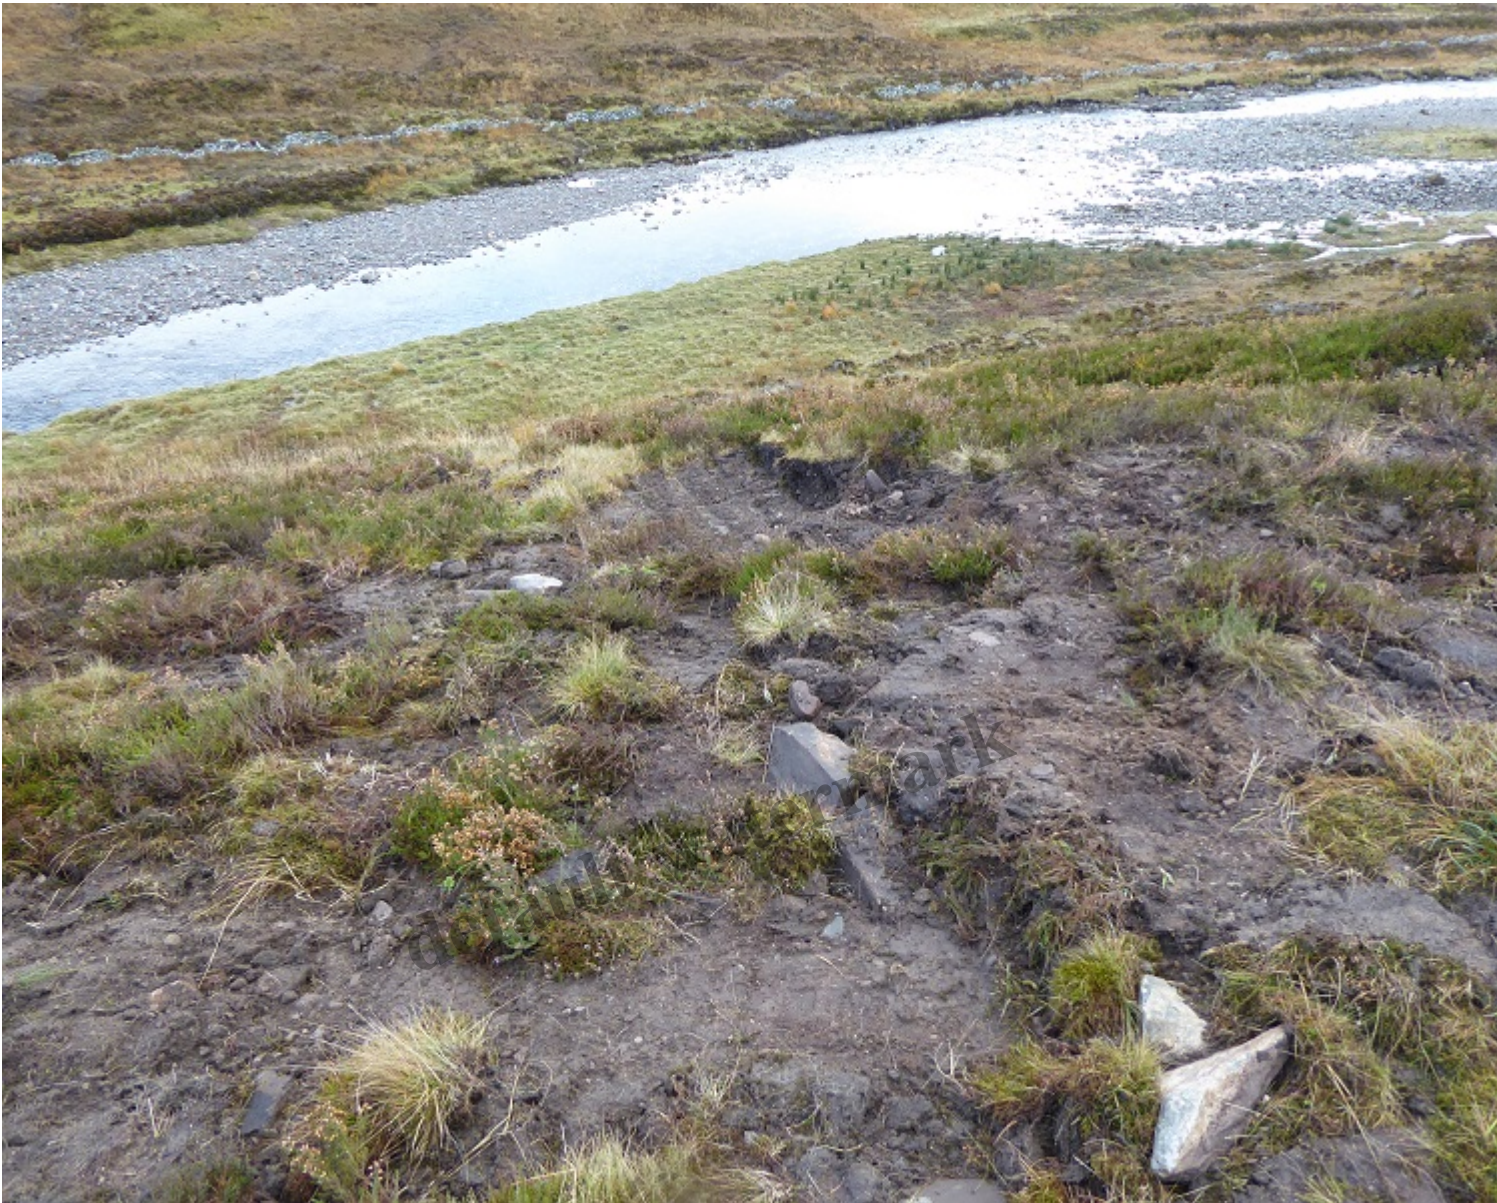
Photo showing how turves and other vegetation has been “robbed” from below the track to cover up the scar above. Note the digger scoop mark centre.[/caption]

Its hard to tell how many boulders have been removed but given the failure to store and re-use vegetation, the only way the scar could be covered up was by robbing vegetation from elsewhere. In Glen Bruar this has been taken from the areas either side of the pipeline. While I am not an ecologist, it appears to have been done very well. There is more bare ground evident in the photo above, which I have used as it shows the work was all done by digger, than is evident along most of the track. Evidence of good practice is that the contractor has managed to remove vegetation without creating deep buckets holes and left sufficient vegetation to prevent soil erosion.

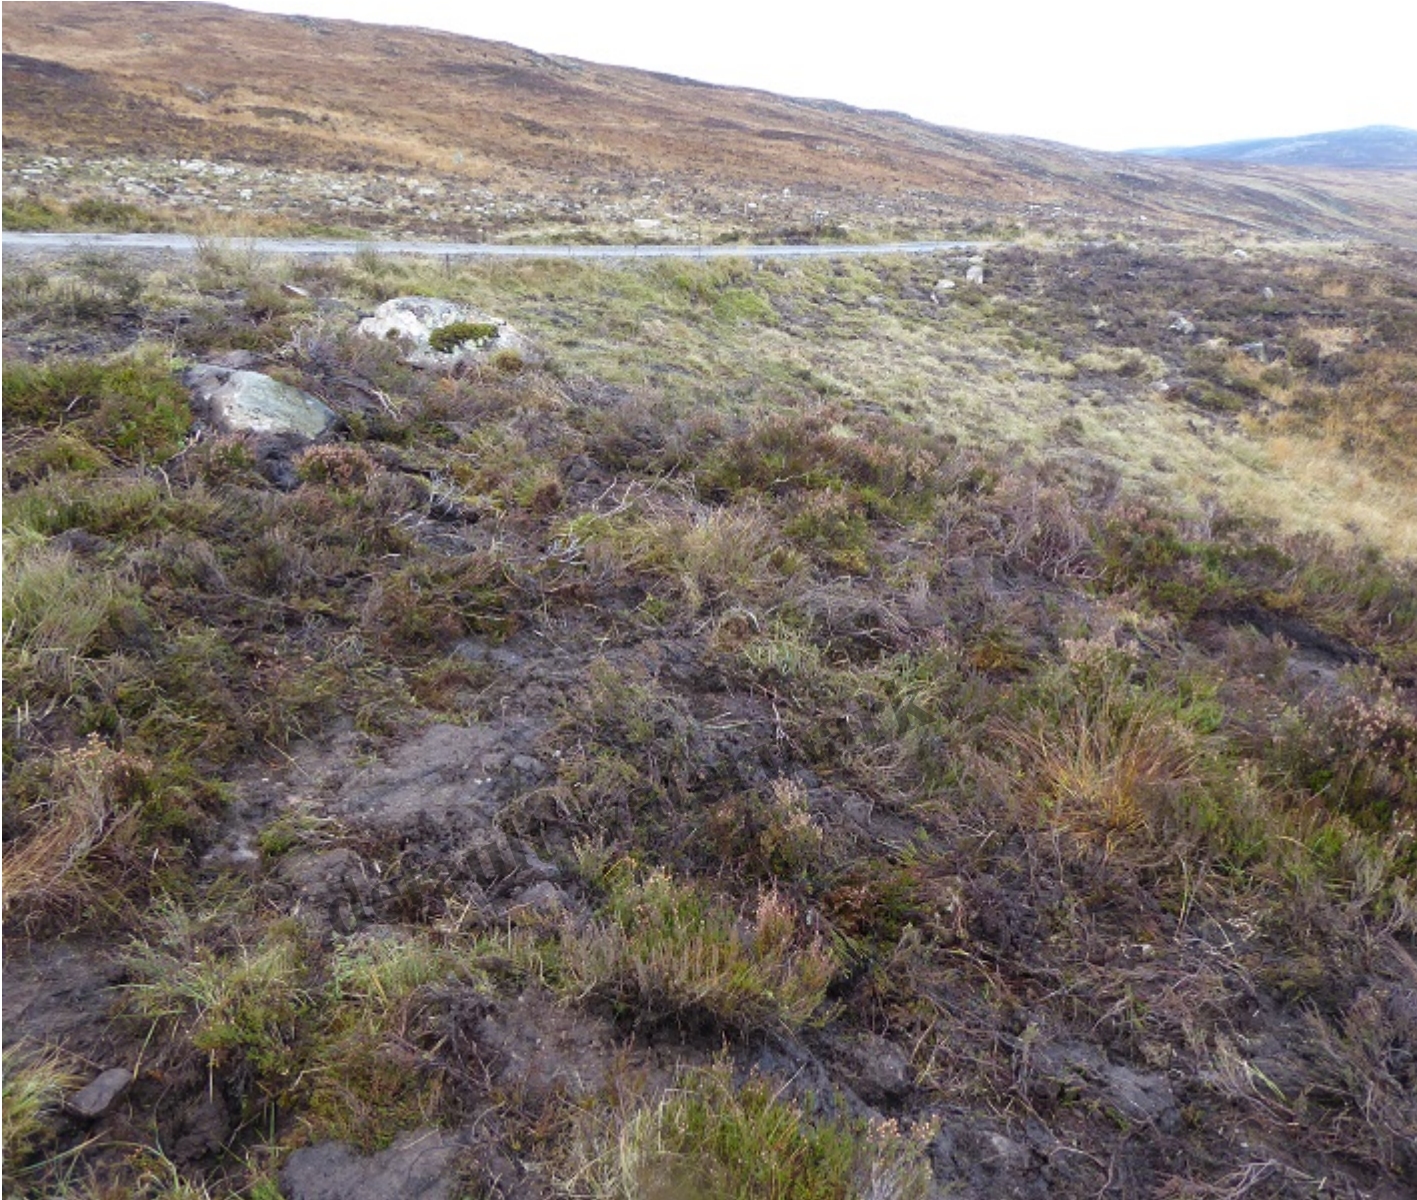
A more typical view of how the ground below the track and pipeline which has been robbed for turves appears

As a consequence the ground which has been "robbed" should recover quite quickly.

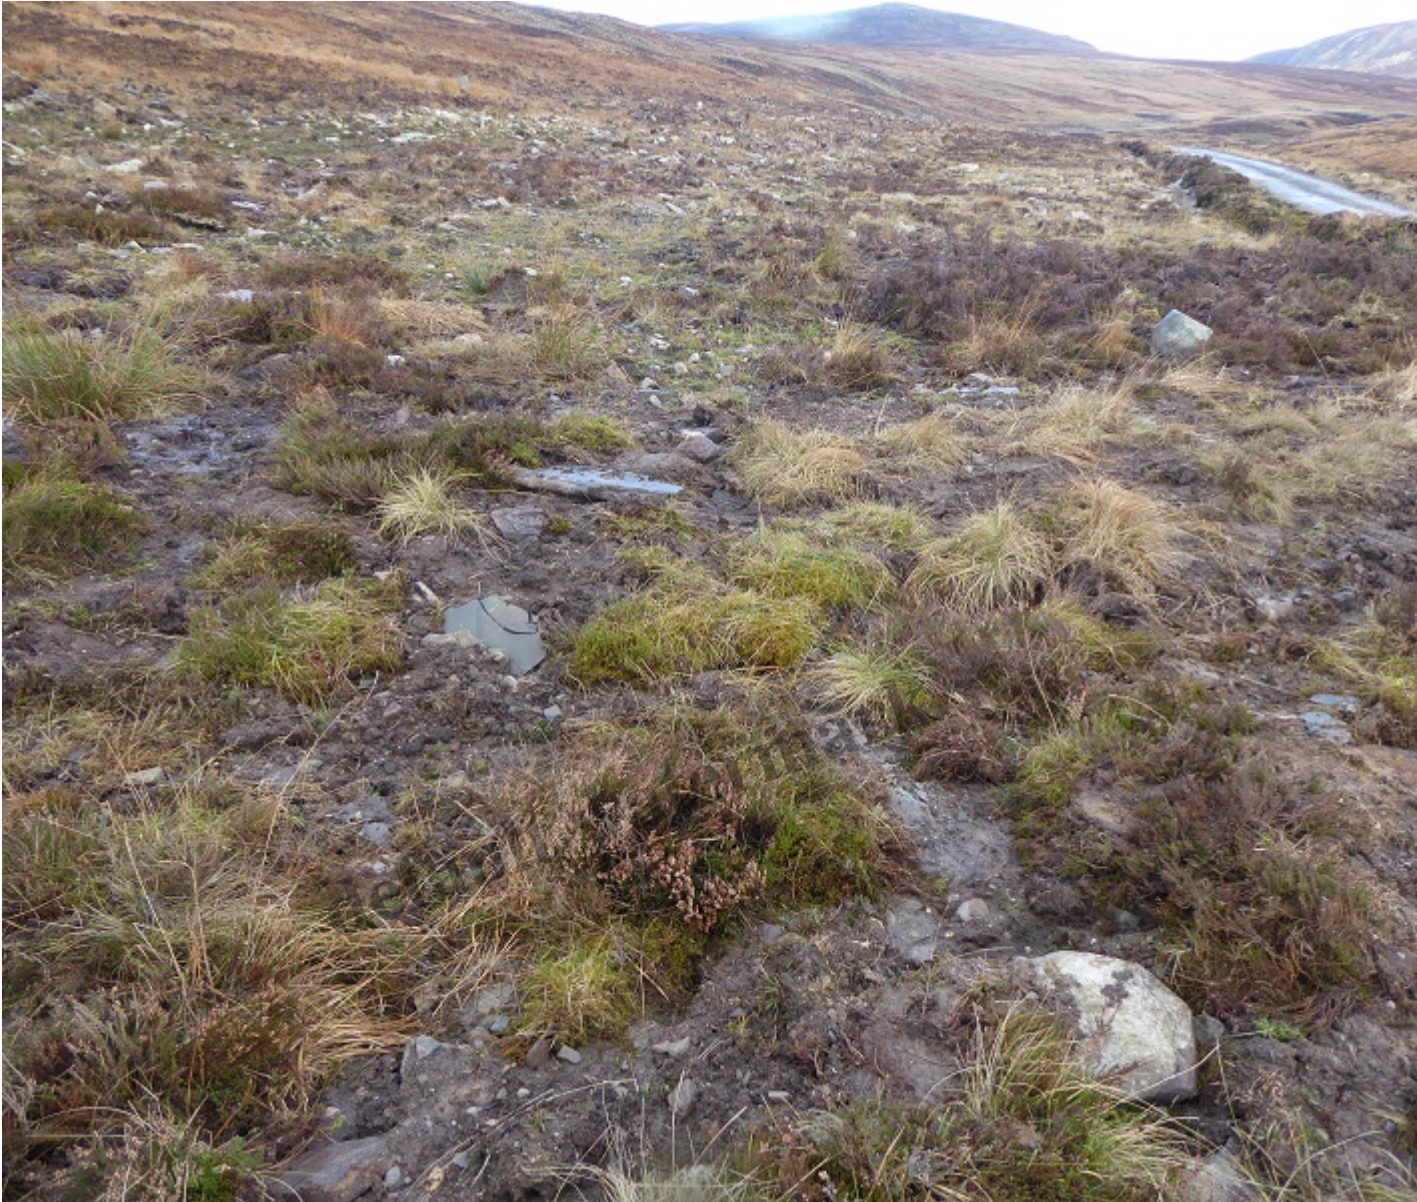
Restored boulder band scar showing how “robbed” turves and soil have been used.

The work on the restored area is also in my view of high quality, with the restored surface being similar to the land on either side (rather than being pockmarked with ankle busting holes) while the transplanted vegetation appears to have taken. The result is that the ground is already blending with that to land around, a complete contrast to a year ago. In landscape terms this looks like an excellent example of disaster recovery. Its interesting that the Reinstatement Note provided by the CNPA suggests that the contractor who did the restoration was different to that who constructed the pipeline. I am tempted to suggest they deserve an award.

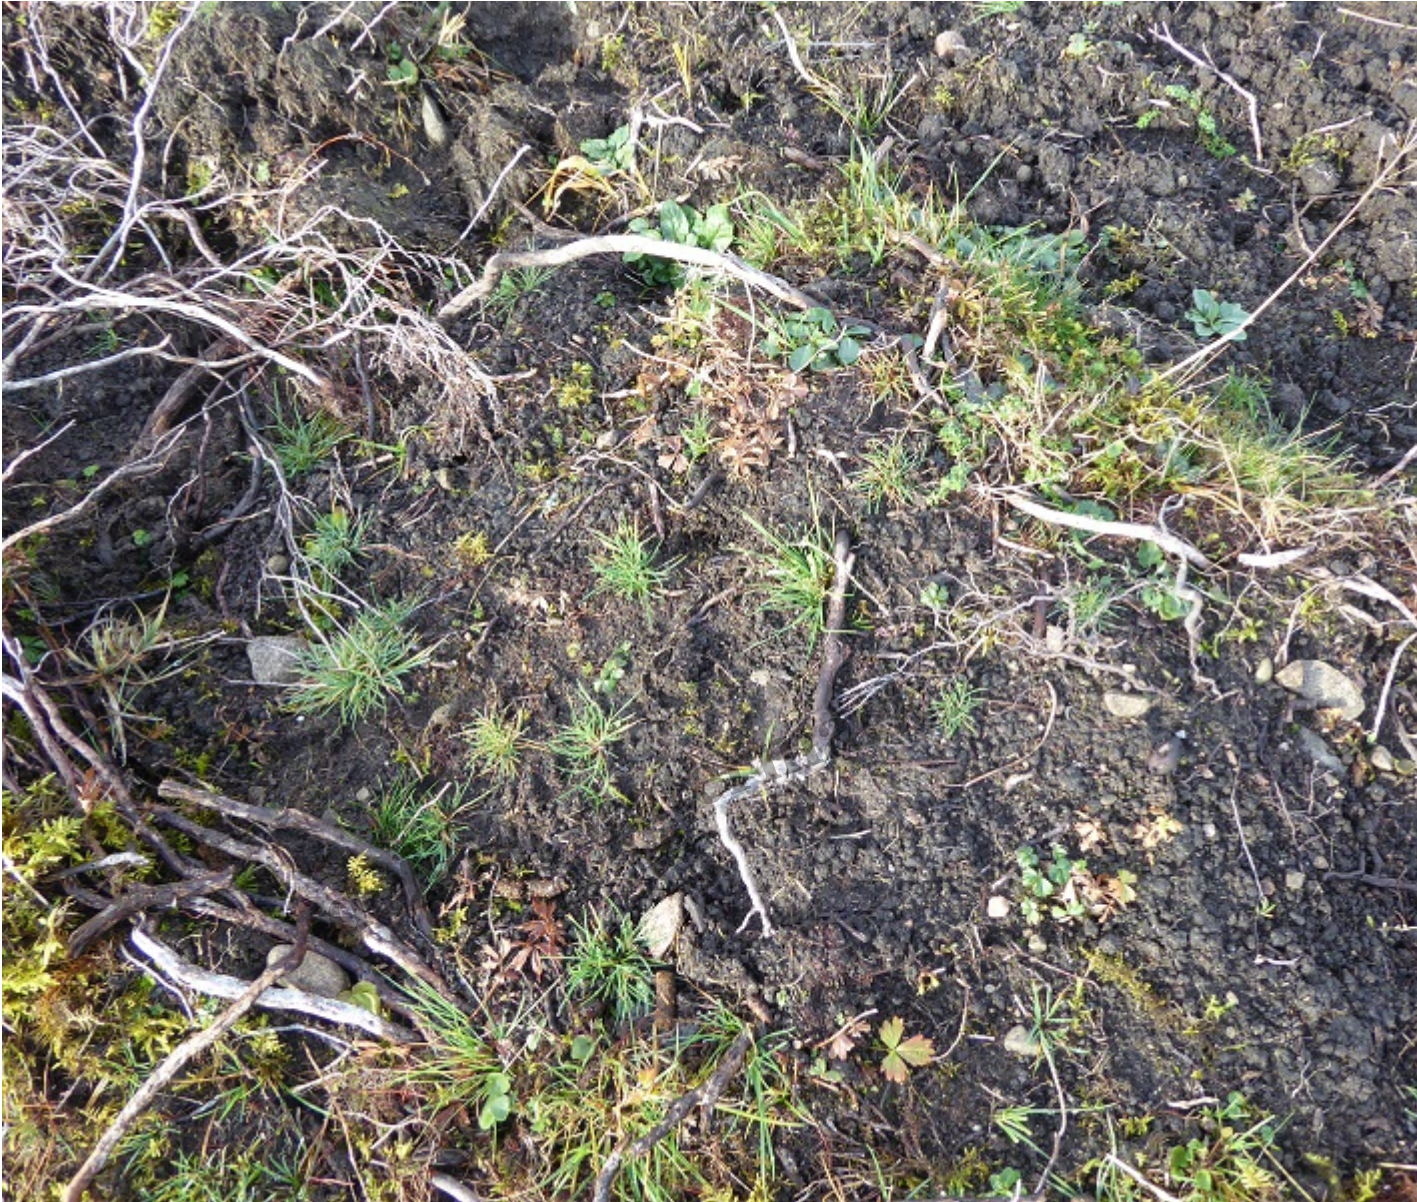
Evidence of plants colonising bare ground. This will help stabilise the soils but which plants will establish themselves in the medium term is uncertain

Its too early to say if the original poor restoration of the pipeline will have a permanent impact on the vegetation in the glen and, for example, allow new invasive species to move in. Once the soils and vegetation had not been stored properly, areas of bare ground were inevitable.

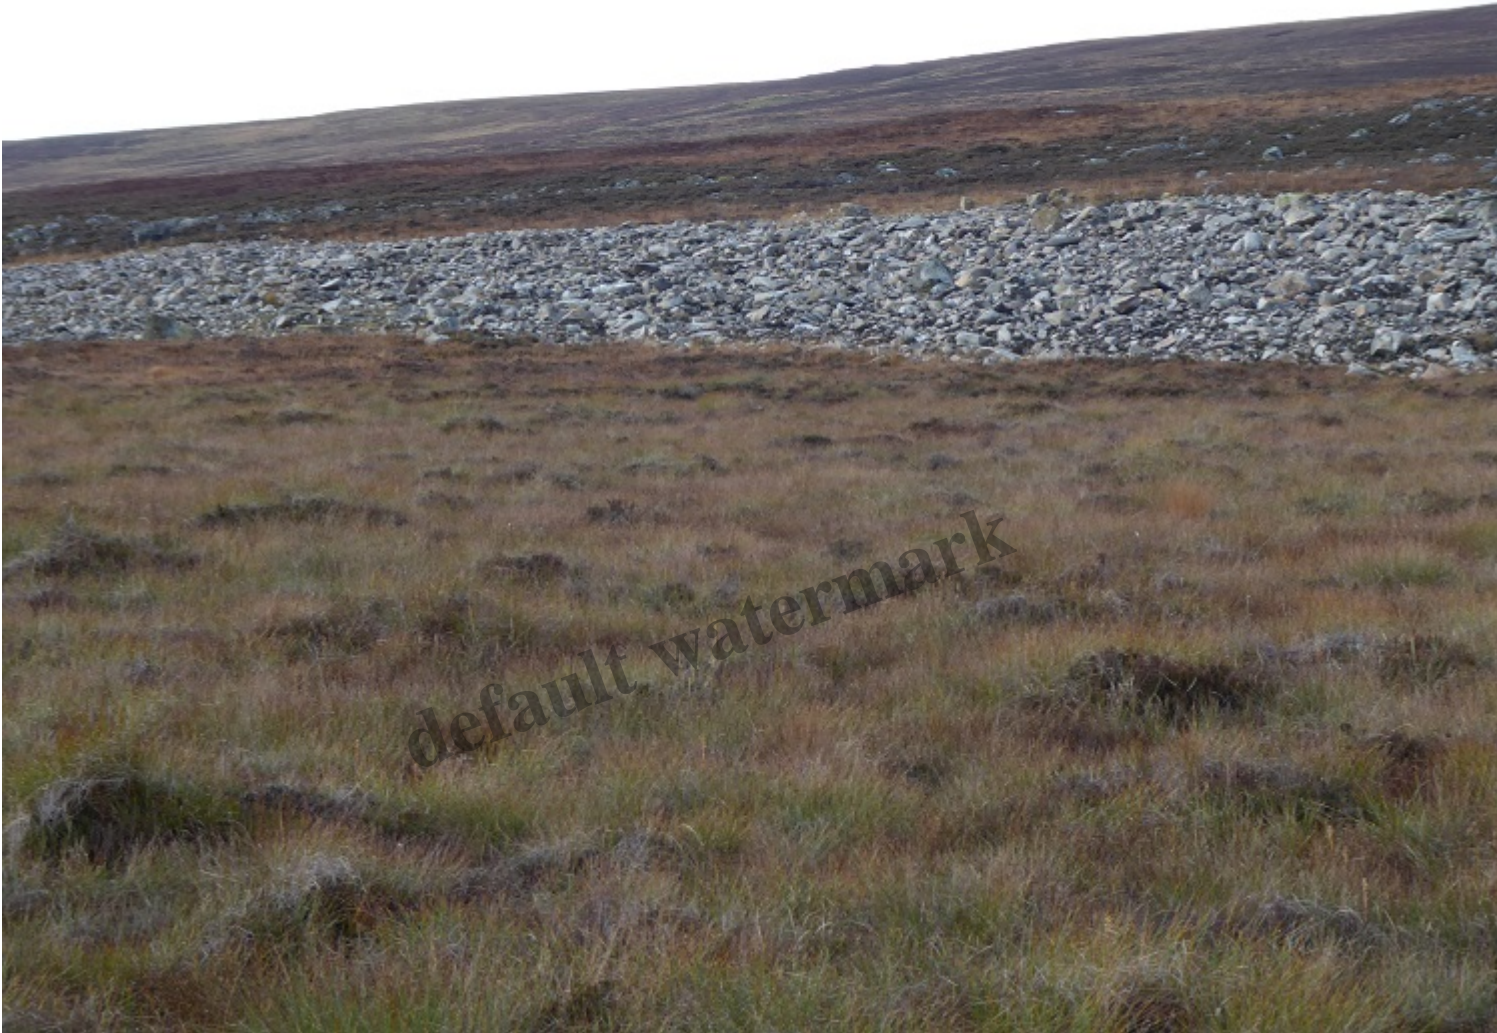
There is also still one area where the landscape scar is prominent, where the pipeline cuts across a slope above an area of deep peat:

At present it looks like very little attempt has been made to restore this.

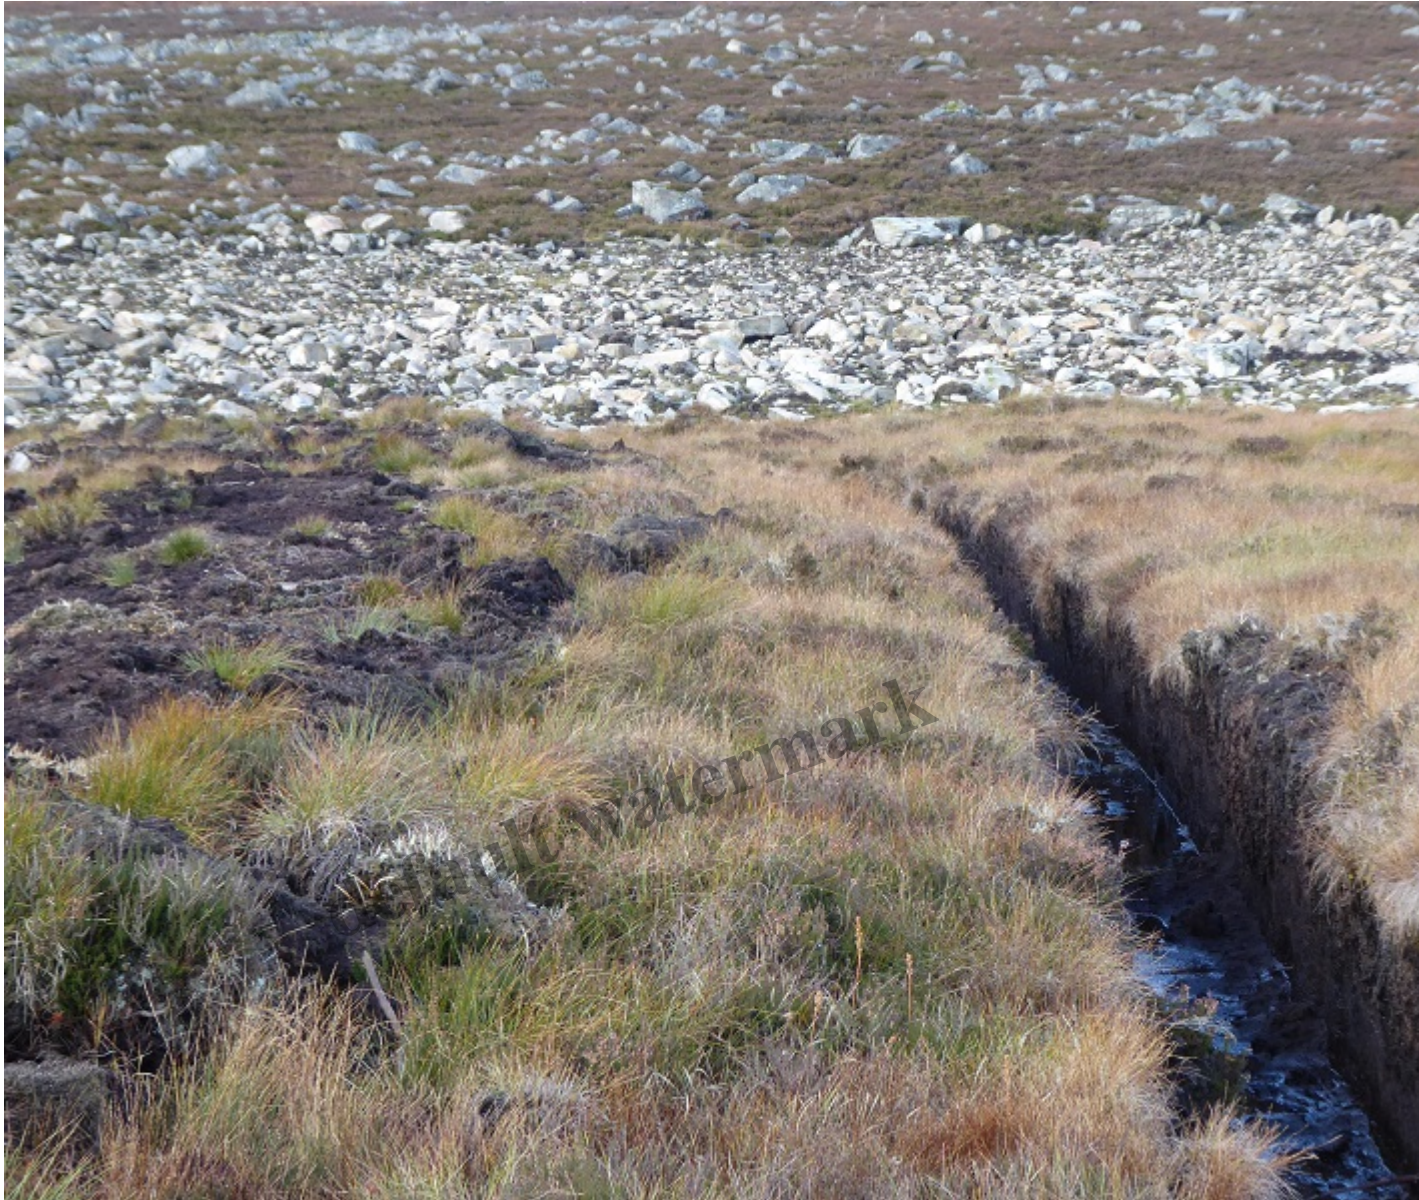
New drainage ditch showing depth of peat. The excavated material has been dumped on left.

There are however some obvious opportunities to do so. The vegetation that has recently been removed to create this ditch could have been used to reinstate part of the boulder band.

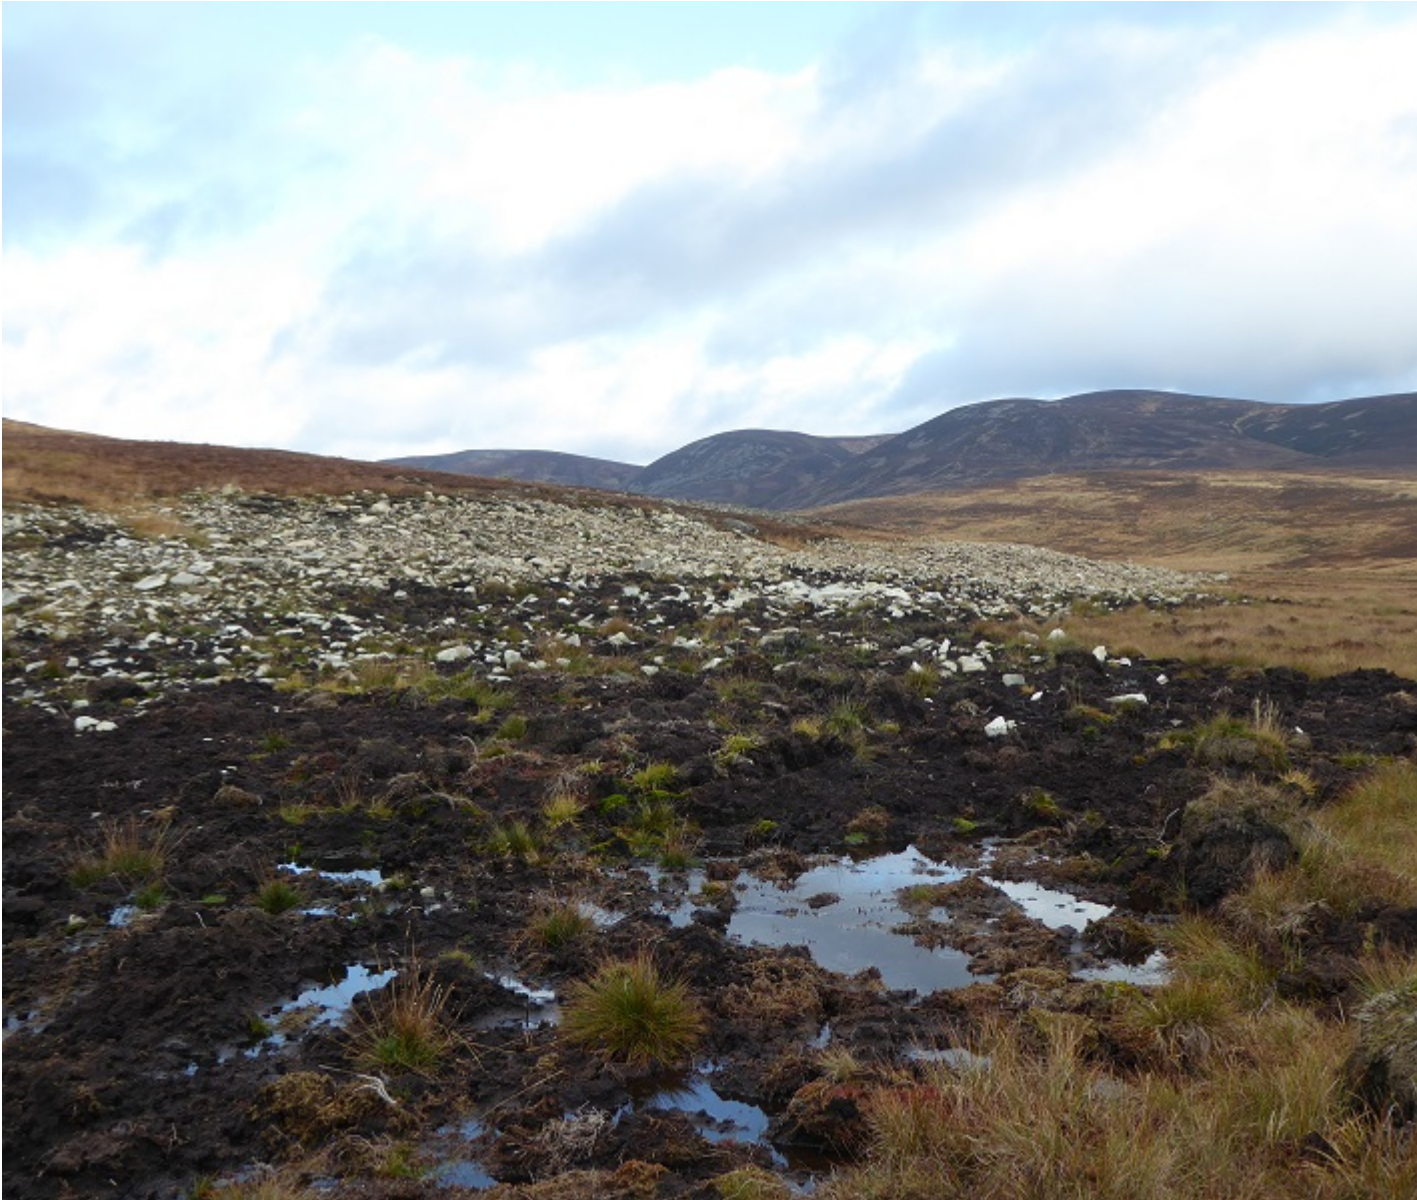
The start of the section of unrestored pipeline marked by the boulder field. Note the large peat turves far right which appear to date from original excavation and have never been used for restoration purposes.

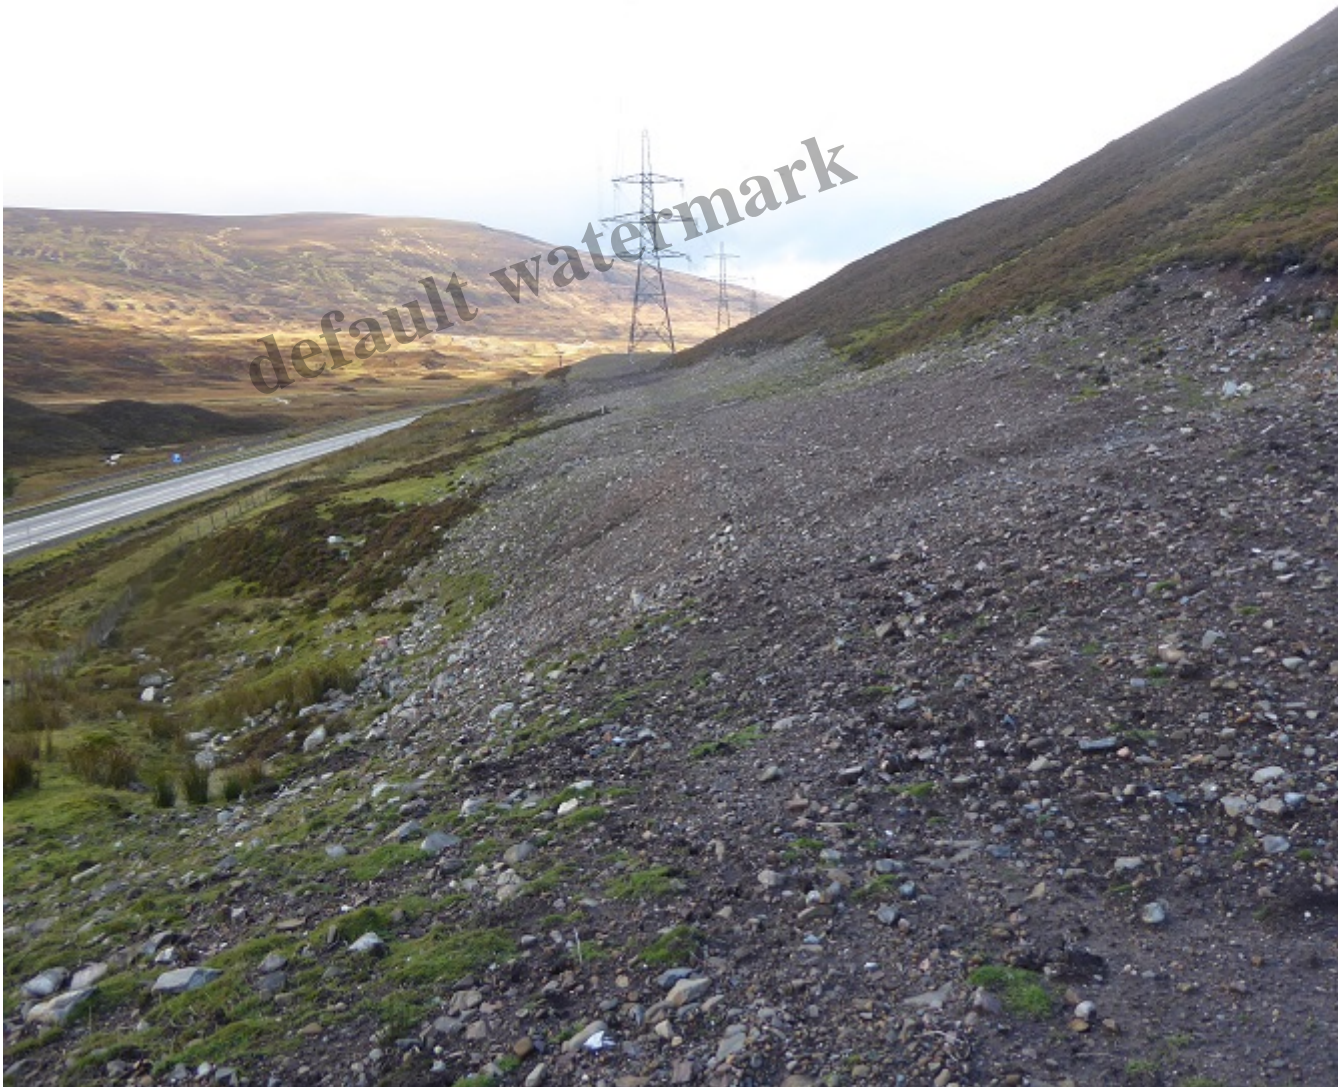
If Glen Bruar can be restored so can Drumochter

3. I hope the CNPA will now use what they have achieved in Glen Bruar to make the case for active landscape restoration in Drumochter.
