The restoration of Glen Bruar

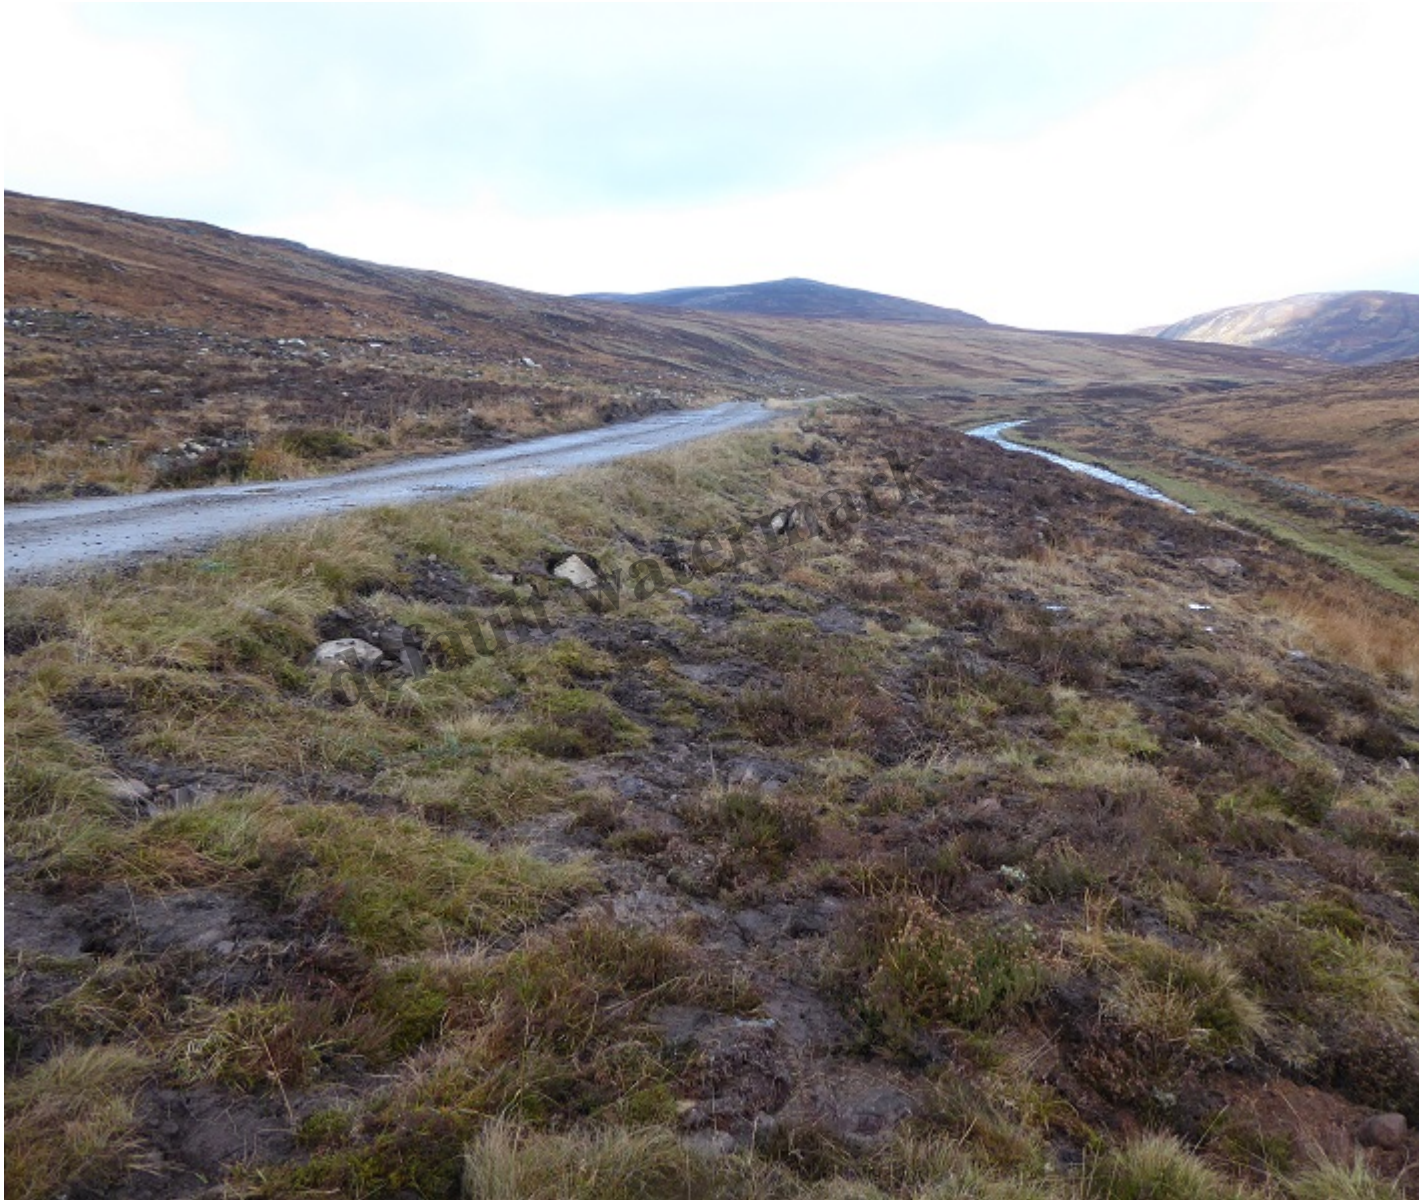
An unexceptional scene? Not when you compare it to how it looked this time last year (see below). The vegetation have been taken from the lower (right) side of track and used to restore the scar on the upper side of the track.

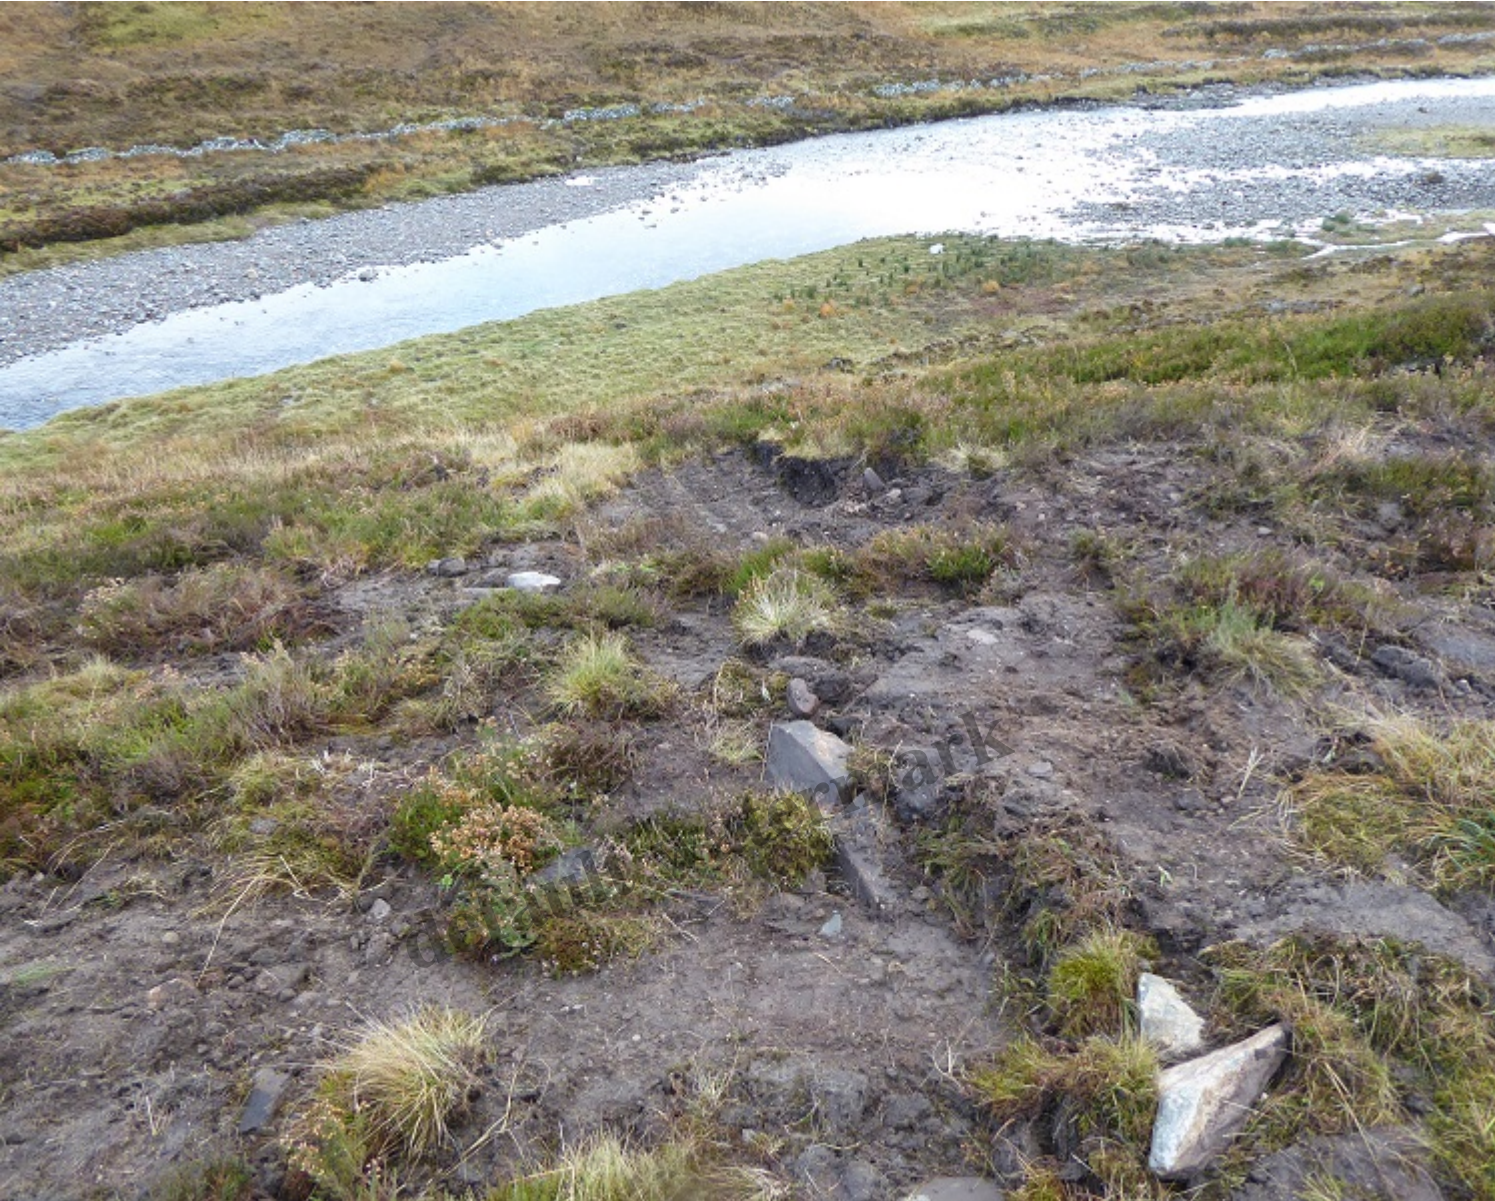
Photo showing how turves and other vegetation has been “robbed” from below the track to cover up the scar above. Note the digger scoop mark centre. [/caption]

Its hard to tell how many boulders have been removed but given the failure to store and re-use vegetation, the only way the scar could be covered up was by robbing vegetation from elsewhere. In Glen Bruar this has been taken from the areas either side of the pipeline. While I am not an ecologist, it appears to have been done very well. There is more bare ground evident in the photo above, which I have used as it shows the work was all done by digger, than is evident along most of the track. Evidence of good practice is that the contractor has managed to remove vegetation without creating deep buckets holes and left sufficient vegetation to prevent soil erosion.

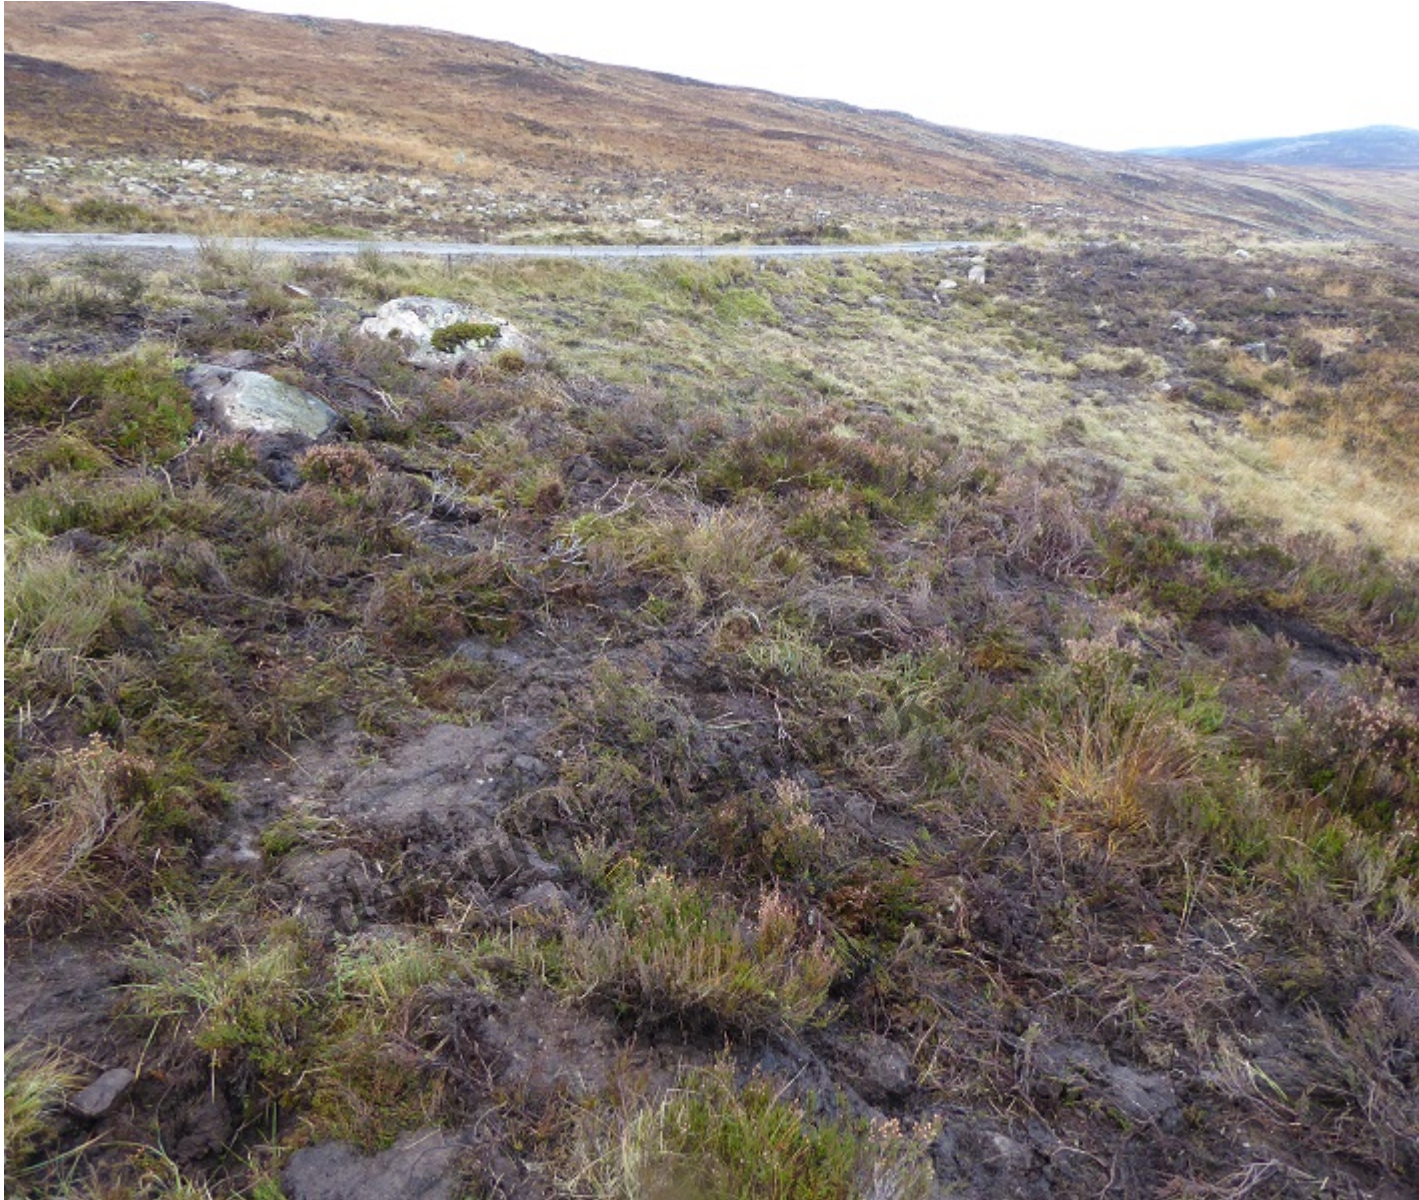
A more typical view of how the ground below the track and pipeline which has been robbed for turves appears

As a consequence the ground which has been “robbed” should recover quite quickly.

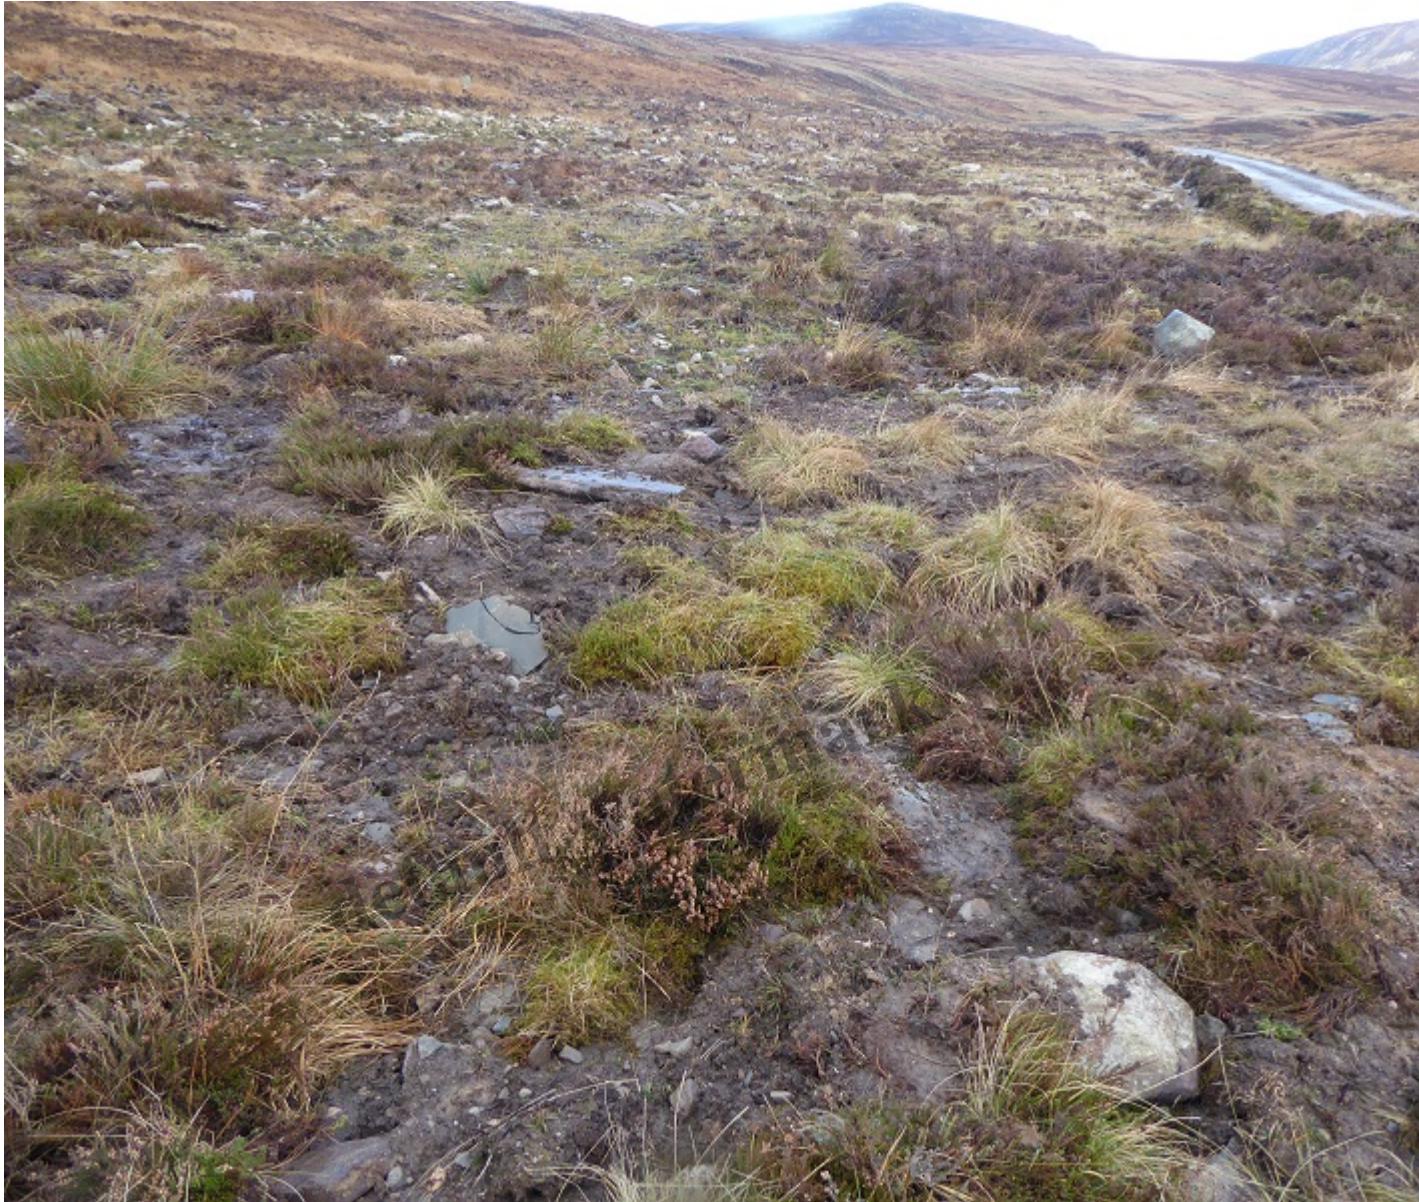
Restored boulder band scar showing how “robbed” turves and soil have been used.

The work on the restored area is also in my view of high quality, with the restored surface being similar to the land on either side (rather than being pockmarked with ankle busting holes) while the transplanted vegetation appears to have taken. The result is that the ground is already blending with that to land around, a complete contrast to a year ago. In landscape terms this looks like an excellent example of disaster recovery. Its interesting that the Reinstatement Note provided by the CNPA suggests that the contractor who did the restoration was different to that who constructed the pipeline. I am tempted to suggest they deserve an award.

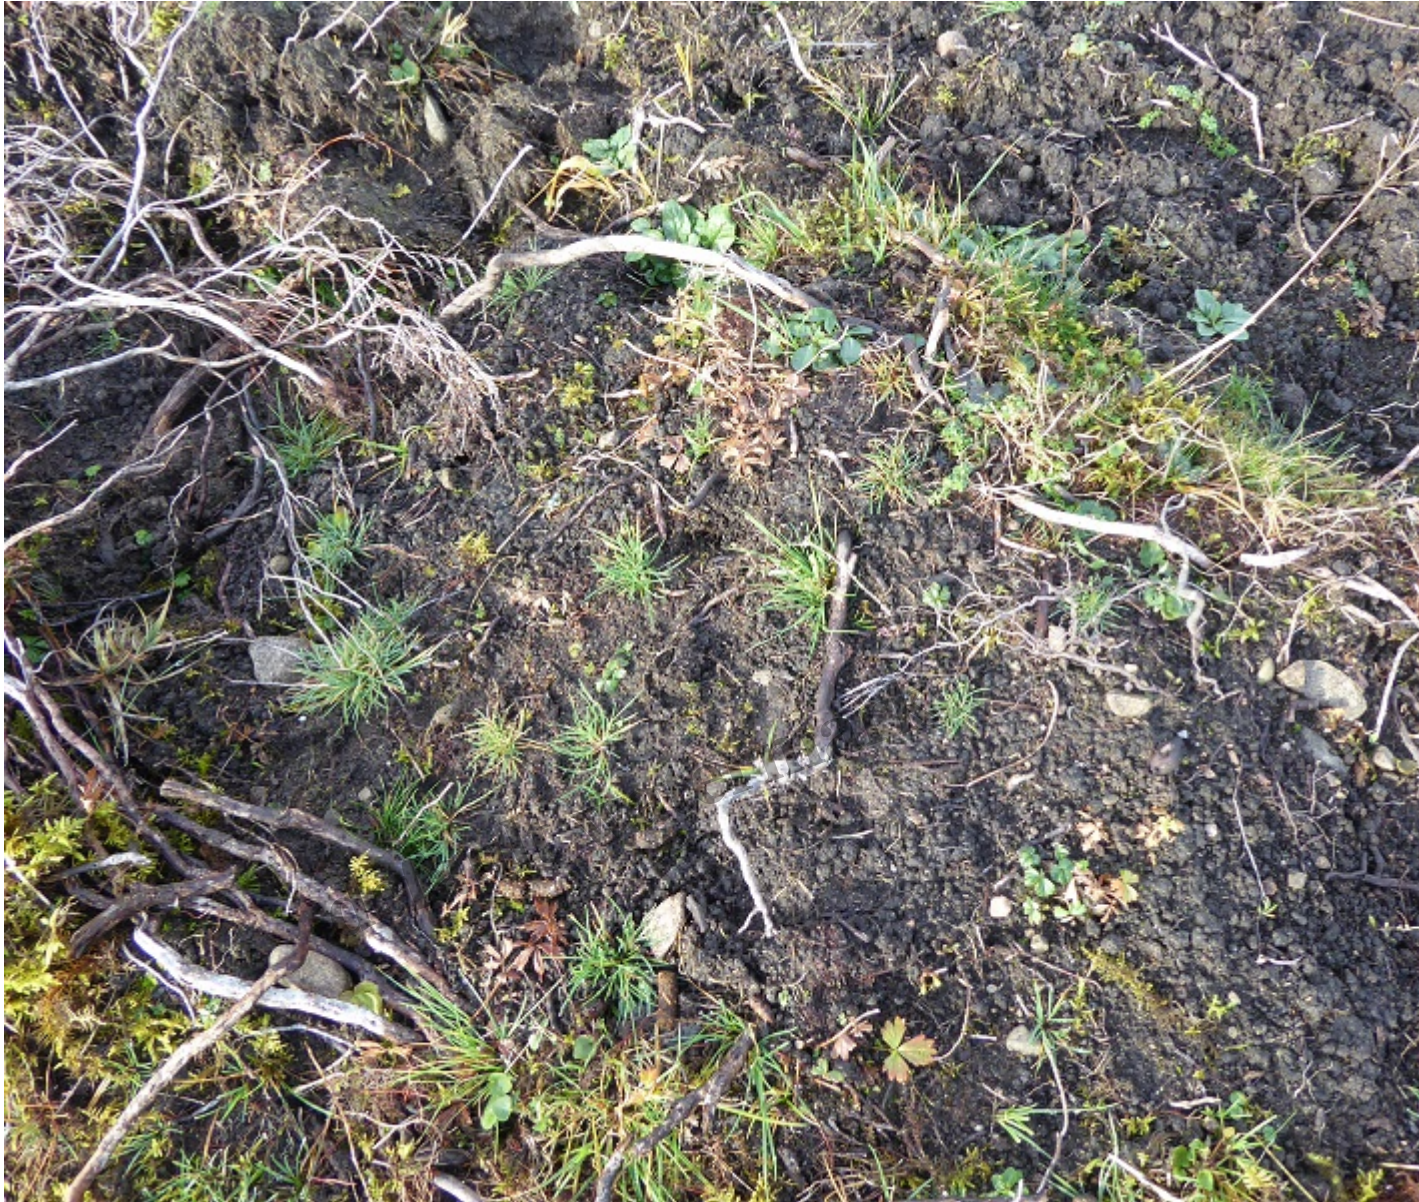
Evidence of plants colonising bare ground. This will help stabilise the soils but which plants will establish themselves in the medium term is uncertain

Its too early to say if the original poor restoration of the pipeline will have a permanent impact on the vegetation in the glen and, for example, allow new invasive species to move in. Once the soils and vegetation had not been stored properly, areas of bare ground were inevitable.
