The restoration of Glen Bruar

Following my two posts last December about the destruction caused by the hydro scheme in Glen Bruar ([see here](#)) and ([here](#)), I took a jog up the glen on Saturday. I was prompted to do so after planning staff at the Cairngorms National Park Authority were kind enough to inform me unprompted that significant restoration work had been undertaken over the summer.

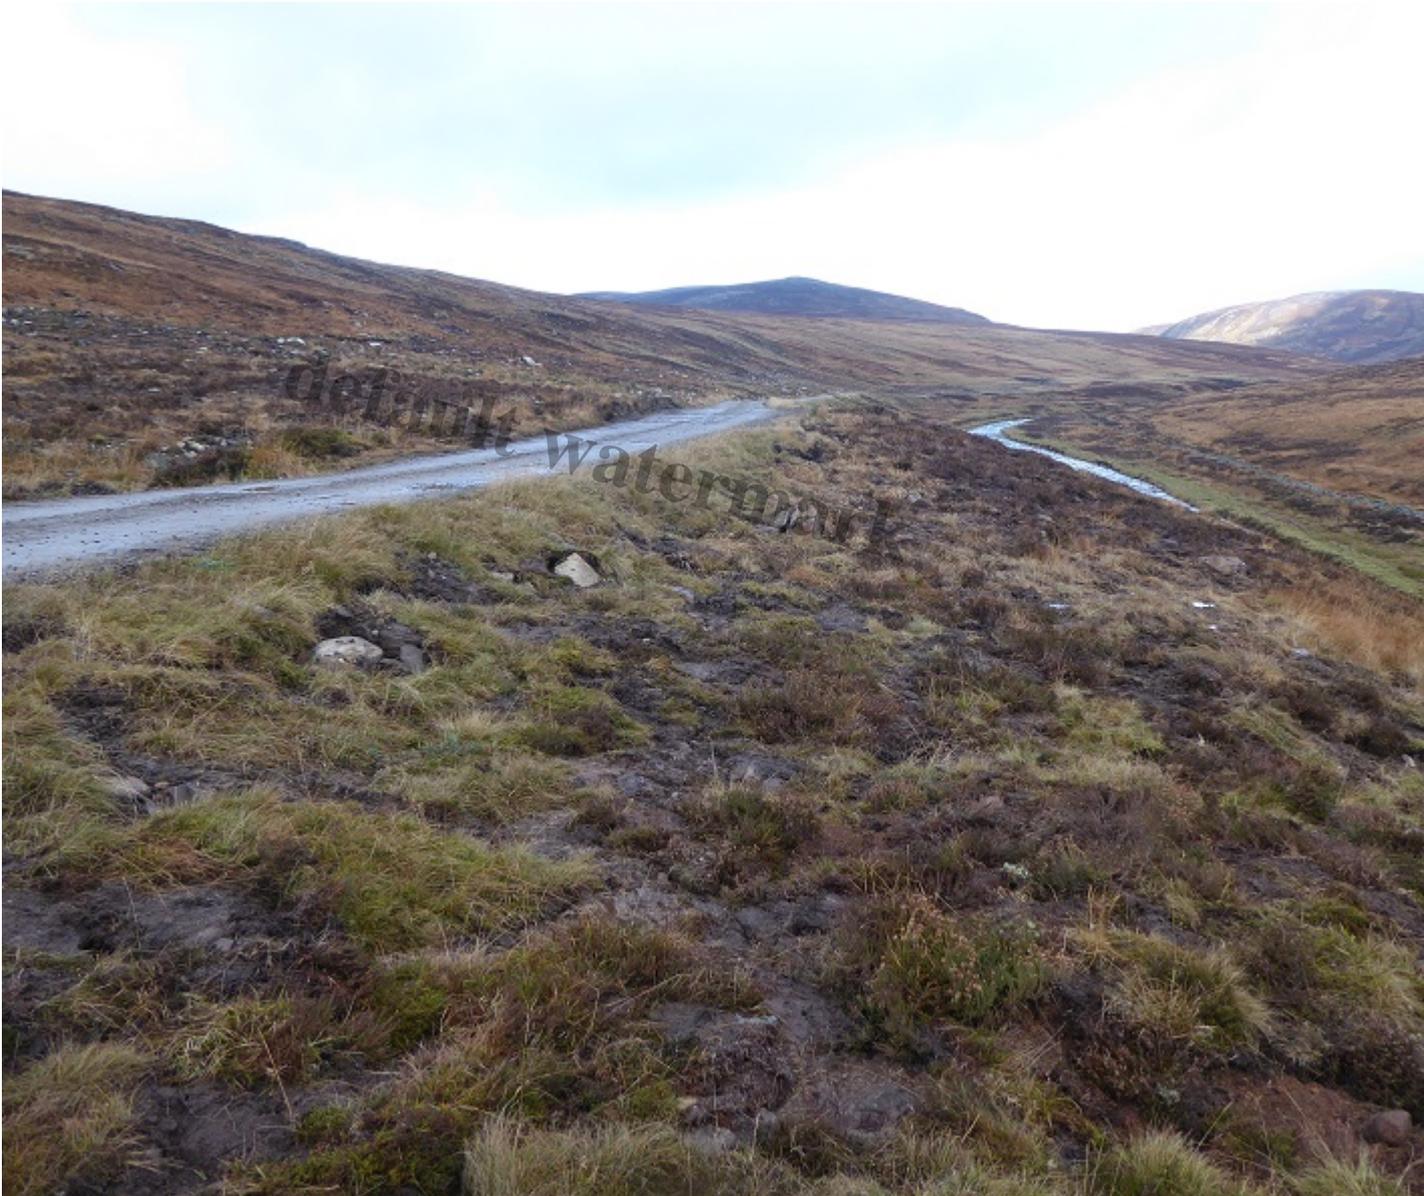
An unexceptional scene? Not when you compare it to how it looked this time last year (see below). The vegetation have been taken from the lower (right) side of track and used to restore the scar on the upper side of the track.

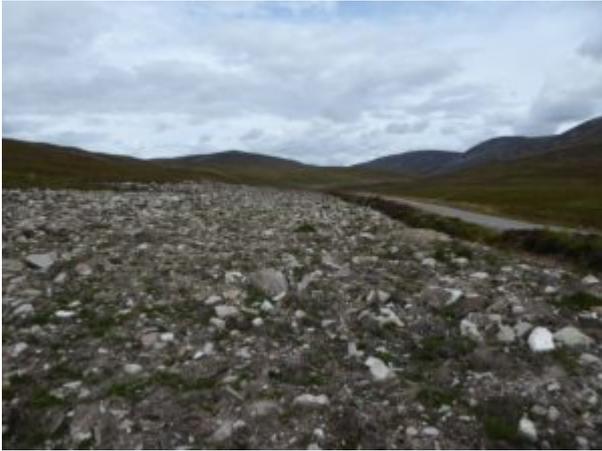
The view in August 2016

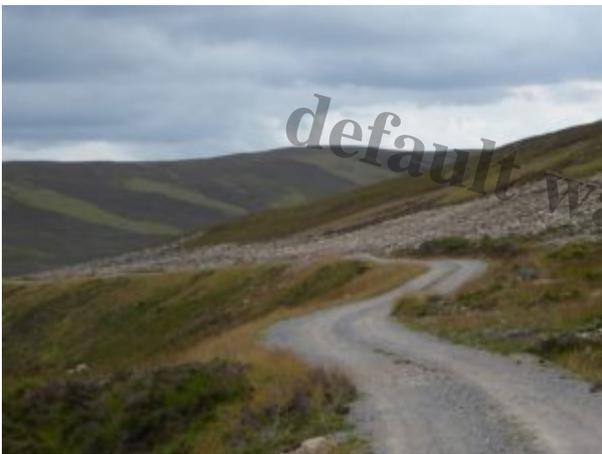
Looking south at the worst section of pipeline scar 2016

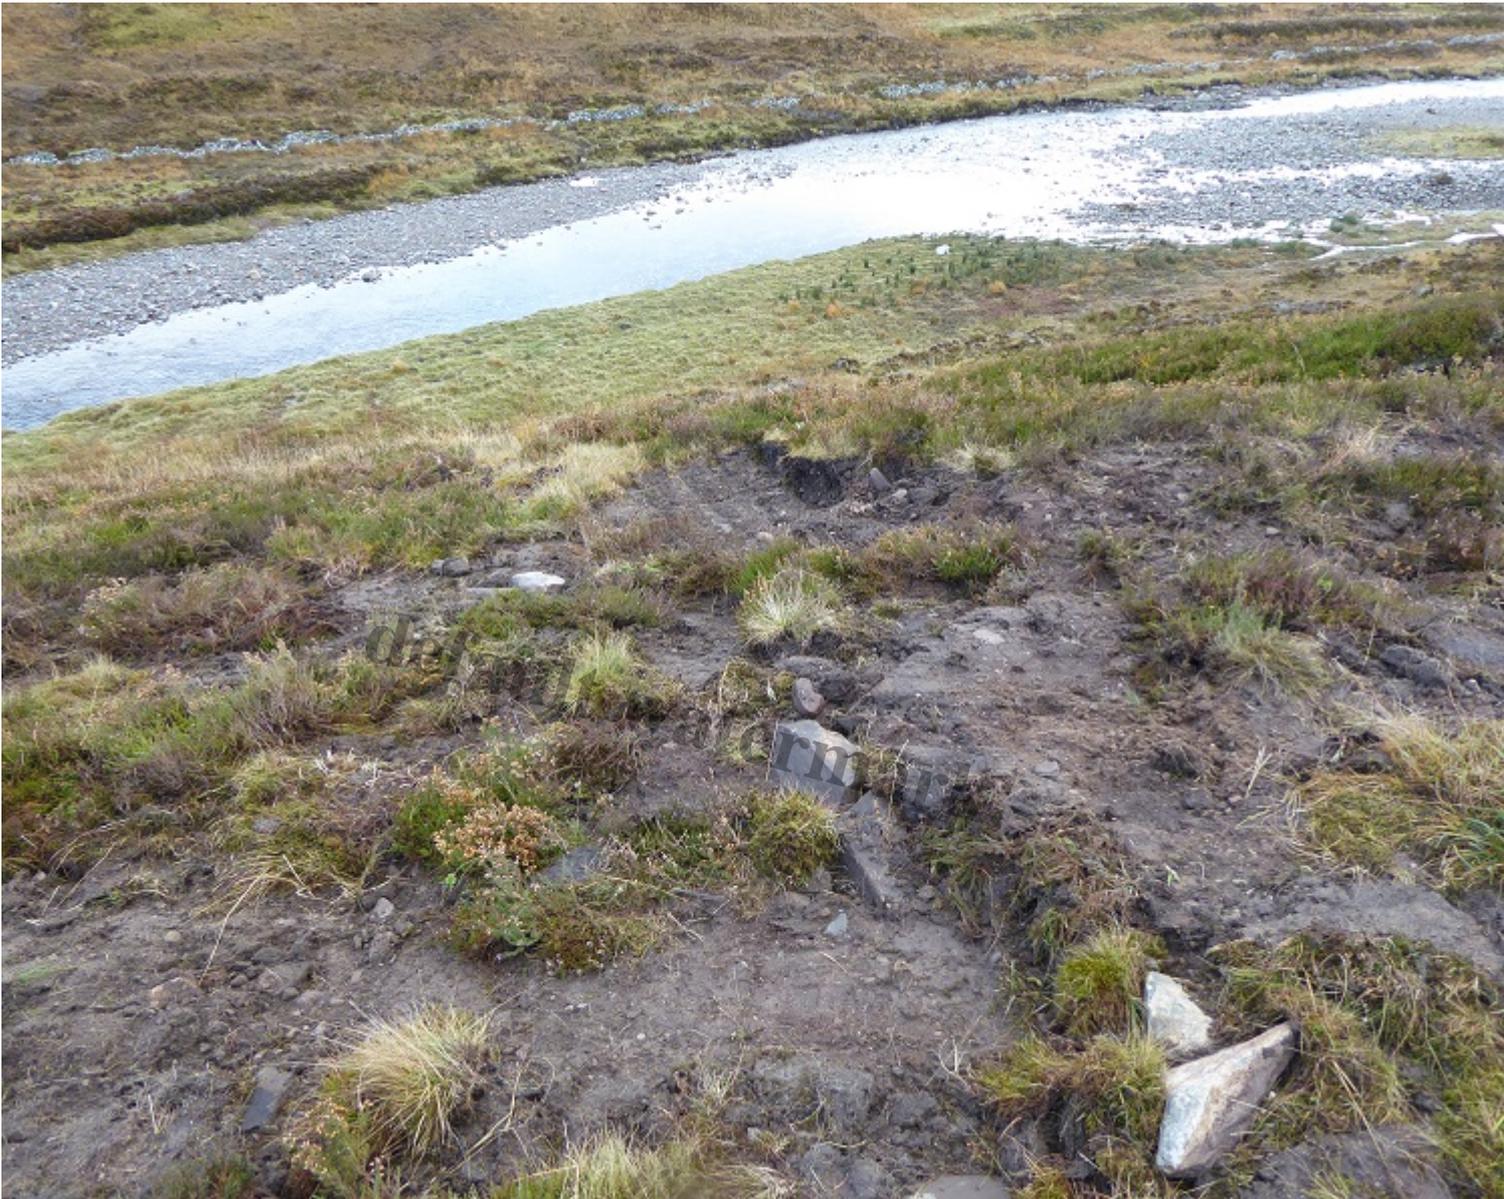
Photo showing how turves and other vegetation has been “robbed” from below the track to cover up the scar above. Note the digger scoop mark centre. [/caption]

Its hard to tell how many boulders have been removed but given the failure to store and re-use vegetation, the only way the scar could be covered up was by robbing vegetation from elsewhere. In Glen Bruar this has been taken from the areas either side of the pipeline. While I am not an ecologist, it appears to have been done very well. There is more bare ground evident in the photo above, which I have used as it shows the work was all done by digger, than is evident along most of the track. Evidence of good practice is that the contractor has managed to remove vegetation without creating deep buckets holes and left sufficient vegetation to prevent soil erosion.

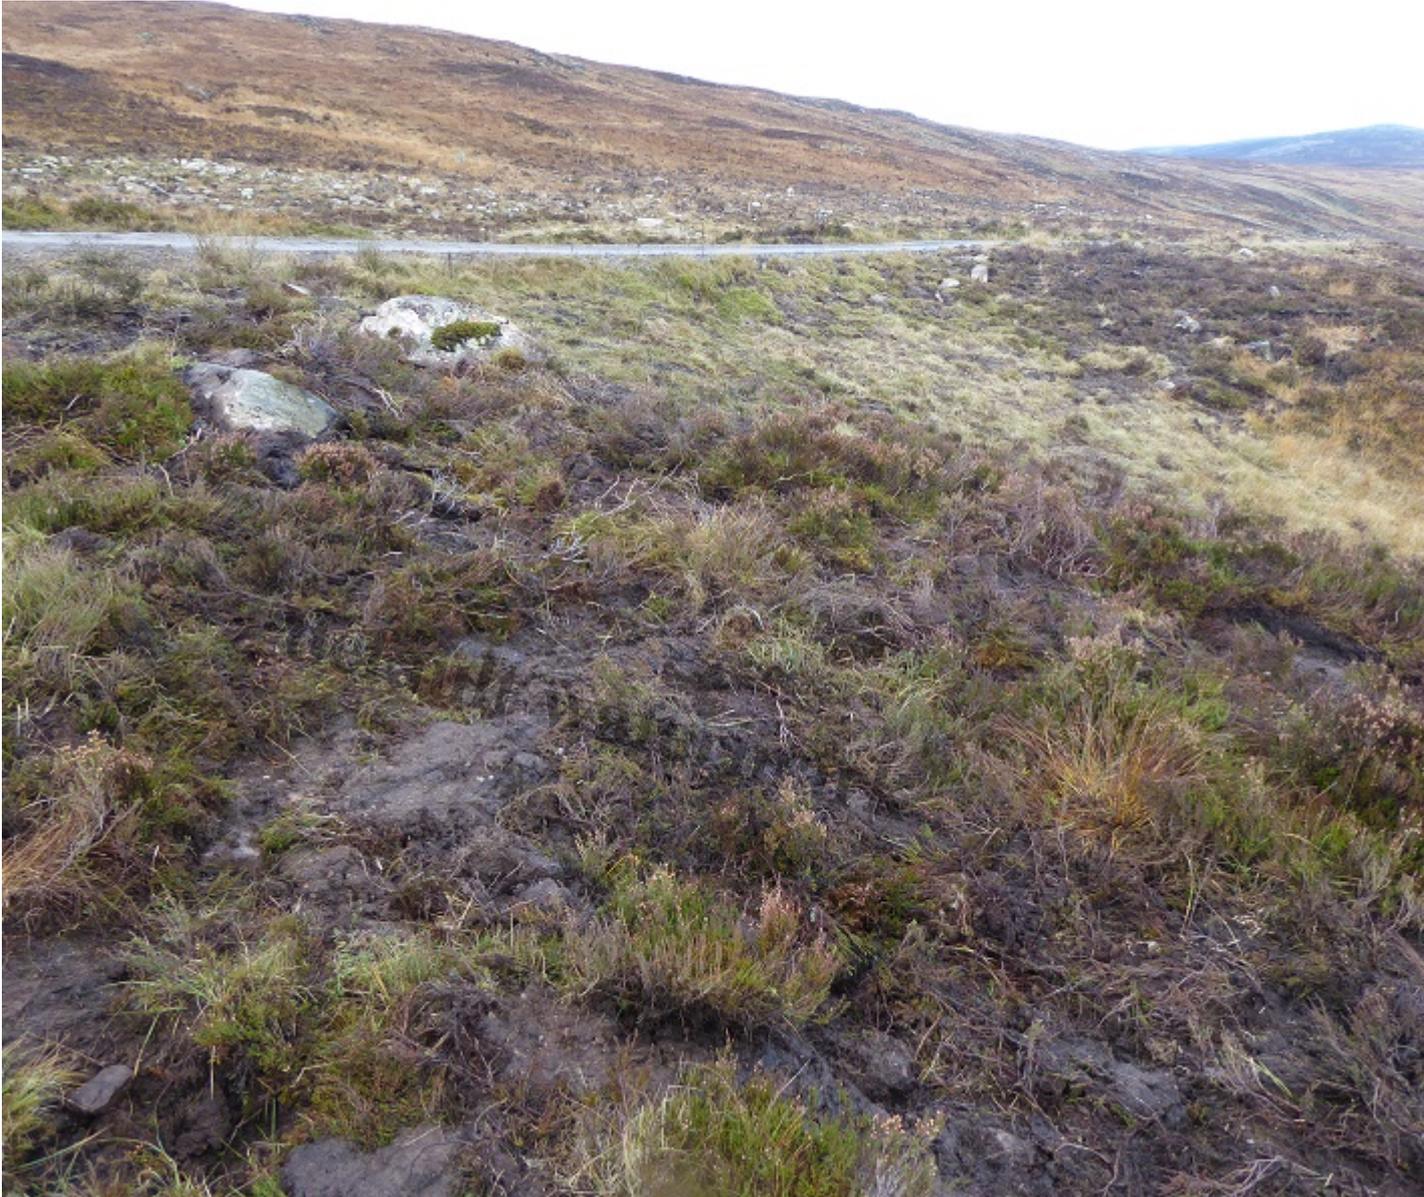
A more typical view of how the ground below the track and pipeline which has been robbed for turves appears

As a consequence the ground which has been 'robbed' should recover quite quickly.

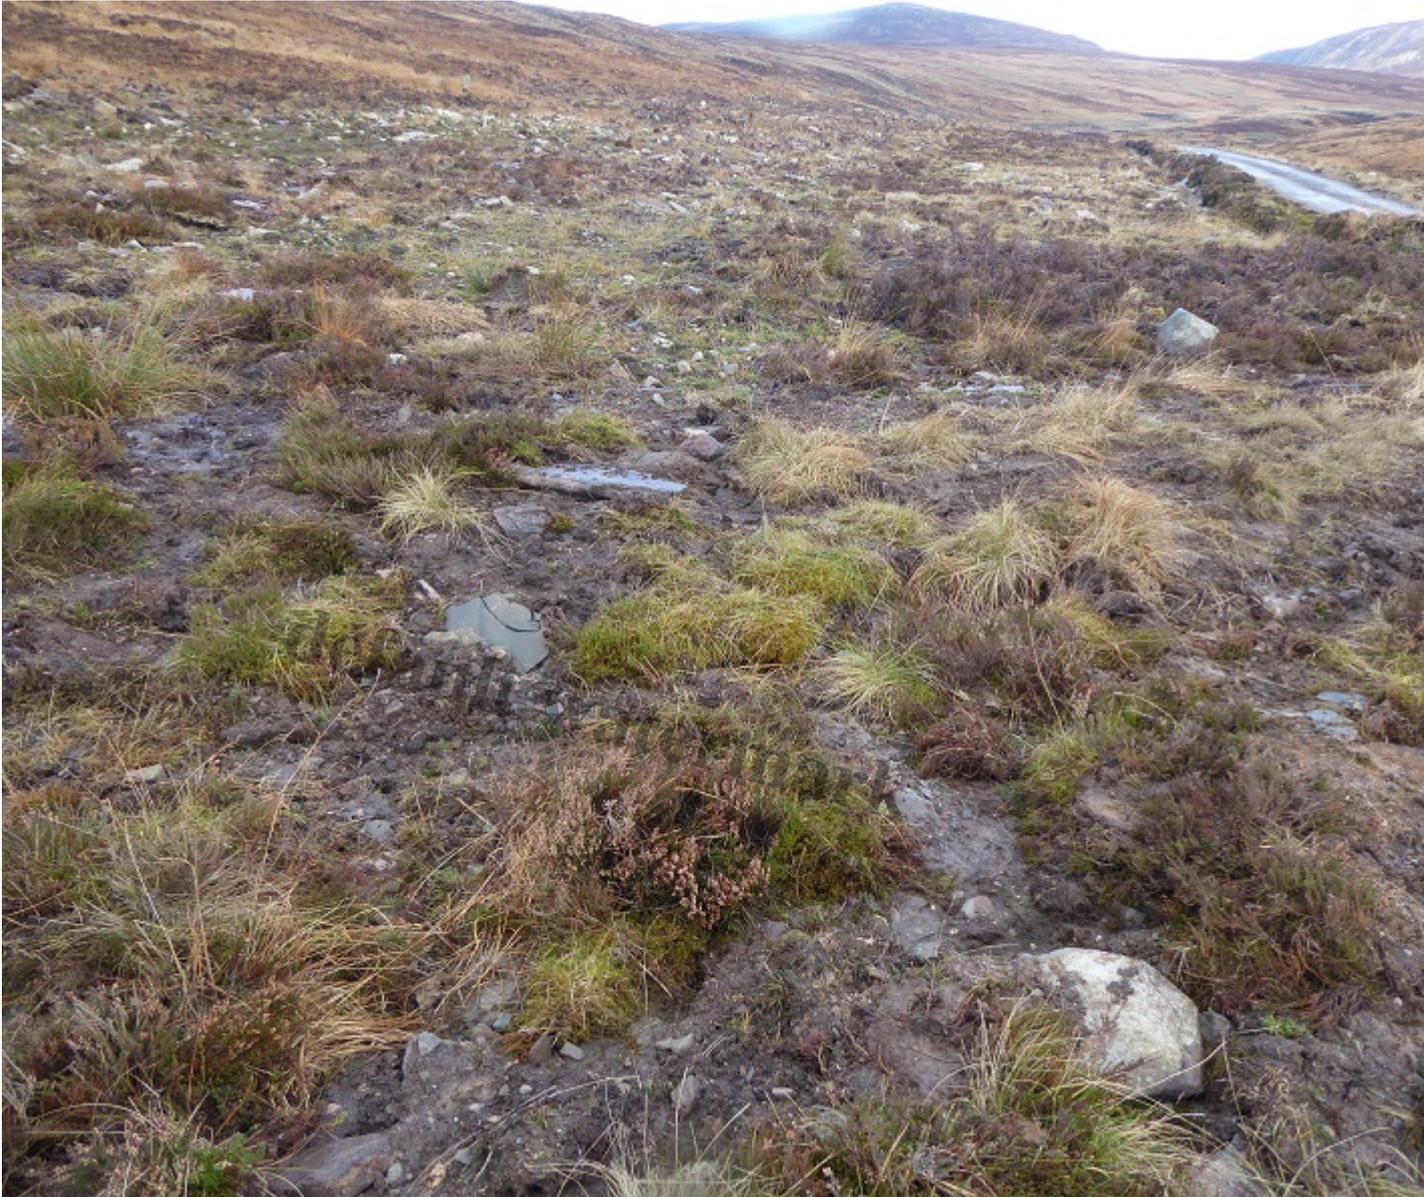
Restored boulder band scar showing how “robbed” turves and soil have been used.

The work on the restored area is also in my view of high quality, with the restored surface being similar to the land on either side (rather than being pockmarked with ankle busting holes) while the transplanted vegetation appears to have taken. The result is that the ground is already blending with that to land around, a complete contrast to a year ago. In landscape terms this looks like an excellent example of disaster recovery. Its interesting that the Reinstatement Note provided by the CNPA suggests that the contractor who did the restoration was different to that who constructed the pipeline. I am tempted to suggest they deserve an award.

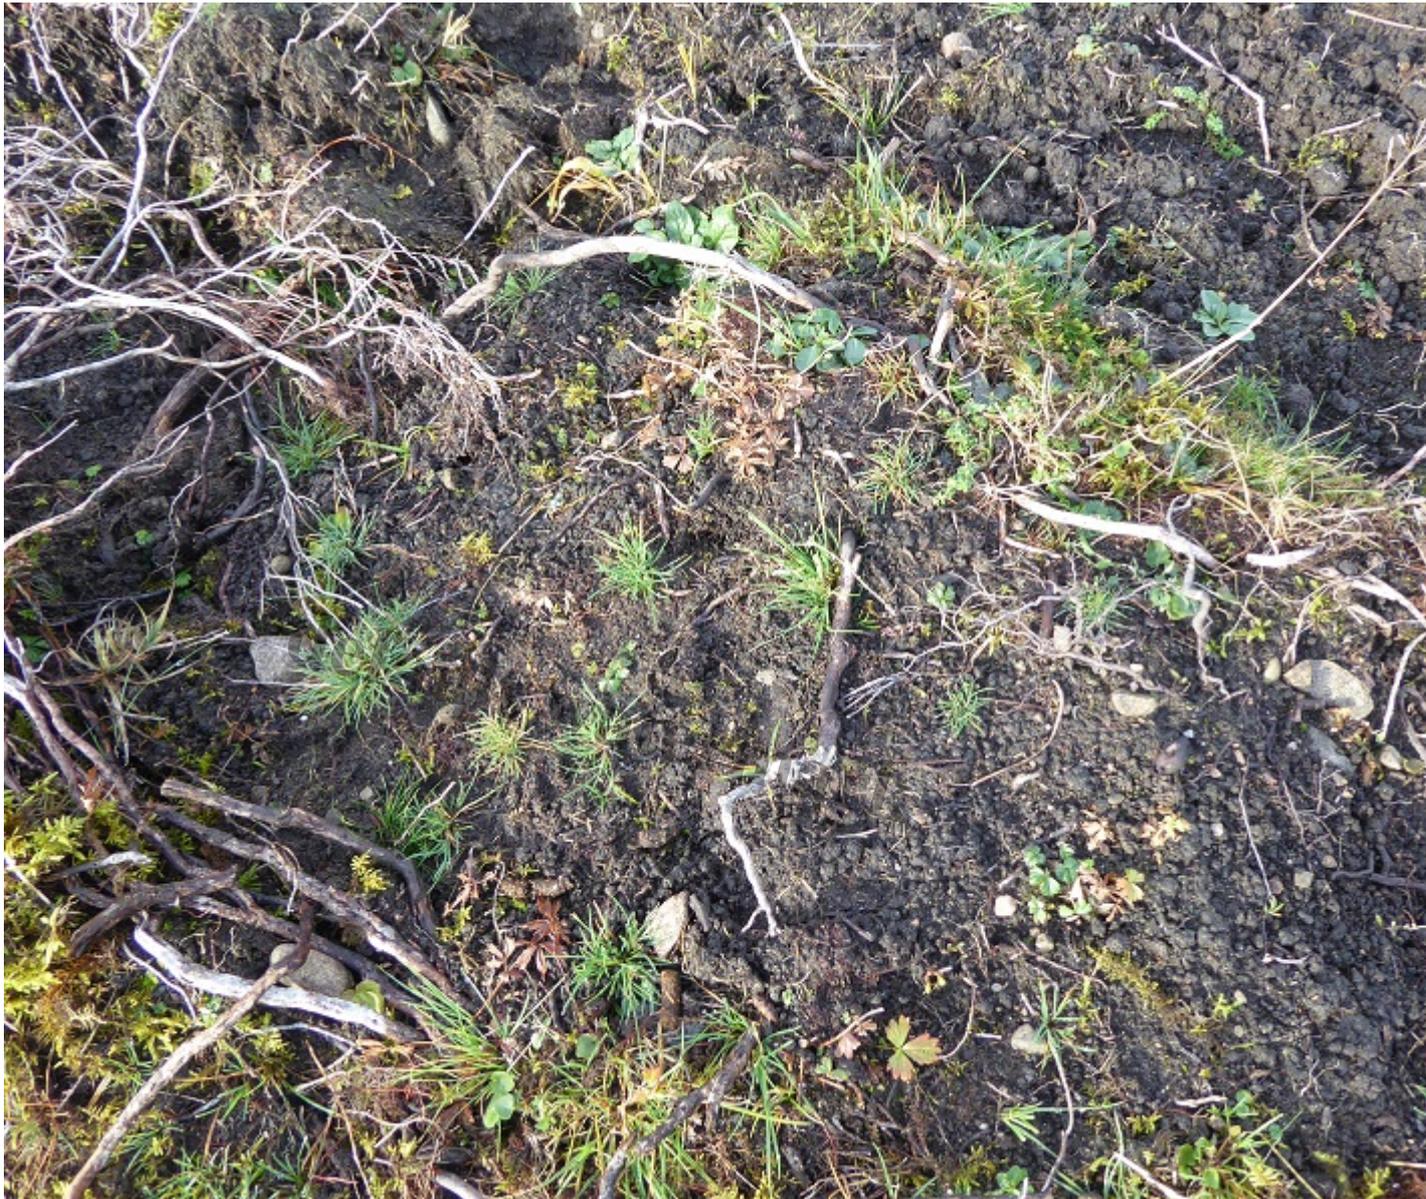
Evidence of plants colonising bare ground. This will help stabilise the soils but which plants will establish themselves in the medium term is uncertain

Its too early to say if the original poor restoration of the pipeline will have a permanent impact on the vegetation in the glen and, for example, allow new invasive species to move in. Once the soils and vegetation had not been stored properly, areas of bare ground were inevitable.

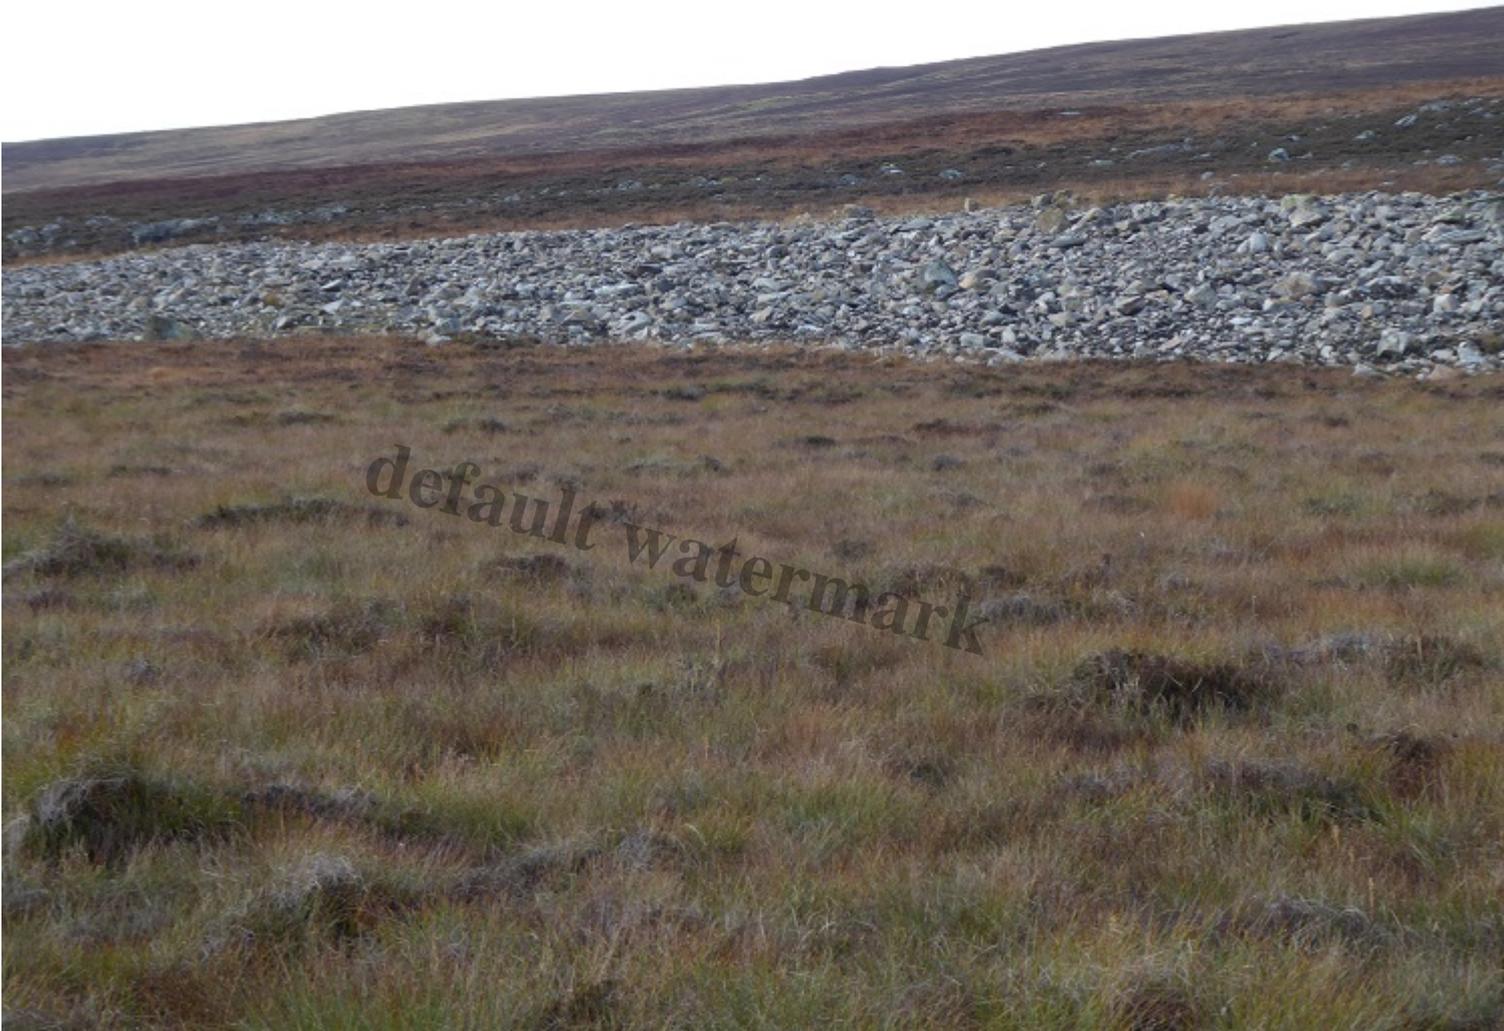
There is also still one area where the landscape scar is prominent, where the pipeline cuts across a slope above an area of deep peat:

At present it looks like very little attempt has been made to restore this.

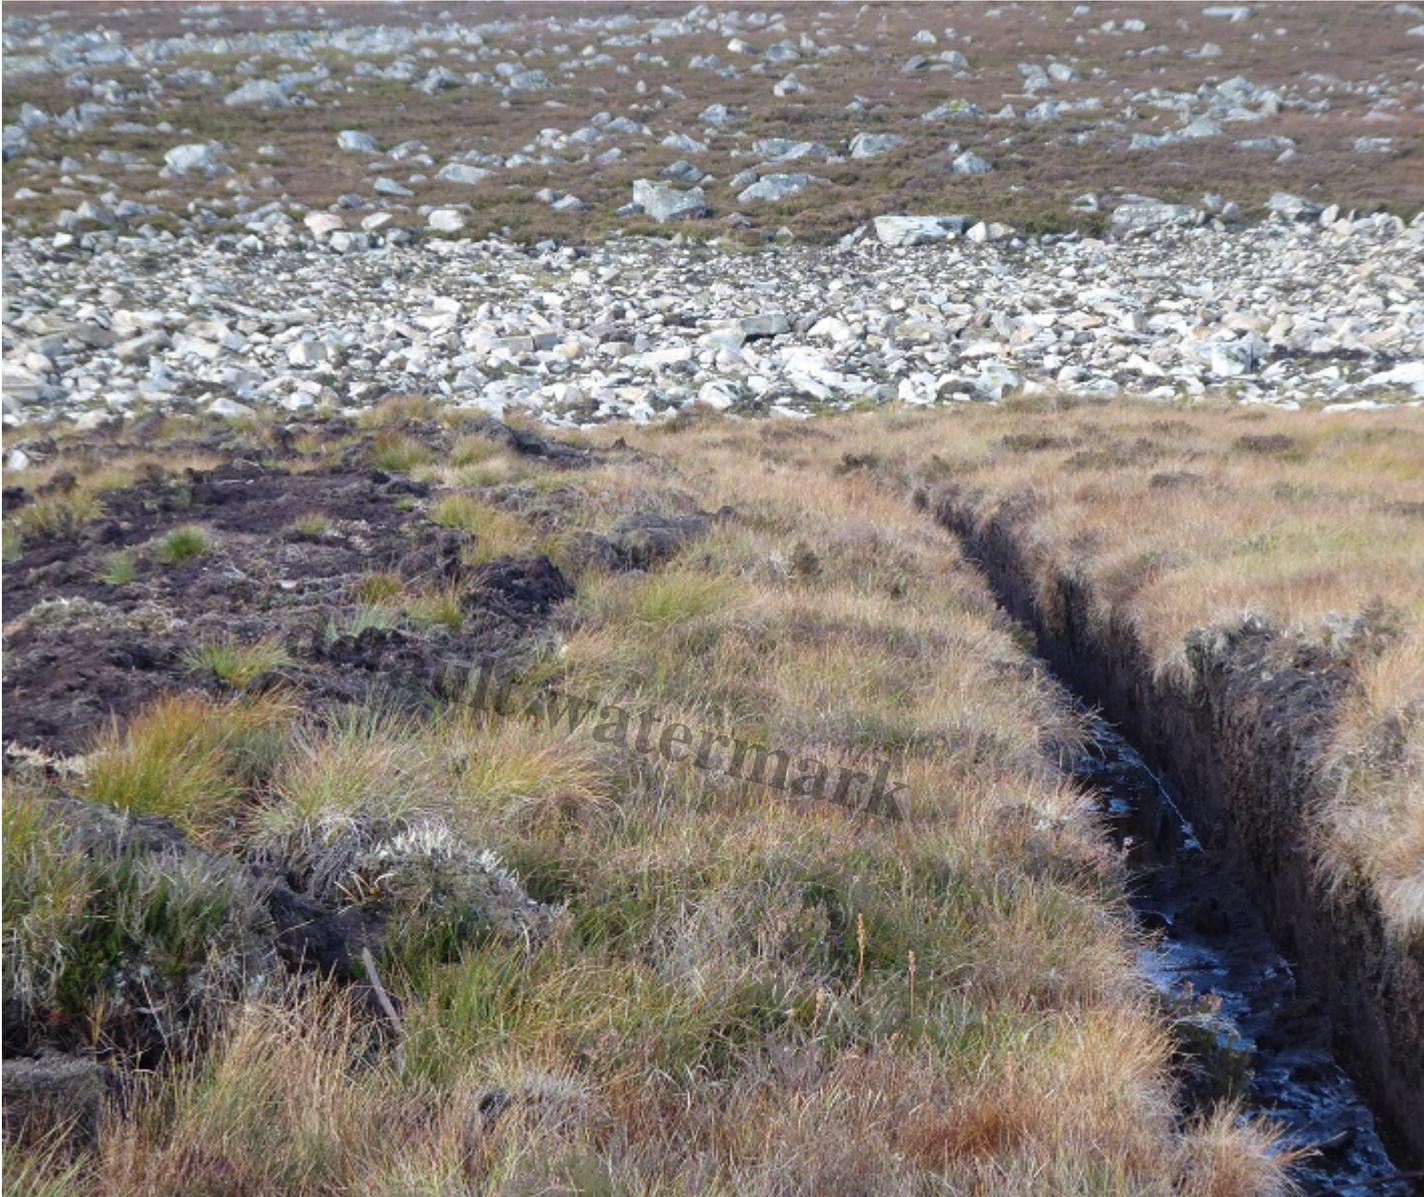
New drainage ditch showing depth of peat. The excavated material has been dumped on left.

There are however some obvious opportunities to do so. The vegetation that has recently been removed to create this ditch could have been used to reinstate part of the boulder band.

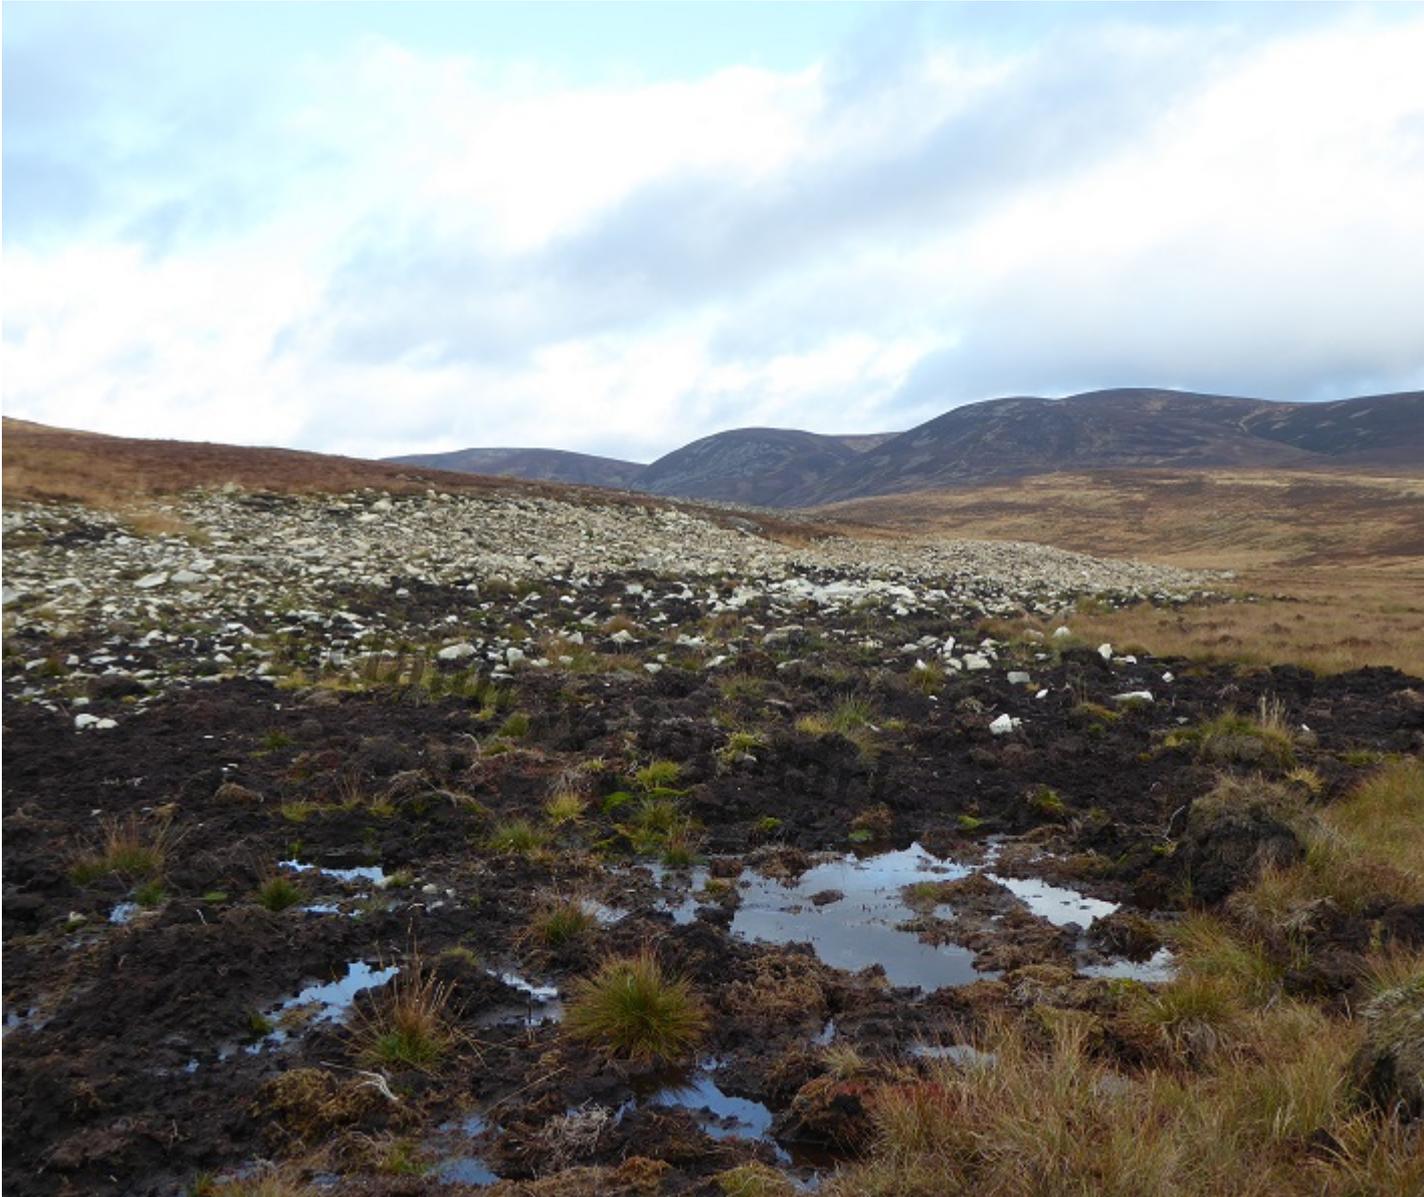
The start of the section of unrestored pipeline marked by the boulder field. Note the large peat turves far right which appear to date from original excavation and have never been used for restoration purposes.
