Forest operations and hill tracks on the Kinveachy estate

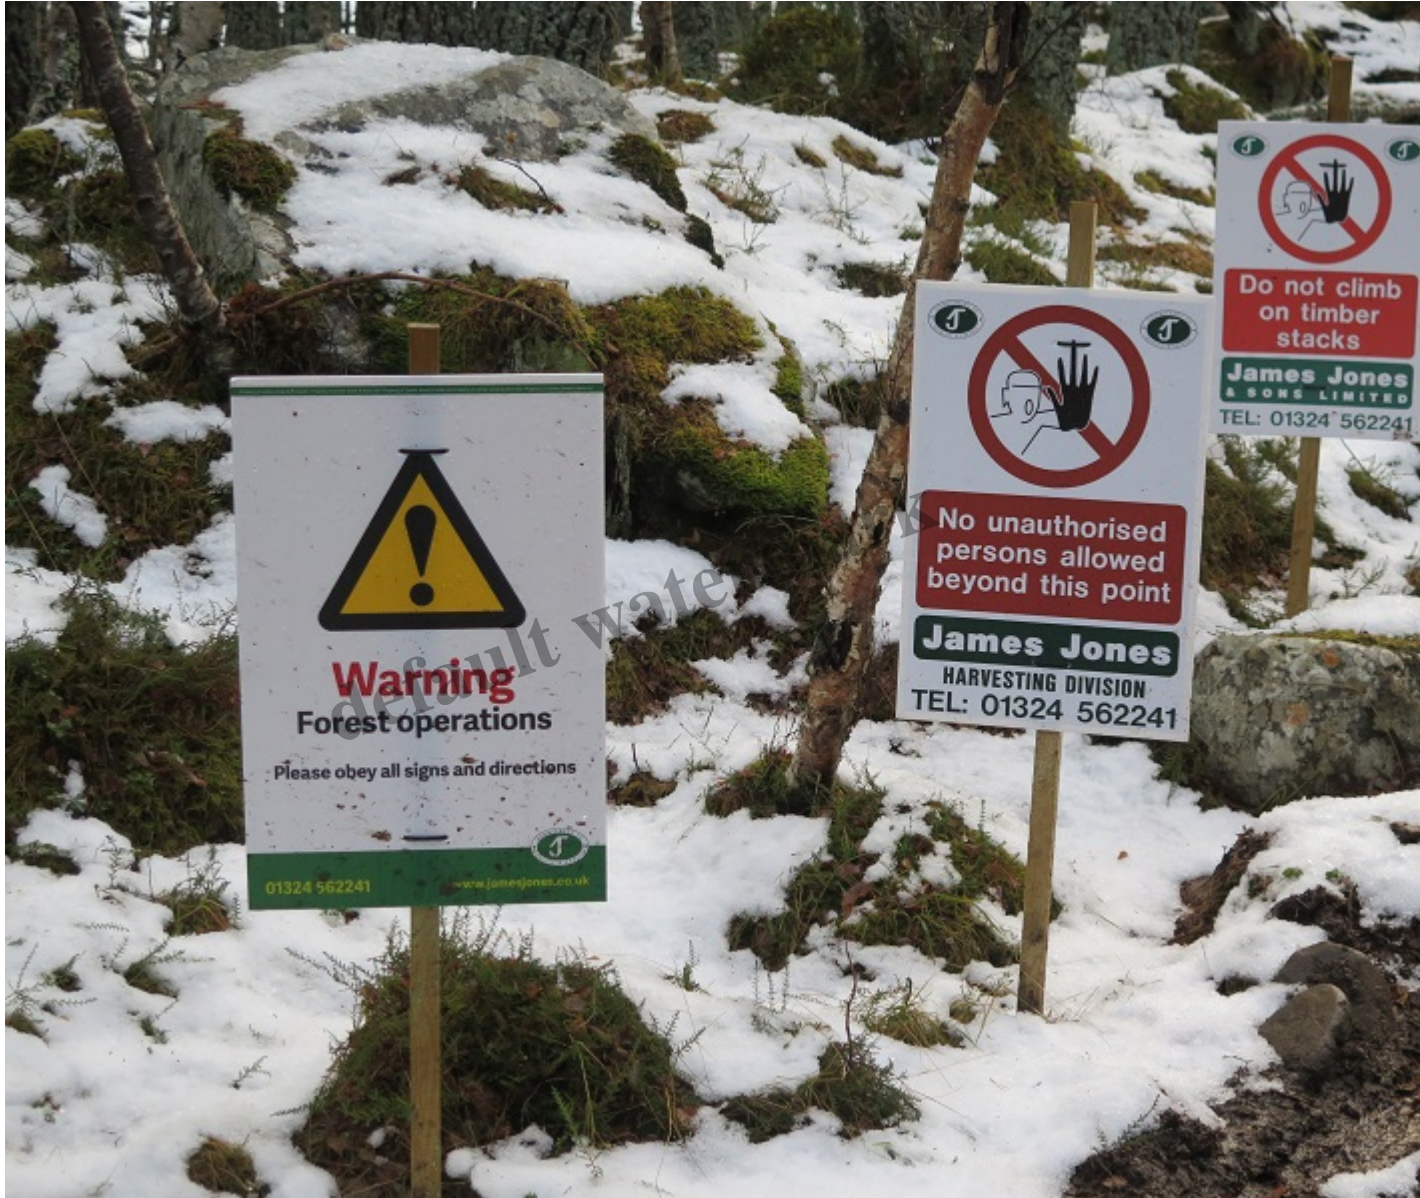
The middle sign beyond provoked disbelief. Yet another sign in our National Parks that contravenes the Scottish Outdoor Access Code. Signs on land management operations are meant to be specific and offer alternatives ([see here for SOAC sign template - woodland management](#)). We reported it to the Cairngorms National Park Authority after our visit and received an immediate acknowledgement and assurance they would investigate. (I have still had no acknowledgement from the Loch Lomond and Trossachs National Park Authority to High Velocity Rifles in use Keep Out signs south of Ardlui which I reported on 4th December ([see here](#)) whereas the CNPA has stated they will refer the "Welcome to the Moor" signs, which featured in that post, to the Cairngorms Local Access Forum for

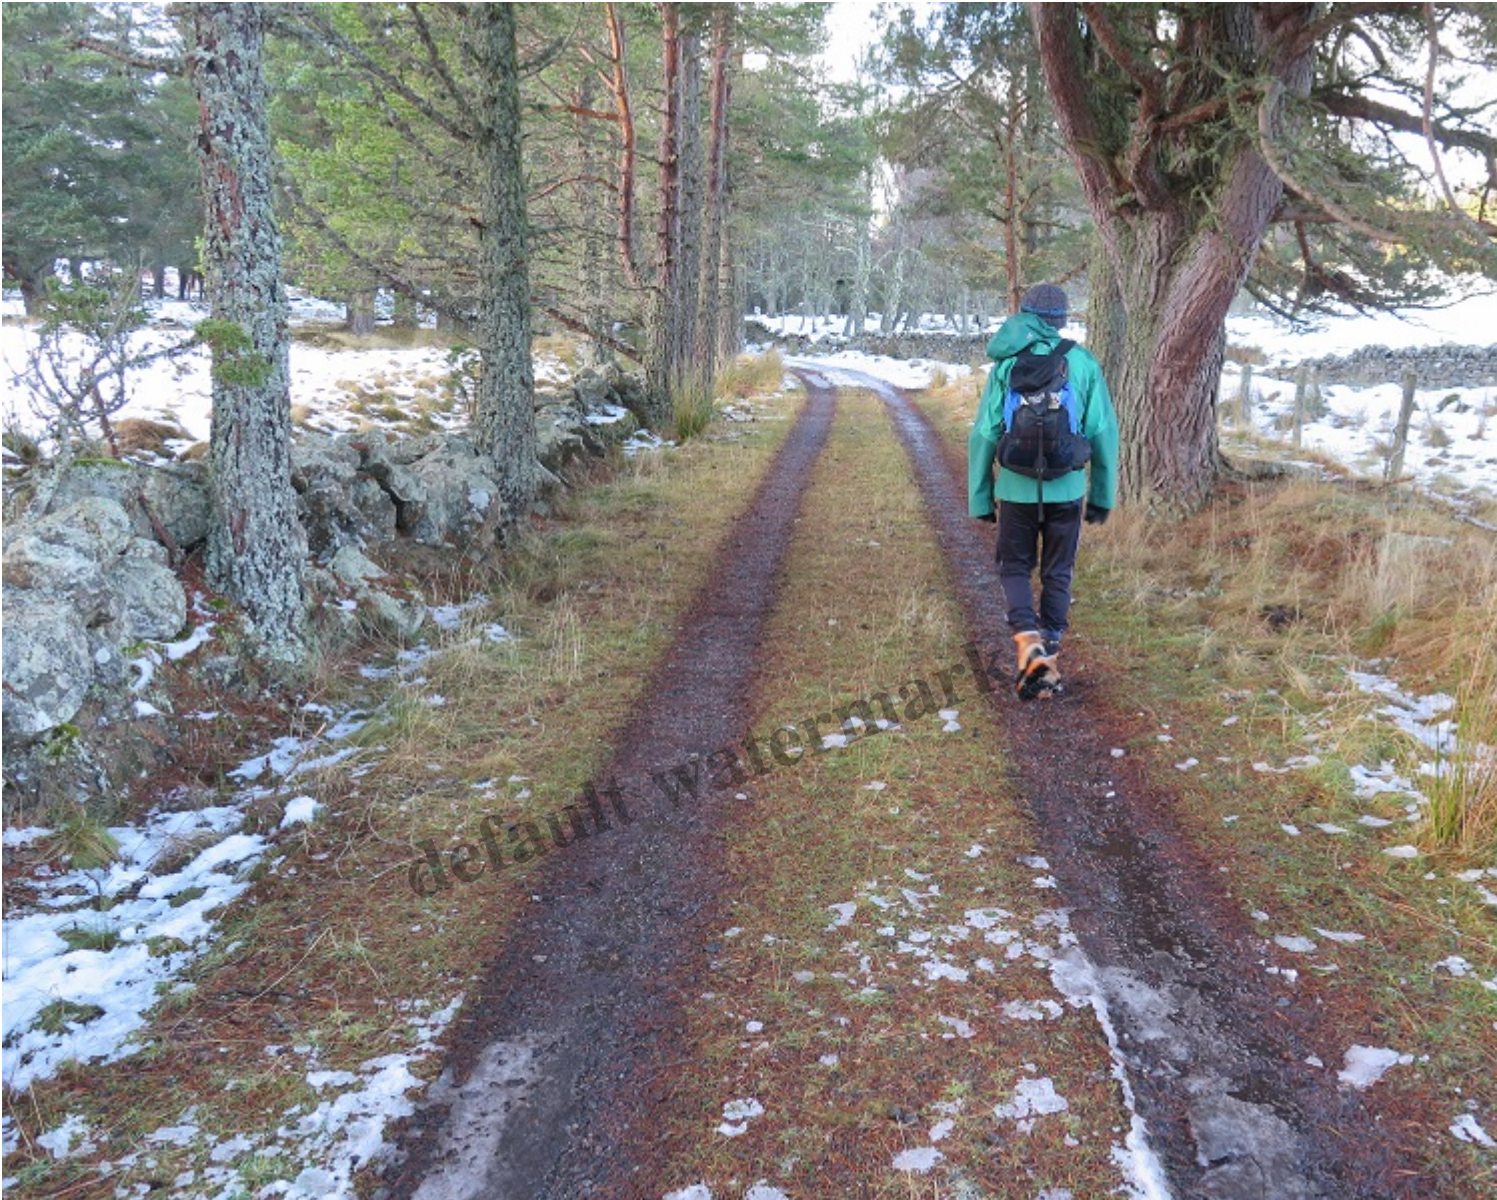
The former Wade Military Road, which forms the northern boundary to the protected nature sites, provided a good walking experience and an example of how tracks should be.

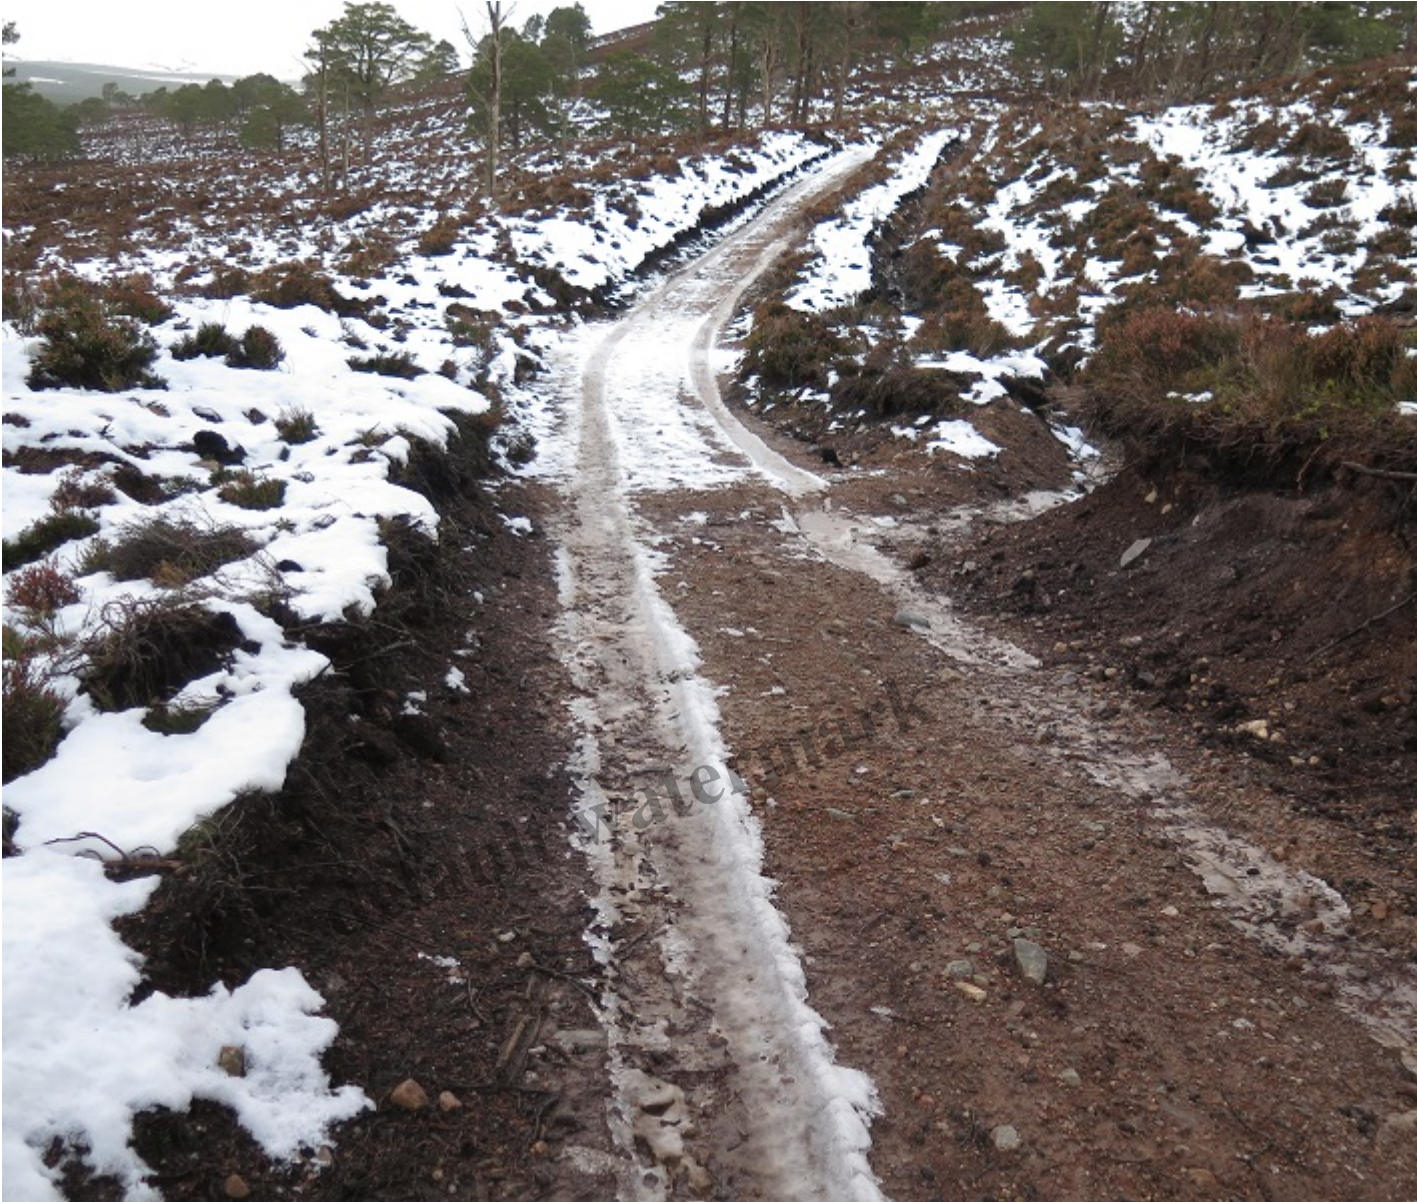
The track – a path formerly followed this line – appears to have been excavated with diggers and the e.g the bank on the right and the drainage ditch beyond, is poor. Photo credit Dave Morris.

The track was still narrow and had very little impact at the landscape scale, being sunken and weaving through the old trees and areas of regenerating woodland (there was lots of signs of recent regeneration – welcome when ten years ago, when this site was last assessed according to information on SNH sitelink, it was in unfavourable condition due to lack of regeneration).

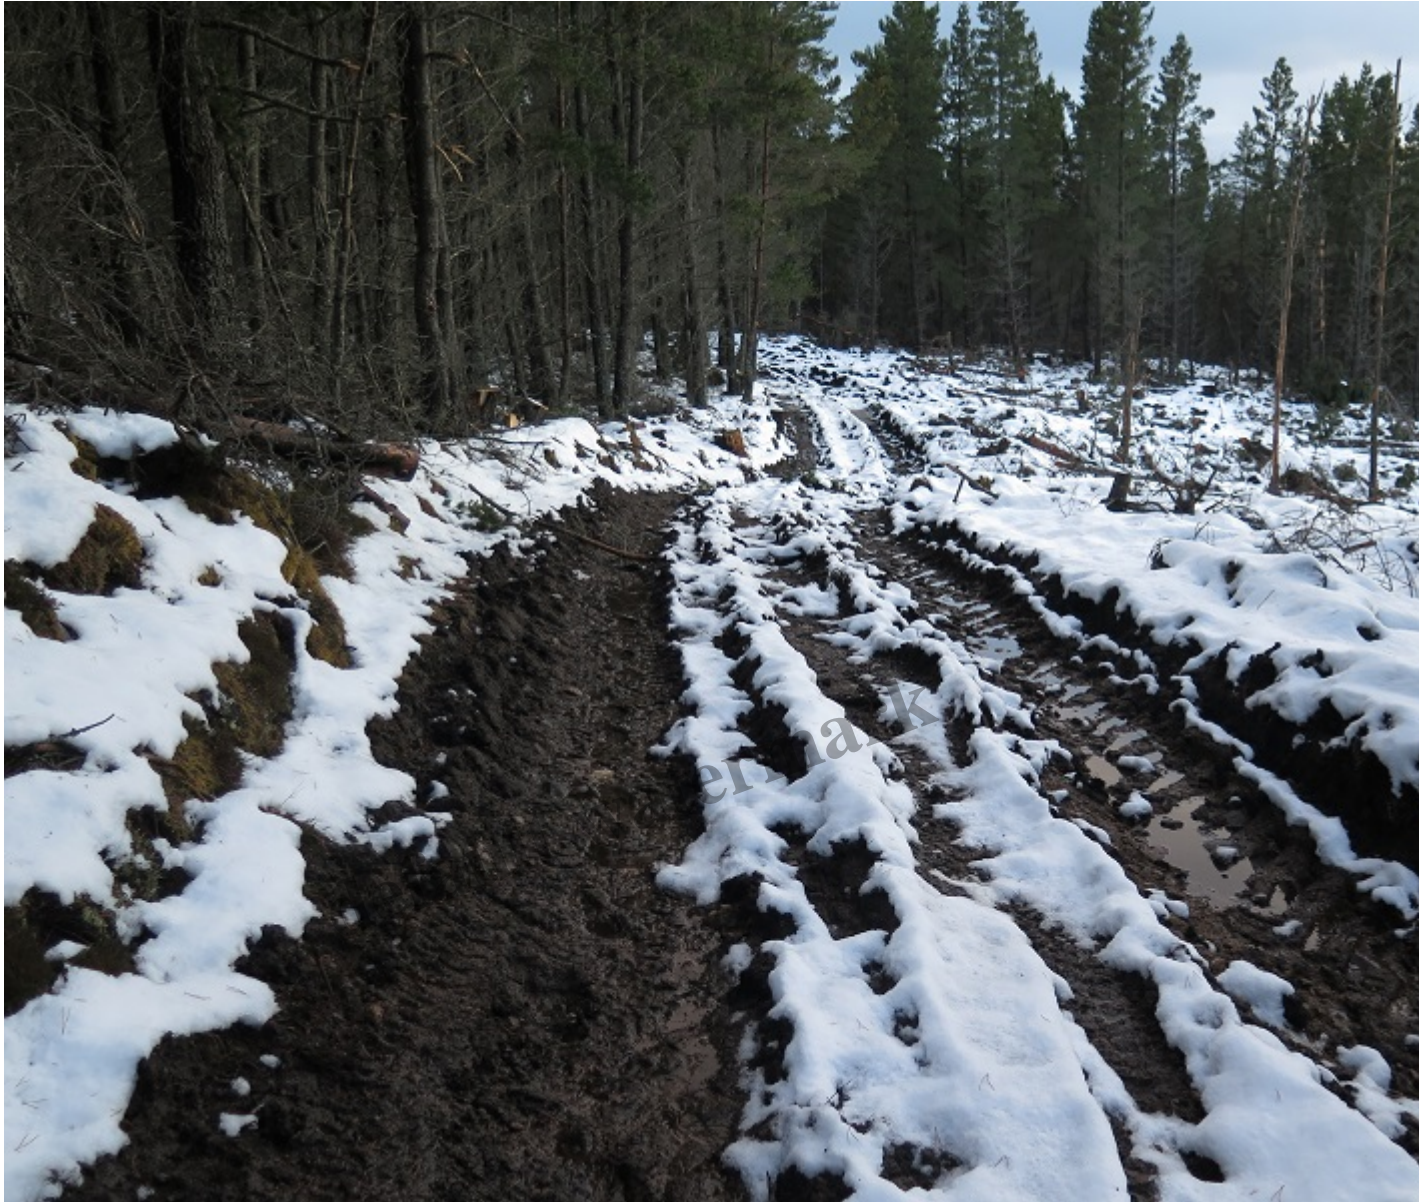
Where the track ended we cut up over the south ridge of Beinn Ghuilbin heading for the forestry tracks marked on my old OS map. Once outside the Special Protection Area we found the tracks and a quagmire.

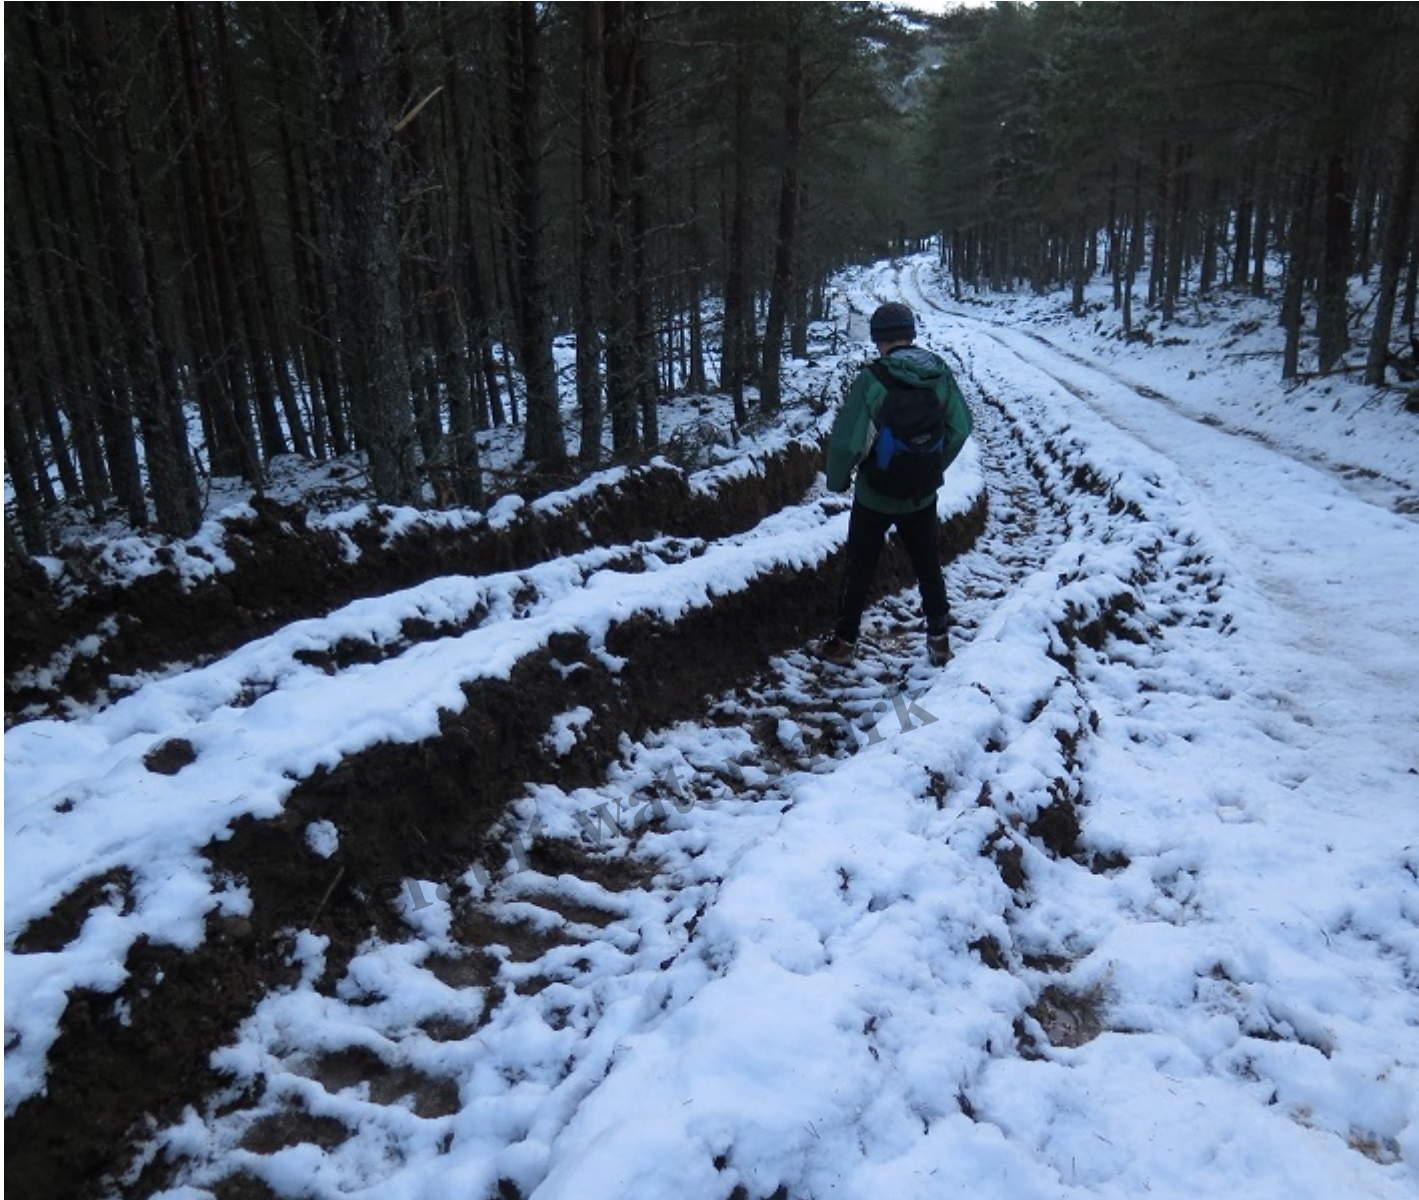
This was only walkable because partially frozen.
