The further potential for undergrounding powerlines in our National Parks and the example of Glen Tromie

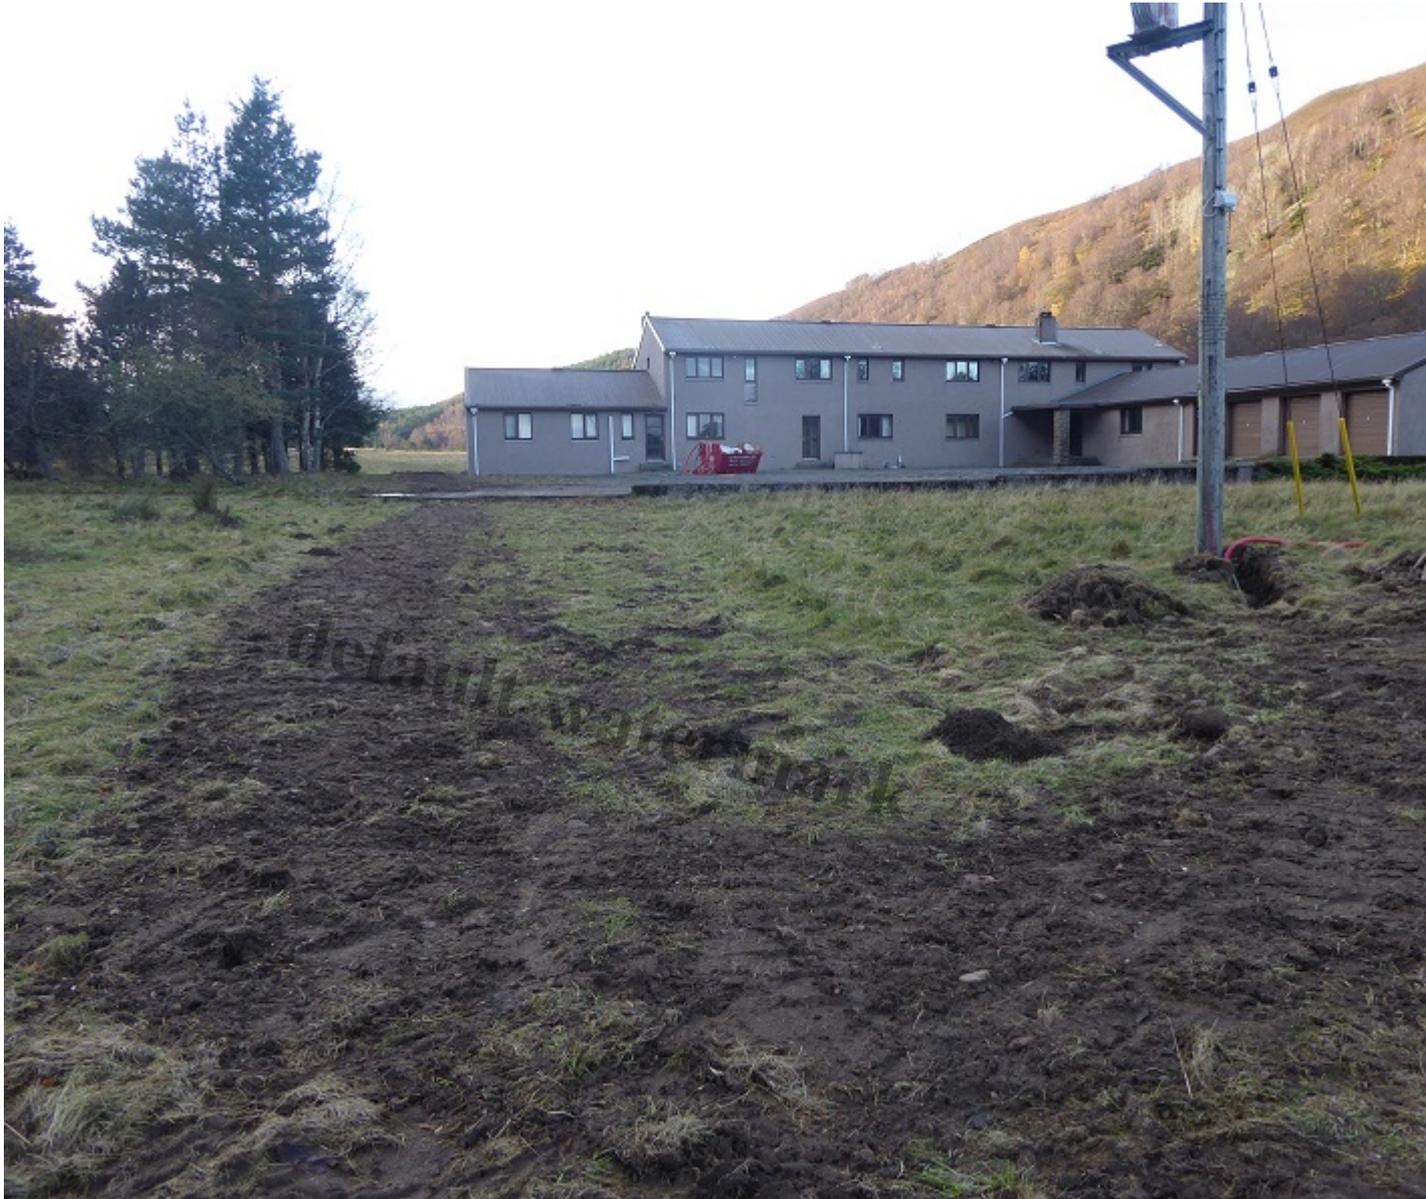
The current work to underground the Glen Tromie powerline starts at the hideous Lynaberack Lodge in Glen Tromie. The ground here, where the undergrounded line joins with the overhead powerline, is more disturbed than almost anywhere else along the route.

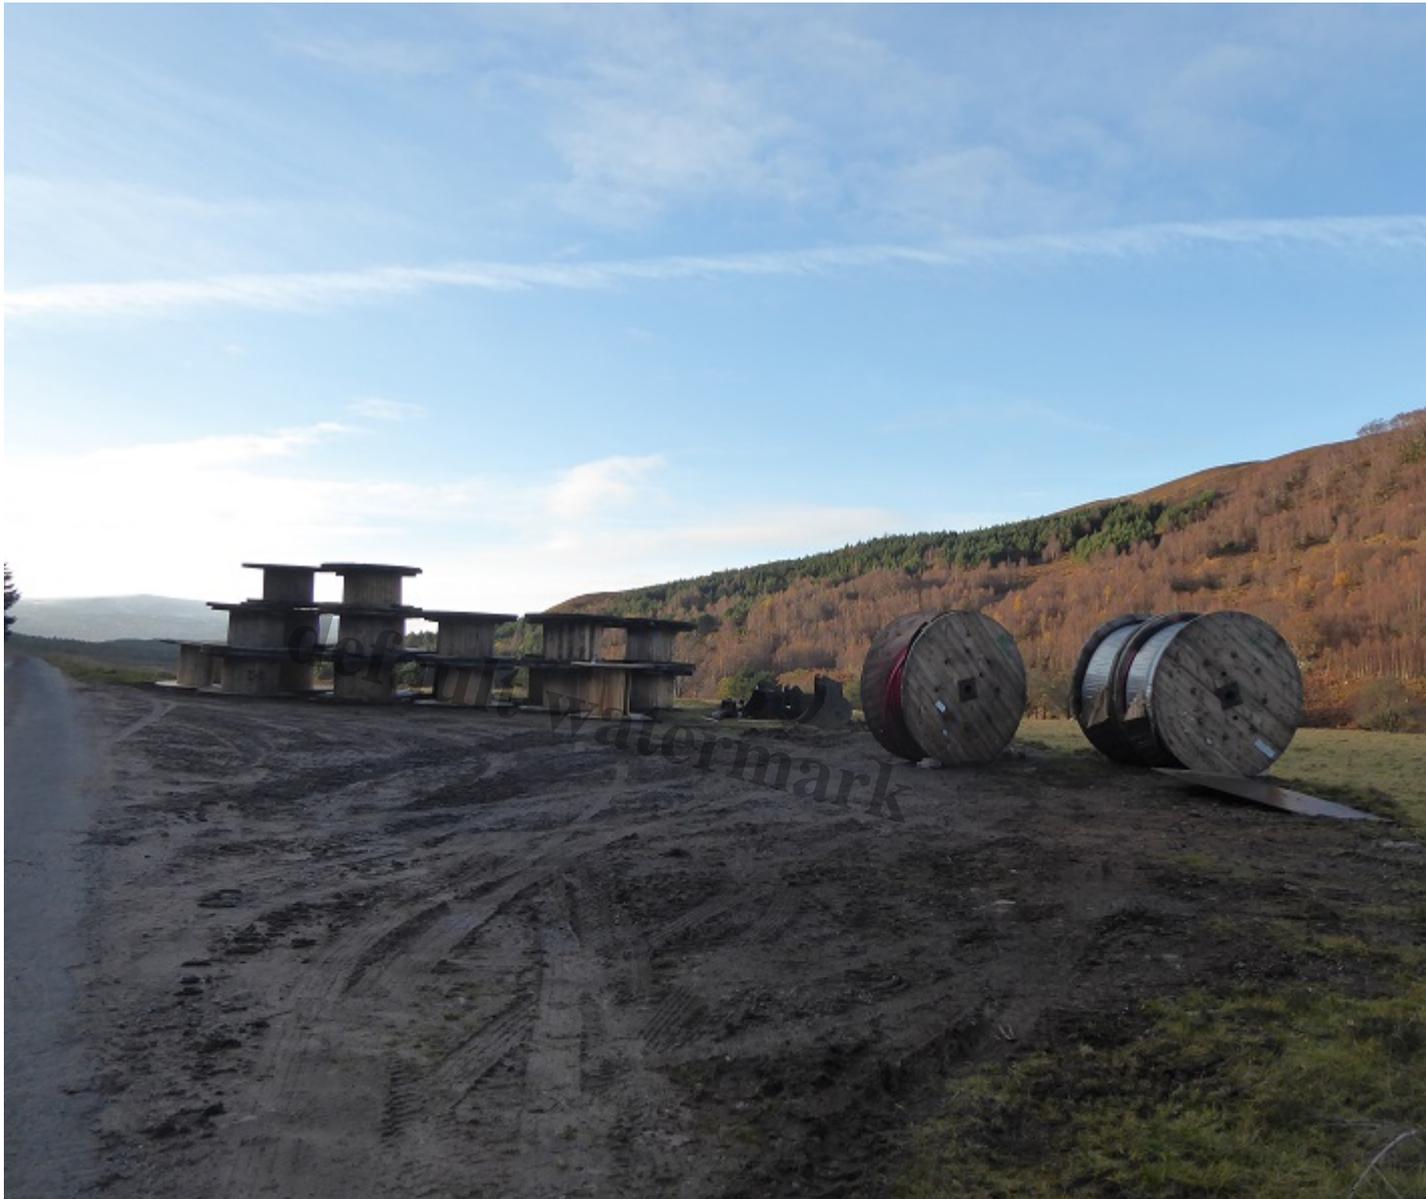
Evidence of the amount of new electric cable which has been undergrounded

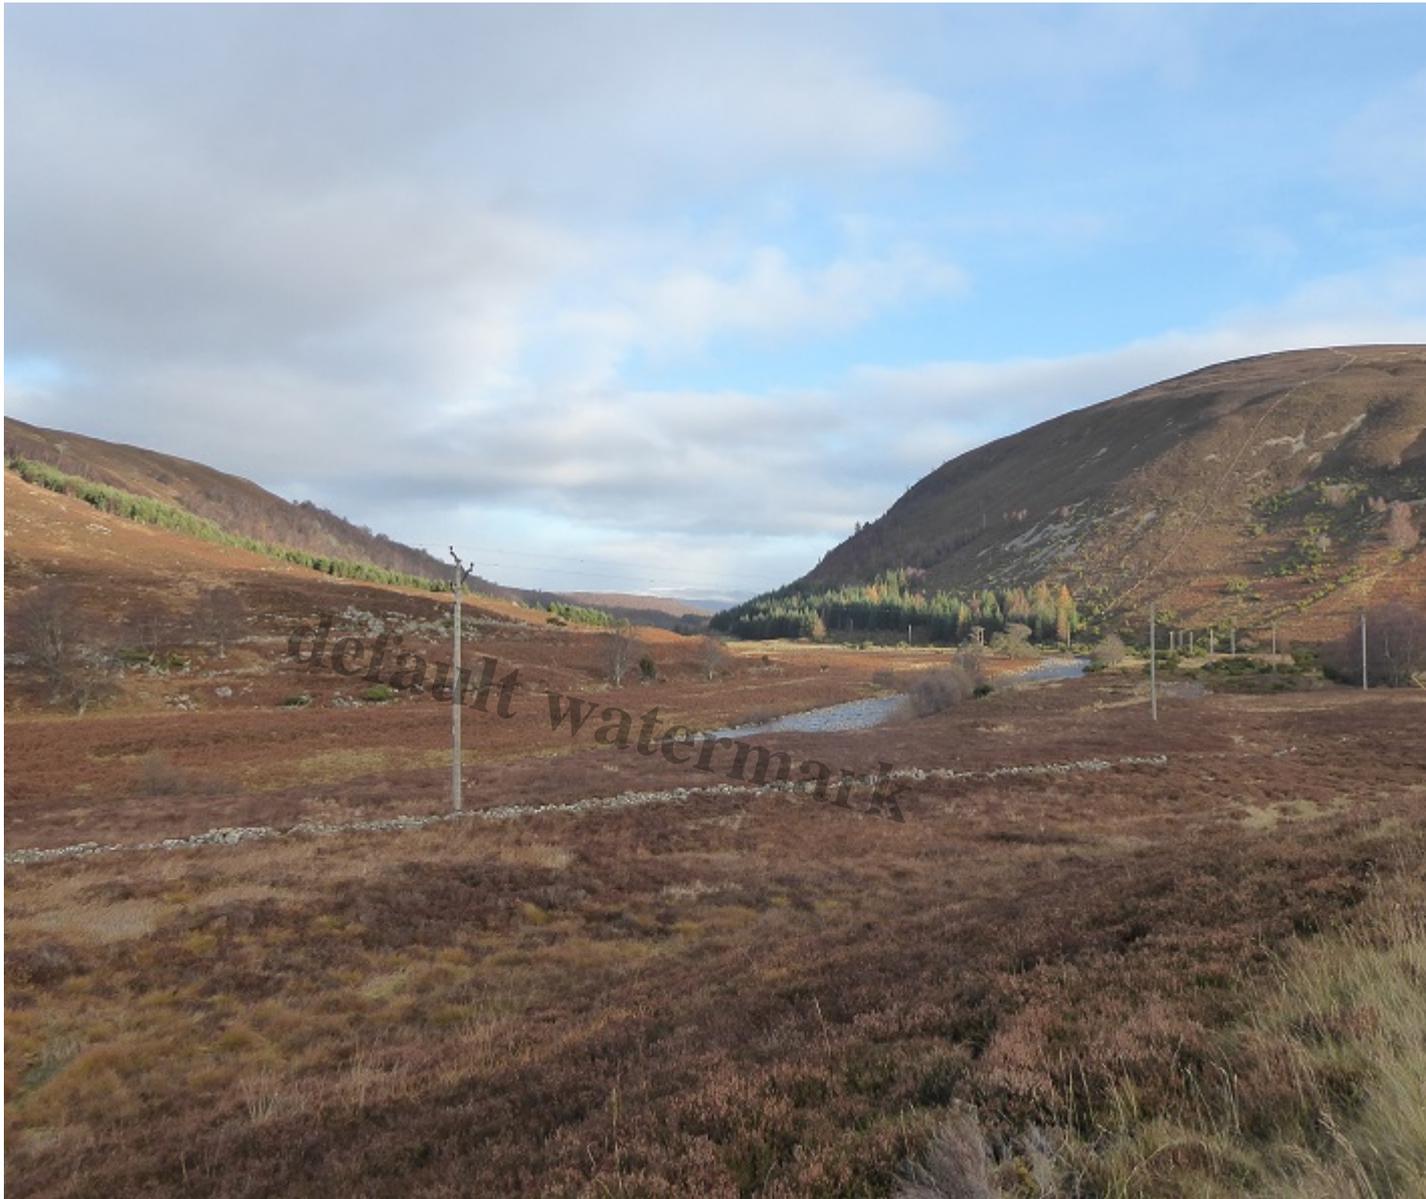
The road is just to the right of the photo

Imagine the difference, when this section of powerline is removed. While there is still a road running up the glen, to the person walking or cycling along it the view will feel significantly wilder.

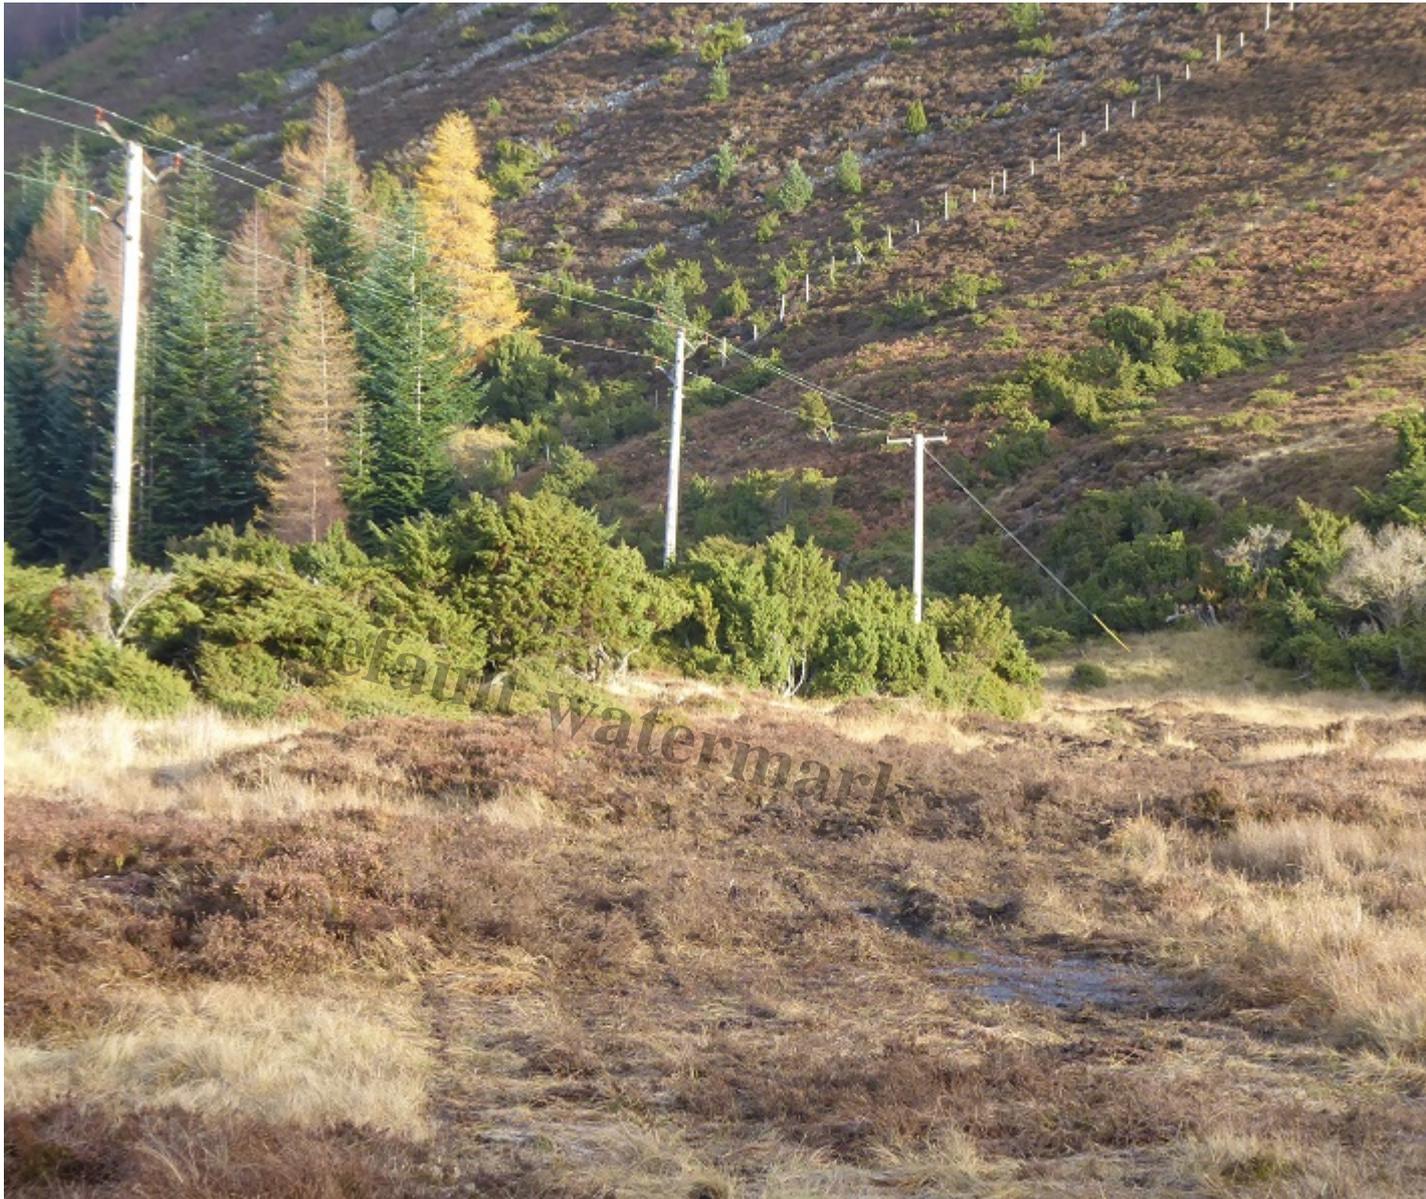
The new powerline, which lies beneath the vehicle track starting bottom centre, will replace the pylor

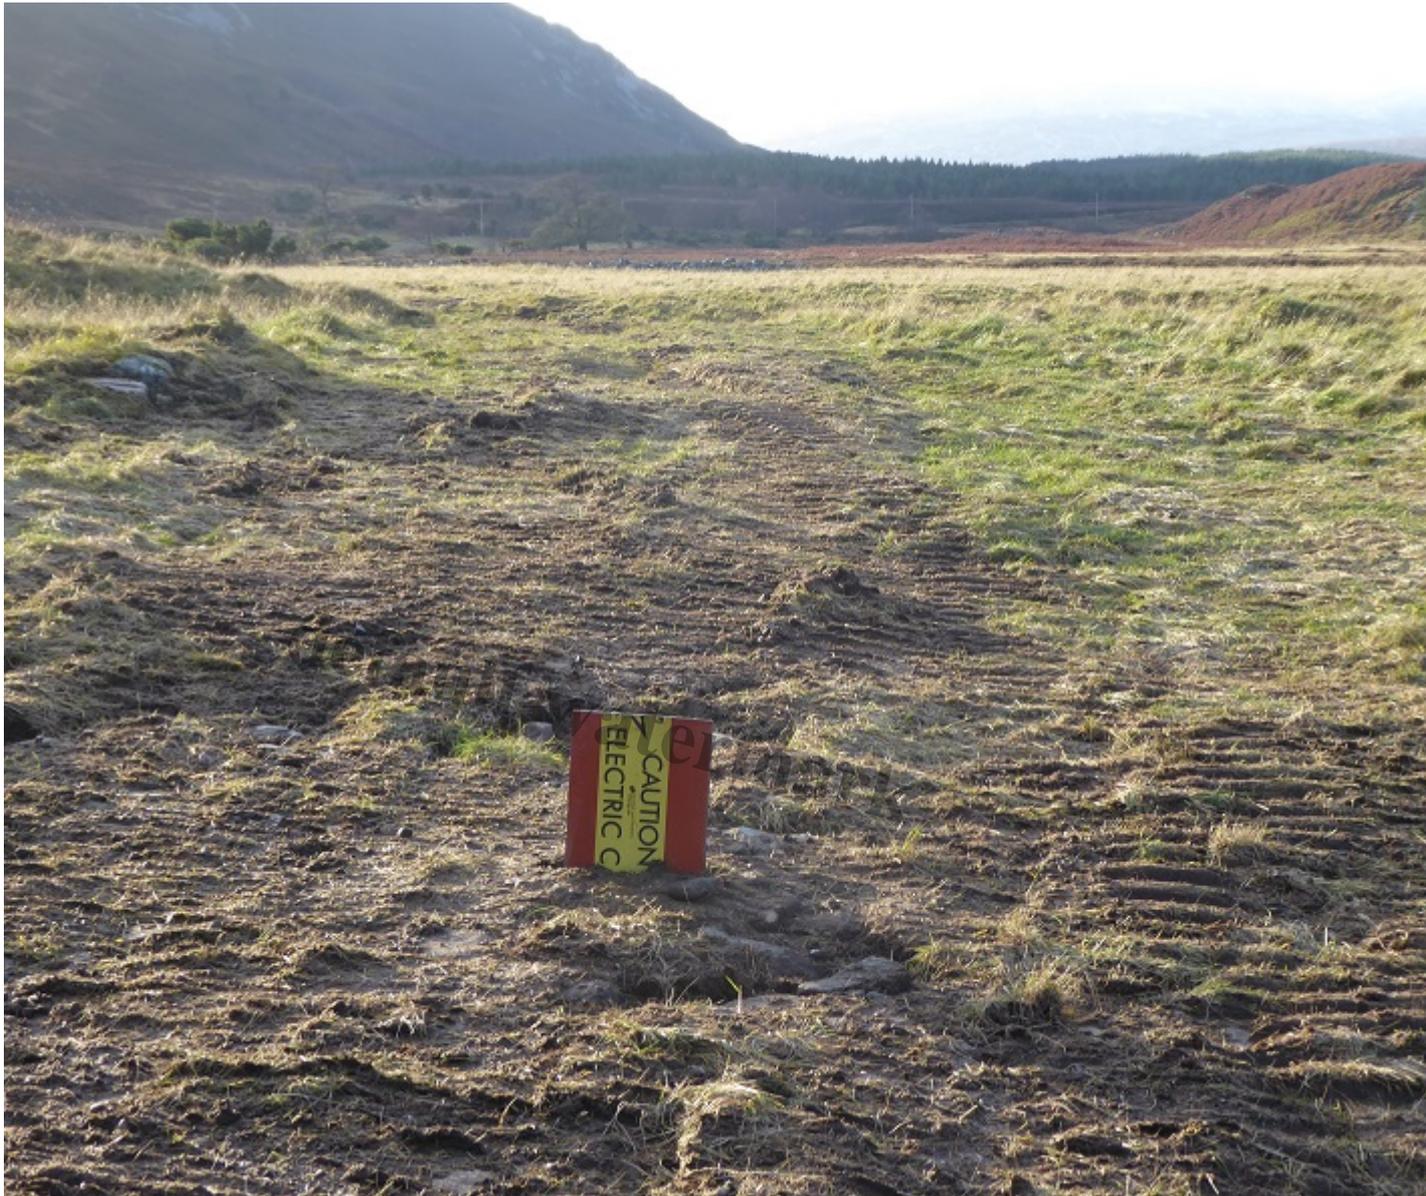
Few people would know, just a couple of week after the work had been carried out, that the reason for the ground disturbance is an electric cable had been buried unless it was for the sign

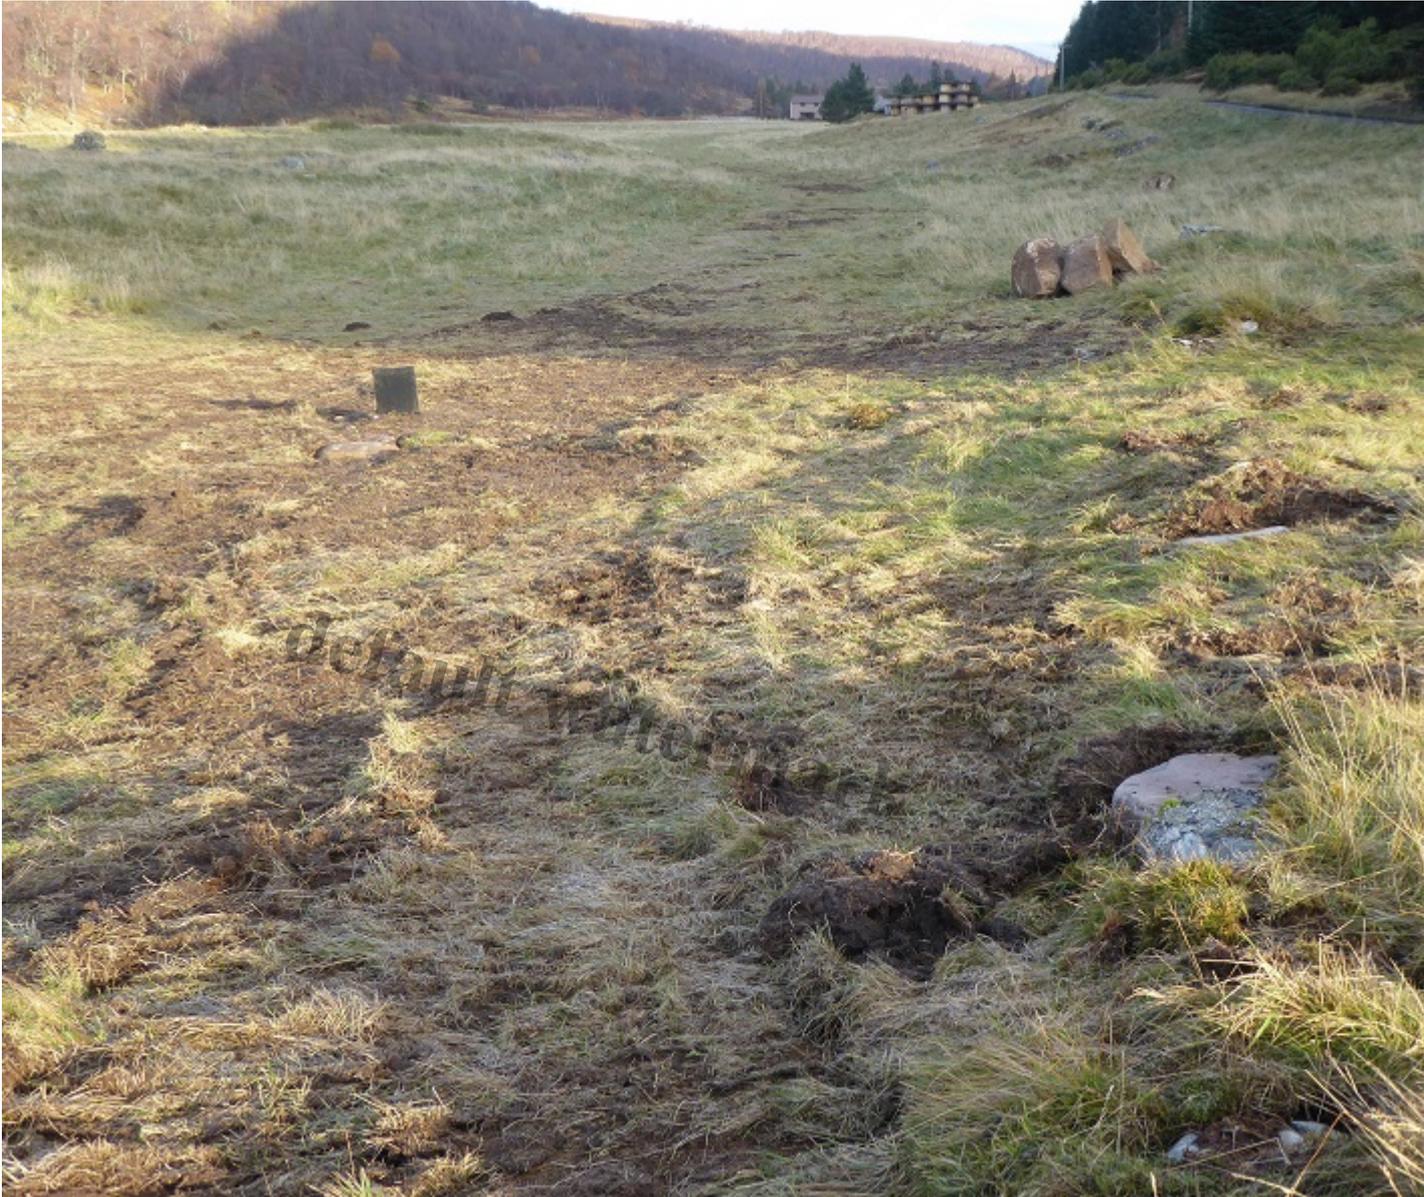
You can however see some evidence that a mole plough has been used. In places boulders have been excavated to allow the passage of the plough and cable.

Apart from the removal of boulders, the vegetation has been little disturbed and on the grassy floor of the glen should recover from the passage of vehicles very quickly. I suspect by next summer, when the grass has had time to grow again, it will be very hard to detect the line of the buried cable.

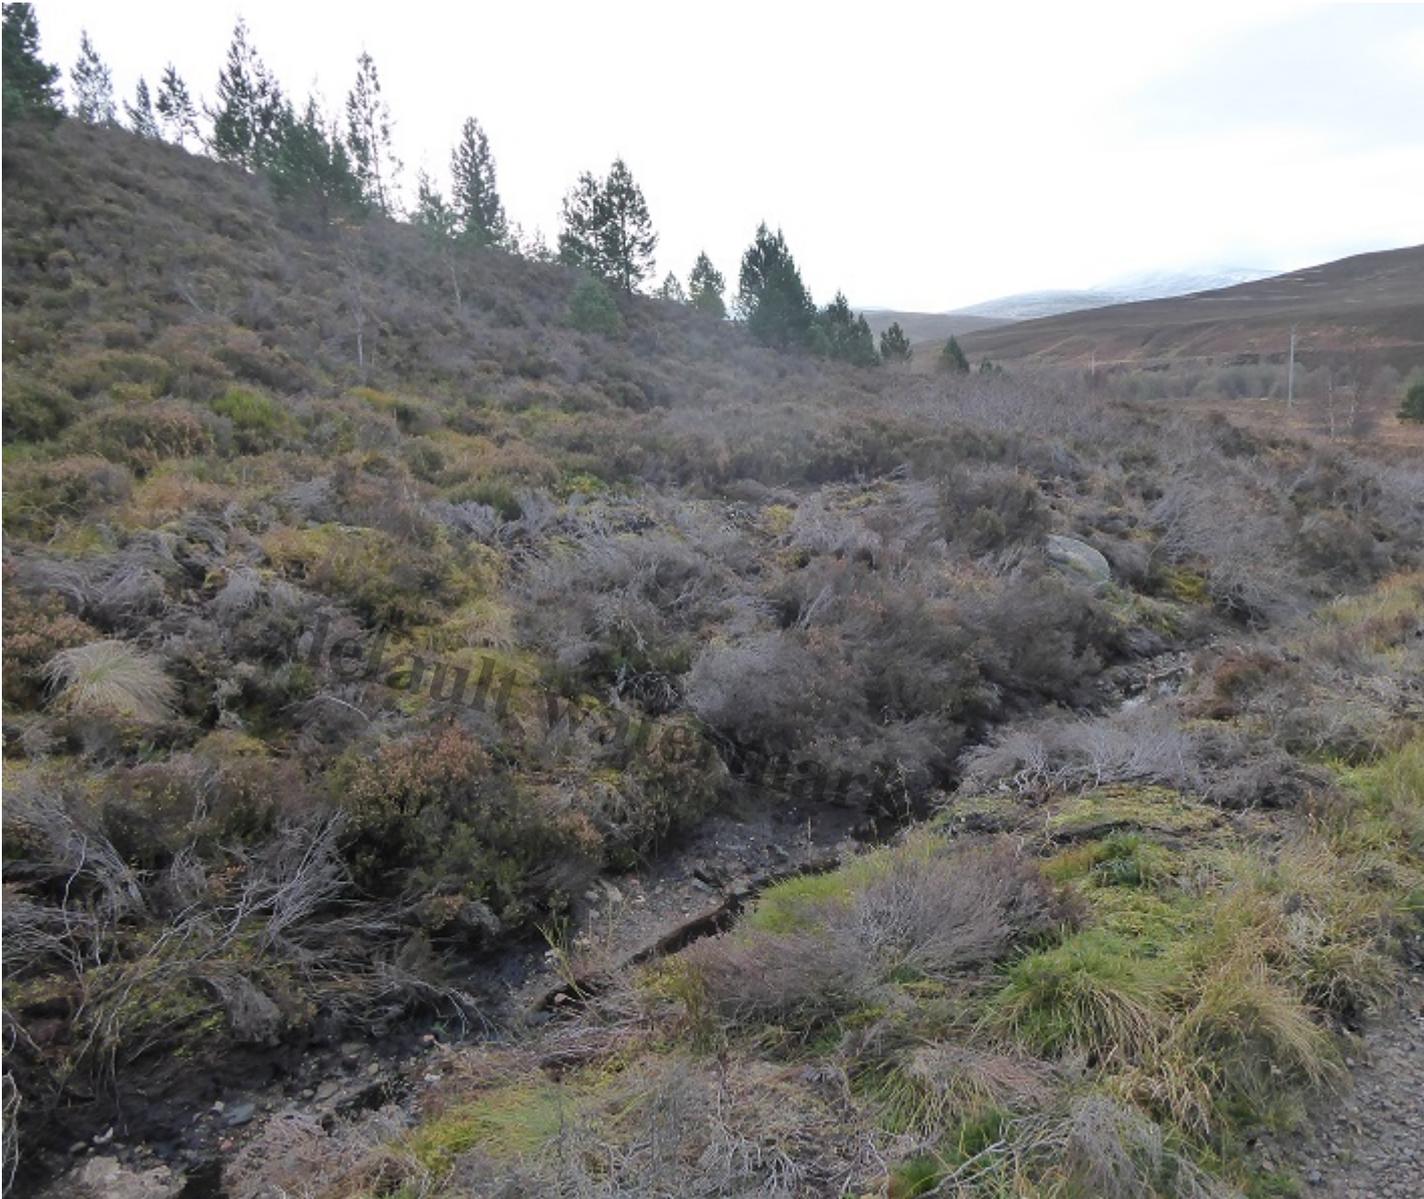
The buried cable is under the disturbed heather on the left side of the road

I was most impressed that the mole plough could also be used on heather moorland and cause so little destruction to vegetation. Again, I think the vegetation here should more or less fully recover in a season.

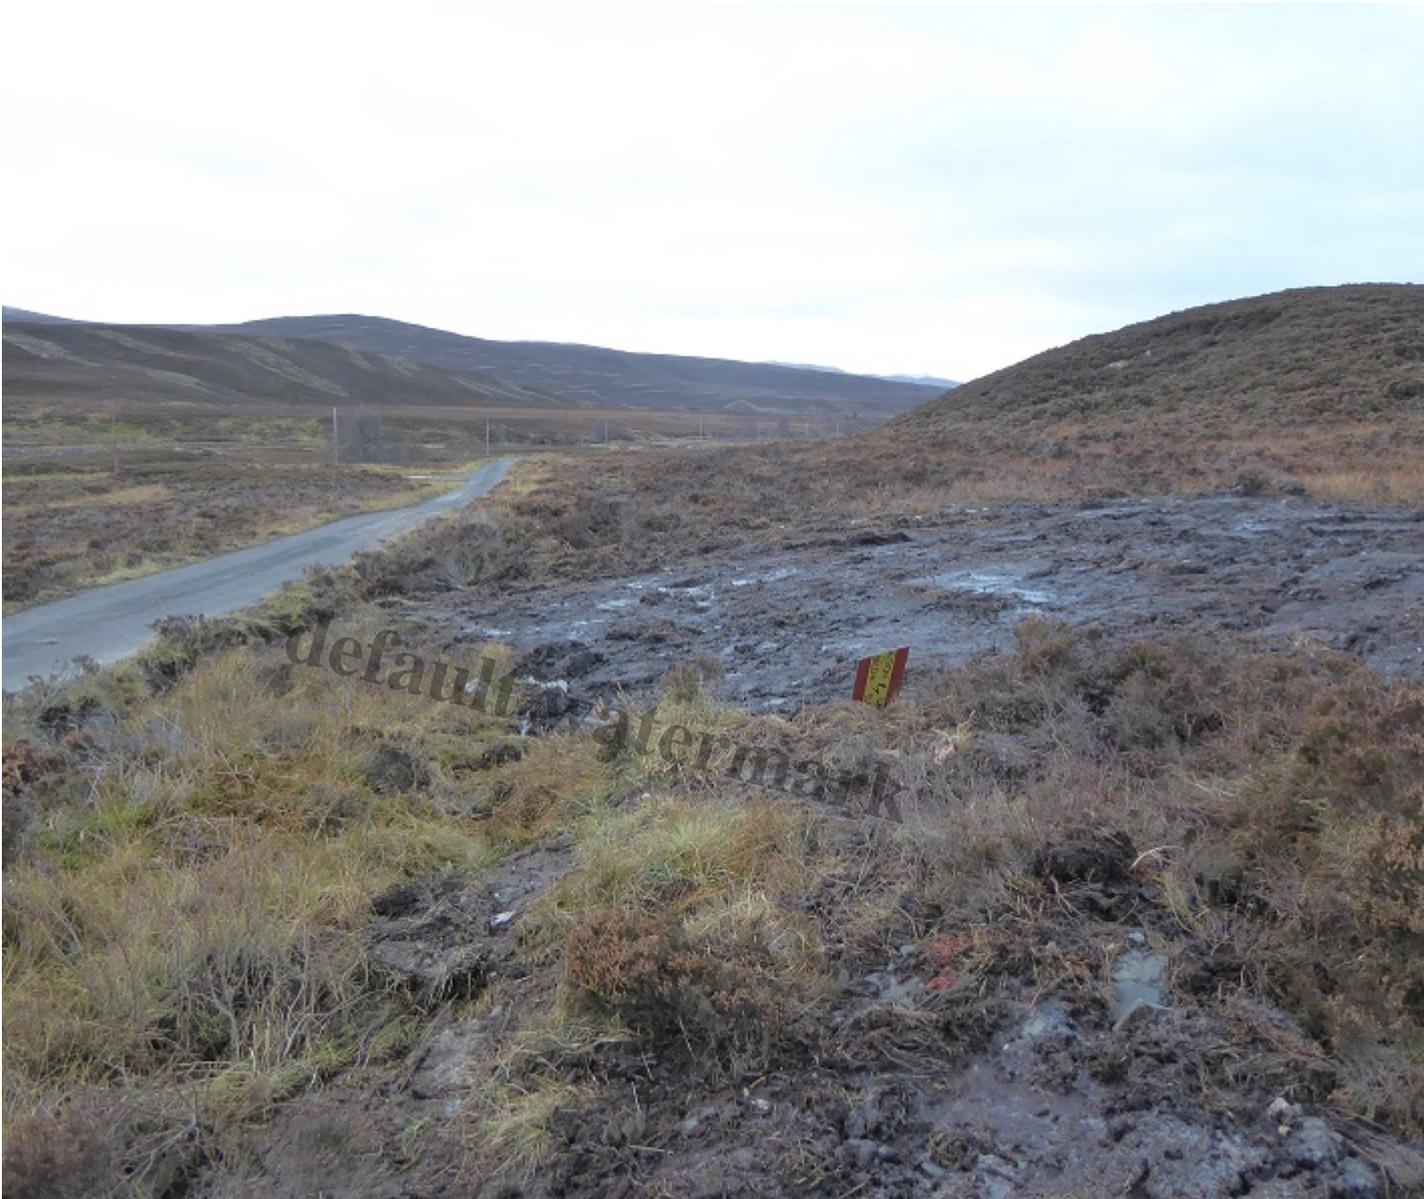
The worst area of ground disturbance/destruction of vegetation on moorland

I then came across the patch of very disturbed ground in the photo above. I was unable to ascertain the cause of this â?? it may have been a consequence of the land being very boggy â?? but in the context of several kilometres of buried cable it just served to illustrate in general how well the work had been done and the potential of using mole ploughs.

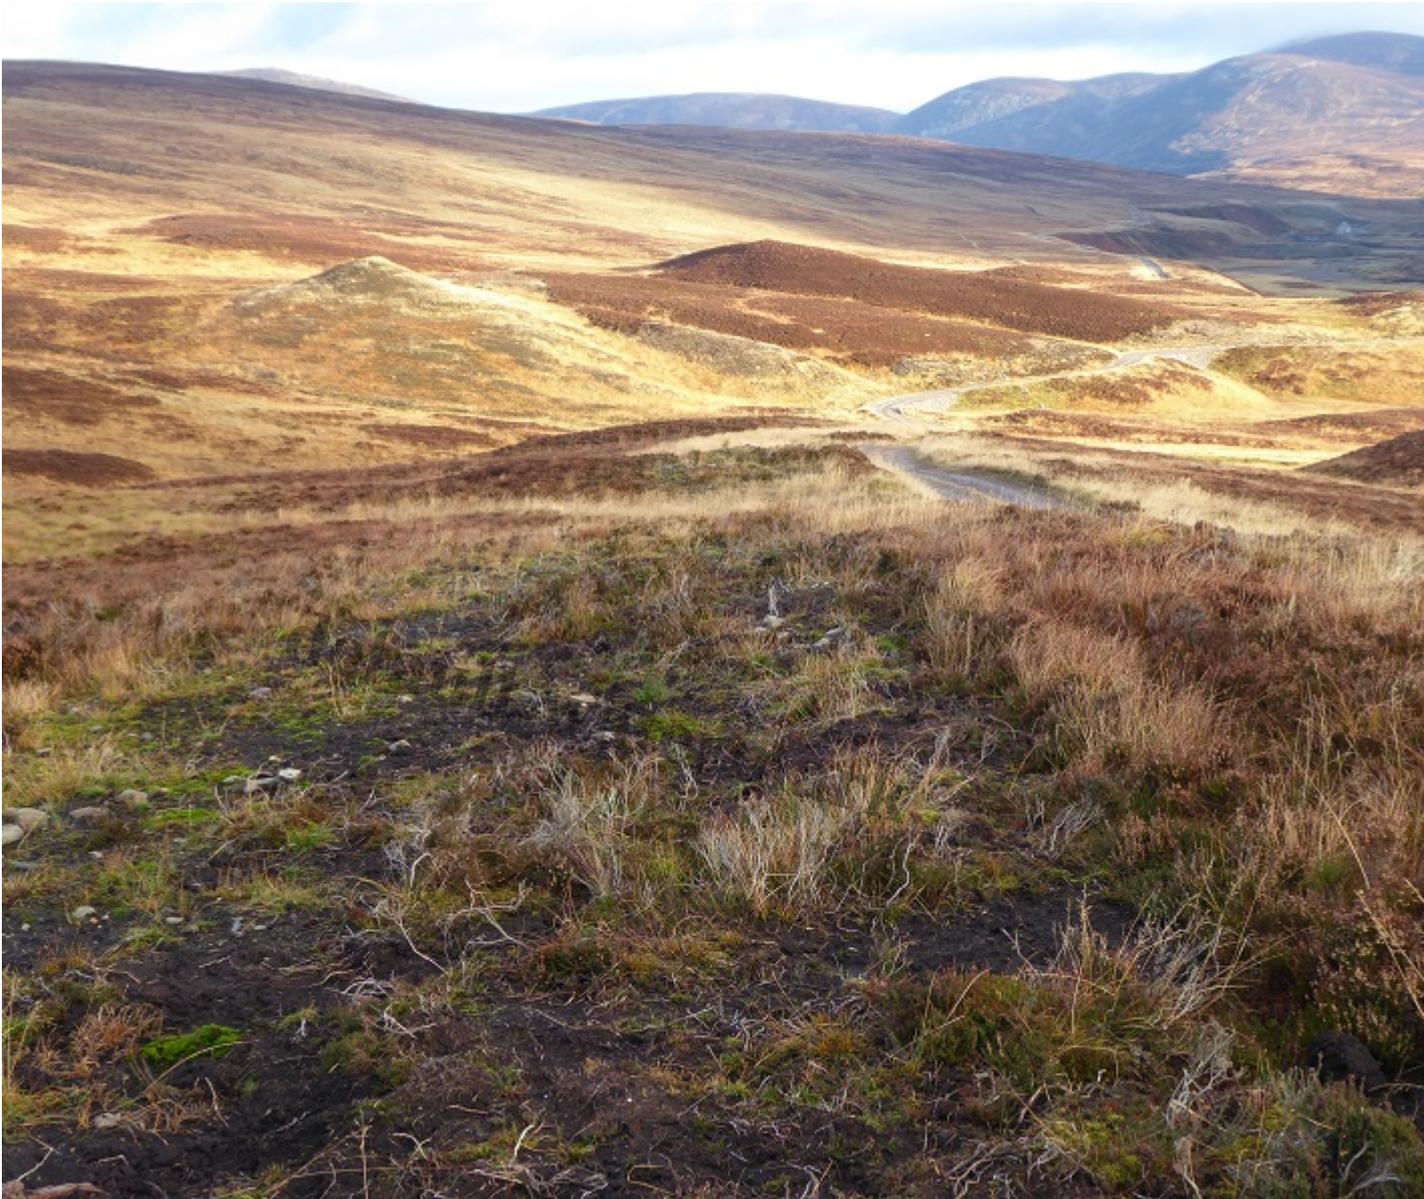
The line of the Glen Bruar power cable runs along the line of disturbed vegetation on the left of the road to the powerhouse which you can just see top right

The advantages of using the mole plough can be seen by comparing the powerline burial in Glen Tromie with that to the new Glen Bruar scheme. While parkswatch has given extensive coverage to the Glen Bruar pipeline restoration above the powerhouse, below it several miles of new electric cable was required to connect it to the grid. The work for this was generally to a high standard and hence I have avoided comment but the methodology used was to excavate a ditch, bury the cable and then refill it. Despite the care taken, over two years on the line of the cable is more visible than that in Glen Tromie two weeks after the work finished. The lesson, I believe, is that burying cable with a mole plough, if done well, does significantly less damage than any methods that involves removing vegetation, excavating a ditch and then trying to restore this work.

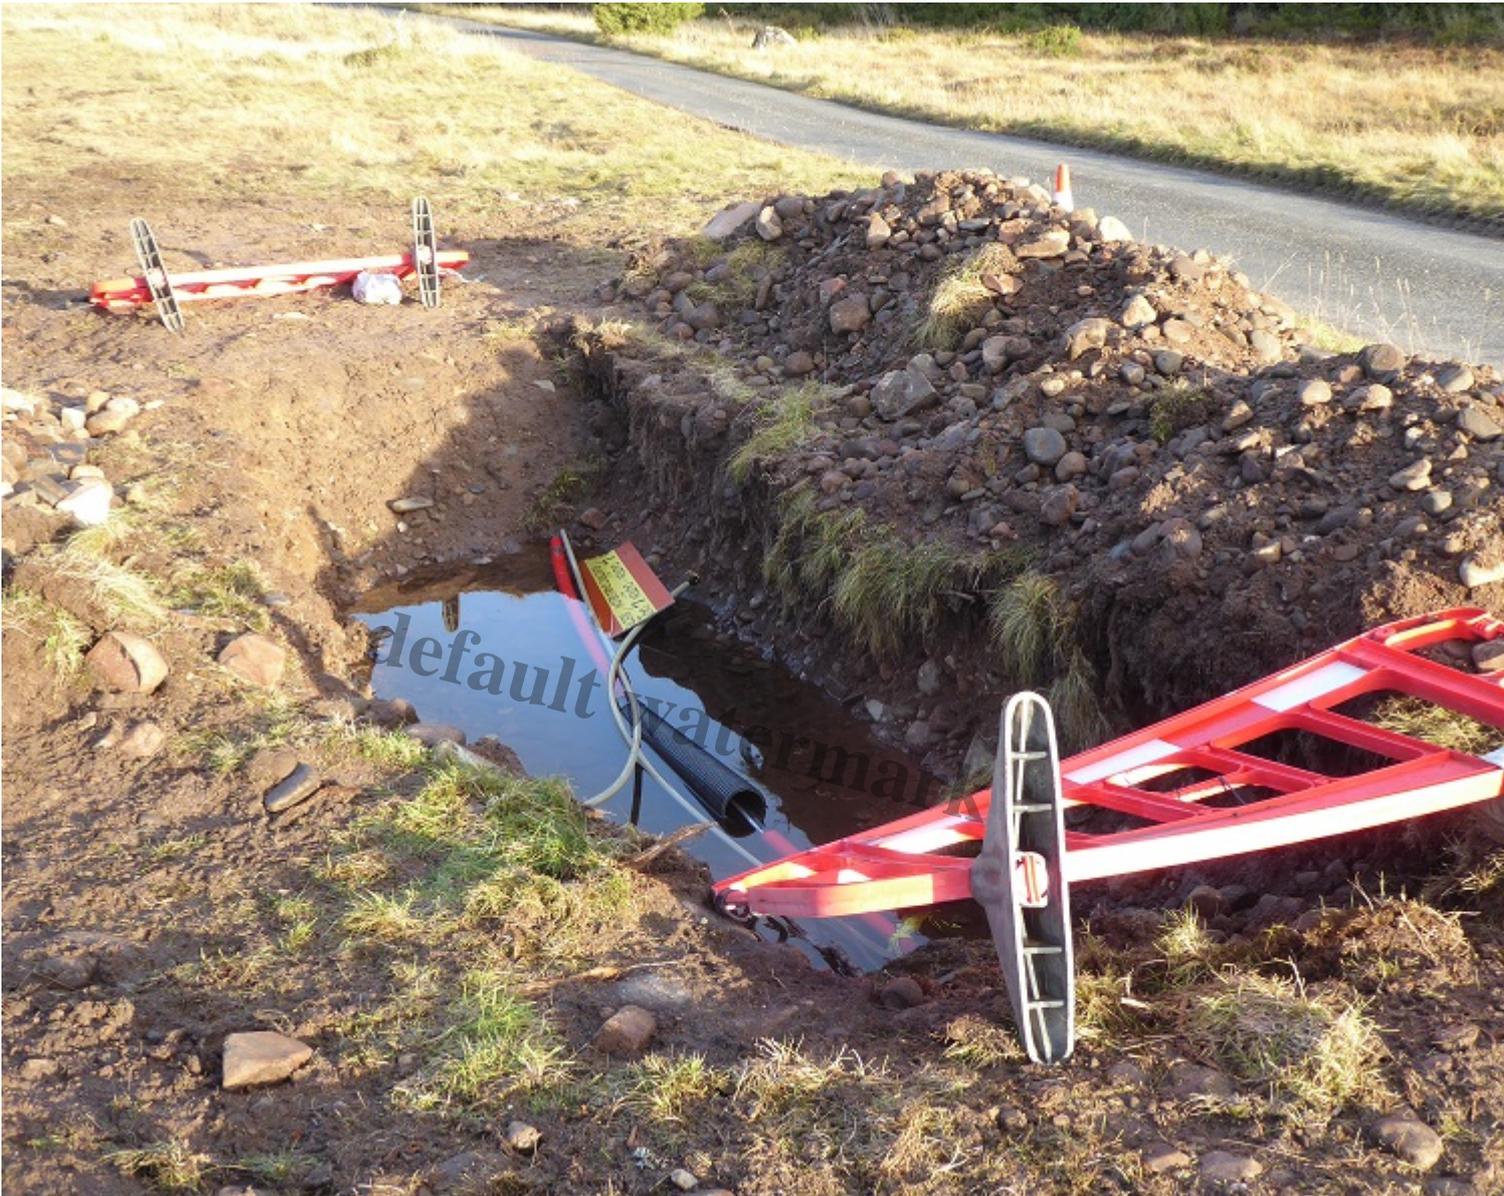
I had seen one example of excavation in Glen Feshie – the hole appeared for connection purposes. It is very difficult – and incidentally far more labour intensive – to restore the ground caused by such digging. Compare this to the impact and work involved in using a mole plough. Thomas MacDonell told us, if my memory is correct, that it had taken just five days to bury the cable in Glen Tromie and, from I saw, very little further work or monitoring will be needed.

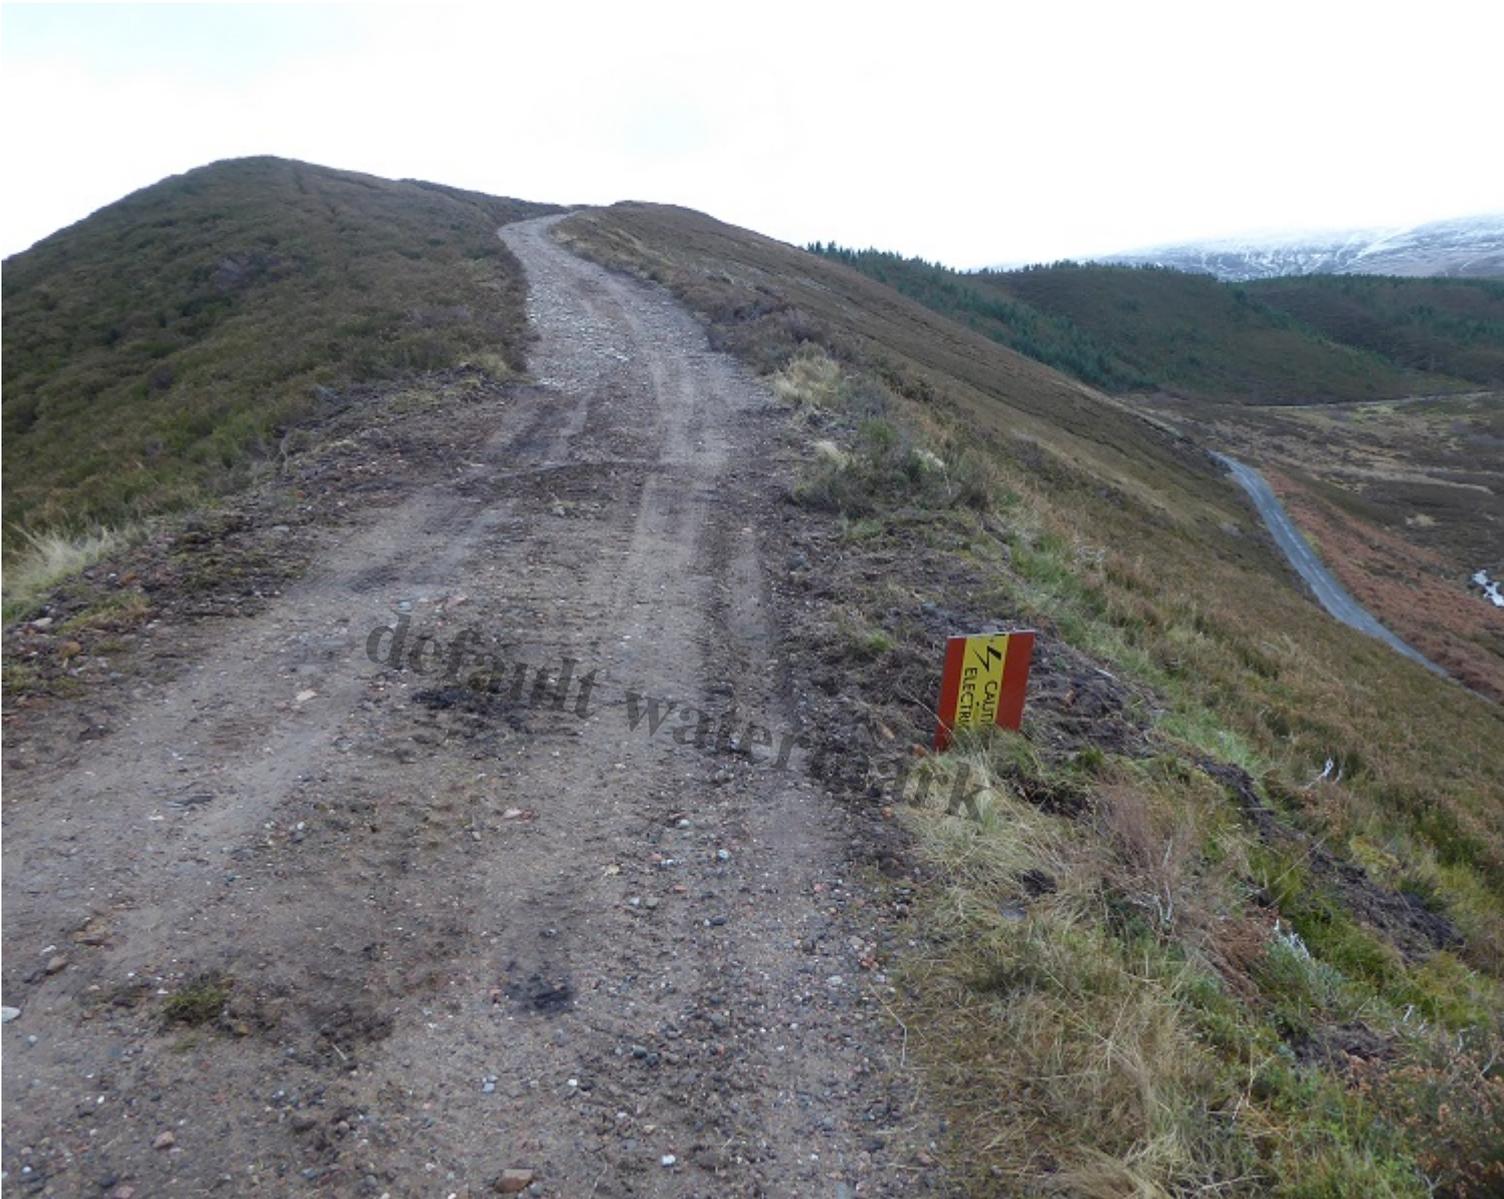
Sign marking where cable crosses the track leading up to the upper Allt Bhran hydro intake â?? the track below the moraine leads to the Gaick
