## The further potential for undergrounding powerlines in our National Parks and the example of Glen Tromie

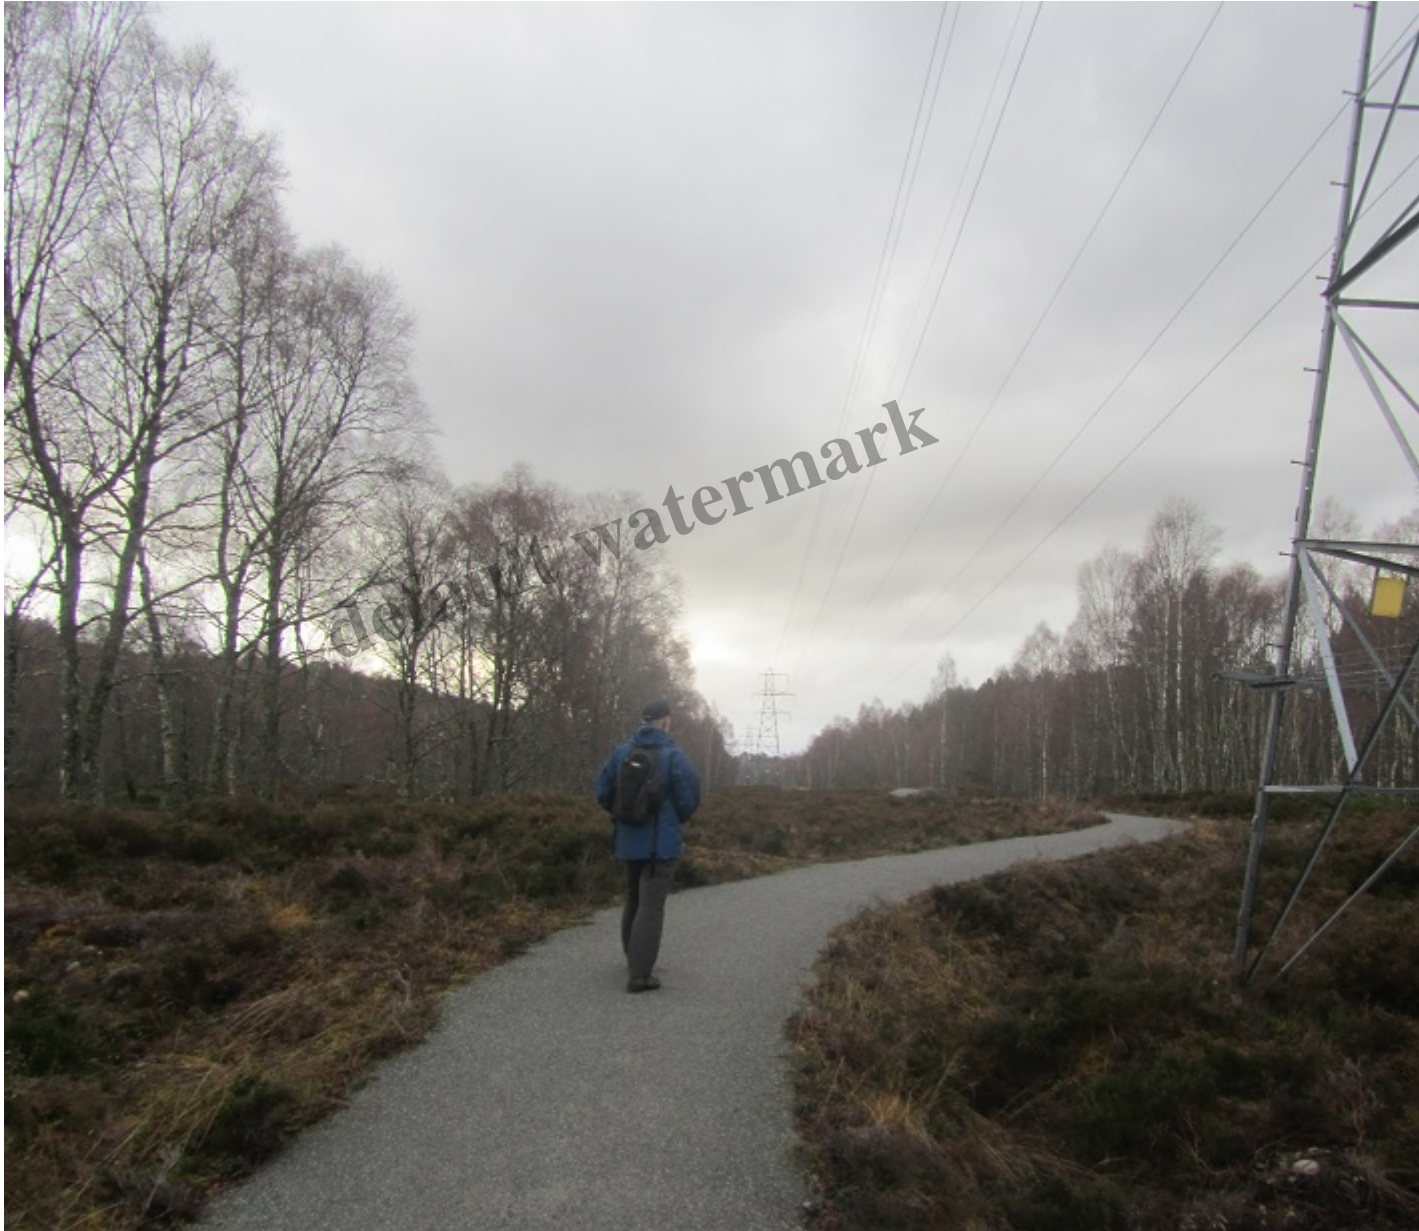
The powerlines which blighted the Speyside Way extension south of Aviemore have now been removed.

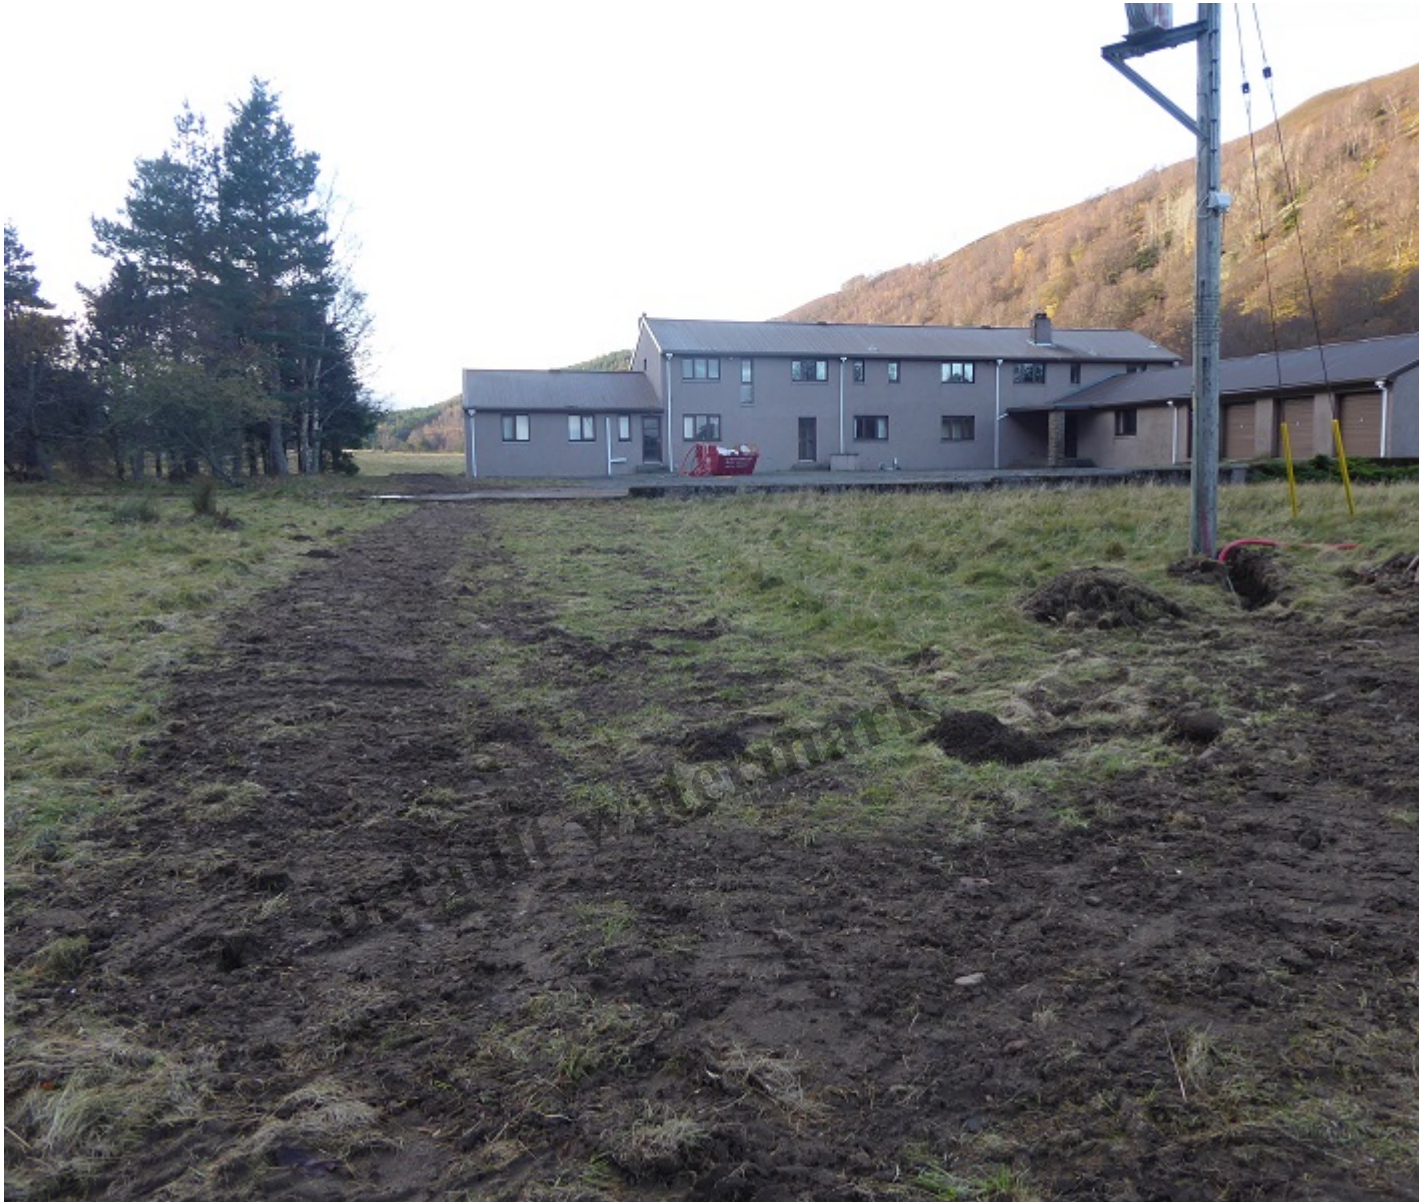
The current work to underground the Glen Tromie powerline starts at the hideous Lynaberack Lodge in Glen Tromie. The ground here, where the undergrounded line joins with the overhead powerline, is more muddy than almost anywhere else along the route.

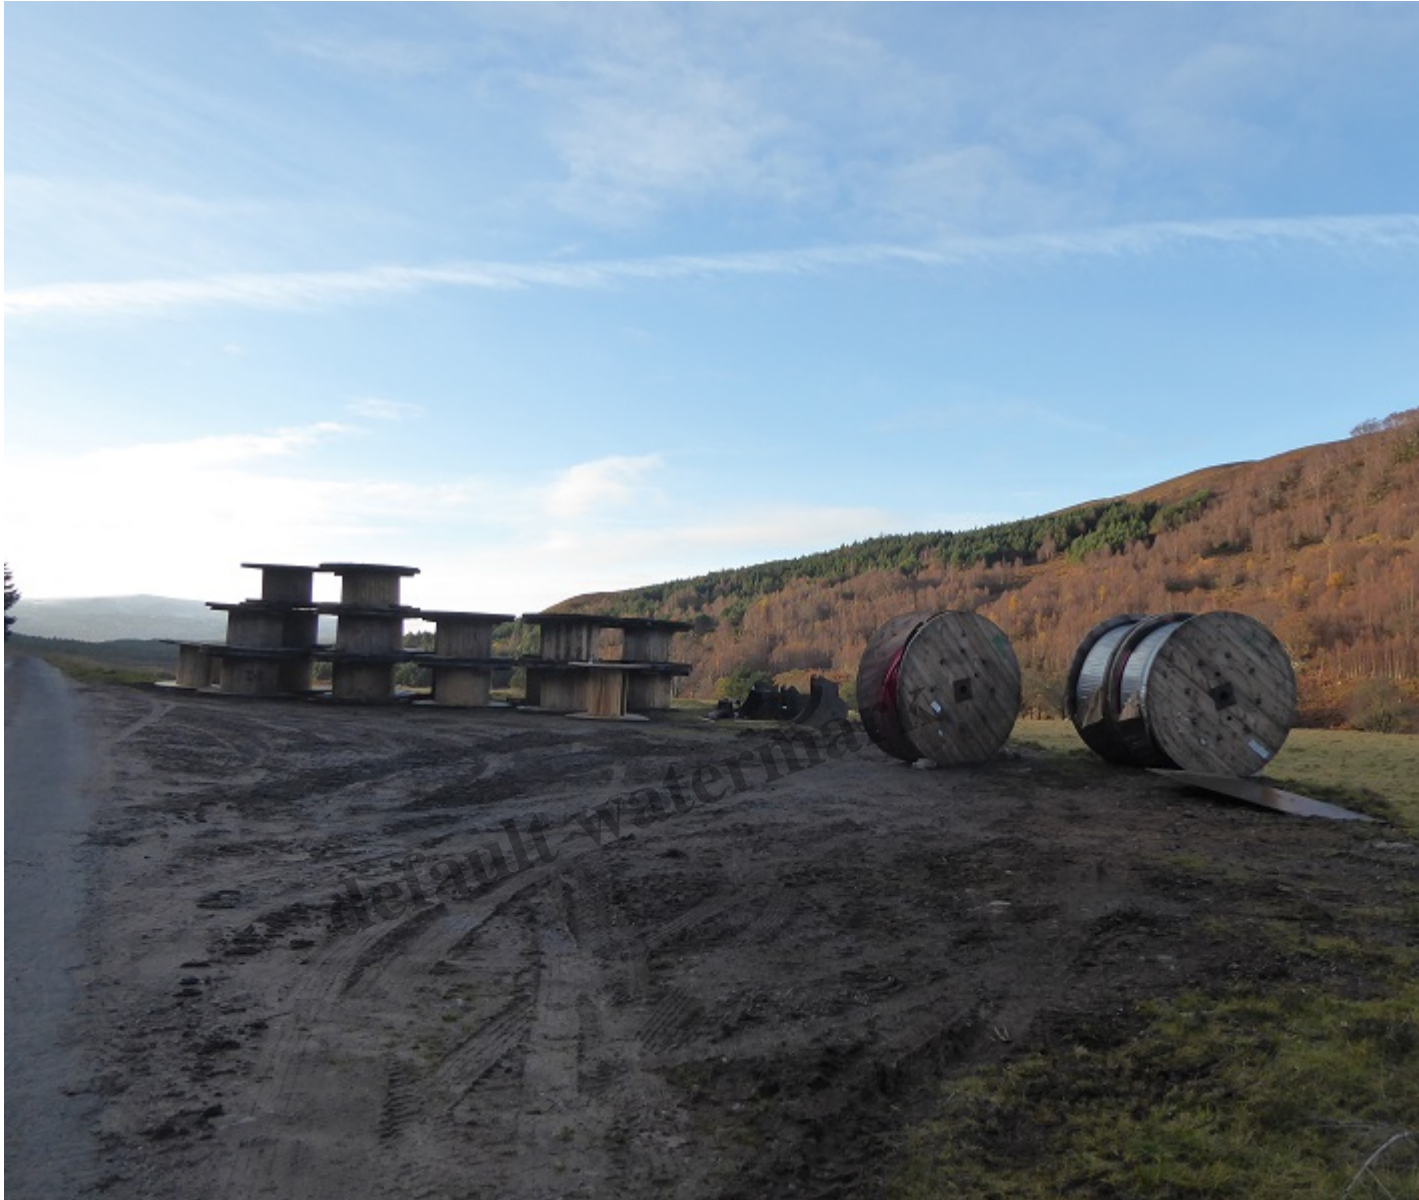
Evidence of the amount of new electric cable which has been undergrounded

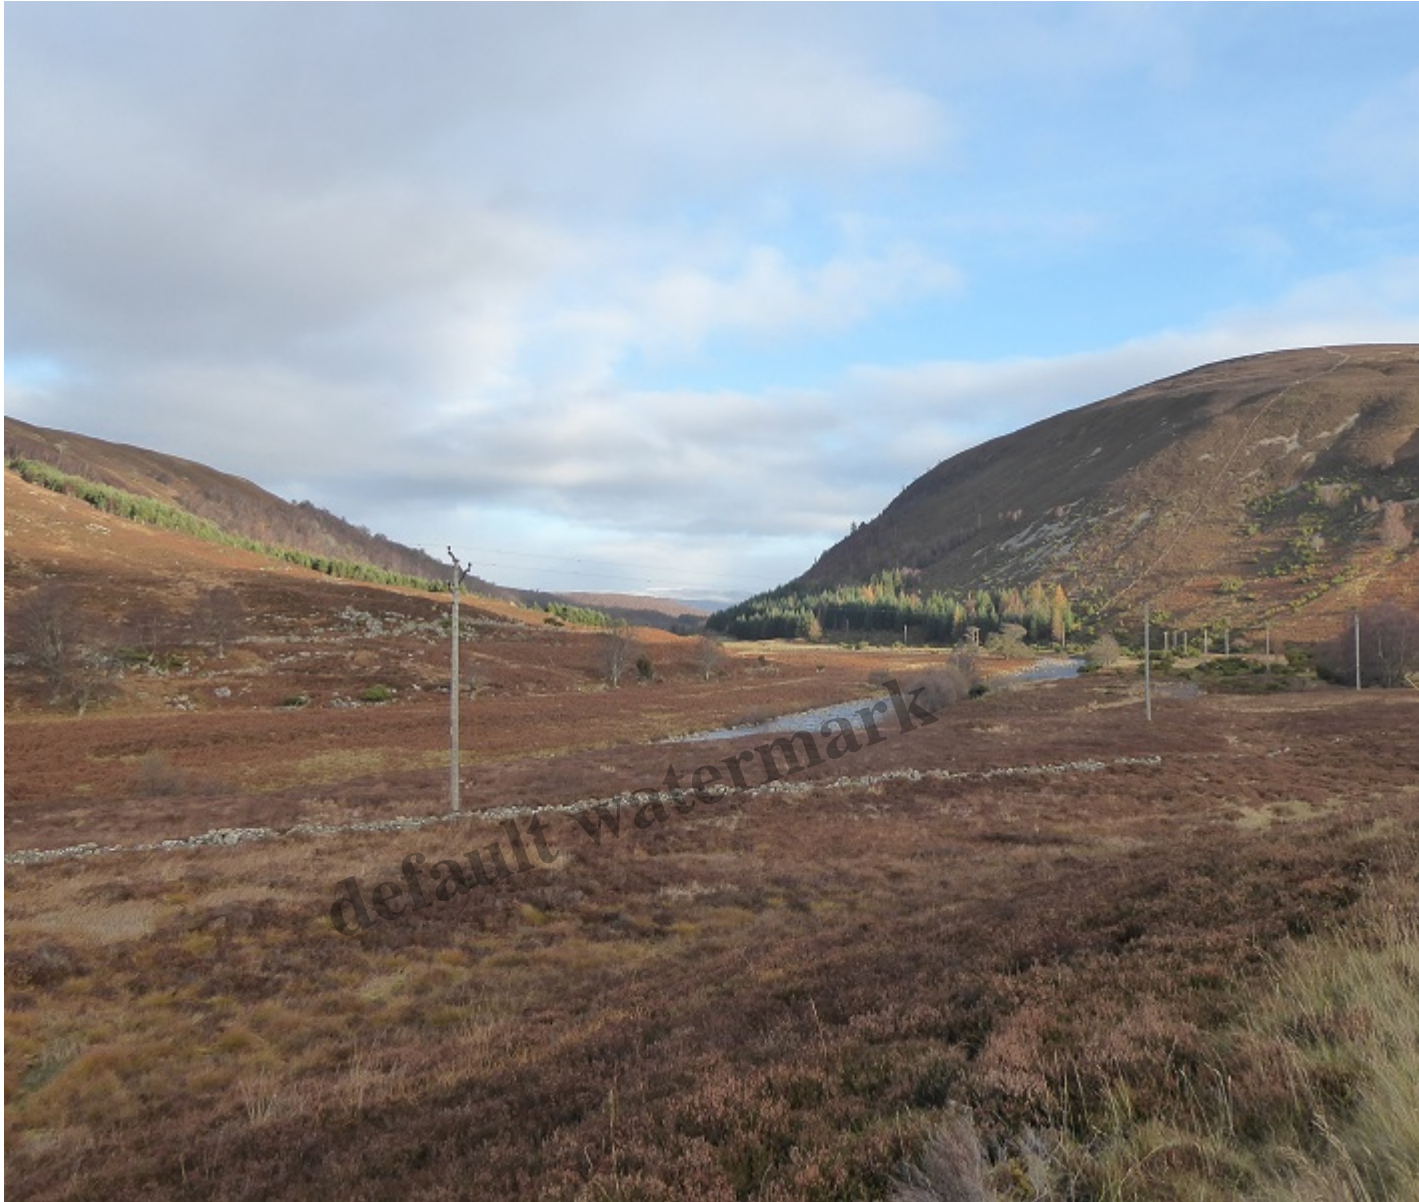
The road is just to the right of the photo

Imagine the difference, when this section of powerline is removed. While there is still a road running up the glen, to the person walking or cycling along it the view will feel significantly wilder.

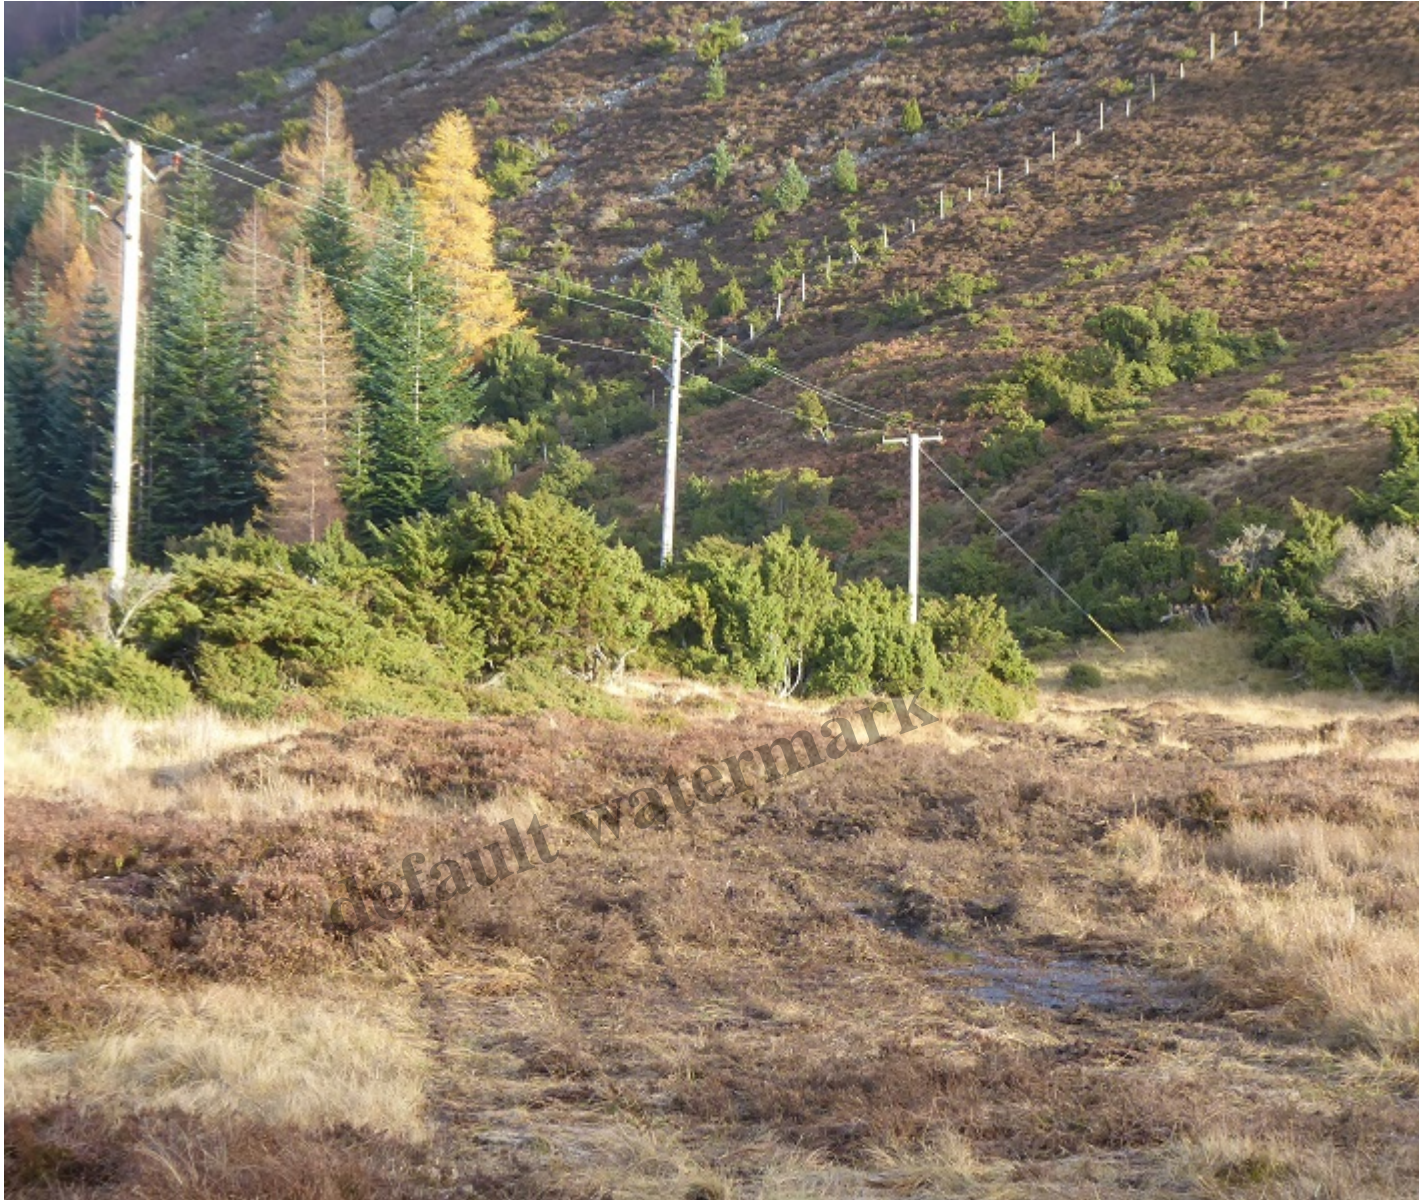
The new powerline, which lies beneath the vehicle track starting bottom centre, will replace the pylor

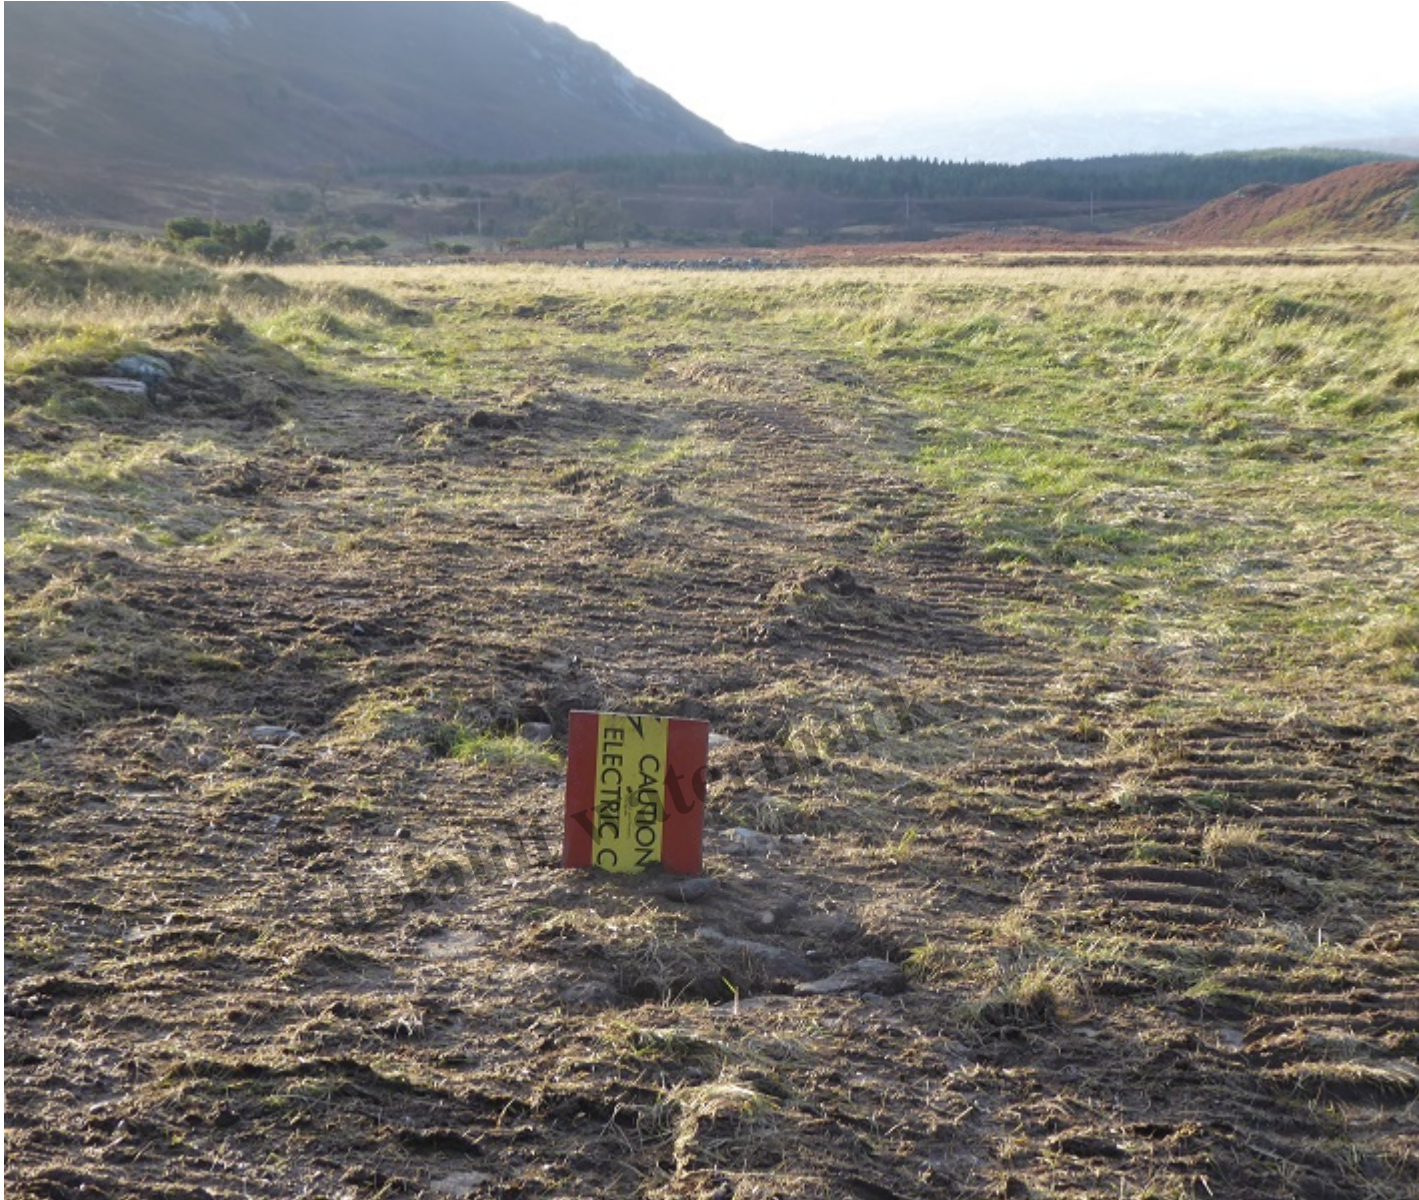
Few people would know, just a couple of week after the work had been carried out, that the reason for the ground disturbance is an electric cable had been buried unless it was for the sign

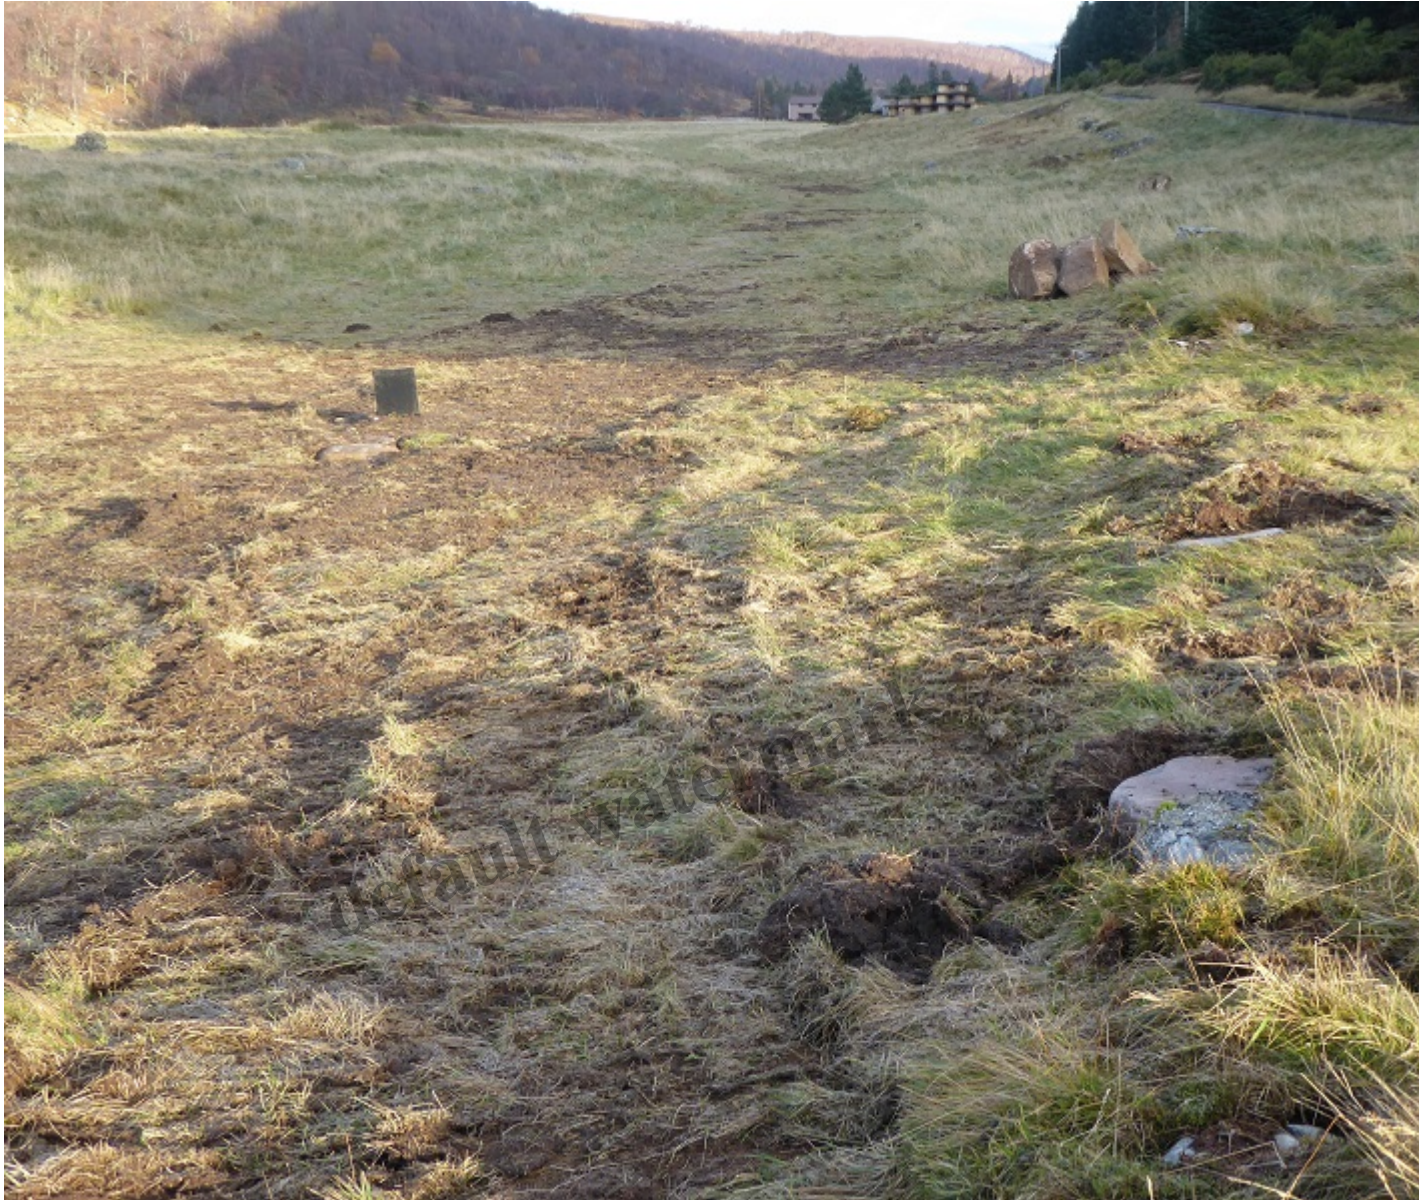
You can however see some evidence that a mole plough has been used. In places boulders have been excavated to allow the passage of the plough and cable.

Apart from the removal of boulders, the vegetation has been little disturbed and on the grassy floor of the glen should recover from the passage of vehicles very quickly. I suspect by next summer, when the grass has had time to grow again, it will be very hard to detect the line of the buried cable.

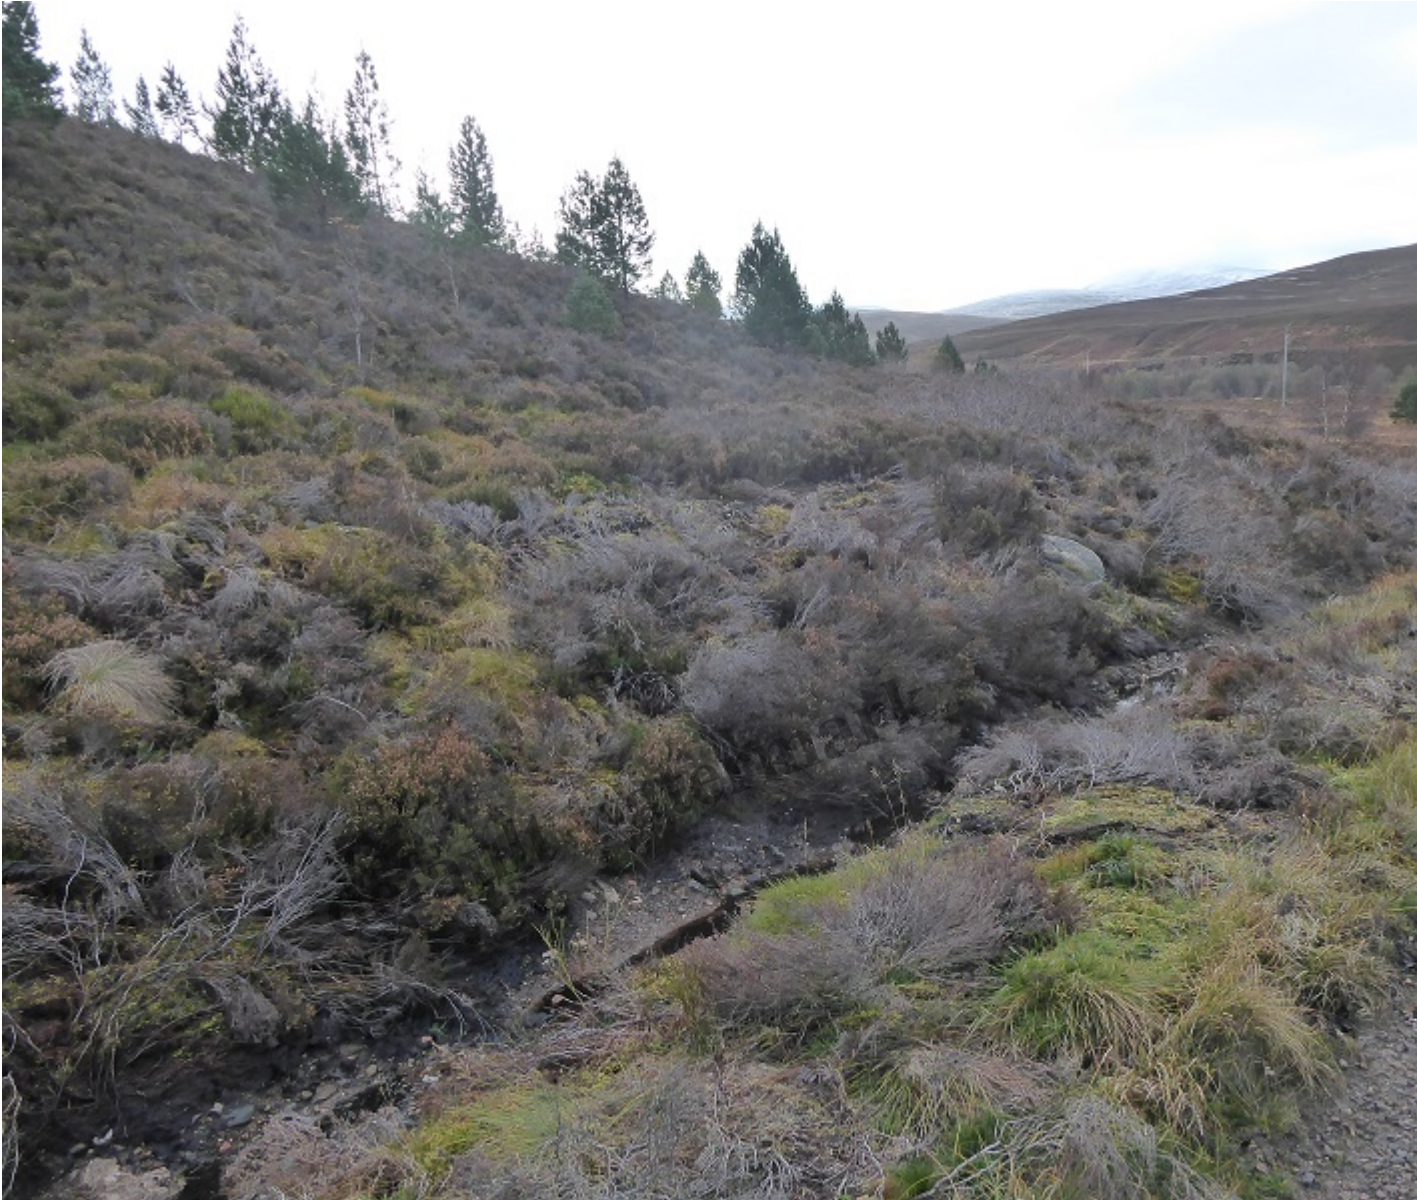
The buried cable is under the disturbed heather on the left side of the road

I was most impressed that the mole plough could also be used on heather moorland and cause so little destruction to vegetation. Again, I think the vegetation here should more or less fully recover in a season.

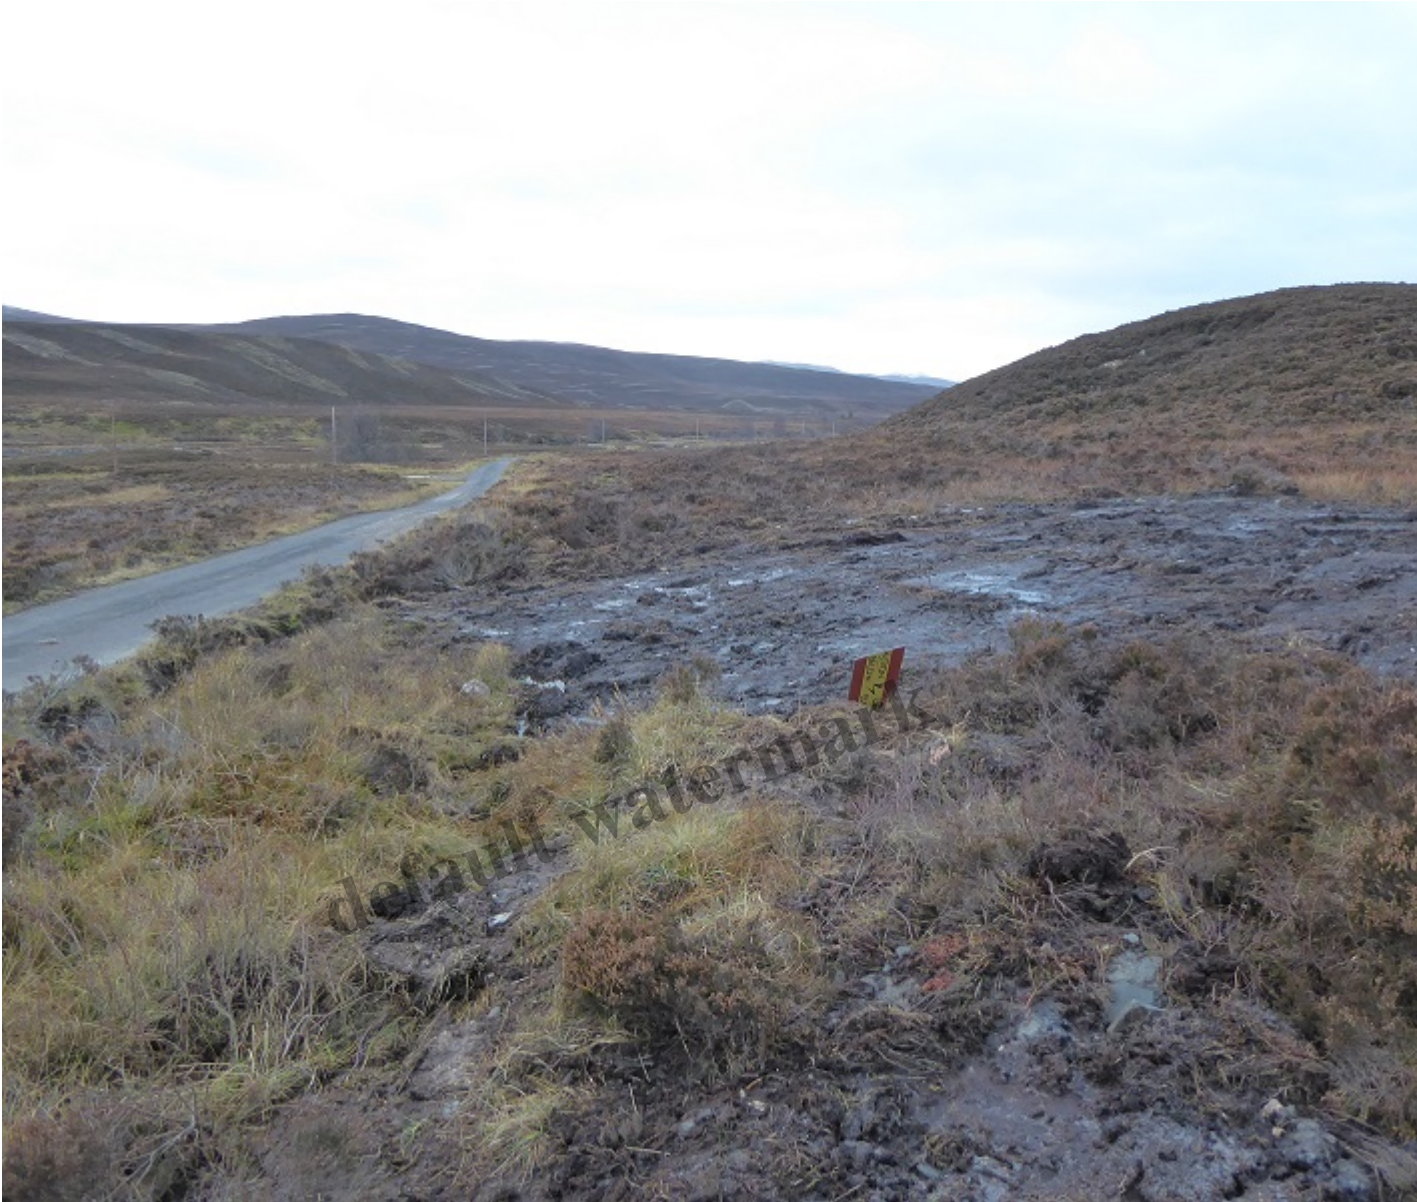
The worst area of ground disturbance/destruction of vegetation on moorland

I then came across the patch of very disturbed ground in the photo above. I was unable to ascertain the cause of this – it may have been a consequence of the land being very boggy – but in the context of several kilometres of buried cable it just served to illustrate in general how well the work had been done and the potential of using mole ploughs.

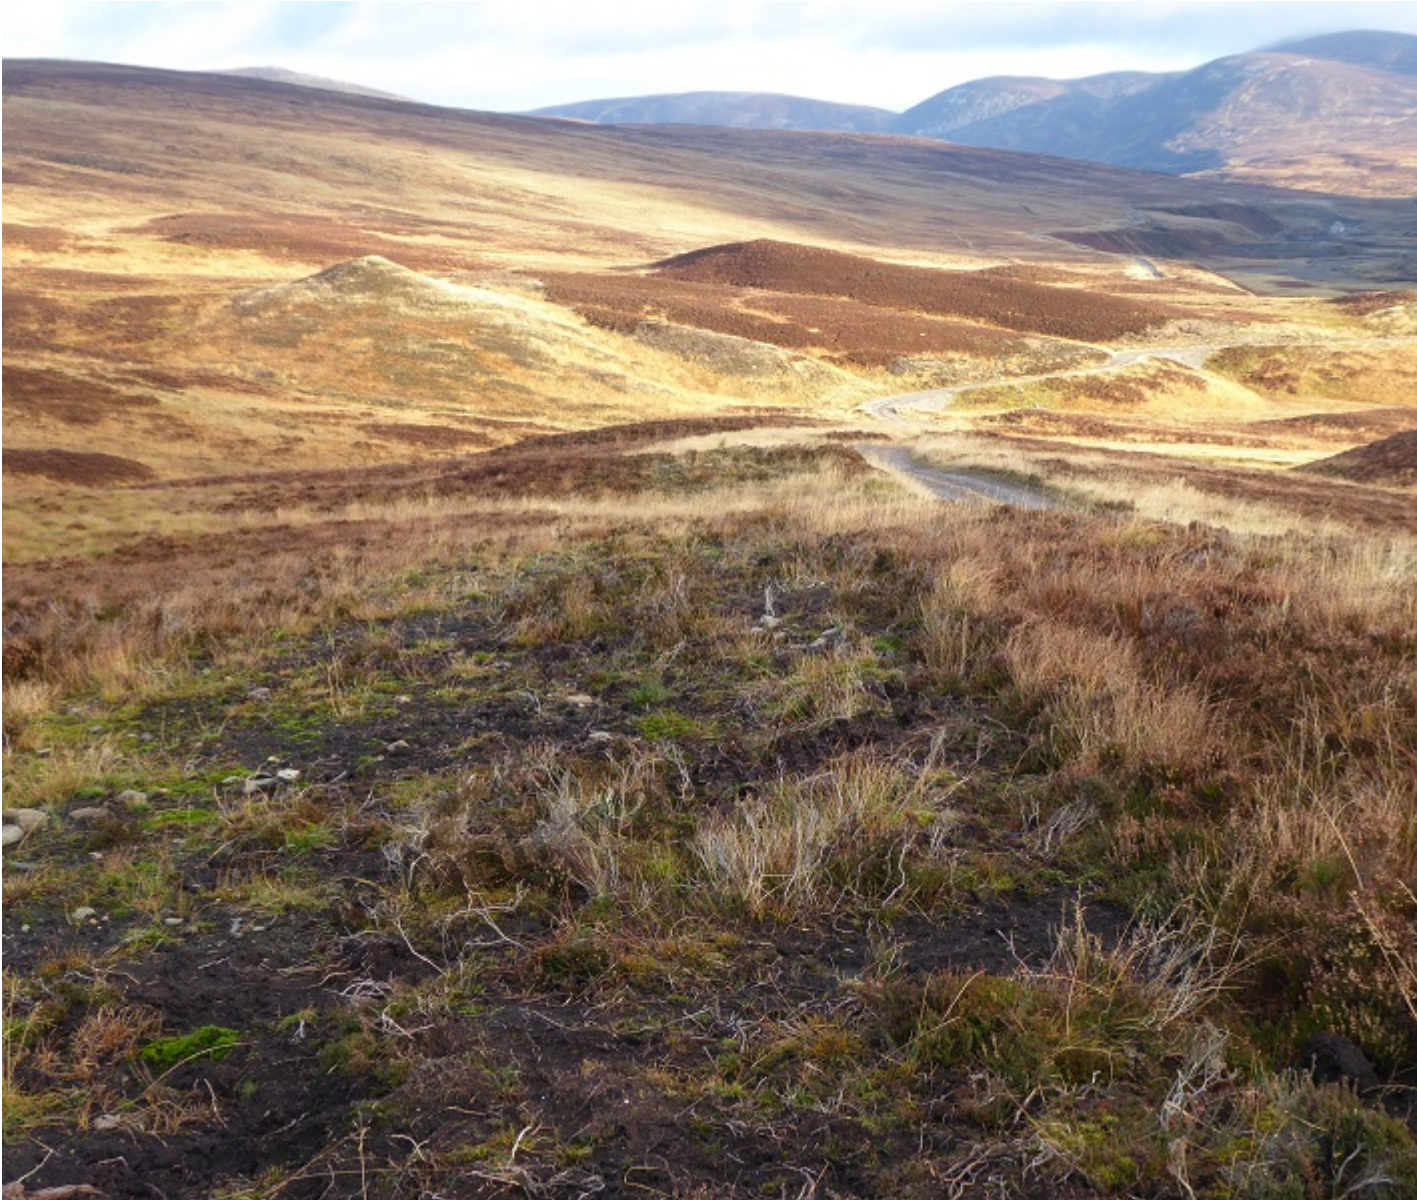
The line of the Glen Bruar power cable runs along the line of disturbed vegetation on the left of the road to the powerhouse which you can just see top right

The advantages of using the mole plough can be seen by comparing the powerline burial in Glen Tromie with that to the new Glen Bruar scheme. While parkswatch has given extensive coverage to the Glen Bruar pipeline restoration above the powerhouse, below it several miles of new electric cable was required to connect it to the grid. The work for this was generally to a high standard – and hence I have avoided comment – but the methodology used was to excavate a ditch, bury the cable and then refill it. Despite the care taken, over two years on the line of the cable is more visible than that in Glen Tromie two weeks after the work finished. The lesson, I believe, is that burying cable with a mole plough, if done well, does significantly less damage than any methods that involves removing vegetation, excavating a ditch and then trying to restore this work.

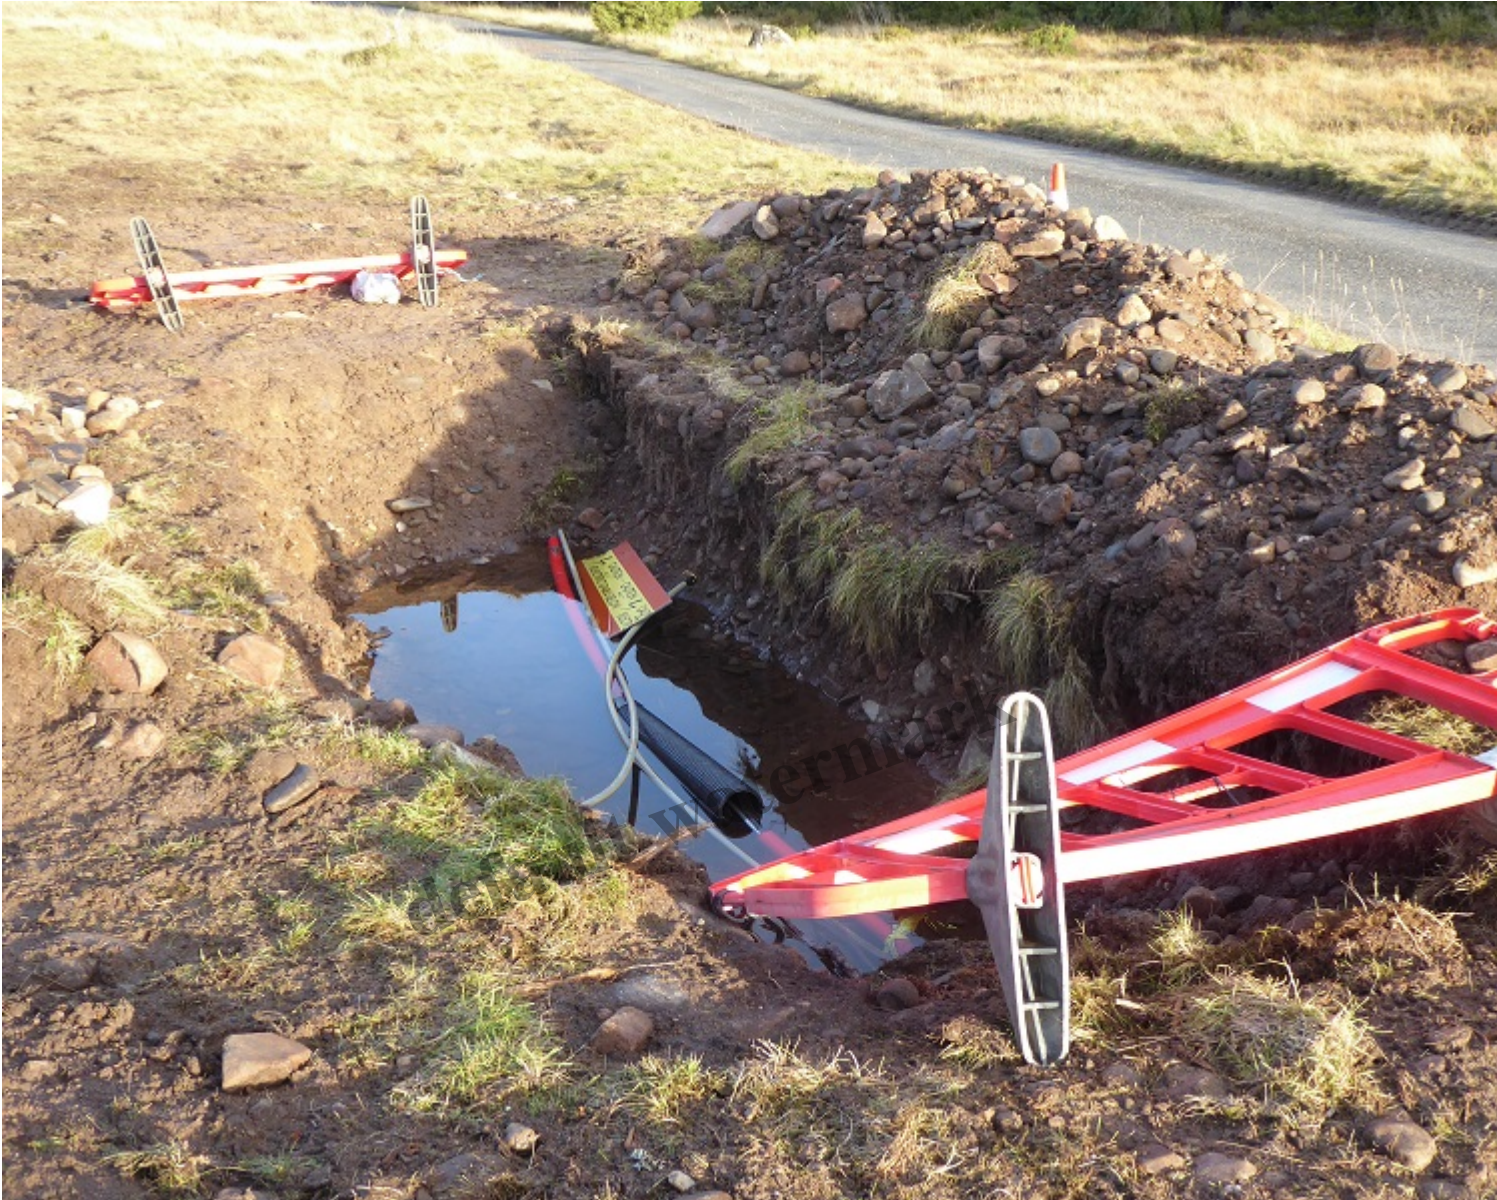
I had seen one example of excavation in Glen Feshie – the hole appeared for connection purposes. It is very difficult – and incidentally far more labour intensive – to restore the ground caused by such digging. Compare this to the impact and work involved in using a mole plough. Thomas MacDonell told us, if my memory is correct, that it had taken just five days to bury the cable in Glen Tromie and, from I saw, very little further work or monitoring will be needed.

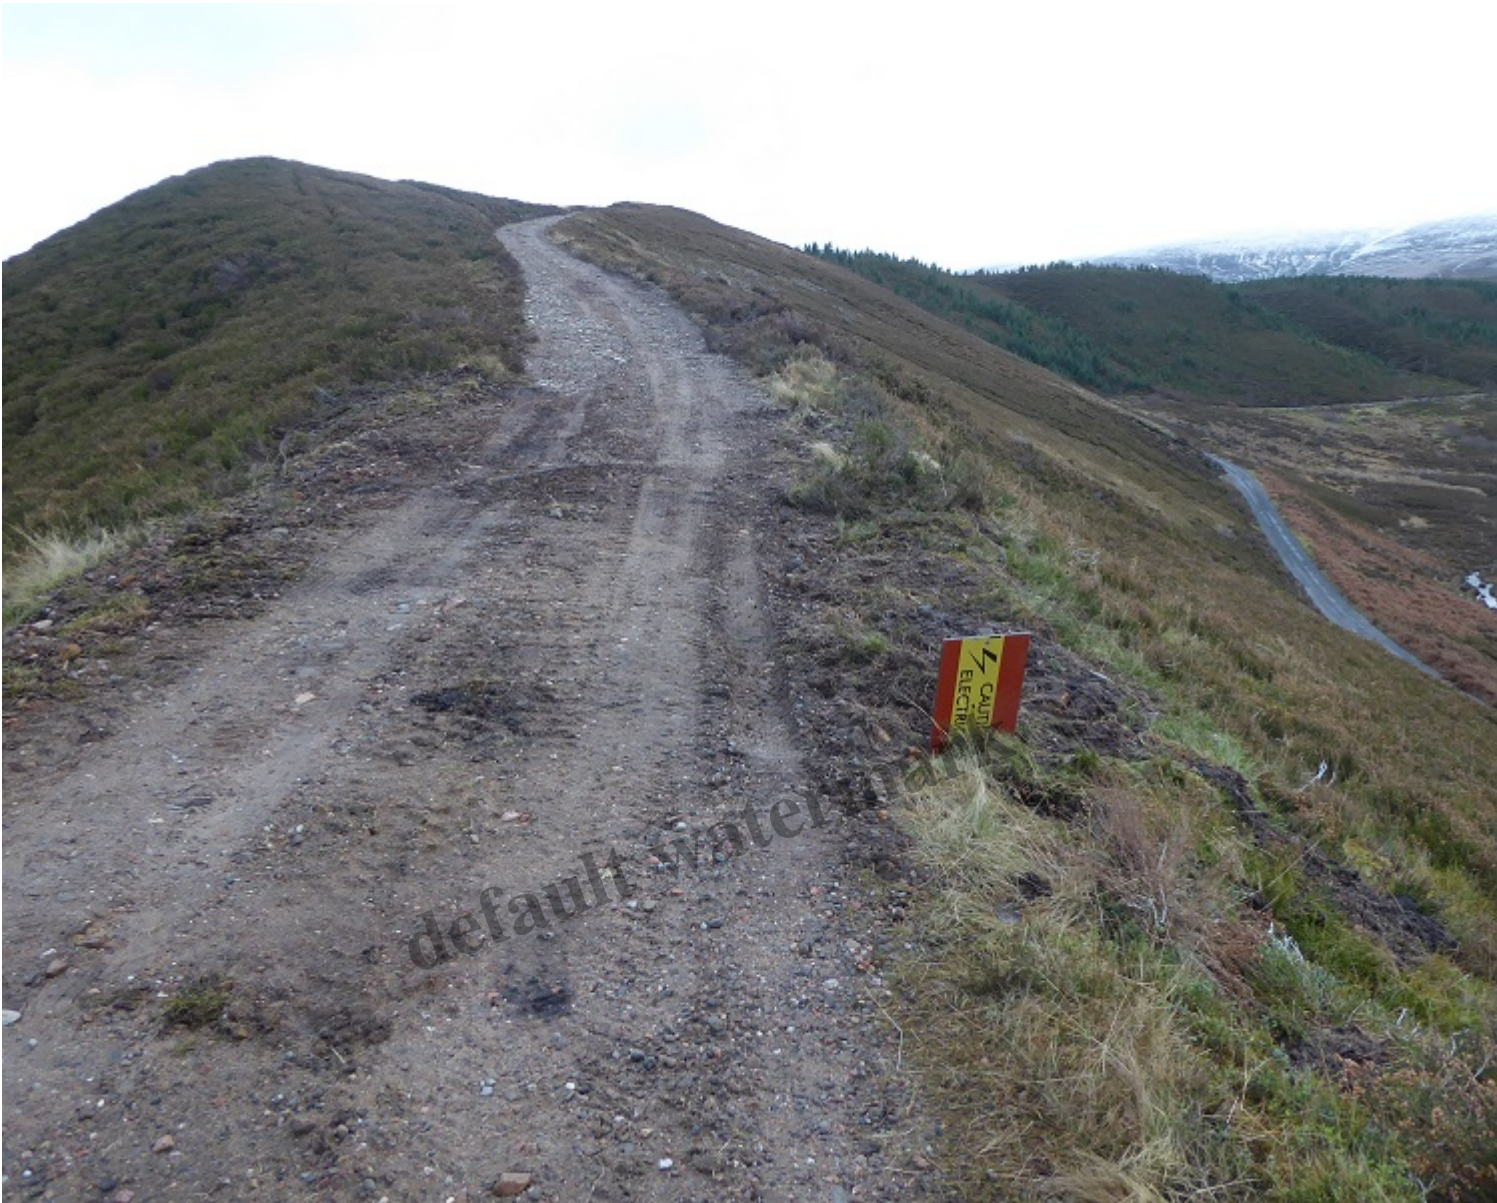
Sign marking where cable crosses the track leading up to the upper Allt Bhran hydro intake – the track below the moraine leads to the Gaick
