The restoration of the Braemar Community hydro scheme at Corriemulzie

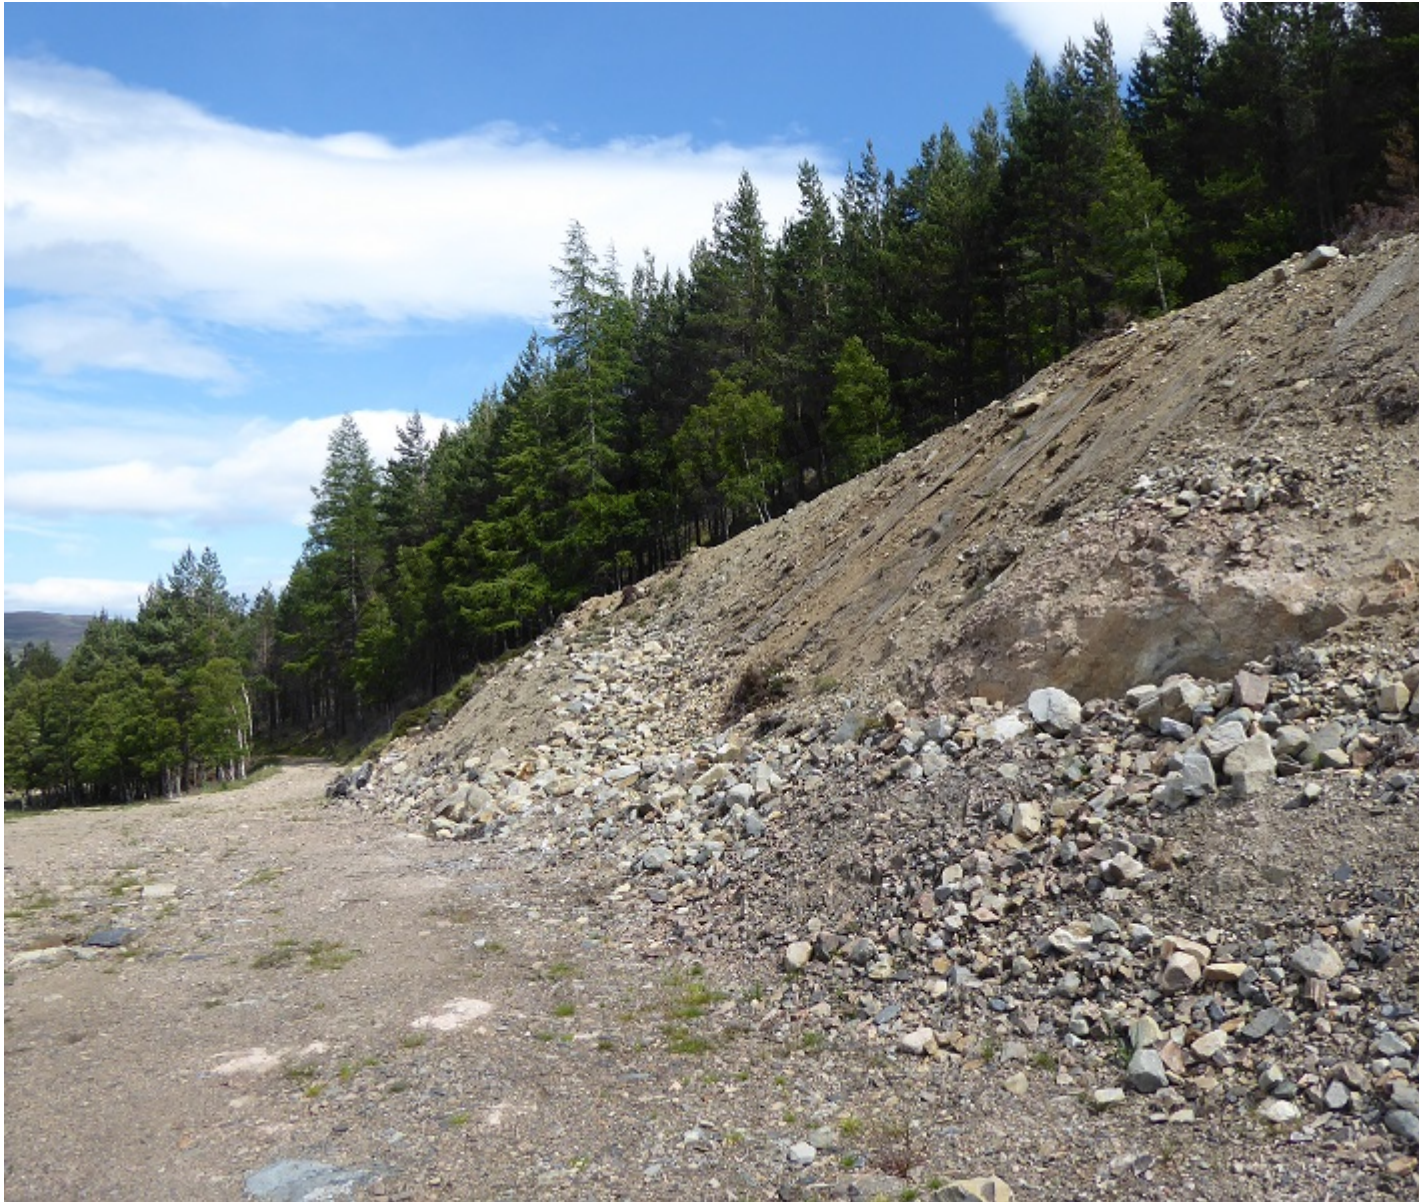
After construction

The slope by the main Corriemulzie intake in July 2017 – note how the geotextile, centre, has failed the slope and the wide area for vehicle use below

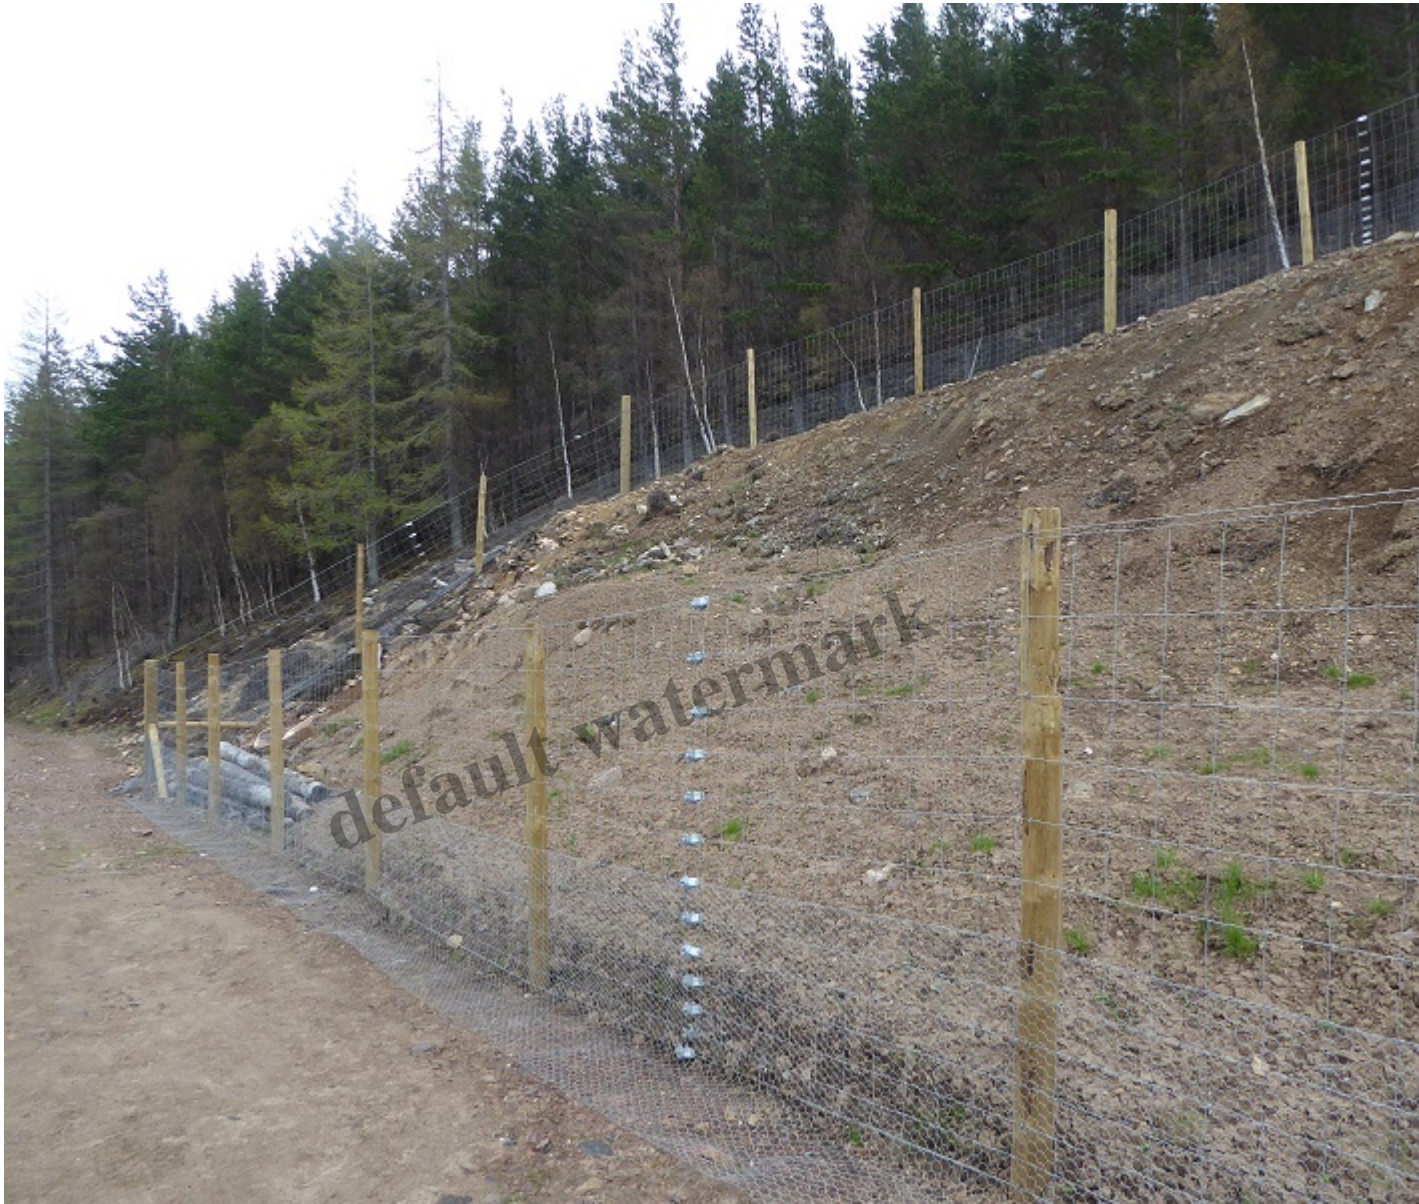
Now

While there are some signs of erosion, the slope has held up well over the winter and is now beginning to vegetate.

The terrible scar in the top photo has been restored by reducing the angle of the slope – a lesson here for all those bare embankments alongside bulldozed tracks – and by fencing the area in order to keep out deer. My post last July had highlighted how deer footfall was contributing to the problem although this is still an issue at the end of the slope nearest the hydro intake:

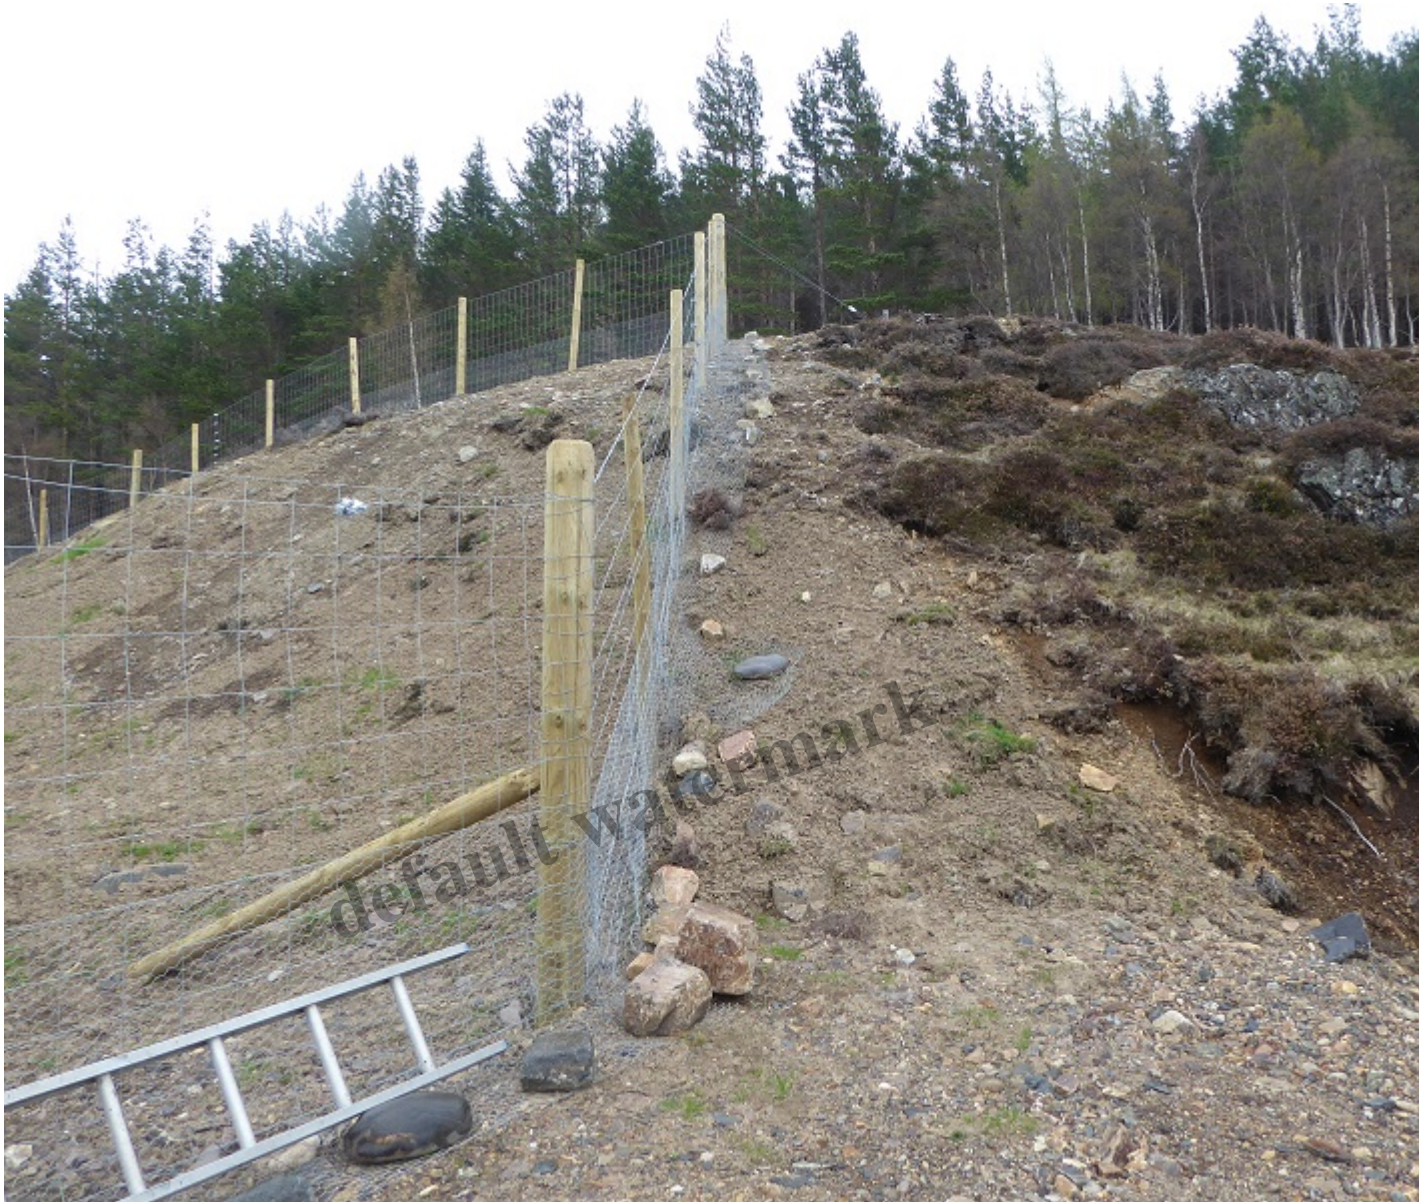
Deer are continuing to walk down the outside of the fence – I could clearly see their hoof prints – and the area is likely to gully.

Had the fence been extended a little further it might have prevented this. This slope though will always be vulnerable to erosion – and I hope the fence can eventually be removed – if deer numbers remain as high as they appear to be at present:

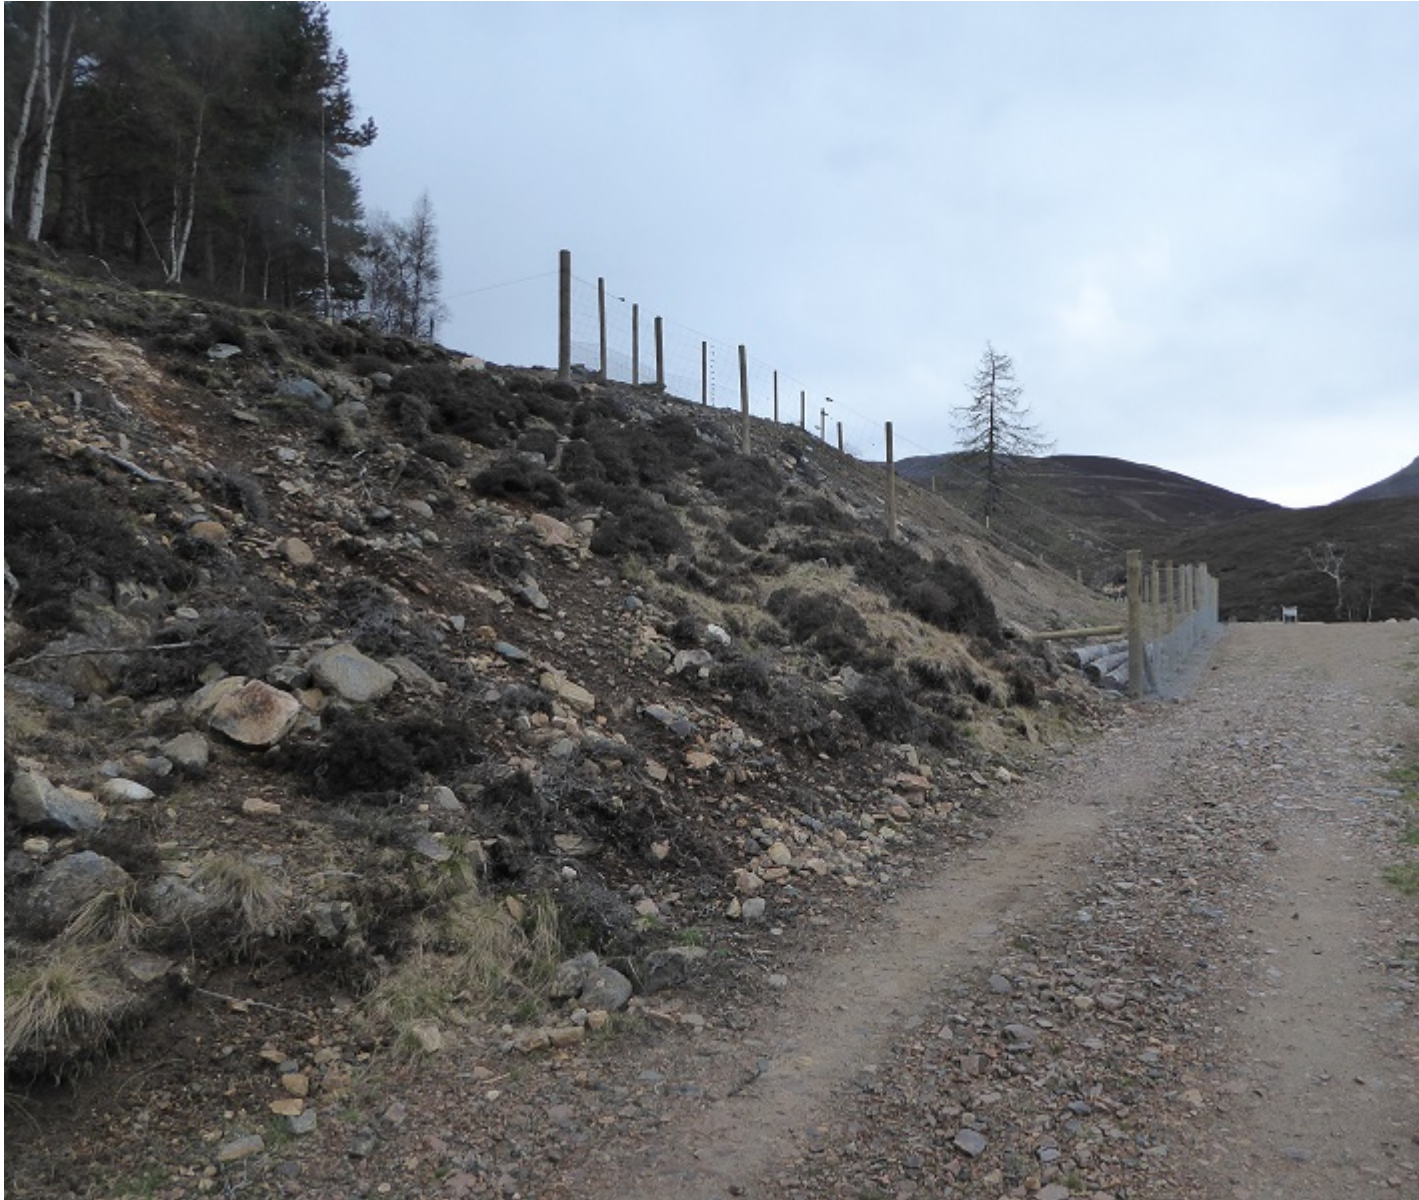
While the slope before the hydro works had previously been eroded – see photo from earlier post – there are some signs here too that erosion may be increasing as deer are diverted around the fence

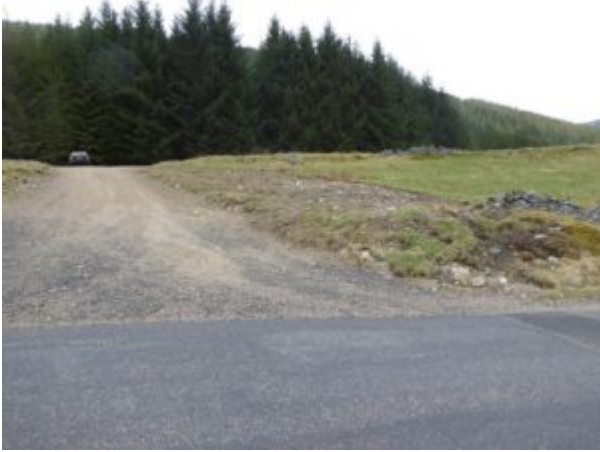
Now – the access track has been narrowed

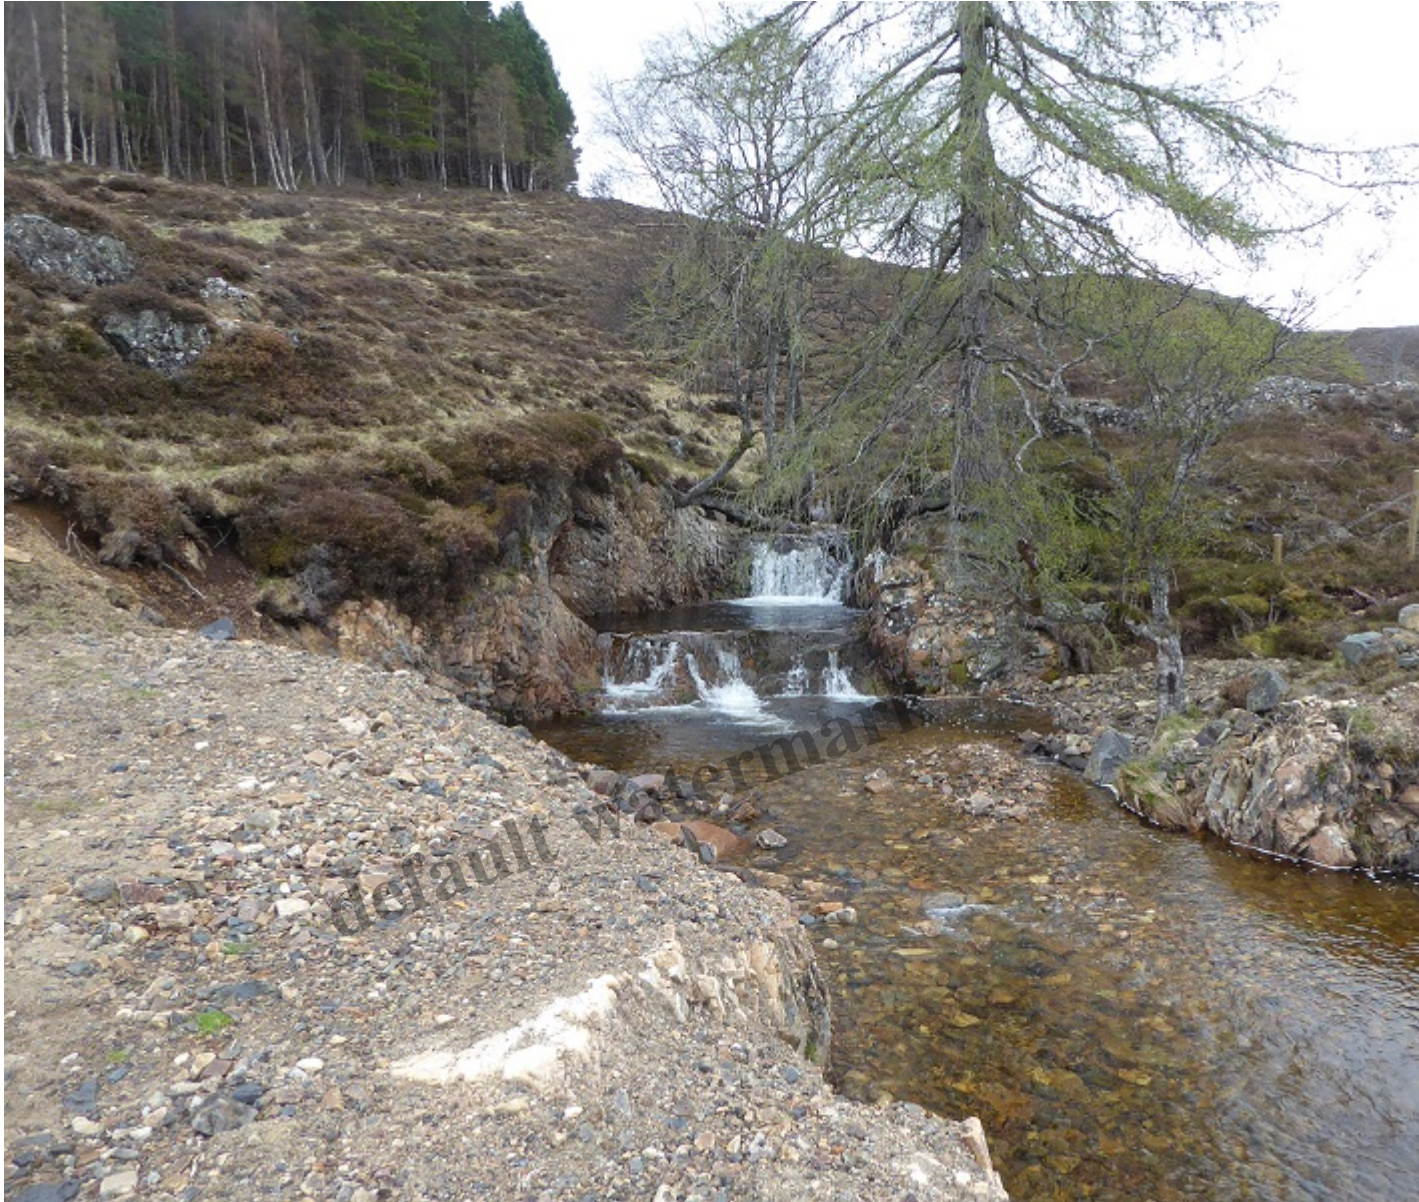
My main remaining landscape concern is that there has still been no effective restoration of the channel which was cut through the rock to divert the burn and enable the hydro to be constructed:

The fenced enclosure is just to the left of the ground in this photo

The LLTNPA's landscape adviser had, in a report on the original proposal, highlighted the potential landscape impact here and unfortunately so far a solution has not apparently been found.
