The restoration of the Braemar Community hydro scheme at Corriemulzie

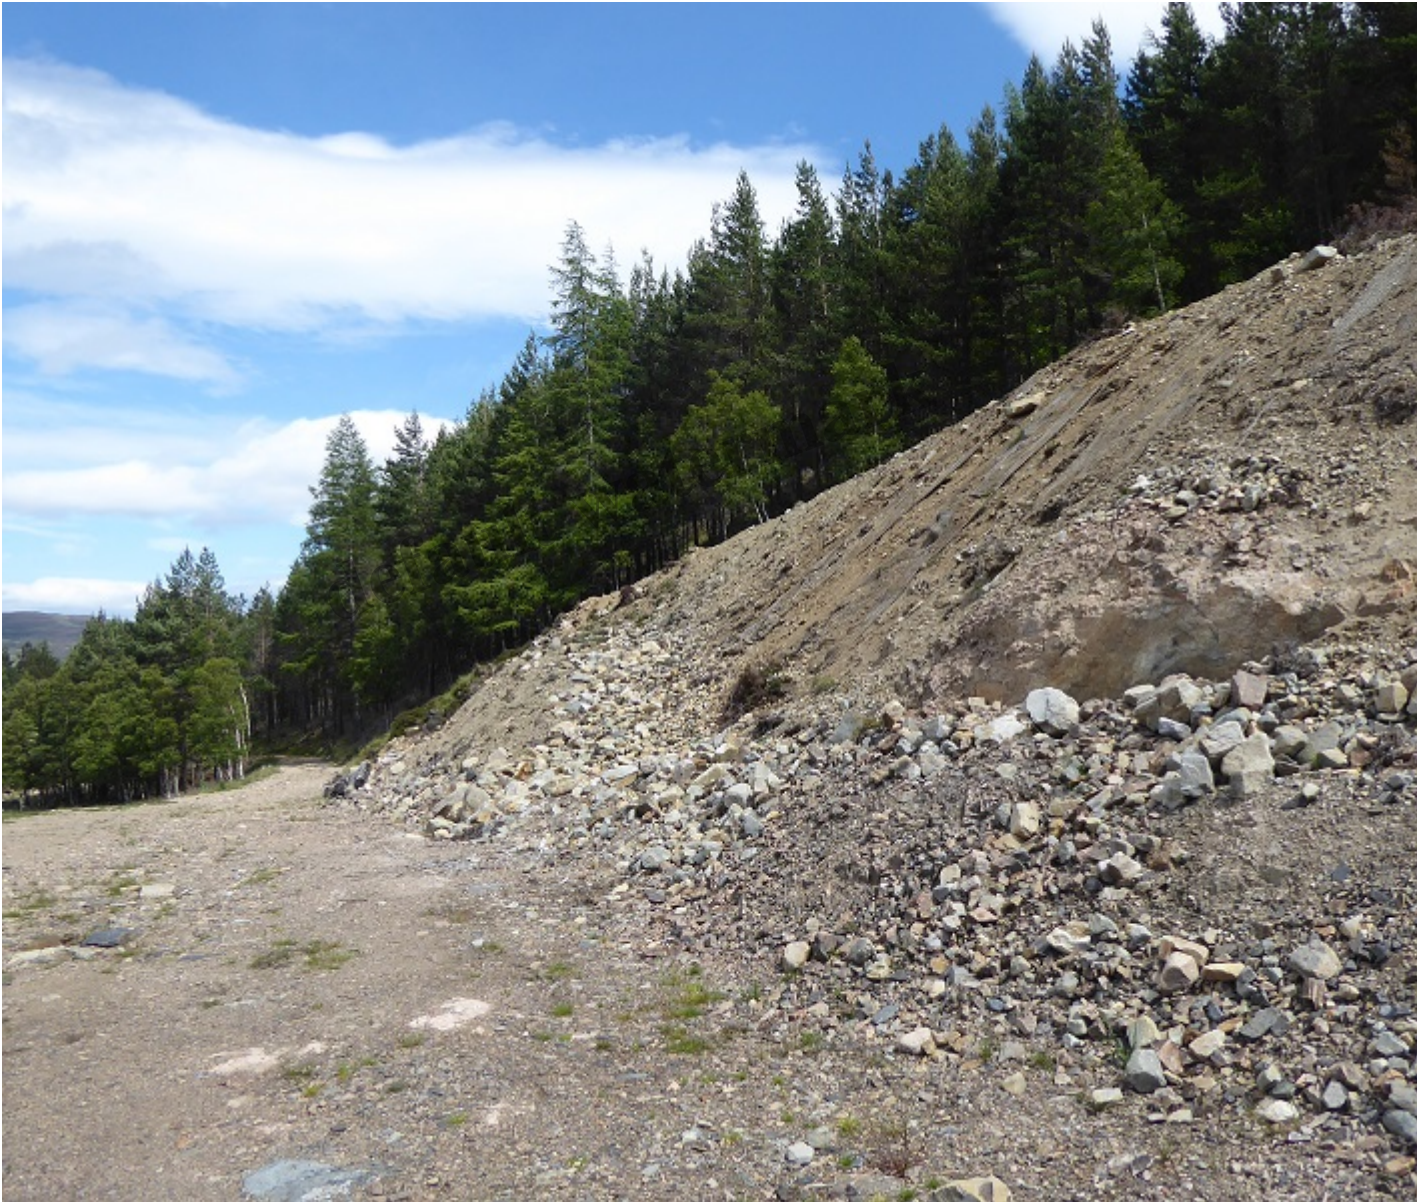
After construction

The slope by the main Corriemulzie intake in July 2017 – note how the geotextile, centre, has failed the slope and the wide area for vehicle use below

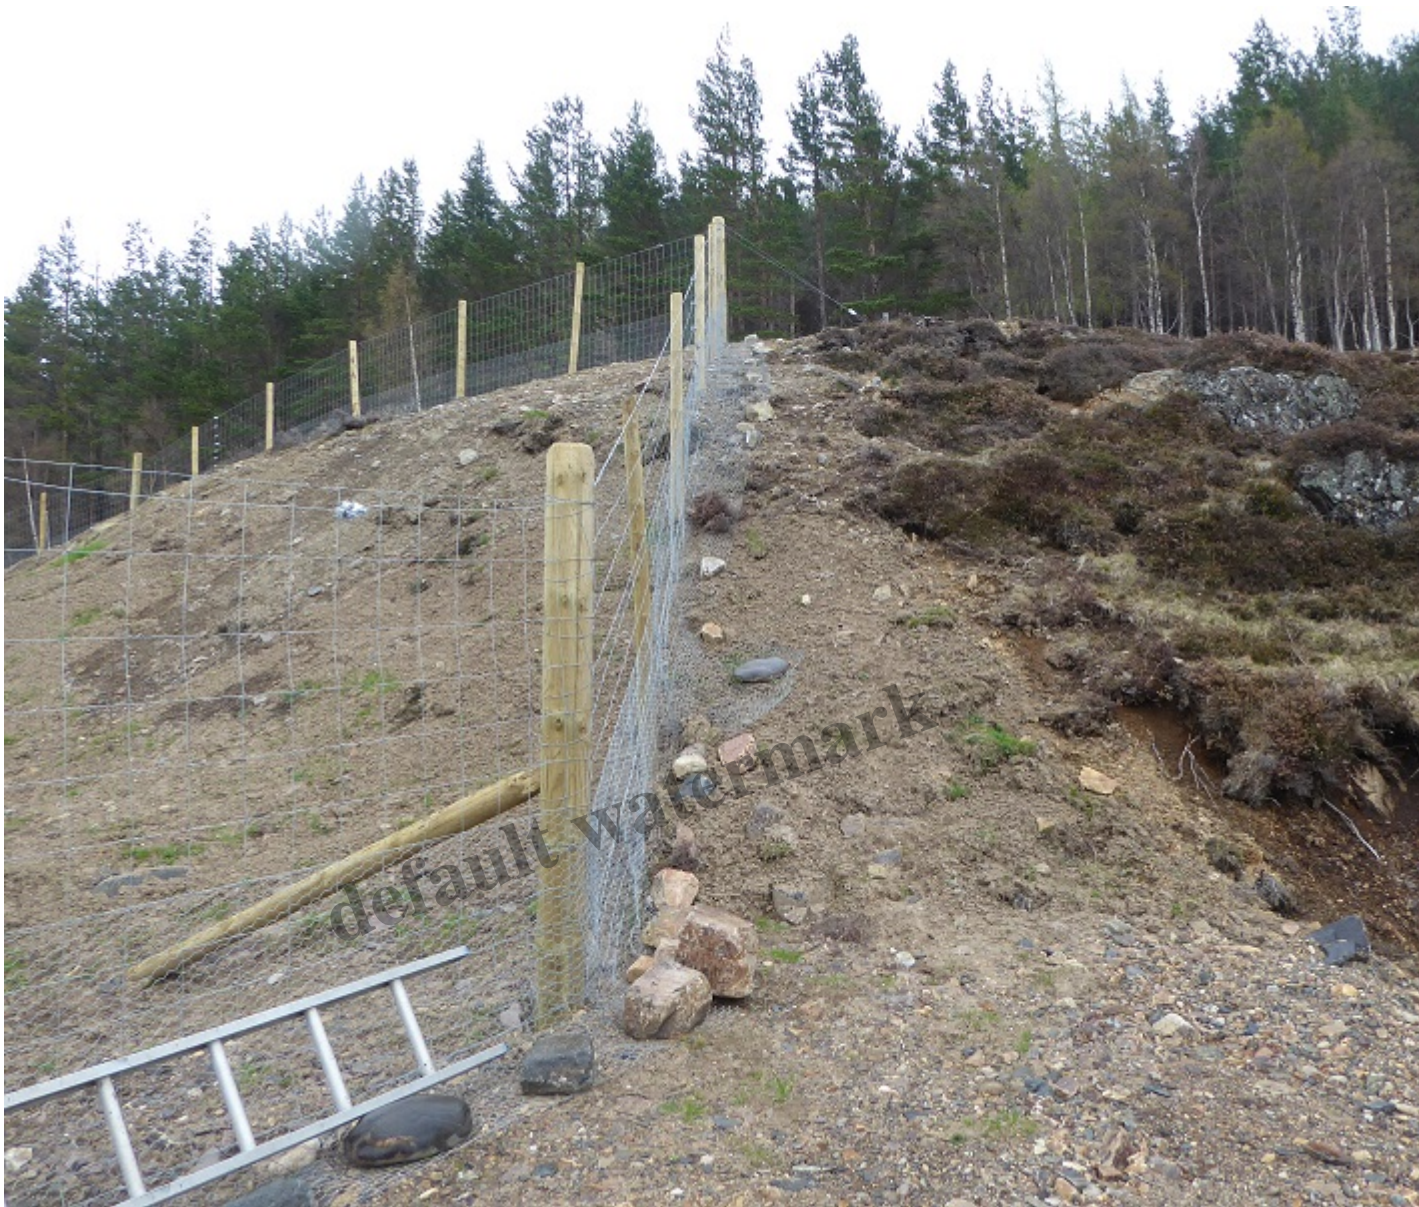
Deer are continuing to walk down the outside of the fence – I could clearly see their hoof prints – and the area is likely to gully.

Had the fence been extended a little further it might have prevented this. This slope though will always be vulnerable to erosion – and I hope the fence can eventually be removed – if deer numbers remain as high as they appear to be at present:

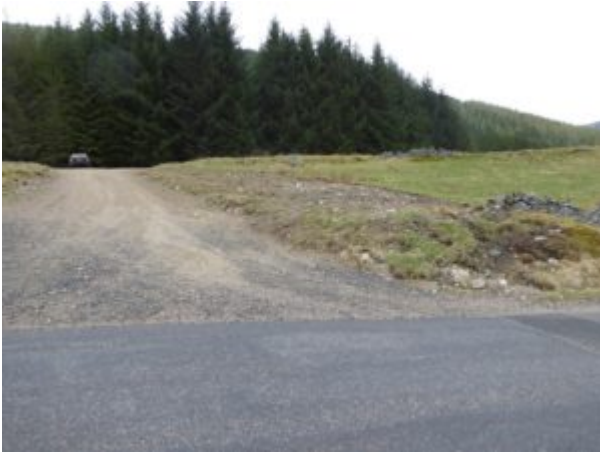
Now – the access track has been narrowed

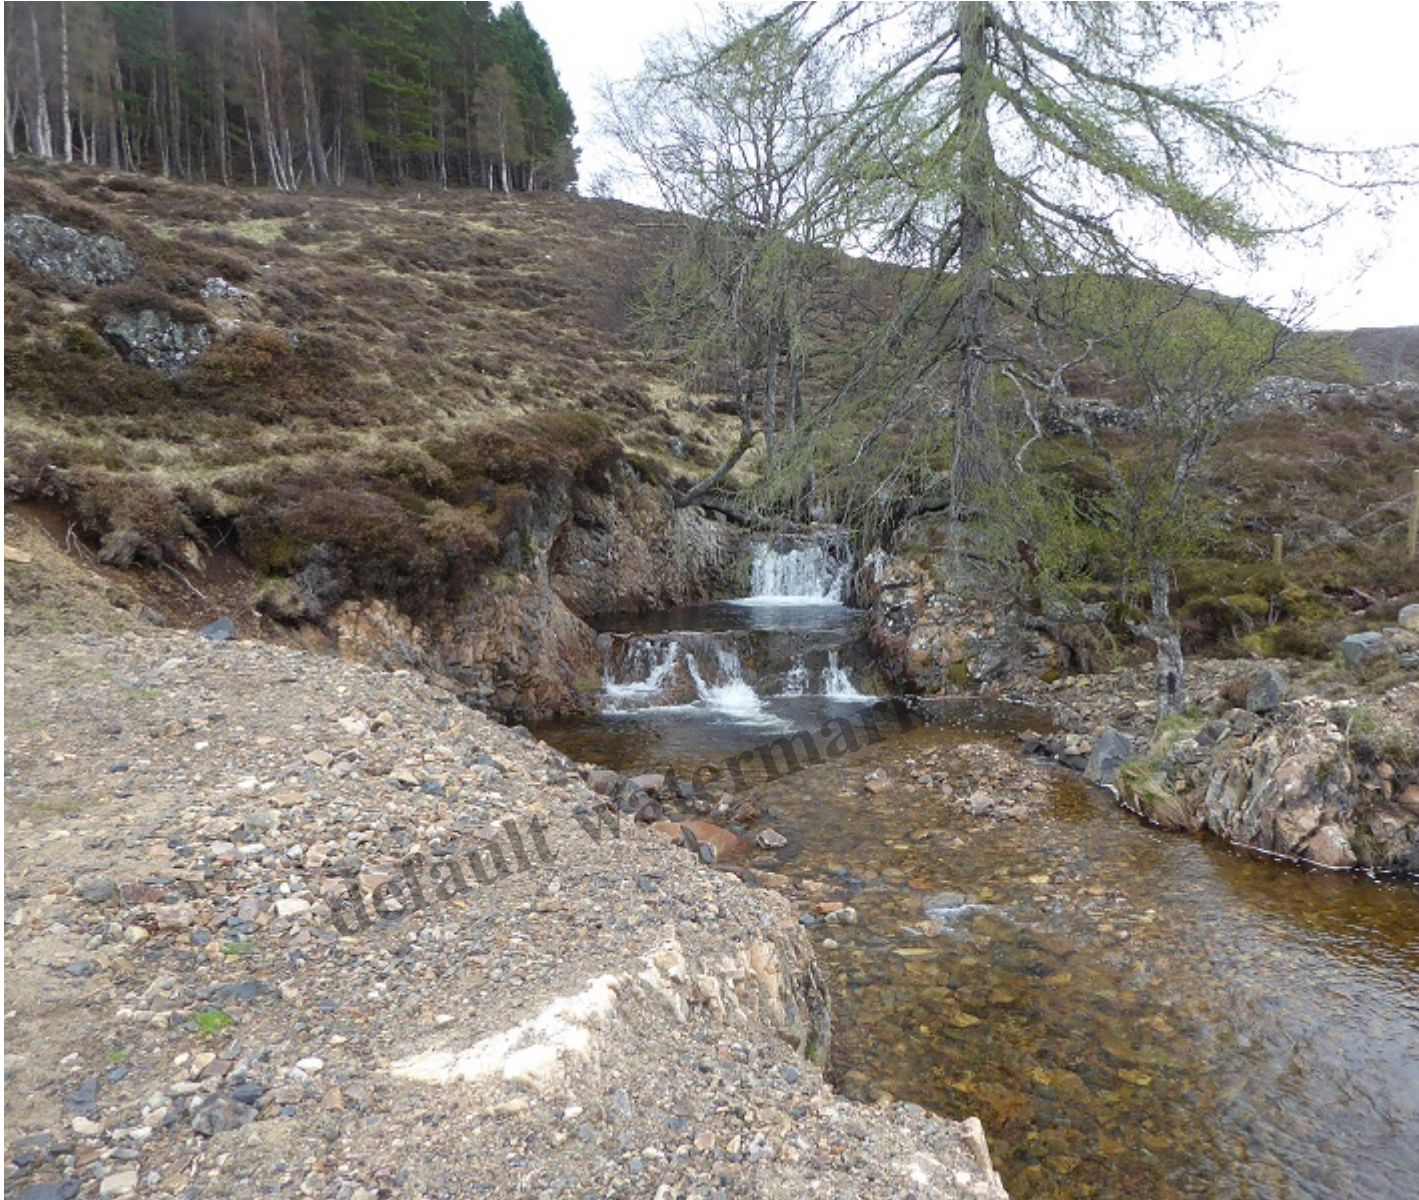
My main remaining landscape concern is that there has still been no effective restoration of the channel which was cut through the rock to divert the burn and enable the hydro to be constructed:

The fenced enclosure is just to the left of the ground in this photo

The LLTNPA's landscape adviser had, in a report on the original proposal, highlighted the potential landscape impact here and unfortunately so far a solution has not apparently been found.
