The restoration of the Braemar Community hydro scheme at Corriemulzie

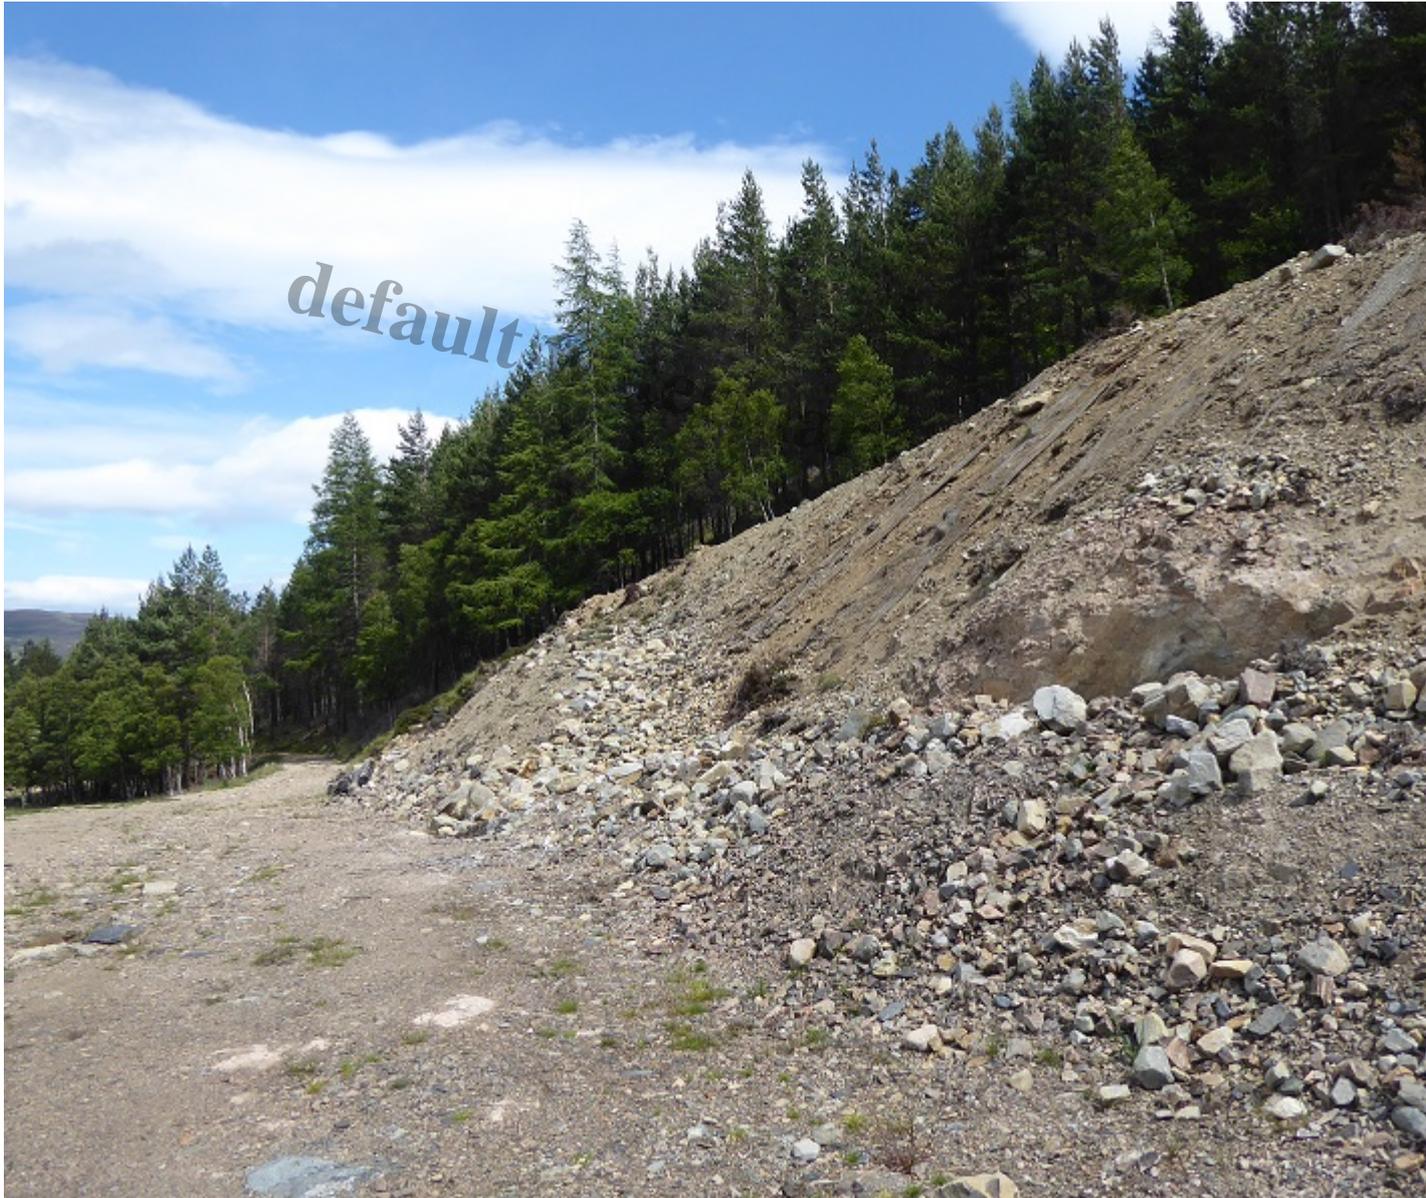
After construction

The slope by the main Corriemulzie intake in July 2017 – note how the geotextile, centre, has failed the slope and the wide area for vehicle use below

The terrible scar in the top photo has been restored by reducing the angle of the slope – a lesson here for all those bare embankments alongside bulldozed tracks – and by fencing the area in order to keep out deer. My post last July had highlighted how deer footfall was contributing to the problem although this is still an issue at the end of the slope nearest the hydro intake:

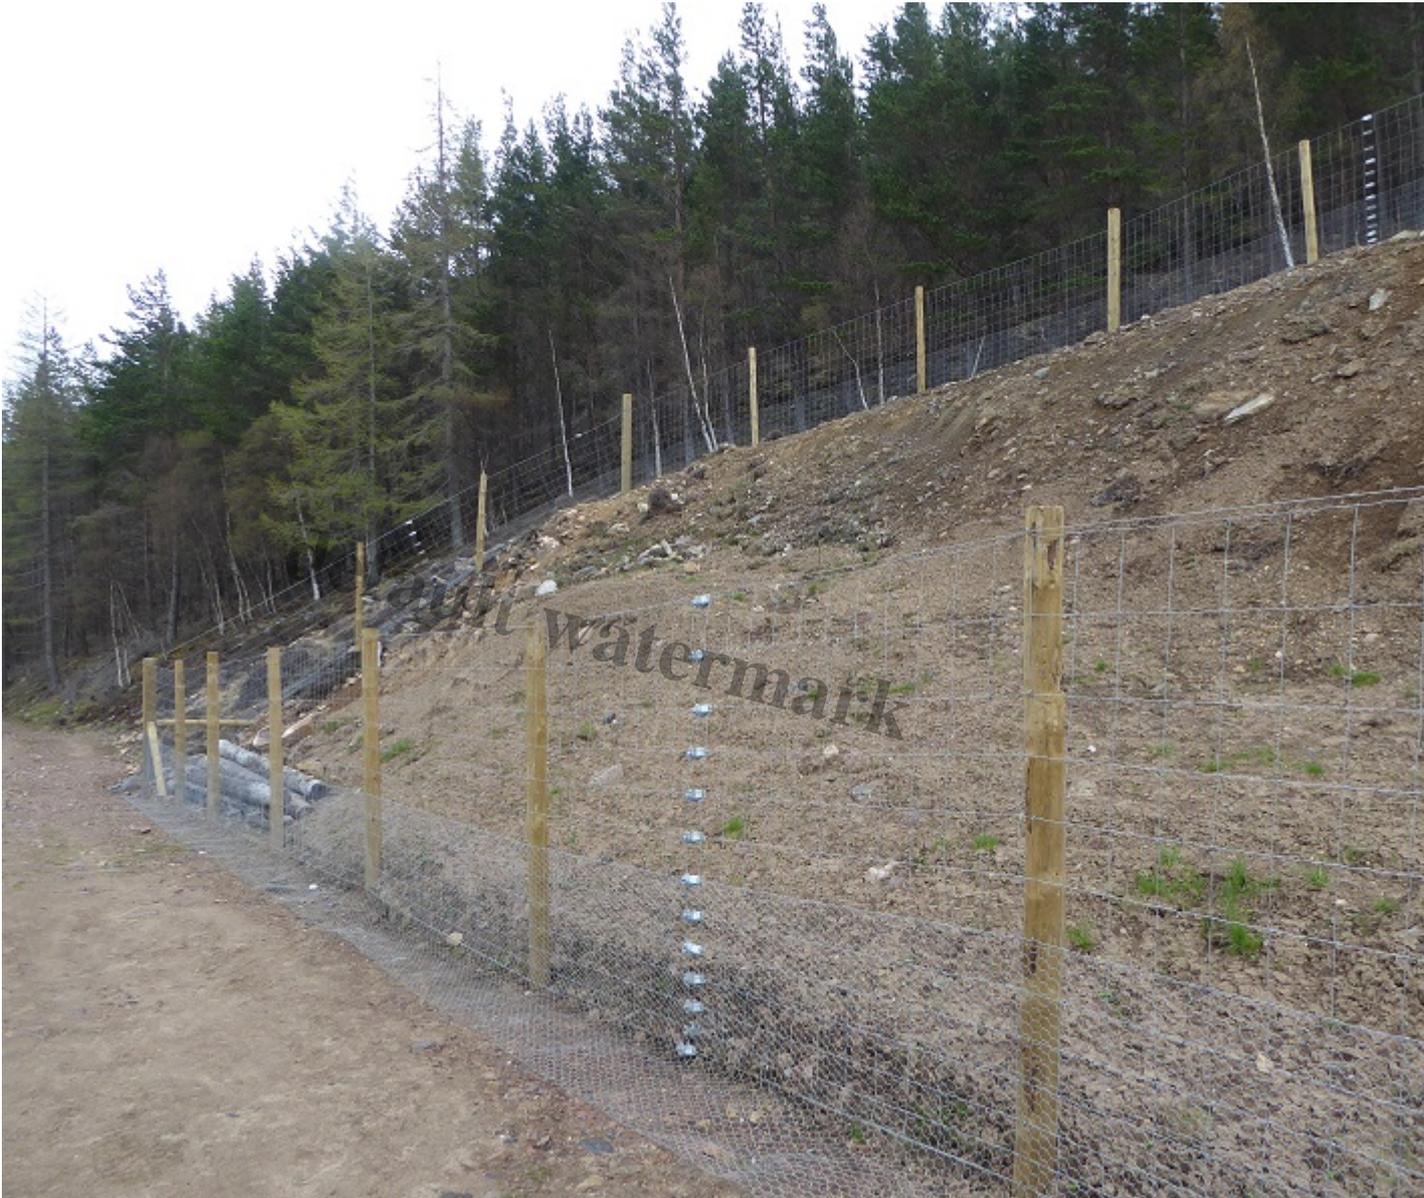
Now

While there are some signs of erosion, the slope has held up well over the winter and is now beginning to vegetate.

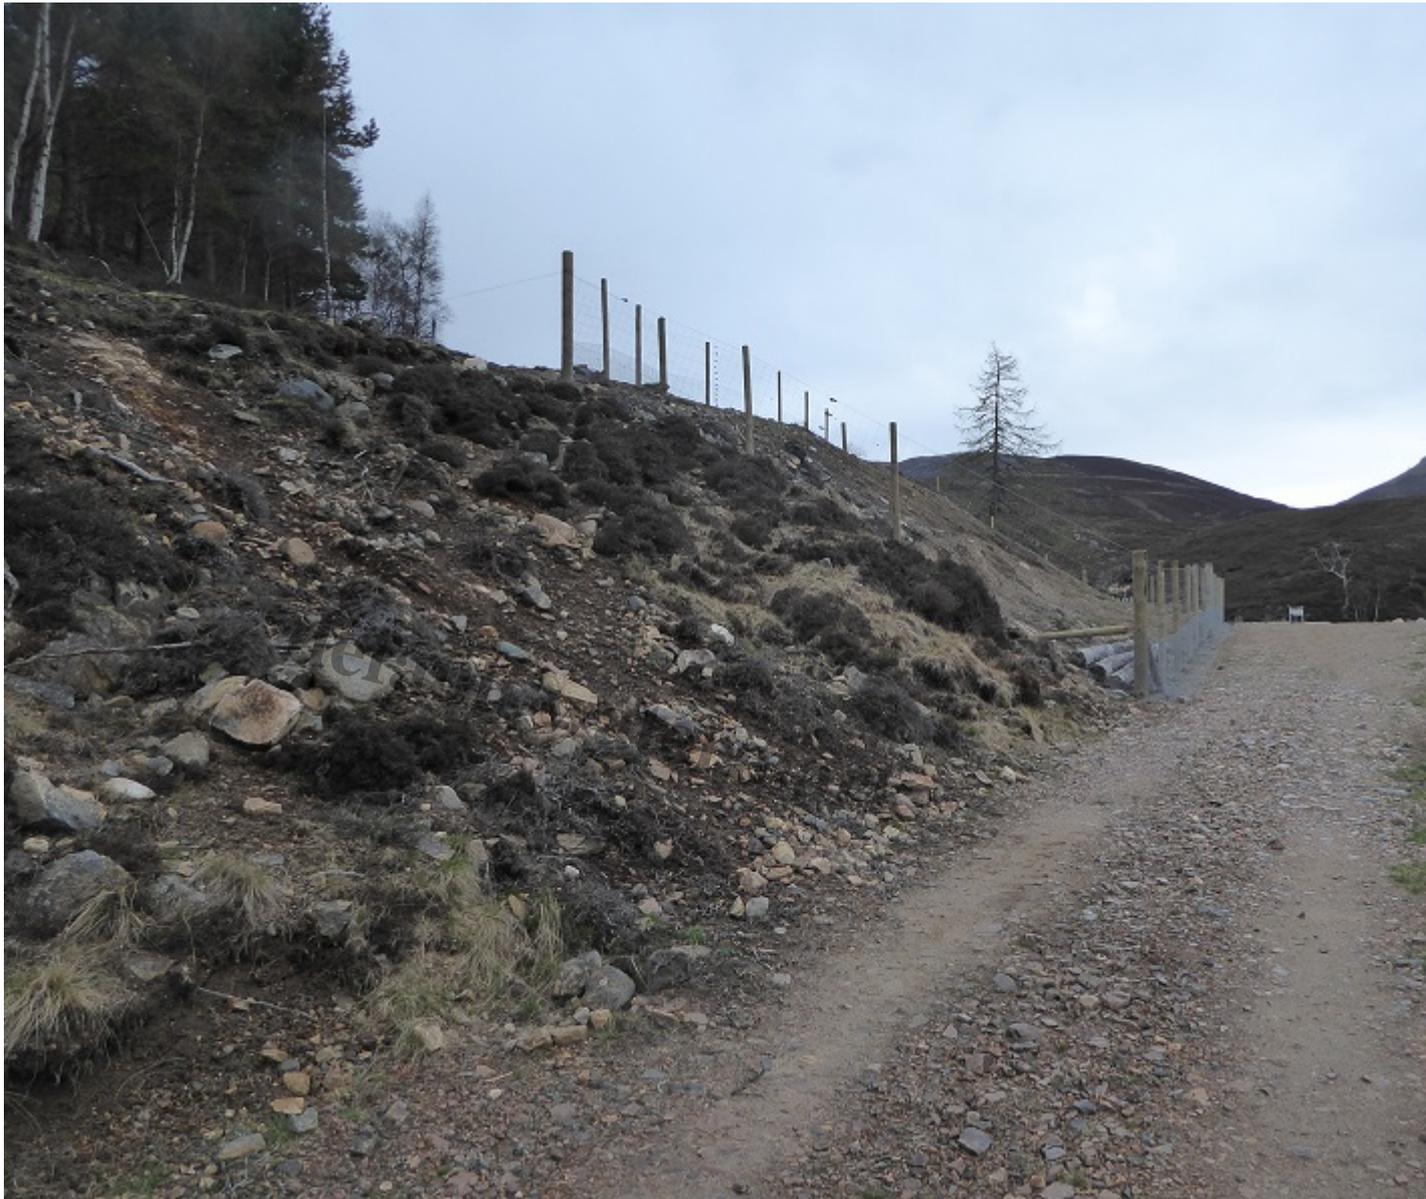
While the slope before the hydro works had previously been eroded â?? see photo from earlier post some signs here too that erosion may be increasing as deer are diverted around the fence

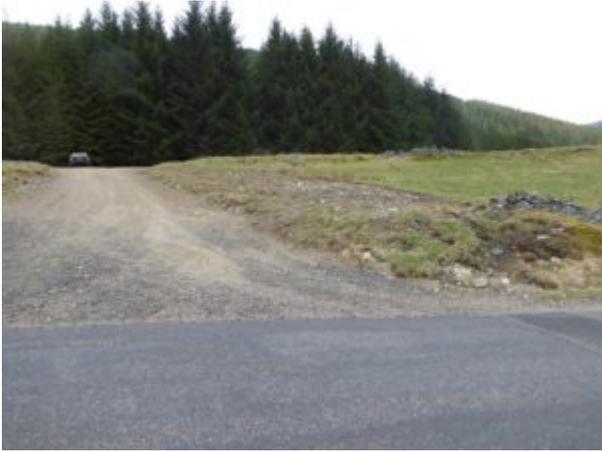
Now ?? the access track has been narrowed

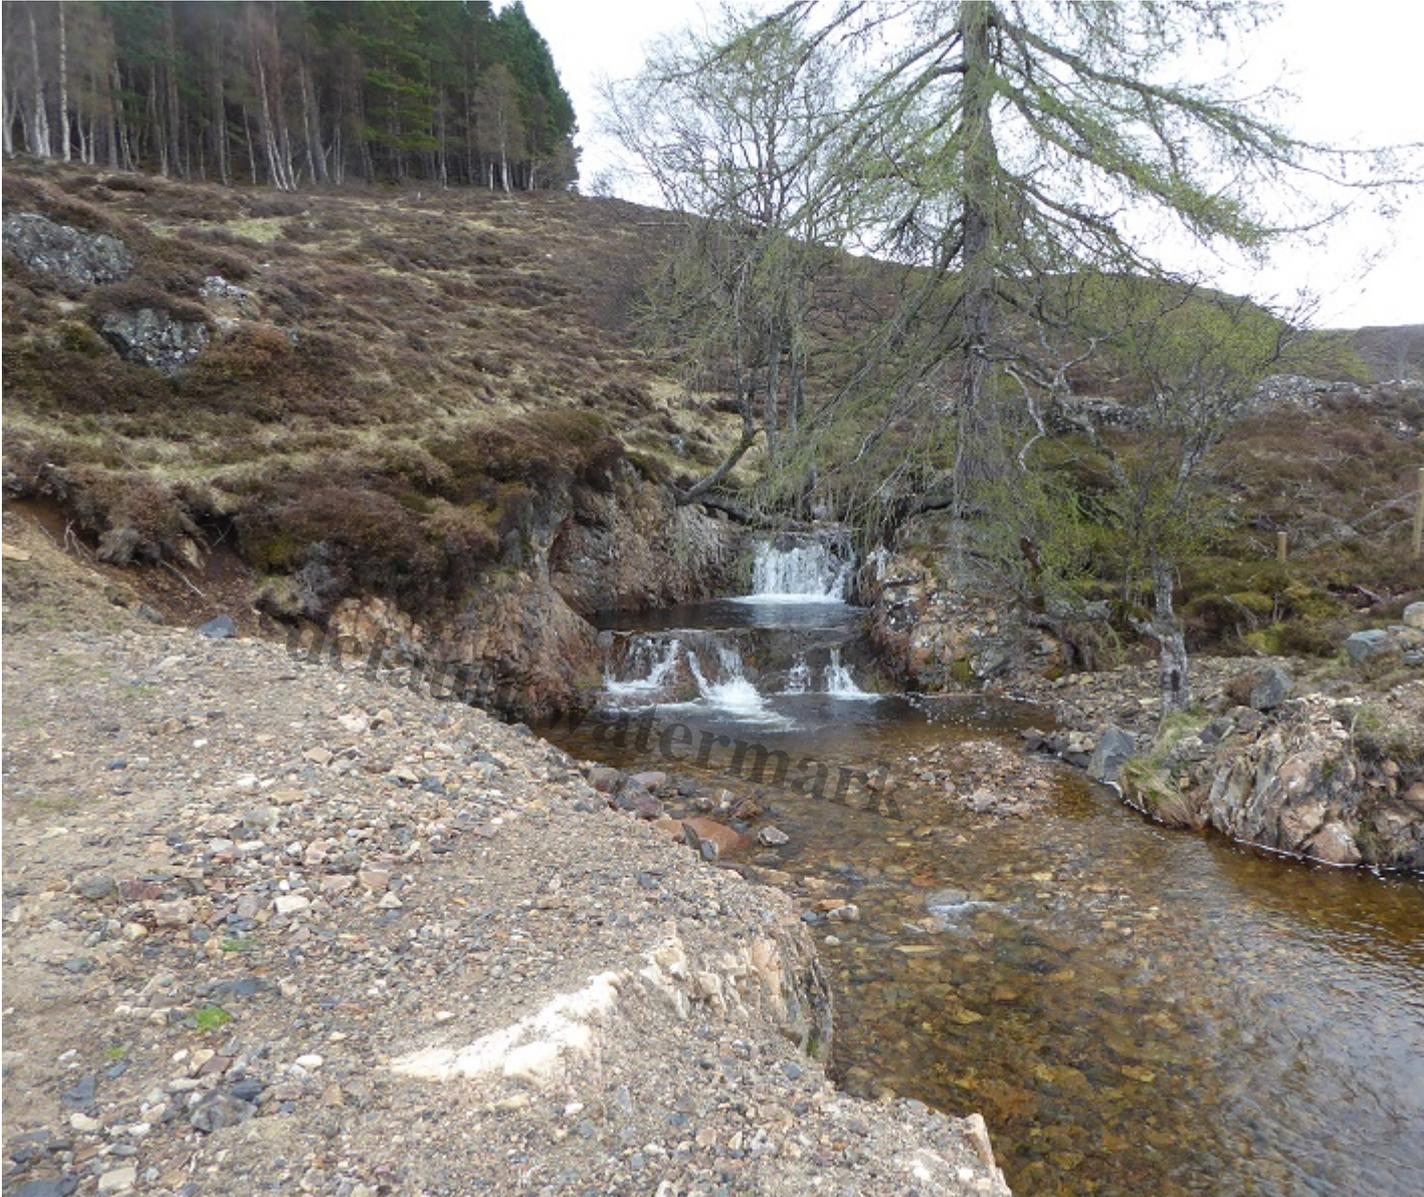
My main remaining landscape concern is that there has still been no effective restoration of the channel which was cut through the rock to divert the burn and enable the hydro to be constructed:

The fenced enclosure is just to the left of the ground in this photo

The LLTNPA's landscape adviser had, in a report on the original proposal, highlighted the potential landscape impact here and unfortunately so far a solution has not apparently been found.

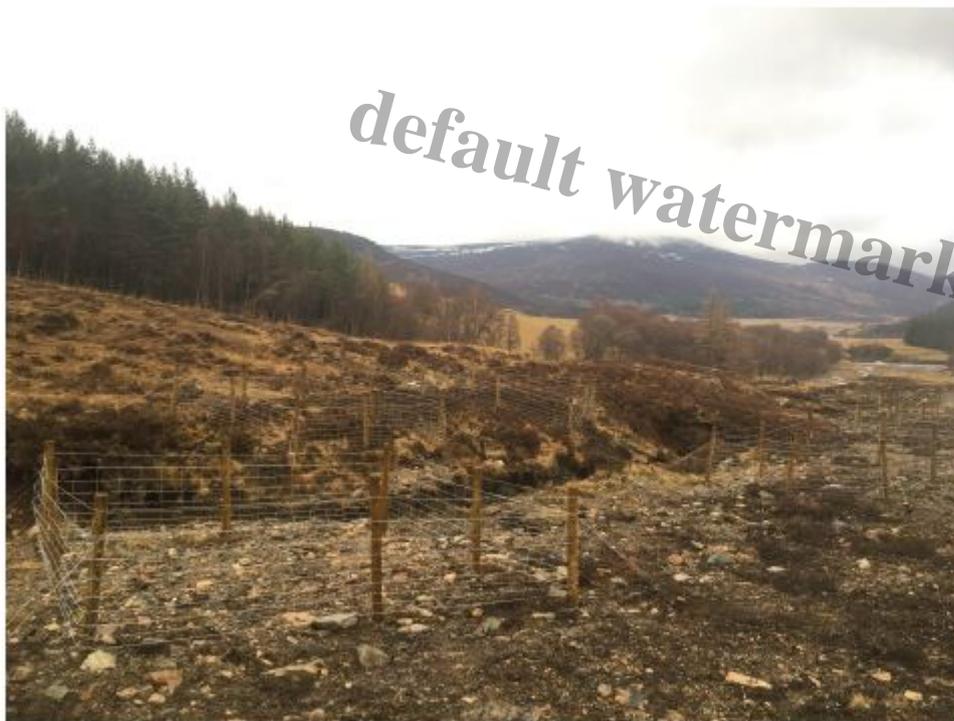
Ongoing landscaping

- In some areas the disturbed habitats taking time to reco
- We have a list of works agreed with the CNPA Planners
- These works are ongoing through our contractor, Highland Eco
- BCH have retained £12,000 pending completion
