## Cairngorm Mountain Clear Up Project

In August of 2017 HIE initiated a clean-up operation on CairnGorm Mountain. A number of environmental groups had campaigned for this action for years and with over 12 months having elapsed since the commencement of the clean-up, it is time now to examine the results and the value for money obtained for the input of 267,000 pounds of public funds

*This post will concentrate on examining the work done on the Coire na Ciste Chairlift Lift Line and Aonach Poma loading area.*

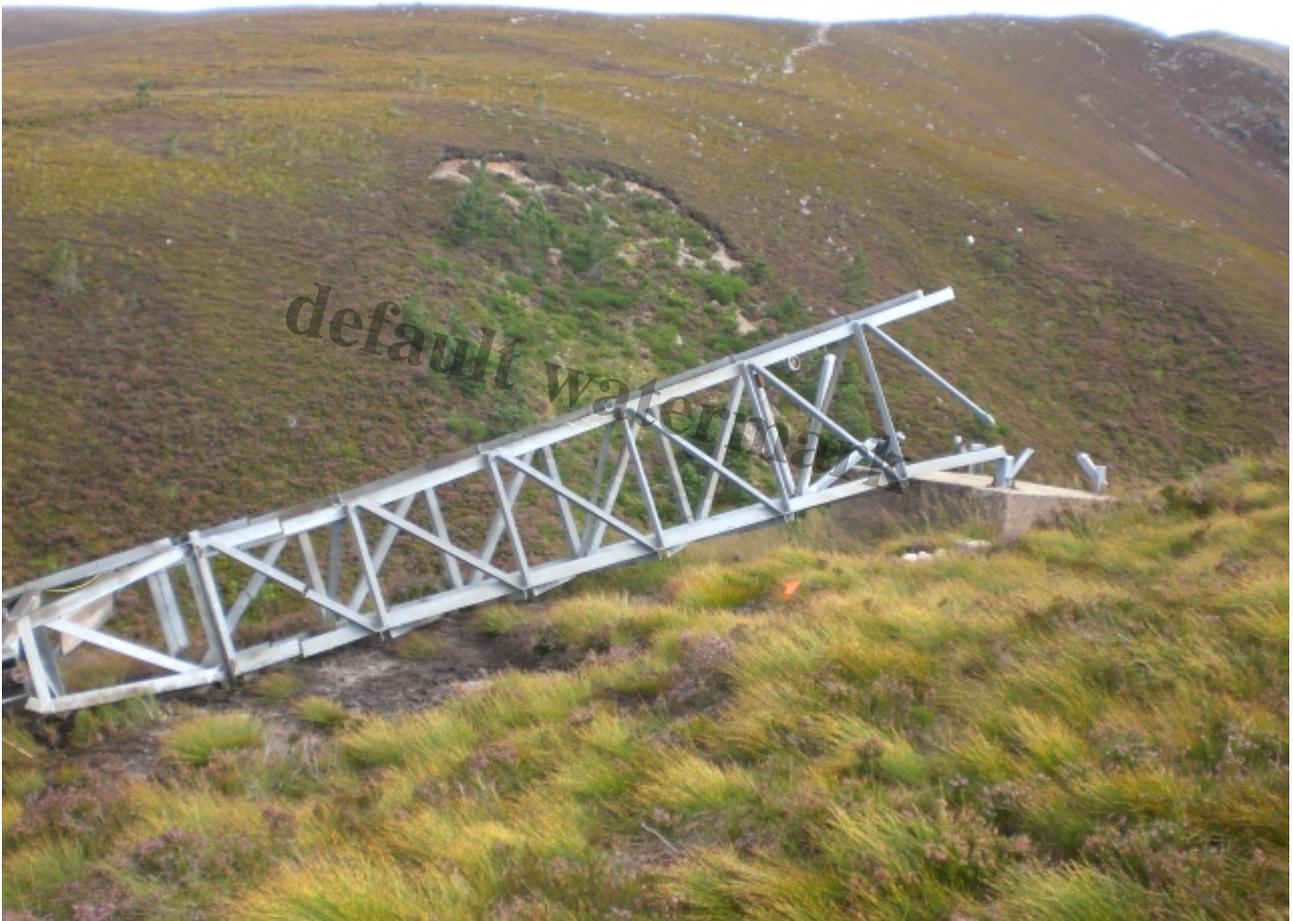
Demolition of lift tower in Coire na Ciste – the cleanup was used as an excuse to destroy potentially re-usable lift infrastructure ([see here](#)).

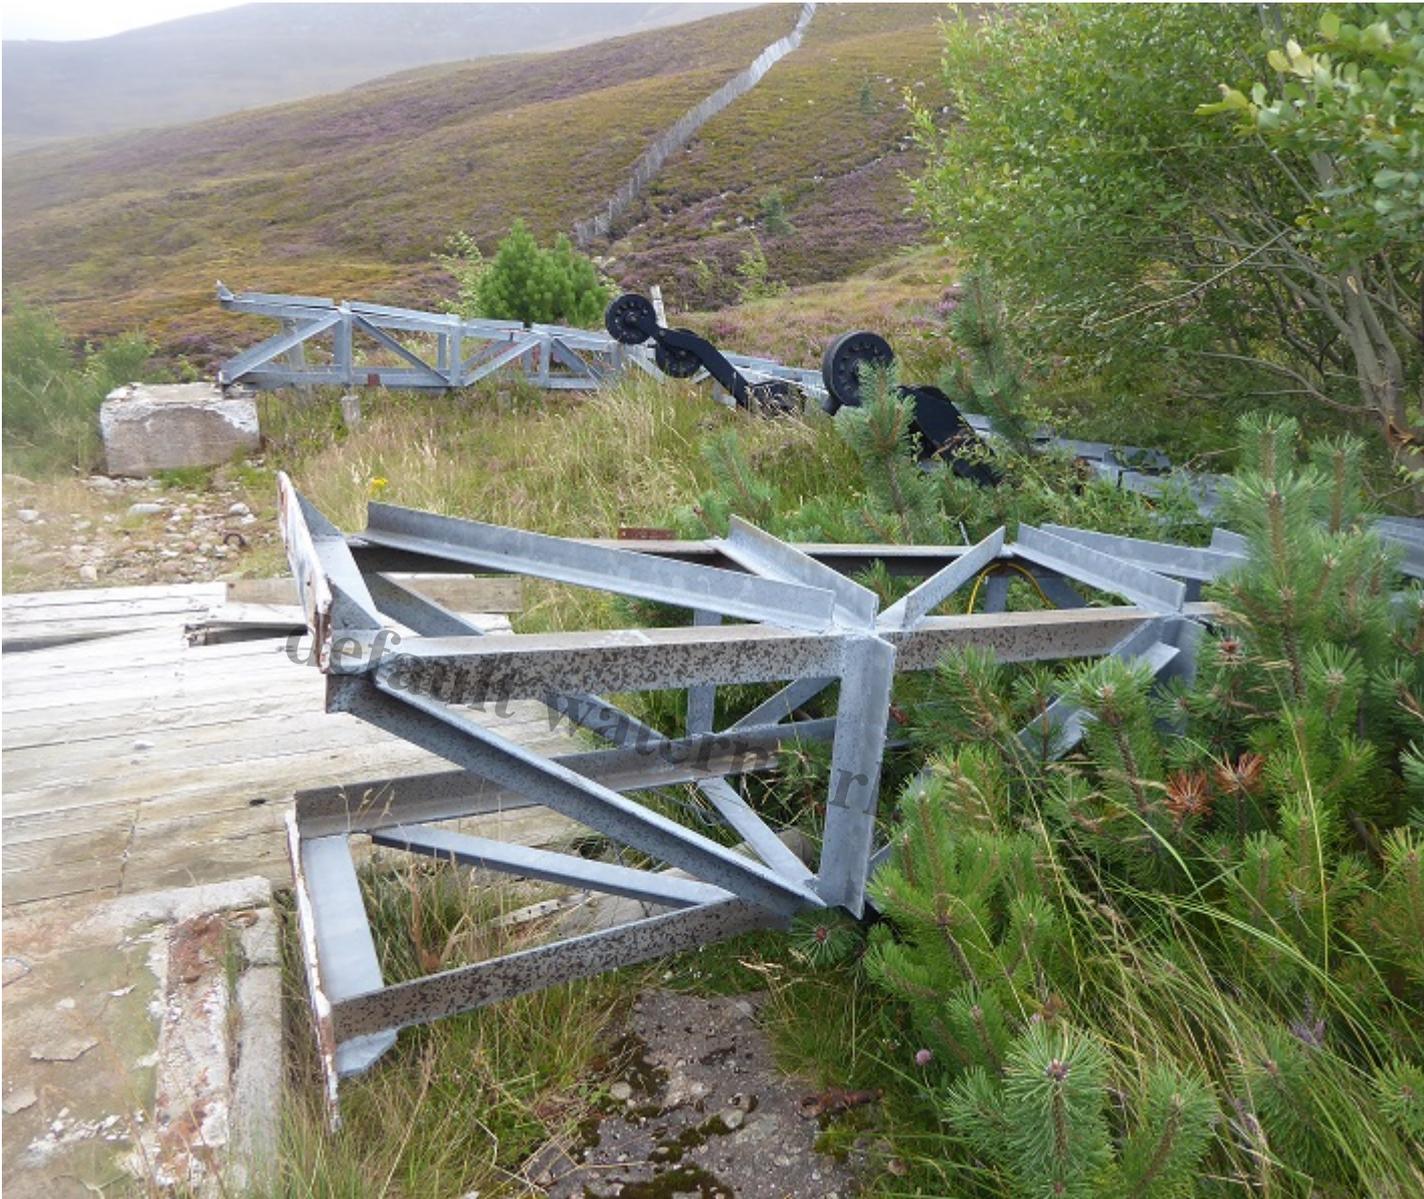
The former lift towers in Coire na Ciste have been completely removed

**Steel Structures and Towers:** These have been completely removed from the mountain and there is no evidence of anything having been left behind. The Coire na Ciste carpark is a different matter though and there are many many pieces of splintered wood and metal shards that await the tyres of unsuspecting vehicle owners.

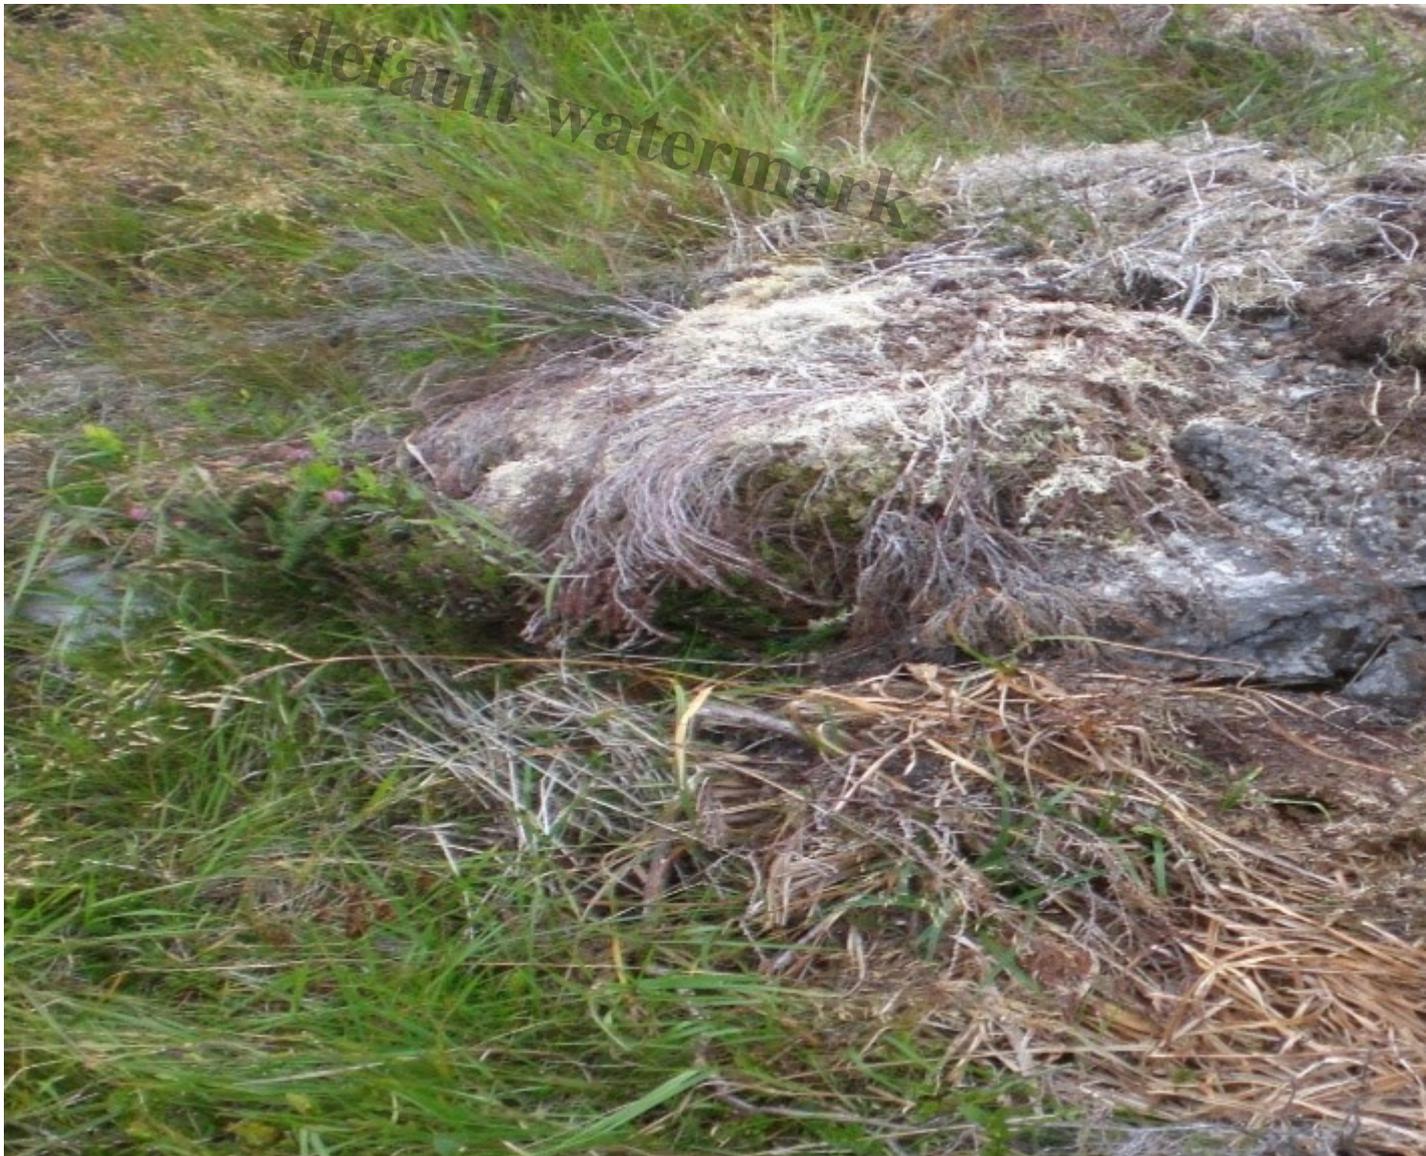
There is multiple evidence that this has not been satisfactorily done. Concrete has not been broken out to 200mm below surface and several of the old tower foundations are clearly identified as mounds that are significantly higher than the surrounding ground. Exposed concrete can be seen and there are steel shards and wood that remain at the site of the Aonach Poma loading area.

Exposed concrete which has not been broken out to 200mm below surface. Photo Credit Alan Bratt

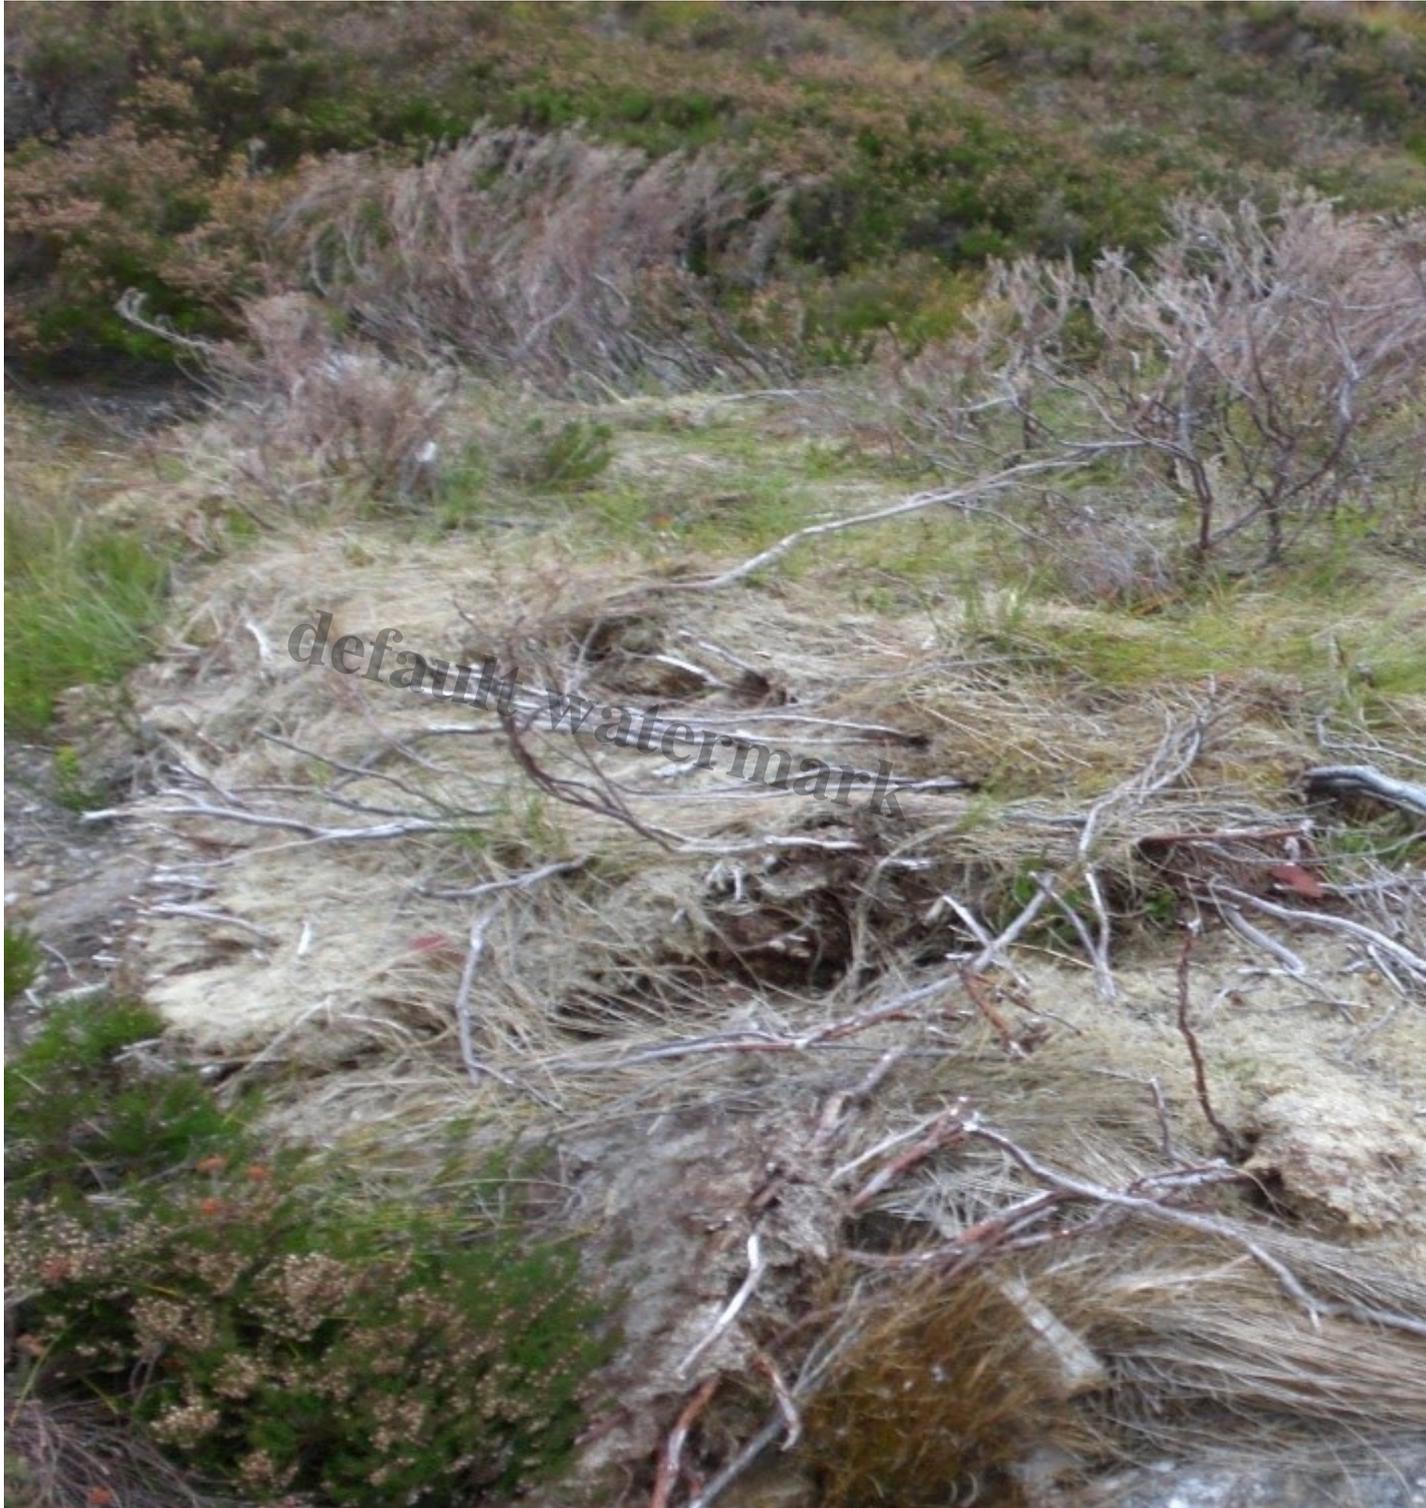
The reinstatement, such as it is, has been done merely by a machine ripping out turves placing them on top of the old foundations. The resultant damage has had no remedial work done whatsoever.

Concrete coverage: Note how the vegetation has died. Photo Credit Alan Bratney

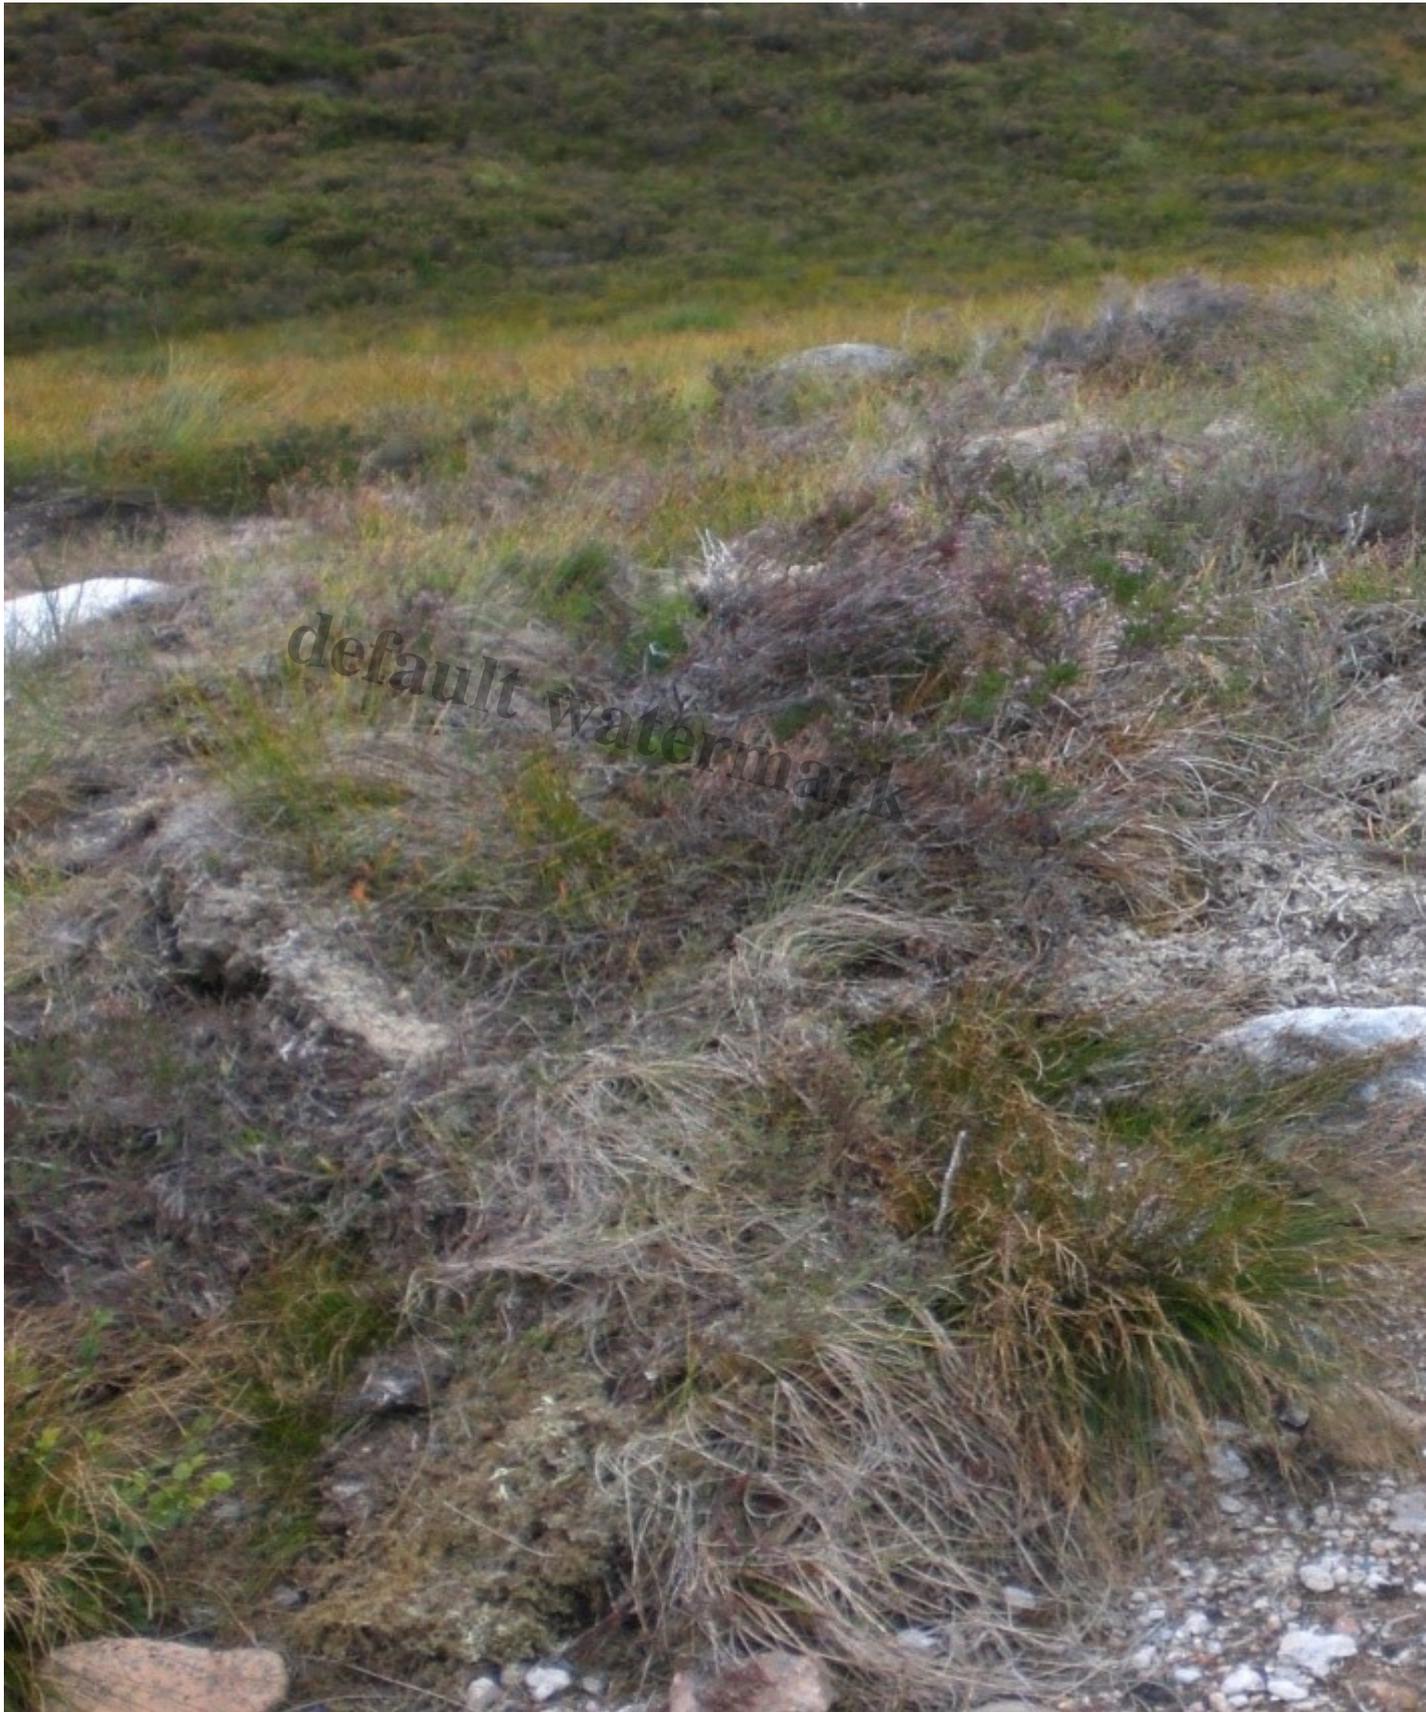
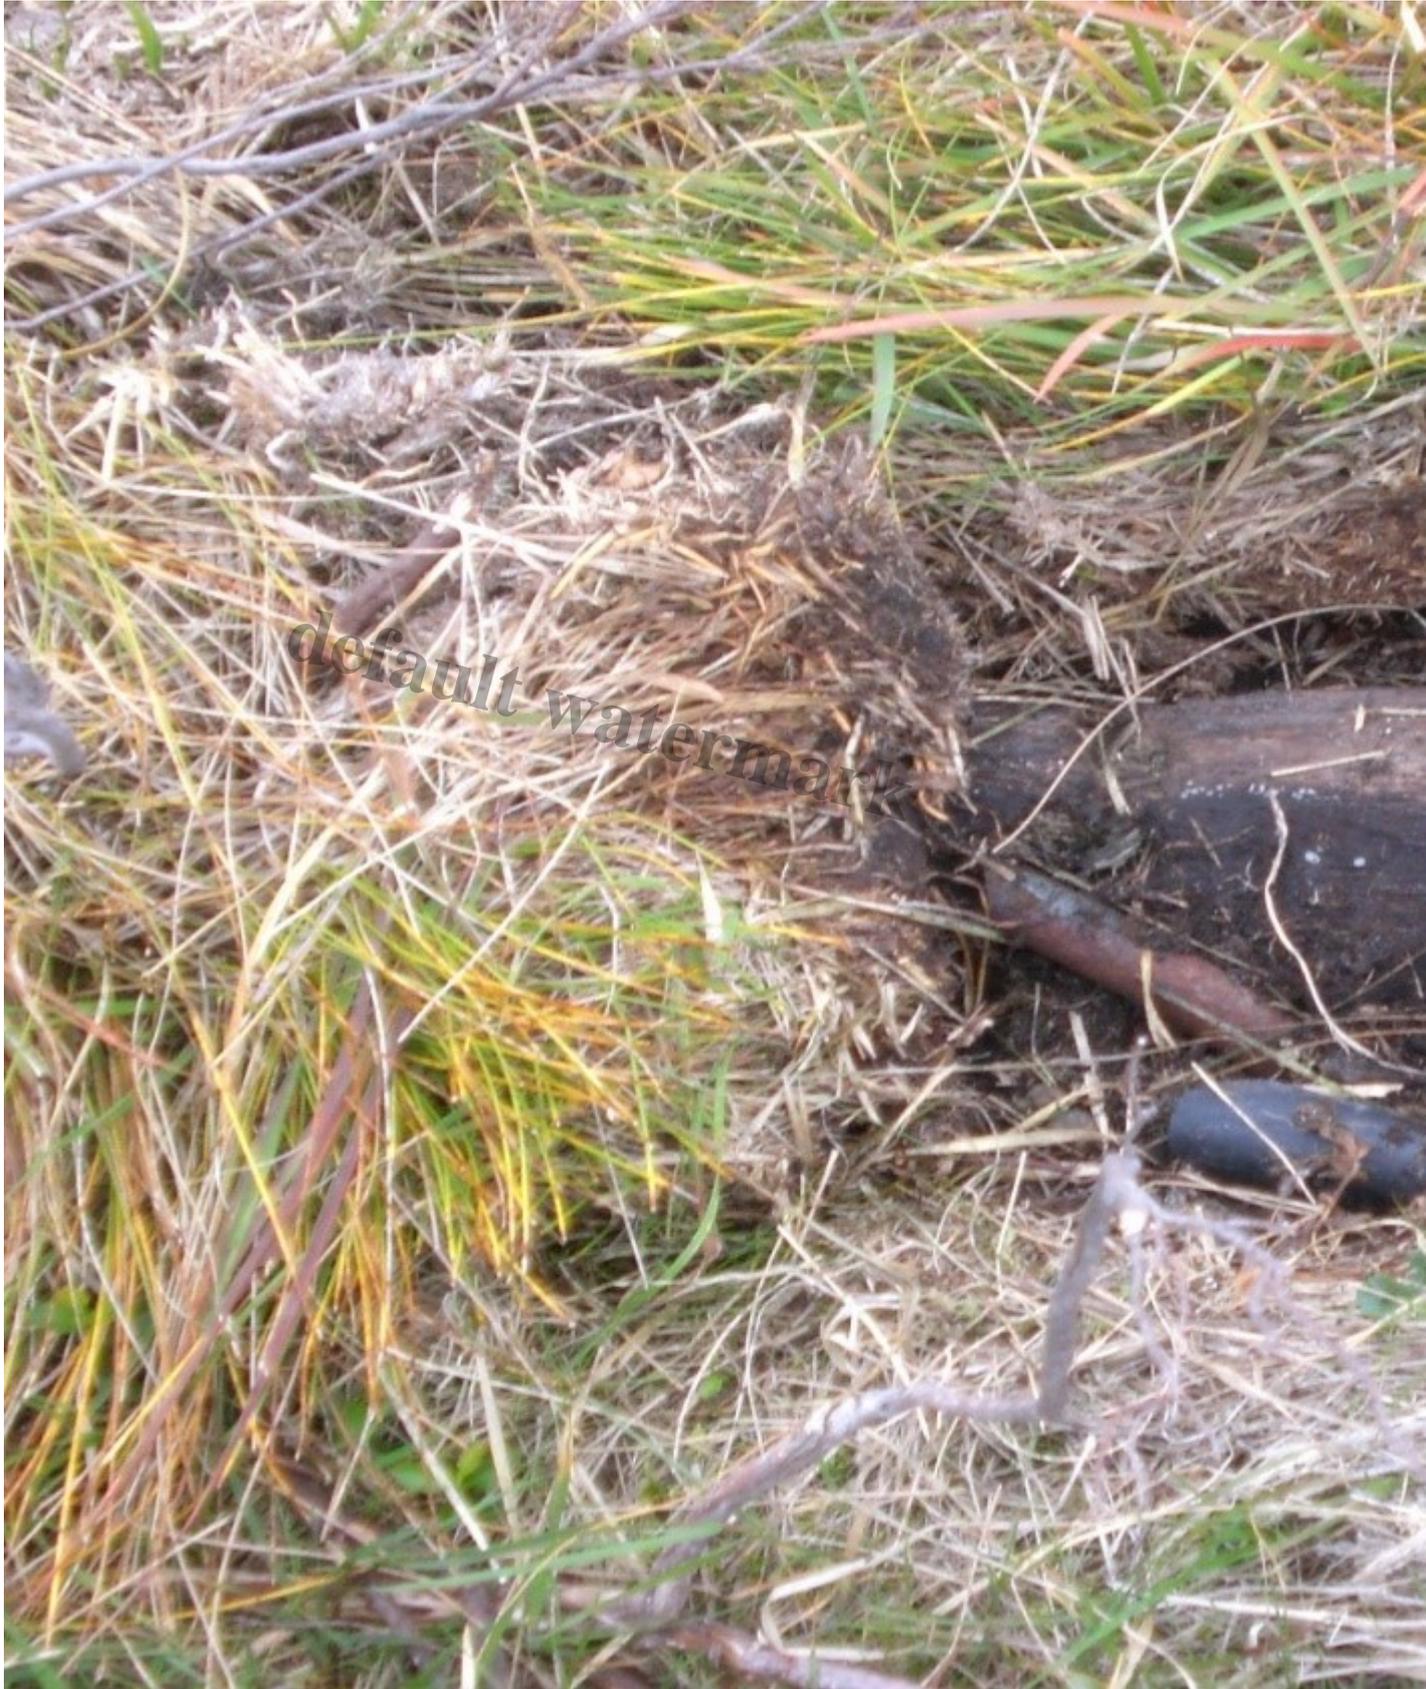
It's very clear that there are tower foundations that remain higher than the surrounding ground.

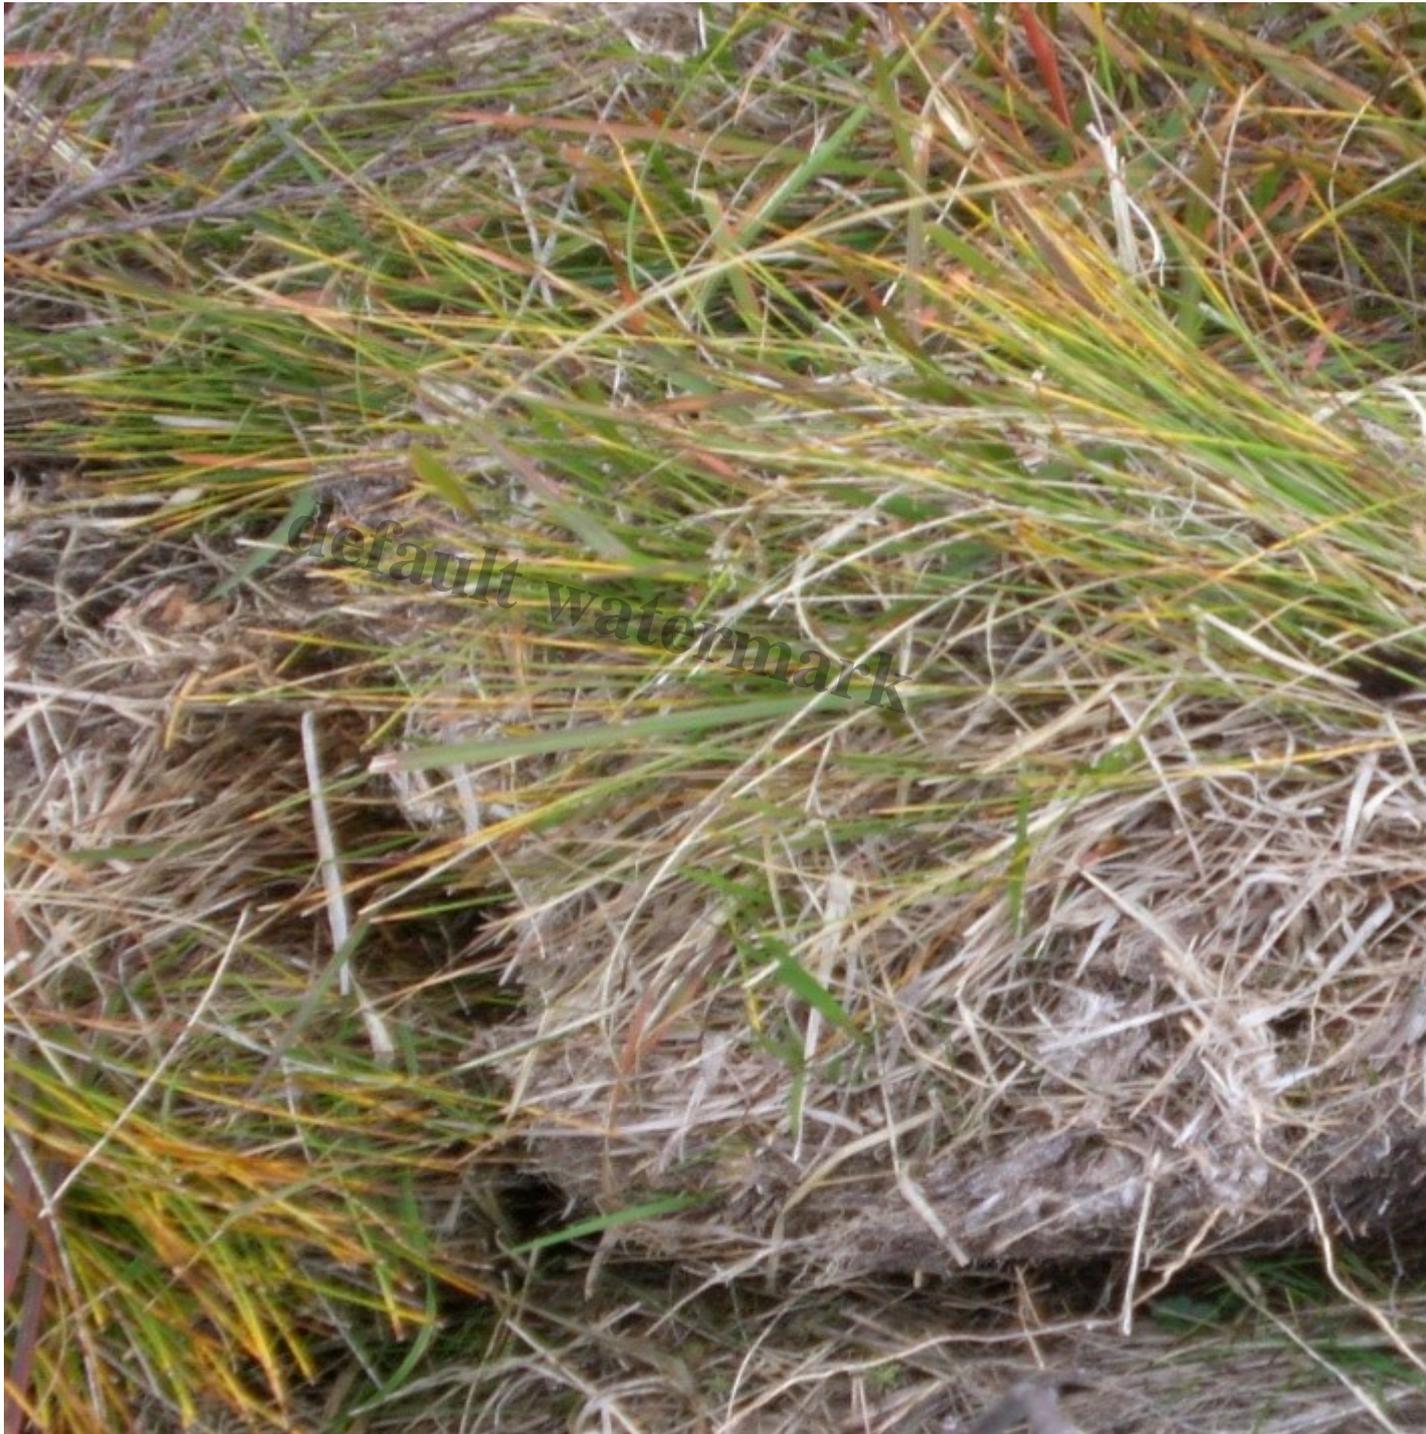
Steel Shard, wood and cable not removed just buried. Someone had clearly been there making checks before us. They had removed turves to see underneath but we kindly replaced them

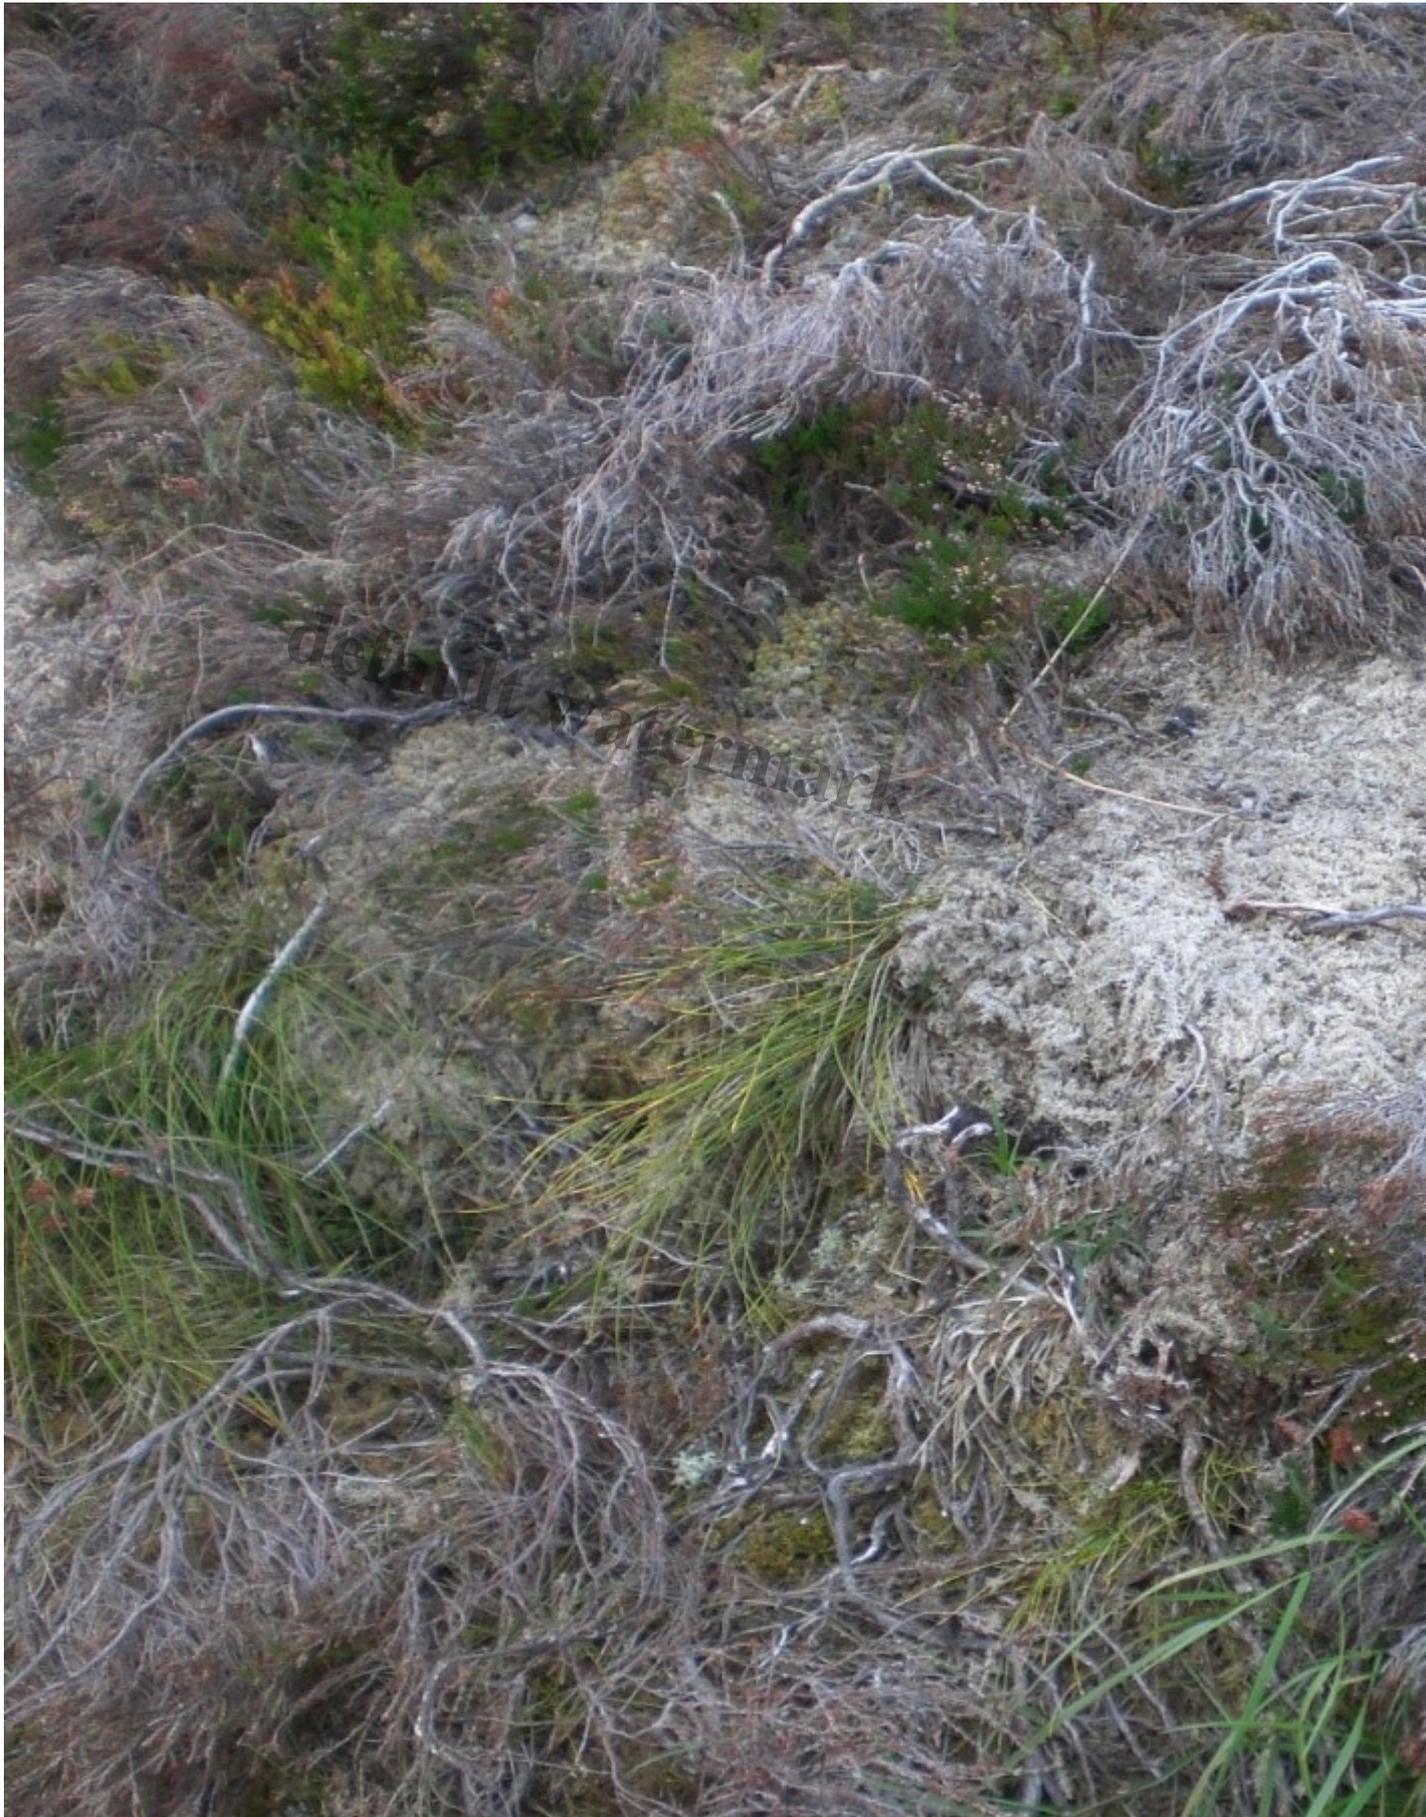
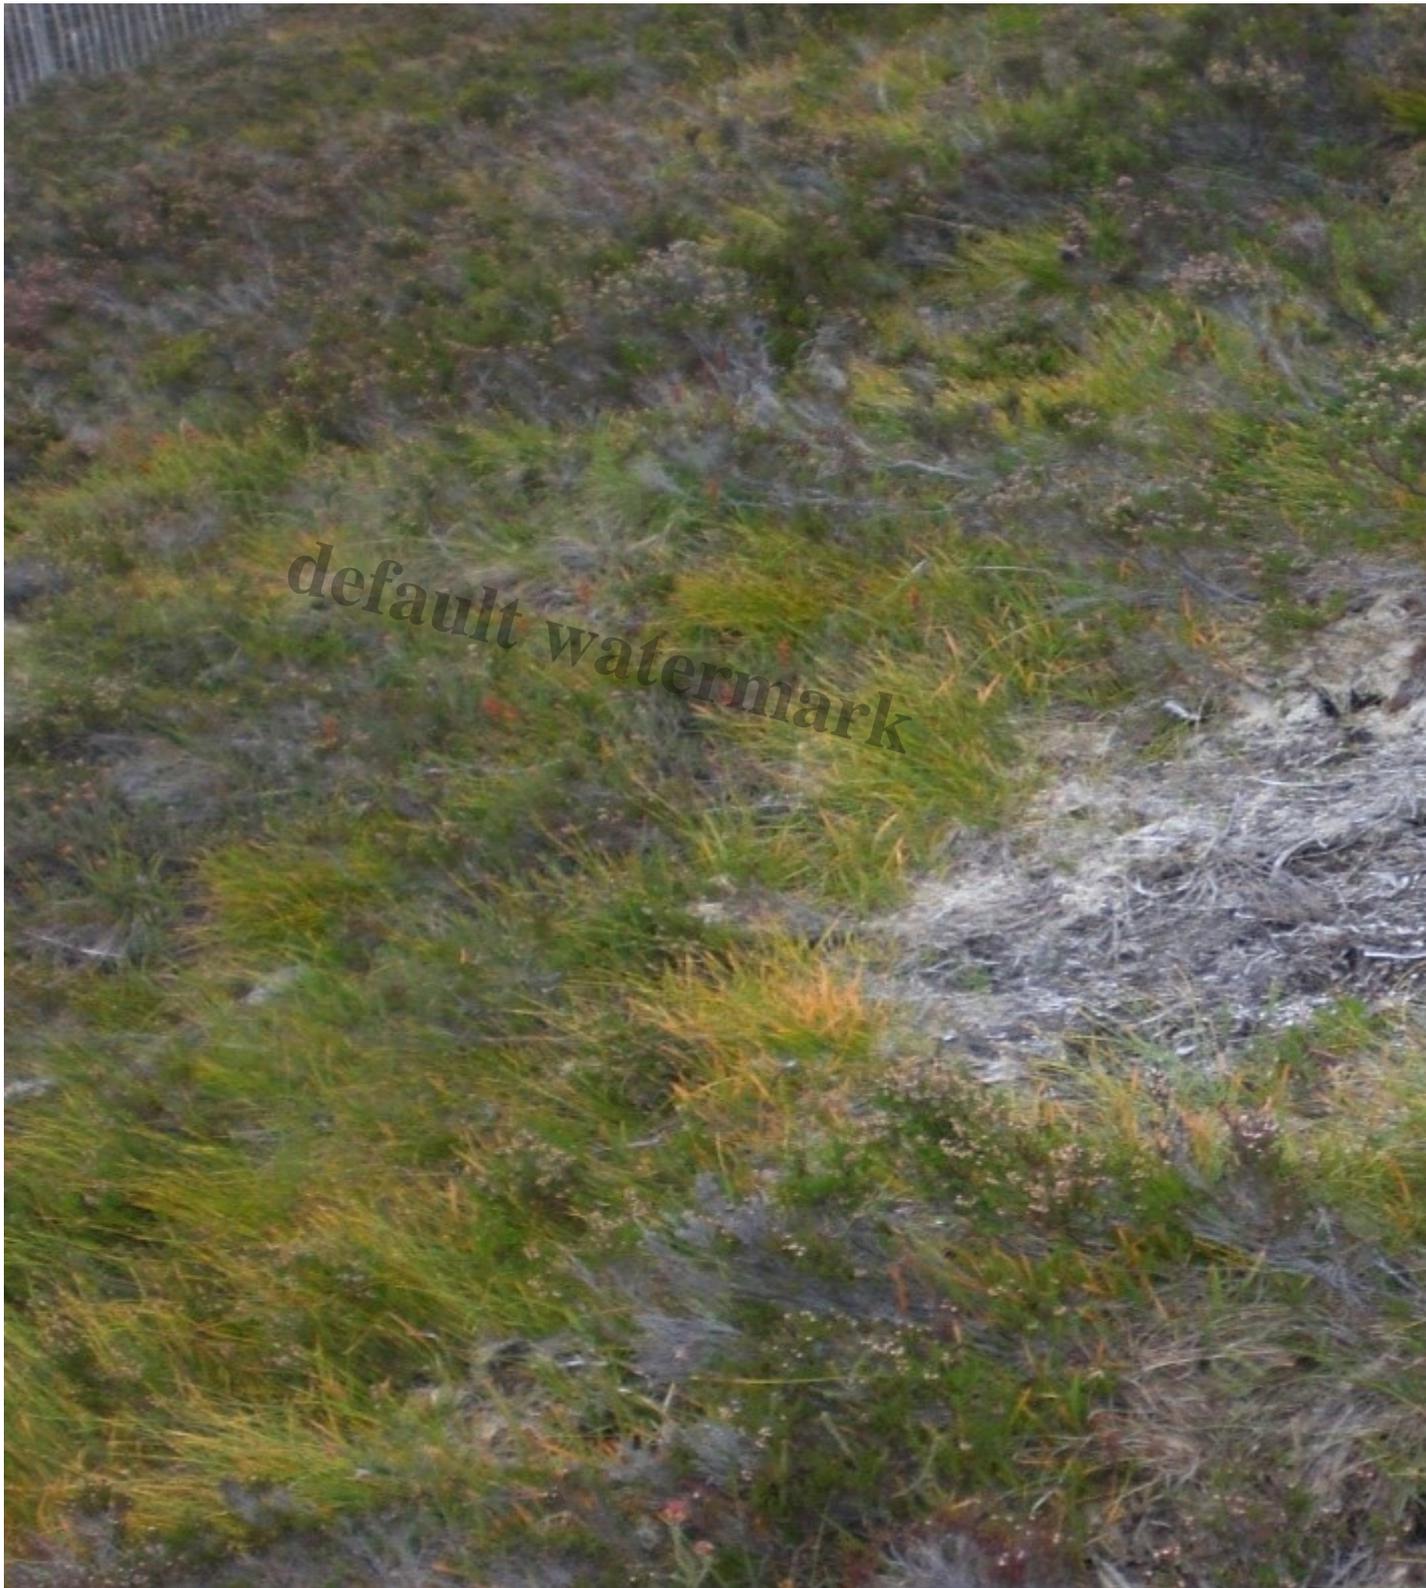
Ripped out turves and no reinstatement work done

The quality of the job is of an unacceptable standard with concrete not ground out and with vegetation simply dumped on top to cover up the remains of the concrete foundations. The dumped vegetation has

died because it has nothing to root into and the areas from where it was ripped out have had zero reinstatement work done.
