## Cairngorm Mountain Clear Up Project

In August of 2017 HIE initiated a clean-up operation on CairnGorm Mountain. A number of environmental groups had campaigned for this action for years and with over 12 months having elapsed since the commencement of the clean-up, it is time now to examine the results and the value for money obtained for the input of 267,000 pounds of public funds

*This post will concentrate on examining the work done on the Coire na Ciste Chairlift Lift Line and Aonach Poma loading area.*

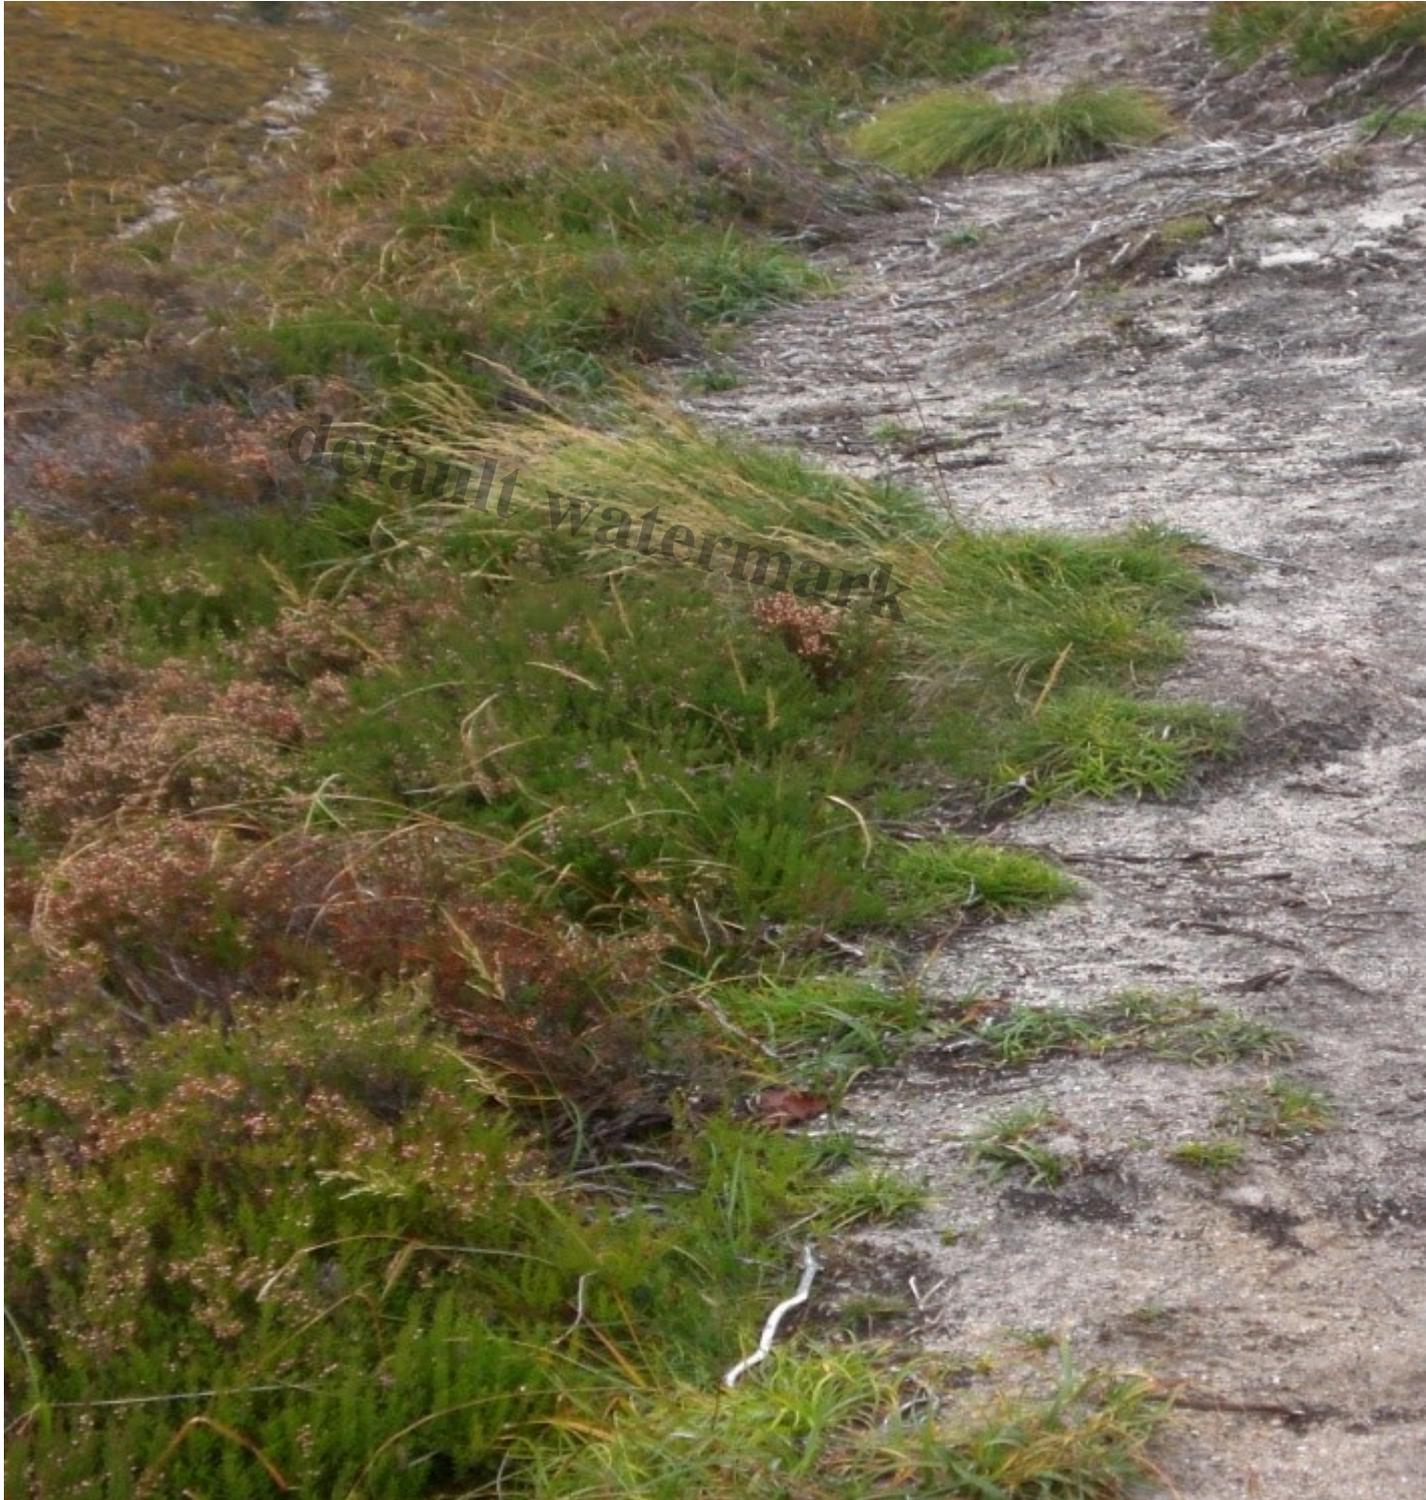
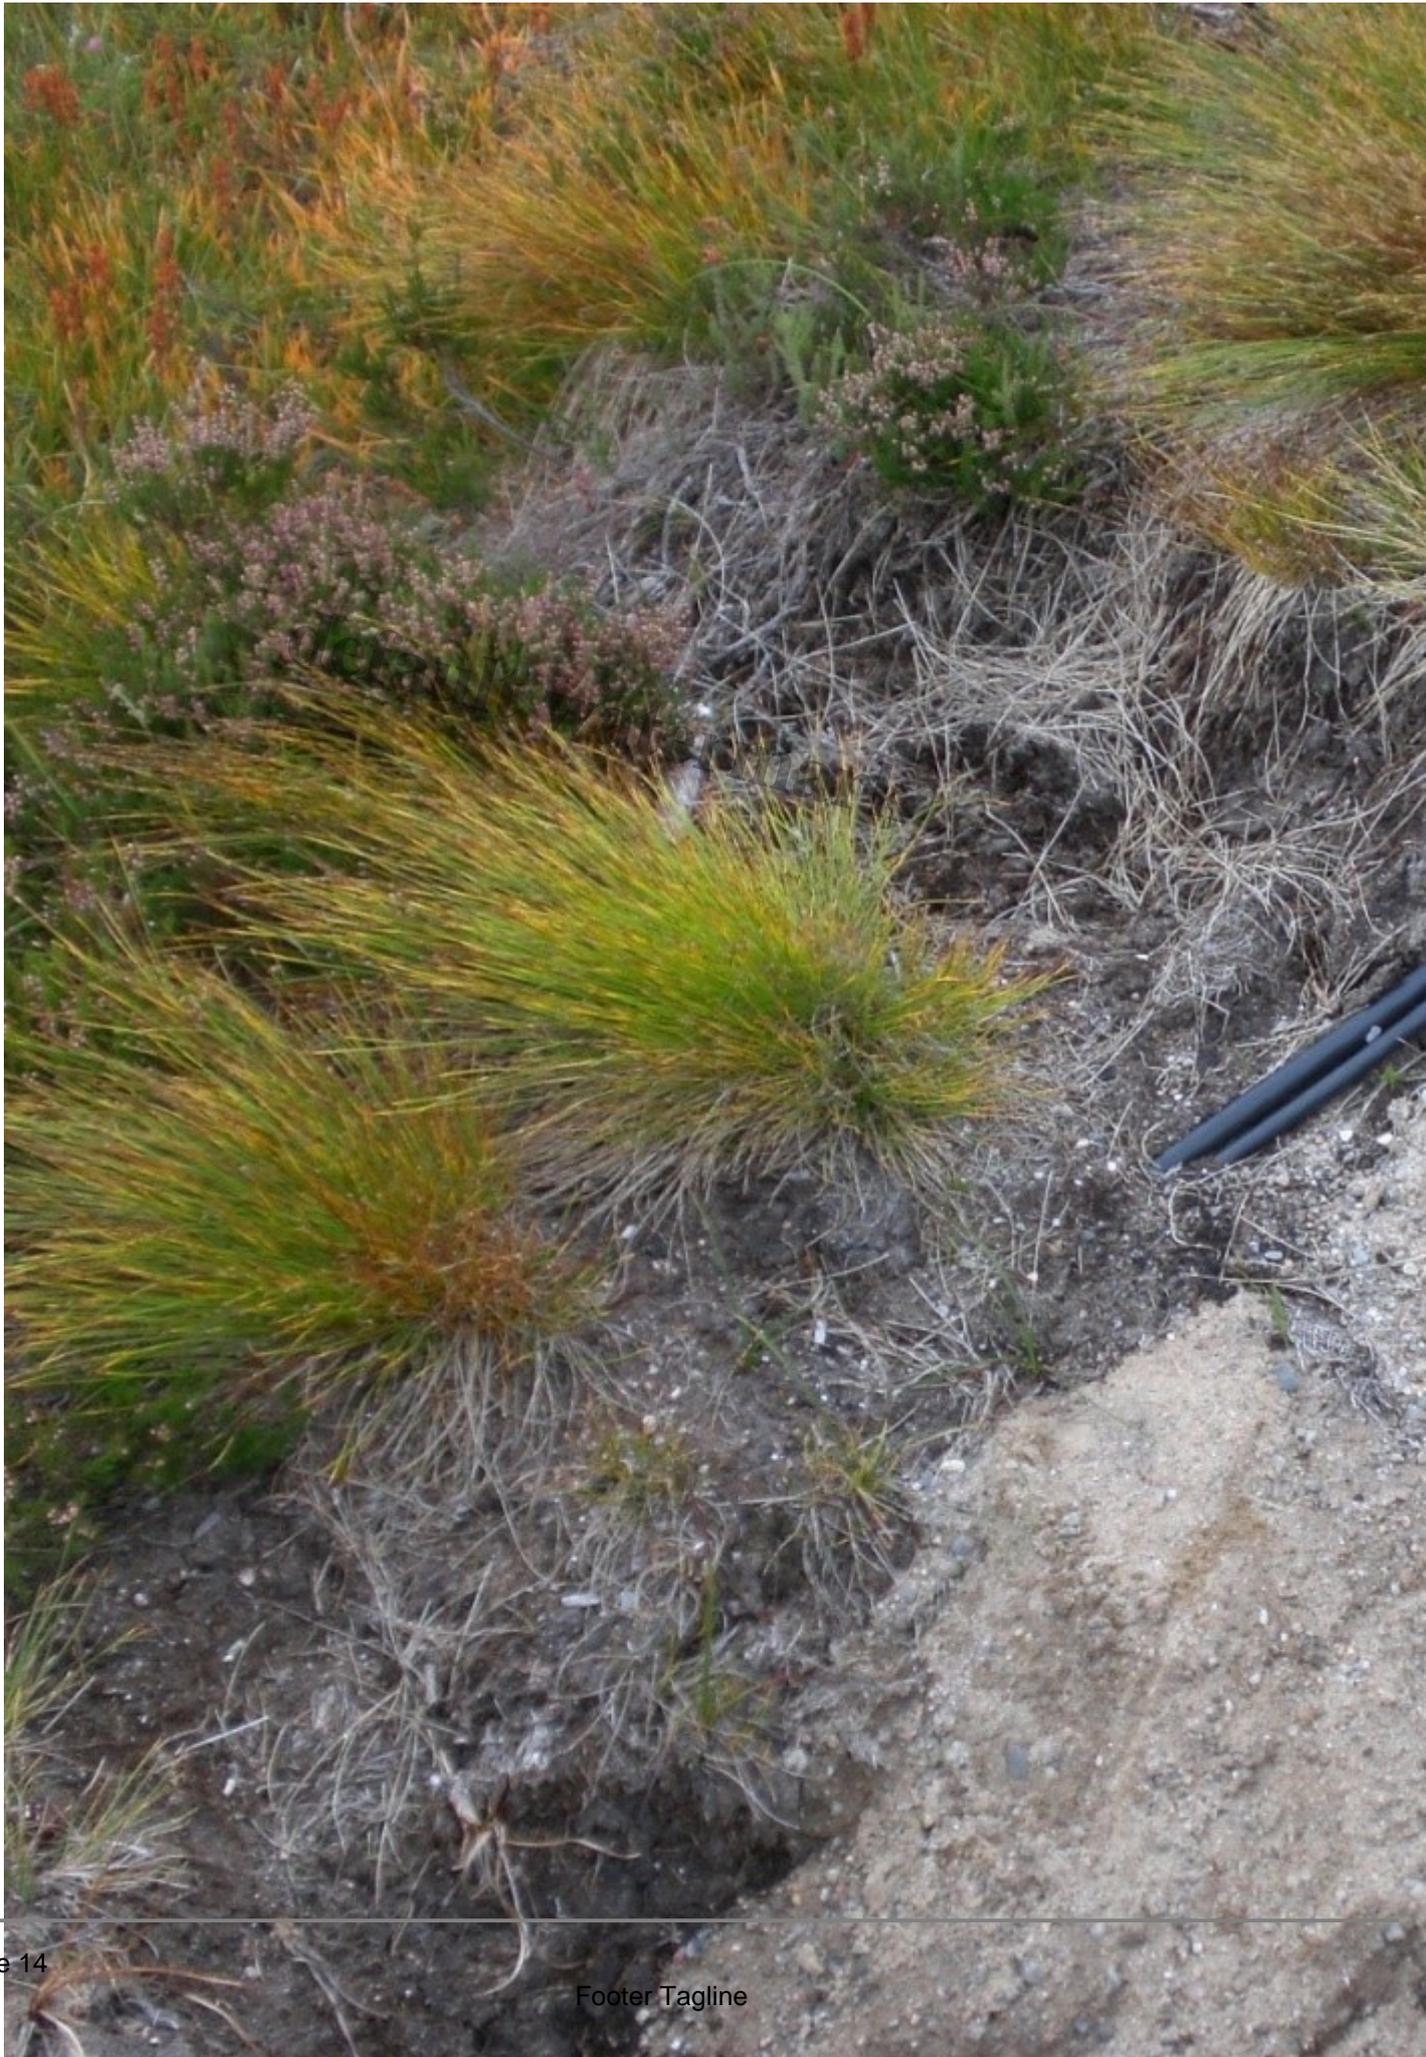
There are multiple points where cabling is on the surface and others where sandbags have been used to cover the exposed cable.

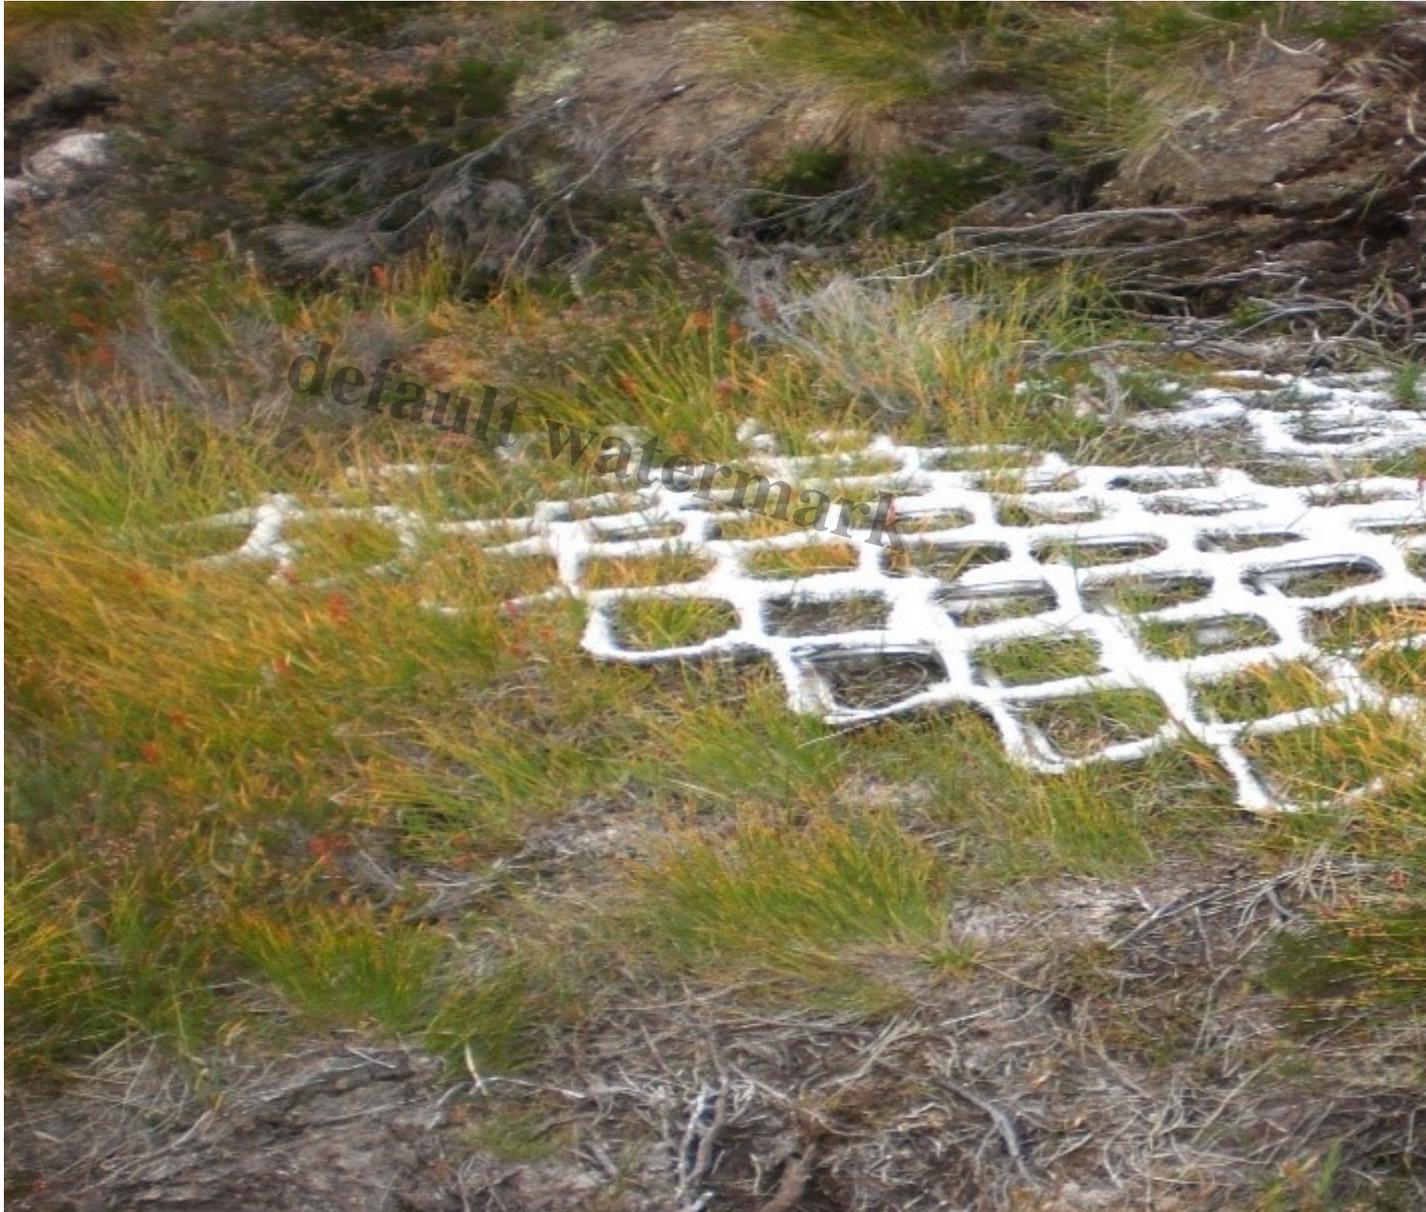
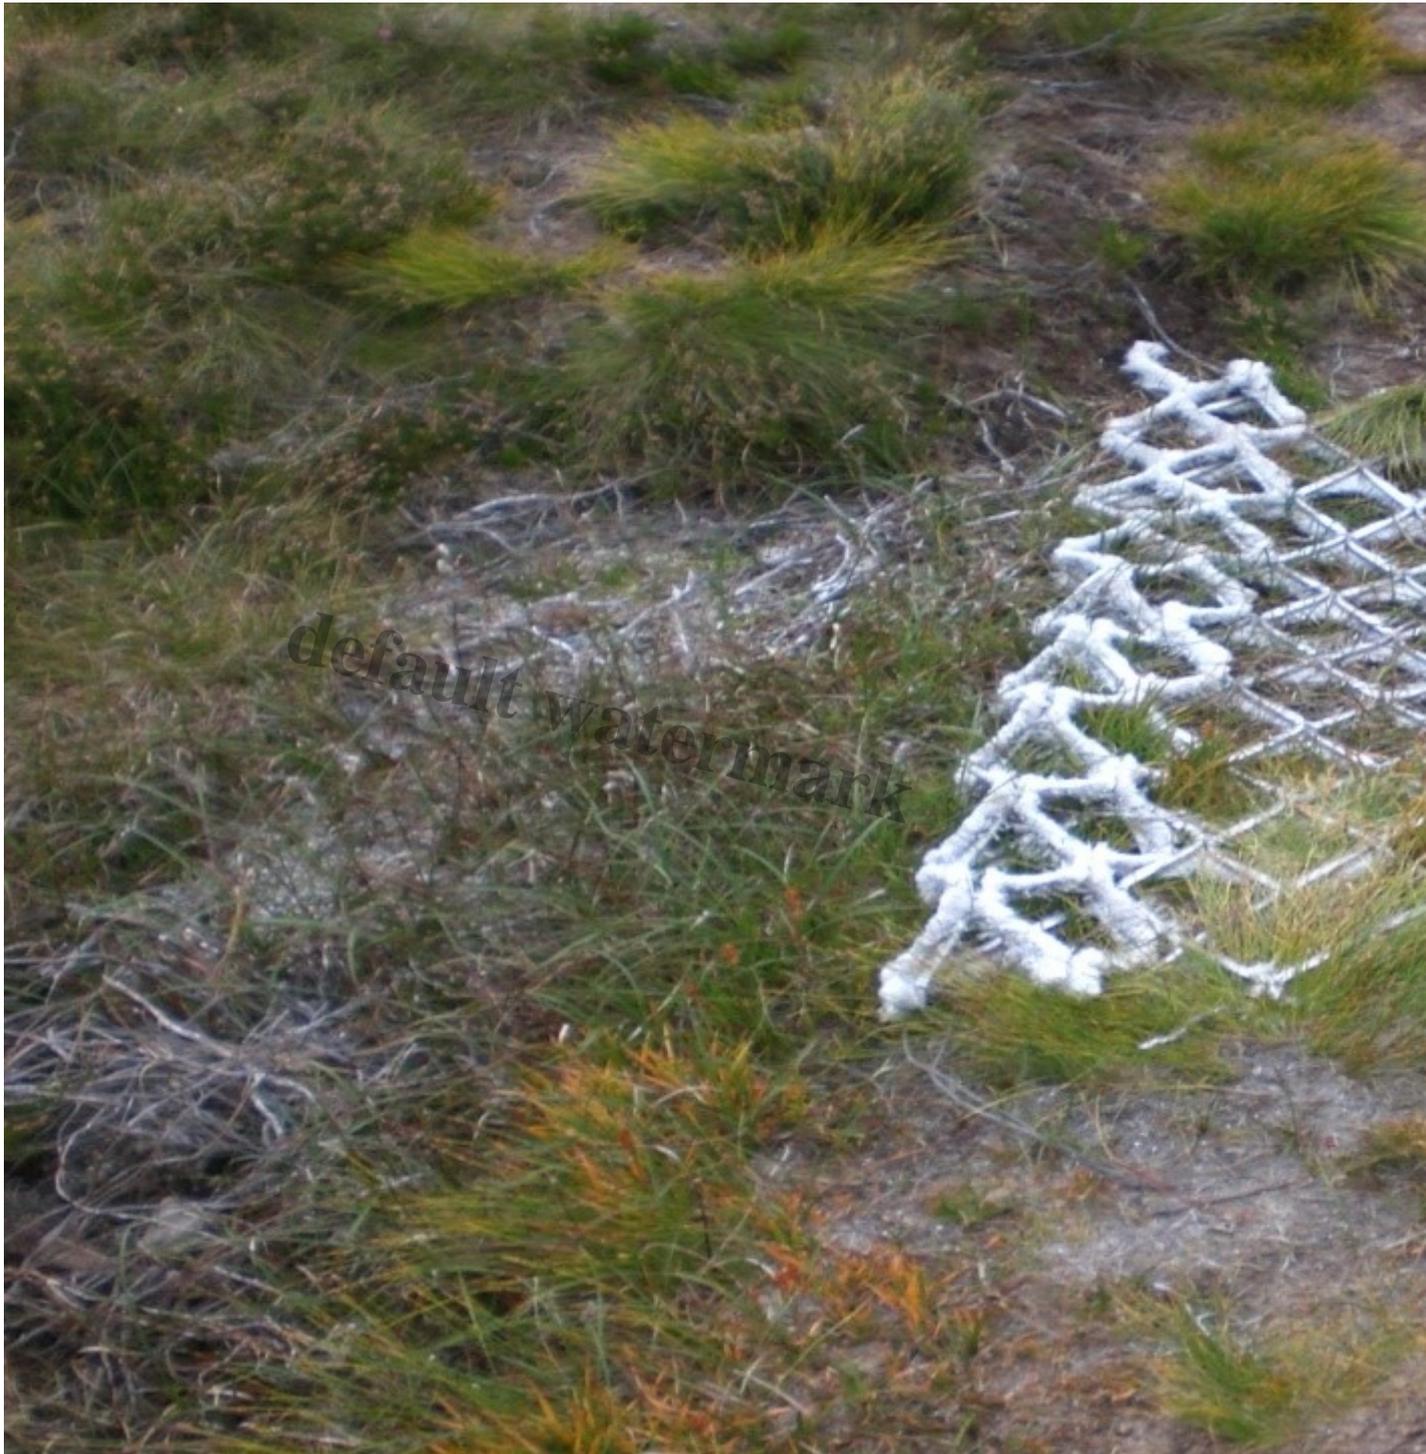
These section of ski matting have been used to bridge wet areas but they are clearly foreign to the area, have no place there and should have been removed.

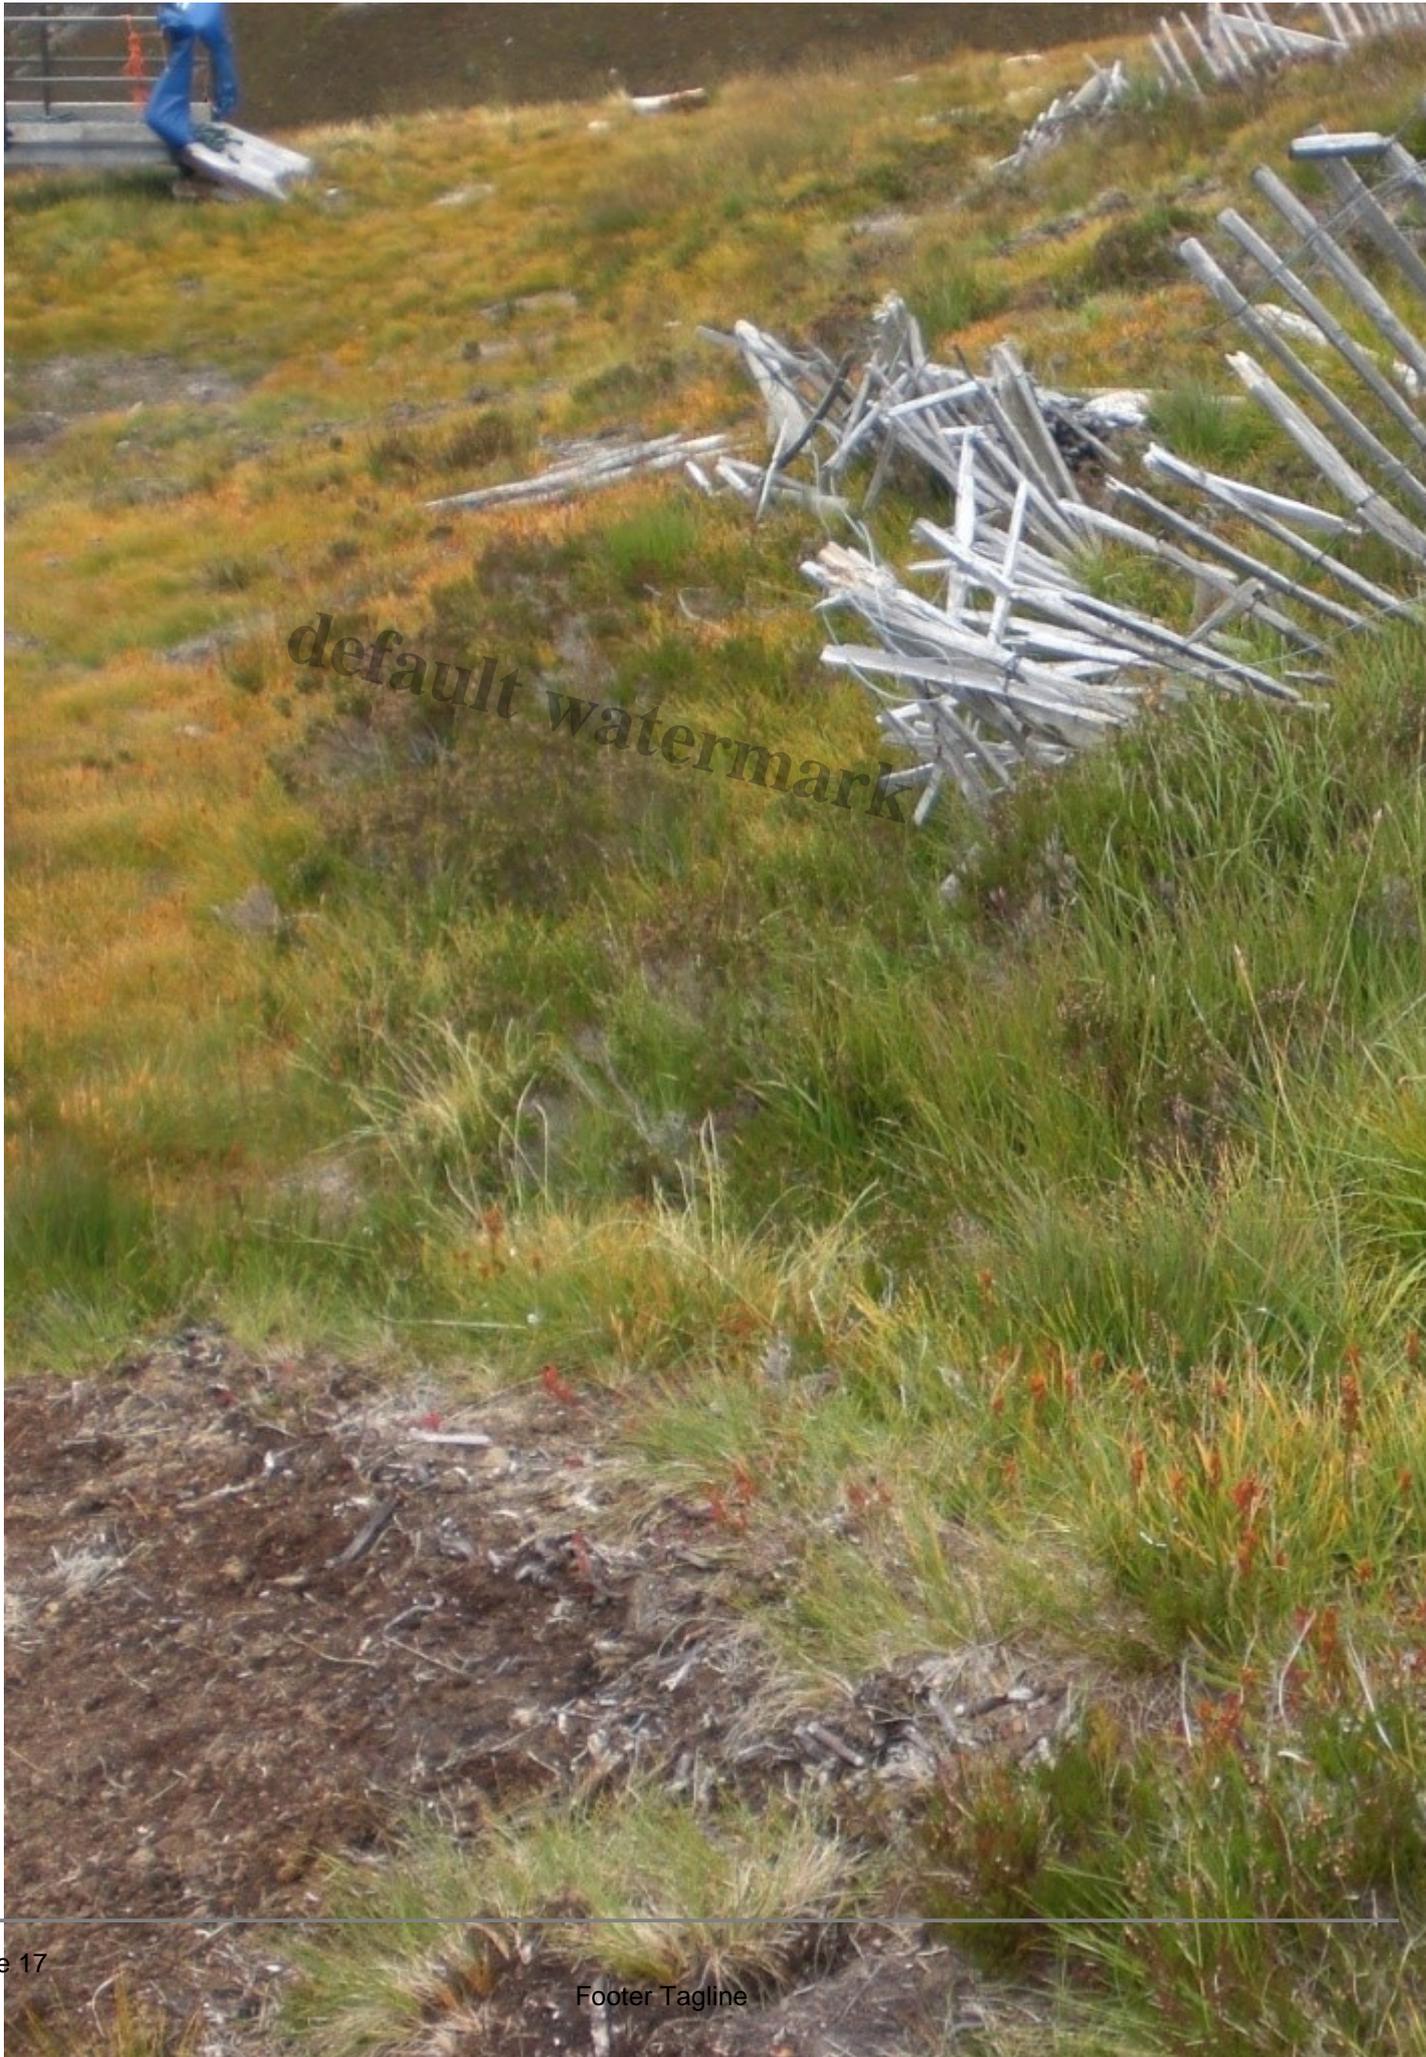
**How about redundant/damaged paling snow fencing?**

The evidence speaks for itself.
