Cairngorm Mountain Clear Up Project

In August of 2017 HIE initiated a clean-up operation on CairnGorm Mountain. A number of environmental groups had campaigned for this action for years and with over 12 months having elapsed since the commencement of the clean-up, it is time now to examine the results and the value for money obtained for the input of 267,000 pounds of public funds

This post will concentrate on examining the work done on the Coire na Ciste Chairlift Lift Line and Aonach Poma loading area.

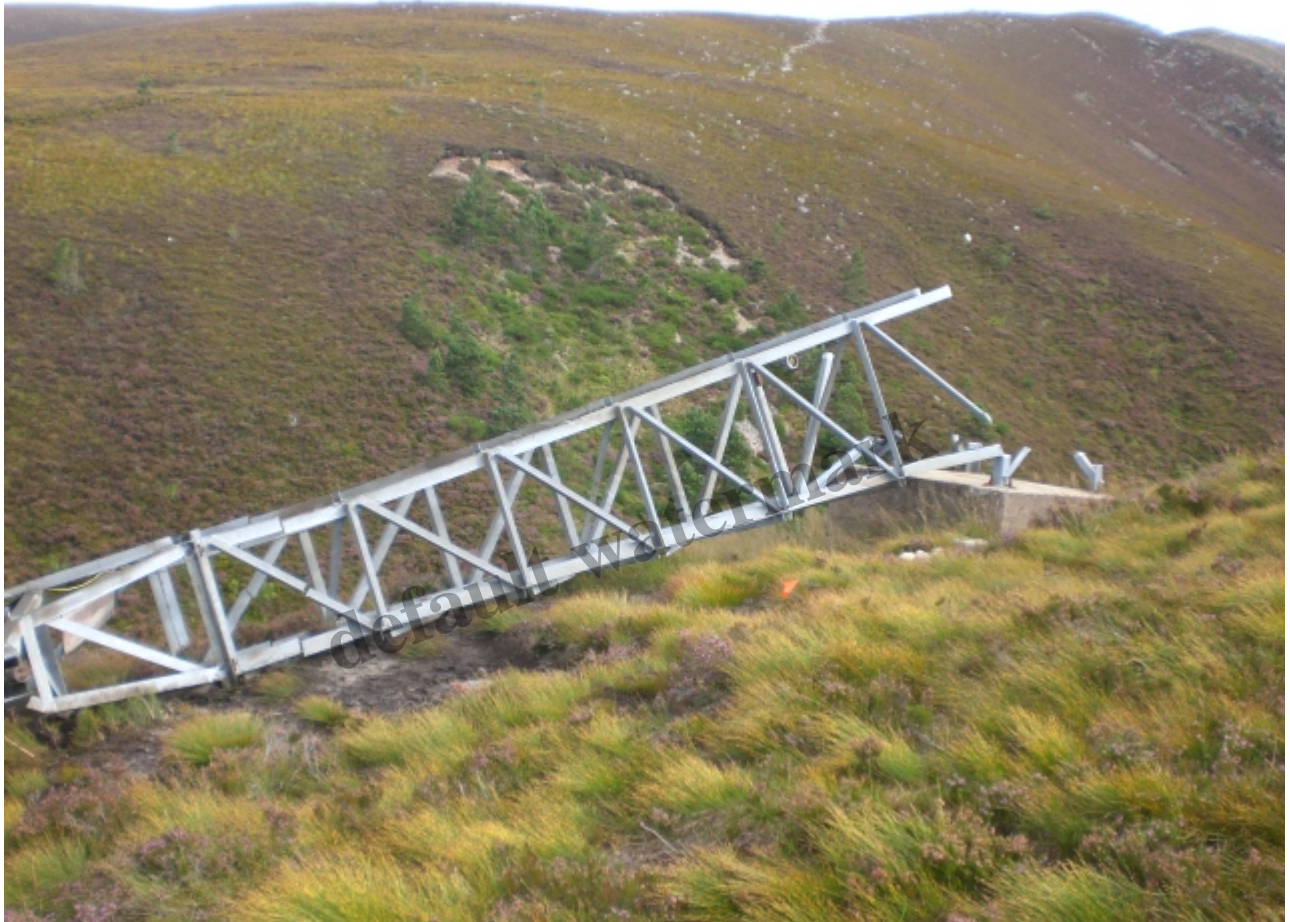
Demolition of lift tower in Coire na Ciste – the cleanup was used as an excuse to destroy potentially re-usable lift infrastructure ([see here](#)).

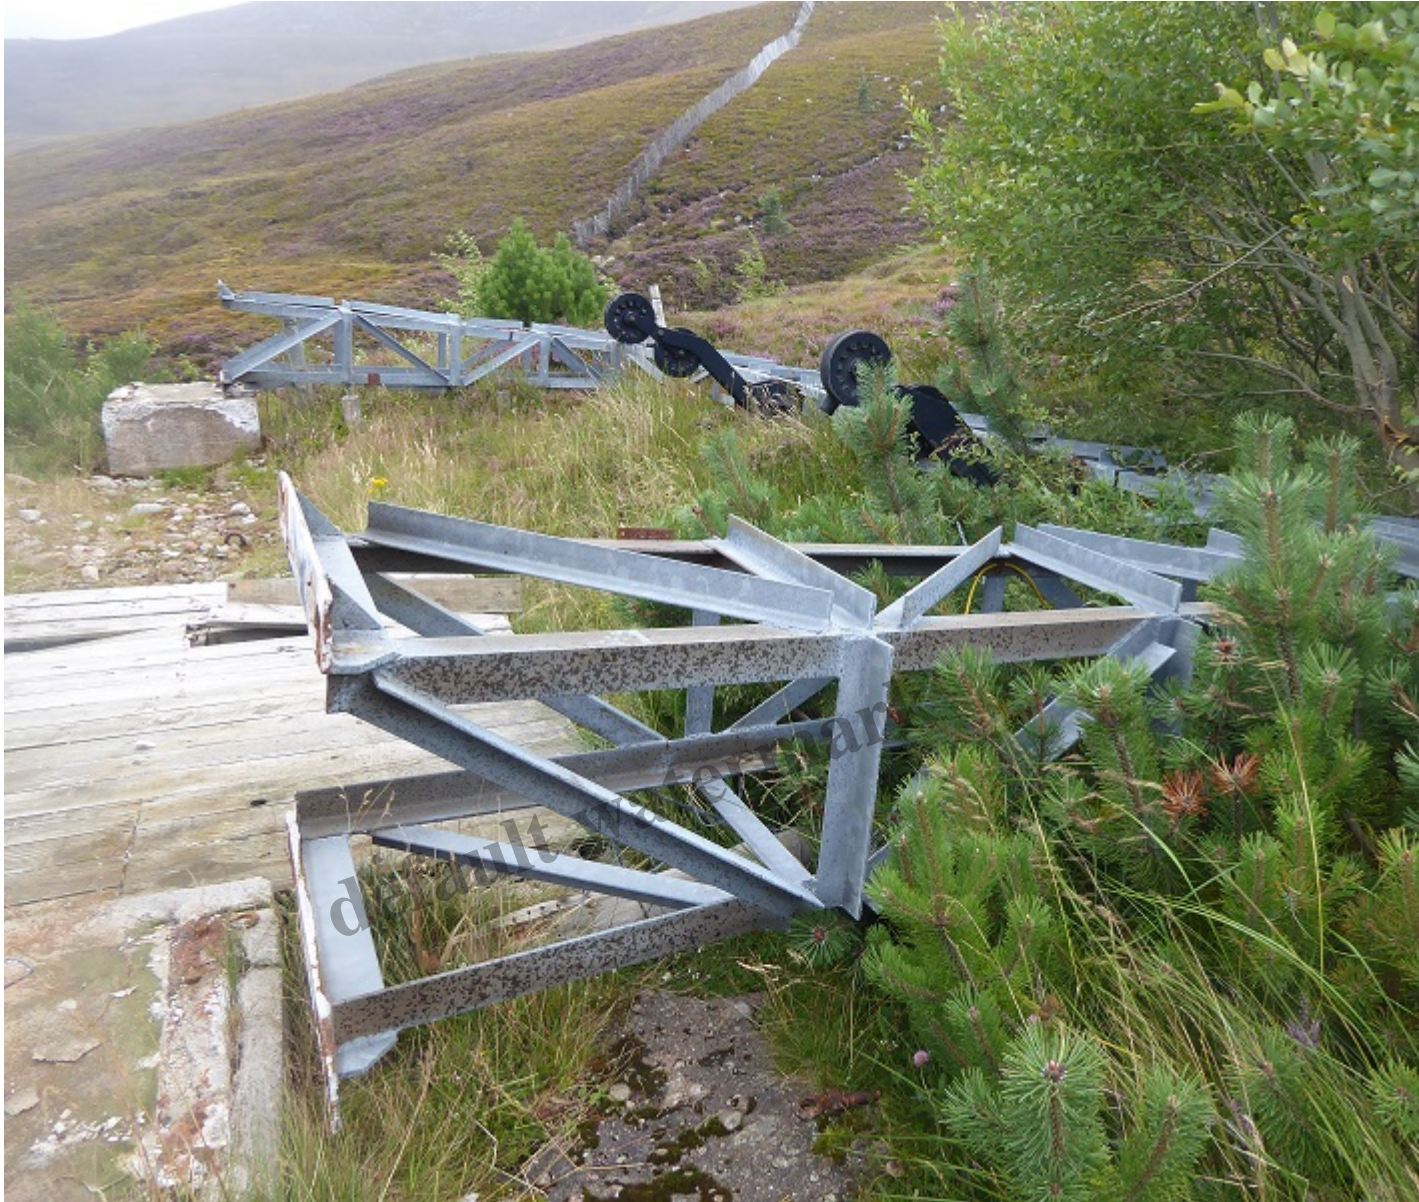
The former lift towers in Coire na Ciste have been completely removed

Steel Structures and Towers: These have been completely removed from the mountain and there is no evidence of anything having been left behind. The Coire na Ciste carpark is a different matter though and there are many many pieces of splintered wood and metal shards that await the tyres of unsuspecting vehicle owners.

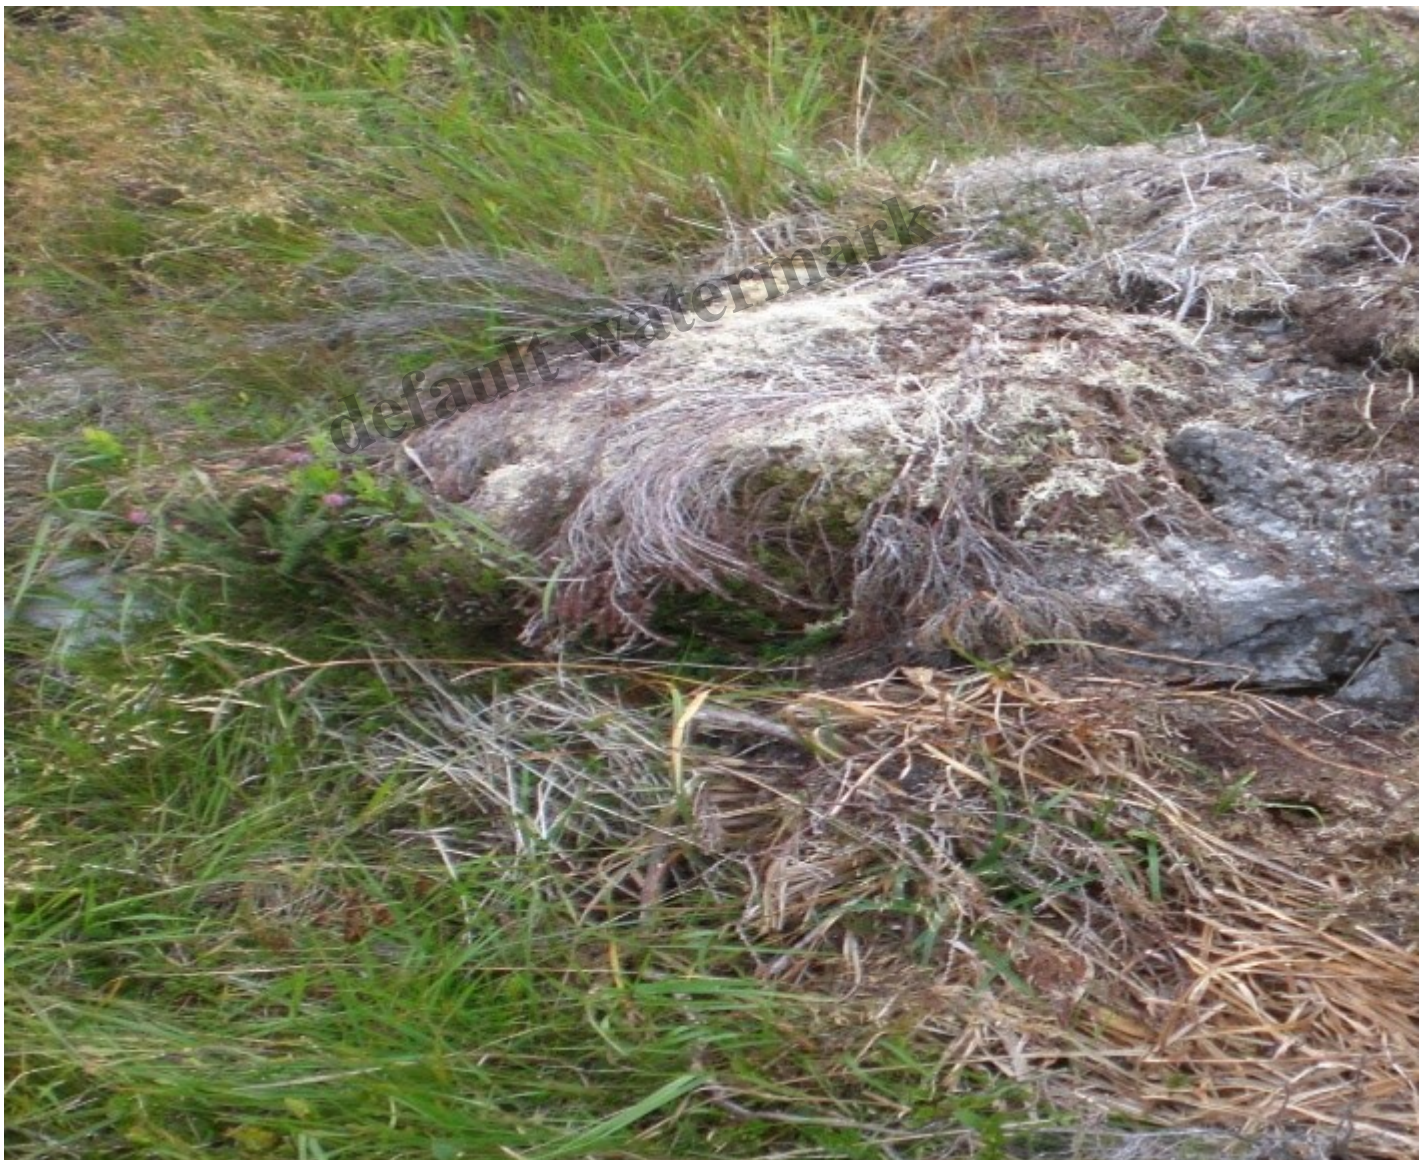
There is multiple evidence that this has not been satisfactorily done. Concrete has not been broken out to 200mm below surface and several of the old tower foundations are clearly identified as mounds that are significantly higher than the surrounding ground. Exposed concrete can be seen and there are steel shards and wood that remain at the site of the Aonach Poma loading area.

Exposed concrete which has not been broken out to 200mm below surface. Photo Credit Alan Bratt

“It is proposed that all concrete structures will be broken out to approximately 200mm below surface and following the profile of the terrain. Reinstatement will include using soil, turfs boulders, gravel and heather materials from surrounding areas and re-landscaping as in the surrounding areas”

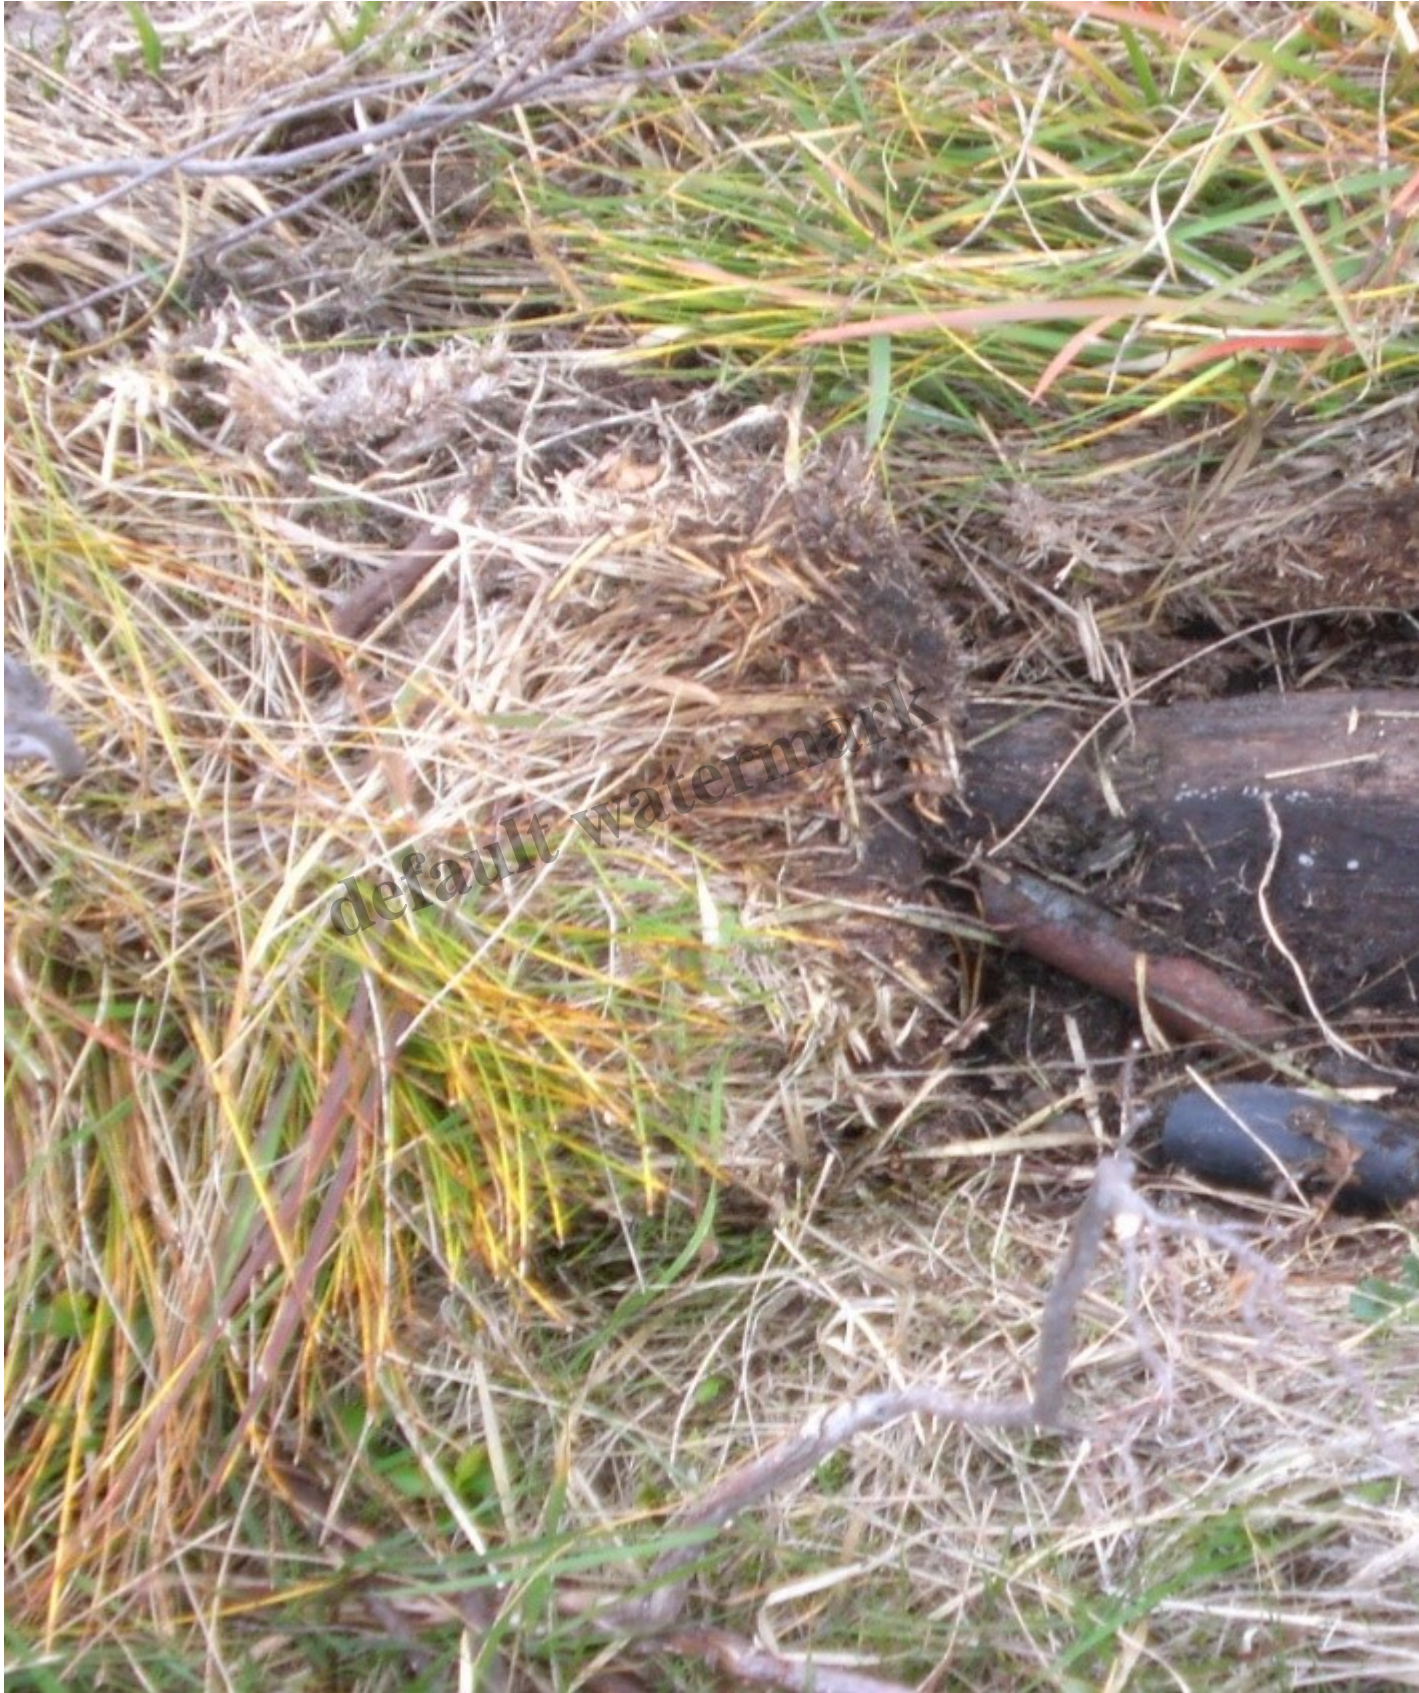
It's very clear that there are tower foundations that remain higher than the surrounding ground.

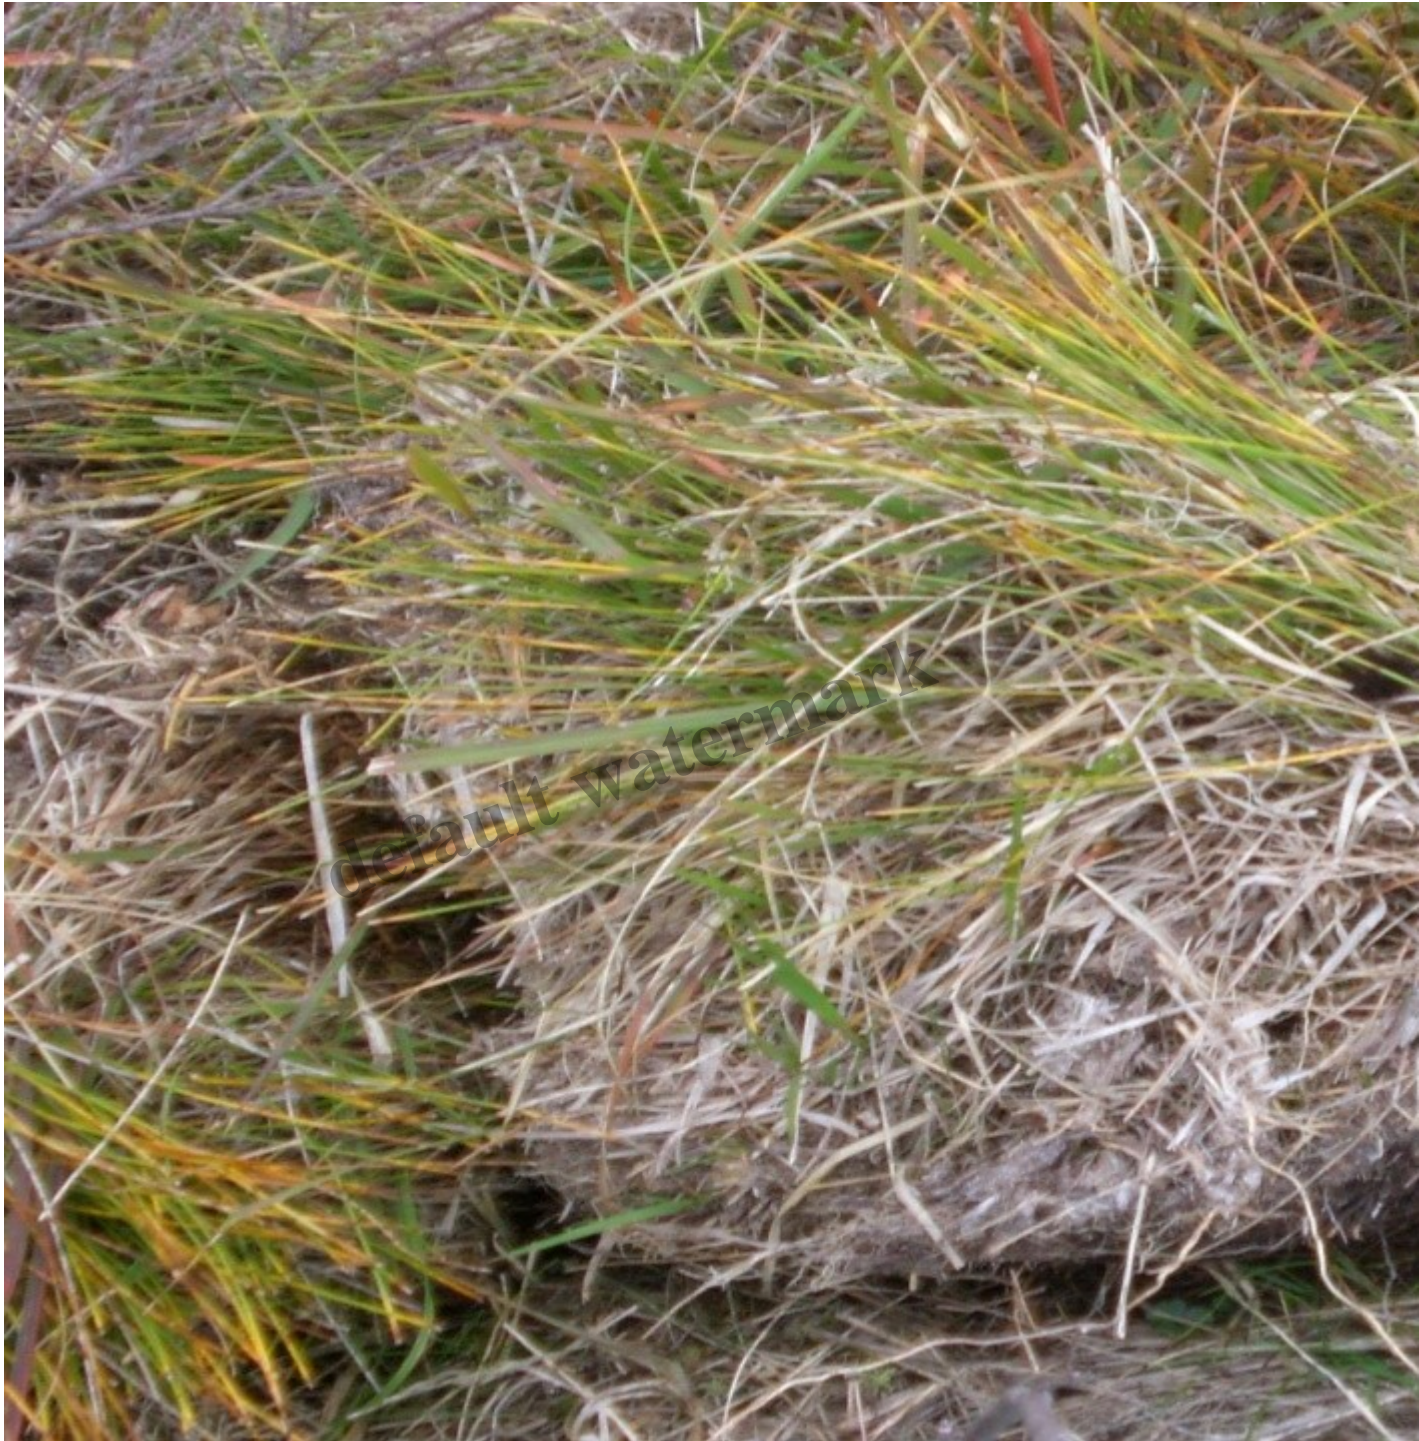
Steel Shard, wood and cable not removed just buried. Someone had clearly been there making checks

before us. They had removed turves to see underneath but we kindly replaced them

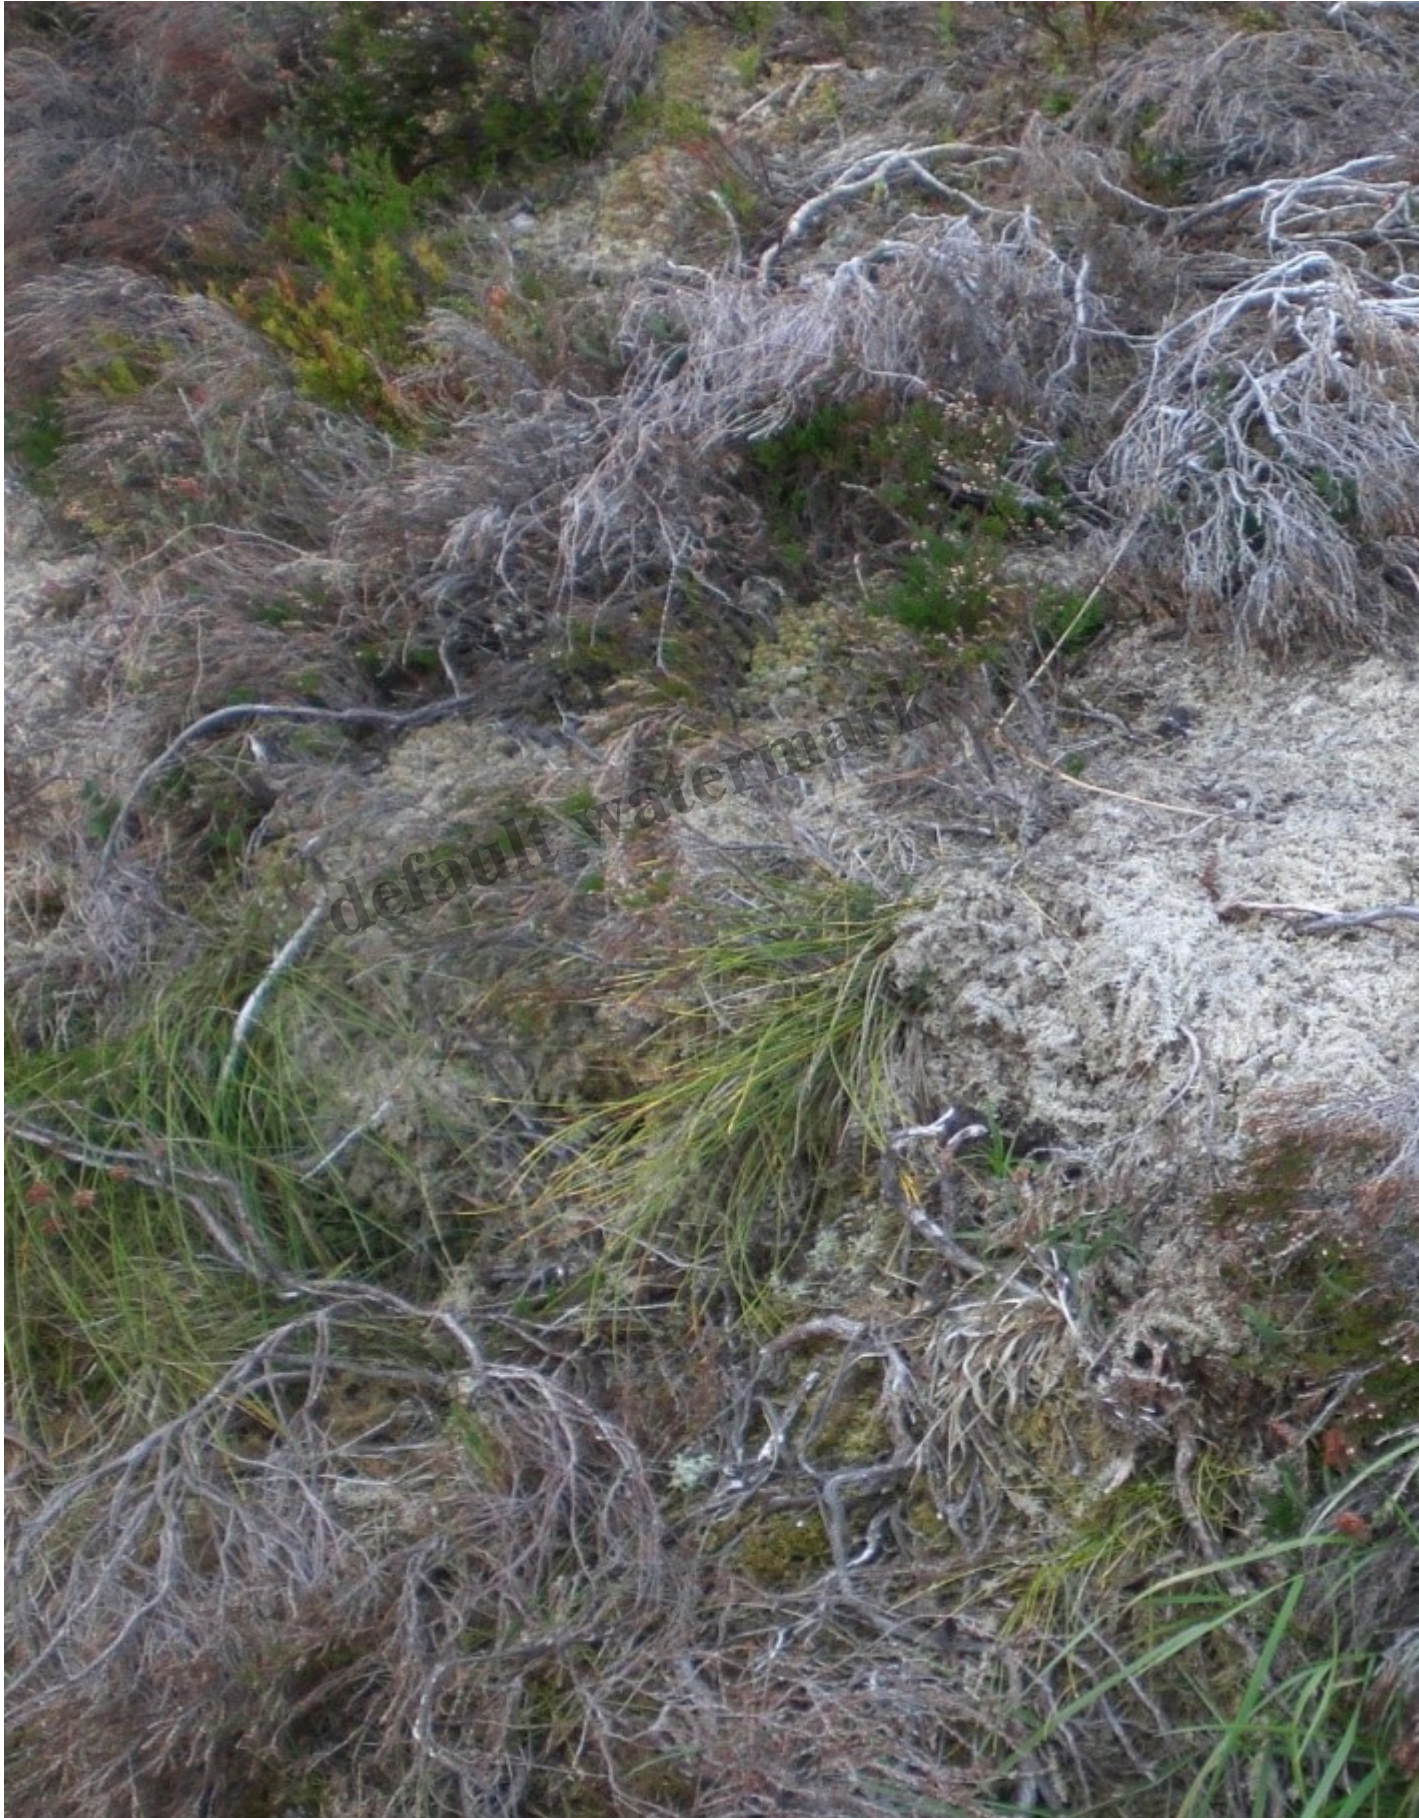
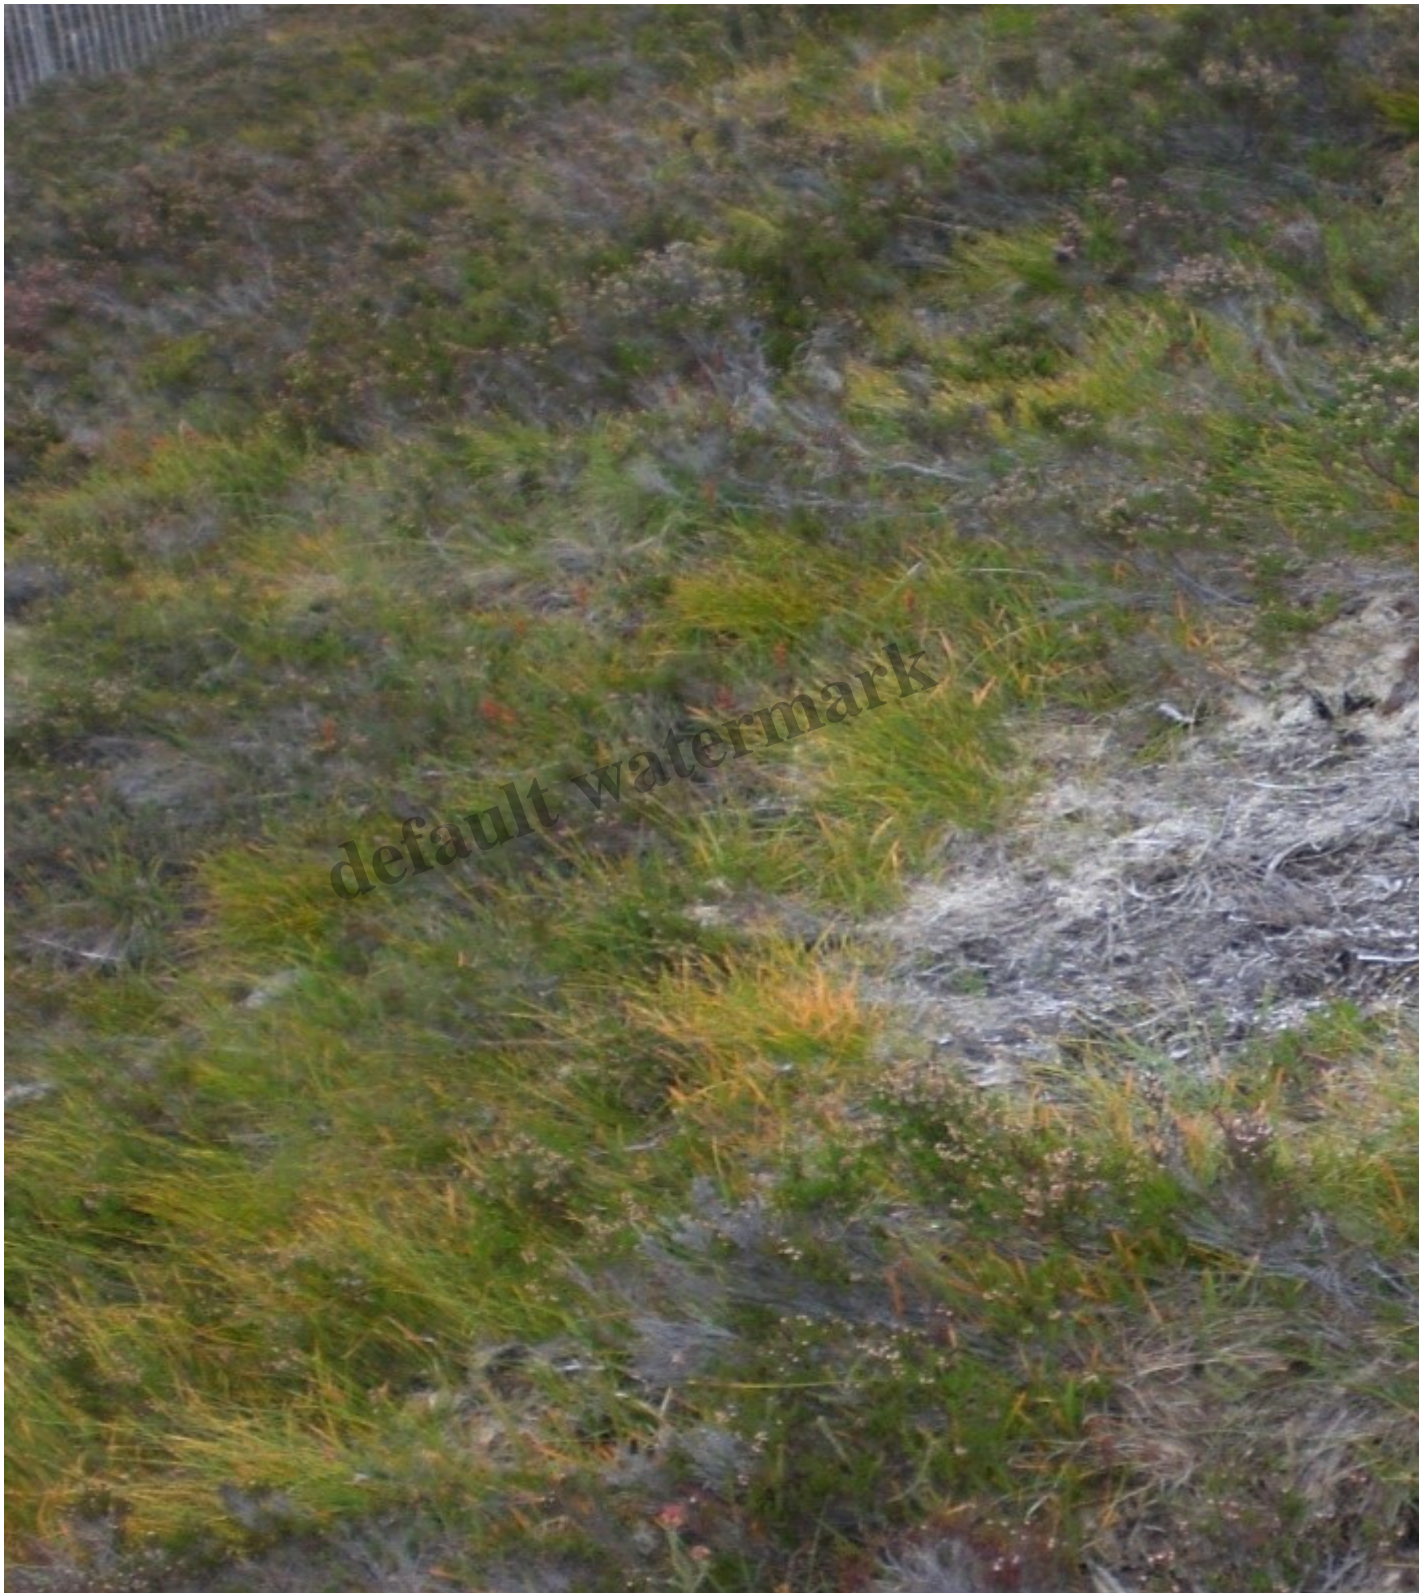
Ripped out turves and no reinstatement work done

The quality of the job is of an unacceptable standard with concrete not ground out and with vegetation simply dumped on top to cover up the remains of the concrete foundations. The dumped vegetation

has died because it has nothing to root into and the areas from where it was ripped out have had zero reinstatement work done.

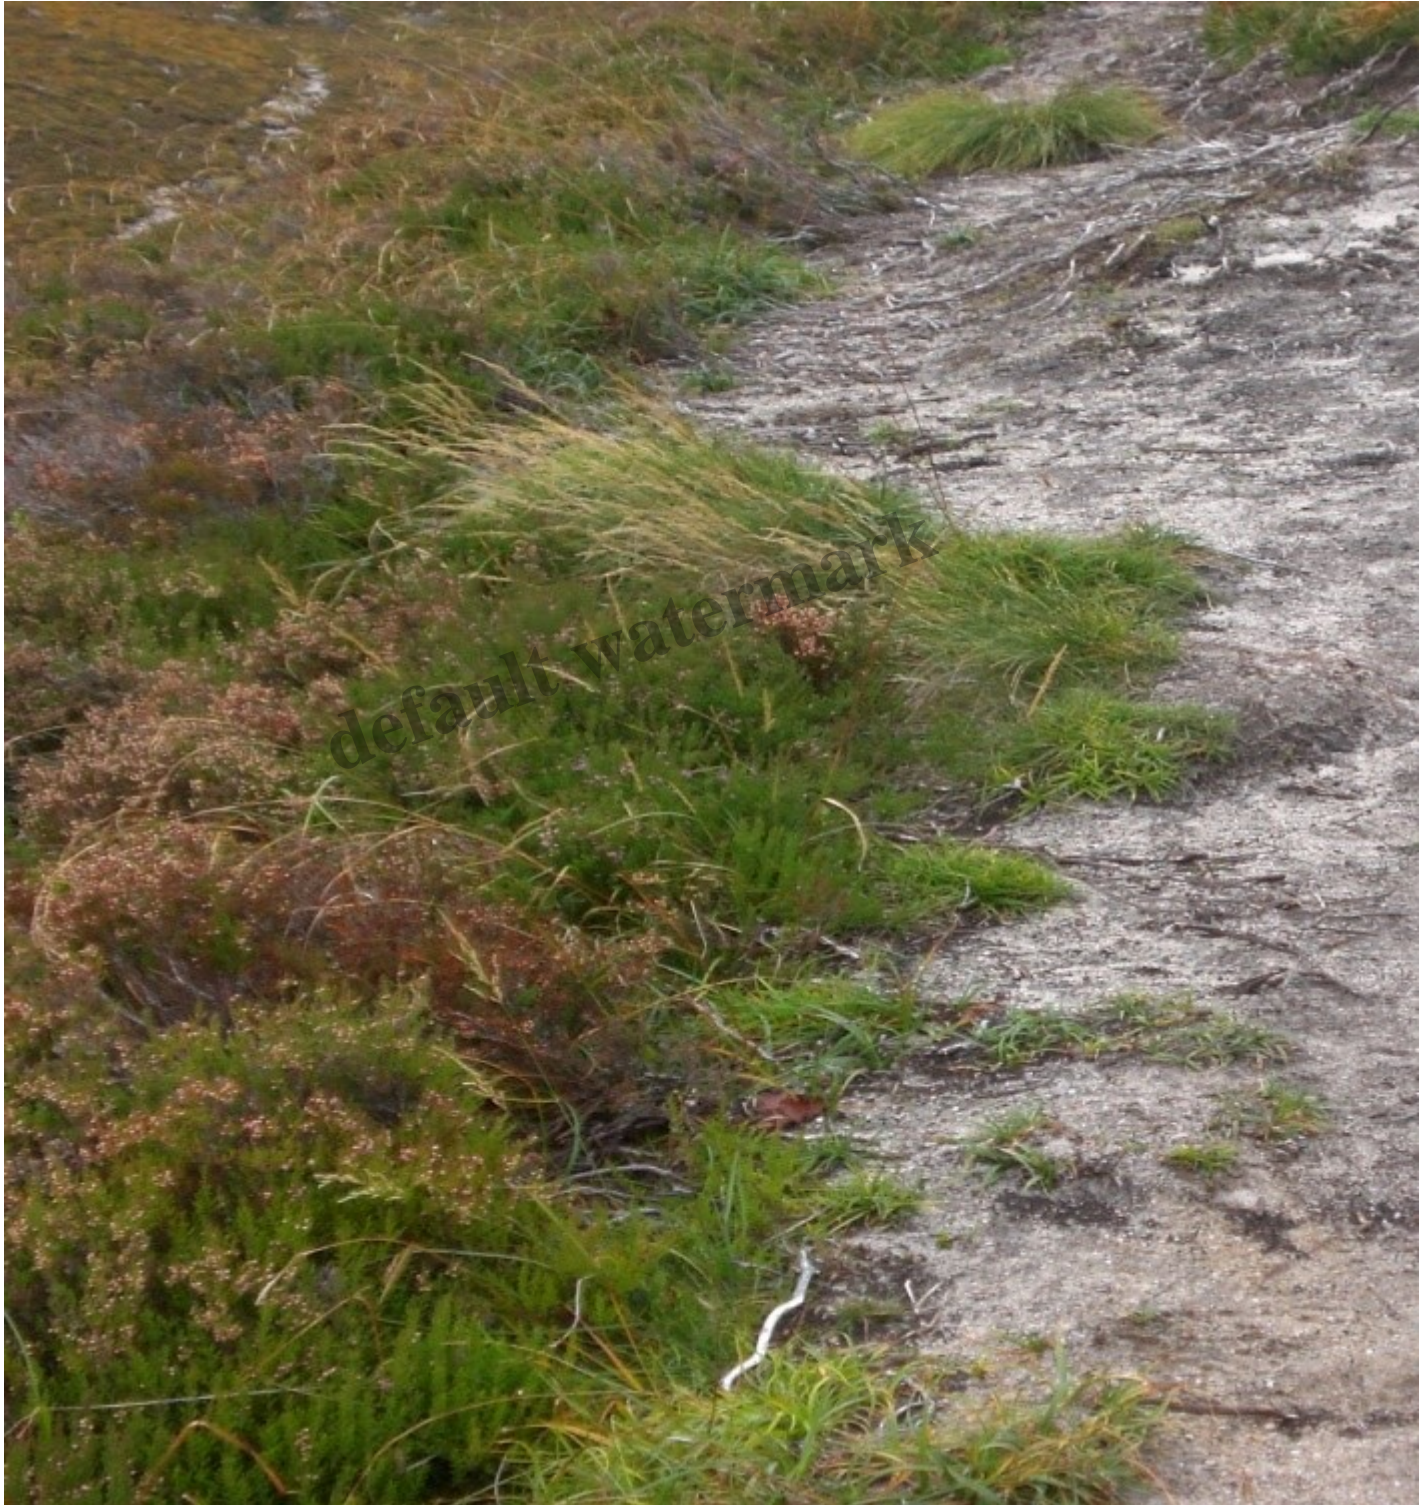
There are multiple points where cabling is on the surface and others where sandbags have been used to cover the exposed cable.

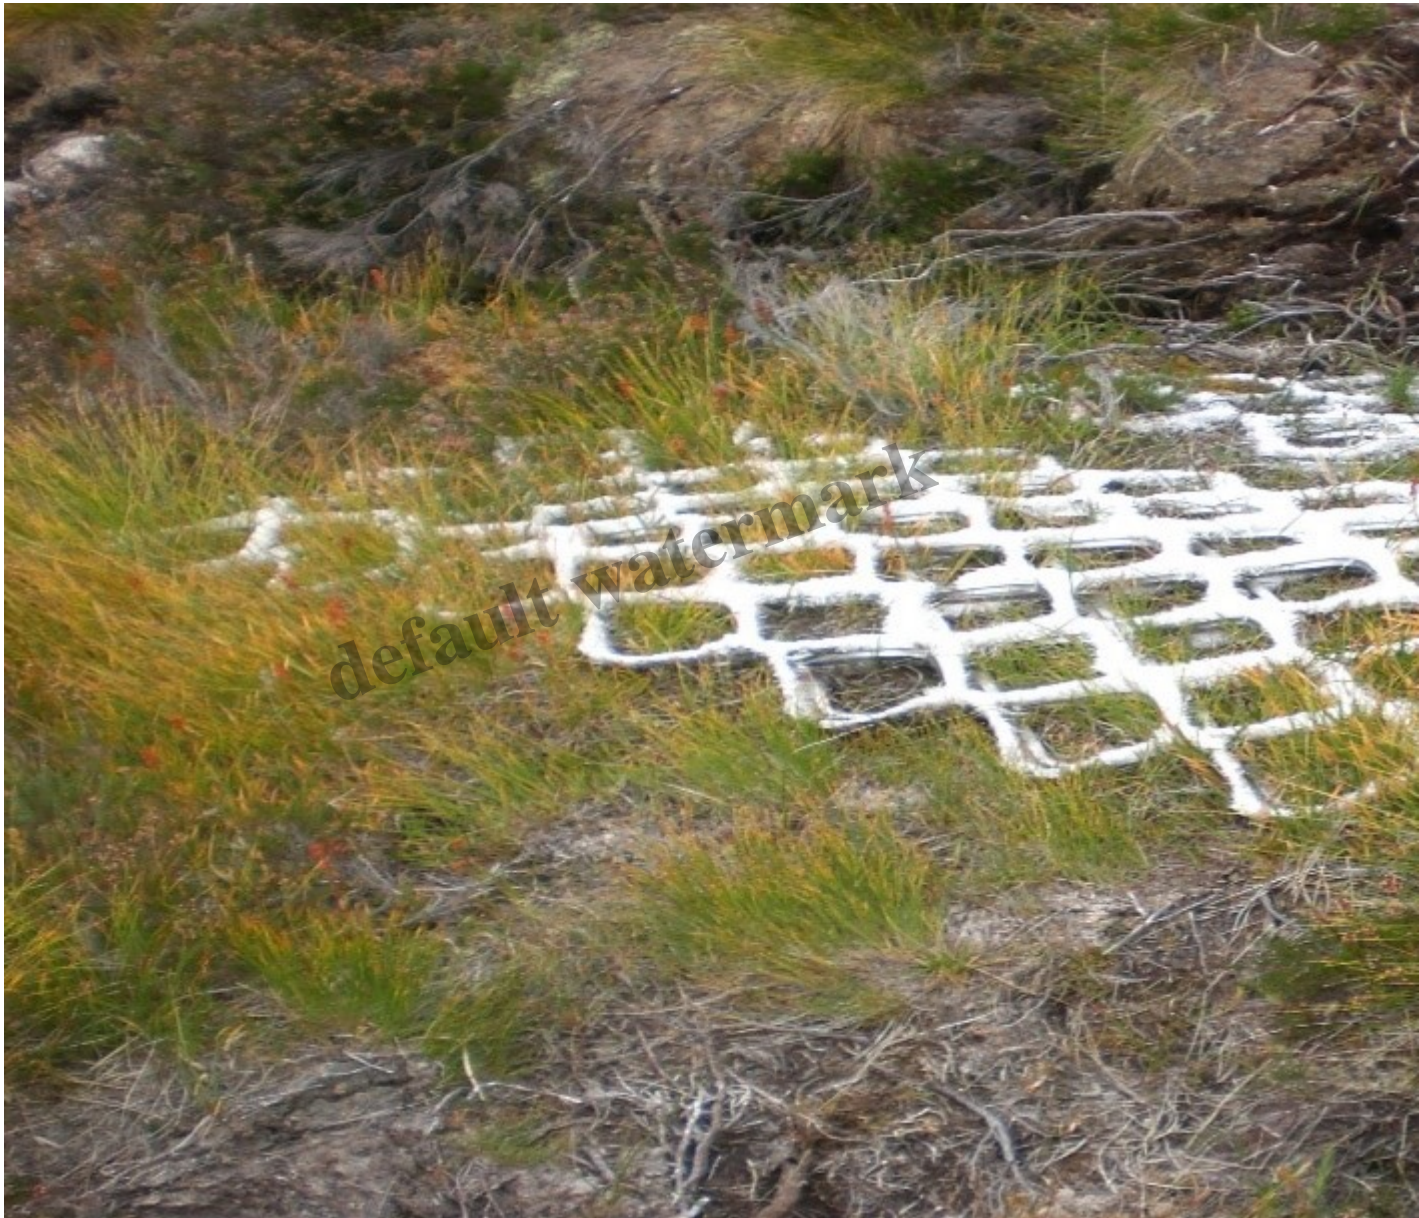
These section of ski matting have been used to bridge wet areas but they are clearly foreign to the area, have no place there and should have been removed.

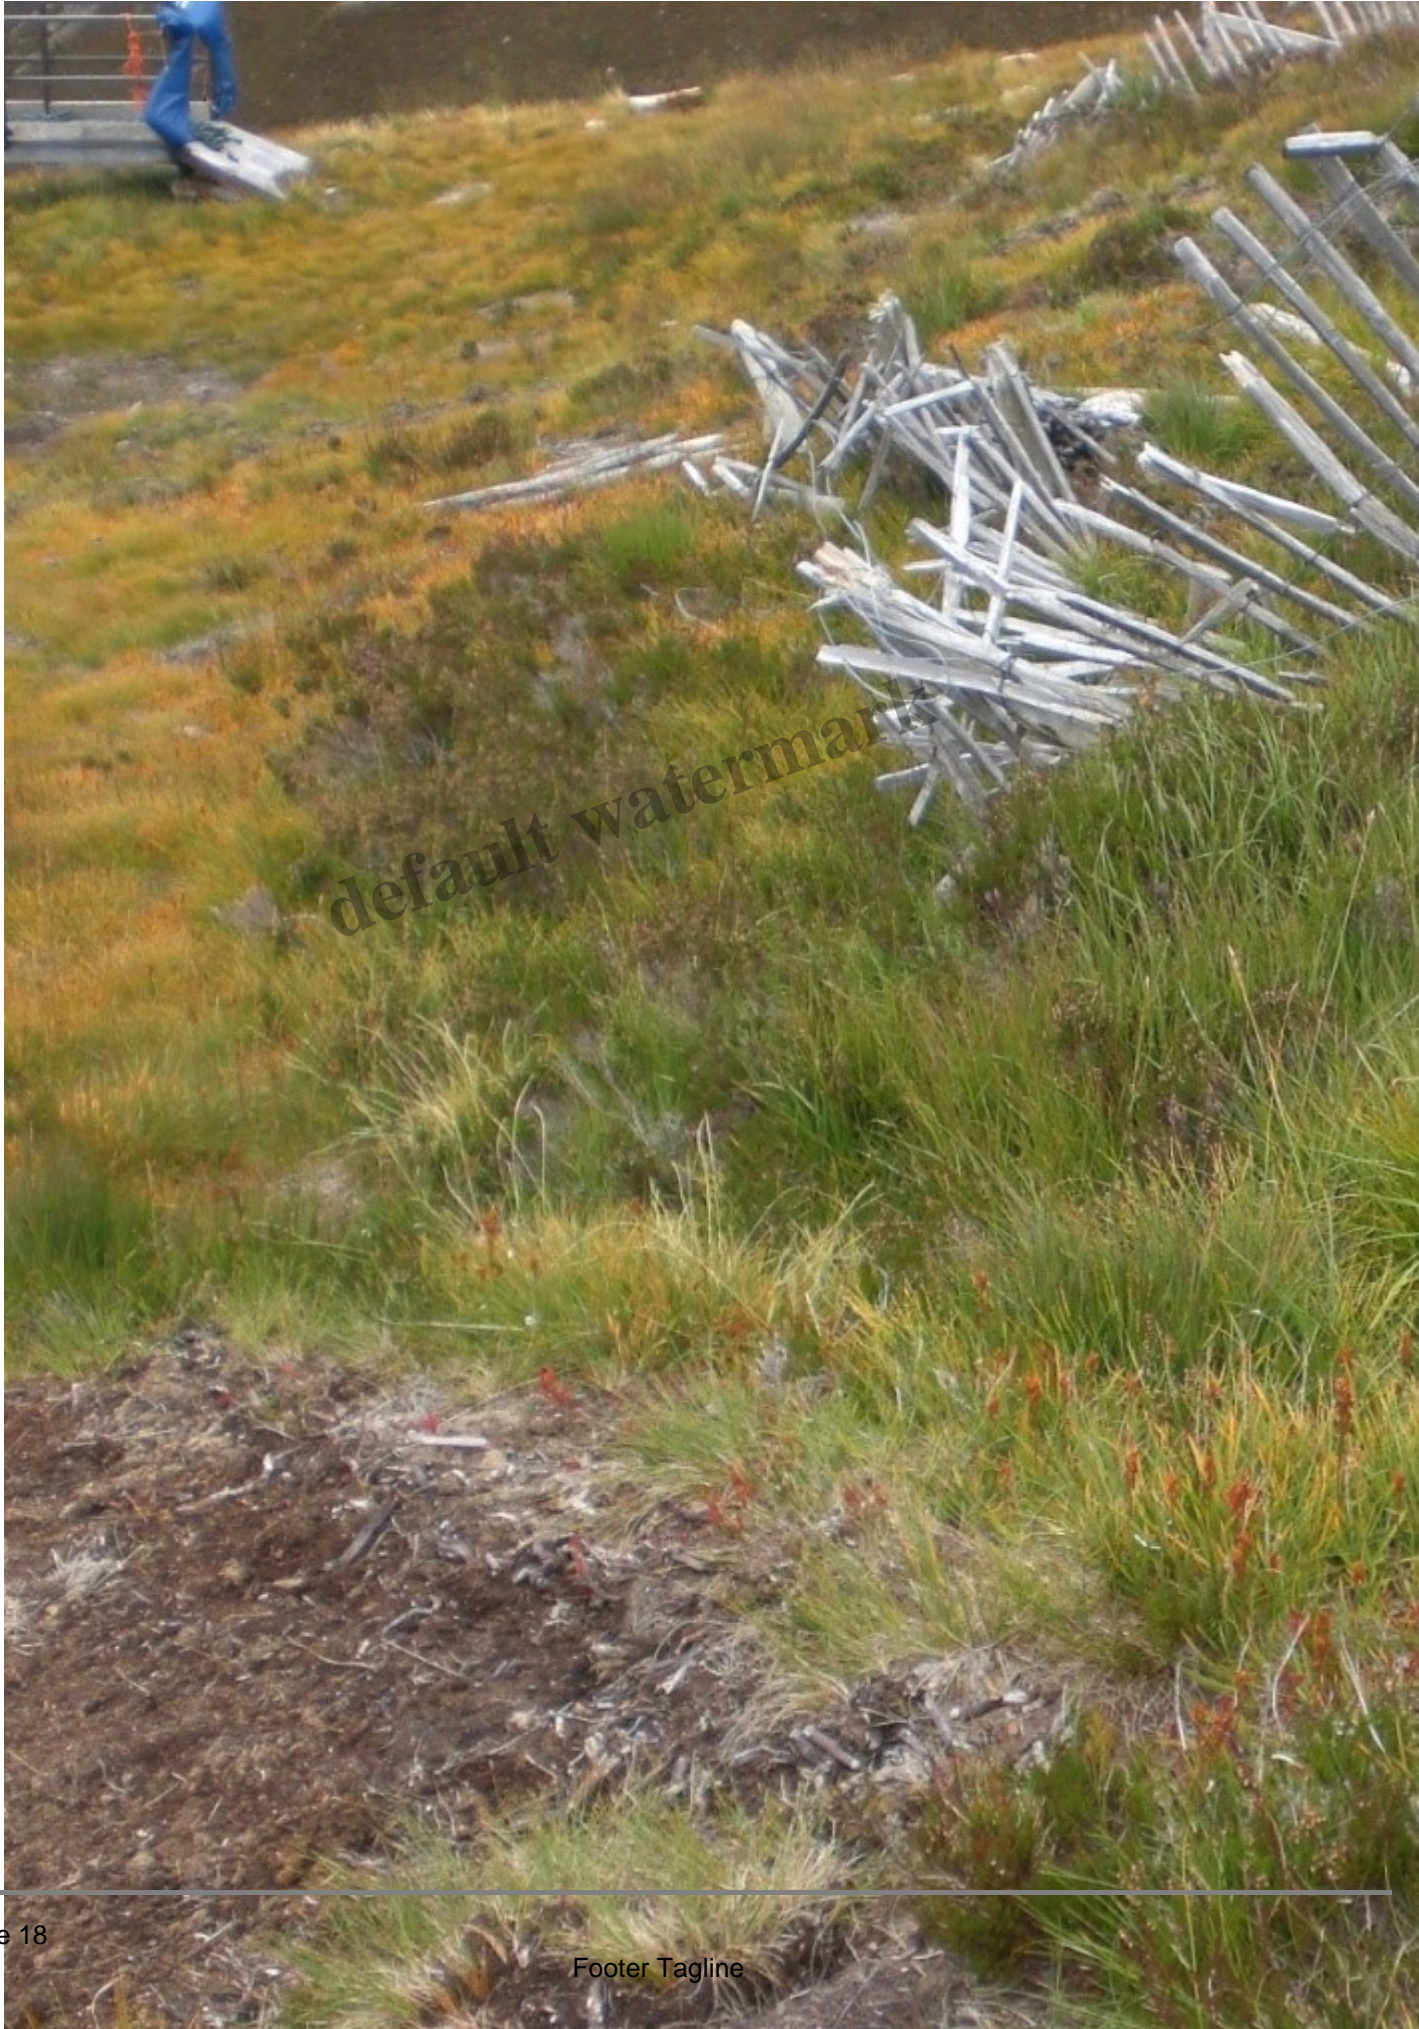
How about redundant/damaged paling snow fencing?

The evidence speaks for itself.
